# RESEARCH MEMORANDUM

ALTITUDE-WIND-TUNNEL INVESTIGATION OF A 4000-POUND-THRUST

AXIAL-FLOW TURBOJET ENGINE

II - OPERATIONAL CHARACTERISTICS

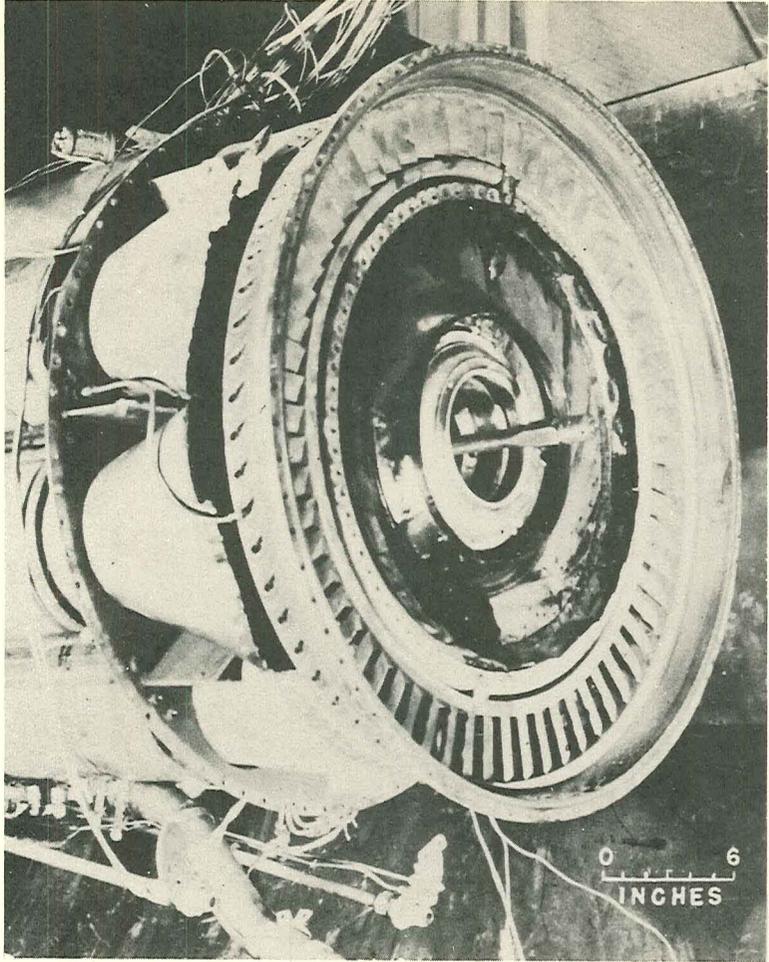
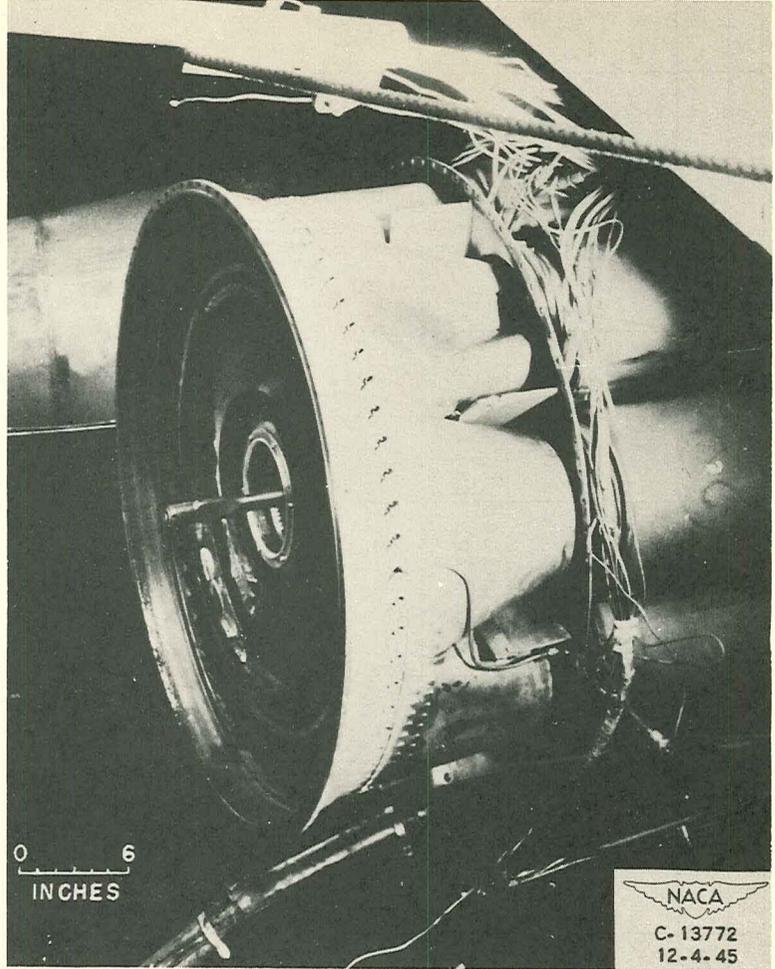
After the change from type B to type C combustion chamber (configuration 9), full speed could be reached at a pressure altitude of 30,000 feet and an indicated airspeed of 400 miles per hour. The only attempt to accelerate the engine to full speed with configuration 9 was made at this altitude; when the engine speed reached 7600 rpm, the tail-pipe temperature suddenly increased and reached a peak of  $1650^{\circ}$  F before the engine speed could be reduced. At 6200 rpm, the tail-pipe temperatures varied from  $1250^{\circ}$  to  $1300^{\circ}$  F. An immediate inspection of the engine revealed that several of the transition sections between the rear of the combustion chambers and the turbine nozzles had failed and choked off part of the area. (See fig. 8.) These transition sections were changed several times because they were continually collapsing and breaking off. After several failures they were tack-welded to the turbine nozzle and this procedure kept them intact for the rest of the runs. An inspection later disclosed that the transition sections installed while the compressor was being changed were slightly larger than the original ones and had no clearance between them for expansion.

(a) Sections broken away.

(b) Section collapsed.

Figure 8. - Transition sections broken away from turbine nozzle and collapsed after operating engine 36 minutes with configuration 9.

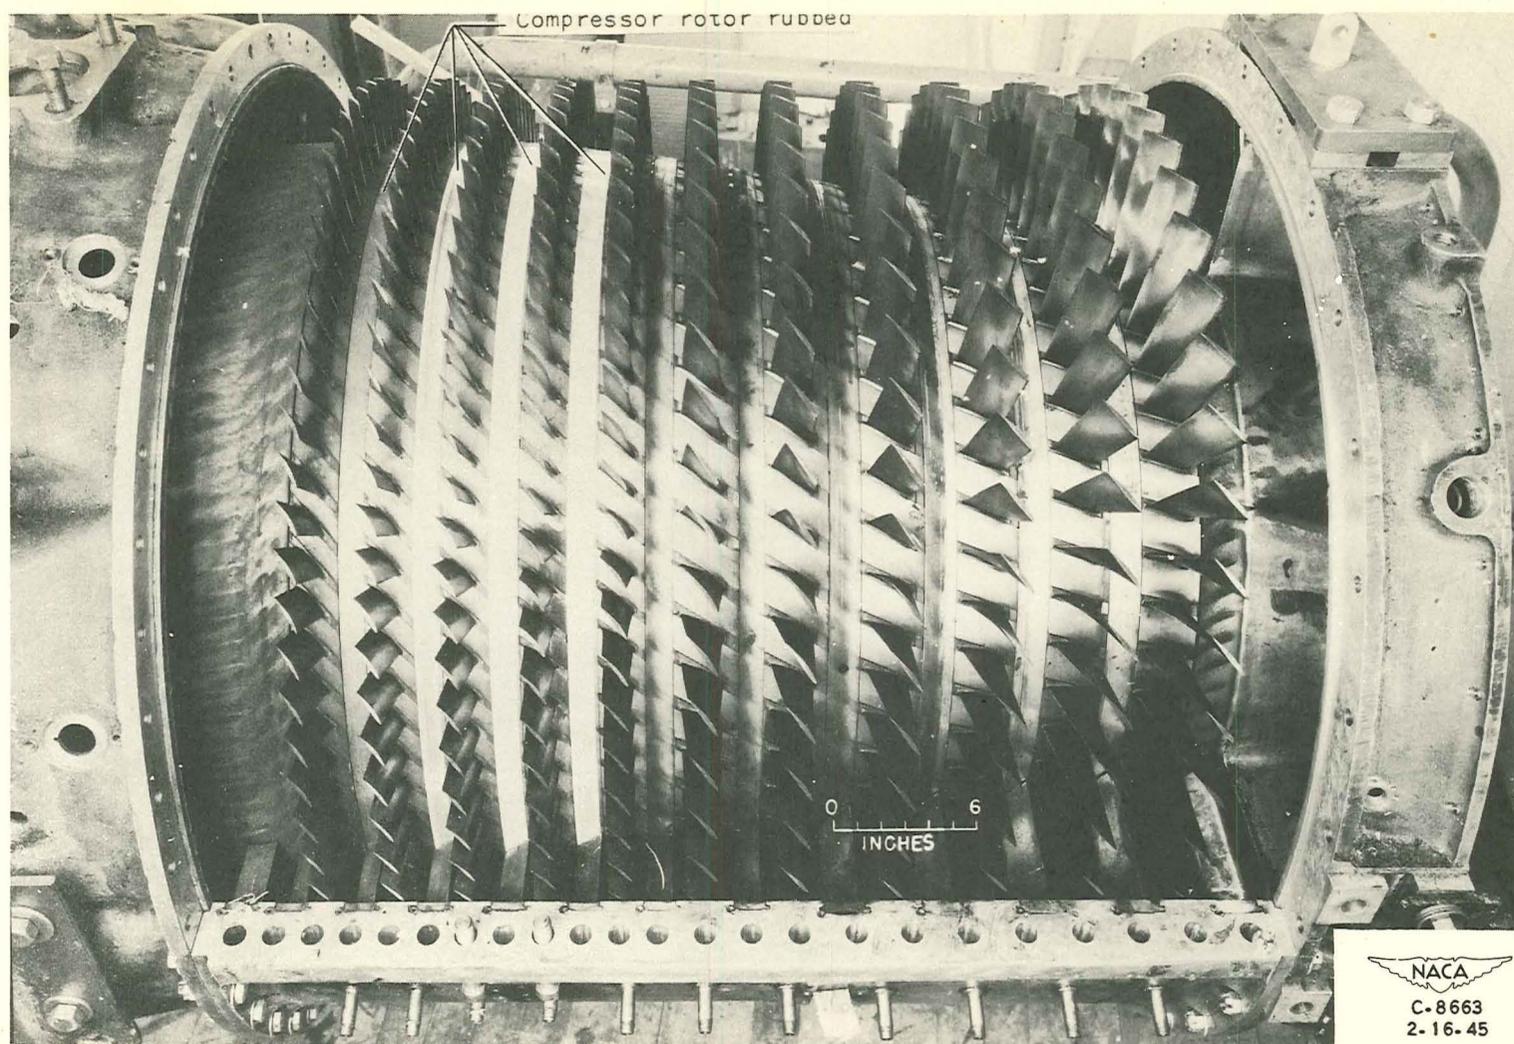
After 54 hours of testing with the low-flow compressor, the mid bearing, which is located at the rear of the compressor, failed. The engine had been operating for several minutes at a pressure altitude of 50,000 feet and engine speeds near 7000 rpm with the mid-bearing temperatures ranging from 275° to 335° F. The engine speed was increased and was being stabilized at 7450 rpm when the mid-bearing temperature reached 340° F and continued to rise rapidly. The fuel was shut off as quickly as possible, but the mid-bearing temperature immediately reached 392° F and soon rose to a maximum of 410° F. The temperature of the rear bearing just ahead of the turbine wheel reached a maximum of 360° F soon after operation of the engine was discontinued. The high temperature of the rear bearing was probably caused by heat transfer from the turbine wheel, which was still hot. While the engine was windmilling immediately after the fuel had been shut off, the amplitude of vibration of the engine indicated on the vibration meter greatly exceeded the allowable limit of 0.005 inch for normal operation.

An inspection of the mid bearing after the engine was disassembled revealed that all the plastic cages that held the balls in place had been ground into small pieces. Operation of the bearing at high temperatures had probably weakened the plastic cages and one of them failed, which enabled the balls to move about and crush the remaining cages. The tips of the rotor and stator blades on the rear stages of the compressor had rubbed after the mid bearing failed. Views of the compressor rotor and case after the blades rubbed are shown in figures 19 and 20.

Figure 19. - View of the compressor rotor after the mid-bearing failure showing the area where the stator blades rubbed the rotor.

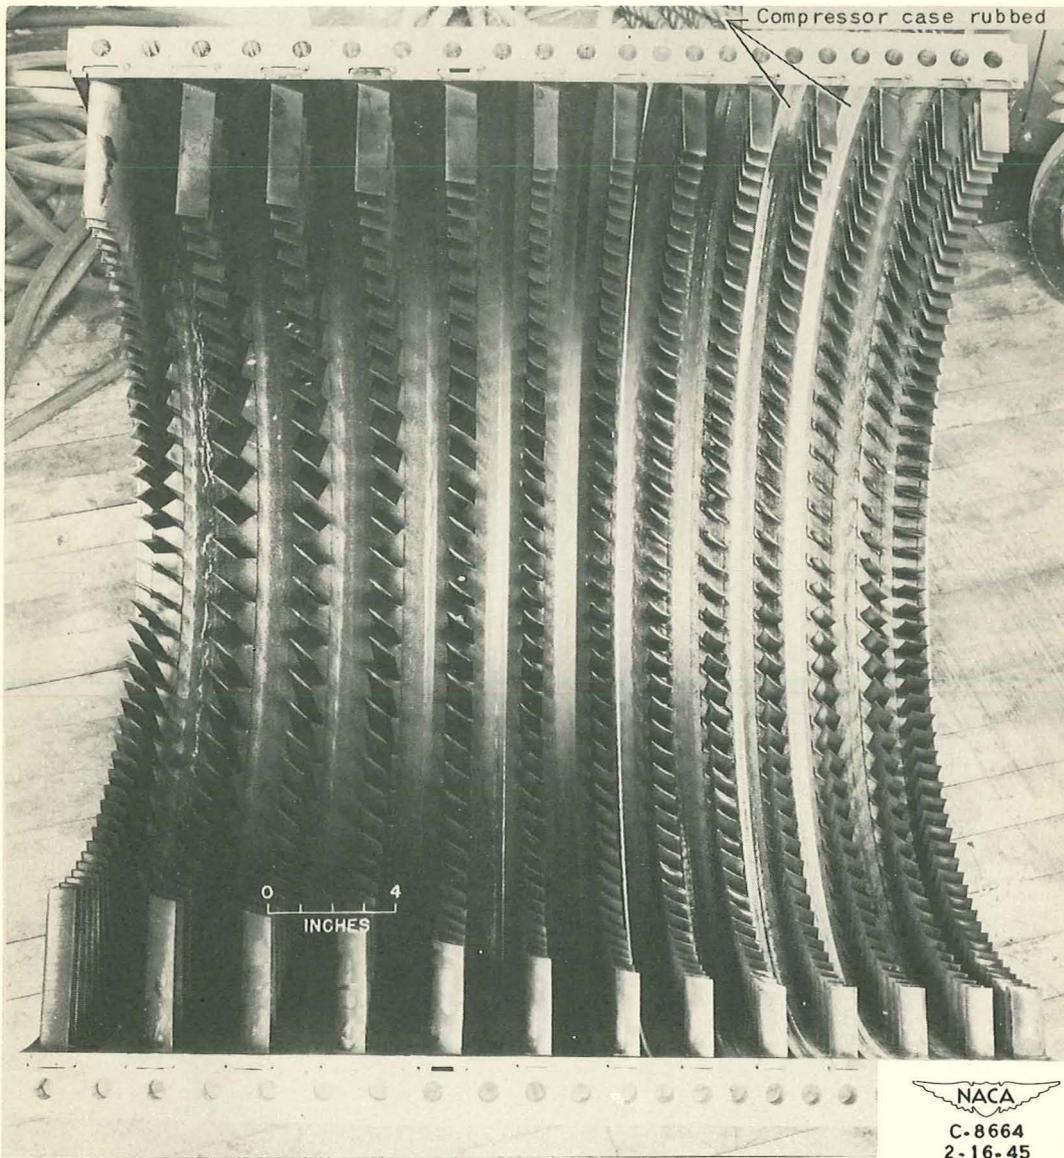
Figure 20. - View of the compressor case after the mid-bearing failure showing the areas where the rotor blades rubbed the casing.

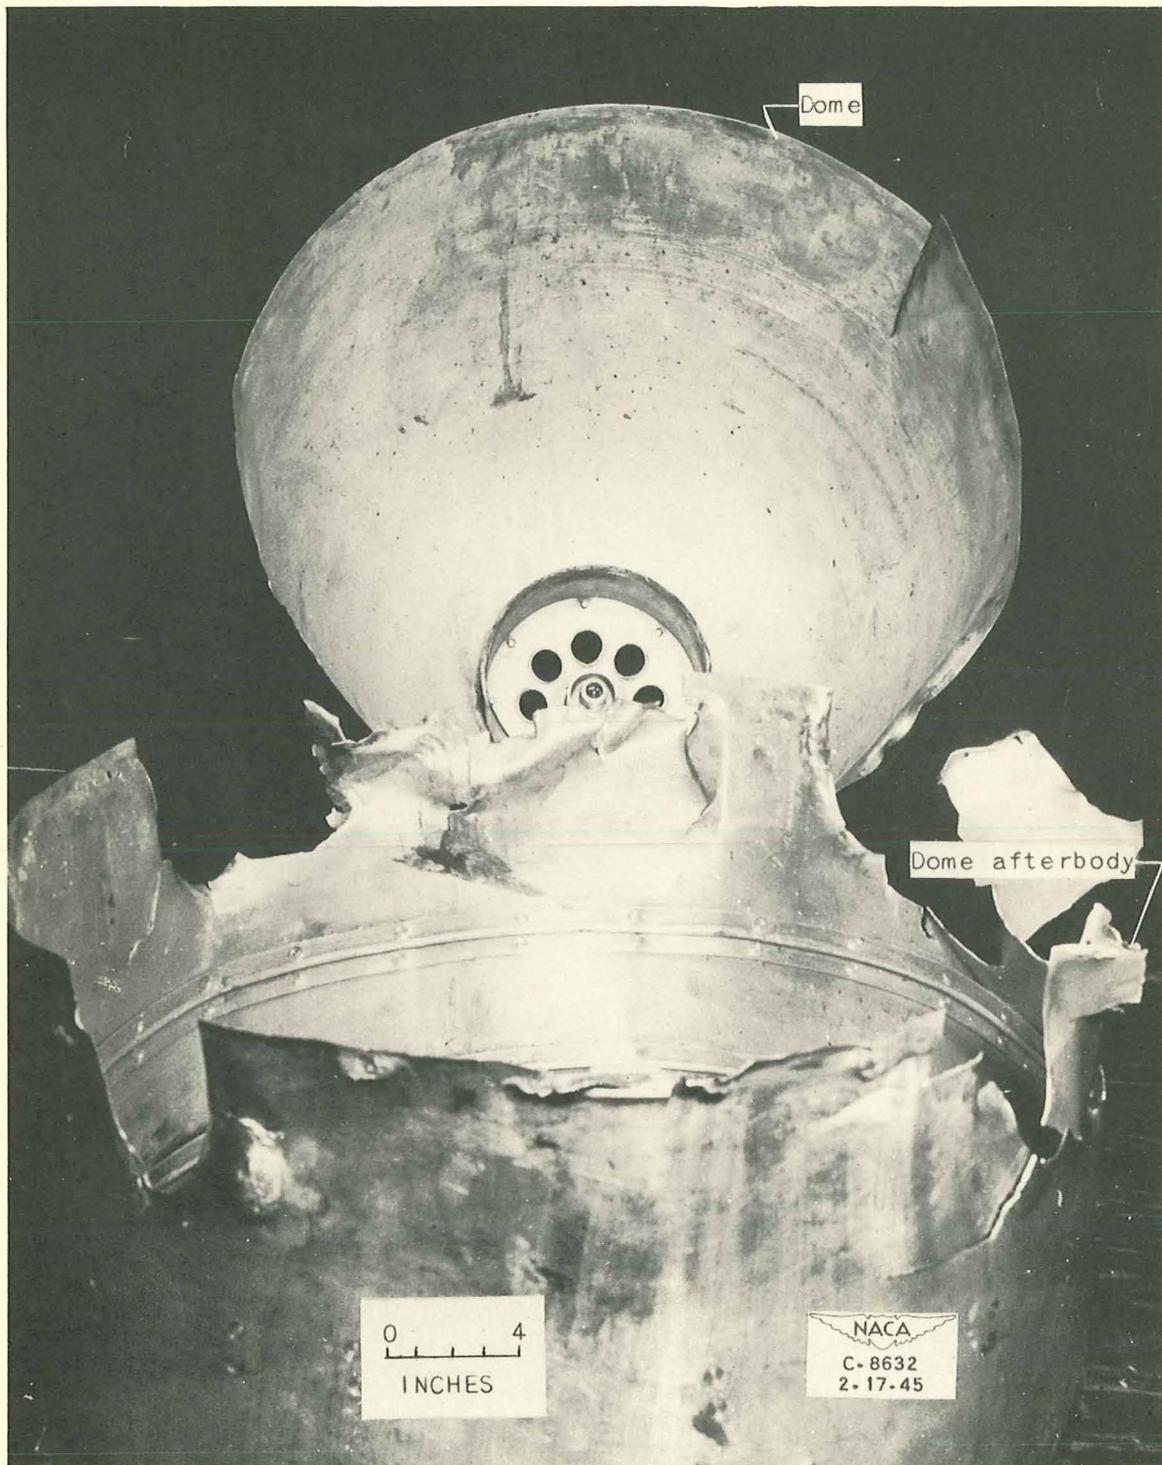
During performance runs at ram pressure ratios up to 1.8 at 40,000 feet, the dome over the accessories collapsed. The dome was repaired and a stiffening ring was riveted around the inside. The dome again collapsed at high ram conditions and was replaced with one made of heavier gage aluminum, which proved satisfactory. The dome afterbody and the vanes in the air guide at the inlet were badly torn during the tests owing to the high ram pressures. The damaged dome and dome afterbody are shown in figure 21. A steel dome afterbody and steel guide vanes were constructed to replace the damaged ones.

Figure 21. - View showing damage to accessory dome and afterbody.
