NASA SP-126

SURVEYOR I

A Preliminary Report

Compiled by
Lunar and Planetary Programs Division
Office of Space Science and Applications

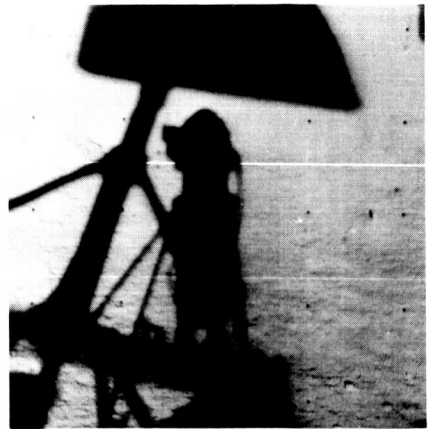
Cover Photo: Surveyor I's survey television camera photographs its own shadow on the lunar surface. Picture was made late in the lunar afternoon (June 12, 1966, at 10:58:28 G.m.t.), after the period covered in this preliminary report.

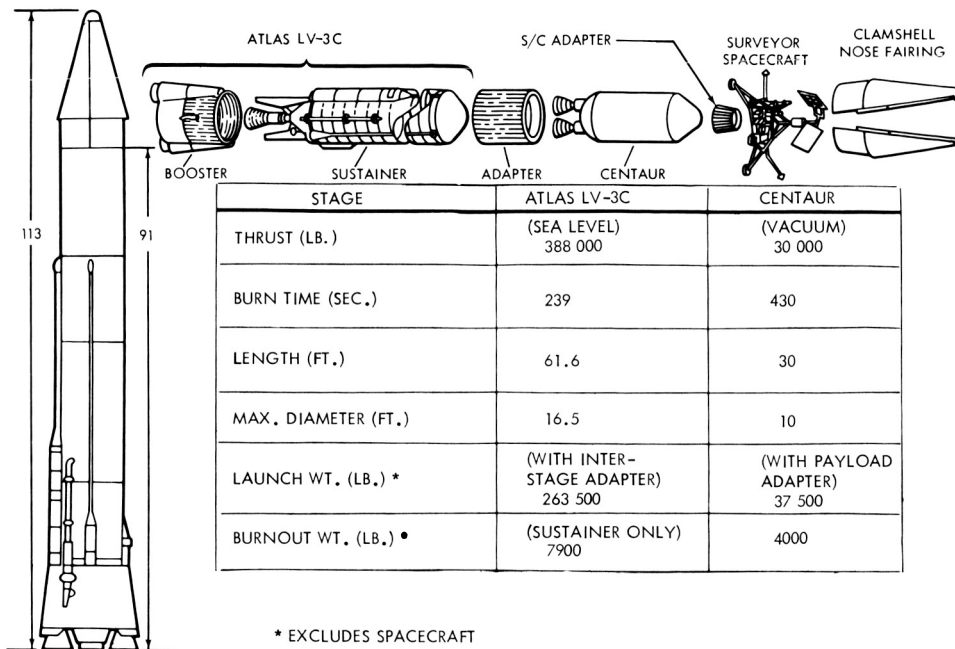
FIGURE 2. — Characteristics of the launch vehicle used for Surveyor I.

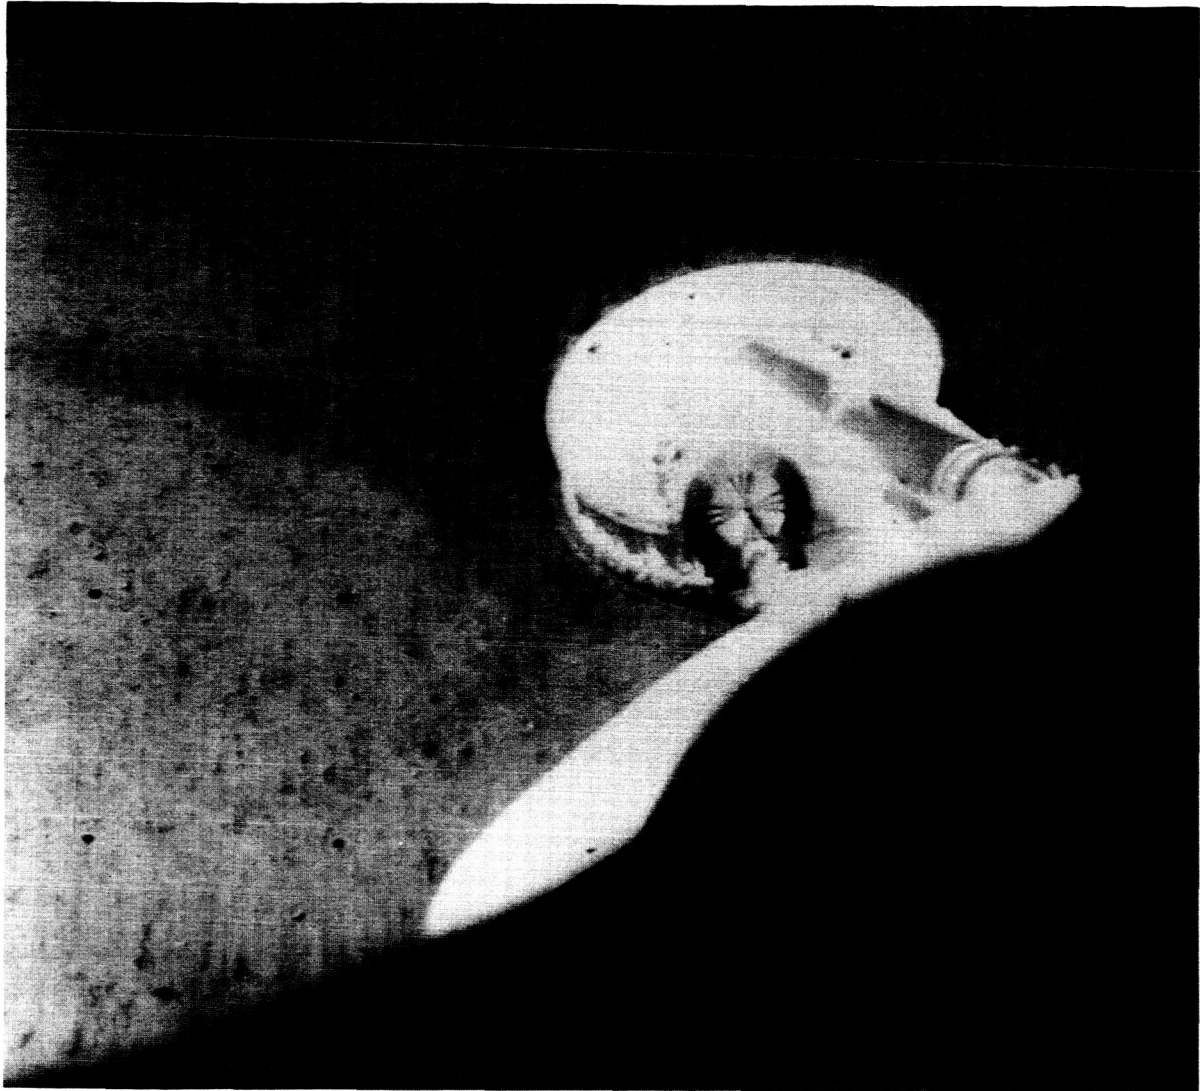
FIGURE 12. — Wide-angle photograph of footpad 2. Note the displaced material that covers the lunar surface beyond the footpad, and the ray extending to the left from the footpad.

Pad 2 (fig. 12) and pad 3 (fig. 13) are both visible; pad 1 is not. The appearance of the lunar surface near pads 2 and 3 indicates similar behavior of the material displaced by the two pads. They appear to have landed in a granular material, to have extended laterally during impact (as shown in figure 9), forcing the surface material

tern over the surface (see figs. 12 and 13), including rays of apparently fine-grained material, to a distance of a foot or two from the edge of the pad. Nearer the pad, the surface material is pushed up by the impact to form a raised rim. The side of the depression and the rim have a chunky or blocky appearance (fig. 15); the blocks or clumps of material are irregular, have a range

small deformations of the surface adjacent to the pad on the side nearest the camera (fig. 16). The deformations resulted in an irregular pattern of cracks or fissures at the surface of the material. The pictures of pad 2 (e.g., fig. 12) clearly show

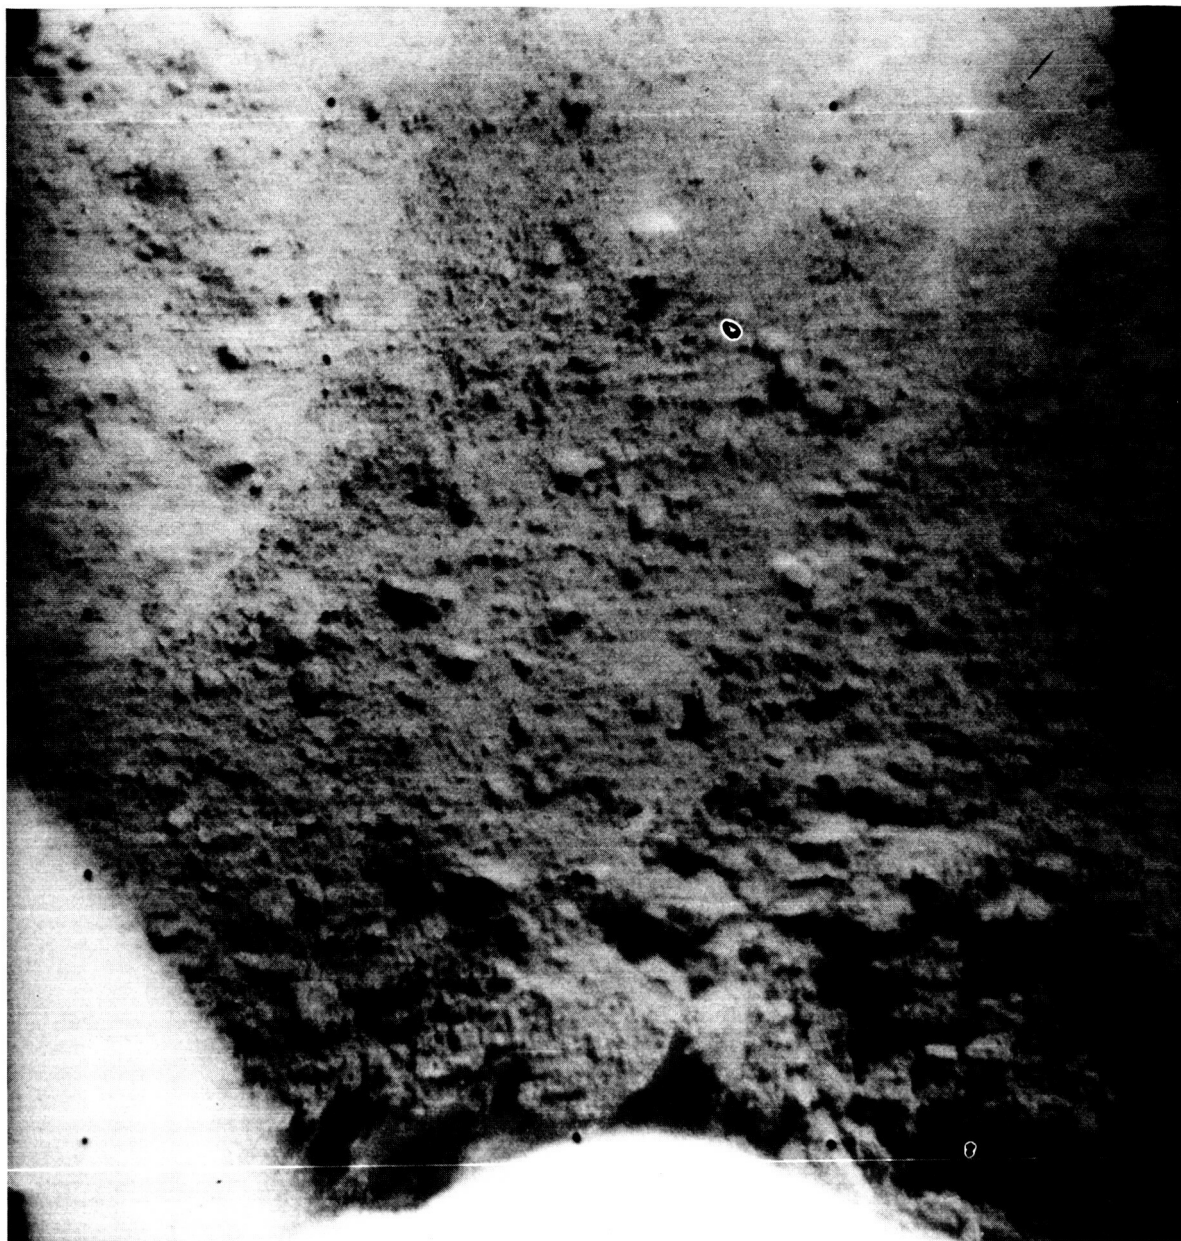
FIGURE 15. — Narrow-angle photograph of the disturbed lunar material beyond footpad 2, which is the circular object at the bottom of the picture.

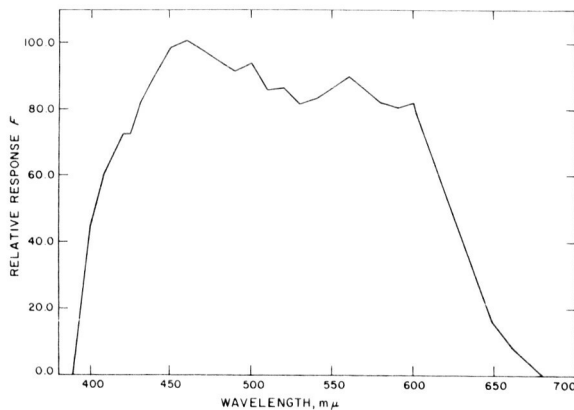
FIGURE 18.— Spectral response curve of the Surveyor I television camera, at the clear position of the filter wheel.

The color filters in the camera filter wheel were selected so that the overall camera-filter spectral response (fig. 18) would match the standard color matching functions of colorimetry

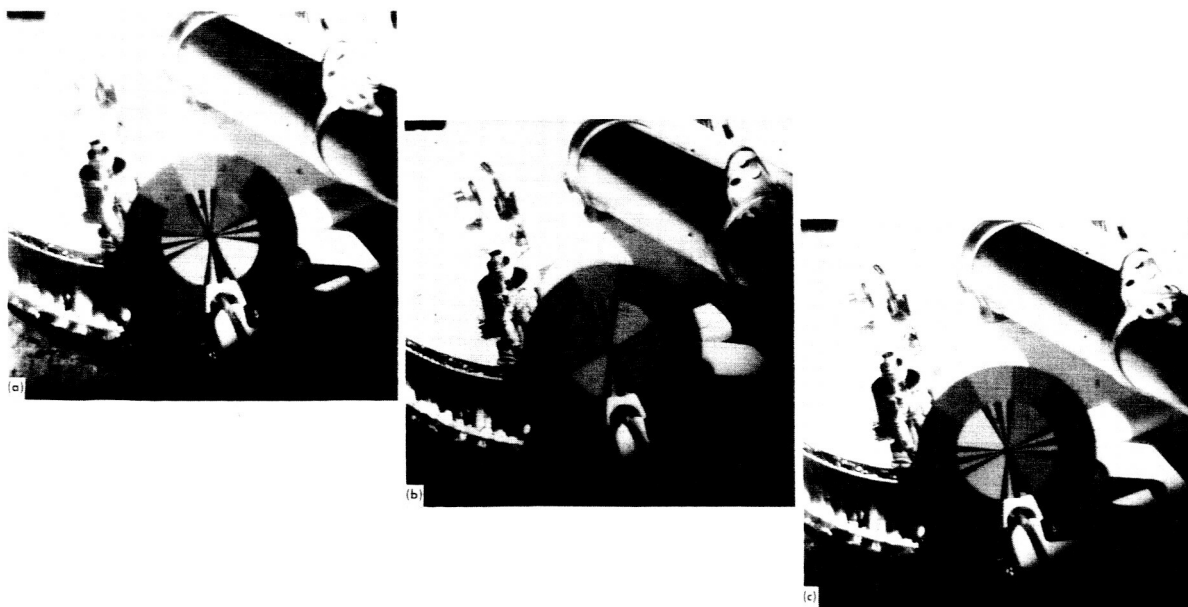
FIGURE 20.— Photometric target on footpad 2 of the Surveyor spacecraft. The target is used for photometric calibration of the television camera during lunar operation. Frame (a) is observed through x' filter, (b) is observed through y' filter, and (c) is observed through z' filter.

so obtained permit estimates to be made of the spectral reflectances. Again, to check and maintain the calibration of the camera-filter combination, the photometric target was observed with each filter before and after the survey (fig. 20). Preliminary examination of the prominent mottled rock lying just southwest of the spacecraft (fig. 26) indicates that any color differences that may be present in the surface of the rock are very small. Much more careful processing of the video data is necessary before subtle color differences can be measured.

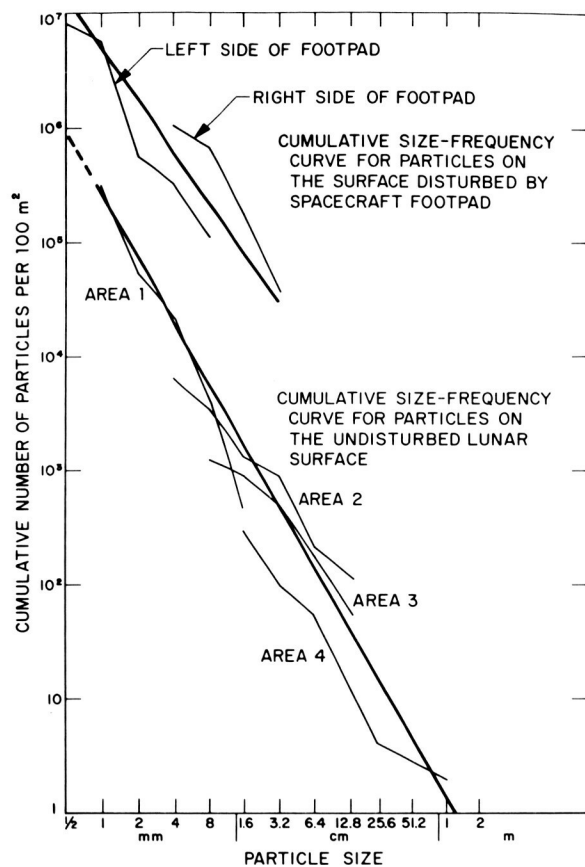
FIGURE 27. — Cumulative frequency distribution of particles on the lunar surface determined from Surveyor I photographs. Area 1 is 0.23 m²; area 2 is 0.90 m²; area 3 is 3.5 m²; area 4 is 50 m² in foreground only.
