# SURVEYOR III

## A Preliminary Report

NATIONAL AERONAUTICS AND SPACE ADMINISTRATION

*Compiled by*  
Surveyor Program  
Lunar and Planetary Programs Division  
Office of Space Science and Applications

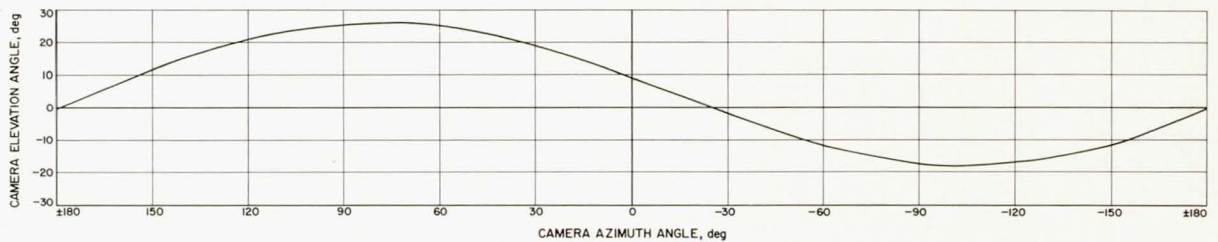
FIGURE 3-10. — Running average trace of the horizon seen from Surveyor III camera, plotted on projection in camera coordinates.

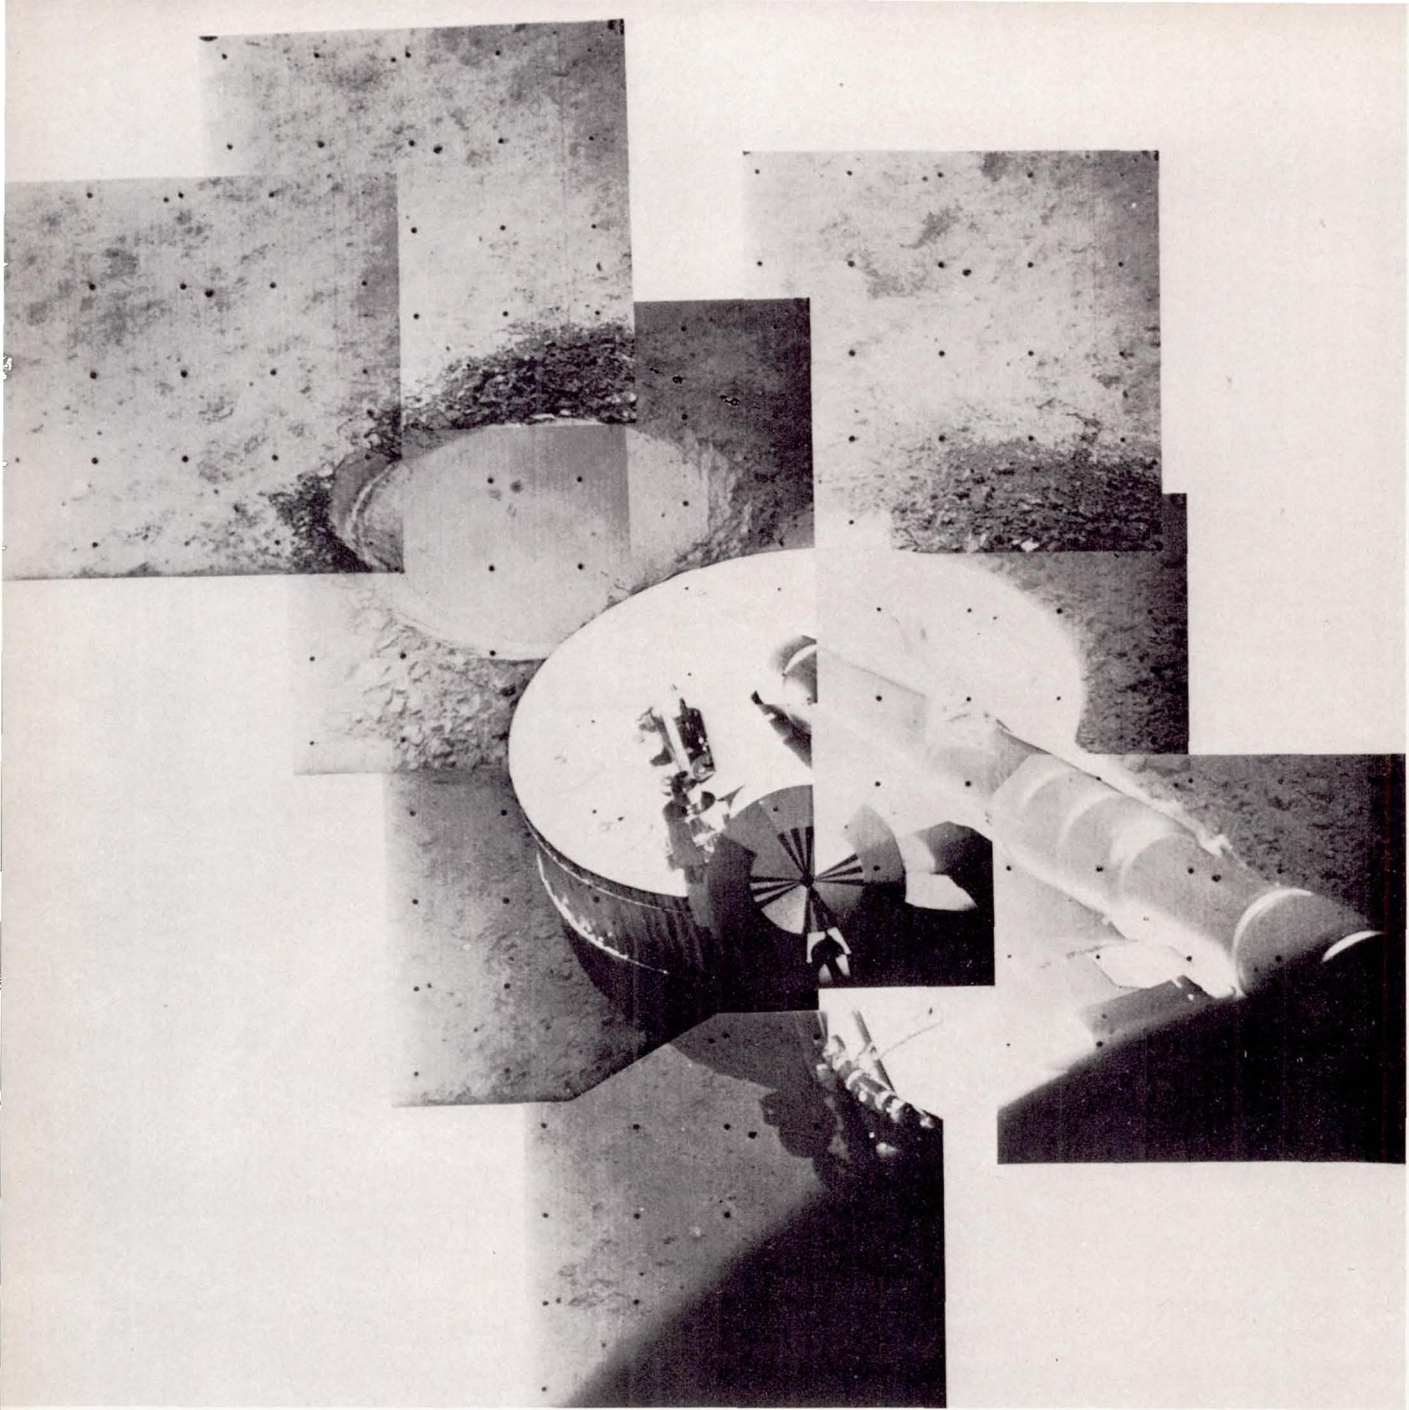
FIGURE 5-16. — Narrow-angle mosaic of footpad 2 and of imprint made during the third landing event (Day 116, between 07:06:46 and 09:27:06 GMT).

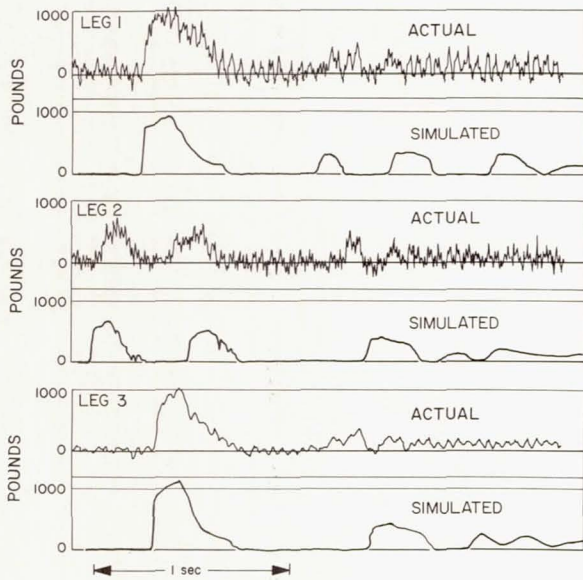
FIGURE 5-24. — Comparison of histories of axial forces in the three landing legs of Surveyor III during the third landing event, with corresponding data obtained from an analytical landing simulation. Conditions for the simulated landing are: horizontal landing velocity, 0.6 m/sec; vertical landing velocity, 1.5 m/sec; landing surface slope, 10.4°; effective friction coefficient between ground and footpads, 1.0.

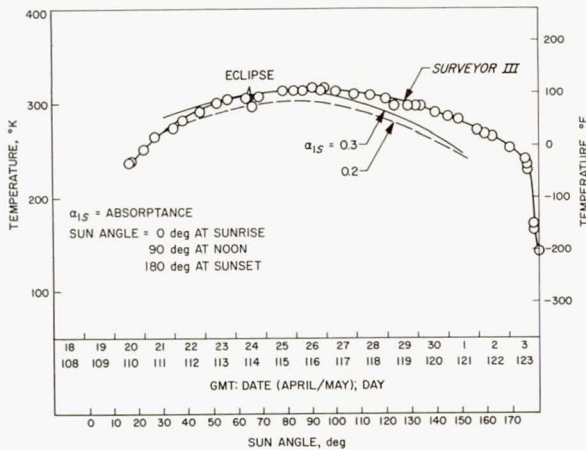
FIGURE 6-25. — Directional predicted and measured temperature of outboard face of Compartment A.
