Paper E 4

MONITORING VEGETATION COVER ON MINE DUMPS WITH ERTS-1 IMAGERY: SOME INITIAL RESULTS

Brian Gilbertson, *Spectral Africa (Pty) Limited, P. O. Box 2, Randfontein,
Republic of South Africa*

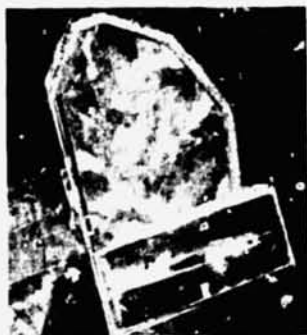
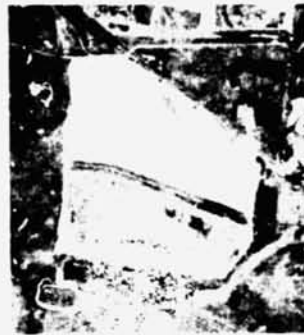
FIGURE 4

Mine dump 1/L/38,39

Mine dump 3/L/5,6

Furthermore, there is a good qualitative relationship between the categories of table 1 and the mine dumps imaged in figure 2, with the more densely vegetated dumps (i.e. those falling in categories 4 and 5) appearing darker than the unvegetated dumps (those falling in categories 0 and 1). In addition, vegetation patterns are visible on the ERTS-1 imagery which are in good agreement with ground truth, i.e. with patterns observed on aircraft overflight photography. This can be seen by comparing figures 3 and 4.
