Paper E 14A

A STUDY ON THE EROSION OF NIIGATA BEACH FROM ERTSA IMAGERY

Takakazu Maruyasu, Institute of Industrial Science, University of Tokyo, Roppongi Minatoku, Tokyo, Japan

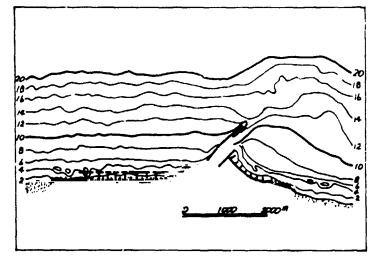
(b) Contour map of Niigata Beach in 1960

- a. Change patterns of Niigata shore line.
- b. Contour map of depth of Niigata beach. (Fig. 3)
- c. Surveys of settlement of the beach
- d. Predominant wind and its velocity.
- e. Wave height.

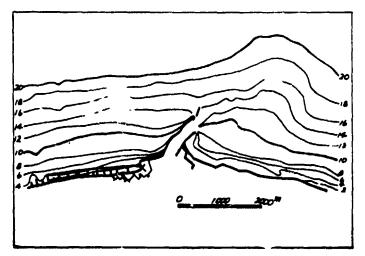
(c) Contour map of Niigata Beach in 1970Fig. 3 Contour map of depth of Niigata Beach

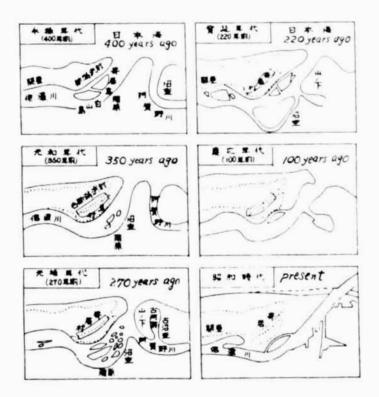
Fig. 1 Historical change pattern of Niigata Beach

In the ancient time before about 80 years ago when the cultural structures such as river improvement works or flood control dams had been carried out along Shinano River, Niigata shore line had grown in the offshore direction with average rate of 30 meters to 120 meters in a year. Fig.l shows schematic change patterns of Niigata shore line in the past.

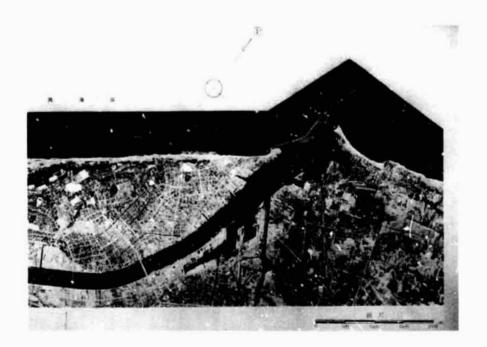
and its coastal environment (1958)

About 70 years ago, the breakwater for the construction of Niigata Port was constructed at the outlet of Shinano River as shown in Fig. 2.

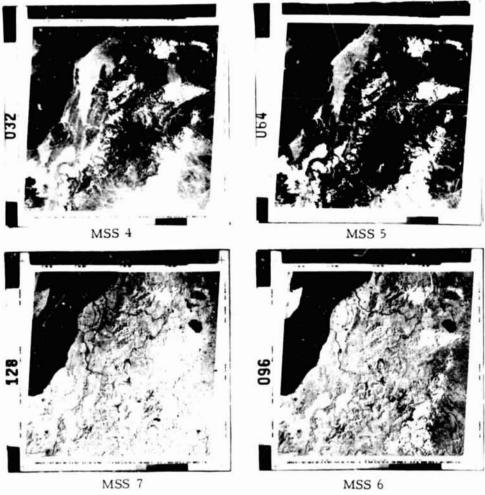
Fig. 4 Contact prints of four bands from ERTS-A

Cloud coverage;	about 10 percent in the mounta-
	eneous sites
Major features included;	Niigata City, Sado Island, Shinano
	River, Agano River, Japan Alps,
	Inawashiro Lake
Fig. 4 shows contact prints of	four bands made from ERTS-A.

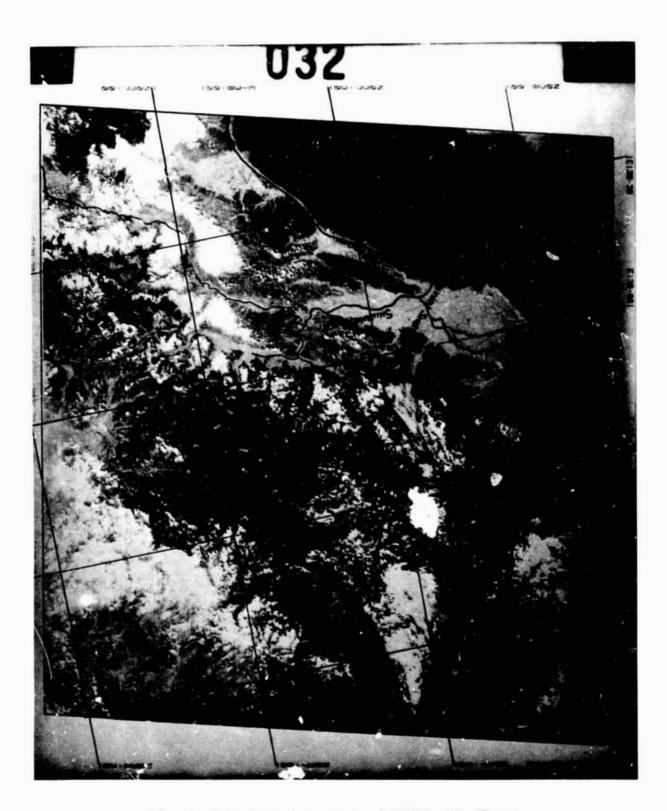
Fig. 5 Enlarged print of the band MSS 4 with effluent

pattern superposed

Fig. 5 shows the enlarged print of the band MSS 4 in the scale of 1:1,000,000 with effluent pattern superposed.

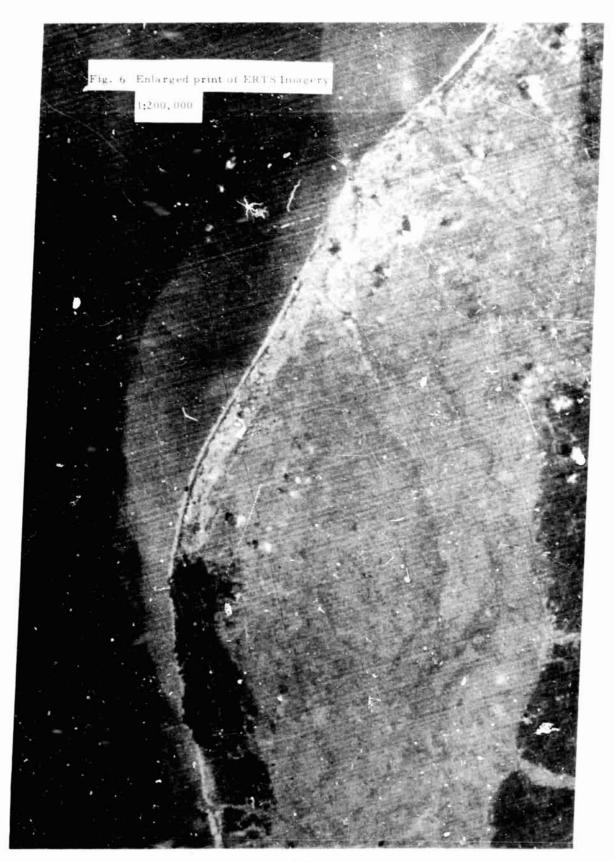
Fig. 6 shows the more enlarged print of Niigata shore line in the scale of 1:200,000 which can provide more detail information about the relations between effluents, breakwater and short cut channel, and coastal current.

Significant results are obtained from ERTS-A as follows. a. Effluents from Ohkozu short cot channel are refracted by the curved coast and Tsushima current, which flows in the direction of the

- north east. They disperse in the offshore fai away from Niigata west beach and sand sedimentation is not active.
- b. The new short cut channel is identified to contribute the sand deposi tion along the west beach as it was estimated by coastal engineers.
- c. Effluents from the breakwater of Niigata port are distributed in the direction of the north east together with those from Agano River. They are also affected strongly by the coastal current.
- d. The east beach has no tendency to have sand deposit from effluents. There will be increase of erosion at the east beach.
