Paper E 14C

**POLLUTED AND TURBID WATER MASSES IN OSAKA BAY AND ITS VICINITY
REVEALED WITH ERTS-A IMAGERIES**

Kantaro Watanabe, Kyoto Gakuen University, Kyoto, Japan

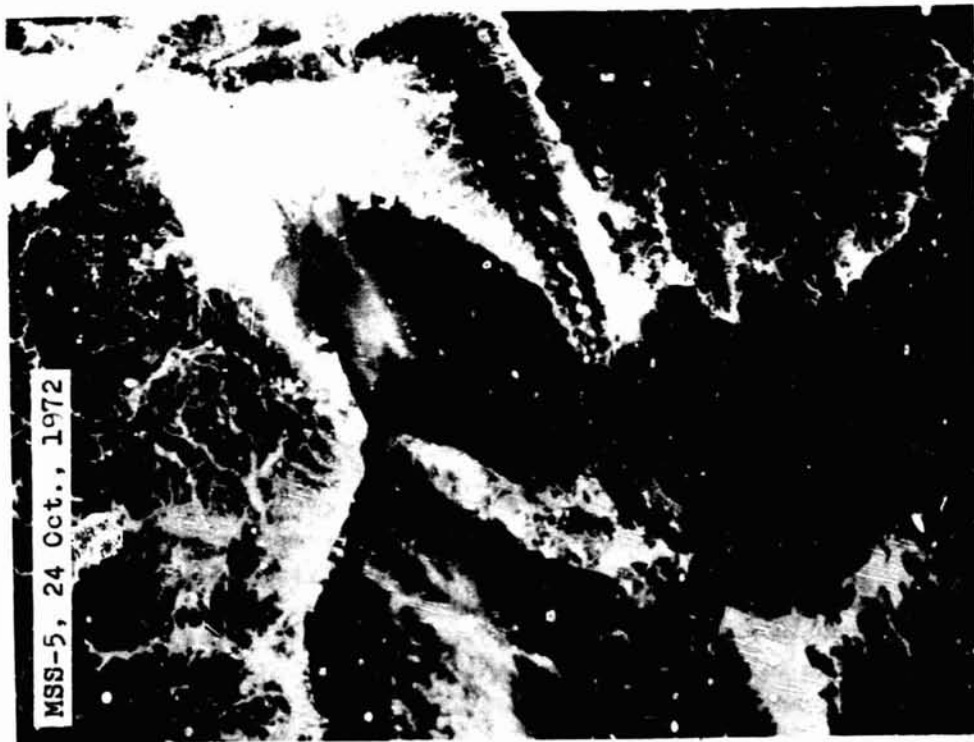
Fig. 1

FIG. 1 Two examples of ERTS-1 MSS imageries taken on October 24, 1972. Cloud covers, heavy smog areas and turbid water masses are represented equally by grey color in imageries of MSS-4 and -5, because they have sensible components of light in these channels. On the other hand, there is no grey-colored image of turbid or polluted water mass but are the ones of cloud cover and smog area in MSS-7 (infrared) imagery since the infrared component of light is strongly absorbed by the sea water.

MSS-5, 24 Oct., 1972

MSS-7, 24 Oct., 1972

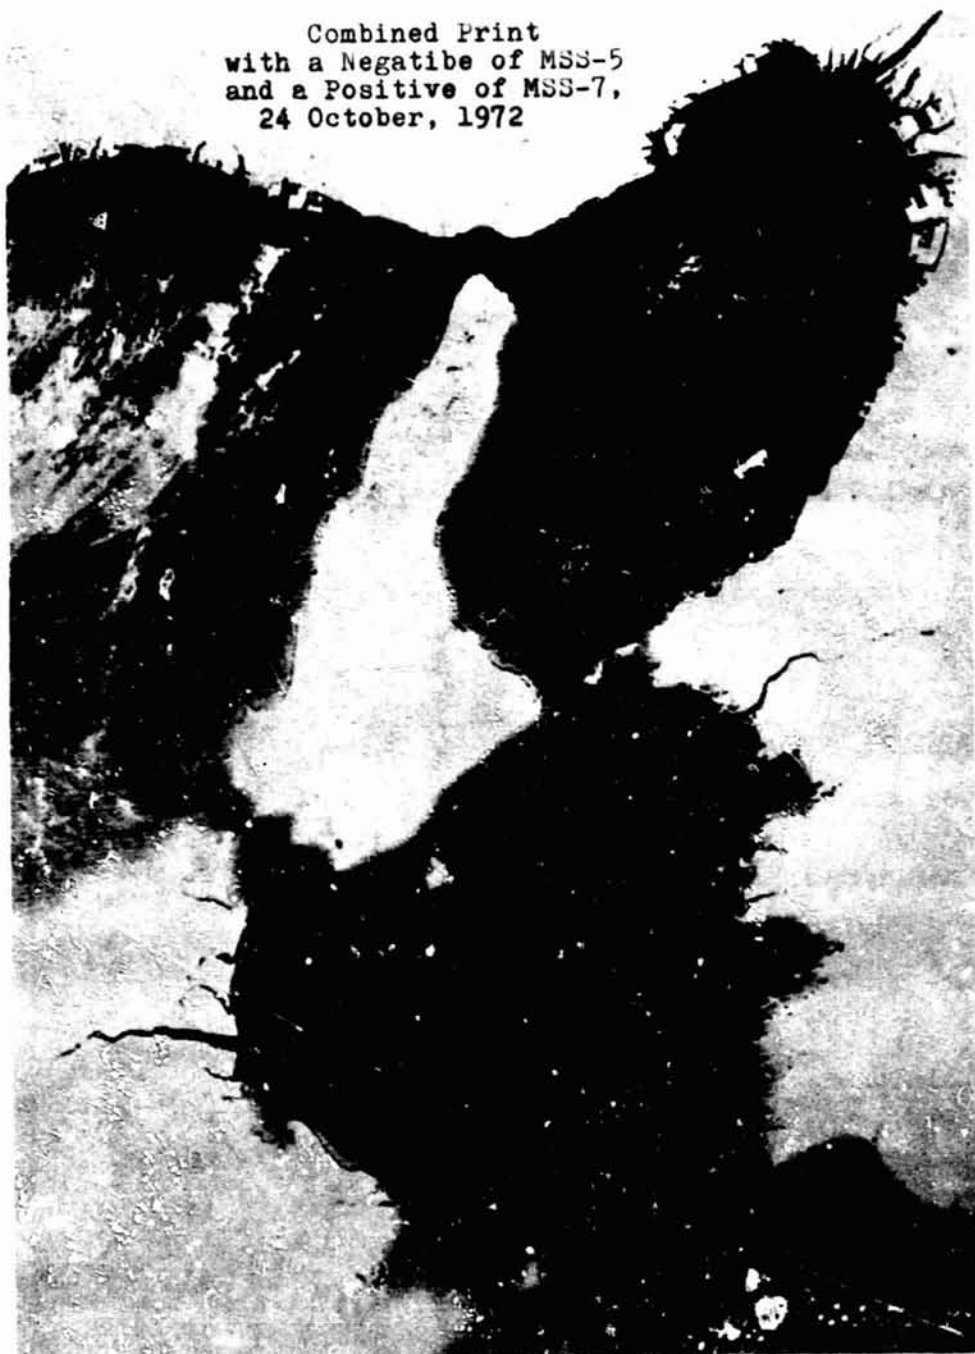
Fig. 2

FIG. 2 Using the difference of grey-colored images over sea regions in MSS-5 (or -4) and MSS-7 imageries explained in Fig. 1, turbid or polluted water masses can be represented by darker images separately from cloud covers and smog areas which are represented by lighter grey images in a combined print made with a negative imagery of MSS-5 or MSS-4 together with a negative imagery of MSS-7 by a photographic enlarger.

Combined Print
with a Negative of MSS-5
and a Positive of MSS-7,
24 October, 1972

In the present investigation, a simple photographic technique was applied using the fact that reflected sun light from cloud including smog and inclined water surfaces of wave have a certain component in the near infrared region, that is MSS 7, whereas the light scattered from fine materials suspended in the sea water has nearly no component in the channel of MSS 7 but has only the green and yellow component sensible in MSS 4 and MSS 5 channels. That is, combined prints were made from a positive imagery of MSS-4 or 5 together with a negative imagery of MSS-7 using a photographic enlarger. In the combined prints areas of clouds and smogs are shown as white or lighter grey, whereas polluted or turbid water masses are clearly represented with black or darker grey tone.

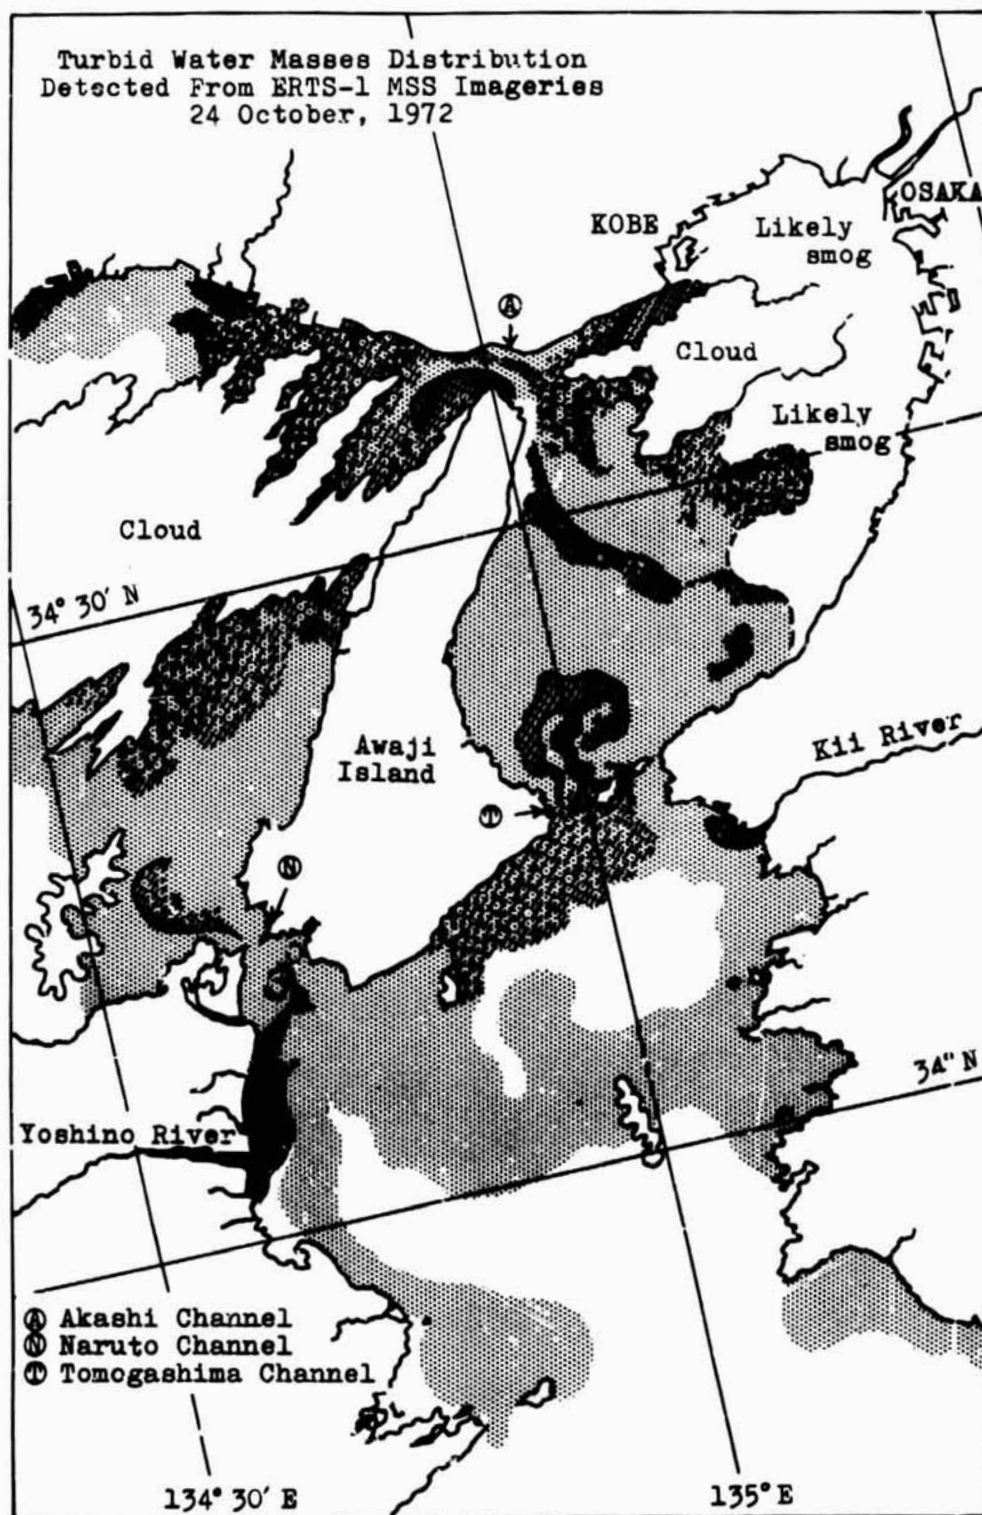
Fig. 3

FIG. 3 Turbid or polluted water masses distribution manually copied from the combined print (in Fig. 2). The darker is any area the heavier is the degree of turbidity or pollution in this chart. The pattern in this chart suggests that turbid or polluted waters diffuse into oceanic water masses flown from the outer sea without any continuous density variation in some short time, but form patches of turbid or polluted water masses. The major mass of polluted water is thought to locate under a cloud cover and smog areas off Osaka and Kobe ports. The patch of turbid or polluted water mass having an eddy-like pattern near the Tomogashima Channel (marked by T) is assumed to have departed from the major mass of polluted water off Osaka and Kobe ports in a former tidal time. Effluents from the Kii and Yoshino Rivers are clearly seen.

- 2) The polluted water does not diffuse continuously into the oceanic water but forms masses of polluted water among masses of the oceanic water flown from the outer sea, that is, the Kuroshio area.
