ANALYSIS OF STATE OF VEHICULAR SCARS ON ARCTIC TUNDRA, ALASKA

Ernest H. Lathram, *U. S. Geological Survey, Menlo Park, California*

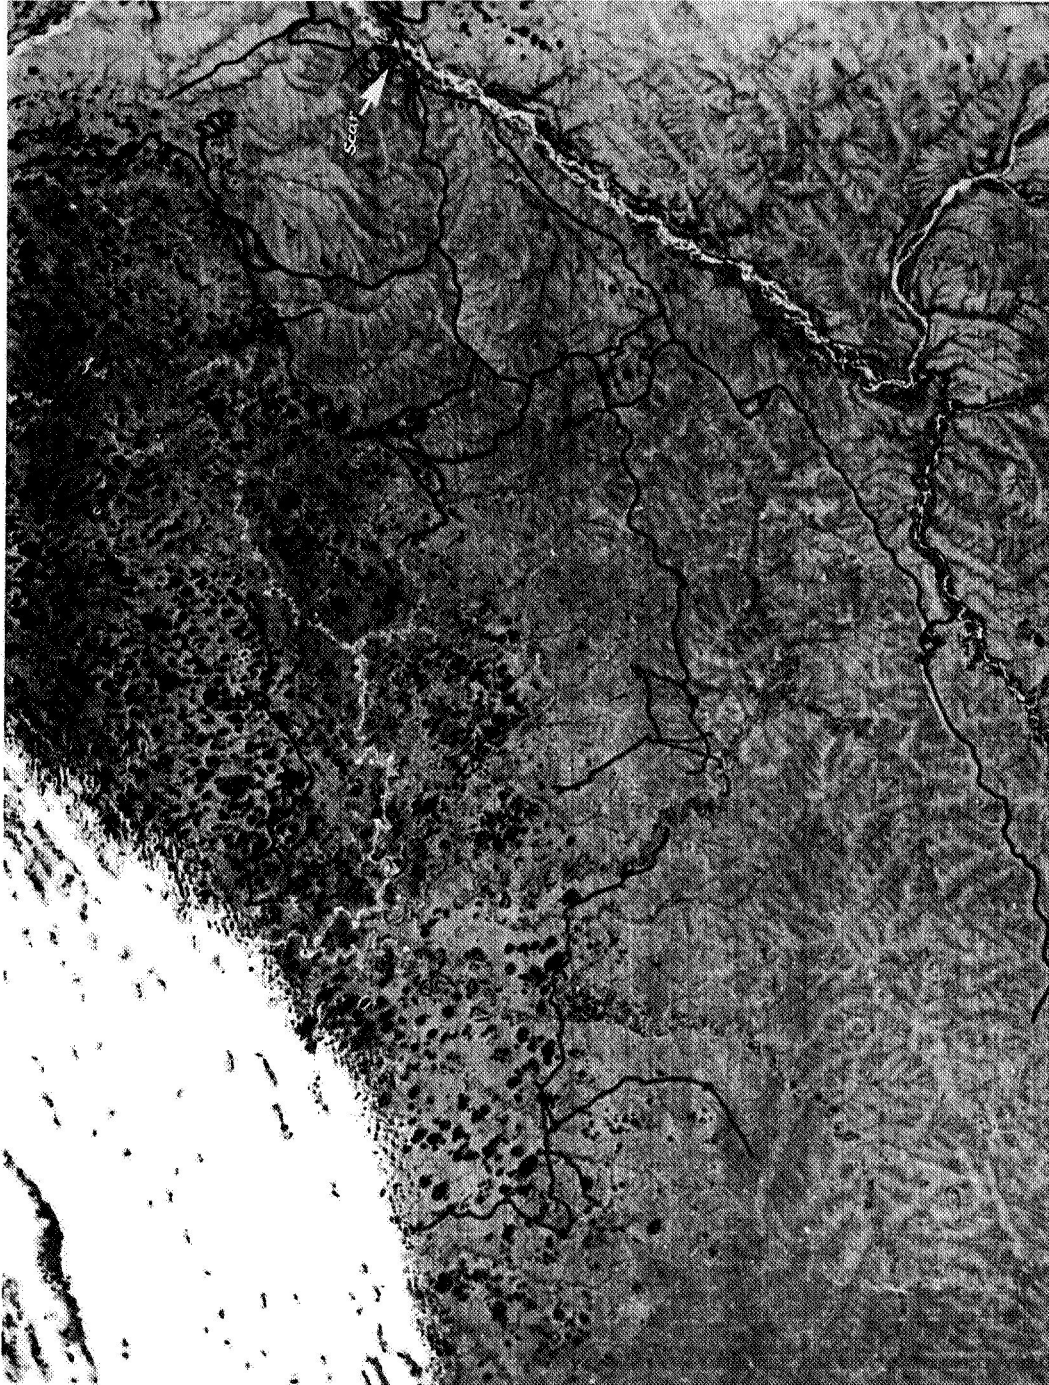
Figure 1 Known trails in the Umiat area.
Arrow shows location of scar visible on band 5 image of ERTS-1 scene 1004-21395.

Preliminary examination of ERTS-1 image 1004-21395 (taken in 1972), which covers the area around Umiat (fig. 1), revealed no trace of scars resulting from this activity (W. A. Fischer, *in* Lathram, Tailleux, Patton and Fischer, 1973, p. 38). Because ERTS sensors lack the resolving power (> 20 meters) required to recognize features as narrow as these tracks were originally, Fischer observed "This does not mean that the scars are gone, for I am confident they are not wholly healed and could be observed on the ground or from a low-flying plane, but it does mean that they are not spreading like cancer, as some purport, over the northern tundra." Subsequent study of this image under the microscope at enlargements up to 1:80,000 revealed that a scar on the ridge north of Umiat can be identified on Band 5 (reflected red light) images of the area.

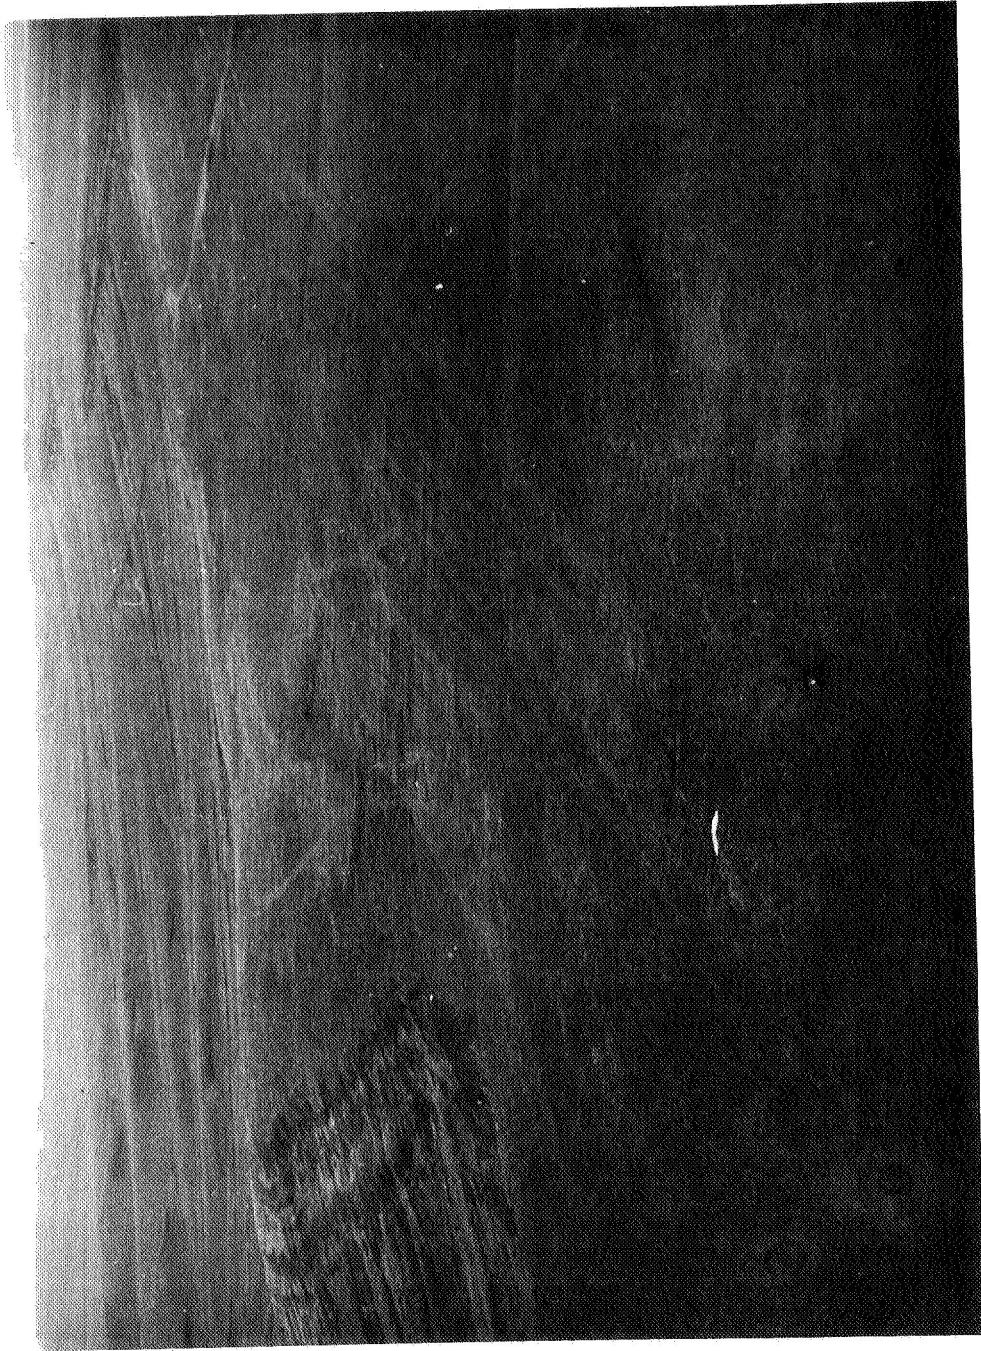
Figure 2. Old trails on hills near Umiat.

The scars presently visible from the air will remain visible from the air for a few years after the physical effects of the disturbance have been healed (fig. 2). The principal indicator of trails is the presence of grasses in the tracks that are not present in surrounding terranes, giving the tracks a greener appearance. Old trails are difficult to see on the ground at present and in 5 to 10 years will probably not be visible on the ground (fig. 3).

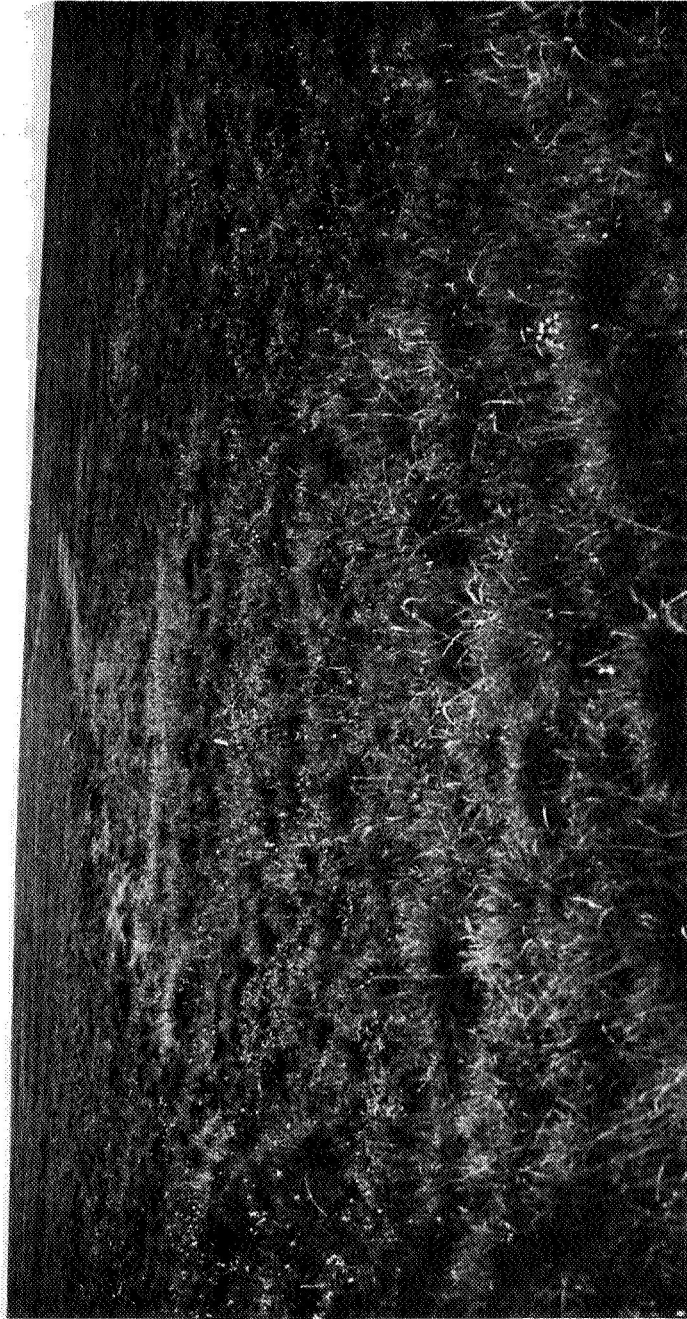
Figure 3. Old trail in ice-poor soil near Umiat seen from ground.

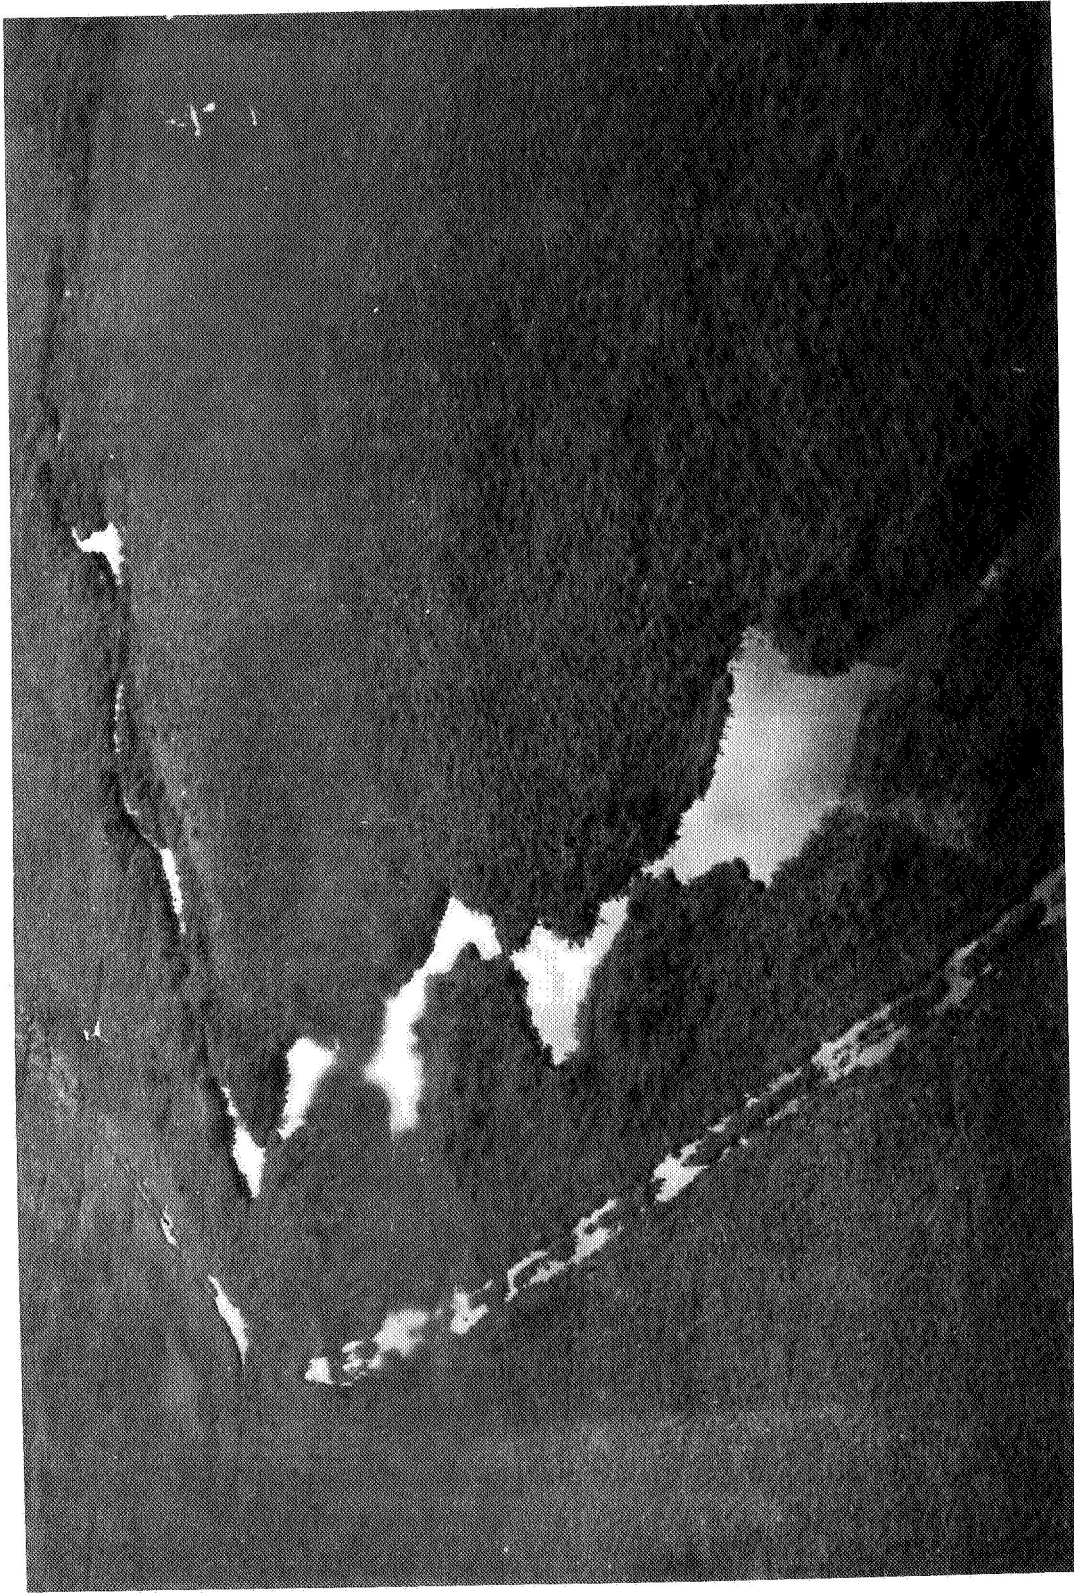
Figure 4. Trail across ice-rich lowlands assuming appearance of beaded stream on right.

Trails crossing ice-rich lowlands that have been heavily bladed are assuming the appearance of the beaded stream prevalent in the tundra, a linear vegetated depression with irregularly spaced water-filled potholes up to 6 feet where an ice wedge was exposed (fig. 4). The beaded lakes will probably enlarge to the size of the ice wedges exposed, but interlake parts of the trails are not becoming wider, and the trails are approaching a stable state.

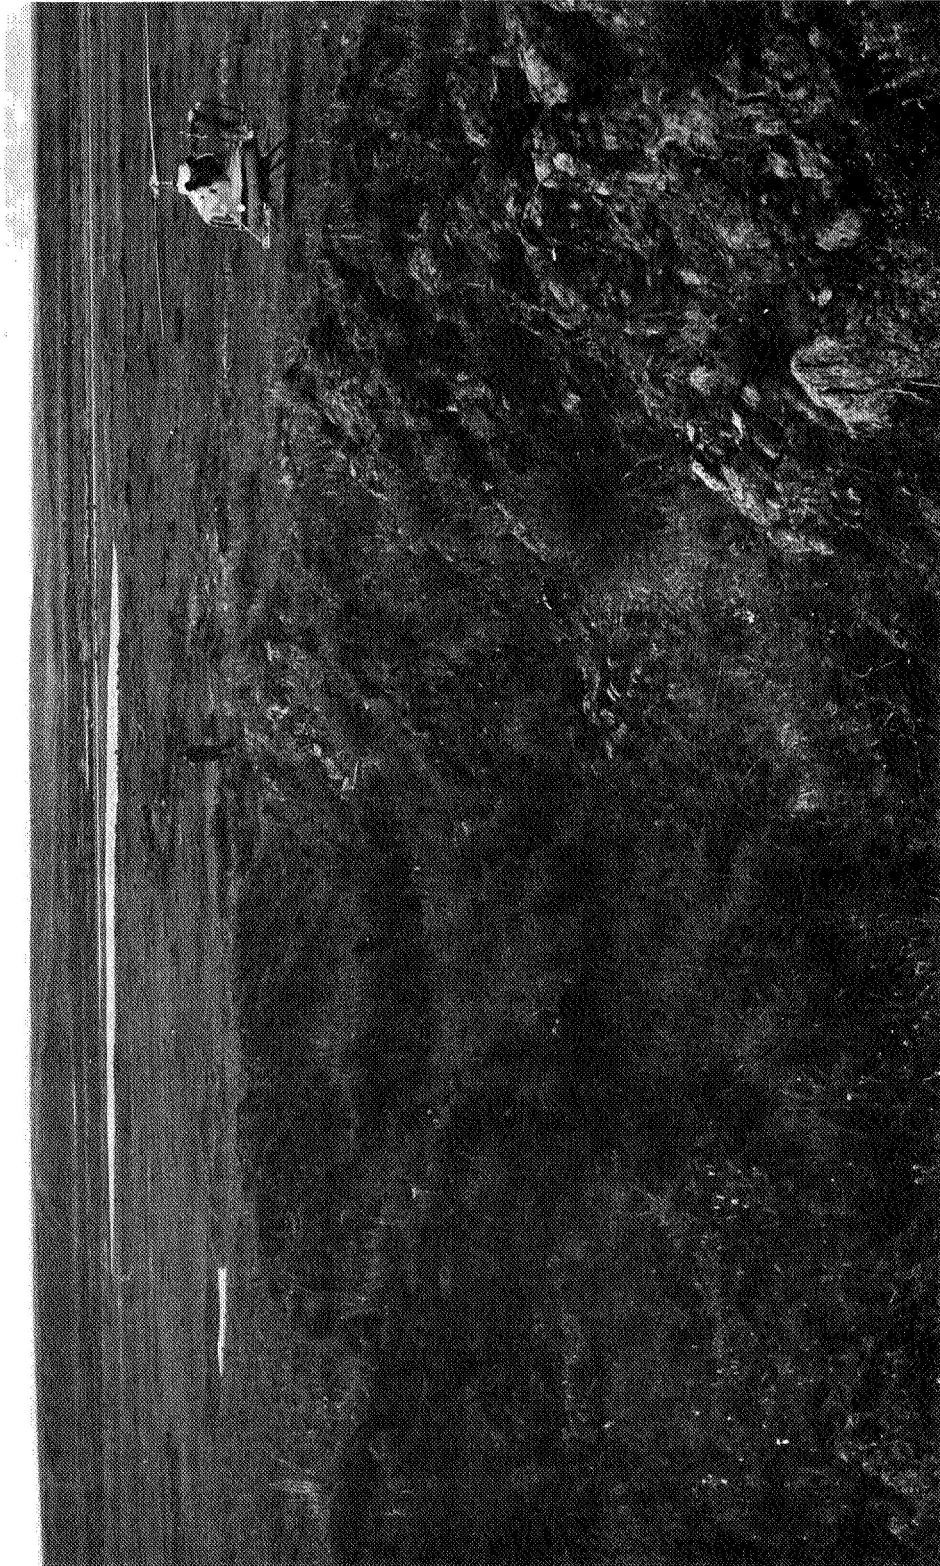
Figure 5. Scar formed by more recent activity than 1952

Hok noted one site near the Colorado Oil and Gas Company Gubik test well, where a bladed trail made since 1960 crossed a 10° slope in ice-poor silt. Re-examination in 1973 shows increased revegetation of the main scar (fig. 5, compare with Hok, 1969, photographs 29 and 32), increased revegetation of part of the silted area at the foot of the slope (Hok, 1969, photograph 30), and little active siltation at present, indicating a reduction and early cessation of active erosion.

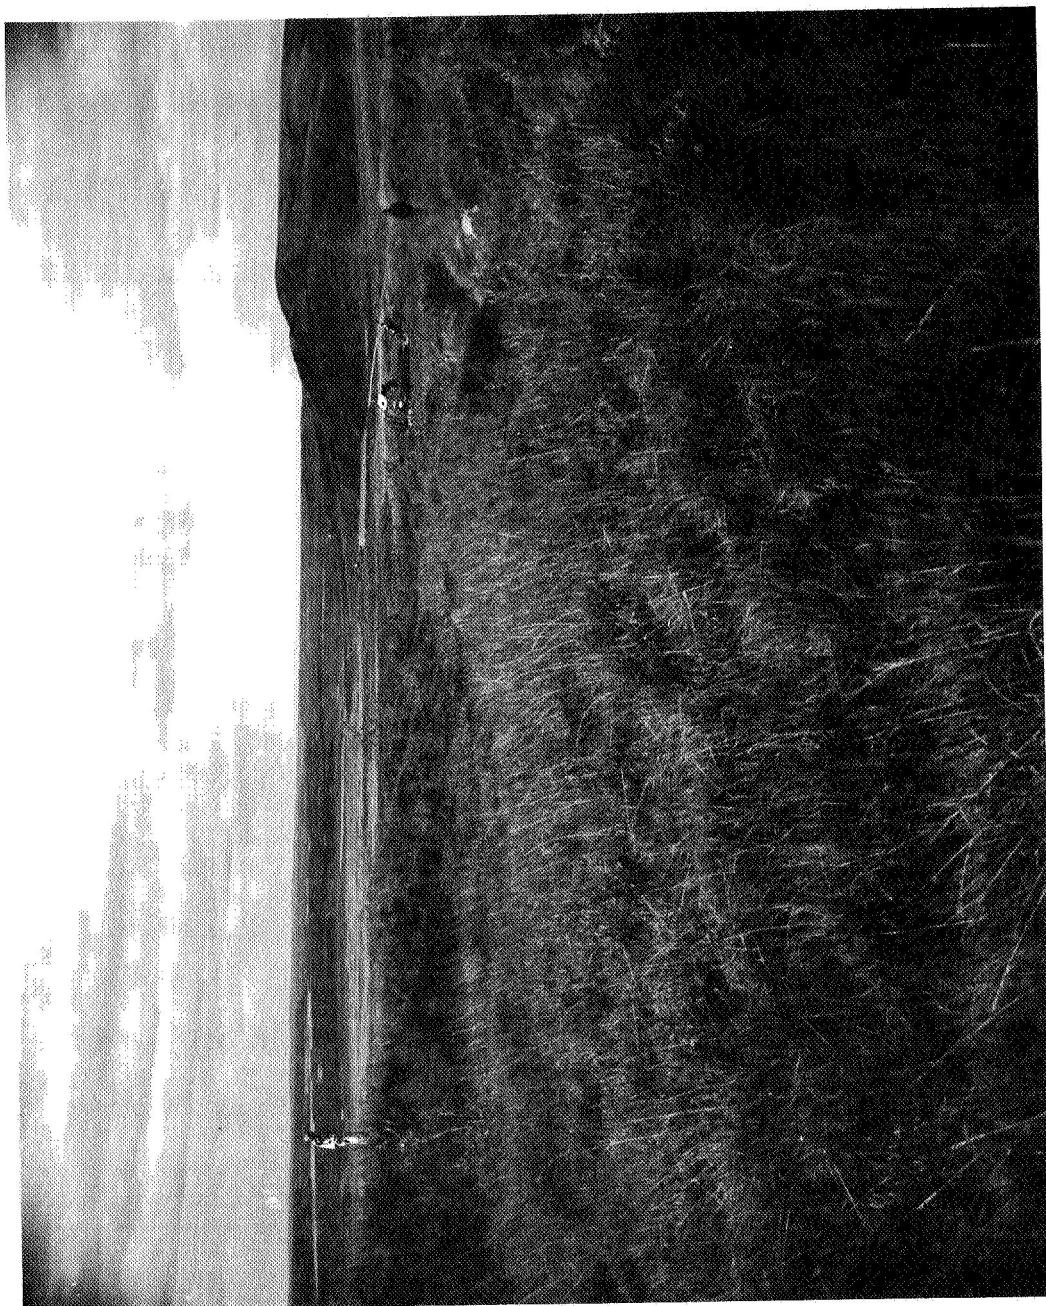
Figure 6. Severe scar on ridge north of Umiat.

The most striking example of scarring, which Hok apparently did not visit, occurs on the ridge north of Umiat. Here a heavily used cat trail, bladed bare of vegetation, leads up a 10° slope to the site of several drill holes. Not only was the trail bladed, but it was also used summer and winter during the 1945 to 1952 period and crosses the exposed area of a bentonitic shale formation. The trail has spread to a depression on the slope about 150' wide and up to 15' deep (fig. 6). This is the scar noted on Band 5 ERTS images of the Umiat area. Here, revegetation is proceeding, with felt-leaf willow, equisetum, and a grass (stipa) not noted elsewhere, indicating the onset of healing, although much more slowly than elsewhere.
