## 5. Materials and Techniques for Spacecraft\* Static Charge Control

L.J. Amore and A.E. Eagles  
General Electric Company  
Space Division  
Valley Forge, Pennsylvania

An overview of the design, development, fabrication, and testing of transparent conductive coatings and conductive lattices deposited or formed on high resistivity spacecraft dielectric materials to obtain control static charge buildup on spacecraft external surfaces is presented.

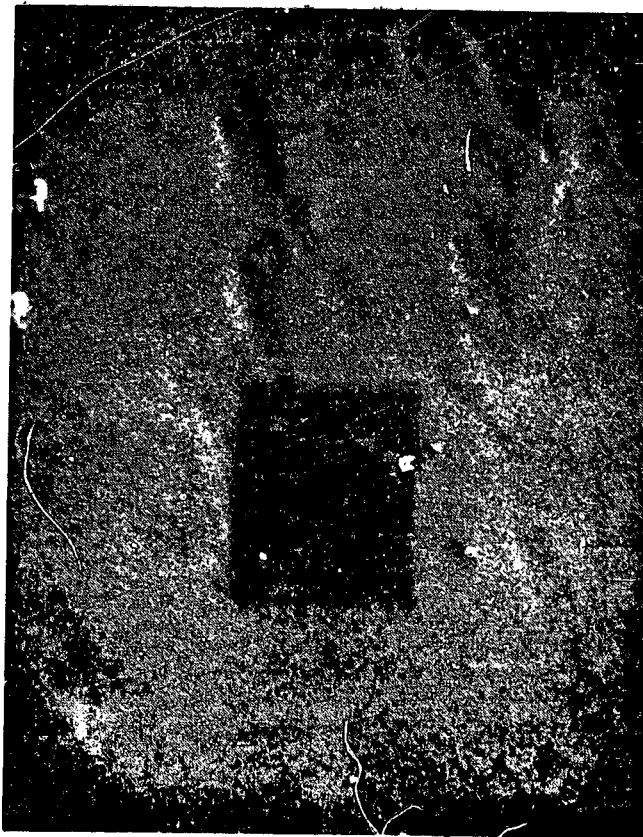
Figure 4. Uncoated Kapton Surface (at 10,000X)

Surface characteristics of Kapton and ITO coated Kapton were observed with an electron microscope at 10,000X (see Figures 4, 5, and 6). Figure 4 reveals a uniform Kapton surface with no evidence of imperfections. Figure 6 reveals a surface that underwent severe flexing (180° bend) with subsequent micro-fracturing of the film. This defect did not affect the conductivity of the film under electron beam bombardment as will be described later.

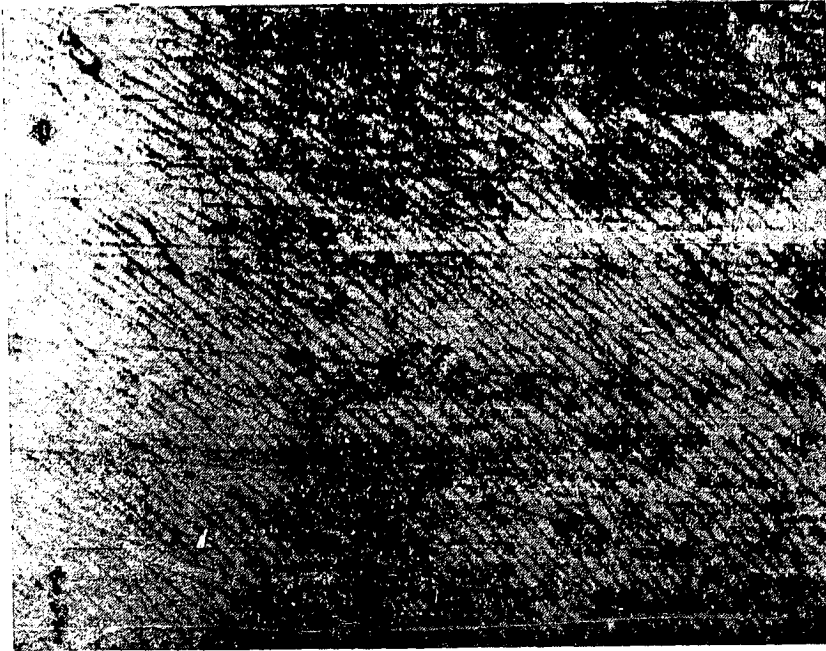
Micrographs of ITO (250 Å) coated FEP Teflon after electron beam irradiation are shown in Figure 18b indicating "electron-etched" cracking and crazing. These craze-cracks (due to large applied anisotropic stress or tensile force) run along parallel direction of stretch lines to which the material was subject (that is, longitudinal drawing or pulling and radial blowing), as is evidence by the micrograph of the unexposed spacecraft material (Figure 18a) and less evident outside the electron beam irradiation area (Figure 18c). The stretch lines correspond to the direction of molecular orientation, preferentially, since the polymer under the coating has less strength perpendicular to the direction of orientation. Crystallization occurs along these oriented molecules.

Figure 18b. FEP/ITO After Electron Irradiation at the Central Region of the Electron Beam. Electron etched craze lines appear on the FEP-Teflon surface, together with fabrication die lines, under the transparent semi-conductor (200X)

Figure 18a. Transparent Semi-Conductor of 250 Å Tin and Indium Oxide (10 percent mole SnO: 90 percent mole In<sub>2</sub>O<sub>3</sub>) on 2-mil FEP-Teflon Before Electron Irradiation. Typical die lines appear on the FEP-Teflon surface, under the transparent semi-conductor

Figure 18c. FEP/ITO After Electron Irradiation  
Near the Edge of the Sample Outside the Primary  
Beam Projection Area

The micron size structure of "spheres" (500 to 1000 Å) denotes distribution of strain, due to fabrication stress. These "spheres" are highly ordered molecular groups and they move as rheological groups. The internal stresses may result from molecular orientation or from thermal stresses due to rapid cooling of the polymer. In the case of single way stretch in fairly evenly spaced long parallel lines of uniform width (for example, to  $7\mu$ ) etched into the surface along the stretch path, the density of the lines (for example, number of lines per unit length) is apparently proportional to the stretch ratio, whereas the line width is proportional to the inverse of this stretch ratio.
