AIRESEARCH QCGAT ENGINE PERFORMANCE AND EMISSIONS TESTS

William M. Norgren
AiResearch Manufacturing Company of Arizona
A Division of The Garrett Corporation

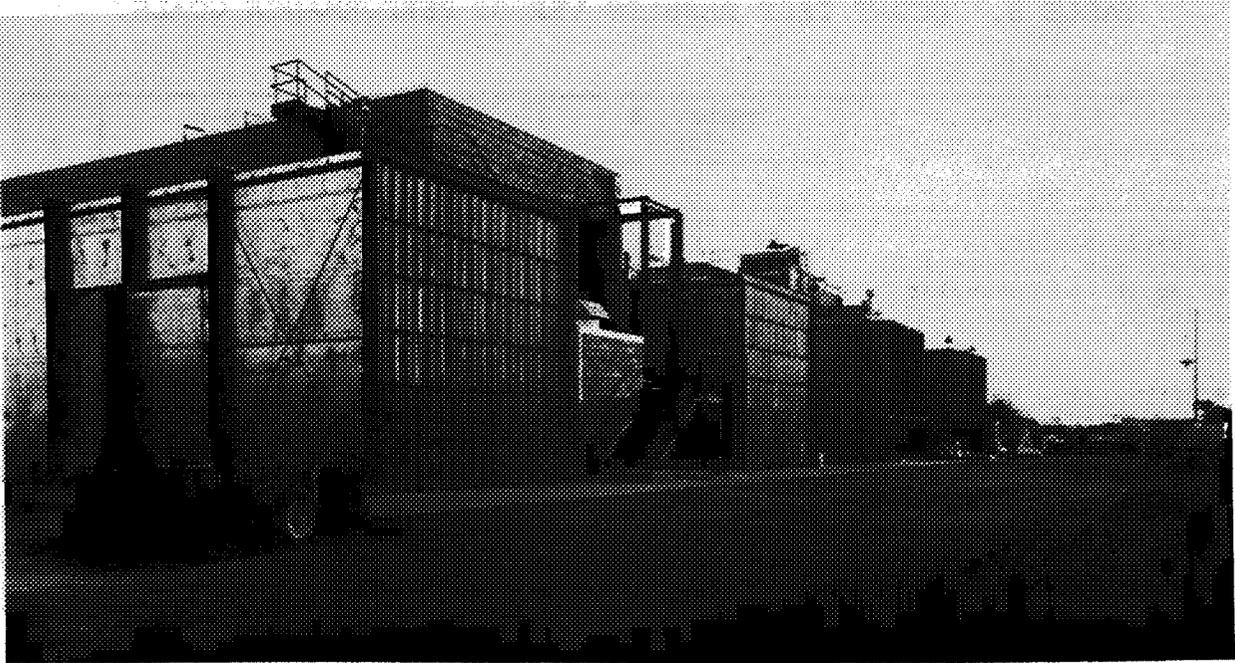
Figure 1. Development and Qualification Test Area.

Due to the requirement to perform a complex series of acoustic tests, as well as performance and emissions tests, two separate test areas were used. Most of the fully instrumented performance testing was conducted in the Phoenix development and qualification test cells shown in figure 1. Another series of performance comparisons were run at the AiResearch San Tan remote test site (fig. 2) to establish a baseline for the subsequent acoustic tests.

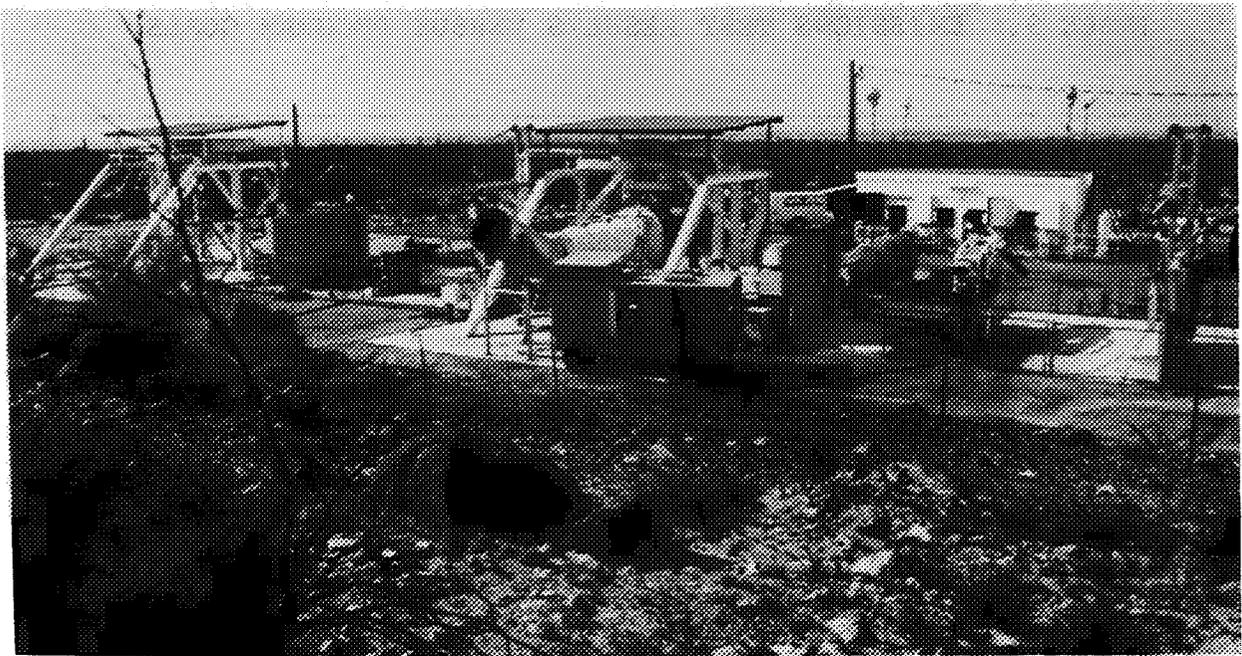
Figure 2. San Tan Test Center.

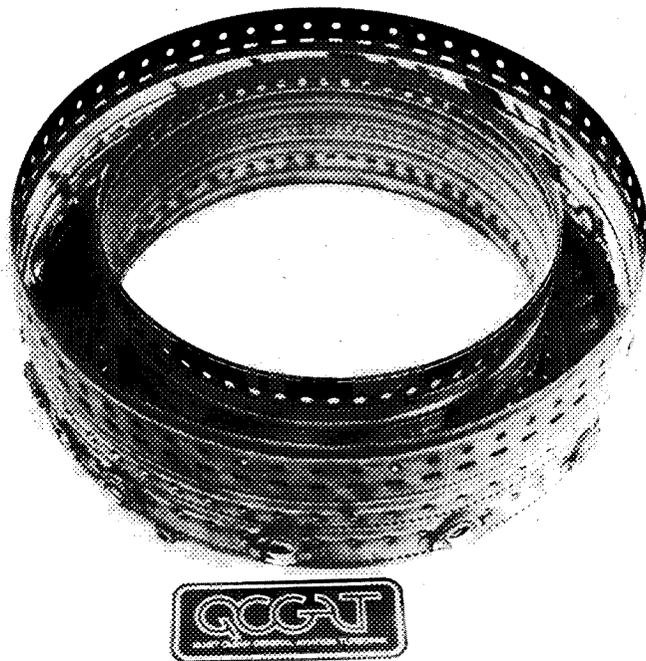
Figure 8. QCGAT Combustor.

The combustor liner used in the QCGAT tests (fig. 8) was a modification of the production TFE731 burner. These modifications consisted of several variations, and included punched versus pierced holes. Different hole locations and sizes were incorporated for smoke number reduction. The actual burner used in the test was an experimental interim design. As a result, the temperature pattern factor was higher than desired during early testing. This condition was corrected on later burners.
