SPACE SHUTTLE ORBITER
LEADING-EDGE FLIGHT PERFORMANCE COMPARED TO DESIGN GOALS

Donald M. Curry
NASA Johnson Space Center
Houston, Texas

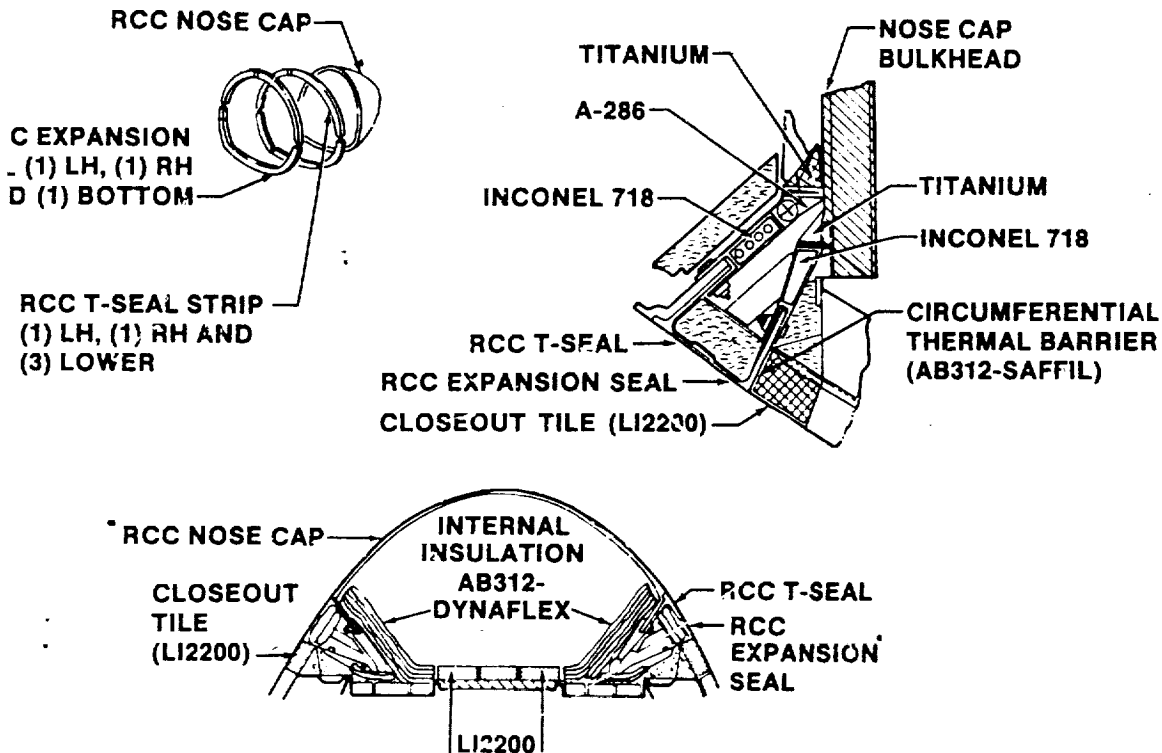
Final design configuration of the RCC nose cap assembly is illustrated in Figure 2, consisting of the dome, five (5) gap seals, and three (3) expansion seals. Functional requirements of the seals are to allow thermal expansion and deflections while simultaneously preventing hot gas influx into the cavity and precluding deflections of the RCC that penetrate into the interface RSI tile envelope. Illustrated pictorially by the representative panel-seal set in Figure 3, the wing leading edge consists of twenty-two (22) similar assemblies on each wing. Gap seals are provided between the panels to serve the same function previously described for the nose cap seals. Optimization of the size of the panels included as significant parameters: structural integrity, producibility in terms of tooling and facility requirements, and weight.

Figure 2.- Nose cap system.

Elevated temperature is the primary factor in the design of the attach fittings as well as the internal insulation system used in the protection of those attachments. Heat resistant metals such as Inconel 718 and A-286 steel are utilized to interface between the RCC and the aluminum support structure. Protection is provided these metal components with various insulation packages composed of Dynaflex, AB-312 ceramic cloth, saffil, or RSI tiles. Dynaflex, contained in formed and welded Inconel 601 foil, is the primary insulation system used in the wing leading edge as illustrated in Figure 3. Blankets of Dynaflex and saffil wrapped with AB-312 cloth are used in the nose cap cavity along with RSI tiles on the forward face of the access door in the support bulkhead as indicated in Figure 2.

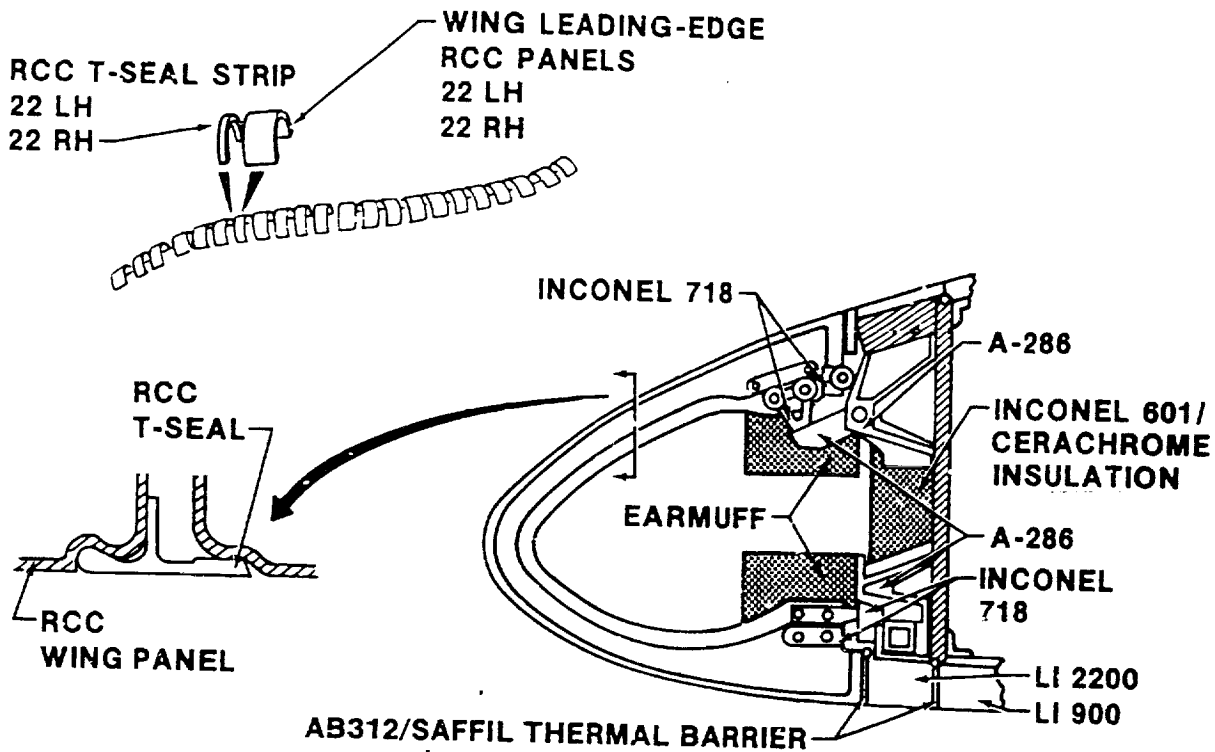
Figure 3.- Wing leading-edge system.

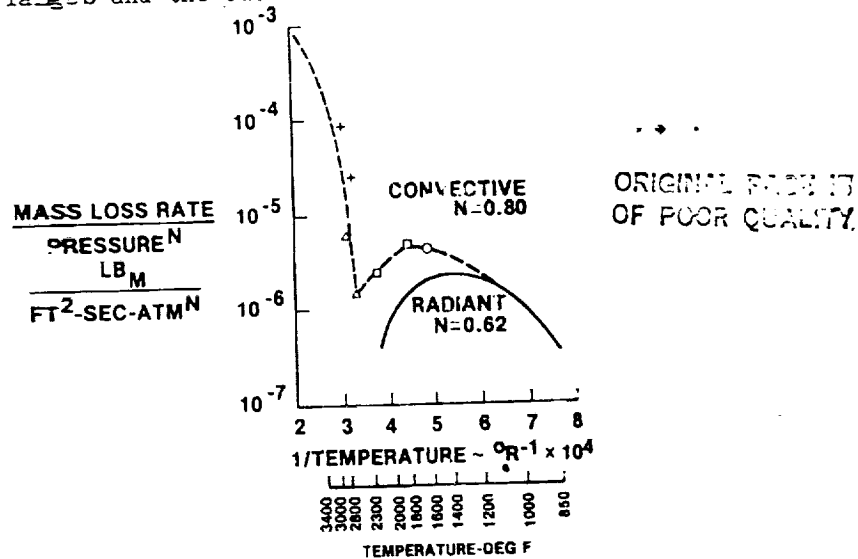
Oxidation rate is the single most important variable parameter in the determination of mission life of RCC parts. Oxidation of the carbon substrate occurs as a result of oxygen penetrating the protective coating through microscopic porosity or fissures inherent in the coating system. Resultant strength degradation^{1,2} caused by the substrate mass loss restricts the mission life capacity through the inability of the RCC to sustain the predicted loads. Oxidation rate is a function of temperature, pressure, time, and the type of environment, either radiant or convective heating.³ Radiant and convective mass loss correlation curves are presented in Figure 4, applicable to the flanges and the outer shell regions respectively.

Figure 4.- RCC mass loss correlation.

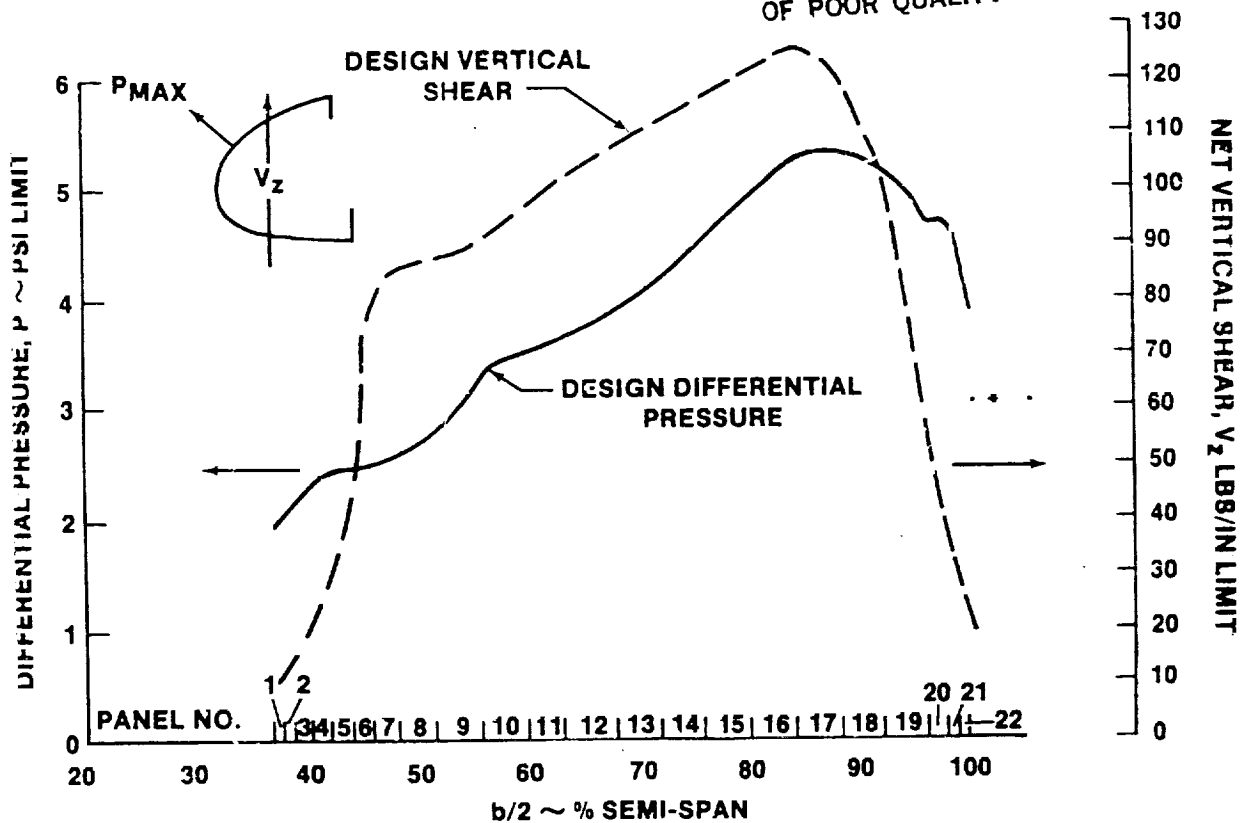
Structural analyses were performed on the nose cap and wing leading edge with the basic objective to determine the resultant stresses, deflections, and margins of safety for the applied environments. The complex nature of the design coupled with the deterioration of the mechanical properties of RCC with each repeated exposure to oxidation created unusual analytical problems. Detailed finite element structural models were constructed for the nose cap and representative wing leading-edge panels to insure adequate resolution of the issues. Verification of the analytical methodology was achieved in the qualification test program which led to flight certification.^{6,7} Additional complexity was introduced with the inherent shape of the parts, the variable stiffness of the support structure, and the interaction of the adjacent parts. Critical stresses had to be determined for each part, dependent upon these parameters and sensitive to the distribution of the applied airloads. Typical spanwise variation in the airloads along the wing span can be observed in Figure 5.

Figure 5.- LESS design airloads.

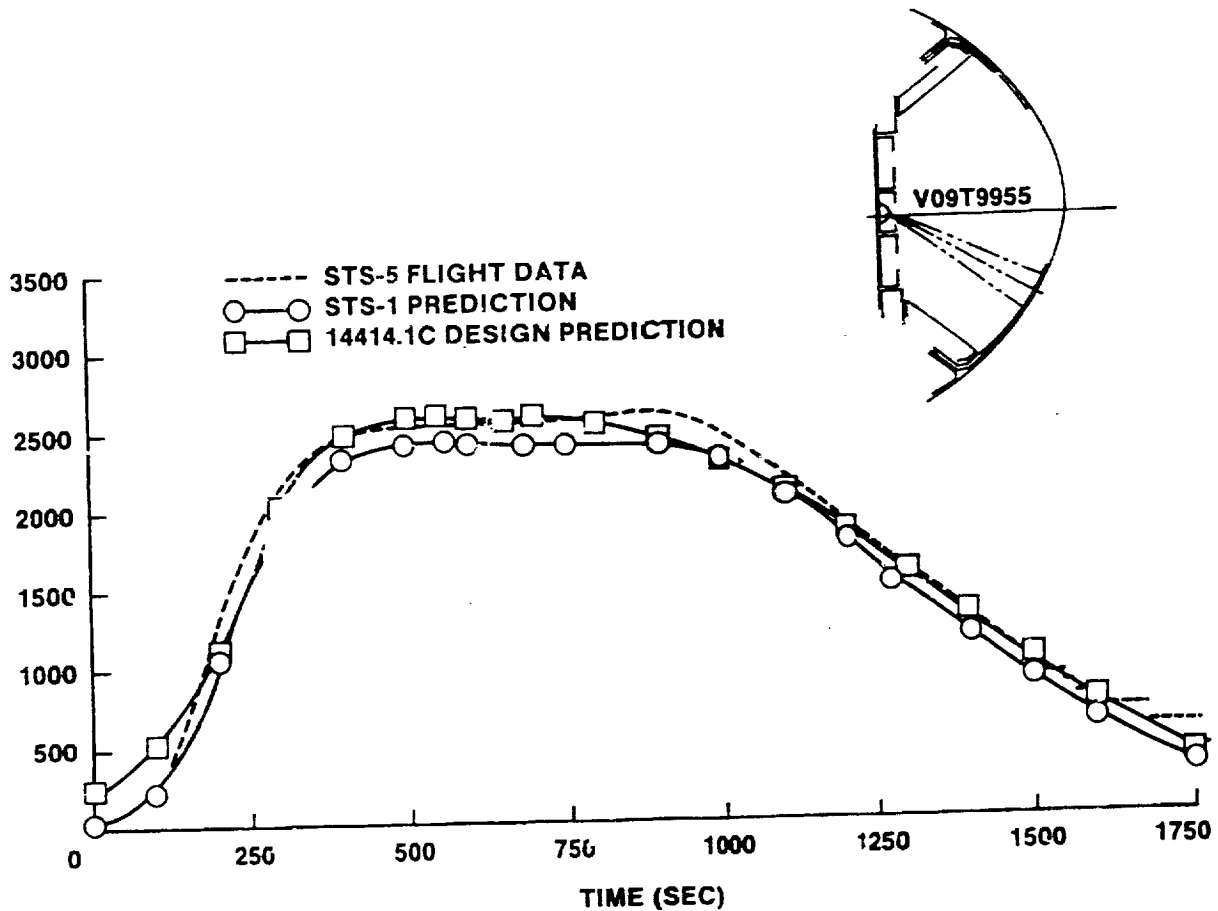
Figure 6.- Nose cap RCC inner moldline (IML) temperature.

Successful completion of the initial flights of Columbia have provided sufficient data from radiometers, thermocouples, and pressure transducers to appraise the thermal performance. STS flight parameters, especially angle of attack, allowed relatively lower total heat load and heat rate on the LESS than that predicted for the design trajectory. STS and design trajectory differences can be assessed by comparing the heat rate and heat load to a one-foot sphere. Peak heat rate varied from 80 percent of design for STS-1 to 96 percent for STS-4; whereas, heat load varied from 64 percent of design for STS-5 to 92 percent of design heat load for STS-2. Radiometer data presented in Figures 6 and 7 for the nose cap and wing leading edge, respectively, indicates good agreement between the predicted and measured temperatures for the RCC shell inner surface. Measured STS flight temperatures for the panel 9 attachment clevis fitting were lower than both the STS and design predictions as indicated in Figure 8. Evaluation of the STS flight data indicates no degradation in the thermal performance of the LESS components, particularly the insulation systems.

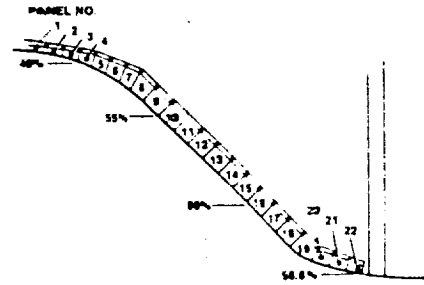
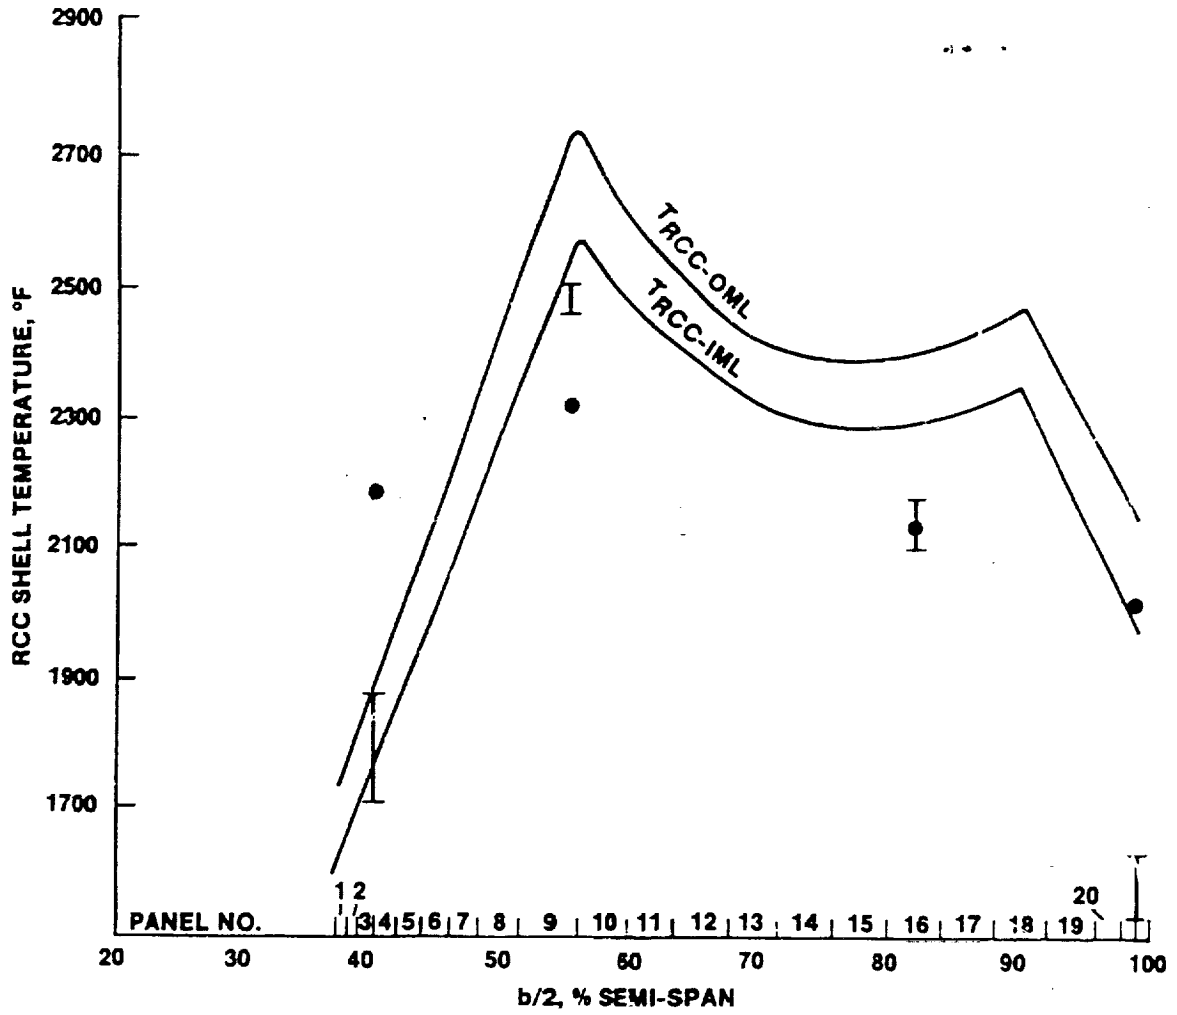
I STS FLIGHT DATA
● STS-2 PREDICTIONS

Figure 7.- Wing leading-edge inner moldline (IML) temperatures.

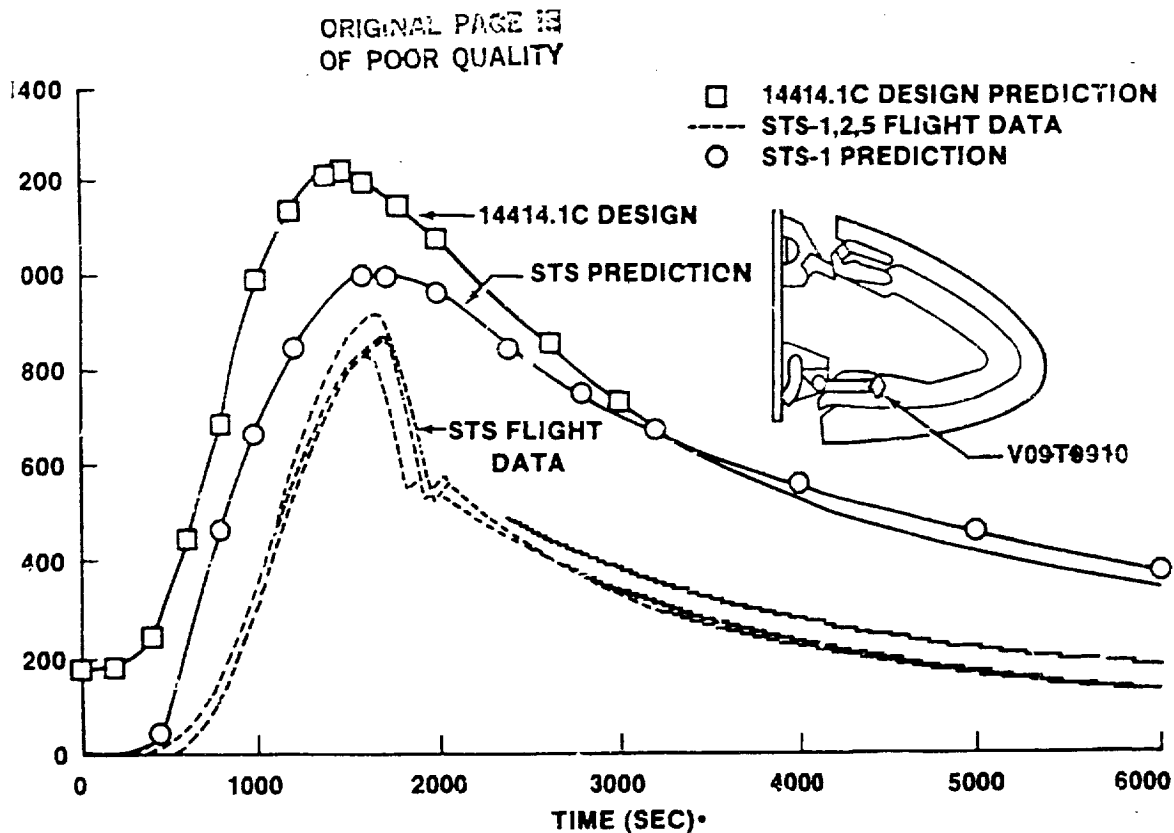
Figure 8.- Wing leading-edge panel-9 lower attach clevis temperature.

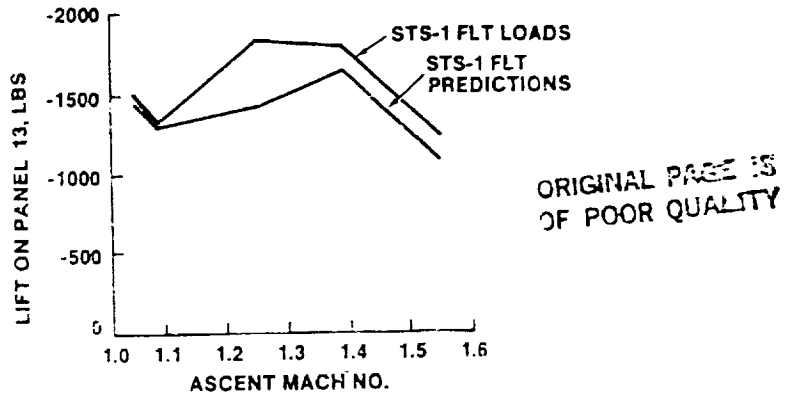
Structural performance evaluation requires a more subjective appraisal since the elevated temperature environment precludes the direct acquisition of flight airload data in the critical regions. Strain measurements were limited to special, instrumented attach fittings on the wing leading-edge panel 13, calibrated to determine the magnitude and direction of the flight airloads during ascent. Effective loads are combined external aerodynamic pressures and internal cavity pressures. Load vectors, parallel to the wing front spar, are developed by integrating the differential pressure over the surface area of a panel. Peak ascent loads occur in the maximum dynamic pressure regime coincident with transonic speeds between 1.0 and 1.5 Mach number. Ascent load vectors, developed from flight strain measurements on panel 13, average about eleven (11) percent higher than the anticipated loads as indicated in Figure 9. This is considered to be excellent correlation and indicative that realistic airloads were used in the LESS structural analyses.

Figure 9.- Wing leading-edge panel-13 airloads comparison.

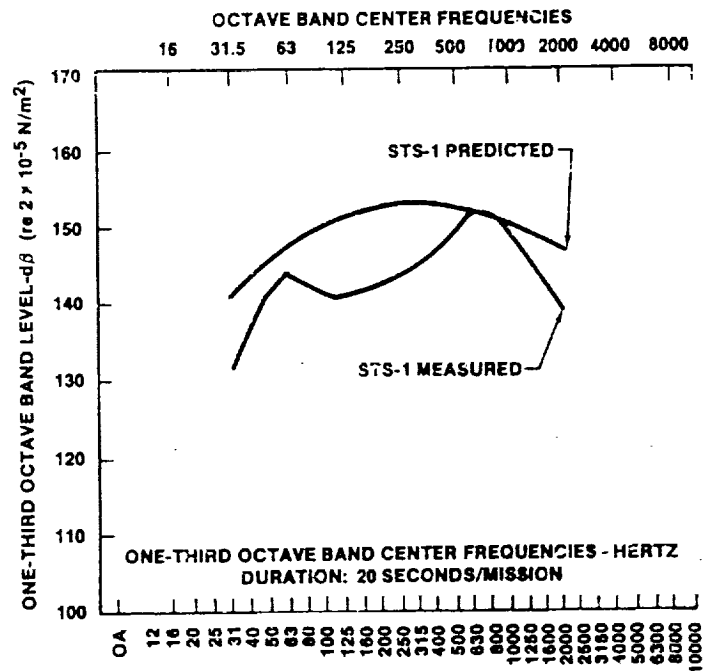
Vibroacoustic environments that were used for the LESS design analysis and flight qualification procedures were determined to be conservative from the flight data. Wing leading-edge flight acoustic data present in Figure 10 is comparatively less than the design environment. Impact of this difference is considered negligible at this time but indicative that the critical margins of safety for the RCC lugs are conservative from the vibroacoustic effects perspective.

Figure 10.- Wing leading-edge acoustic environment comparison.

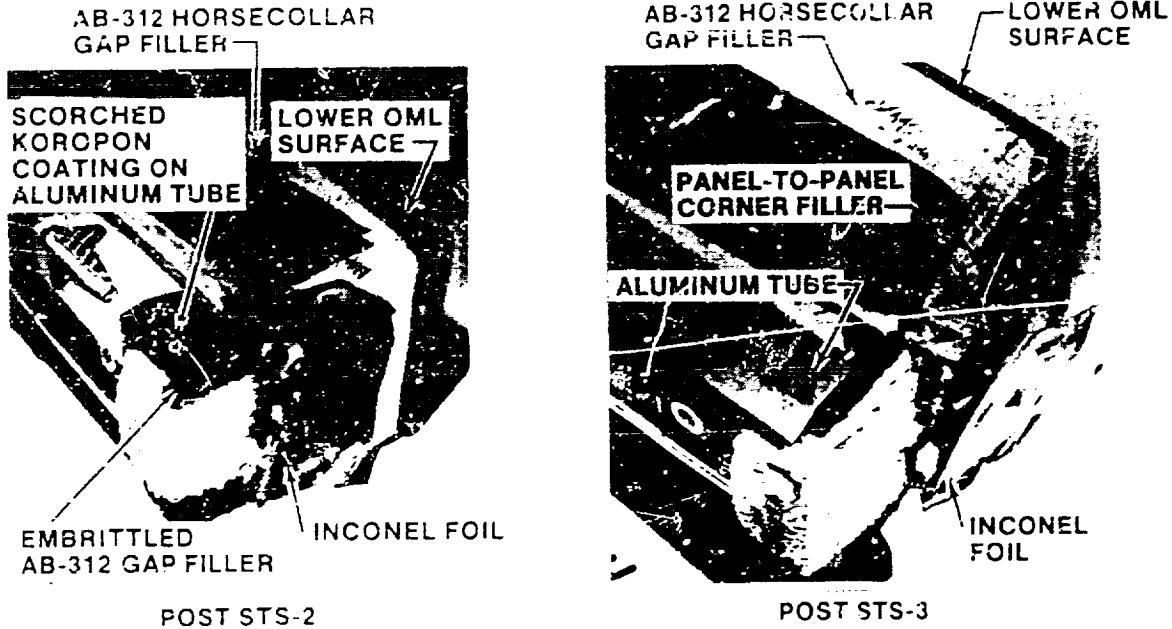
Figure 12.- Wing leading-edge panel-10 heating effects comparison.

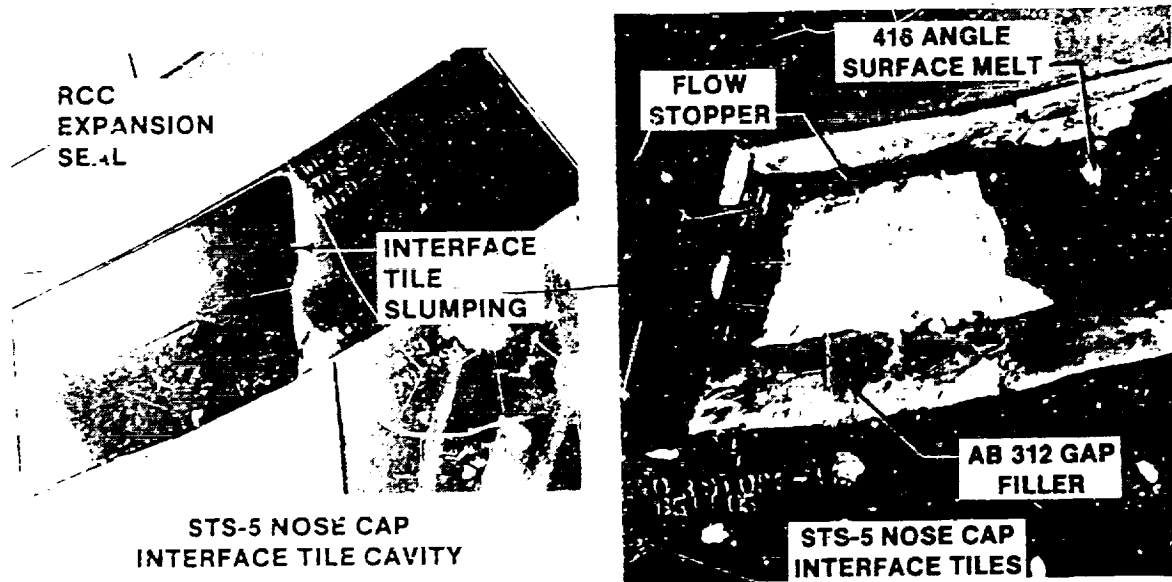
Figure 13.- Interface tile gap heating.

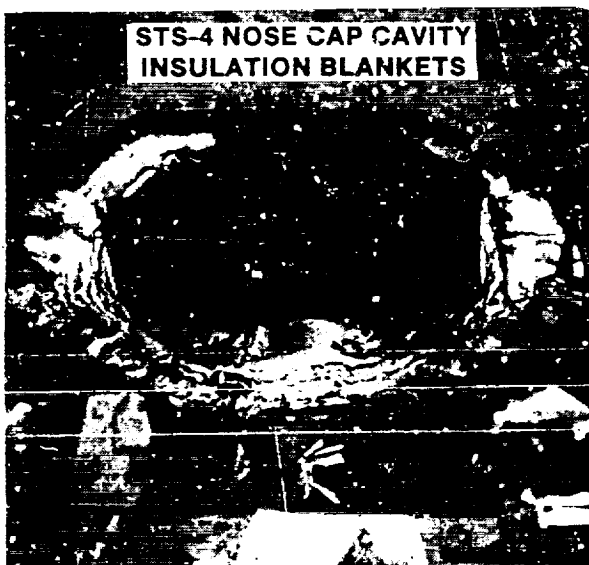
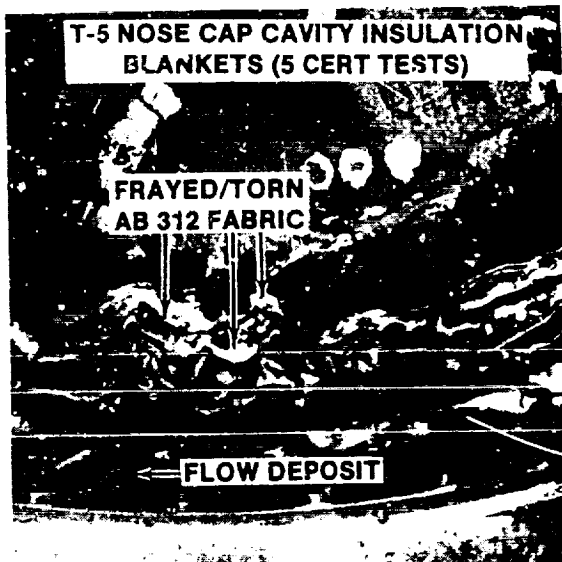
STS-4 NOSE CAP CAVITY
INSULATION BLANKETS

T-5 NOSE CAP CAVITY INSULATION
BLANKETS (5 CERT TESTS)

FRAYED/TORN
AB 312 FABRIC

← FLOW DEPOSIT

Figure 15.- Nose cap insulation system thermal effects comparison.

Insulation blankets of AB-312 wrapped Dynaflex used in the nose cap have a higher temperature capacity than the Inconel sheathed Dynaflex used in the wing leading edge; however, it is more susceptible to installation handling damage. Exposure to temperatures in the range of 2300°F causes the AB-312 fabric to become friable. Damaged insulation as a result of handling in the nose cap qualification test article after five (5) cycles is illustrated in Figure 15 and compared to the Columbia insulation after four (4) flights. Inspections of the insulation systems on the Columbia after four (4) flights reveal no deterioration, and the flight data has revealed no thermal performance degradation. Additional life tests will be used in conjunction with continued, scheduled inspection of the flight insulation system to establish the actual life capacity.

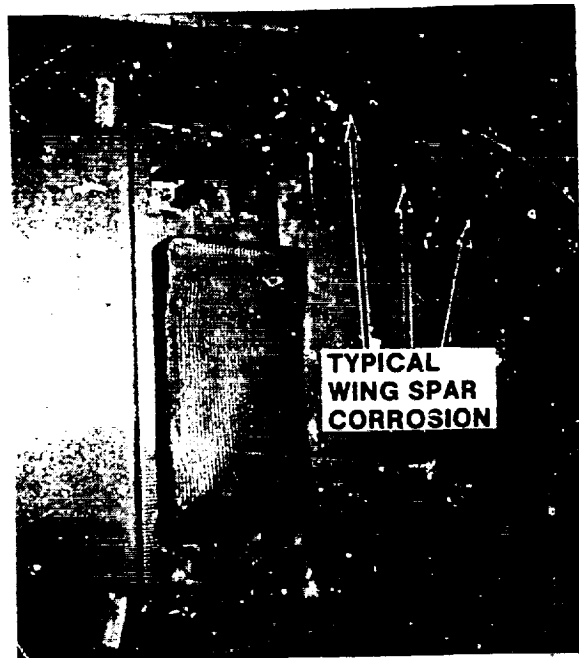
Related to the insulation system is a phenomena occurring on the wing front spar where the Inconel sheathed Dynaflex insulation is attached directly to the aluminum honeycomb spar. Corrosion of the aluminum, appearing as blisters in the Super Koropon paint as illustrated in Figure 16, is assumed to be a result of galvanic activity caused by the contact of dissimilar metals with the source of moisture being the humid air flowing through the LESS vent system. Direct exposure to the salt atmosphere could also be a contributing factor to the corrosion problem. The OV-102 wing front spar is constructed of aluminum honeycomb with face sheet thicknesses ranging from 4 mils to 120 mils that is painted with 1 mil of Super Koropon for corrosion protection. The insulation is contained in 4-mil thick waffled Inconel foil. Corrosion, occurring in discrete areas, created pits in the aluminum 80 to 100 mils in diameter and 1 to 14 mils in depth, some of which penetrated the face sheet. Ramifications of the corrosion range from no impact for the minor pitting to potential structural damage for the areas under major attack. Viable solutions include additional coats of Super Koropon and RTV to the painted aluminum surface, thereby providing a much more tolerant protection system.

Figure 16.- Wing front spar corrosion.

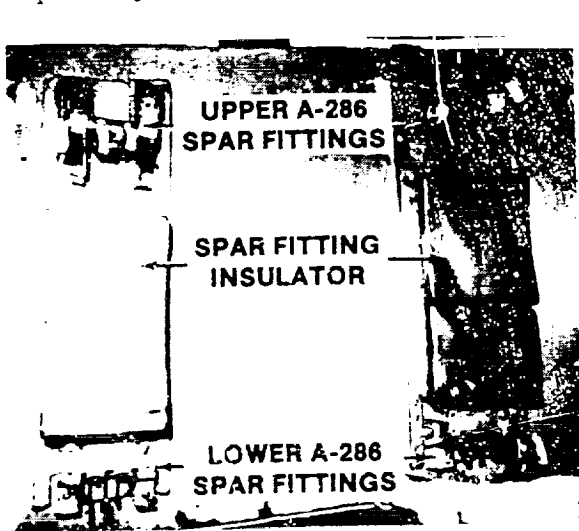
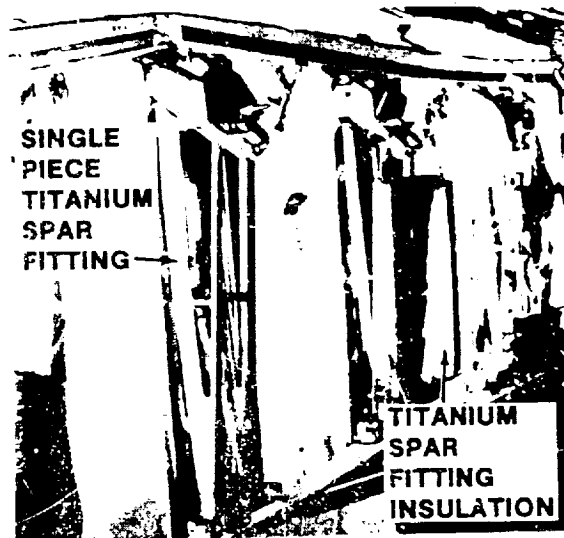
Wing leading-edge RCC panels are cantilevered off the front spar at four points by high-temperature, A-286 steel fittings. Figure 18 shows the general configuration. The initial material selection and sizing for these fittings were driven by expected temperatures (about 1000°F) and large airloads. In addition, producibility required a minimum gage of 100 mils for this very tough material. As the design environments matured and the analysis methods became more refined, peak temperatures dropped below 600°F. This allowed 6AL-4V titanium to be used in lieu of steel. At the same time, the load paths were optimized, resulting in one piece fittings. Producibility gains allowed the minimum gage to drop to 60 mils compared to the 100 mils required in the A-286 steel design. A weight reduction of about 300 pounds per shipset was realized with this change.

Figure 18.- Wing leading-edge spar fittings.

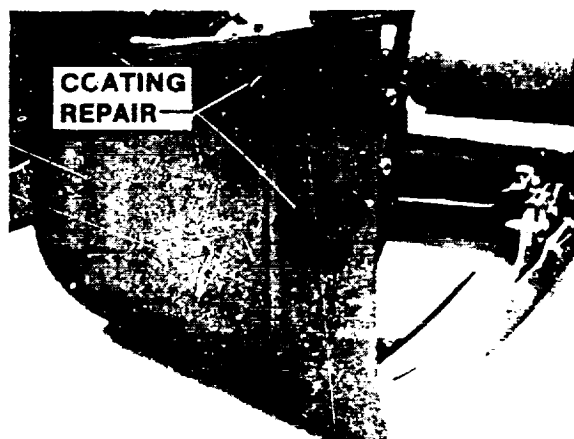
Susceptibility of the SiC coating to chipping, primarily ground handling damage on the edges of the RCC parts, necessitates a repair capability. Development of a repair procedure included a repair for major type damage that would be performed at the manufacturer's facility and a repair for minor type damage that could be performed at the launch site. Differentiation between major and minor damage is primarily determined by whether the black carbon substrate is exposed by the coating damage. Although the launch site repair would provide some protection from local oxidation for damage exposing the substrate, limitations have been placed on the procedure restricting it to one flight only. Several major coating repairs were made on the Columbia prior to STS-1, typically pictured in Figure 19. Additional launch site repairs were made subsequent to each of the first three missions. Flight exposure of these repairs has allowed several observations. Performance of the major repairs has been consistent with ground test results in that the repairs have remained intact with no appearance of shrinkage, craze cracking, or any other deleterious anomalies. Assuming congruency with test results, absence of flaws in the repair also suggests that the substrate is adequately protected from oxidation. Durability of the launch site repairs applied to minor damage areas also confirms the validity of this procedure to achieve and maintain the aerodynamic surface. Launch site repairs, utilizing the re-entry thermal environment to complete the cure process, will occasionally require touch-up to remove flaws that developed due to shrinkage or flow of the repair material.

Figure 19.- Typical coating repair.

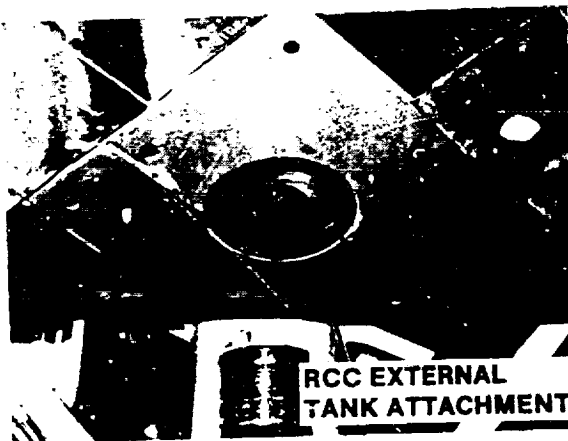
The RCC arrowhead, illustrated in Figure 20, was a redesign and retro-fit of the original RSI tile design that failed the qualification tests of the explosive separation of the external tank. Configured in two pieces to facilitate installation around the attach mechanism, the RCC arrowhead parts are independently attached to the carrier plate with fasteners countersunk into the outer RCC surface. Design alterations required a rework of the Columbia arrowhead to provide a 45° bias joint instead of the joggle overlap at the interface of the two RCC components. Removal of the flange necessitated a major coating repair which, due to the lack of flight experience of coating repairs, caused a one-flight restriction to be placed on this particular assembly. Performance of the RCC arrowhead during STS-1 was superb, not only surviving the punishing explosive separation but also providing its primary function, along with the internal insulation, of thermal protection of the metal structure. Contrary to pre-flight, pessimistic expectations, the extensive coating repair exhibited no shrinkage or obvious detrimental effects from the initial flight exposure. Approval was therefore granted for an additional mission. In fact, this arrowhead eventually flew three missions prior to being replaced and used as a "guinea pig" to subjectively evaluate the multi-mission capability of an extensive coating repair and the integrity of the substrate around the attach holes. Sections taken in several areas revealed that the substrate around the attach holes locked good, contrary to the condition of the ground test article subsequent to the simulated separation tests. Interface conditions between the substrate and the coating repair were not ideal, but the repair was in excellent condition. The presence of localized mass loss was minimal and could actually have been caused by shrinkage of the repair material rather than oxidation of the substrate.

Figure 20.- RCC arrowhead.
