Advanced Gas Turbine

1985 Annual Report

Allison
GAS TURBINE DIVISION
General Motors Corporation
P.O. Box 420
Indianapolis, Indiana 46206-0420

This report presents a technical summary of the Allison Gas Turbine project to develop an automotive gas turbine power-train system under NASA Contract DEN 3-168 (Department of Energy funding). The report covers the 1985 calendar year.

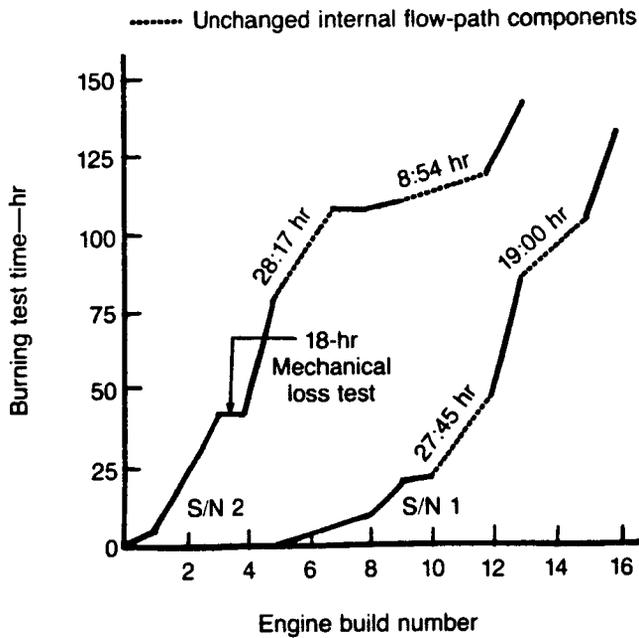
Figure 8. Cumulative burning test hours of AGT 100 experimental engine.

Figure 8 graphically displays the burning operating time, in a cumulative manner, for the two experimental engines.

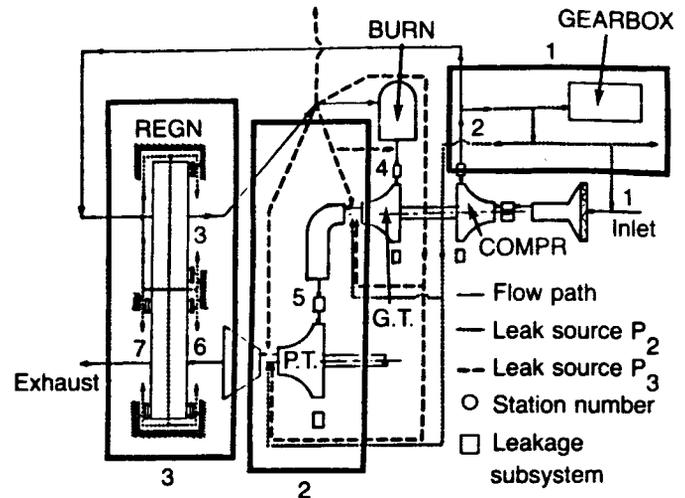
Figure 9. AGT 100 leakage system.

Engine S/N 1 BU13 and Test. There are several locations within the engine where working fluid leakage can occur. The sources of leakage, as schematically depicted in Figure 9, can involve flow paths to overboard, compressor discharge to gearbox, compressor discharge to turbine exhaust (regenerator seals), and burner inlet pressure to several points within the turbine flow path.

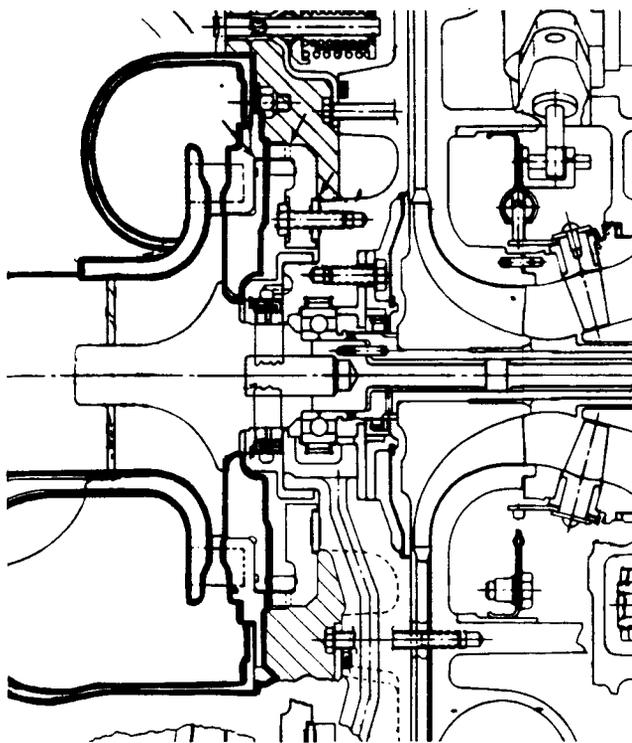
Figure 10. AGT 100 gasifier turbine backplate air leakage sources.

The potential leakage points involving the turbine backface cavities are denoted in Figure 10. Leakage paths may exist at surfaces shown by the arrows at the gasifier turbine and at comparable locations at the power turbine. A test configuration was assembled using several engine parts with added inlet and outlet plugs at locations as depicted in Figure 11. Application of air pressure to the burner inlet cavity produced leakage that was individually measured by flow tubes at each turbine. The resultant leakage values are plotted in Figure 12 and compared to the leakage values used in the engine performance computation model. Both the power and gasifier turbine measured leakage rates determined from this cold test are lower than their predicted values used in the calculated engine performance model.

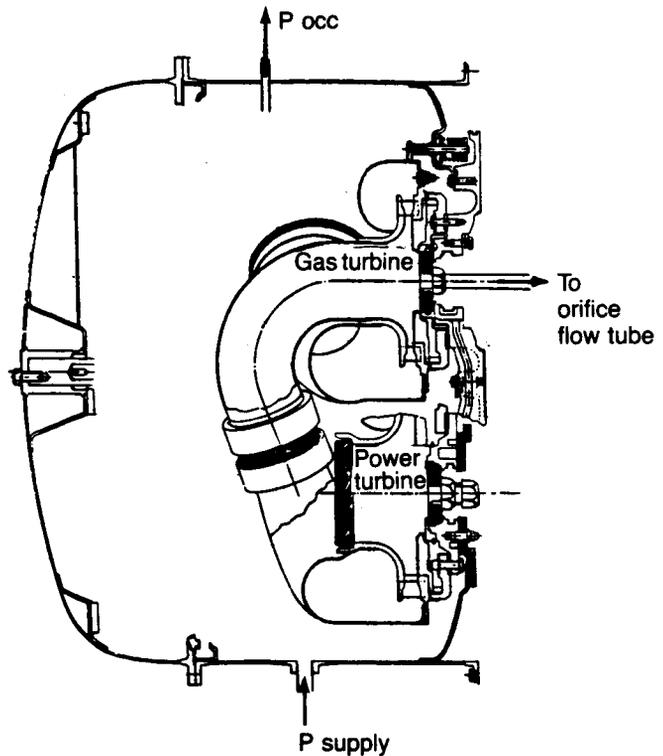
P_{occ} = Pressure, outer combustor case, virtually equal to pressure within the combustion case

Figure 11. AGT 100 backface leakage test configuration.

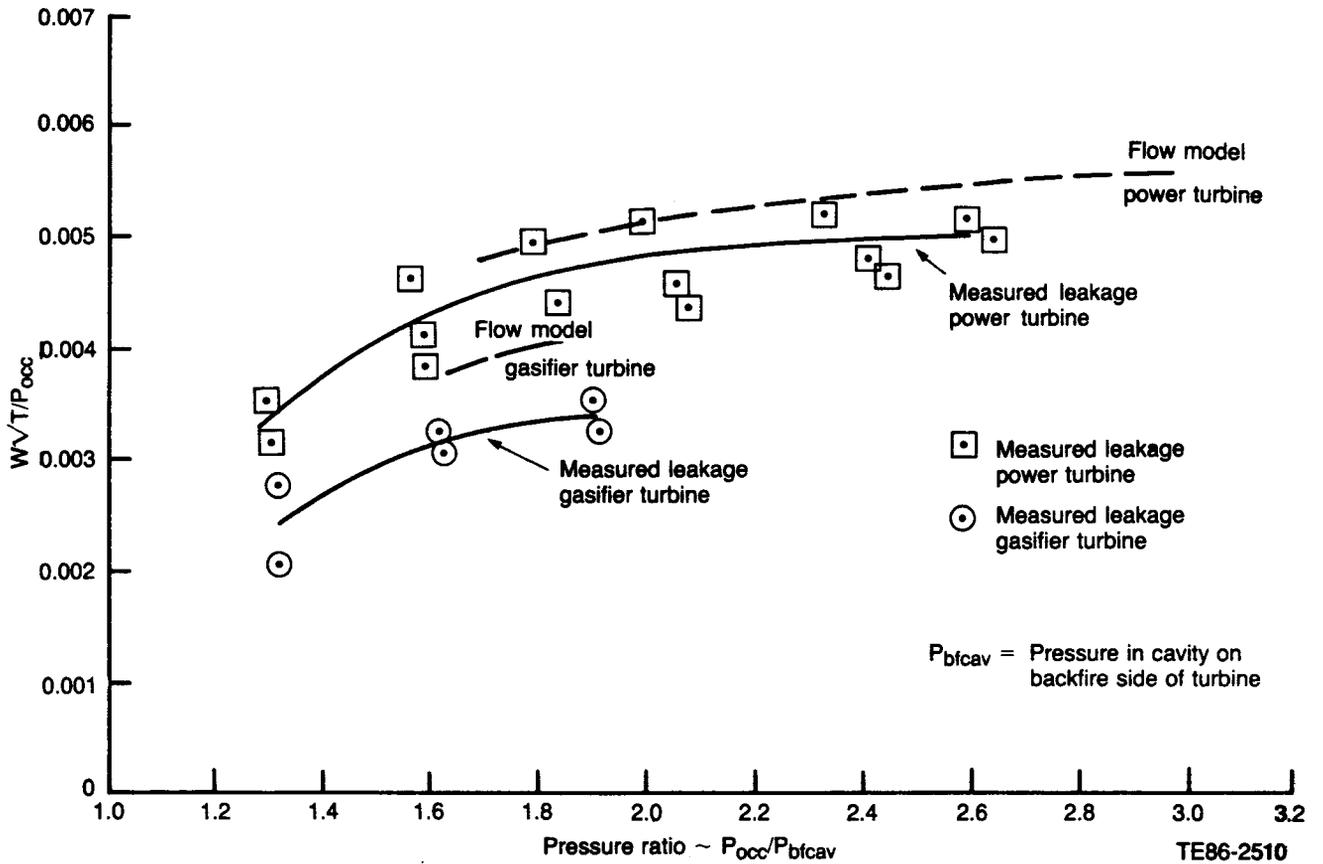
Figure 12. Turbine backface leak test.

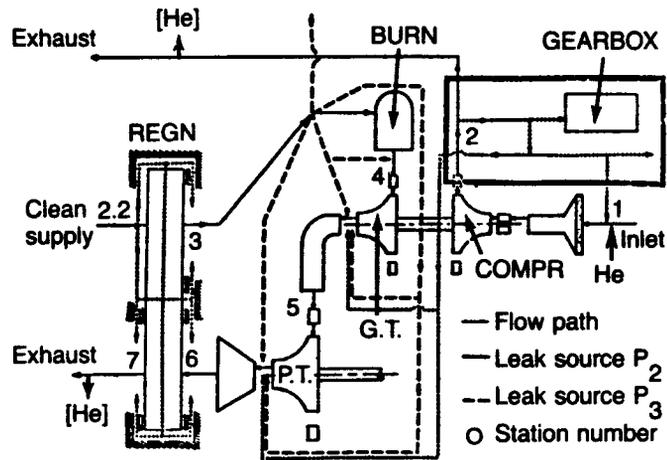
Figure 13. Schematic of leak detection flow path.

The third step in the leakage test program involved hot testing in the engine using both the calibrated turbines and tracer gas. The leakage source and amount was determined by using an engine configuration in which air exiting the compressor was exhausted to the atmosphere and clean air was supplied to the regenerator. A schematic of this test setup is depicted in Figure 13. Airflow was measured at the following locations:

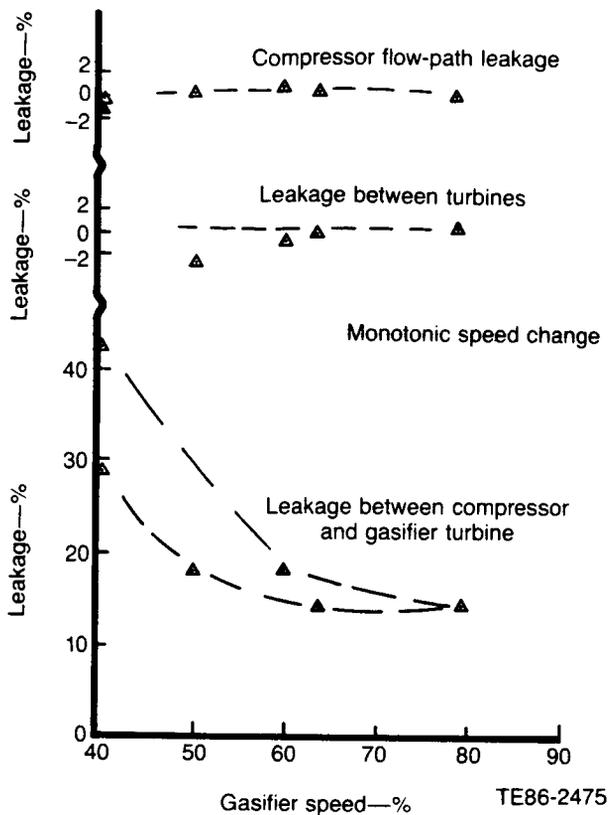
Figure 14. Leakage as determined by orifice measurements.

Engine leakage (orifice airflow) testing was performed in the speed range of 40% to 80% of full speed of the gasifier shaft. Leakage was determined from the orifice flow pressure measurements made at the compressor inlet, compressor discharge, regenerator inlet, gasifier turbine, and power turbine. The results of these airflow measurements are presented in Figure 14. Leakage between the compressor inlet and compressor outlet was determined to be nearly negligible. Similarly, the measured leakage between the turbines is inconsequential. However, leakage between the compressor and gasifier turbine was found to be excessive, particularly at speeds below 65%. This leakage was primarily through the regenerator seals. At teardown, measurements showed the hot seal to be substantially warped. A design modification has been identified; refer to the regenerator section for details.

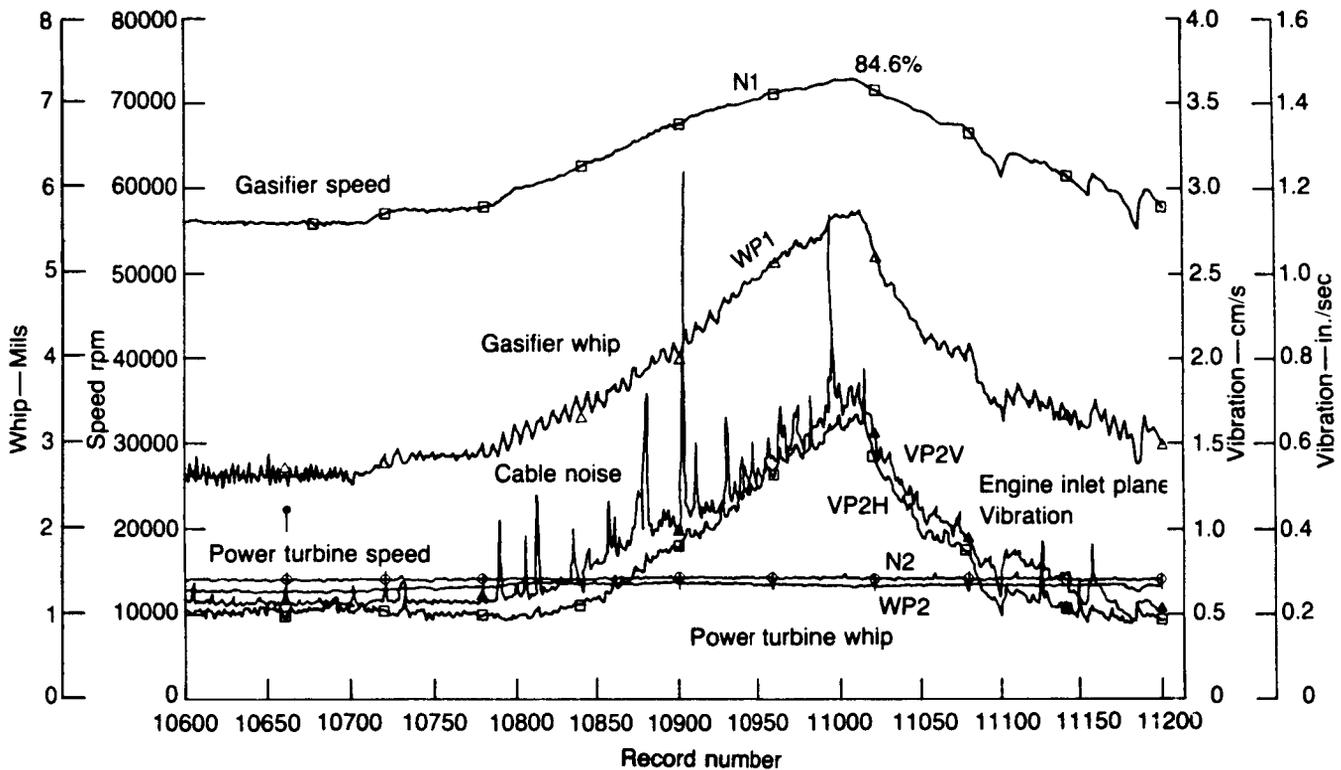
Figure 15. Typical vibration and whip during test of engine S/N 1 BU13.

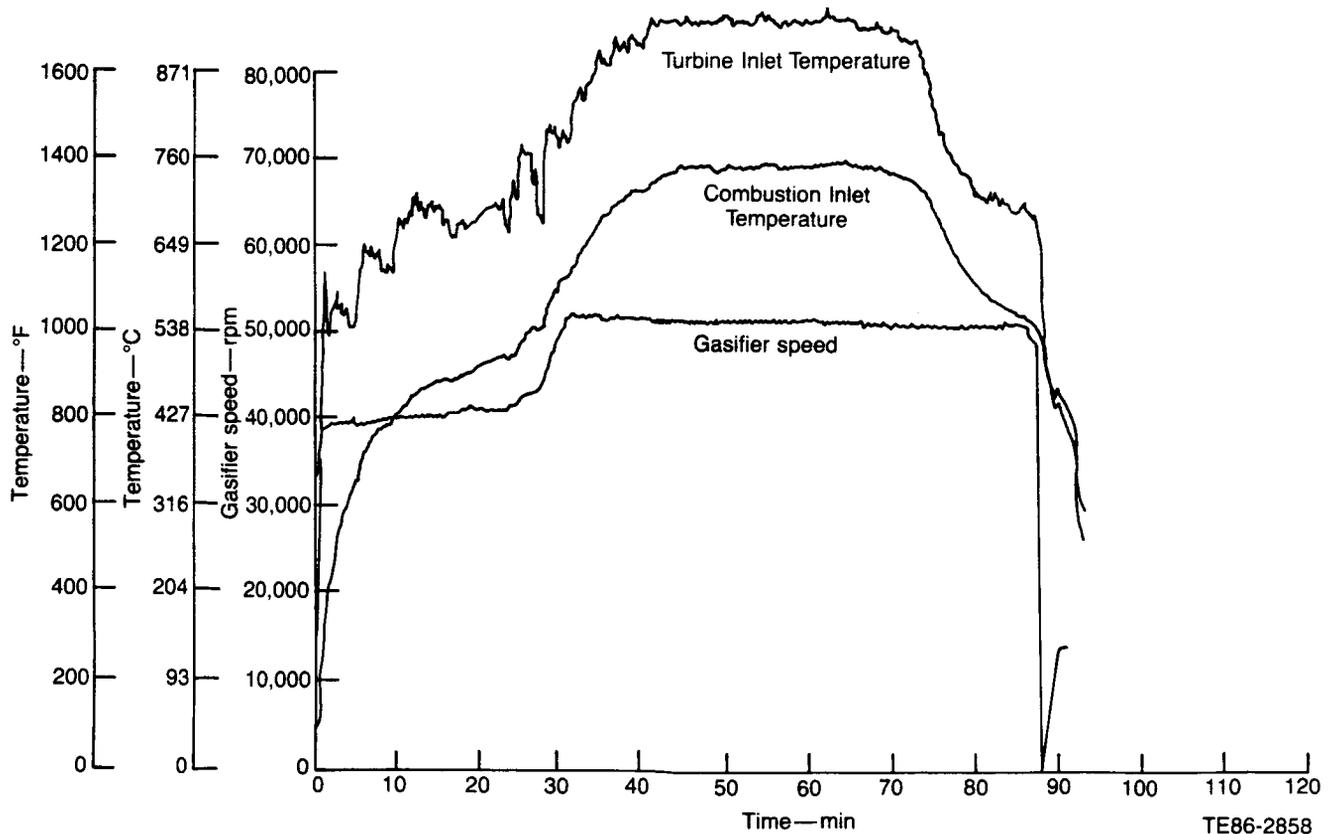
Figure 16. Ceramic gasifier scroll test cycle.

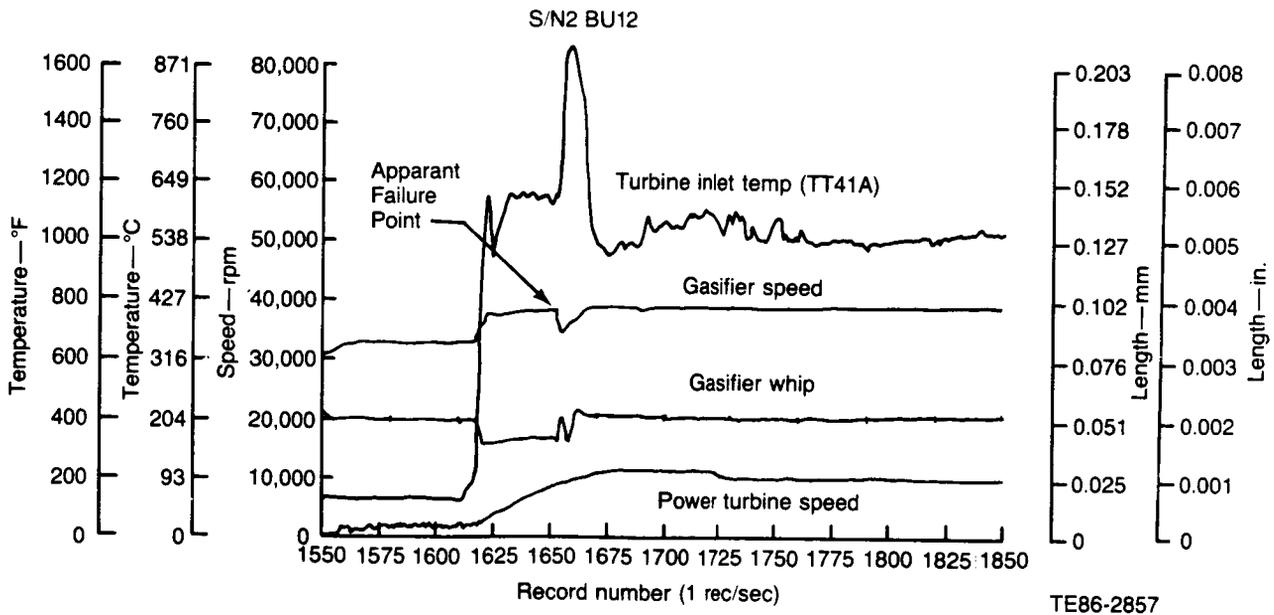
Figure 17. Apparent failure incident indication as depicted by data trace during test of ceramic rotor, S/N 2 BU12 engine test data.

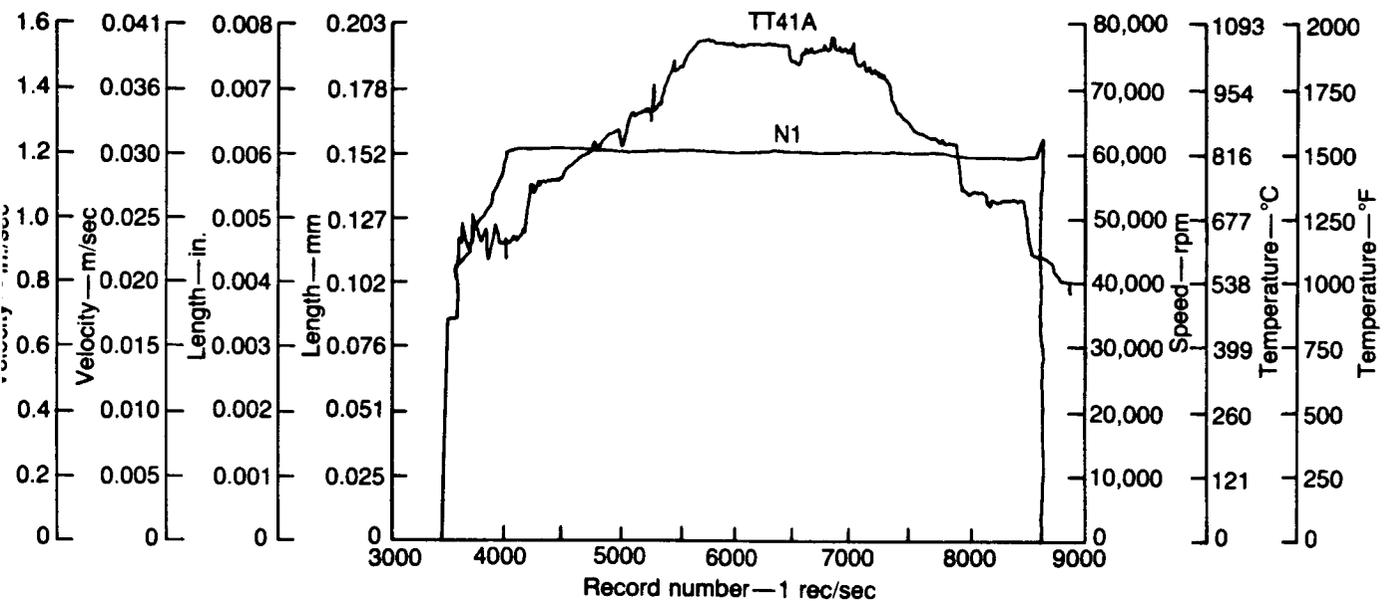
Figure 18. Typical data trace depicting test of Kyocera ceramic part.

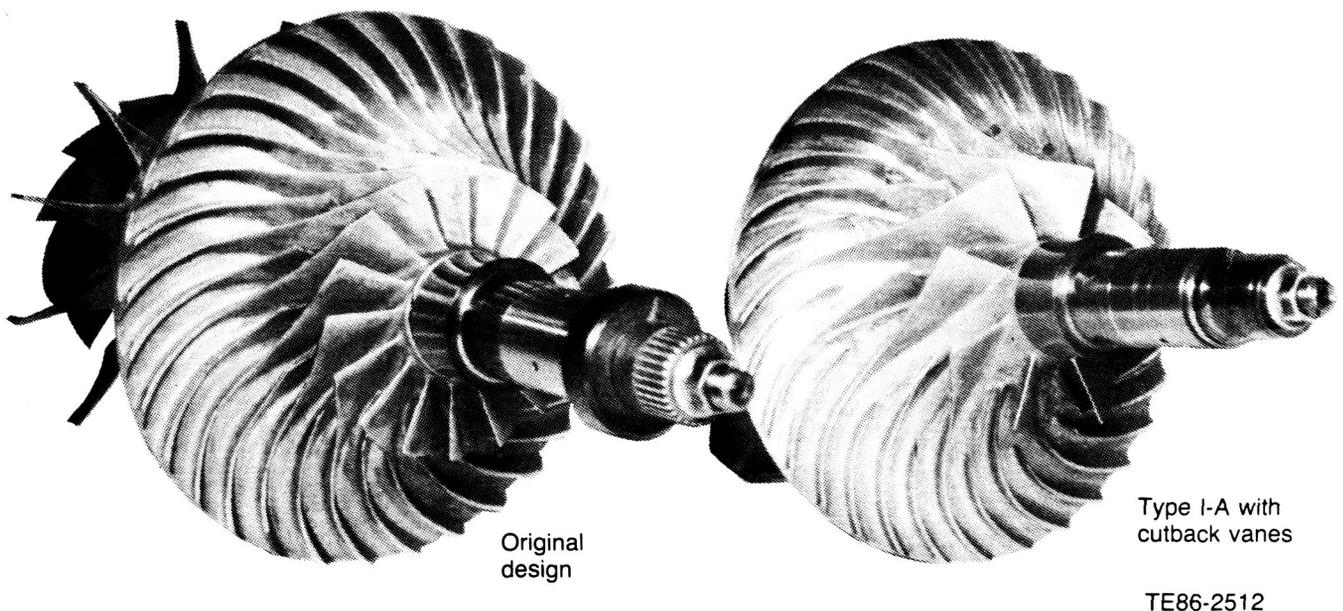
Figure 21. Comparison of original type 1A and double-splitter reduced blade friction compressor impellers.

Type 1A impeller, obtained during rig testing, were presented in last year's annual report. Although the gain was considerable it was short of the design goal and the impeller modification was judged insufficient to justify replacement costs of the original impeller in both of the engines. Consequently, the Type 1A impeller was used as the test piece to make the double splitter impeller. The rework involved cutting the original Type 1A splitters to 60% of the meridional distance while every other full length blade was cut back to the original splitter location of 30% of the meridional distance. Both sets of splitter leading edges were blended to reduce the abrupt change in blade thickness blockage produced by the modifications. This yielded an impeller with eight full blades, eight primary splitters, and 16 secondary splitters. A photograph (Figure 21) of the original and the double splitter impellers illustrates the rework performed. The Type-1A impeller incorporated identical blade shape but reduced blade thickness as compared to previous AGT 100 impellers. Previous rig tests (CX-40 BU5) incorporating both reduced blade thickness and exit height (reducing diffusion) indicate that these modifications improve performance. The impeller flow paths (Figure 22) depict the narrowed exit blade height and the double splitter locations.

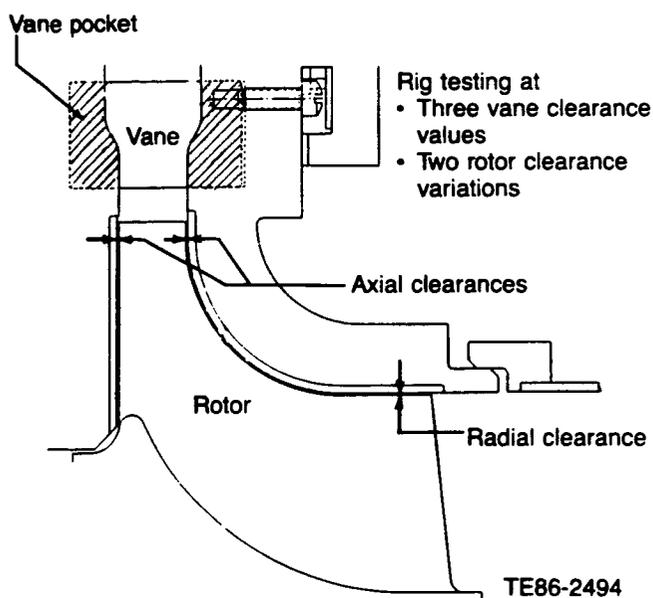
Figure 55. Gasifier turbine rig configuration.

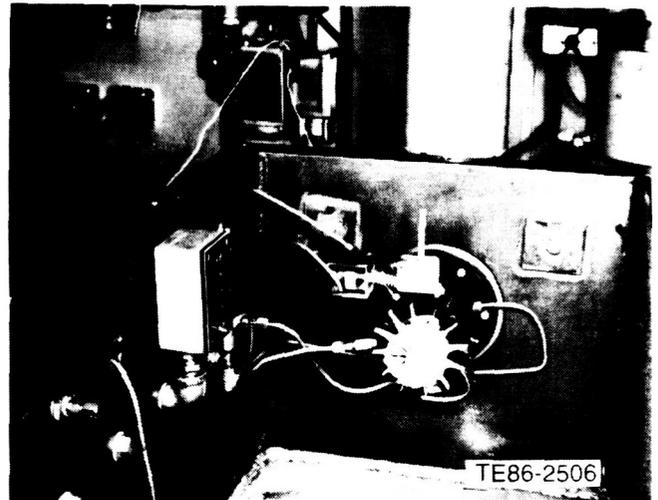
Figure 62. Foreign object damage rig used to investigate potential impact damage to the ceramic gasifier rotor.

The coffin rig is built with the axis of rotor rotation parallel to the base of the coffin. The rotor is bonded to an arbor and spin driven. The dropping mechanism is basically a trap door arrangement, actuated by a solenoid, allowing the particle to free fall without any initial velocity. FOD particles investigated include steel ball bearings and shot varying in size from 0.406 mm (0.016 in.) to 3.175 mm (0.125 in.) in diameter. A thick, wax ring encircles the rotor to catch the FOD particle as it is deflected from the inducer tips, as well as any resulting rotor debris. This technique reduces the probability of secondary impacts. The coffin rig is evacuated to less than 1 mm (0.039 in.) of mercury, absolute pressure, by a combination of two vacuum pumps.

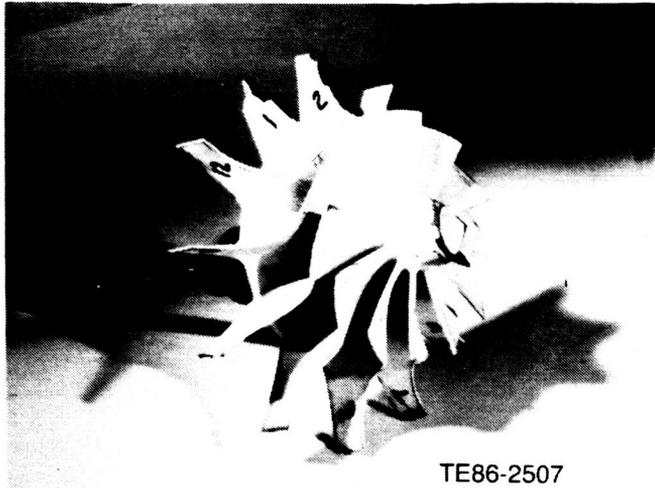
Figure 63. Airfoil damage resulting from FOD impact, SiC gasifier turbine.

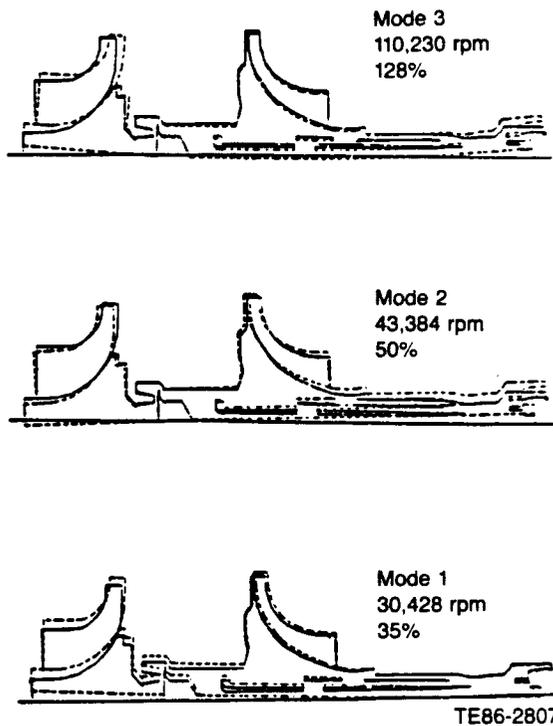
Figure 68. Calculated gasifier rotor assembly modes-brazed rotor/shaft attachment.

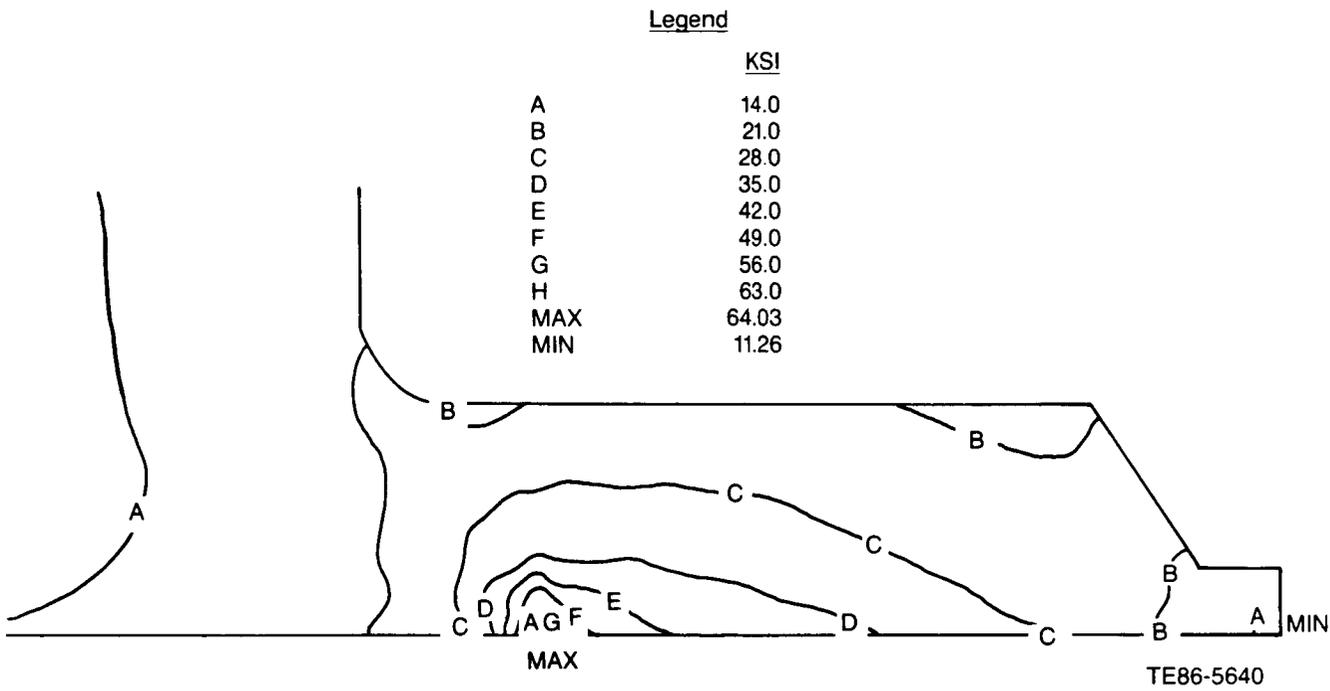
Figure 71. Equivalent stresses, Inco 907 shaft at 100% speed and 1080°C (1976°F) TIT for interference fit attachment.

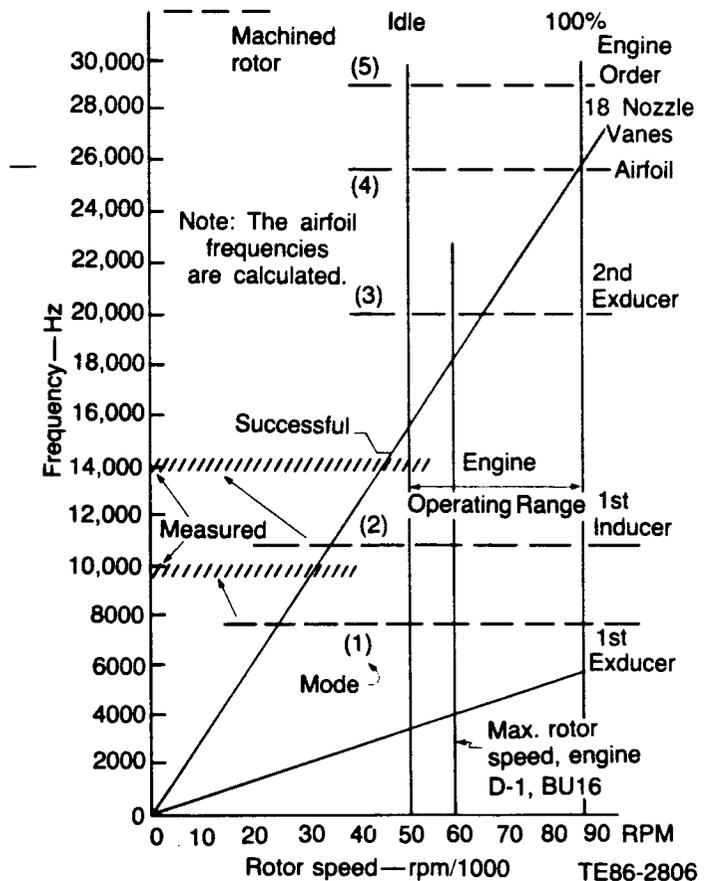
Figure 74. Frequency-speed interference diagram gasifier turbine-silicon nitride, drawing airfoil thickness.

Airfoil natural frequencies were calculated for the finished machined Si_3N_4 rotor, and the results are shown in Figure 74. The interference diagram compares the calculated frequencies with possible vane passage excitation throughout the rotor speed range. Potential resonant response of the third and fourth modes is possible within the engine operating range. The calculated mode shapes for these modes are presented in Figure 75.

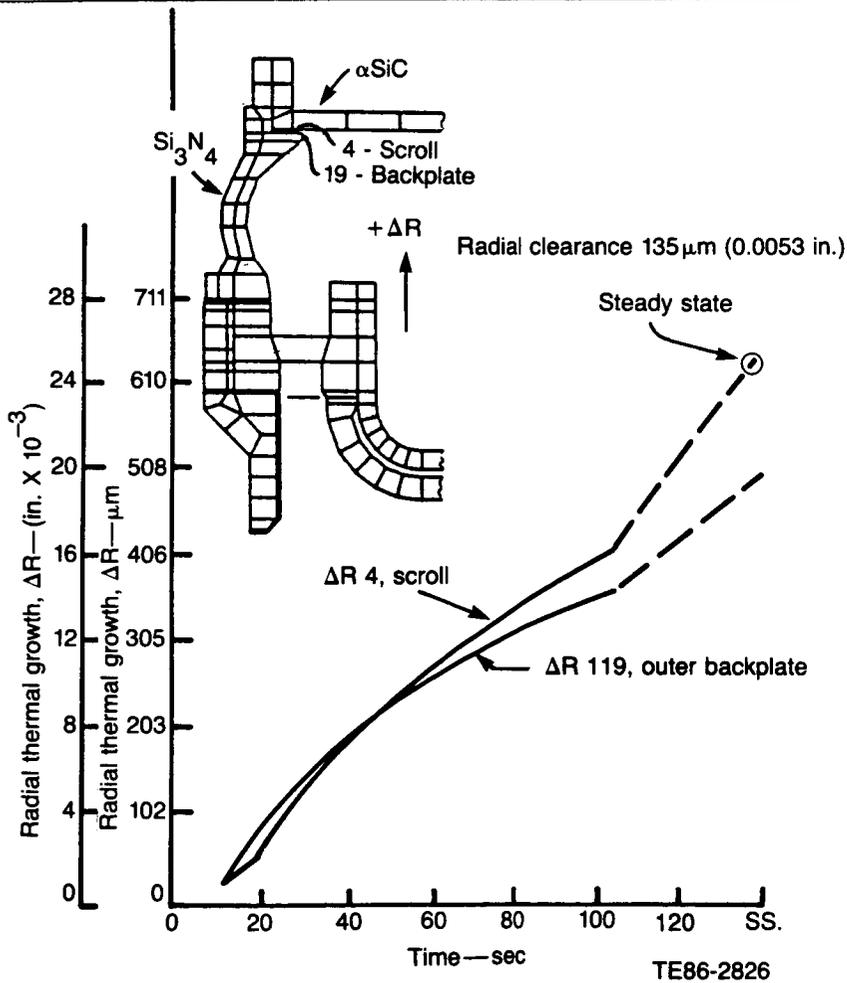
Figure 77. Radial thermal growth of gasifier turbine Si_3N_4 outer backplate and SiC scroll.

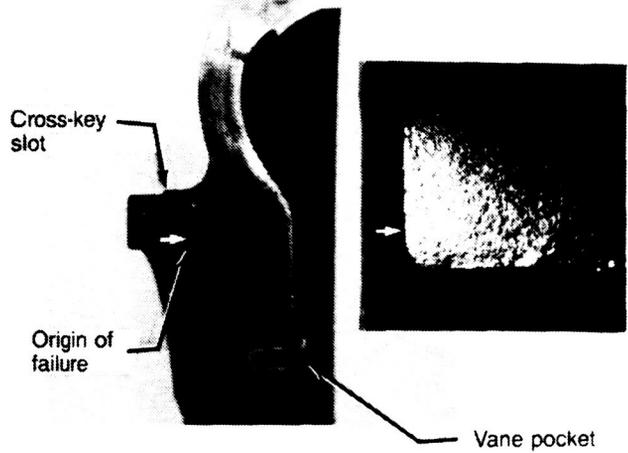
Figure 81. Origin of failure in α SiC gasifier turbine outer backplate.

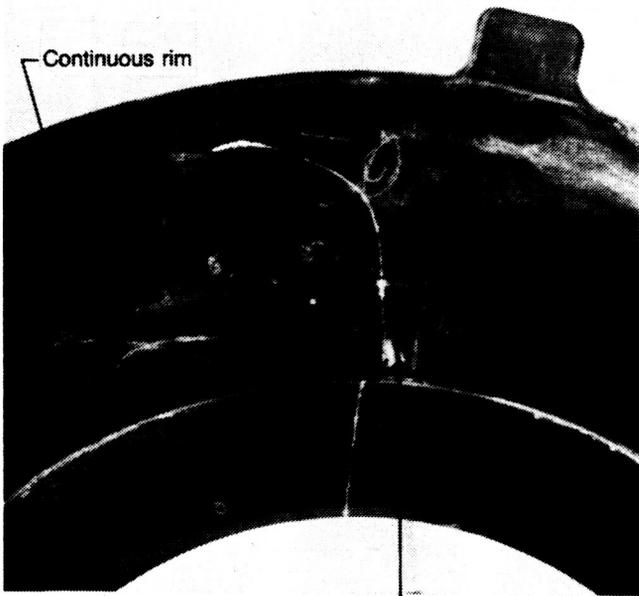
Cross-key slot

Figure 80. Crack indications in α SiC gasifier turbine outer backplate after engine test.

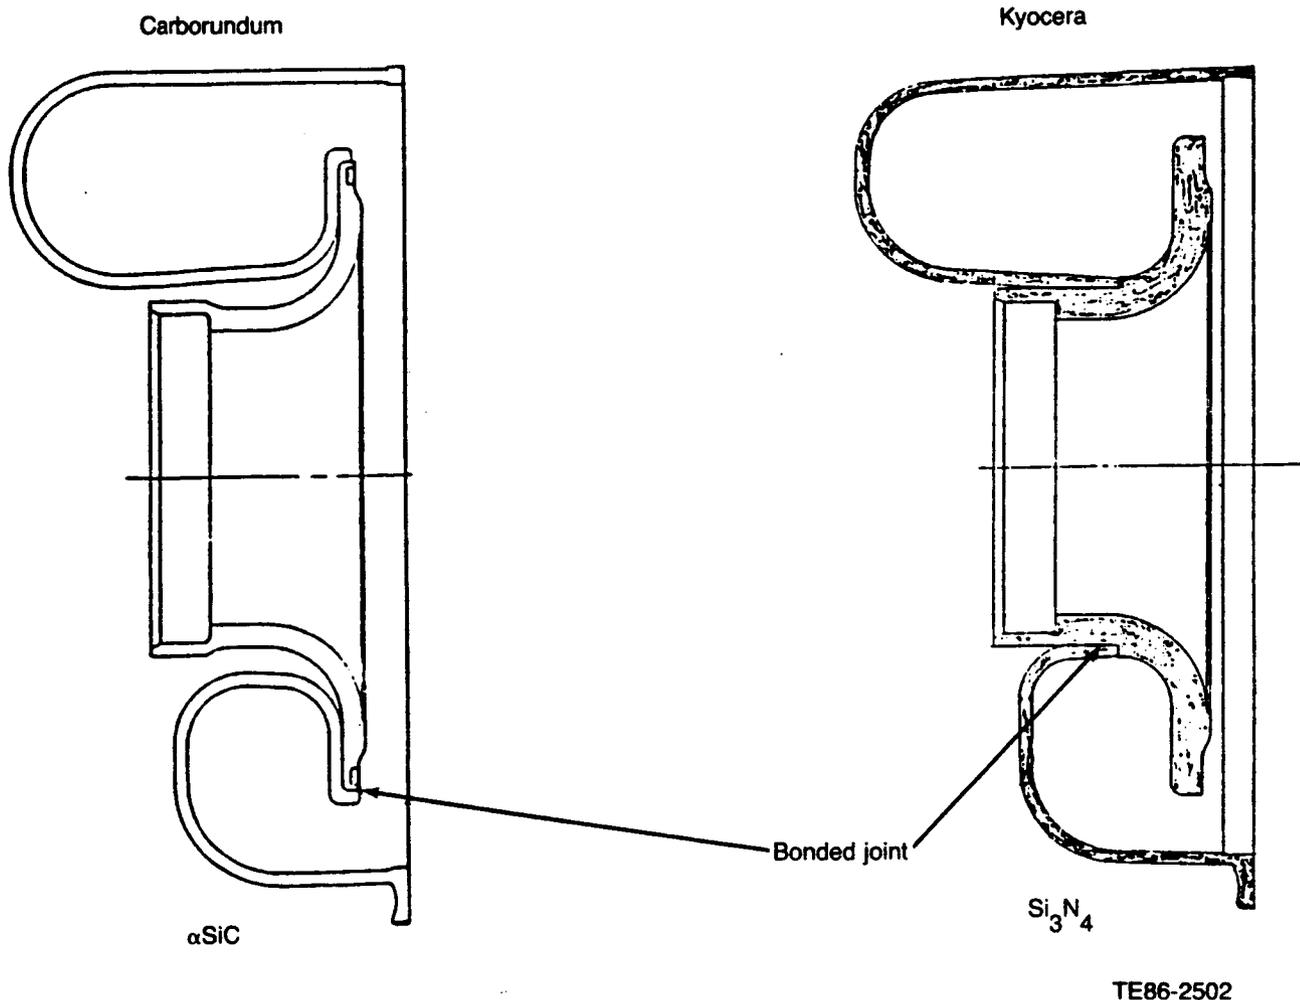
Figure 89. Comparison of original design SiC power turbine scroll and Kyocera alternate design Si₃N₄ power turbine scroll.

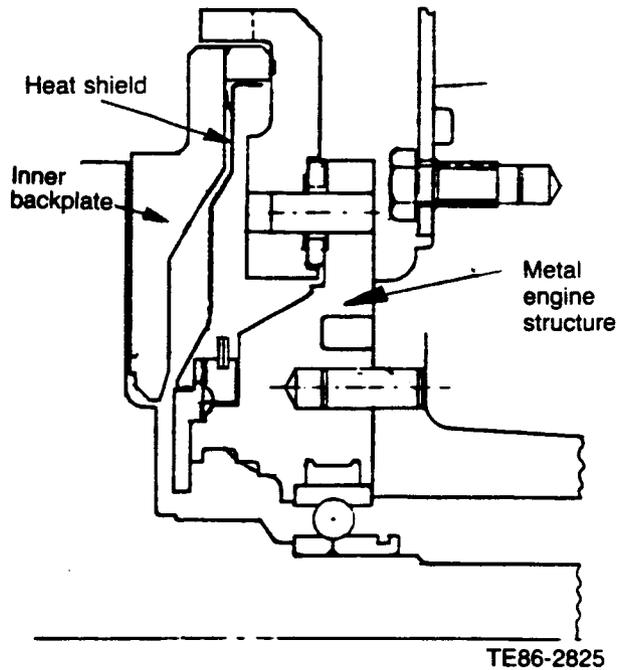
Figure 91. Power turbine heat shield installation.

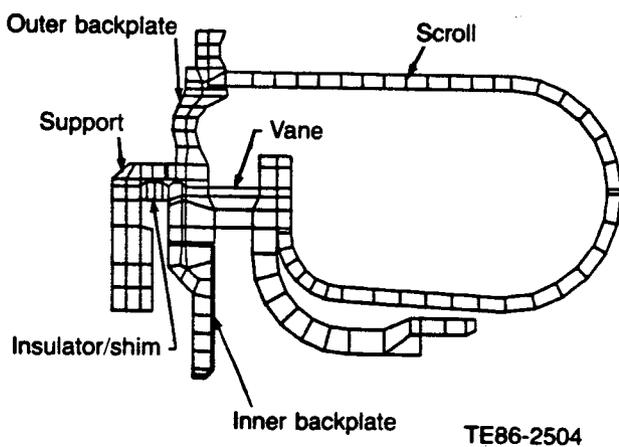
Figure 92. Power turbine scroll assembly finite element model.

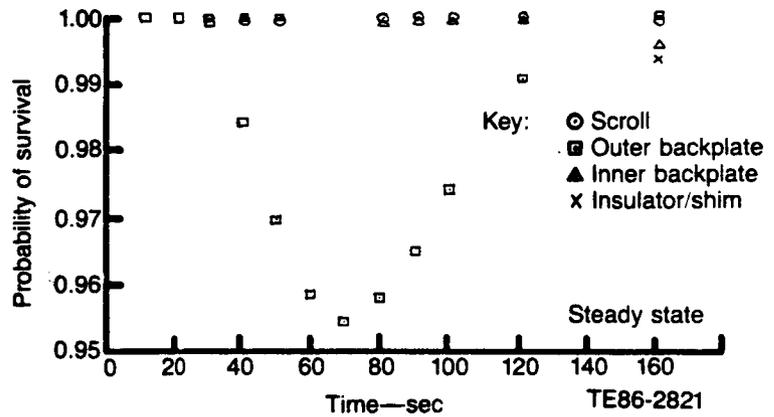
Figure 96. Probability of survival of SiC ceramic power turbine scroll assembly components as a function of time during start-up cycle.

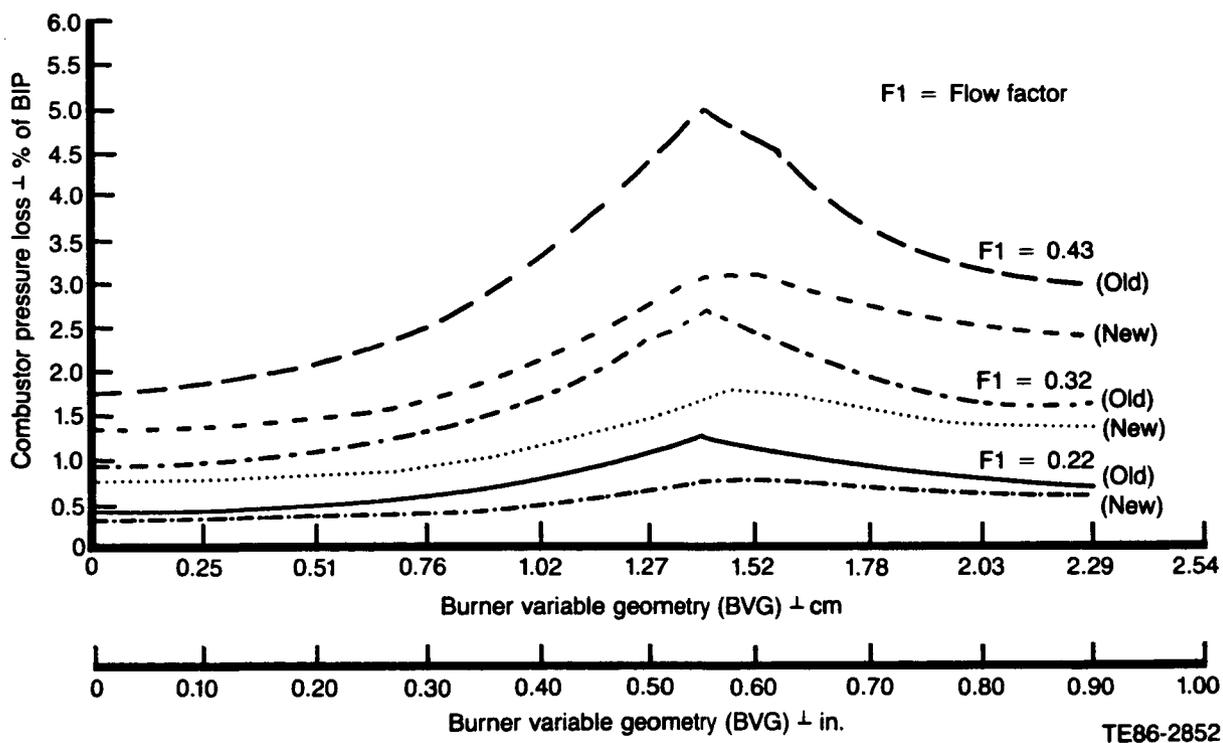
Figure 102. AGT 100 combustor pressure loss calibration comparison of BU16 (old) and BU19 (new) data.

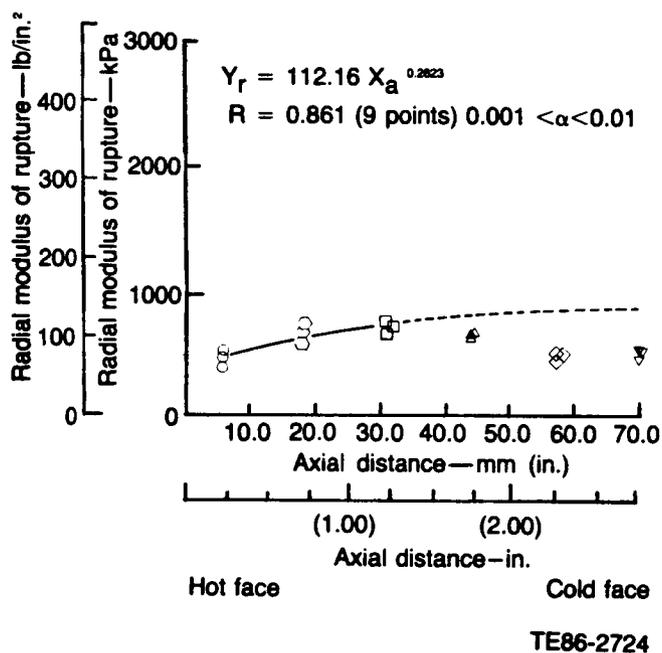
Figure 106. Power curve regression of radial modulus of rupture (MOR) on axial position.

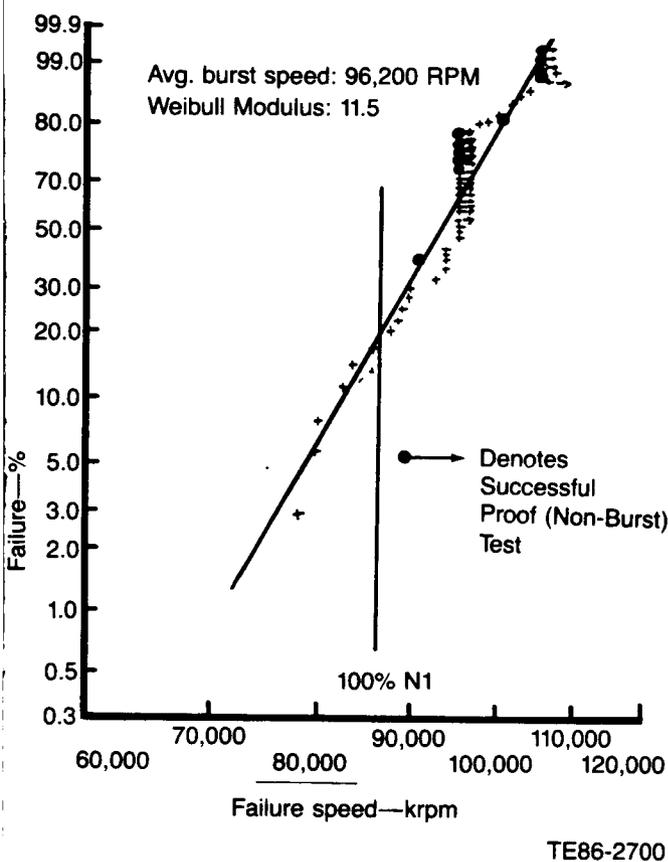
Figure 119. Cumulative probability of failure as a function of spin speed, Group 8 (1985) SiC gasifier rotors.

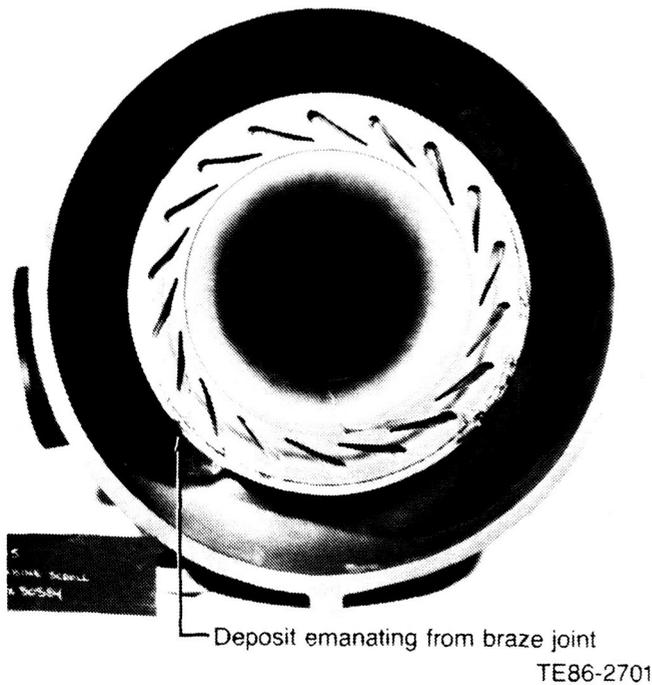
Figure 121. SiC scroll body following 1925°F proof test.

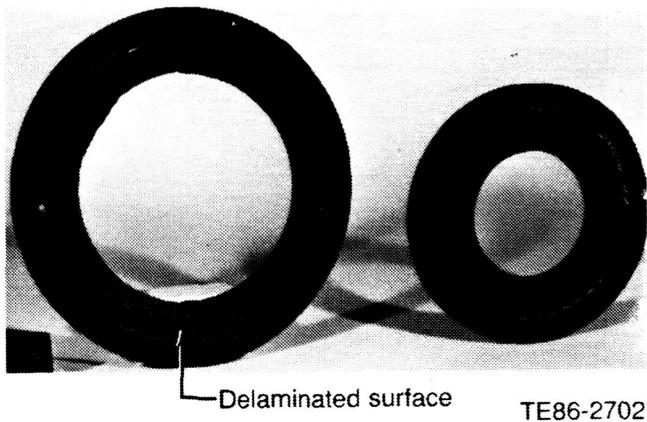
Figure 122. Corning composite ceramic inner backplate following 1925°F proof test.

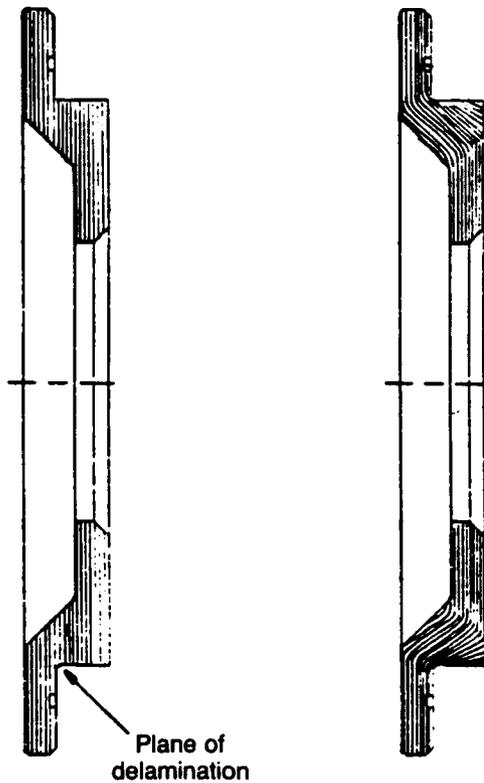
Flat laminate configuration Stepped laminate configuration
Failed in proof test Successfully engine tested

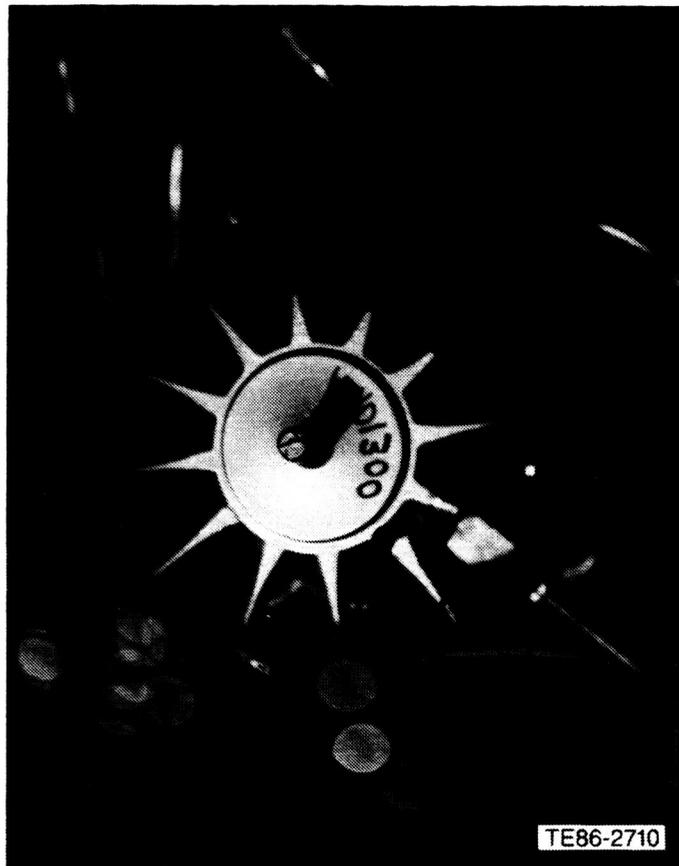
Figure 135. Initial failure, airfoil release at root (4:00 position) at 54,800 rpm, siliconized gasifier rotor, S/N 1-11.

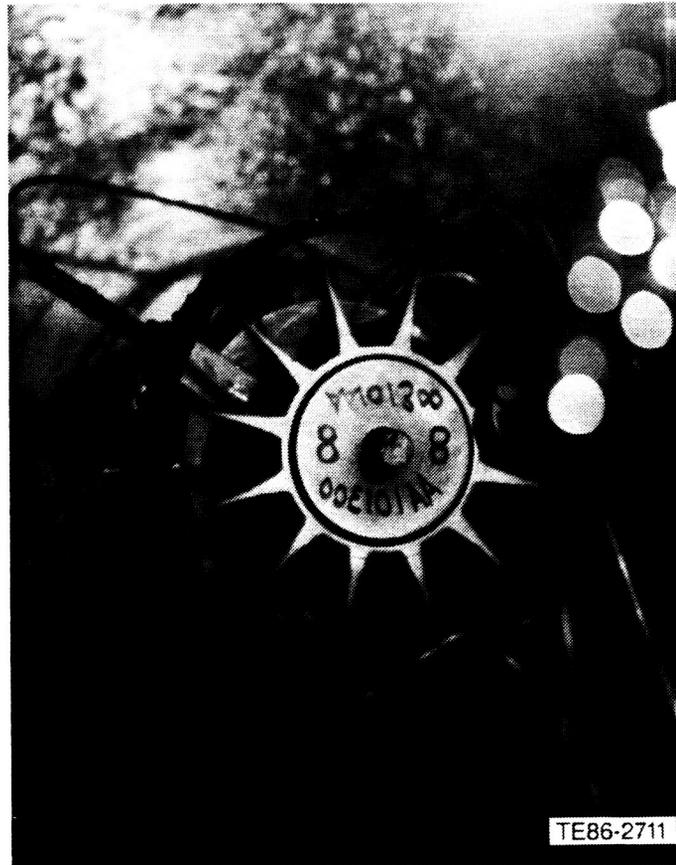
Figure 136. Initial failure, airfoil release at root (2:00 position) at 48,100 rpm, siliconized gasifier rotor, S/N 8-11.

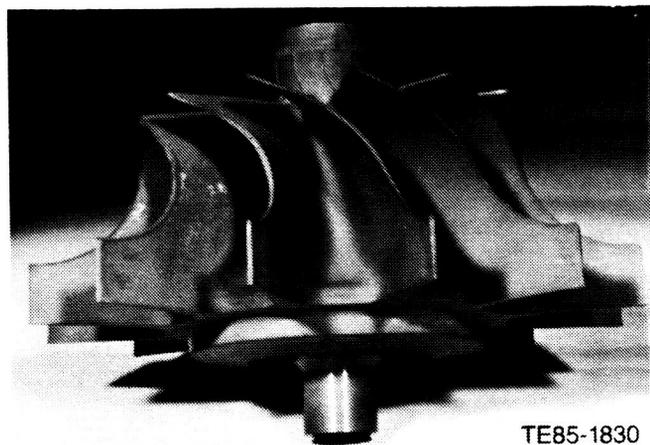
Figure 137. Kyocera slip-cast SN220M sintered Si_3N_4 gasifier turbine rotor.
