**RESULTS OF THE  
FIRST UNITED STATES  
MANNED ORBITAL SPACE FLIGHT  
FEBRUARY 20, 1962**

**RESULTS OF THE FIRST  
U.S. MANNED  
ORBITAL SPACE FLIGHT  
FEBRUARY 20, 1962**

**MANNED SPACECRAFT CENTER  
NATIONAL AERONAUTICS  
AND SPACE ADMINISTRATION**

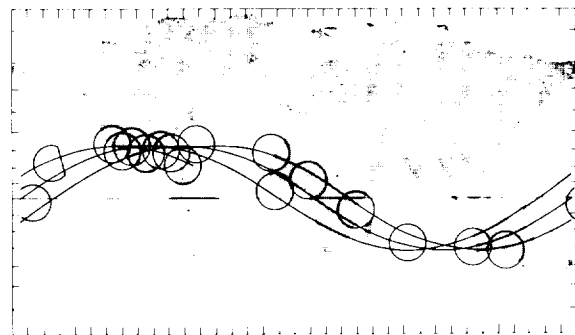
FIGURE 1-1.—Network stations distribution for Project Mercury

In order to perform real-time analysis of both the powered phase and orbiting flight, a network of 16 stations located along the three-orbit ground track was constructed. The location of these sites is shown in figure 1-1 and table 1-I. The sites were chosen for a great number of reasons but primarily to take advantage of the existing tracking and data-gathering facilities that were available at the start of the project. In addition, it was desirable to make available continuous real-time tracking during

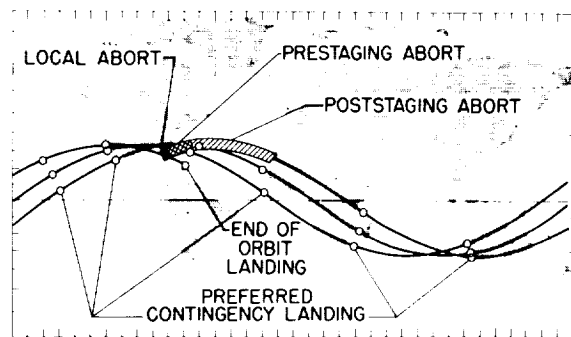
FIGURE 1-2.—Project Mercury recovery areas.

One of the biggest considerations for Mercury operations planning was to provide for safe and quick recovery of the astronaut. Plans were made to place forces in a large number of strategic locations to cover possible aborted flights during all phases of the mission. Figure 1-2 gives a general picture of the recovery operation. Plans were made for recovery in the launch area on the basis of any foreseeable catastrophe from an off-the-pad abort to aborts occurring at or shortly after lift-off. From this period to the point at which the spacecraft was inserted into orbit, a number of recovery areas were located across the entire Atlantic Ocean, based on the probabilities of aborted flights occurring as a result of launch vehicle or spacecraft malfunctions. It was possible to choose discrete areas on the basis of using the spacecraft retrorockets to control the total range traveled. In addition, certain areas around the world were set up for contingencies should

it be necessary to reenter the spacecraft as a result of some inflight emergency. These areas are as indicated in figure 1-2.

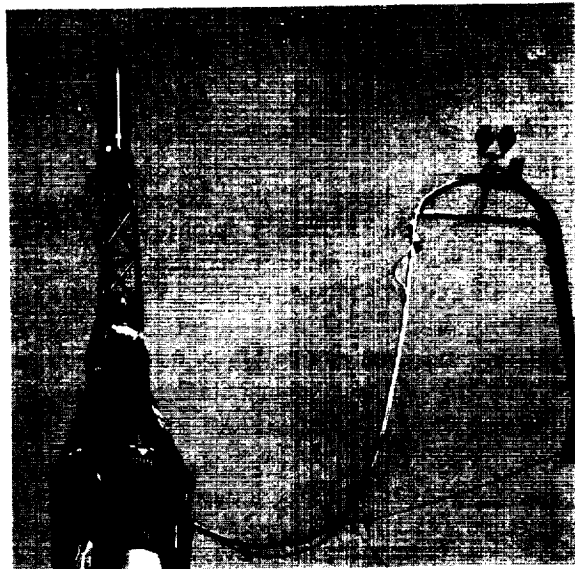
FIGURE 2-1.—Exterior view of spacecraft 13.

The external arrangement of the spacecraft is shown in figure 2-1. At the time this photograph was taken the spacecraft was mounted on the launch vehicle and was undergoing final preparation for flight. The spacecraft is just large enough to contain the astronaut and the necessary equipment. The main conical por-

The large face of the spacecraft is protected against reentry heating by an ablation-type heat shield. A package which contains three post-graduate rocket motors and three retrograde rocket motors is held to the spacecraft at the center of the heat shield by three straps.

The spacecraft escape system includes an escape-rocket motor on top of a tower which is fastened to the top of the recovery section by a clamp ring. The escape-tower assembly also incorporates a small rocket motor which jet-

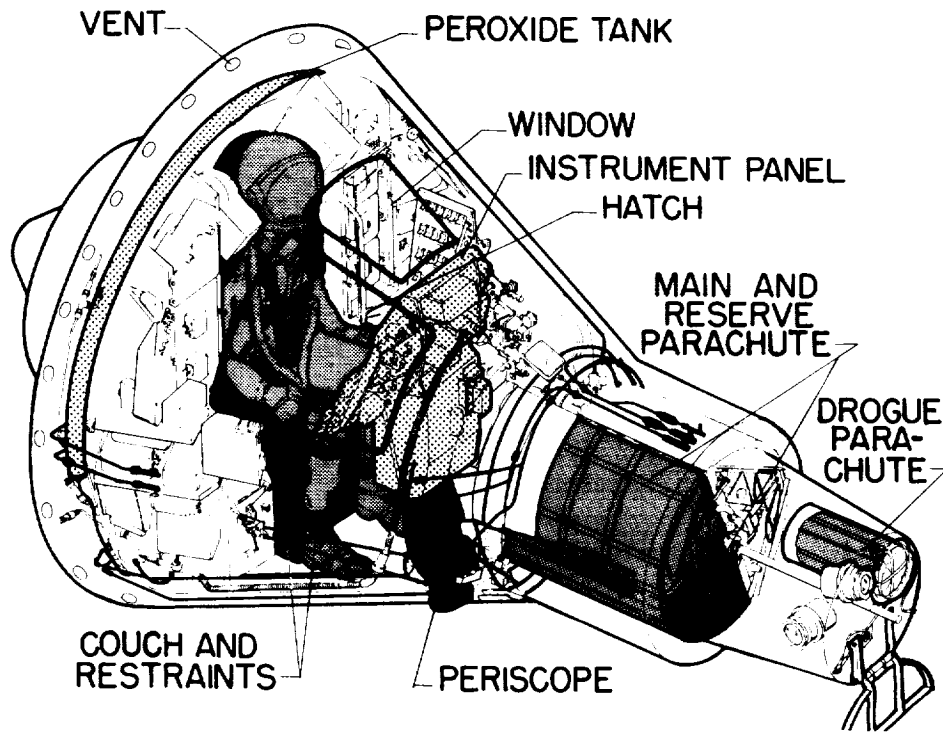
FIGURE 2-2.—Interior view of spacecraft.

Figure 2-2 shows an interior view of the spacecraft. The astronaut is supported by a molded couch and other restraints and faces the small end of the spacecraft. Accelerations during both exit and reentry act in the same direction and thus enable his support couch to be effective without reorientation. The astronaut faces a display of the surface of the earth through a periscope and an instrument panel as shown in figure 2-3.

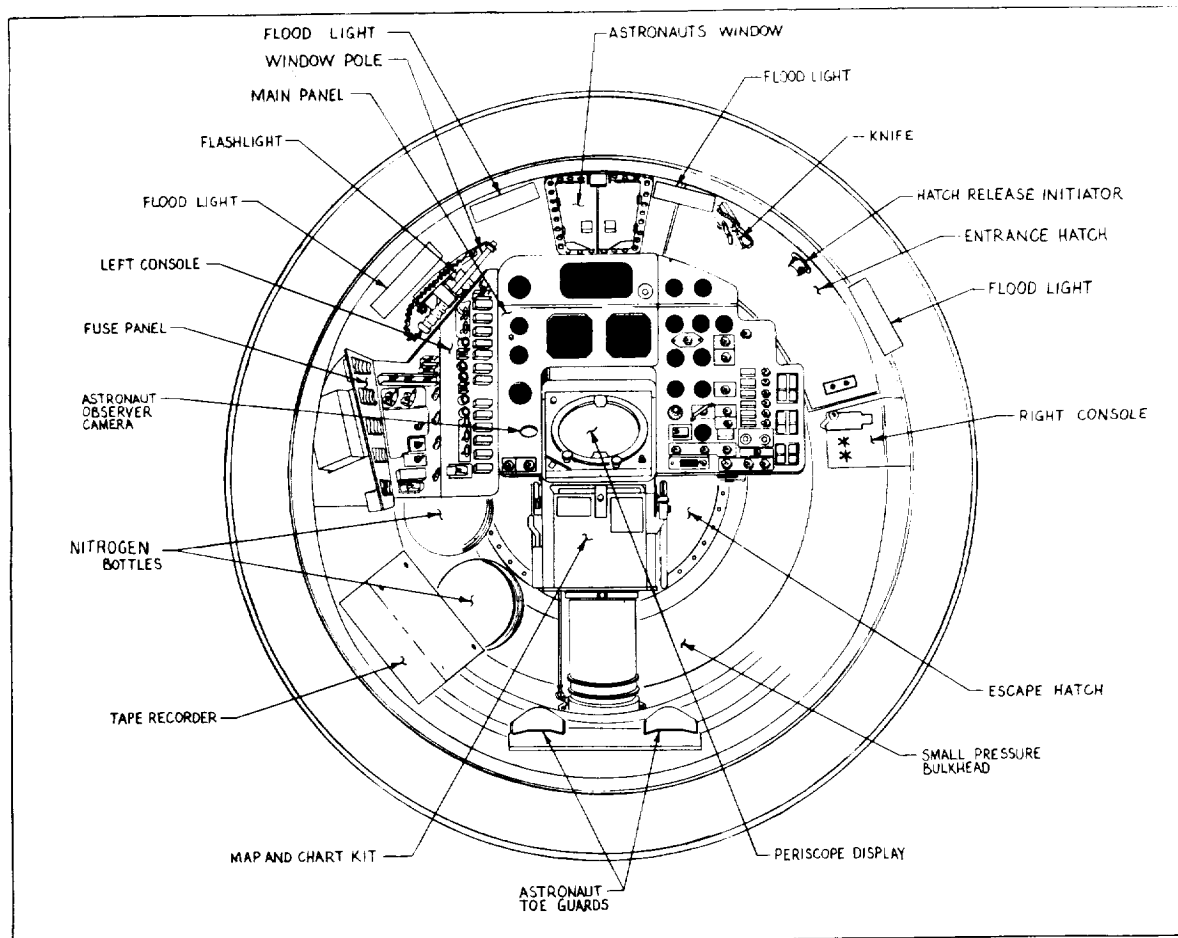
FIGURE 2-3.—Spacecraft cabin arrangement.

A window is provided, in the conical section over the astronaut's head, for the astronaut to use for observations and for obtaining visual attitude references. The astronaut entrance and egress hatch is located in the conical section as indicated by the outline to the astronaut's right. The astronaut can also egress through

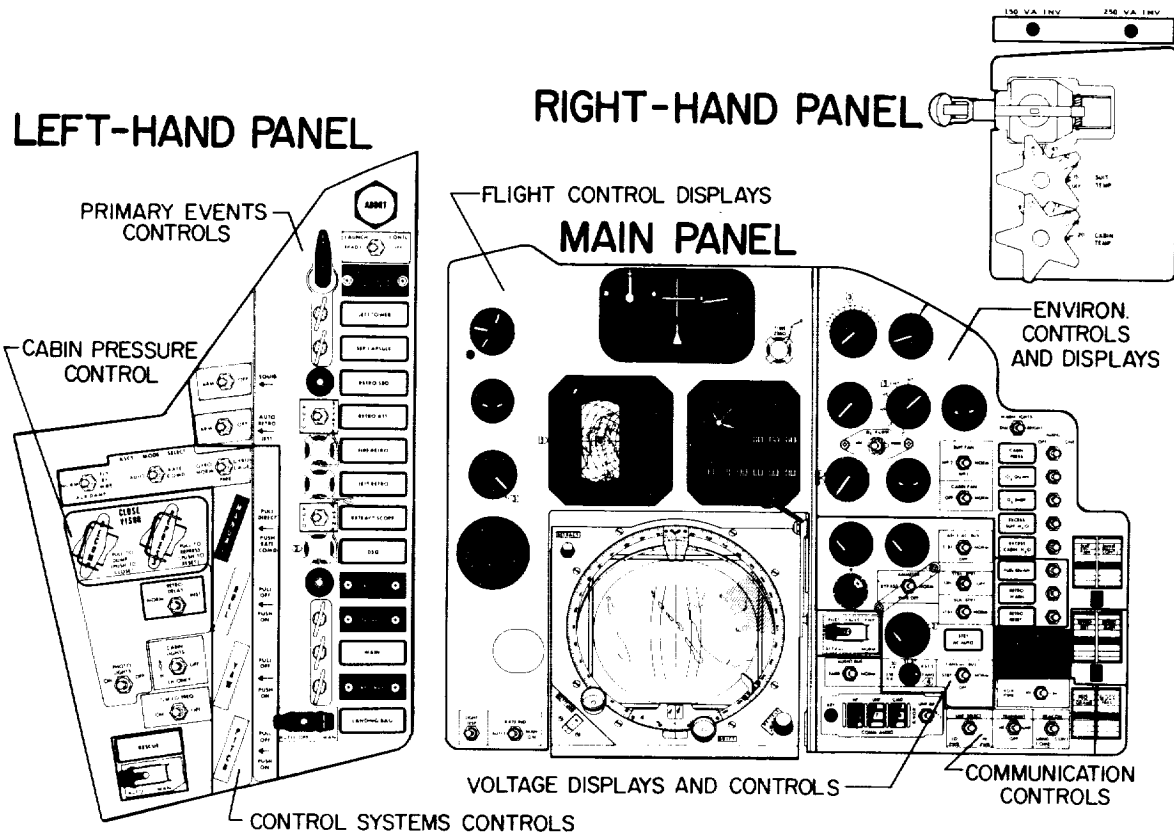
FIGURE 2-4.—Instrument panels.

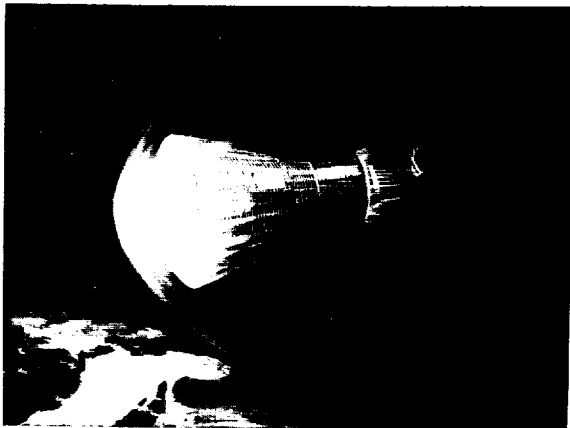
FIGURE 2-5.—Artist's conception of spacecraft during reentry.

products during reentry since most of the afterbody, with its inward sloping sides, is in the dead-air region behind the ablation shield. The afterbody surface thus receives only 5 to 10 per-

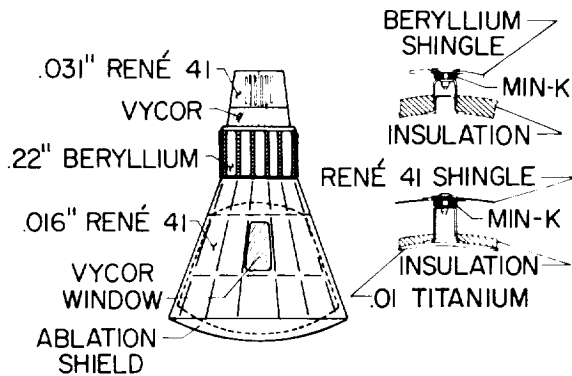
FIGURE 2-6.—Arrangement of heat-protection elements.

cent of the heating that is experienced by the ablation shield; therefore its heat protection arrangement can be the more conventional double-wall construction with insulation between the inner and outer walls (see fig. 2-6). The Mercury spacecraft afterbody heat protection, as shown in figure 2-6, consists of a double-wall construction with insulation between the outer and inner walls. In figure 2-6 lightweight fiberglass blankets are labeled "insulation," and compressed surface-clad insulation is labeled "Min-K." On the outer conical surface and antenna section thin high-temperature alloy (René 41) shingles are used. On the outer cylindrical section thicker shingles of beryllium are used in a heat-sink arrangement. The shingles are blackened to aid the radiation of heat away from the spacecraft, and they are attached to the basic structure in such a manner that they can expand and contract with temperature changes without transferring loads to the primary-load-carrying spacecraft structure.

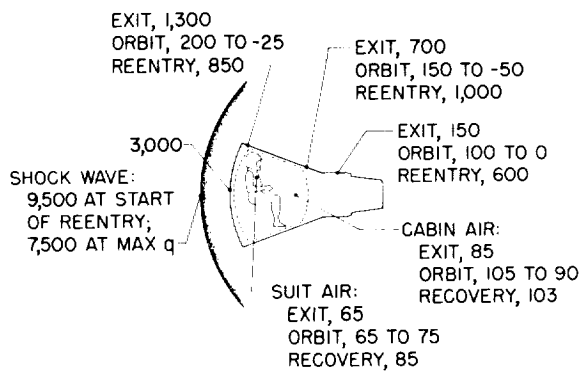
FIGURE 2-7.—Representative temperatures in degrees Fahrenheit.

During the exit flight, when the small end of the spacecraft points in the direction of flight, the afterbody shingles are also subjected to aerodynamic heating, attaining maximum temperatures as high as about 1,300° F. With the local temperatures dependent upon local flow conditions and the thermal mass of the spacecraft surface.

The temperature variation of the outer shingles around the astronaut's pressure compart-

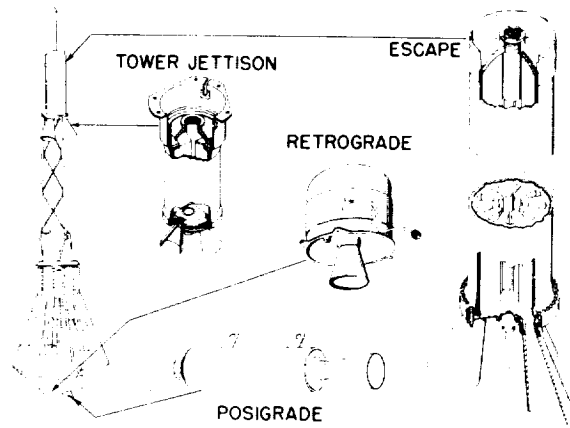
FIGURE 2-9.—Spacecraft rocket motors.

The three posigrade and three retrograde rocket motors are mounted in a package which is held to the spacecraft at the center of the heat shield by three straps. The posigrade rockets are salvo-fired to separate the spacecraft from the launch vehicle. The retrograde

rocket motors are ripple-fired (5-second delays between motor ignitions) and provide the velocity decrement necessary to initiate reentry.

The escape rocket is mounted at the top of the escape tower and incorporates three canted exit nozzles to direct the exhaust gases away from the side of the spacecraft.

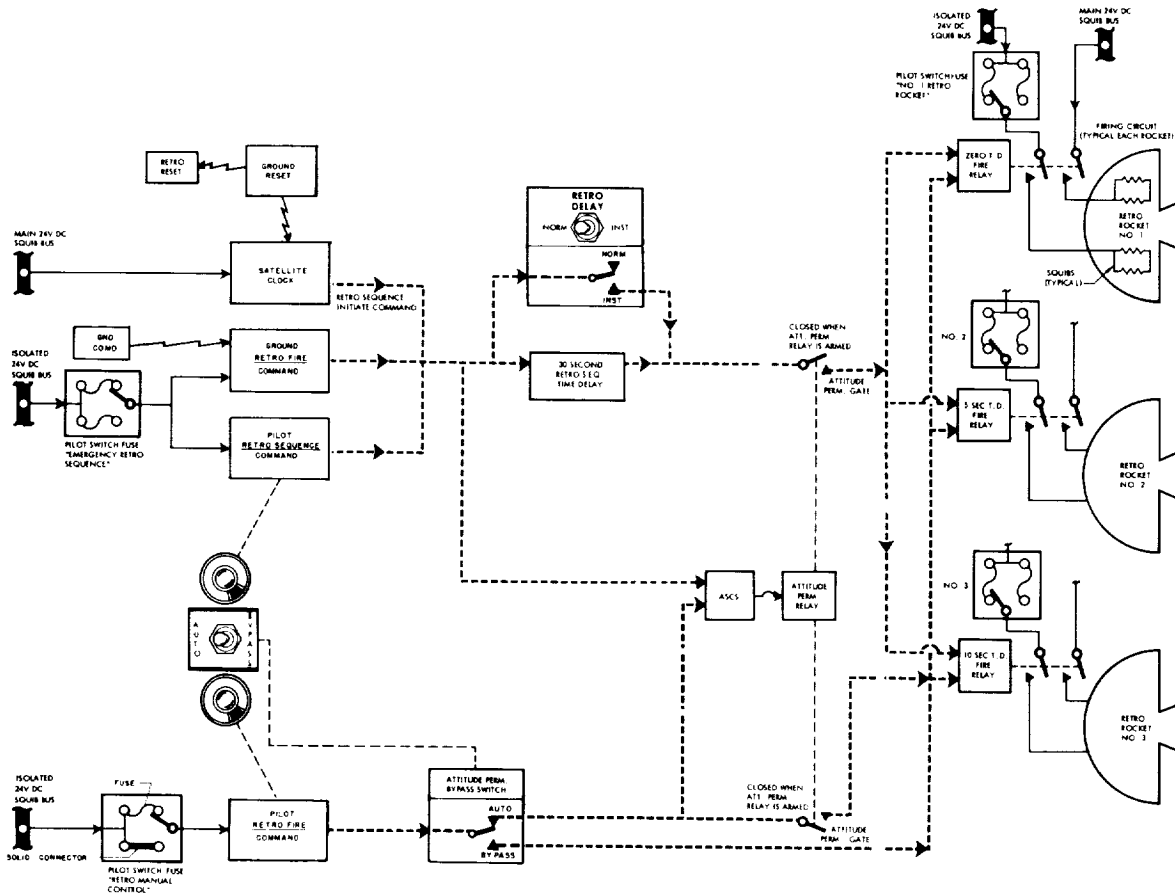
FIGURE 2-10.—Retrorocket fire schematic diagram.

All rocket motors have dual ignition systems from separate electrical power sources. In addition, each ignition system has dual squibs

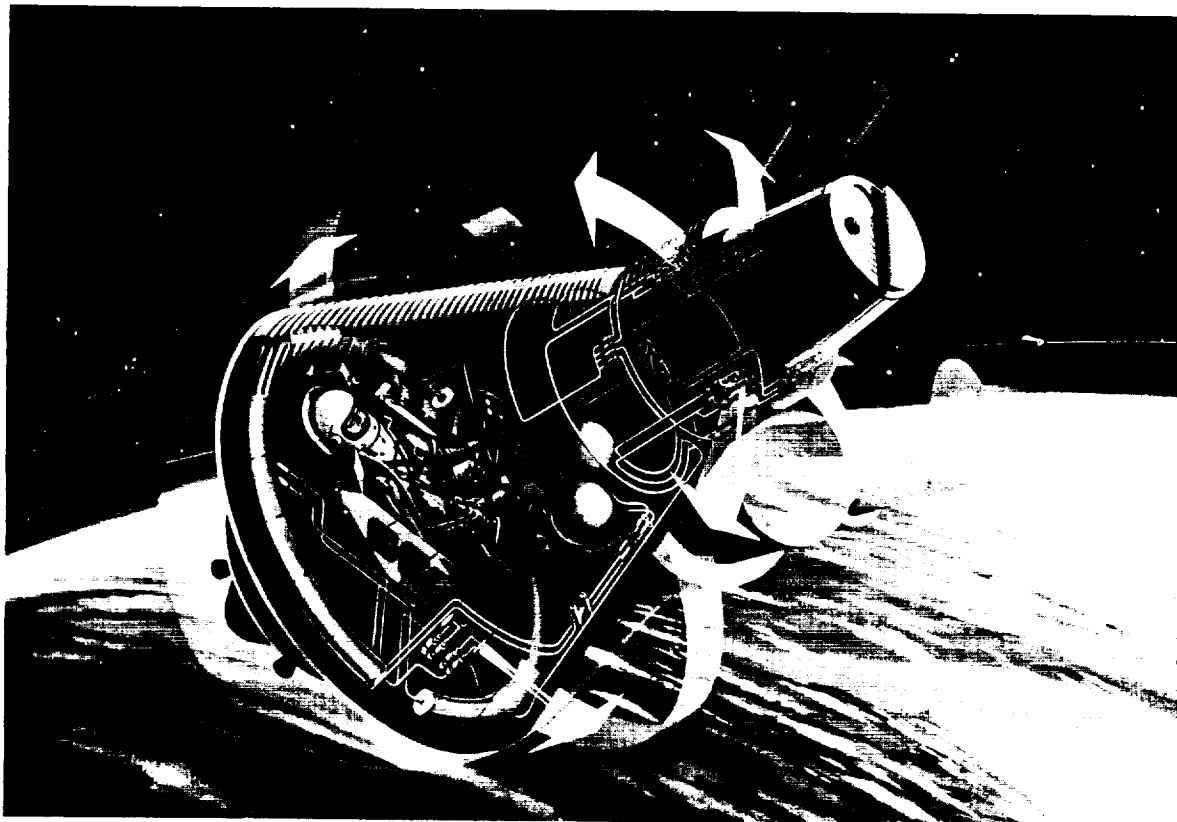
FIGURE 2-11.—Arrangement of reaction control system.

The thruster impulse is directed by the four basic control modes through 18 individual system, as shown in figure 2-11. Figures 2-12(a) and 2-12(b) show the A and B systems RCS schematic diagrams. Figures 2-12(a) and 2-12(b) do not show completely the methods of electrically controlling the thrusters; in figure 2-12(a) there is a switch missing between the hand controller and the ASCS control box which permits selection of either FBW or ASCS. Similarly, in figure 2-12(b) the connection of the hand controller through a switch and the ASCS control box to the thruster solenoids for RSCS control is missing. Metered quantities of hydrogen peroxide are decomposed in silver-plated catalyst beds in each of the thruster chambers to provide the desired impulse. Twelve of the thrusters used on the Mercury spacecraft are sized to provide adequate control during the retromaneuver.

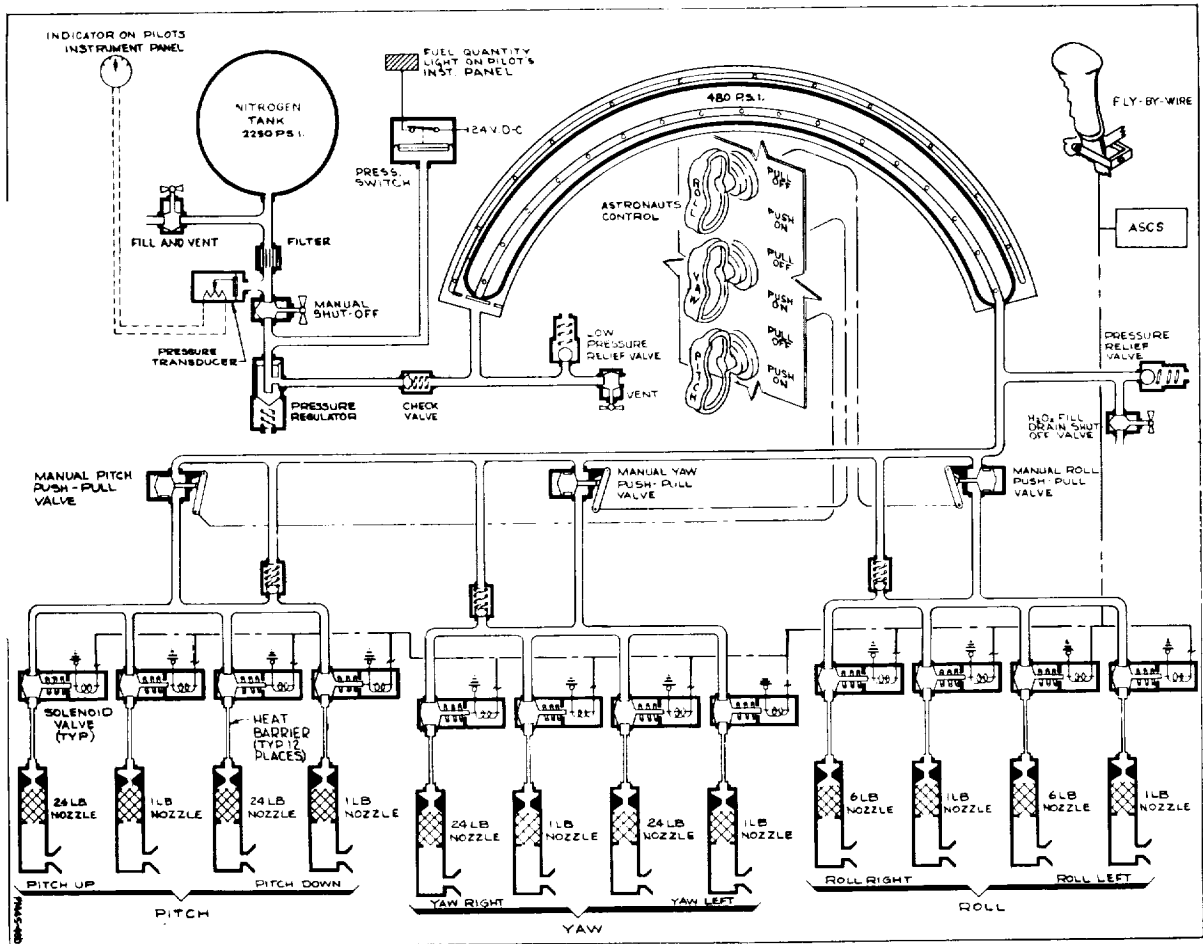
(a) System A.

FIGURE 2-12.—Reaction control system schematic diagrams.

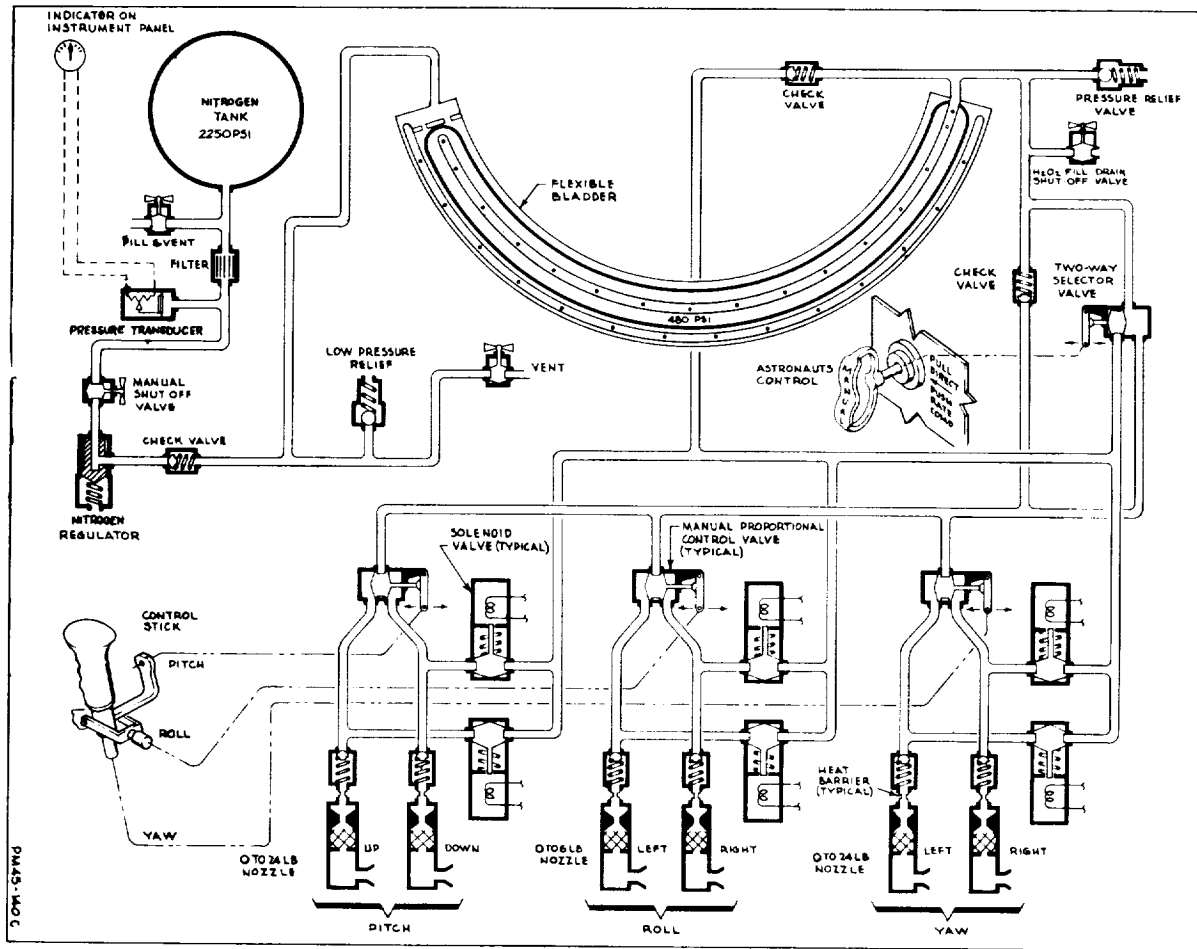
(b) System B.

FIGURE 2-12.—Concluded.

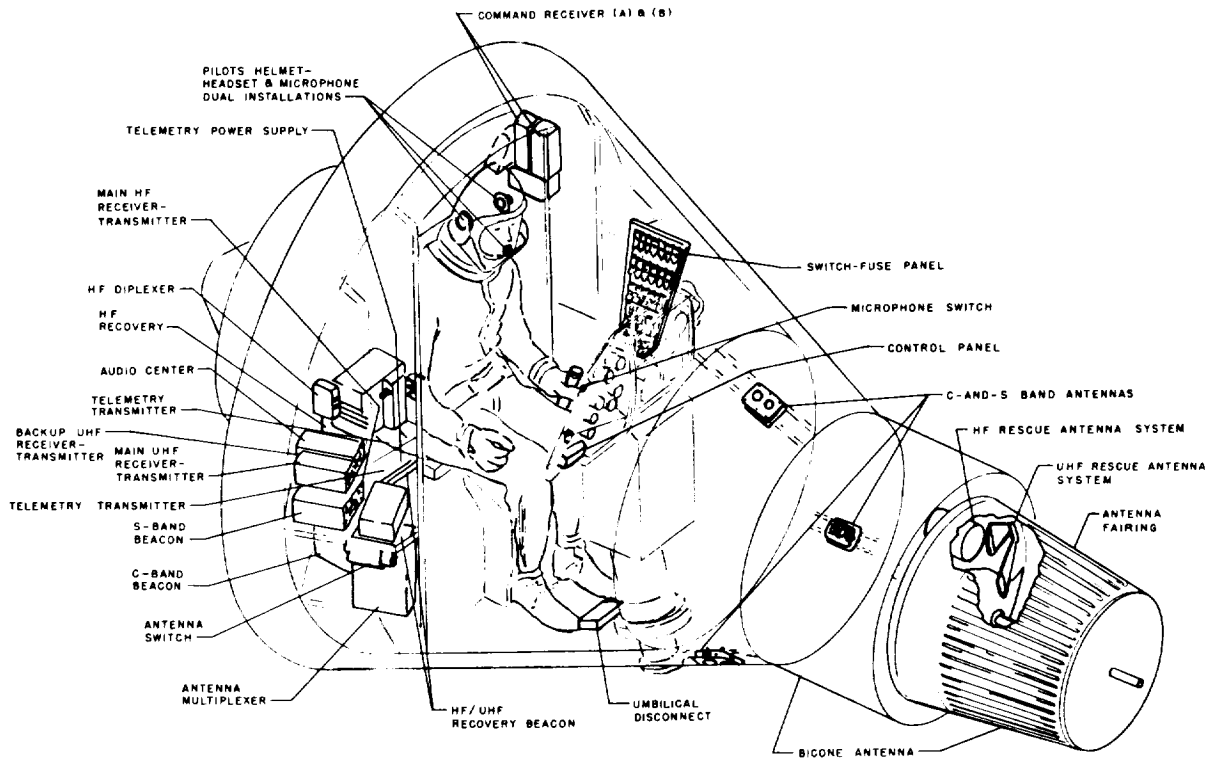
FIGURE 2-13.—Locations of major components of communications system.

The spacecraft communications and instrumentation systems consisted of voice, radar, command, recovery, and telemetry links. Each system had main and backup (or parallel) equipment for redundancy, with selection of the desired system generally at discretion of the astronaut through switches mounted on the instrument panel. Table 2-II is a list of the systems, and figure 2-13 shows the physical lo-

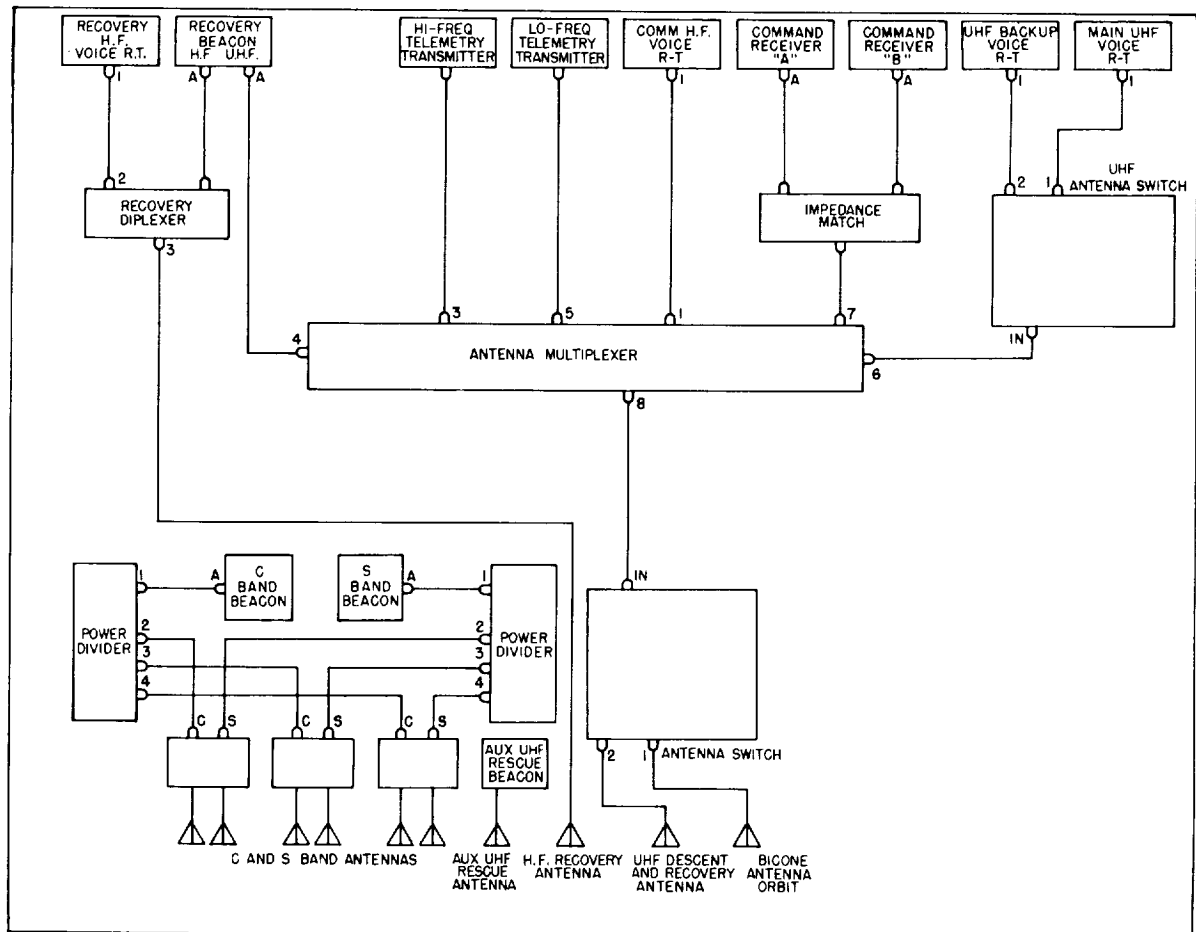
FIGURE 2-15.—Communications and antenna systems schematic diagram.

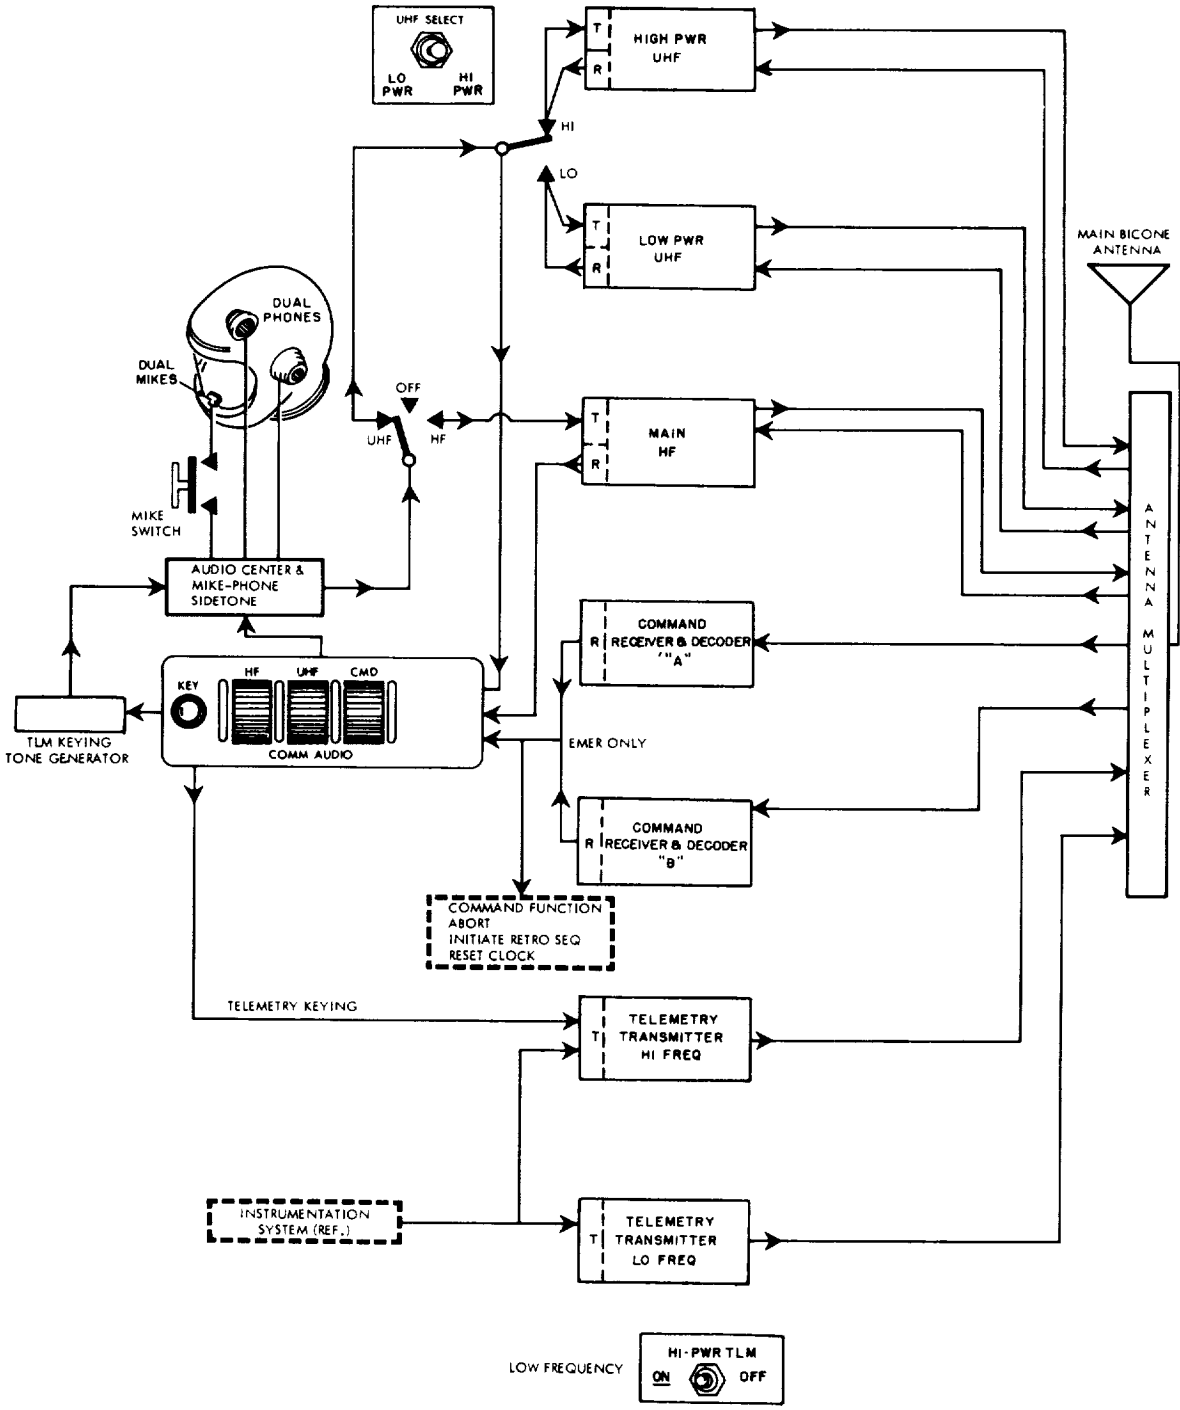
FIGURE 2-16.—Voice systems schematic diagram.

perience and ground tests, it was known that the HF system had somewhat poorer voice fidelity but longer range than the UHF system. The UHF system, because of its slightly better voice quality, was considered to be the primary system. From previous experience, it was known that the range of the UHF system was approximately equal to the line-of-sight range and was entirely adequate for a normal mission. The main voice traffic was therefore conducted on the UHF system, with a small amount of traffic conducted on the HF system to verify system operation. It might be noted that the UHF system consisted of a main and a backup transmitter-receiver. Thus, three separate voice systems were available for choice of the astronaut—HF, UHF main, and UHF backup—as shown in figure 2-16. Also, a redundant ground-to-air voice link is available through the command receiver channel. An additional air-to-ground communication link is available to the astronaut by keying the low-frequency telemeter carrier. It should be noted that all of these links use the main bicone antenna through the use of a multiplexer.

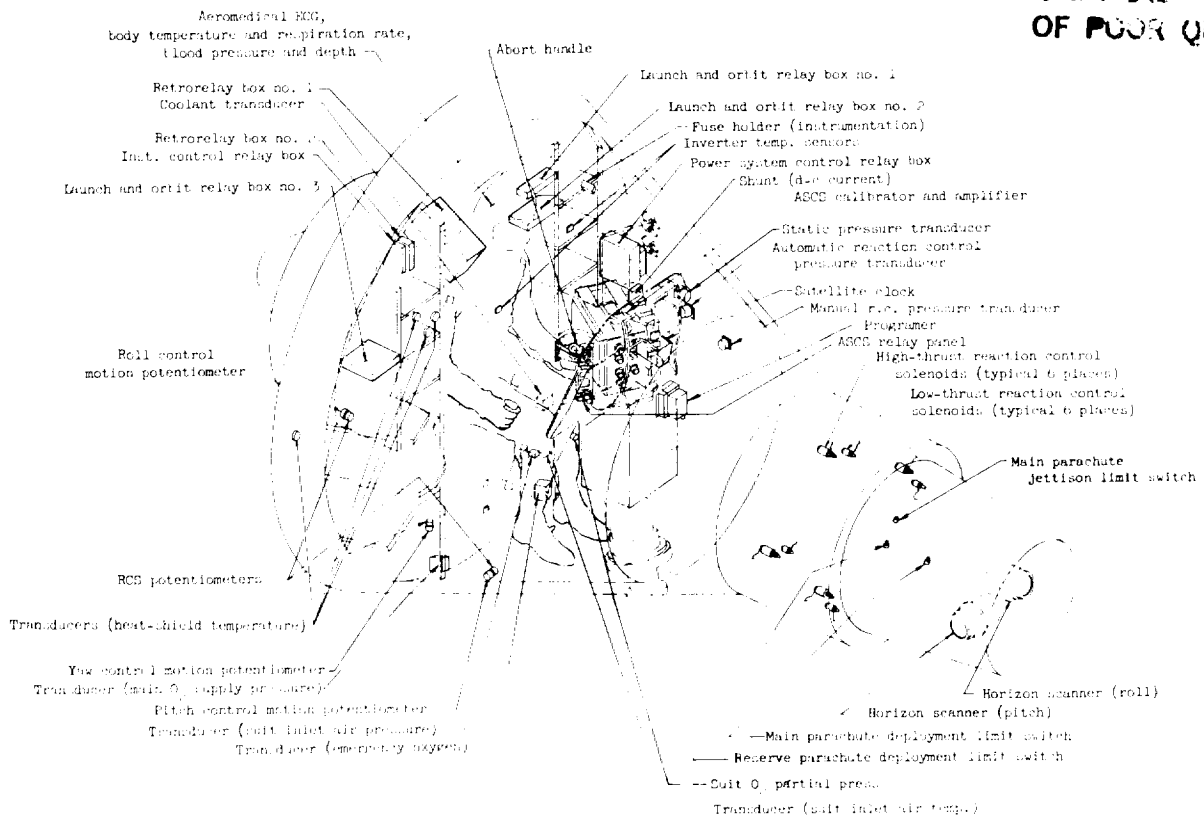
FIGURE 2-17.—Location of some spacecraft instrumentation sensors.

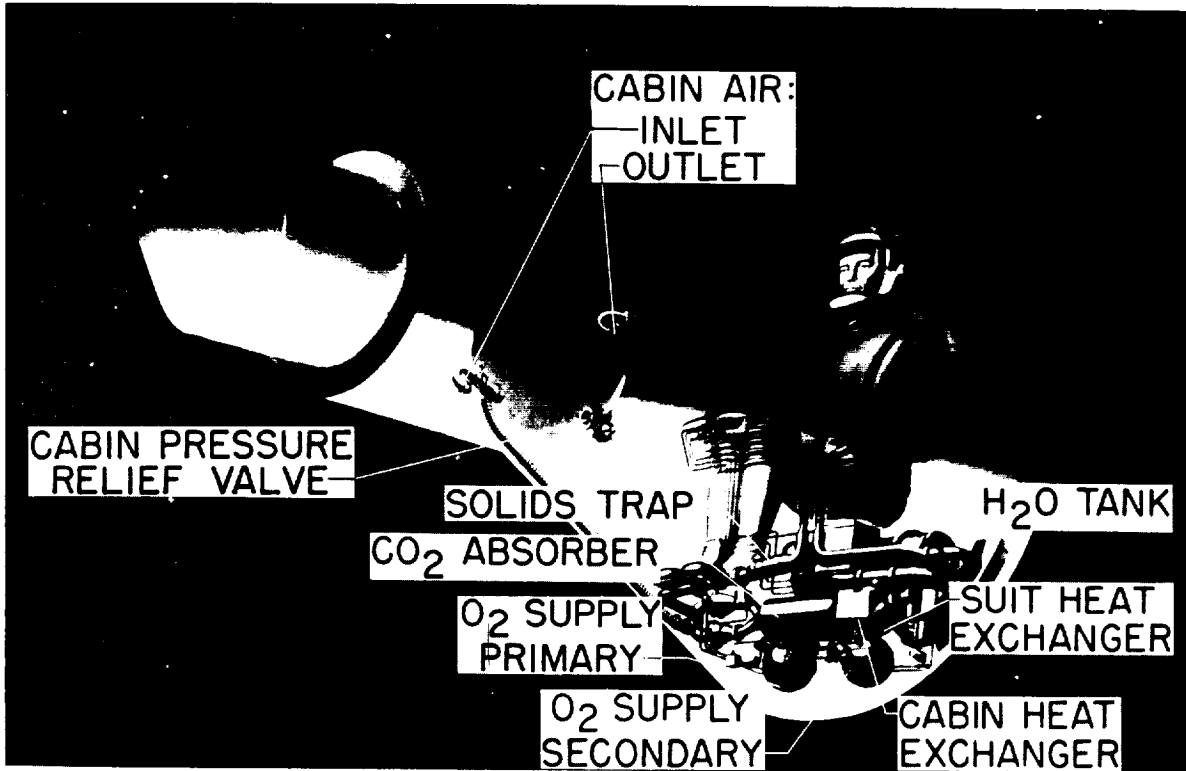
FIGURE 2-19.—Approximate physical arrangement of spacecraft environmental control system.

As shown in figure 2-19, the environmental control system is located principally under the astronaut's support couch. This all-important system provides an oxygen atmosphere, temperature control, and pressure regulation for the astronaut's suit and the cabin. The cabin and suit are independent redundant circuits for automatically providing proper environmental

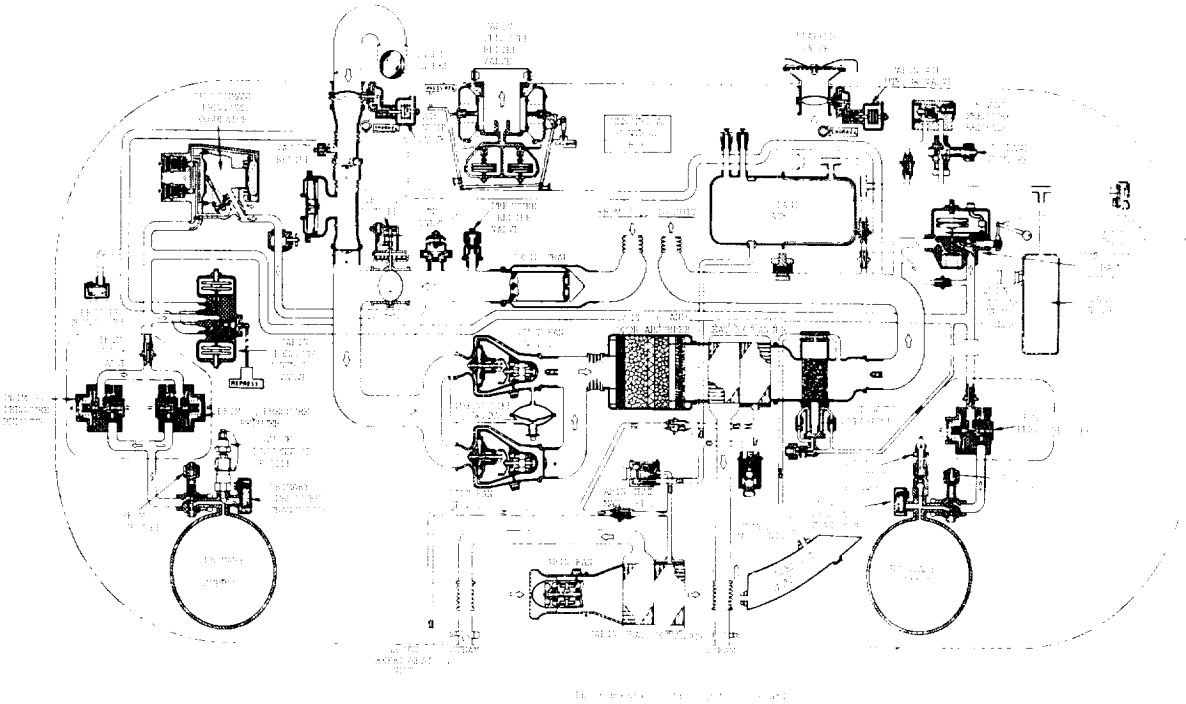
FIGURE 2-20.—Schematic diagram of environmental control system.

A simplified schematic diagram of the environmental control system is shown in figure 2-20, and the system is discussed in more detail in papers 3 and 5.

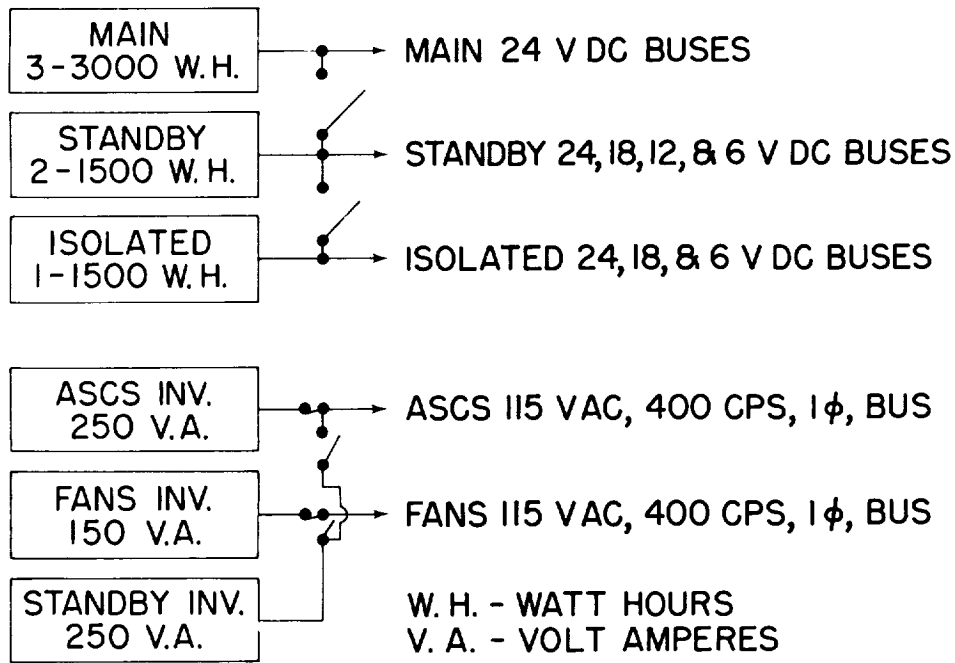
FIGURE 2-21.—Schematic diagram of spacecraft electrical power system.

Figure 2-21 shows the spacecraft electrical power system. Rechargeable silver-zinc batteries of both 3,000-watt-hour and 1,500-watt-hour ratings are arranged into three power sources to provide a total of 13,500 watt-hours. Nominal discharge rate for each type of battery is 4.5 amperes but each battery is capable of supplying pulse currents up to 42 amperes for a few milliseconds. Silicon diodes in each positive leg of all batteries prevent discharge of normal batteries into defective or low-voltage batteries in parallel configurations. The individual battery voltages and the total current are monitored in flight by the astronaut. In event of battery failure or equipment failure, he can manually switch off individual batteries or all battery power.

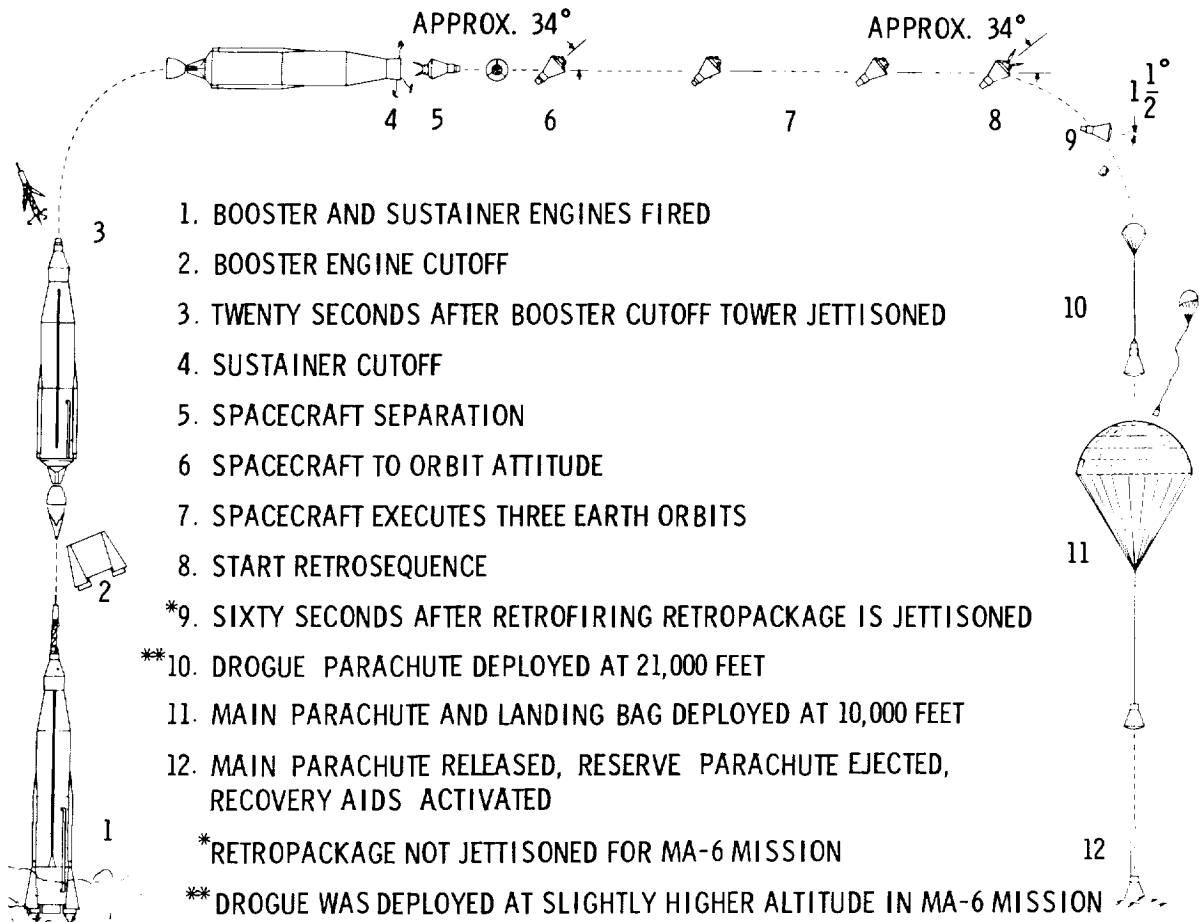
FIGURE 2-22.—Sequence of major events for the MA-6 mission.

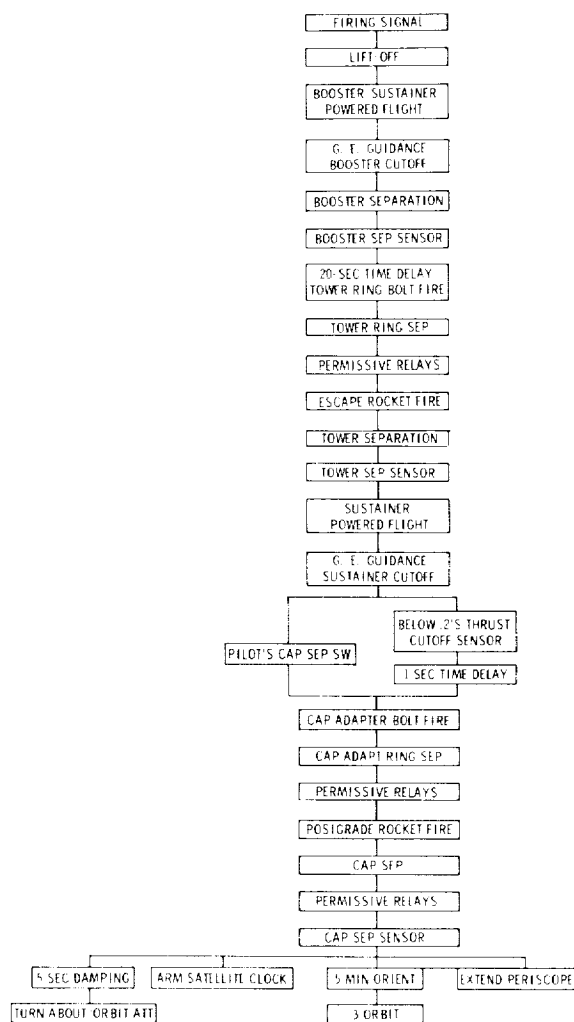
FIGURE 2-23.—Master sequential diagram for the MA-6 spacecraft.

Figure 2-22 shows the sequence of major events for the MA-6 mission. The only exception to the planned sequence occurred during event (9) as a result of the astronaut being advised to retain the retropackage during reentry and manually overrode the automatic sequencing as directed by instructions from the ground. Figure 2-23 shows the spacecraft master sequential system.

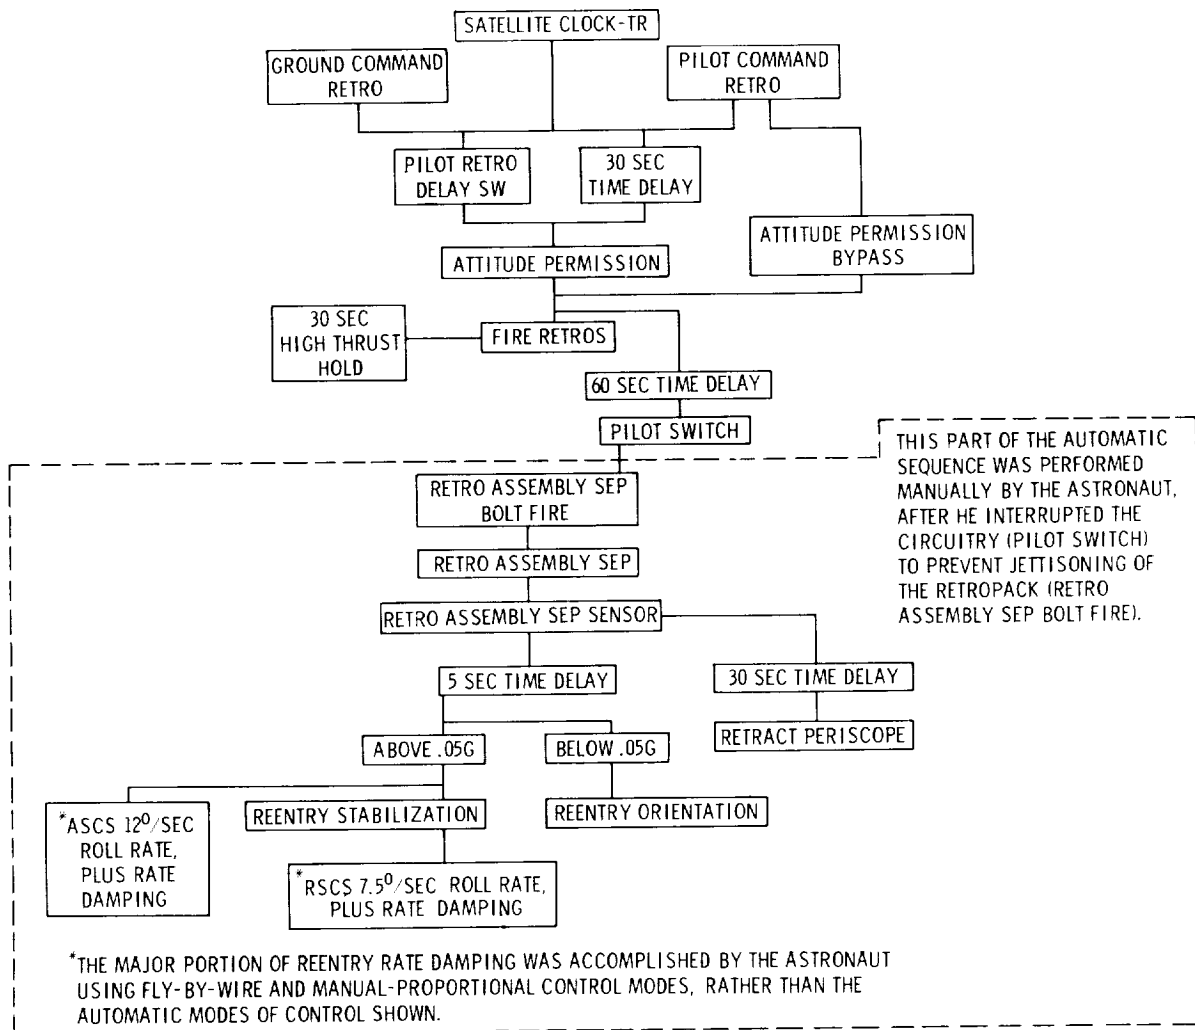
(b) Retrograde and reentry.

FIGURE 2-23.—Continued.

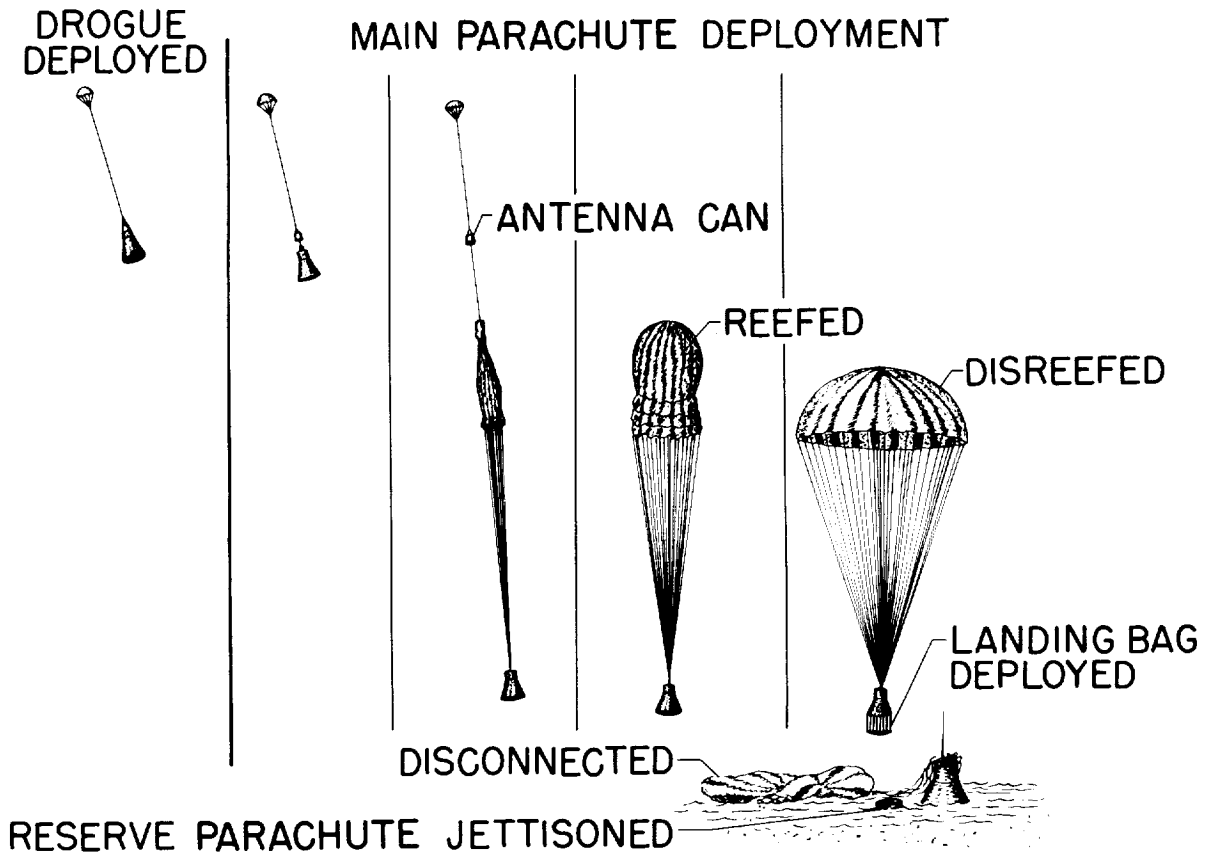
FIGURE 2-24.—Sketch depicting use of spacecraft landing systems.

The landing system is normally actuated at an altitude of about 21,000 feet by either one of two barostats which sense atmospheric pres-

sure. At this time, the drogue parachute is deployed to decelerate and stabilize the spacecraft. At about 10,000 feet, the antenna section and drogue parachute are jettisoned by the signals from another dual barostat and the main parachute is deployed in a reefed condition opened to 12-percent of the maximum diameter for 4 seconds to minimize the opening shock. The main parachute deploys fully after 4 seconds of reefing. A reserve parachute may be deployed by the astronaut in the event the main parachute is unsatisfactory. After main parachute deployment, the landing bag is extended to provide attenuation of the landing load. Immediately after landing, the main parachute is automatically disconnected and the reserve parachute is ejected.
