**RESULTS OF THE  
FIRST UNITED STATES  
MANNED ORBITAL SPACE FLIGHT  
FEBRUARY 20, 1962**

**RESULTS OF THE FIRST  
U.S. MANNED  
ORBITAL SPACE FLIGHT  
FEBRUARY 20, 1962**

**MANNED SPACECRAFT CENTER  
NATIONAL AERONAUTICS  
AND SPACE ADMINISTRATION**

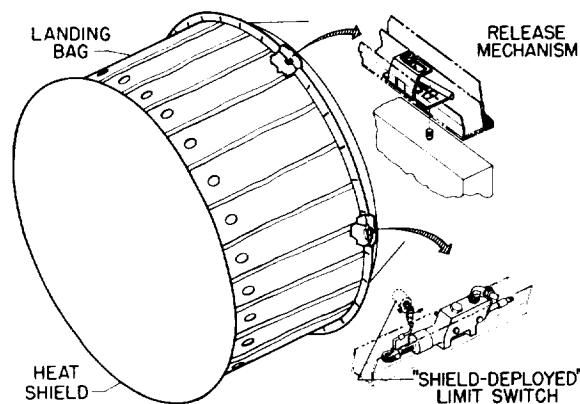
FIGURE 2-25.—Details of heat-shield deployment mechanism and sensing switches.

The "heat-shield-deployed" signal, that is sent to the telemetry system, is furnished by either one of two limit switches which sense the movement of the heat-shield retention devices as shown in figure 2-25. During the orbital flight portion of the MA-6 mission, one of these switches sent a "shield-deployed" signal to the ground monitoring stations. Post-

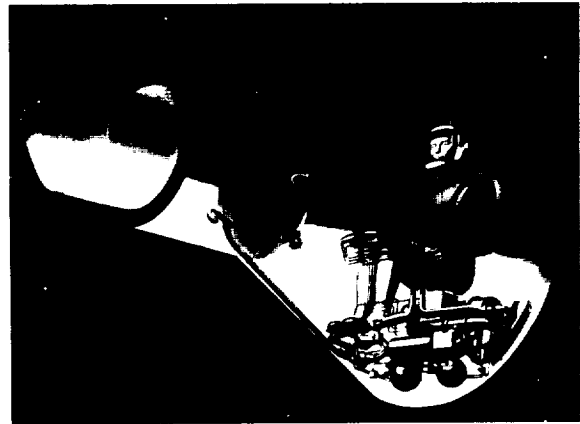
FIGURE 3-1.—Project Mercury environmental control system.

The environmental control system shown in figure 3-1 is located in the lower portion of the

spacecraft under the astronaut support couch. The astronaut is clothed in a full pressure suit to provide protection in the event of a cabin decompression.

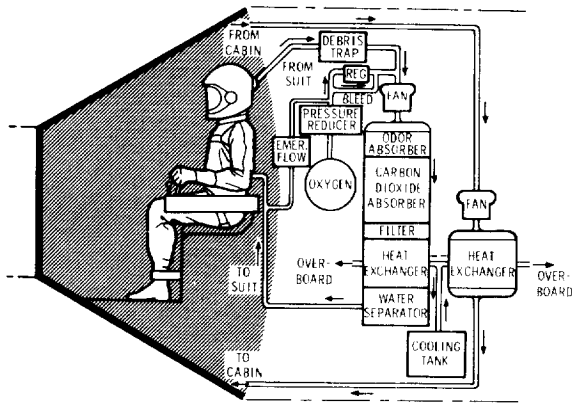
FIGURE 3-2.—Schematic diagram of the Mercury environmental control system.

The pressures in the cabin and pressure suit are maintained at 5.1 psia in normal flight with a 100-percent oxygen atmosphere. The system is designed to control automatically the environmental conditions within the suit and cabin throughout the flight. Manual controls are provided to enable system operation in the event of automatic control malfunction. In describing the environmental control system, it can be considered as two subsystems; the pressure-suit control system and the cabin system. Both of these systems operate simultaneously from common coolant water and electrical supplies. The coolant water is stored in a tank with a pressurized bladder system to facilitate weightless flow of water into the heat exchanger. Electrical power is supplied from an onboard battery supply. Oxygen is supplied at an initial

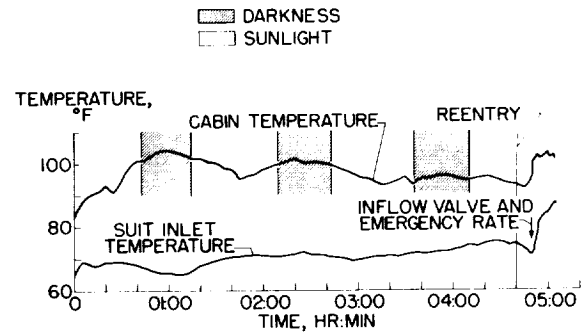
FIGURE 3-3.—Variation of suit and cabin temperatures with time.

The cabin air temperature (fig. 3-3) fluctuated between 90° F and 104° F as the spacecraft passed from darkness into sunlight. The astronaut reported that at least five attempts to reduce cabin air temperature by increasing water flow to the cabin heat exchanger resulted in the illumination of the excess-water light. This light indicated that the cabin heat ex-

changer was operating near its maximum capacity for the existing conditions. Even so, the mean cabin air temperature was steadily reduced during the mission after the first hour in orbit.

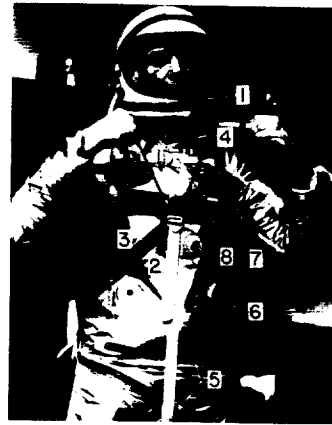
FIGURE 3-4.—Pressure suit torso.

The suit torso, as shown in figure 3-4, is a closely fitted overall tailored for each of the astronauts. It covers all of the body except for the head and hands. The torso section is of two-ply construction: an inner gas-retention ply of neoprene and neoprene-coated nylon fabric and an outer ply of heat-reflective, aluminized nylon fabric. The helmet is attached to the torso section by a rigid neck ring. A tie-down strap is provided on this neck ring to prevent the helmet from rising when the suit is pressurized. Straps are also provided on the torso section for minor sizing adjustments of leg and arm length and circumferences and to prevent the suit from ballooning when pressurized.

1. NECK RING
2. HELMET TIEDOWN STRAP
3. PRESSURE SEALING ENTRANCE ZIPPER
4. NECK ZIPPERS
5. WAIST ZIPPER
6. INLET VENT PORT
7. PRESSURE INDICATOR
8. BLOOD PRESSURE FITTING

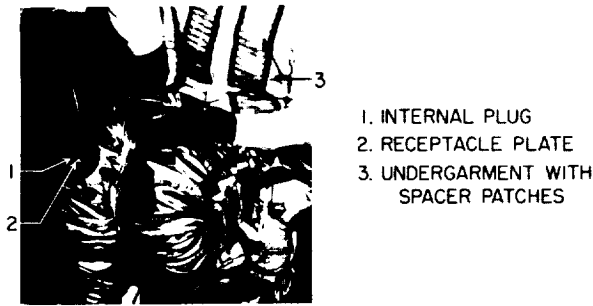
FIGURE 3-5.—Bioconnector (installation).

*Bioconnector.*—The bioconnector provides a method for bringing medical data leads through the pressure suit. The bioconnector consists of a multipin electrical plug to which the biosensors are permanently attached, a receptacle plate mounted to the suit torso section and an outside plug which is connected to the spacecraft instrumentation system. With this system, the biosensor harness is fabricated with the bioconnector as an assembly and no additional electrical connectors are introduced

into the transducer system. In operation (fig. 3-5) the male internal plug is inserted inside the suit receptacle and locked into place. The internal plug protrudes through the suit to allow the spacecraft plug to be attached. The bioconnector system has proven to be a much more satisfactory connector than the previously used biopatch.

The undergarment is a one-piece, lightweight, cotton garment with long sleeves and legs. Thumb loops are provided at the sleeve ends to prevent material from riding up the arms during suit donning. Ventilation spacer patches (see fig. 3-5) of a trilock construction are provided on the outside of the undergarment to insure ventilation gas flow over certain critical areas of the body.

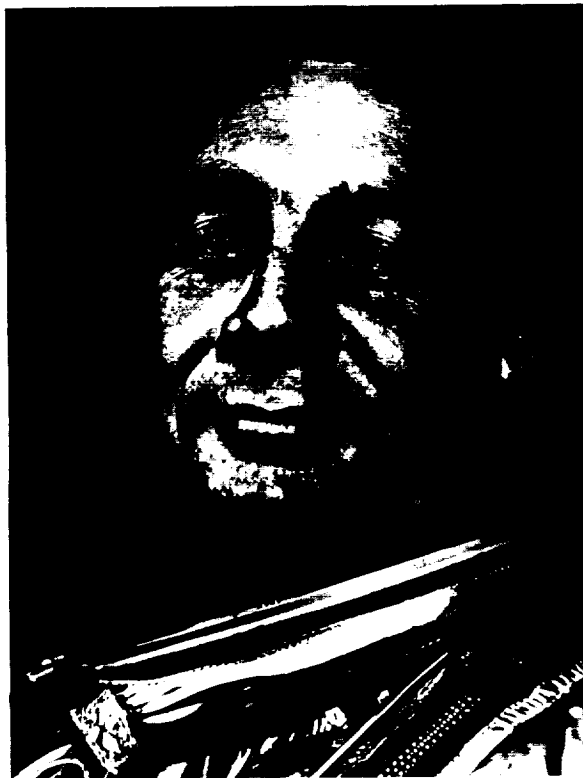
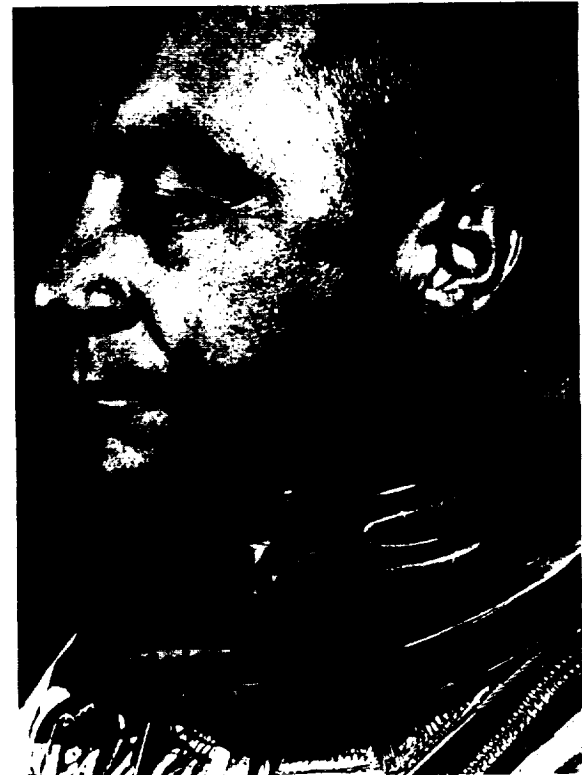
FIGURE 3-6.—Neck dam.

*Neck Dam.*—A conical rubber neck dam is attached to the torso neck ring as shown in figure 3-6. The purpose of this neck dam is to prevent water from entering the suit in event of water egress with the helmet off. The

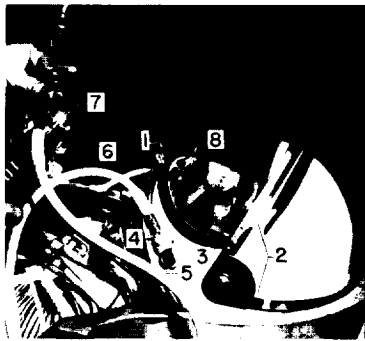
FIGURE 3-7.—Helmet assembly.

The helmet assembly, shown in figure 3-7, consists of a resinous, impregnated Fiberglas hard shell; an individually molded crushable impact liner; a ventilation exhaust outlet; a

1. NECK RING AND LATCH
2. PLEXIGLAS VISOR
3. PNEUMATIC VISOR SEAL
4. "ON-OFF" VISOR VALVE
5. DEFLATE BUTTON
6. VISOR SEAL HOSE
7. VISOR SEAL BOTTLE
8. MICROPHONES

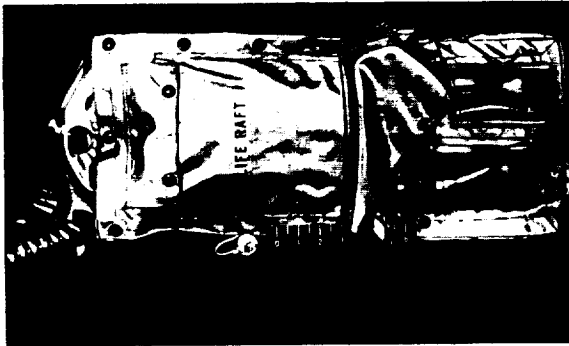
FIGURE 3-8.—Packed survival kit.

The MA-6 spacecraft was equipped with a survival kit (fig. 3-8) made up of standard

Department of Defense (DOD) survival items and other items recently developed by the NASA. This survival equipment is carried for emergency recovery contingencies and has not been used in the three manned flights to date.

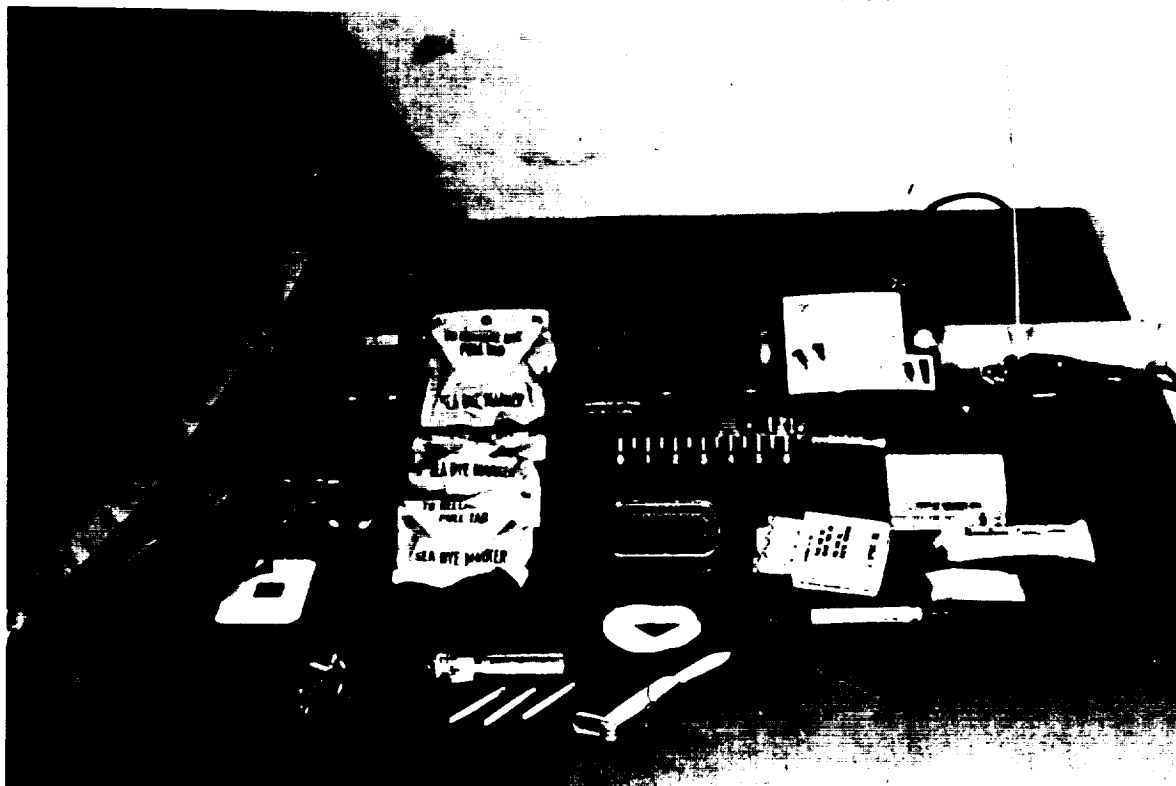
FIGURE 3-9.—Survival kit components.

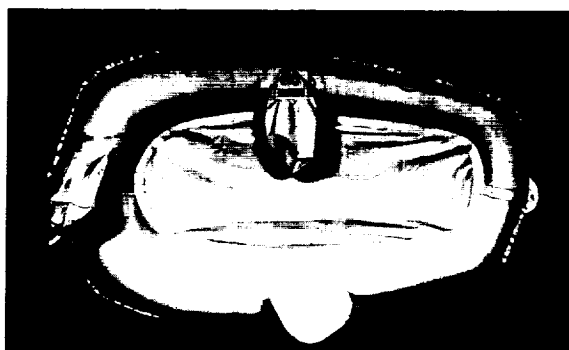
FIGURE 3-10.—Liferaft showing stabilizing buckets.

An inhouse program was then initiated to improve the raft reliability and reduce its weight by decreasing the number of fabrication seams through the utilization of new materials. Figures 3-10 and 3-11 are photographs of the rafts developed by NASA.

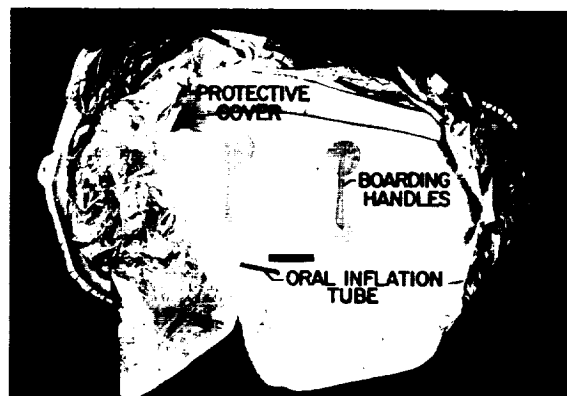
FIGURE 3-11.—Liferaft top view.

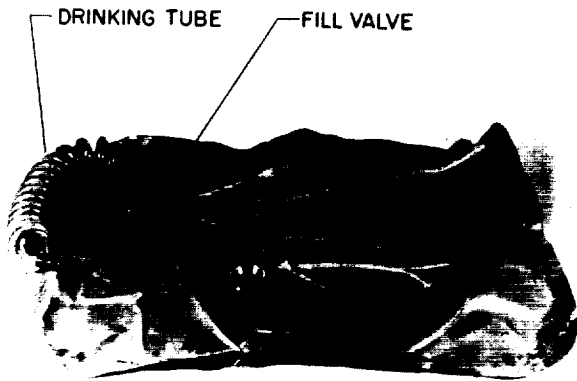
FIGURE 3-12.—Water container.

Figure 3-12 shows the water container in the uninflated, unfilled condition. Water is forced under pressure into the container by means of the one-way pressure valve shown in the lower, middle, left-hand section. The astronaut drinks through the plastic, spiral tube. An Estane

liner within the bag insures tasteless water. Figure 3-13 shows how the water container packs into the survival kit. The liferaft is placed on top of the water container.

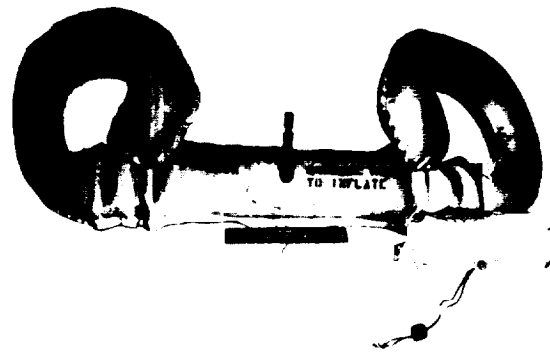
FIGURE 3-14.—Life vest.

Two basic configurations were fabricated, one a simple tube similar to a ski belt, the second a belt with inflated hooks (fig. 3-14). The inflatable hooks were constructed to provide a positive grasp to the wearer's shoulders; easy donning and doffing features; and adequate flotation characteristics without impairing rescue, recovery, or swimming of the astronaut.

A packet to stow the vest was developed. The present configuration (fig. 3-14) is trapezoidal, 5- by 4- by 3- by 1-inch in thickness. The packet and vest weigh less than 1 pound (0.99 lb) and contain an oral inflater in addition to the internal carbon dioxide charge. Presently, the packet is affixed to the suit below the neck ring. A lanyard is provided to preclude accidental loss upon inflation. Placement tests of the package indicate the chest area to be as satisfactory as the lower leg. The entire unit can be opened, inflated, and donned with one hand in less than 10 seconds when attired in the pressure suit.

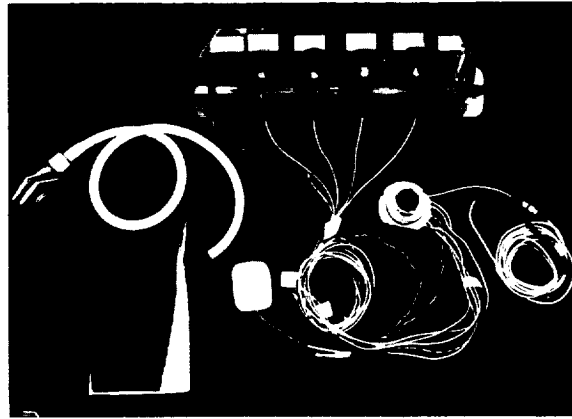
FIGURE 3-15.—Flight sensor harness.

The ECG sensors consist of rings composed of silicone rubber. The rings are constructed

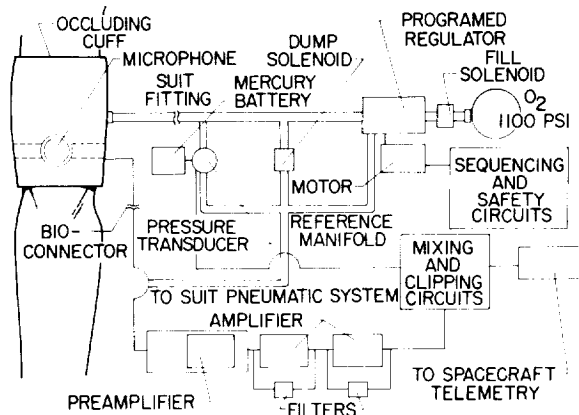
FIGURE 3-16.—Block diagram of automatic BPMS.

The original concept of the BPMS (fig. 3-16) was an automatic system, which would be initiated from a tracking station through the command receiver, by an automatic sequencing device onboard or by the pilot. The automatic system incorporated special safety circuits to dump the cuff pressure if the cuff stayed above

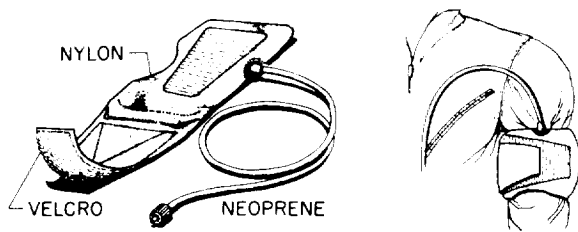
FIGURE 3-17.—BPMS cuff.

During the testing of the preliminary system on astronauts and other flight personnel it became evident that the standard 5-inch clinical cuff was unsatisfactory because of its stiffness, bulk, and the fact that arm movement was restricted. A new cuff (fig. 3-17) was devised by

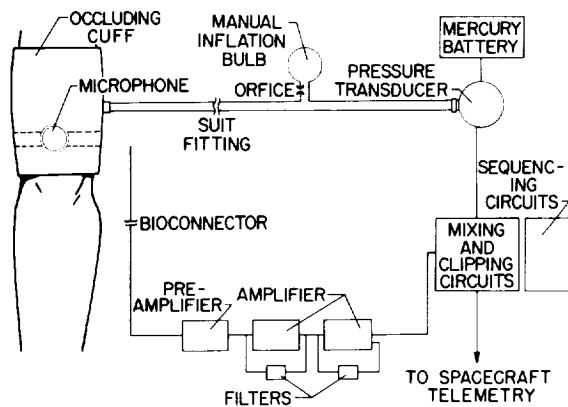
FIGURE 3-18.—Block diagram of manual BPMS.

velop the BPMS as late as 1961 resulted in the system being a retrofit item instead of planned spacecraft equipment. A number of late changes were made in the configuration of the system to reflect developments in the spacecraft equipment. The area originally selected for the mounting of the BPMS was proved undesirable due to egress difficulty. Alternate areas selected required repackaging of various components and finally resulted in the elimination of the gas pressure source, regulator, and motorprogrammer and the installation of a hand-pumped inflation system with a simple orifice to release cuff pressure (figs. 3-18 and 3-19).

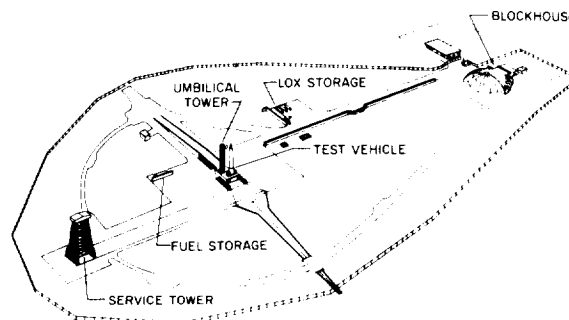
FIGURE 4-1.—Standard Atlas D launch complex.

launch complex was basically designed to support Atlas D operations. Both the complex and the launch vehicle, however, were modified to provide various and specific features that were necessary for a manned spacecraft operation. A brief description of a standard launch complex and launch vehicle is given first so that the special features for Mercury will be more readily recognized. Figure 4-1 shows a standard Atlas D launch complex. The term "complex" includes such facilities as the blockhouse, fuel and liquid oxygen storage, electrical power

supply, service tower, and the launching pad. All equipment necessary to check out completely each system on the complex and in the launch vehicle is located in these facilities and each of these systems is completely validated prior to each launch operation. Figure 4-2 shows a view of some of the checkout equipment located inside the blockhouse.

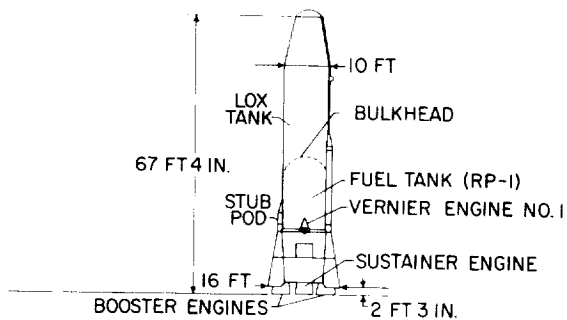
FIGURE 4-3.—Standard Atlas D launch vehicle.

The general configuration of the launch vehicle is shown in figure 4-3. The launch vehicle is a 1½ stage, liquid-propellant launch vehicle with five engines: 2 booster engines, 1 sustainer engine, and 2 small vernier engines. These engines produce a total thrust of approximately 360,000 pounds. The fuel tank is lo-

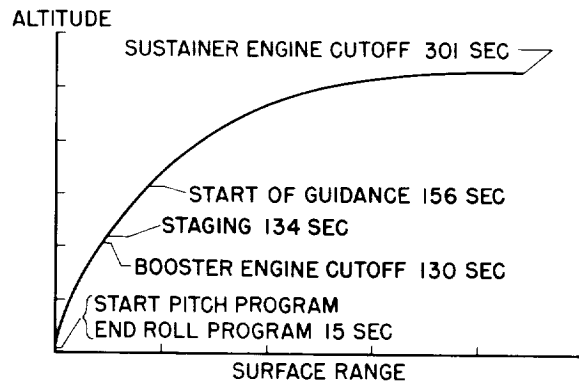
ALTITUDE VS SURFACE RANGE FOR LAUNCH-VEHICLE POWERED FLIGHT PATH

FIGURE 4-4.—Sequence of events during powered flight.

Perhaps the best way to explain the normal functions of the launch vehicle is to look at the sequence of events during powered flight. Such a sequence is shown in figure 4-4. The figure shows the launch-vehicle trajectory plotted as

altitude against range. Two seconds after lift-off, the roll program is initiated by onboard flight equipment. This maneuver is necessary because the launch pad is oriented so that the pitch axis of the launch vehicle is aligned on an azimuth of  $105^\circ$  while the Mercury spacecraft insertion head is about  $75^\circ$ . Therefore, the roll program has to rotate the launch vehicle approximately  $30^\circ$  to align it with the Mercury spacecraft insertion heading. At 15 seconds after lift-off the roll program is complete and then the pitch program is started. Although

the pitch program is active throughout the remaining portion of powered flight, the rate at which the pitch program changes the pitch attitude varies throughout the trajectory. At  $T+130$  seconds, the ground guidance station sends a command which shuts off the two booster engines. Then the sustainer engine is locked in the neutral position and the booster engines are jettisoned. The sustainer engine is then unlocked and the vehicle is guided to insertion by the controllable sustainer engine which is positioned by commands from the ground guidance station. At approximately  $T+300$  seconds, the ground guidance station, once satisfied that all insertion parameters are attained, sends a command which shuts off the sustainer and vernier engines.

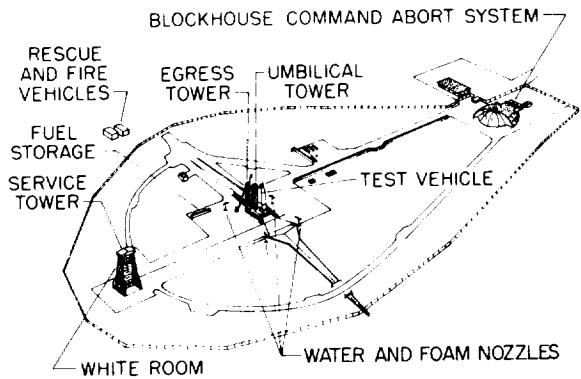
FIGURE 4-5.—Mercury modifications to launch complex.

As mentioned previously, in order to support Mercury missions, both the complex and the launch vehicle were modified. Figure 4-5 shows the major modifications that were made to the complex. In the service tower, a room was built to enclose the spacecraft. Figure 4-6 shows an external view of the service tower and the specially built room. This room, commonly called the "white room," is located near the top of the service tower. The spacecraft is shown in the figure immediately outside of the sliding doors of the white room. Figure 4-7 presents a close-up view looking into the white room. The figure shows the sliding doors in the open position and the spacecraft suspended just above the adapter. The figure also shows the roof in the folded position, but the floor is shown intact. It should be pointed out

A special firefighting system was also installed. The four nozzles shown in figure 4-5 were remotely controlled from the blockhouse in such a manner that water or fire-smothering foam could be directed to any area inside the

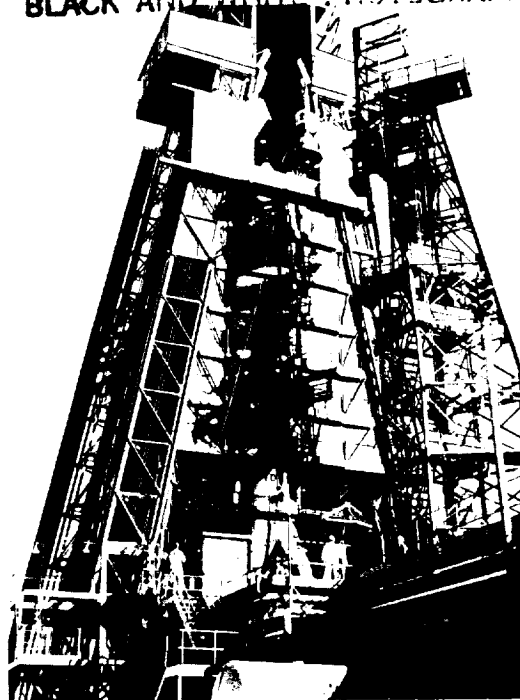
FIGURE 4-6.—Service tower showing white room.

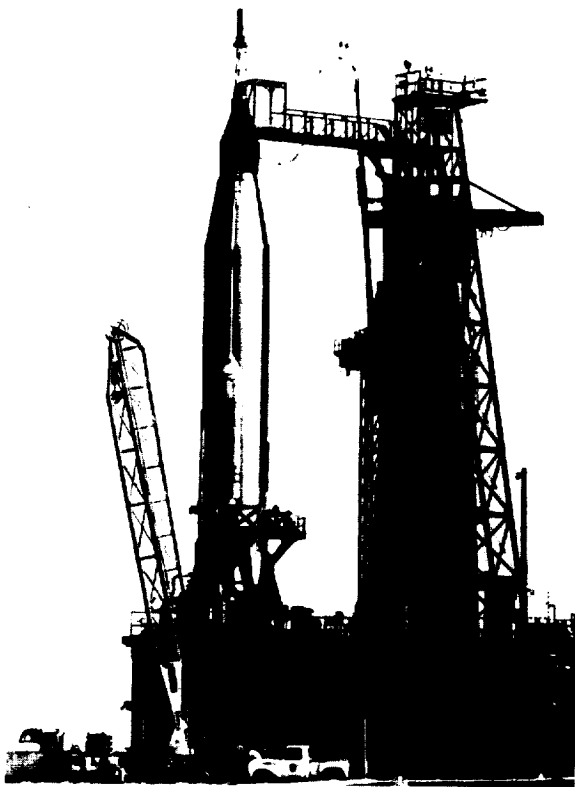
FIGURE 4-8.—Emergency egress tower.

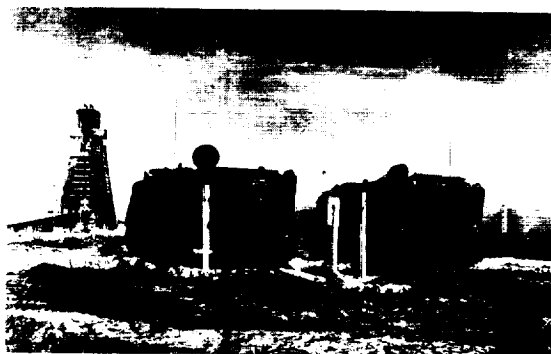
FIGURE 4-9.—Rescue and firefighting vehicles.

Special rescue and firefighting vehicles were stationed just outside of the complex to transport the egress crew to the tower and/or to meet the astronaut at the tower and transport him away from the complex. Figure 4-9 shows the position of these vehicles relative to the launch pad. The astronaut-transport vehicle, with its covering of special thermal insulation, can be seen in this figure. The egress procedure was practiced many times and it is interesting to note that the astronaut could evacuate the spacecraft and be delivered to a safety zone outside of the complex in about 21½ minutes.

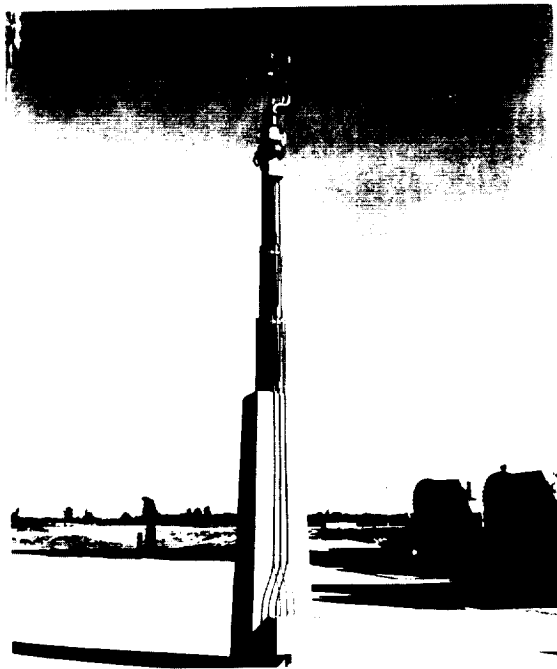
FIGURE 4-10.—Firefighting nozzle.

complex. Figure 4-10 shows a close-up view of one of the nozzles.

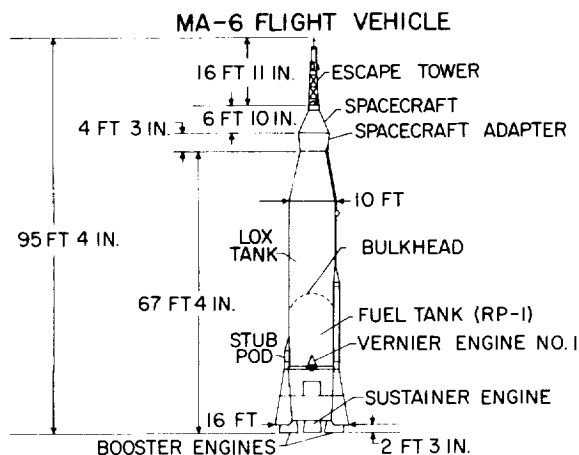
FIGURE 4-11.—Mercury configuration of flight vehicle.

The Mercury configuration of the flight vehicle is shown in figure 4-11. The adapter which mates the spacecraft to the launch vehicle is immediately above the liquid oxygen tank

and the spacecraft is mounted on top of the adapter.

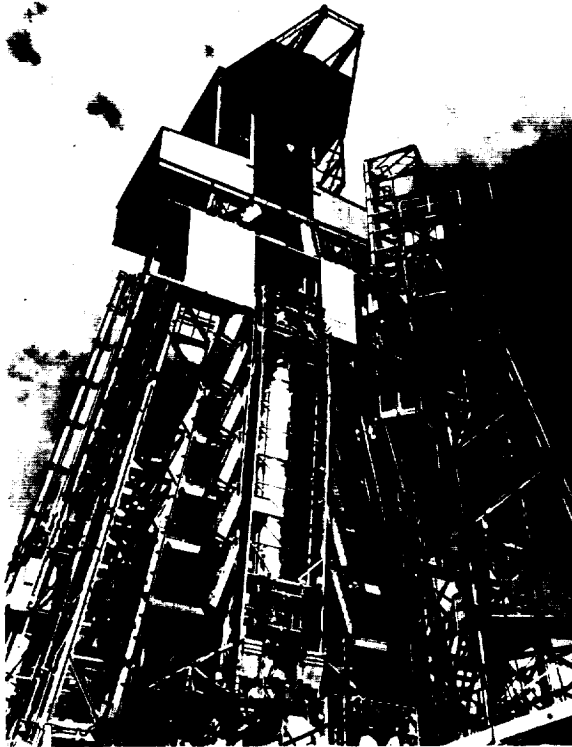
FIGURE 4-13.—Launch vehicle after erection.

After erection it was learned that the launcher mechanism, in which the launch vehicle was mounted, could not be adjusted sufficiently to aline the launch vehicle properly. Therefore, the launch vehicle was taken down, the launcher mechanism was replaced, and the launch vehicle was reerected. All systems on the complex and the launch vehicle were then tested individually. For example, complete tanking tests were conducted in which the fuel and liquid oxygen tanks were loaded and pressurized to flight pressure. This test is performed to determine if any leaks are in the systems and also to check out the controls related to each system. During this test on the

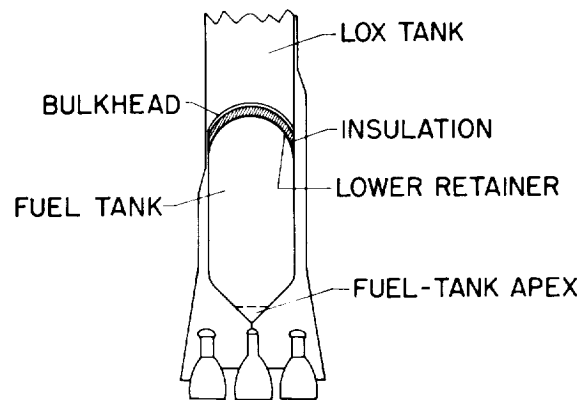
FIGURE 4-14.—Bulkhead between fuel and liquid oxygen tanks.

After electrical mating, the launch vehicle and spacecraft participate jointly in all tests. These tests are discussed in paper 5 on spacecraft preparation. The first attempt to launch MA-6 was on January 27, 1962. The launch vehicle was loaded with fuel on January 24. However, the mission was canceled because of excessive cloud cover in the launch area and was rescheduled for February 1; so the fuel tank was drained. On January 30, the fuel tank was again loaded; however, normal inspection procedures disclosed that the insulation-retaining bulkhead in the fuel tanks was leaking. Figure 4-14 shows a sketch of this bulkhead.

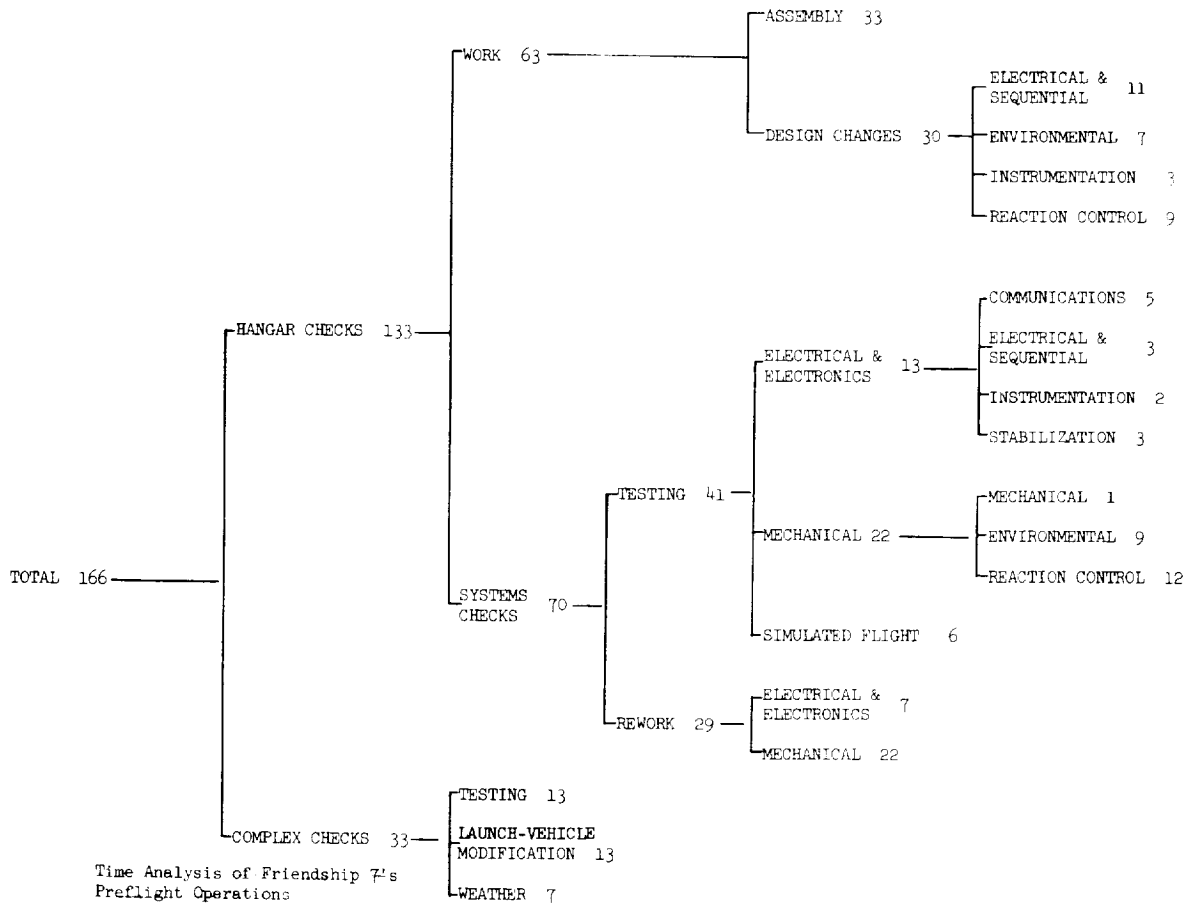
FIGURE 5-1.—Time analysis of preflight operations on Friendship 7.

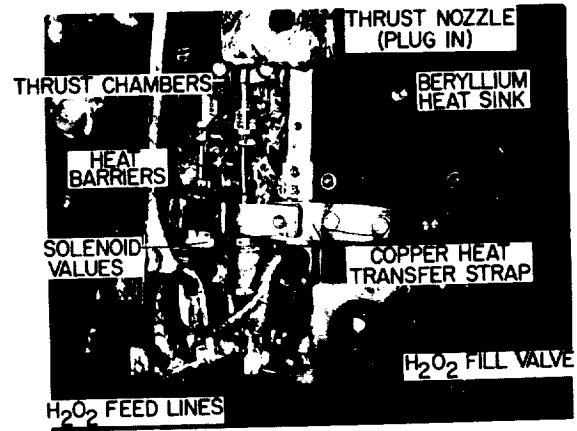
FIGURE 5-3.—Heat sinks added to roll thruster assemblies in reaction control system.

(2) Heat sinks were added to both manual and automatic roll thruster assemblies (fig. 5-3). Tests at McDonnell Aircraft Corp., St.

Louis, Mo., and data obtained from the spacecraft 9 flight indicated a need for removing the excess heat generated by the thrusters. This heat resulted in undesirable fuel temperatures.

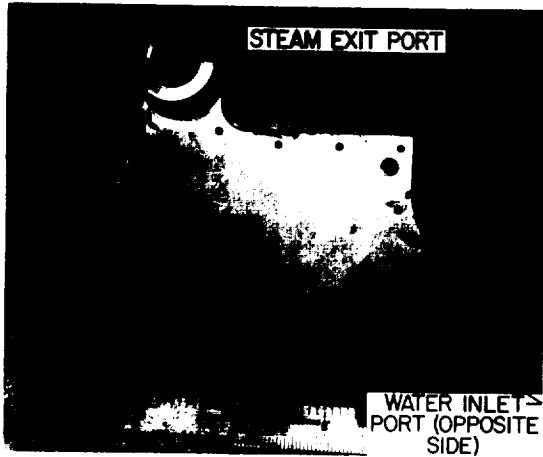
FIGURE 5-4.—Inverter cooling plate.

(1) Advanced water-type heat exchangers (cold plates) were installed under the 150 and 250 main inverters (fig. 5-4). The results obtained on the spacecraft 9 flight indicated insufficient cooling.

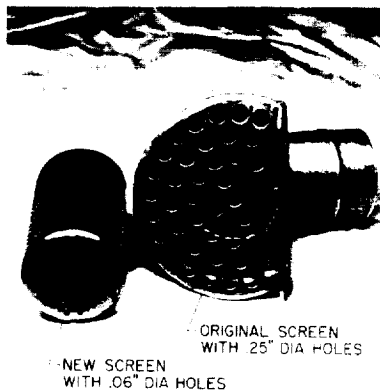
FIGURE 5-5.—Cooling fan duct inlet screens for Friendship 7 and Spacecraft 9.

(2) The cooling fan duct inlet screens were changed to screens having 0.06-inch diameter holes. (See figure 5-5.) This change was required when the postflight inspection of spacecraft 9 revealed that the cabin fan was jammed by small bits of metal, fabric, and rubber, shown in figure 5-6, which were ingested into the fan under zero-g conditions through the 0.25-inch diameter holes in the inverter cooling duct screens.

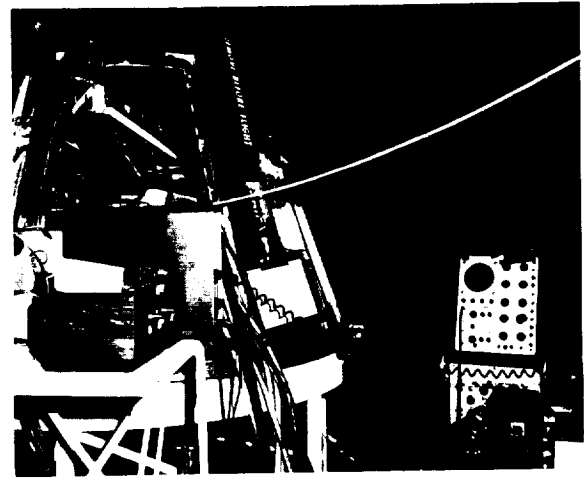
FIGURE 5-7.—Spacecraft cabled for electrical power system tests.

Power surges on the d-c bus were experienced when the 150 v-amp main inverter was switched on the line. Because an excessive number of

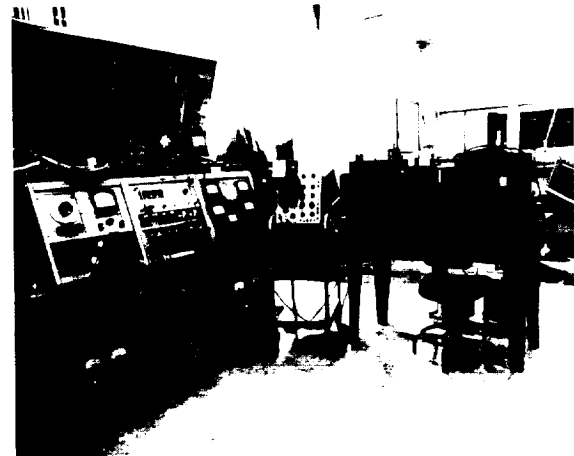
FIGURE 5-8.—Bench setup for testing spacecraft instrumentation.

The instrumentation system was thoroughly tested and calibrated on the bench as shown in figure 5-8 at Cape Canaveral prior to its installation in the spacecraft. The system was tested again after it had been installed in the spacecraft. The primary purpose of the latter test is fourfold: (1) to determine the error, if any, between the hardline signal normally used to transmit data to the blockhouse or other test equipment in the hangar and the signal radiated through the transmitter; (2) to determine possible system interference with the system operating in the spacecraft; (3) to make a sin-

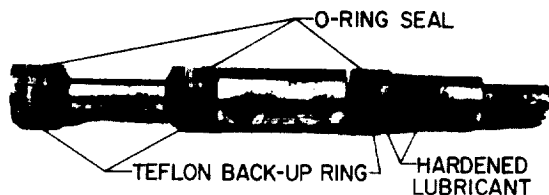
FIGURE 5-9.—High-pressure shutoff oxygen valve stem shown with hardened lubricant.

(1) Excessive leakage of the high-pressure oxygen shutoff valve was noted. The stem was removed from the valve body and the lubricant was found to have hardened on the O rings and sealing surfaces (fig. 5-9). The O rings and backup seals were replaced, and the component was lubricated and replaced in the valve body. The valve continued to show a leakage caused by the seals not seating properly. The

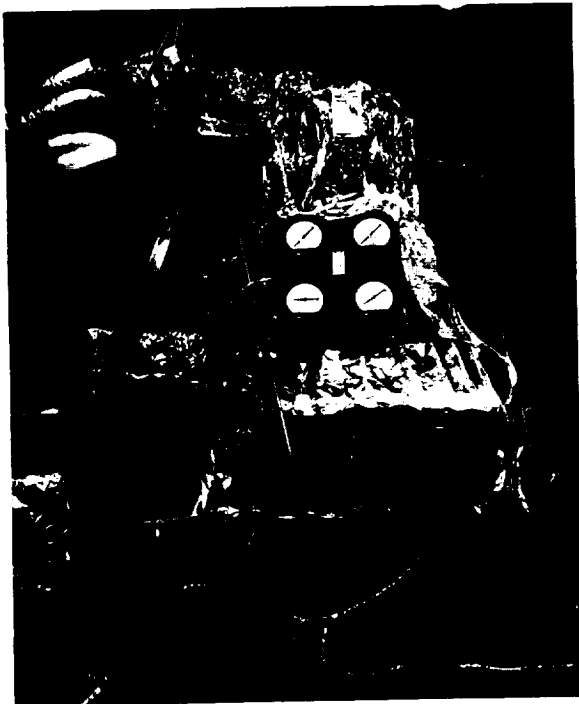
FIGURE 5-11.—Spacecraft in reaction control system facility for functional test of system.

The reaction control system (RCS) checkout procedure determined the condition and operation of the RCS system. Tests were conducted in a special test cell (fig. 5-11). Several gas checks were employed to determine the overall

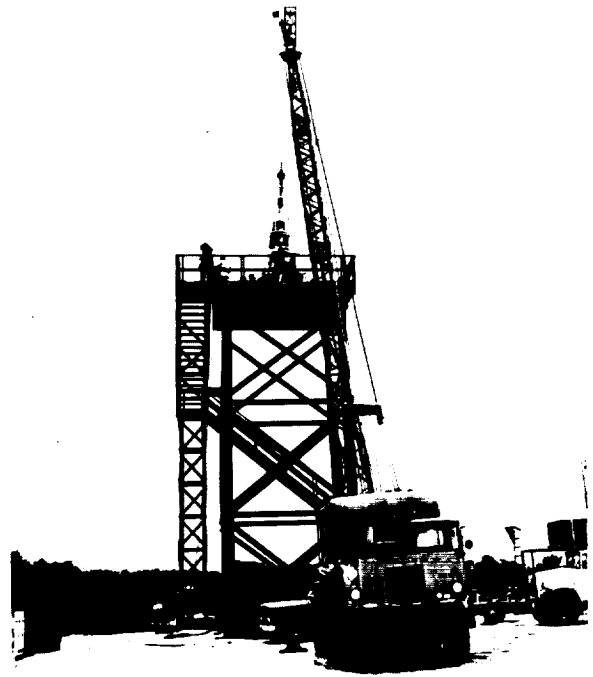
FIGURE 5-12.—Spacecraft being installed on communications tower for communication antenna tests.

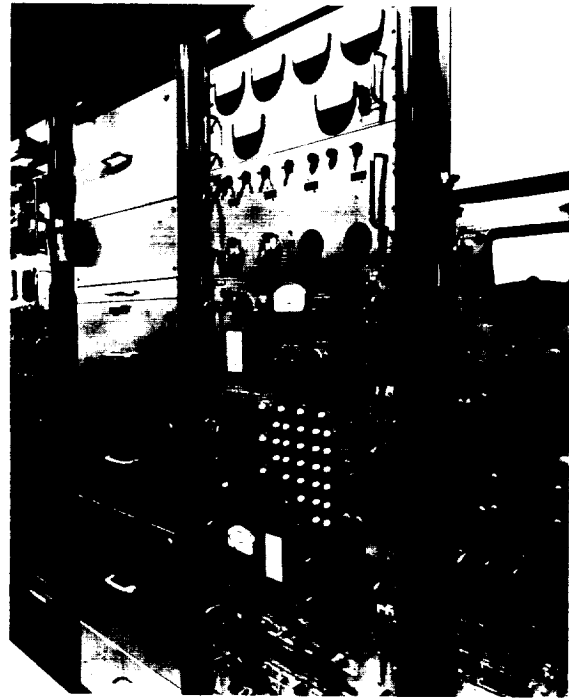
FIGURE 5-14.—Automatic checkout equipment for checking logic of autopilot.

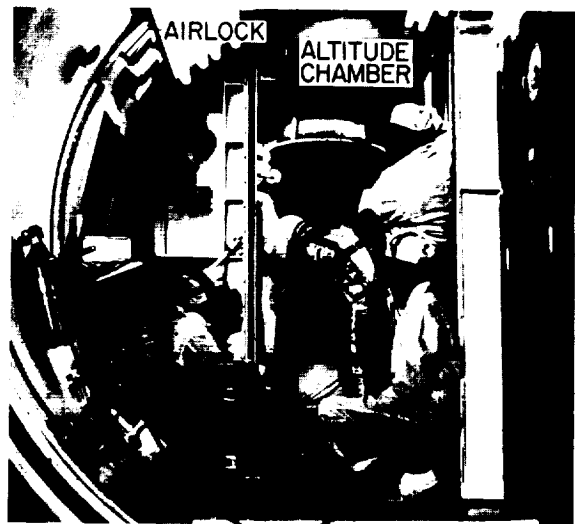
FIGURE 5-15.—Overall evaluation of the environmental control system in altitude chamber.

The altitude-chamber tests (fig. 5-15) were used to determine the operating characteristics of the overall environmental control system (ECS). The astronaut was suited and connected into the ECS for the first time during the altitude-chamber tests. The chamber was pumped down to a simulated altitude of ap-

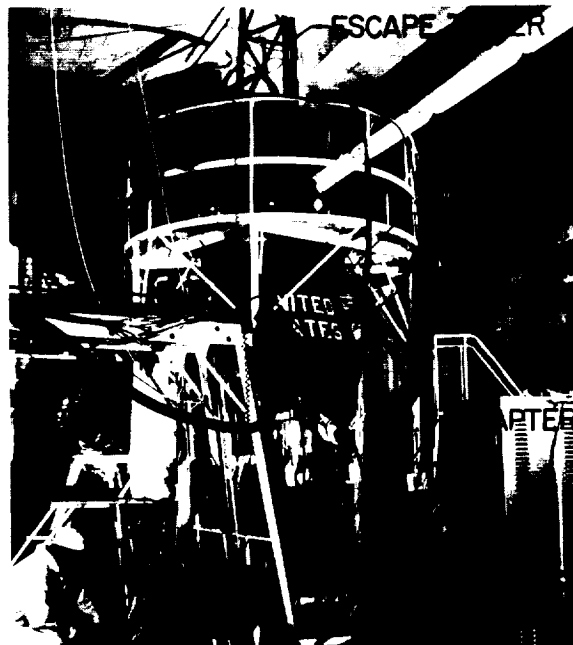
FIGURE 5-17.—Spacecraft during final simulated flight test in Hangar S.

The configuration of the spacecraft during the simulated flight test was as follows and is shown in figure 5-17.

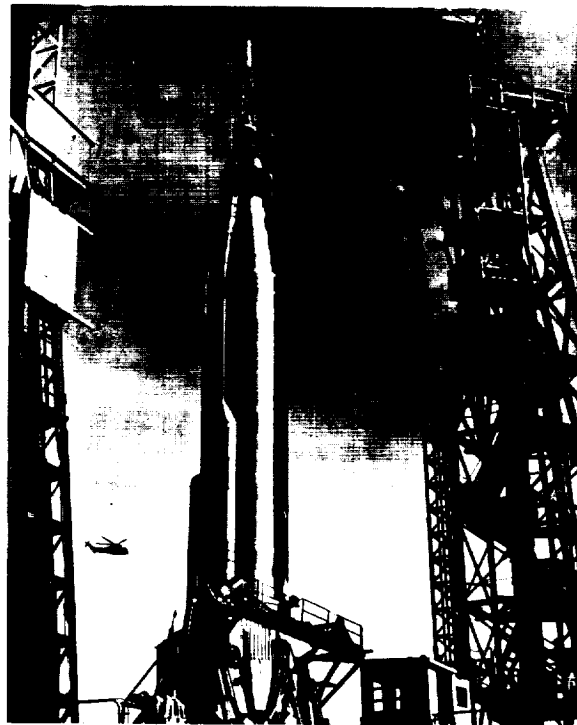
FIGURE 5-19.—Spacecraft on Atlas launch vehicle undergoing launch complex testing.

As originally planned the launch pad operations were scheduled for completion in 13 days; however, due to delays caused by changes in the spacecraft and launch vehicle after mating, trouble encountered during tests, and adverse weather conditions, the actual time the spacecraft spent on the launch pad is somewhat longer than the 13 days as shown in figure 5-18. For Friendship 7 this period extended from January 3, 1962, through February 20, 1962. Figure 5-19 shows the spacecraft on the launch vehicle during these launch pad operations.

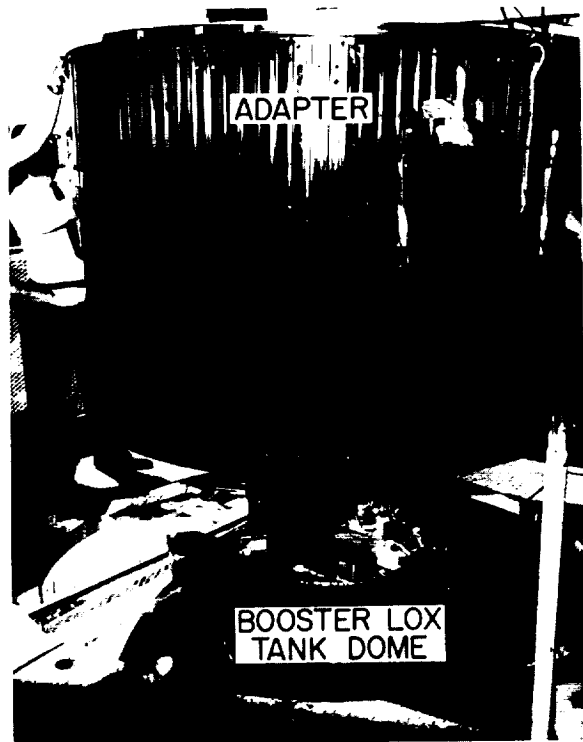
FIGURE 5-21.—View of spacecraft adapter being mounted on launch vehicle.

Prior to mating the spacecraft to the launch-vehicle adapter, it was necessary to verify that all items in the adapter section had the proper clearance and that there was no debris. Figure 5-21 shows the adapter being mounted on the launch vehicle. Following the inspection and mating of the spacecraft to the launch vehicle, all openings into this vital section were sealed. These seals are not removed again except for emergency work and just prior to launch. The adapter and interface area met all requirements and the spacecraft was then mated with the launch vehicle.

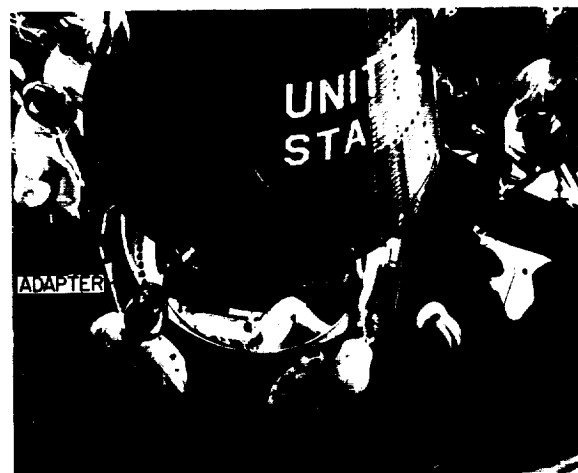
FIGURE 5-22.—Mechanical mating of spacecraft to adapter.

Mechanical mating was primarily a mechanical fit operation in which the spacecraft was placed on the launch-vehicle adapter (fig. 5-22) and the main clamp ring was installed. In addition, prior to hoisting the spacecraft to the

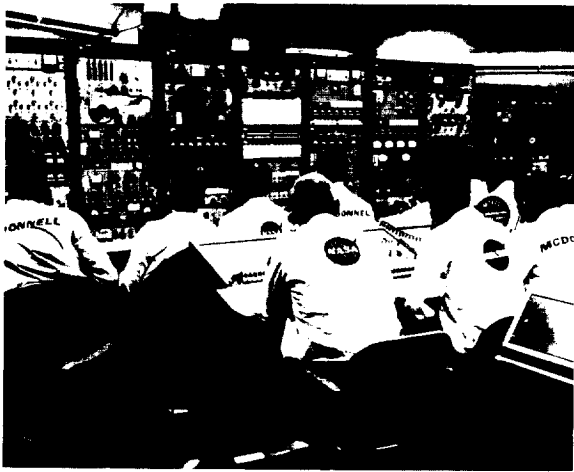
FIGURE 5-23.—Blockhouse consoles for monitoring spacecraft operation during the launch complex operation.

Spacecraft systems tests were performed primarily to check the spacecraft systems functionally and to check the remote-control capability from the blockhouse. Figure 5-23 shows the spacecraft blockhouse consoles. Following this test the spacecraft was ready to proceed with tests which integrate the launch vehicle and the spacecraft. During these tests trouble was experienced with the coolant quantity indicating system indicator, the auxiliary beacon, and minor discrepancies in ground-servicing equipment (GSE) cabling. These items were corrected and those parts of this system tests required were rerun to validate the changes.

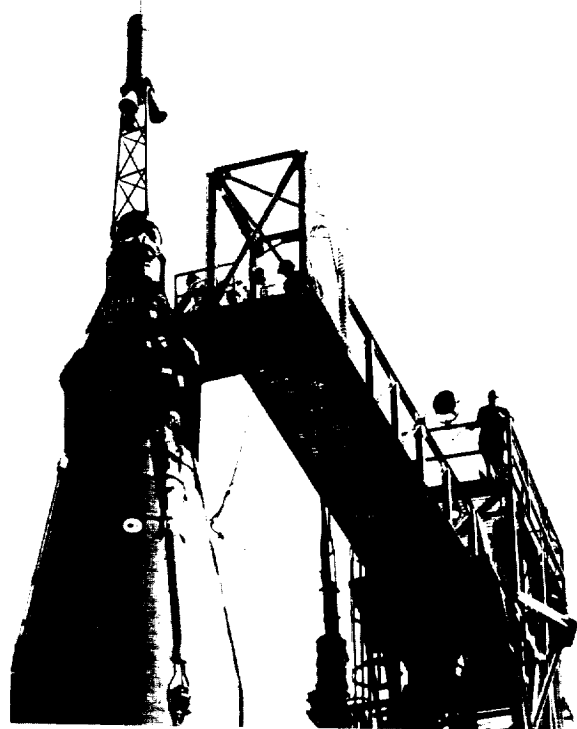
FIGURE 5-24.—Emergency egress tower ramps in place during emergency egress tests.

the launch-day procedures. At the same time this test provides an opportunity to practice emergency egress procedures (fig. 5-24). No problems were encountered in this test.

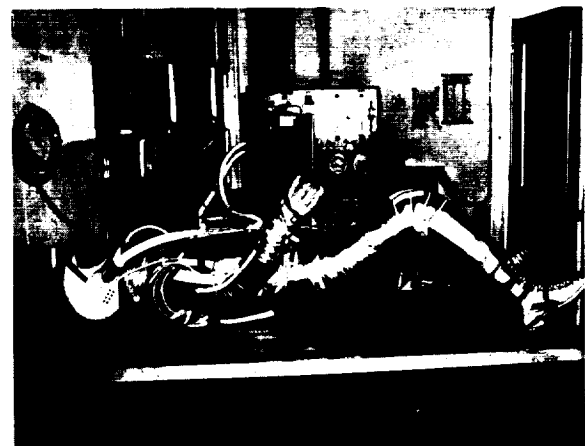
FIGURE 5-25.—Pressure tests of astronaut's pressure suit at 5 psi.

Prior to and after astronaut donning of the pressure suit the complete assembly was pressurized and leak checked at 5 psig, and at 5 inches of water differential pressure. This test console provides the pressure control and leakage measurement system required.

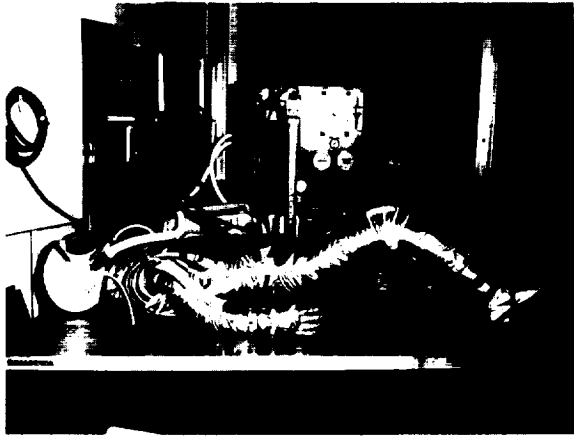
FIGURE 5-26.—Low pressure tests of suit.

flight, operates at a pressure of only a few inches of water above cabin pressure and would operate at 5 psi differential only if the cabin should become decompressed. No leak checks previously had ever been made at these low pressures. Inspection of the suit cuff and zipper seals indicated that pressure was required to effect a good seal at these points. Upon testing of the suit at low pressure (fig. 5-26) it was found that the cuff seals at the wrists (fig. 5-27) leaked as the cuff was rotated.

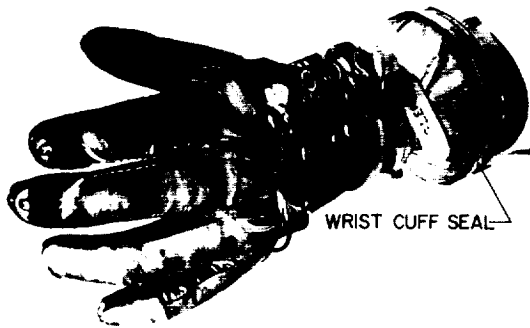
FIGURE 5-27.—Pressure-suit gloves showing cuff slip joint.

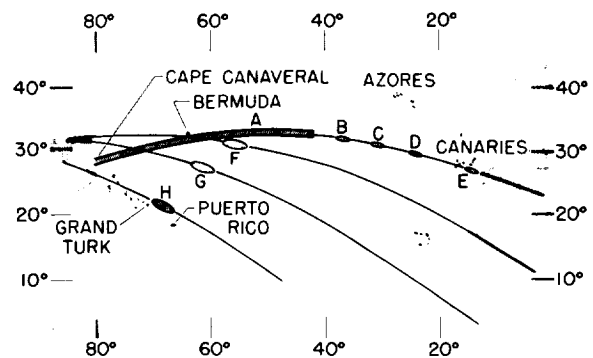
FIGURE 7-1.—MA-6 planned recovery areas.

The planned recovery areas were all located in the North Atlantic Ocean as shown in figure 7-1, and table 7-I is a summary of the support positioned in these areas at launch time for the MA-6 flight.

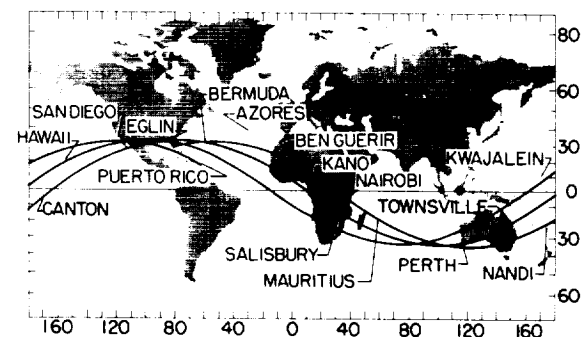
FIGURE 7-2.—MA-6 staging locations for contingency recovery.

port was planned for contingency recovery; however, a large force is required because of the extensive areas covered in three orbits around the earth. The location of contingency recovery units for the MA-6 flight is shown in figure 7-2. A typical unit consists basically of two search aircraft specially equipped for UHF/DF homing on spacecraft beacons, point-to-point and ground-to-air communications, and pararescue personnel equipped to provide on-scene assistance on both land and water. No retrieval forces were deployed in support of contingency landings; procedures were available for retrieval support for after the fact. These search and rescue units were stationed at the 16 locations shown in figure 7-2, and were all linked by communications with the recovery control center at Cape Canaveral. Throughout the MA-6 flight, the astronaut was continually provided with retrofiring times for landing in favorable contingency recovery areas. However, the contingency forces deployed had the capability of flying to any point along the orbital track if required.
