**RESULTS OF THE  
FIRST UNITED STATES  
MANNED ORBITAL SPACE FLIGHT  
FEBRUARY 20, 1962**

**RESULTS OF THE FIRST  
U.S. MANNED  
ORBITAL SPACE FLIGHT  
FEBRUARY 20, 1962**

**MANNED SPACECRAFT CENTER  
NATIONAL AERONAUTICS  
AND SPACE ADMINISTRATION**

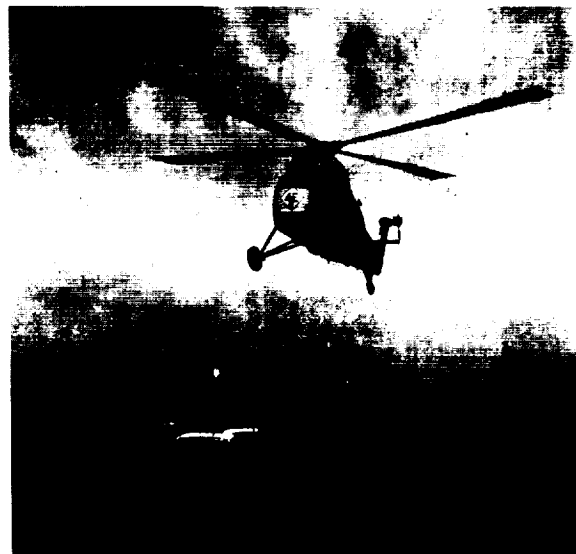
FIGURE 7-3.—Helicopter retrieval technique.

The helicopters which were in the launch site and in each of the end-of-orbit landing areas have three techniques available for retrieval. They are: deployment of a flotation collar and retrieval of the astronaut only, simultaneous retrieval of the astronaut and the spacecraft with transfer of the astronaut to the helicopter, and simultaneous retrieval of the astronaut and the spacecraft with the astronaut remaining in the spacecraft. Only the first case is discussed since this method of retrieval was planned as the primary technique for use by helicopters had they become involved in MA-6. Two swimmers are deployed into the water from the retrieval helicopter and they affix a flotation collar to the spacecraft as shown in figure 7-3. This collar is positioned about

the spacecraft before inflation; and when the dual rings are inflated, the spacecraft is partially supported and, relative to the spacecraft, becomes a very stable working platform. After collar installation, the astronaut can egress either through the tower as shown in figure 7-3 or through the side hatch for transfer to the helicopter by personnel hoist.

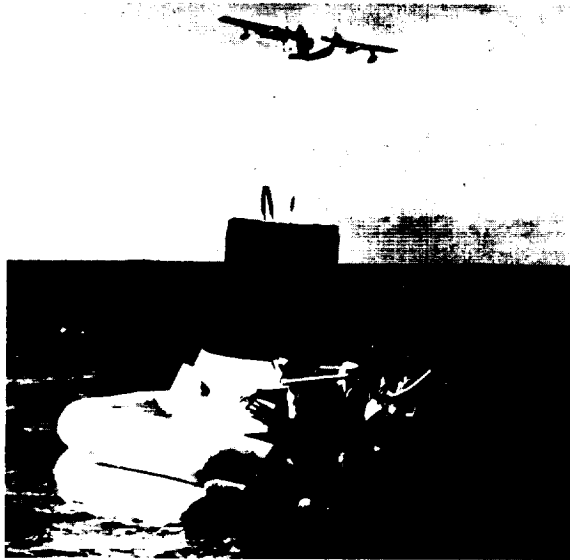
FIGURE 7-4.—On-scene assistance to contingency landing on water.

The flotation collar is also utilized in providing contingency recovery forces with an on-scene assistance capability for remote water landings. This mode of operation is depicted in figure 7-4 which shows pararescue personnel at the spacecraft following their deployment by parachute from a contingency search aircraft.

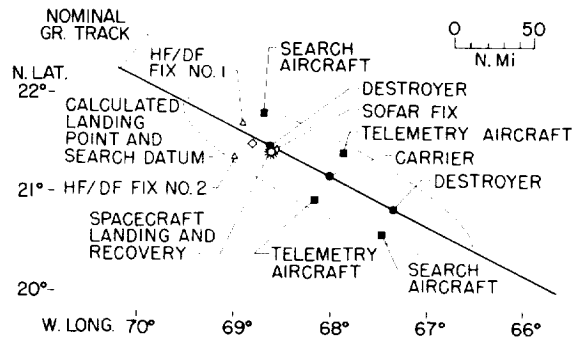
FIGURE 7-5.—MA-6 landing area.

Recovery forces in all areas were notified of mission progress by the recovery control center. Consequently, units located at the end of the third orbit knew they were to become involved, and figure 7-5 presents recovery details in the MA-6 landing area. An aircraft carrier with retrieval helicopters was located in the center of the planned landing area, one destroyer was

located about 40 nautical miles downrange, and a second destroyer was located about 40 nautical miles uprange. Telemetry and search aircraft were airborne in the areas as shown. After the retrorocket maneuver and about 15 minutes prior to the estimated time of landing, the recovery control center notified the recovery forces that according to calculations, the landing was predicted to occur near the uprange destroyer as shown in figure 7-5. The astronaut was also provided with this information by the Mercury Control Center as soon as communications were reestablished after the spacecraft emerged from the ionization blackout. Lookouts aboard the USS *Yoo*, the destroyer in the uprange position, sighted the main parachute of the spacecraft as it descended below a broken cloud layer at an altitude of about 5,000 feet from a range of approximately 5 nautical miles. Communications were established between the spacecraft and the destroyer, and a continuous flow of information was passed throughout the remainder of the recovery operation.

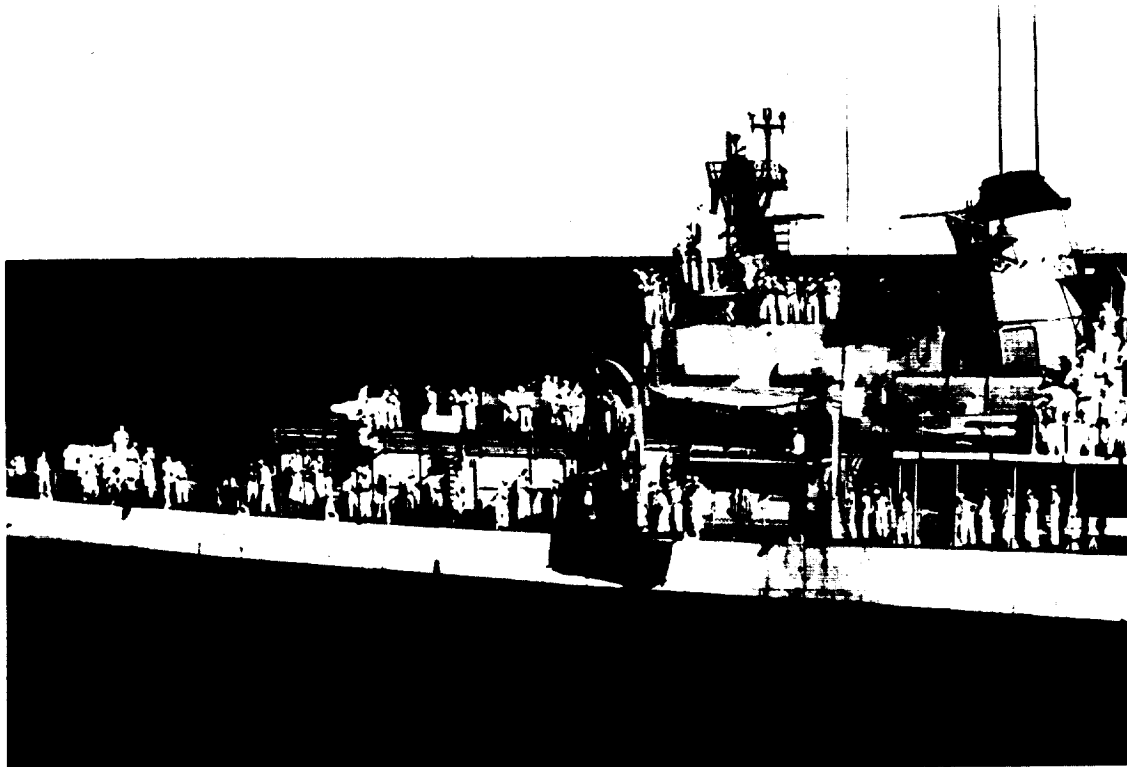
FIGURE 7-6.—MA-6 retrieval by destroyer USS *Noa*.

The *Noa* had the spacecraft aboard 20 minutes after landing. Figure 7-6 shows the spacecraft as it is being lowered to the deck. Astronaut Glenn remained in the spacecraft during pickup; and after it was positioned on the ship's deck, he egressed from the spacecraft through the side hatch. Original plans had called for egress through the top at this time; however, the astronaut was becoming uncomfortably warm and decided to leave by the easier egress path.

as shown in figure 7-6. A deck winch is used for inhauling the lifting line, and when the spacecraft is properly positioned vertically, the davit is rotated inboard to position the spacecraft on deck. A brace attached to the davit is lowered over the top of the spacecraft to prevent swinging once the spacecraft is clear of the water.

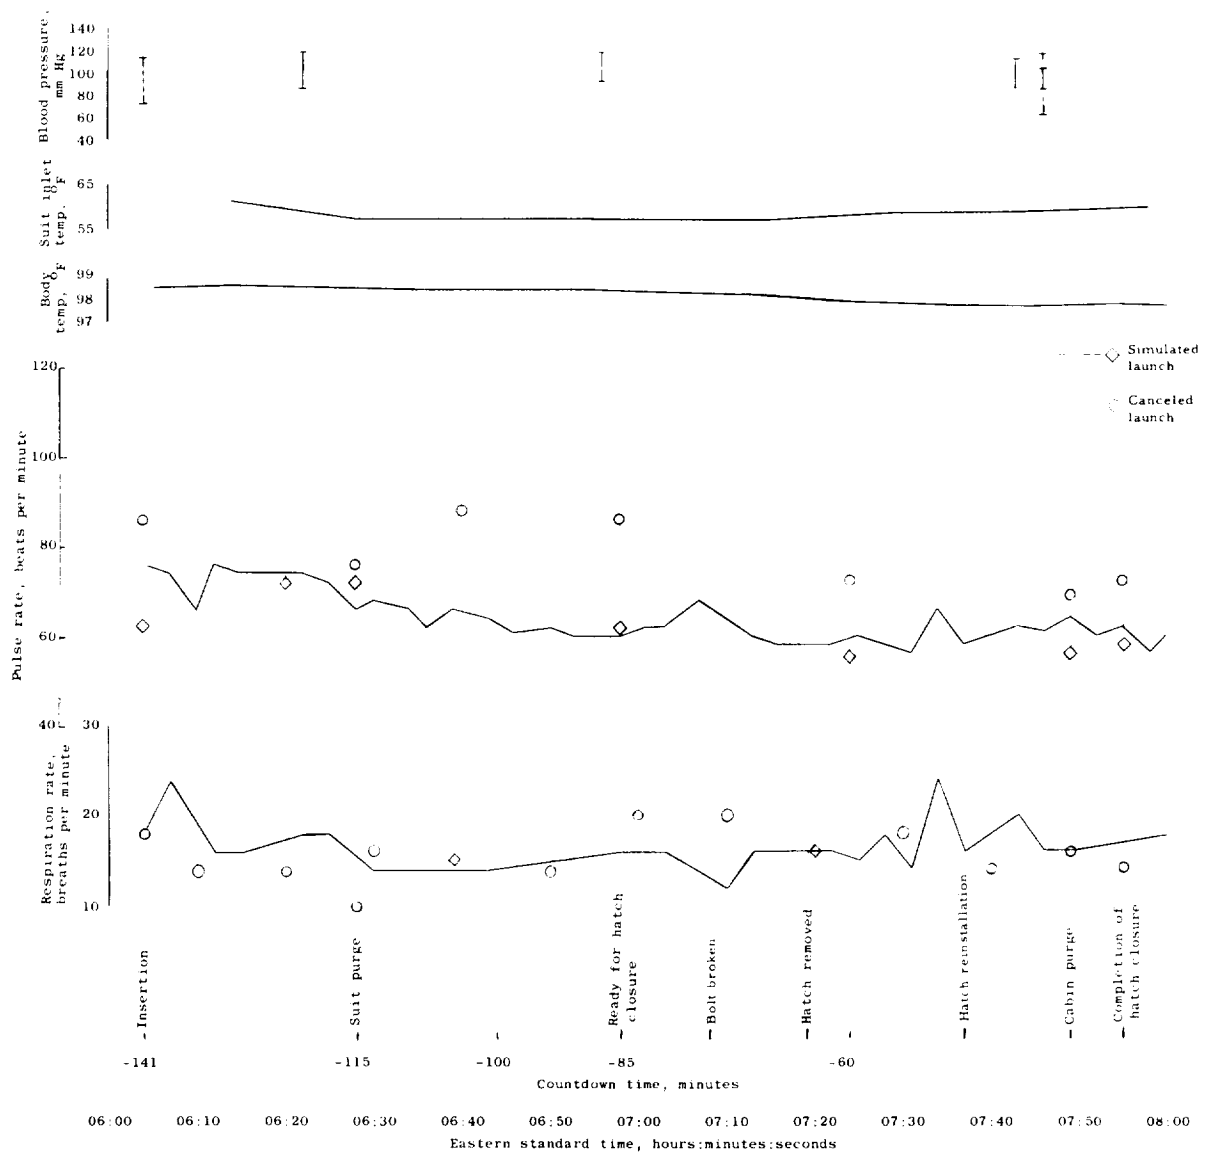
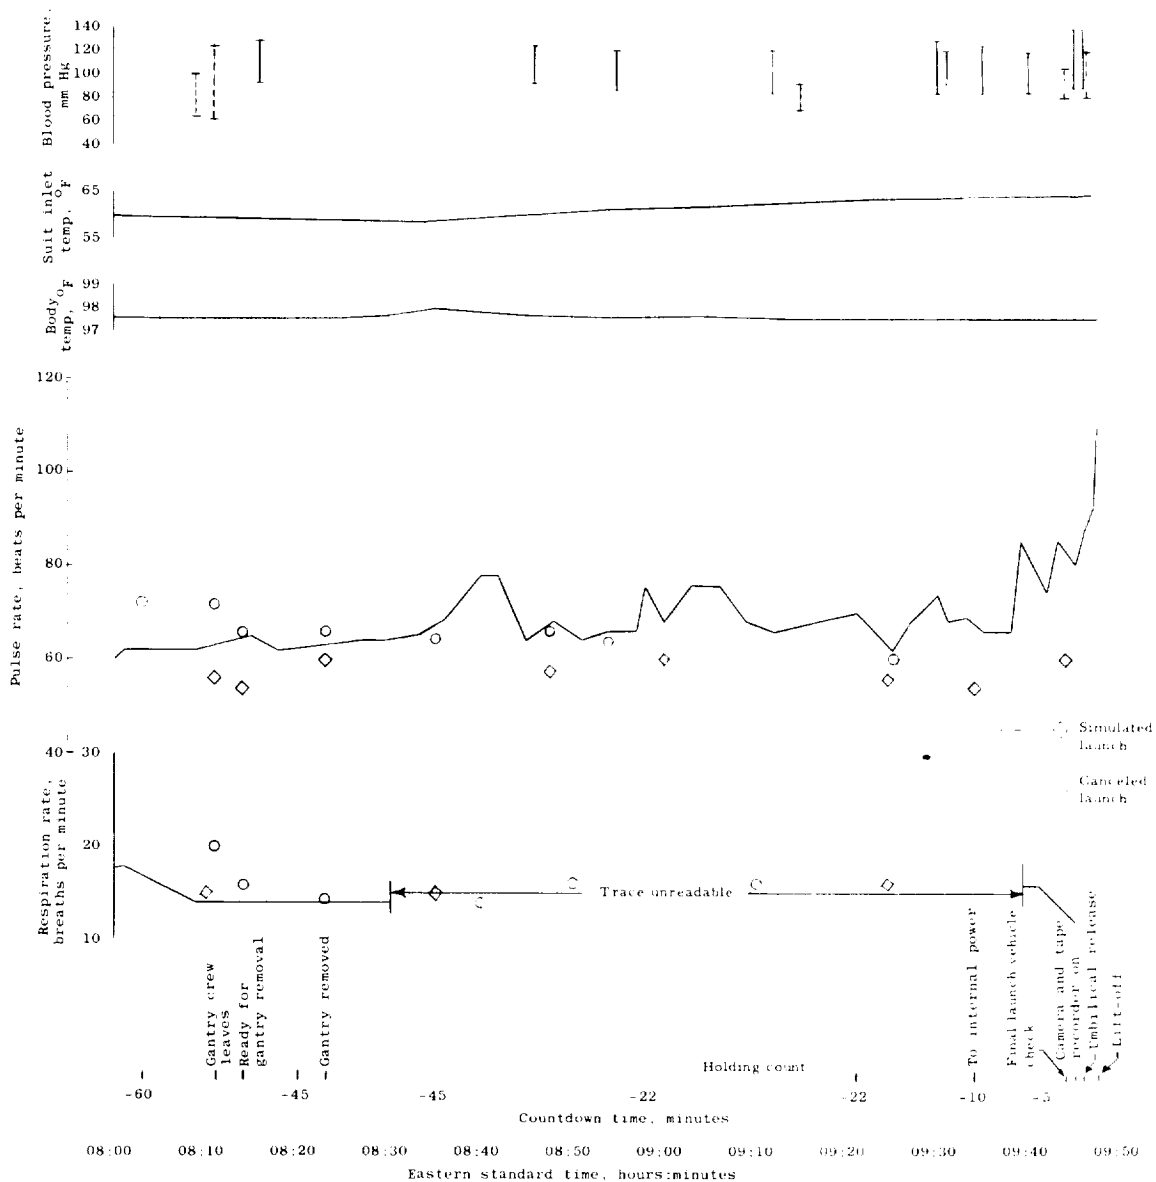
(a) Countdown 06:00 to 08:00 a.m. e.s.t.

FIGURE 9-1.—Preflight: Respiration rate, pulse rate, body temperature, suit-inlet temperature, and blood pressure for MA-6 countdown with values at selected events from the simulated launch of January 19, 1962, and the launch attempt of January 27, 1962.

(b) Countdown, 08:00 to lift-off, 09:47 a.m. e.s.t.  
 FIGURE 9-1.—Concluded.

Figure 9-1 depicts the pulse rate, respiration rate, body temperature, suit-inlet temperature, and blood pressure values recorded during the MA-6 countdown. Values at selected events for the same physiological functions obtained from the simulated launch of January 19, 1962, and the launch attempt of January 27, 1962, are also shown. Pulse and respiration rates were determined by counting the rates for 30 seconds every 3 minutes until 10 minutes prior to lift-off when 30-second duration counts were made each minute.

The pulse rates during the launch attempt of January 27, 1962, varied from 60 to 88 beats/minute with a mean of 70 beats/minute. These rates were essentially the same as those observed during the MA-6 countdown, as shown in figure 9-1. Respiration rates were similar, varying from 12 to 20 breaths/minute. Blood pressure values from the simulated launch also approximated those observed during the MA-6 countdown. A pulse rate of 110 beats/minute and a blood pressure 139/88 mm Hg was observed at lift-off.

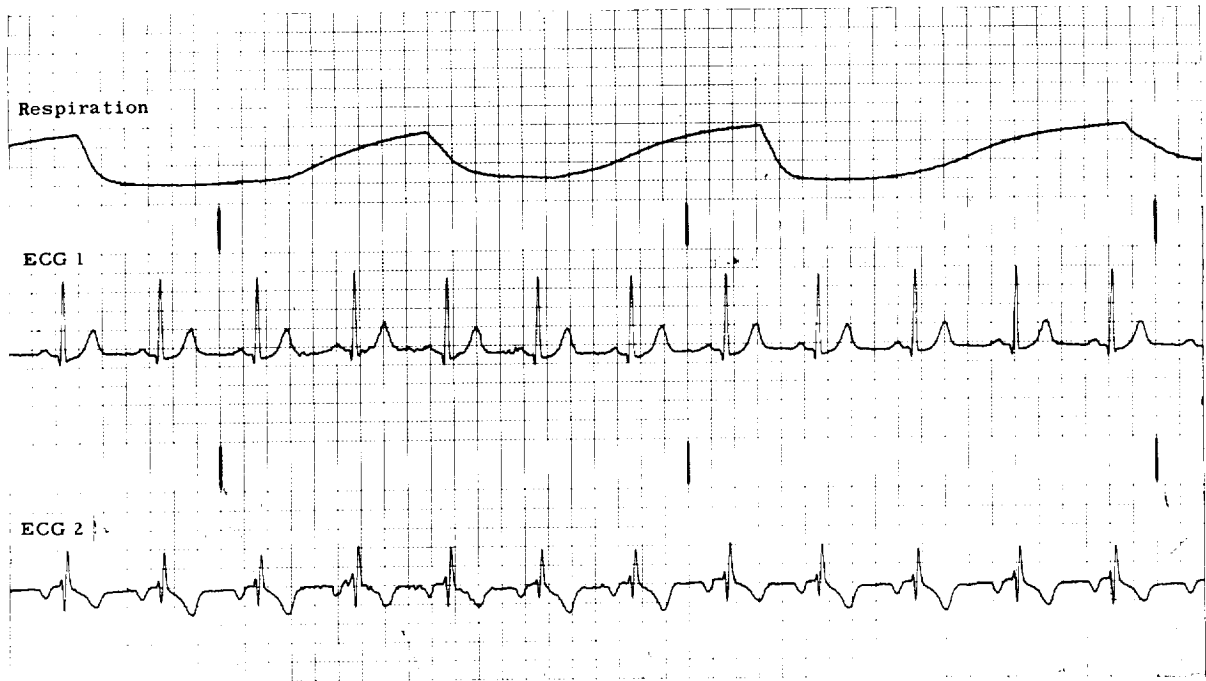
FIGURE 9-2.—Sample of blockhouse physiological record at insertion, 6:06 a.m. e.s.t. Lead 2 is inverted. (Recorder speed 25 mm/sec).

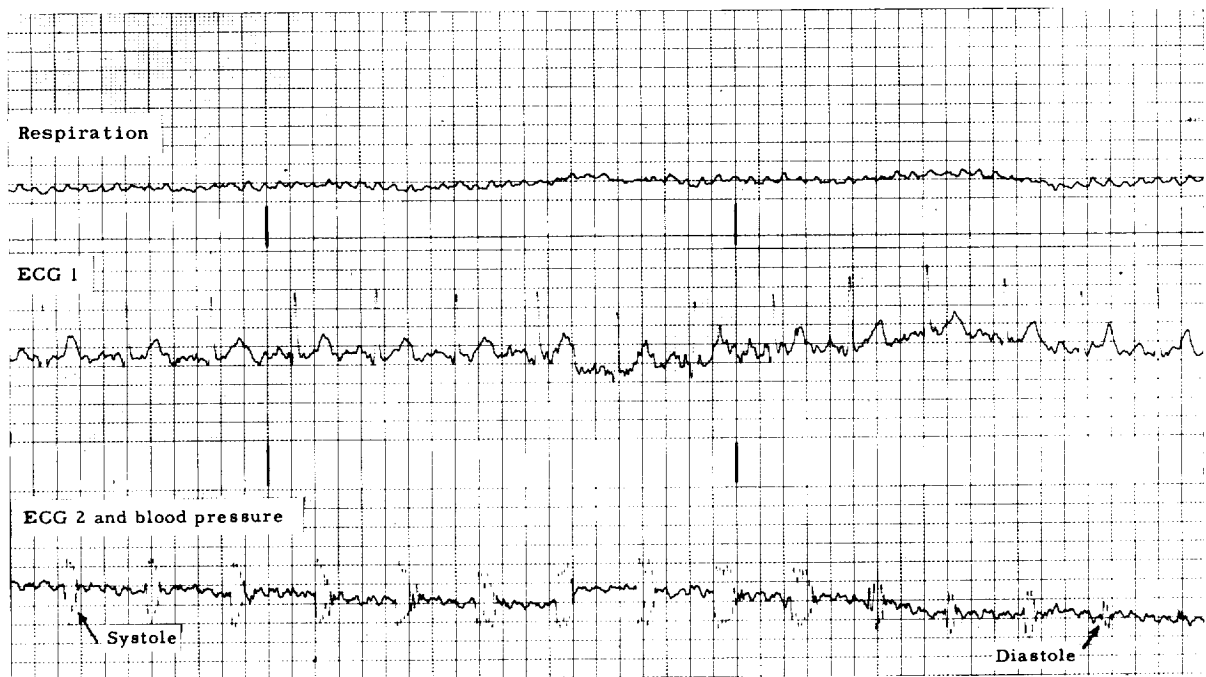
FIGURE 9-3.—Sample of blockhouse record at T-50 seconds, 9:46 a.m. e.s.t., with blood pressure tracing, value 139/80. (Recorder speed 25 mm/sec).

were not observed at any other time. All of the above are not unexpected physiologic variations. (Samples of MA-6 blockhouse records from the time of insertion and at T-50 seconds are shown in figs. 9-2 and 9-3.)

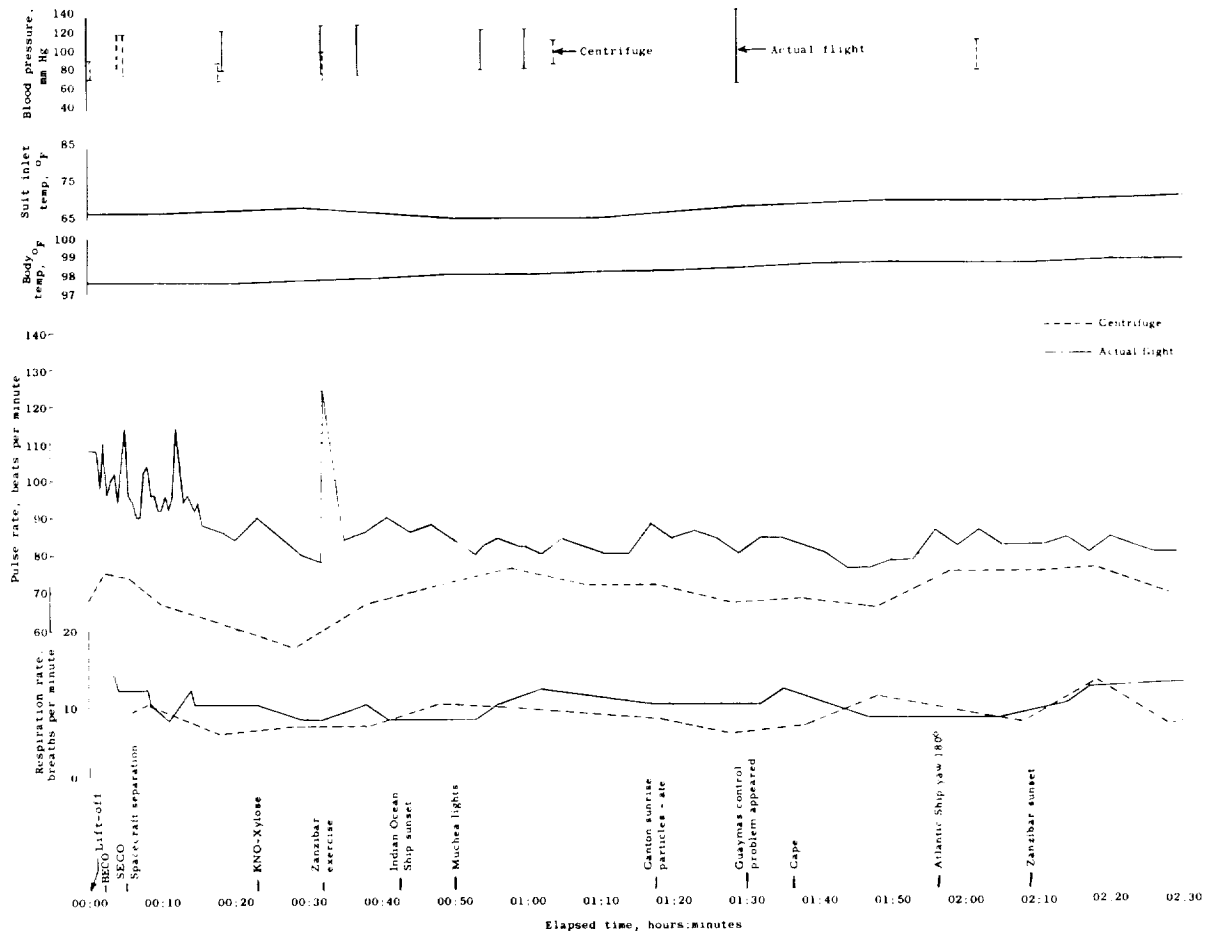
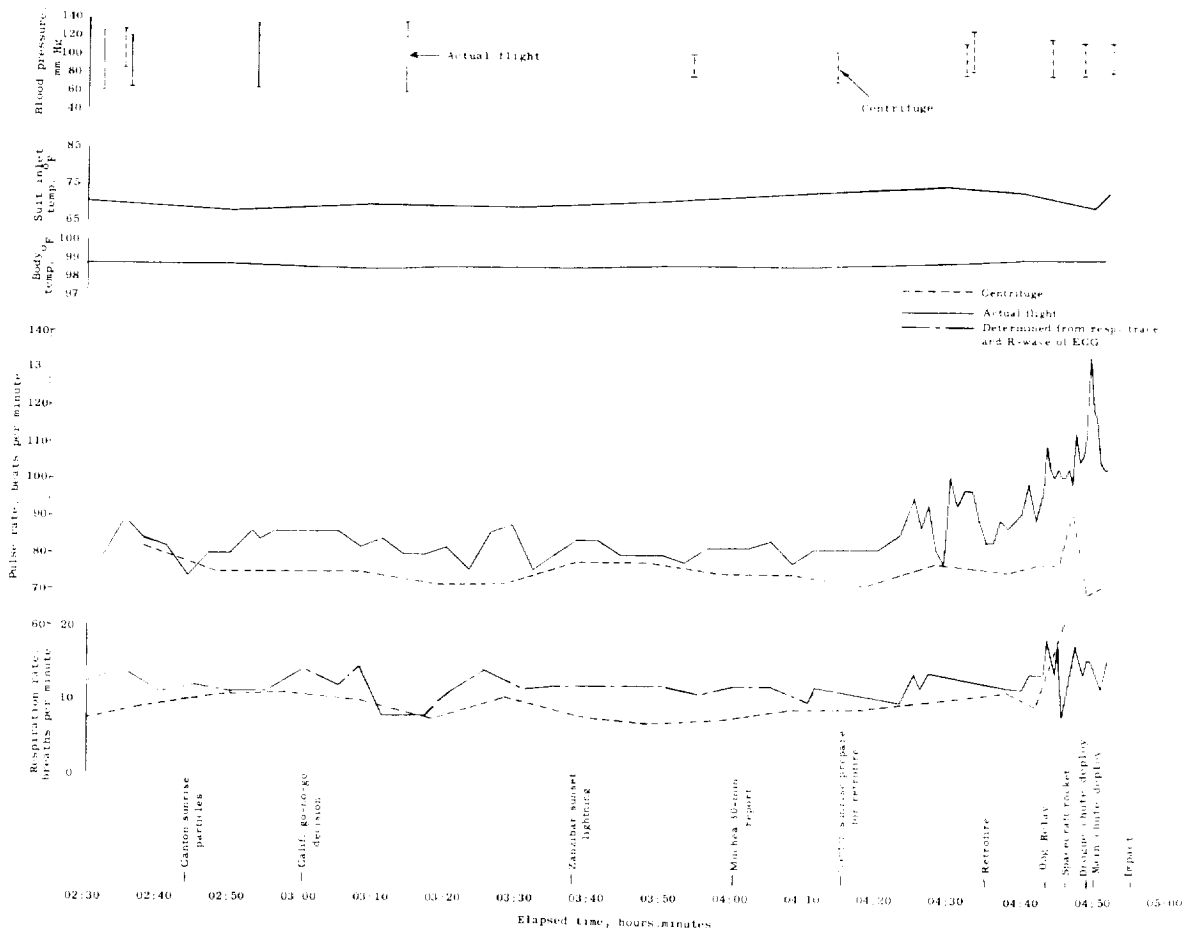
(a) Flight elapsed time 00:00 to 02:30.

FIGURE 9-4.—Flight: Respiration rate, pulse rate, body temperature, blood pressure, and suit-inlet temperature during the MA-6 flight, with values from the Mercury-Atlas three-orbit centrifuge simulation.

(b) Flight elapsed time, 02:30 to biosensor disconnect, 04:53.

Figure 9-4 illustrates the inflight physiological data and includes values from the Mercury-Atlas three-orbit centrifuge simulation for comparison. Minute pulse rates were determined by counting every 30 seconds during MA-6

Ten blood pressure determinations were made in flight; the first at T+18 minutes and 30 seconds and the last at T+3 hours and 14 minutes. The values are shown in figure 9-4, and range from 119 to 143 mm Hg systolic and from 60 to 81 mm Hg diastolic. The mean blood pressure values and the ranges from physical examinations, static procedures trainer simulations, Mercury-Atlas three-orbit centrifuge simulations, launch pad tests, MA-6 countdown, and the MA-6 flight are presented in the following table:

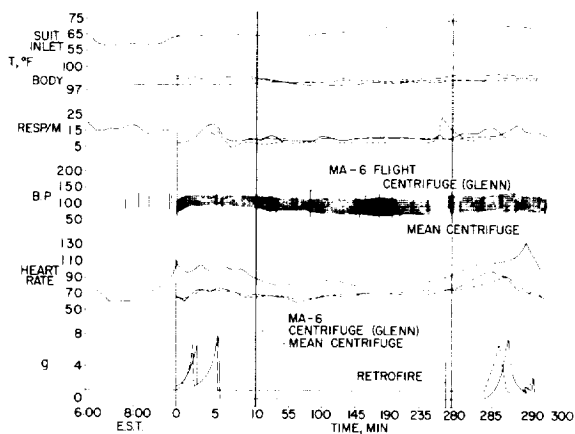
FIGURE 9-5.—Comparison of Astronaut Glenn's inflight physiologic data during the Mercury-Atlas three-orbit centrifuge simulation, and the mean physiologic data of six astronaut centrifuge simulations.

erated within acceptable physiological limits. Figure 9-5 compares Astronaut Glenn's in-flight pulse rate, his pulse rate during Mercury-Atlas three-orbit centrifuge simulation, and the

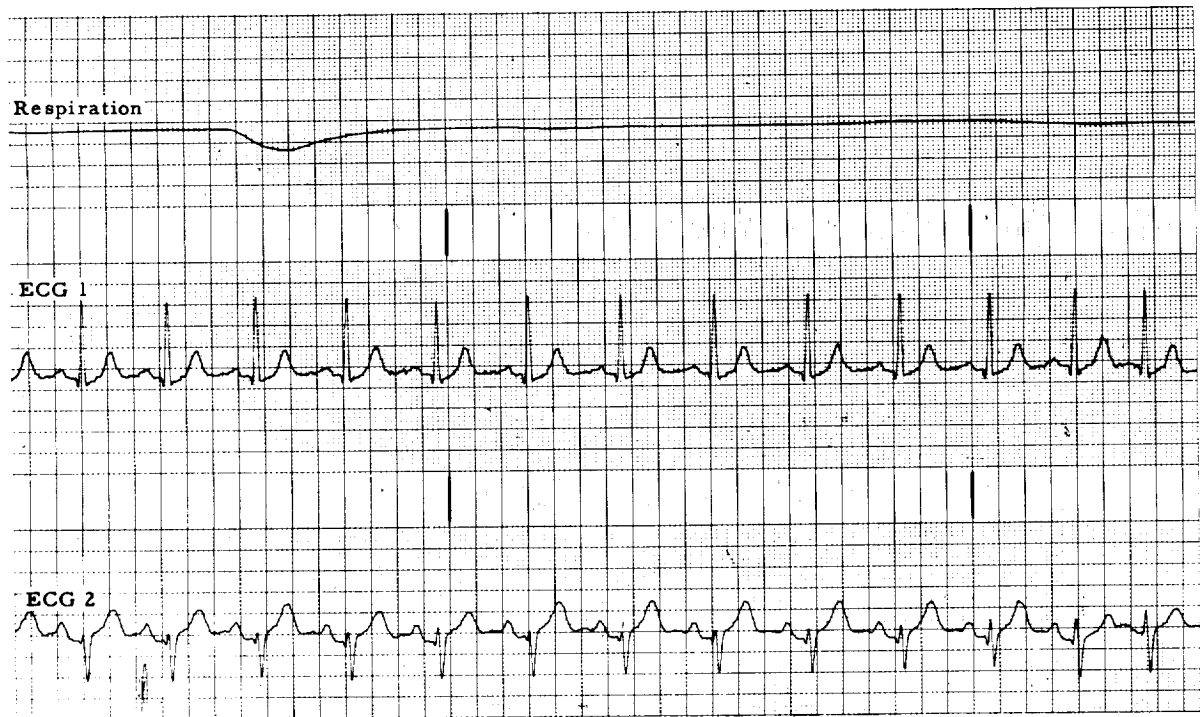
FIGURE 9-6.—Sample of physiological record received at Bermuda Range Station during powered phase of flight, approximately 4 minutes after lift-off. (Recorder speed 25 mm/sec).

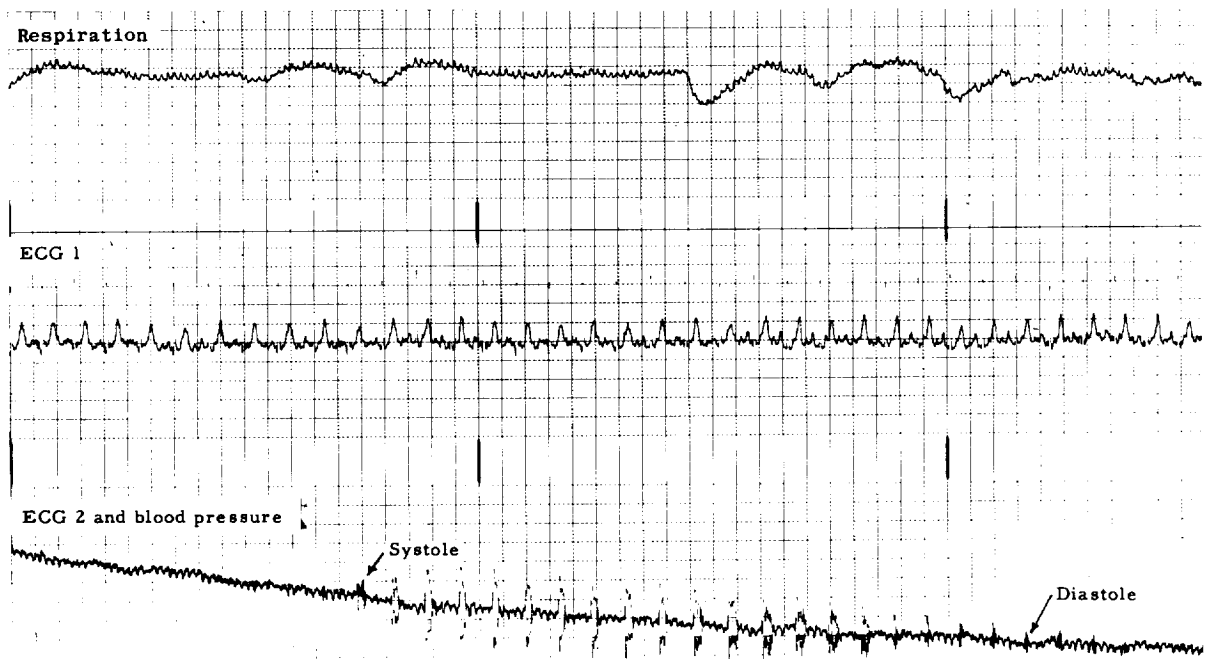
FIGURE 9-7.—Sample of playback record from the onboard tape showing physiological data after 2 hours and 53 minutes of weightlessness, with inflight blood pressure trace, value of 135/64. (Recorder speed 10 mm/sec).

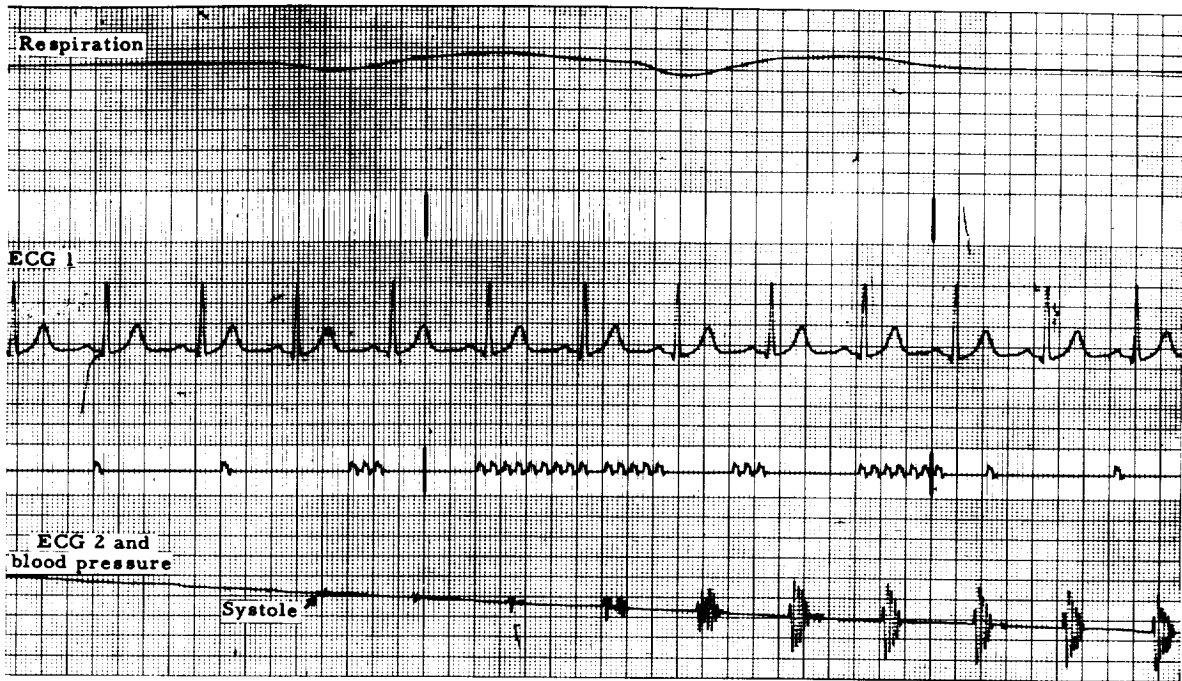
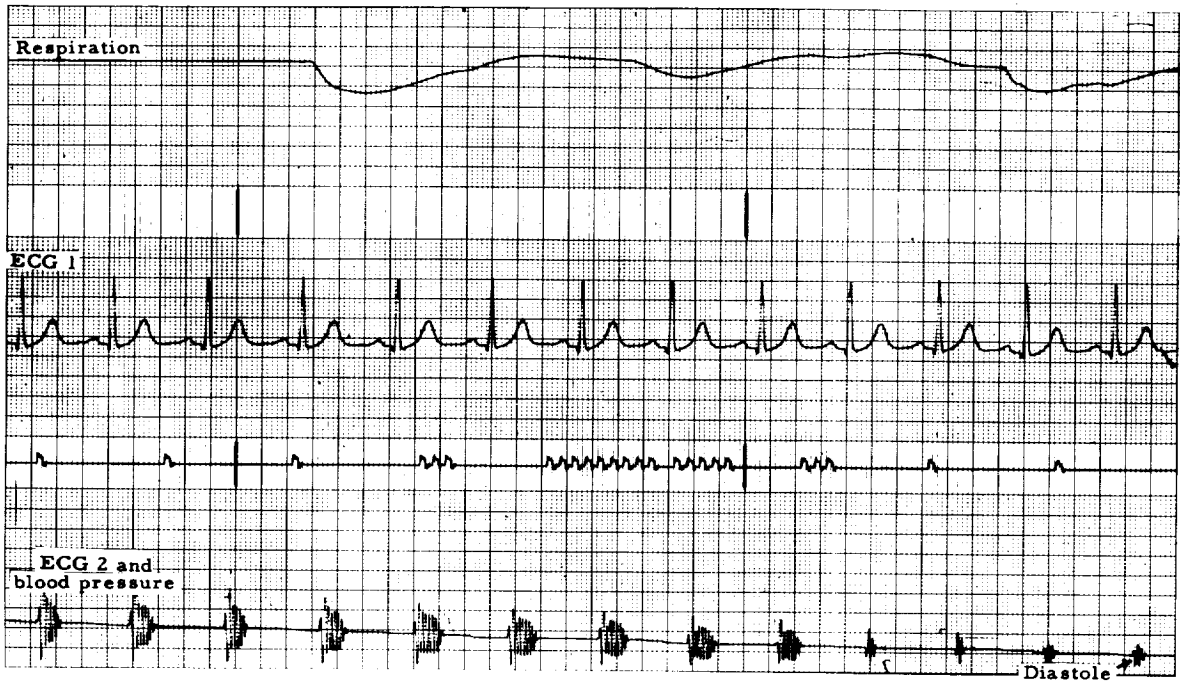
FIGURE 9-8.—Sample of physiological record received at the Hawaii Range Station corresponding to figure 9-7. (Recorder speed 25 mm/sec).

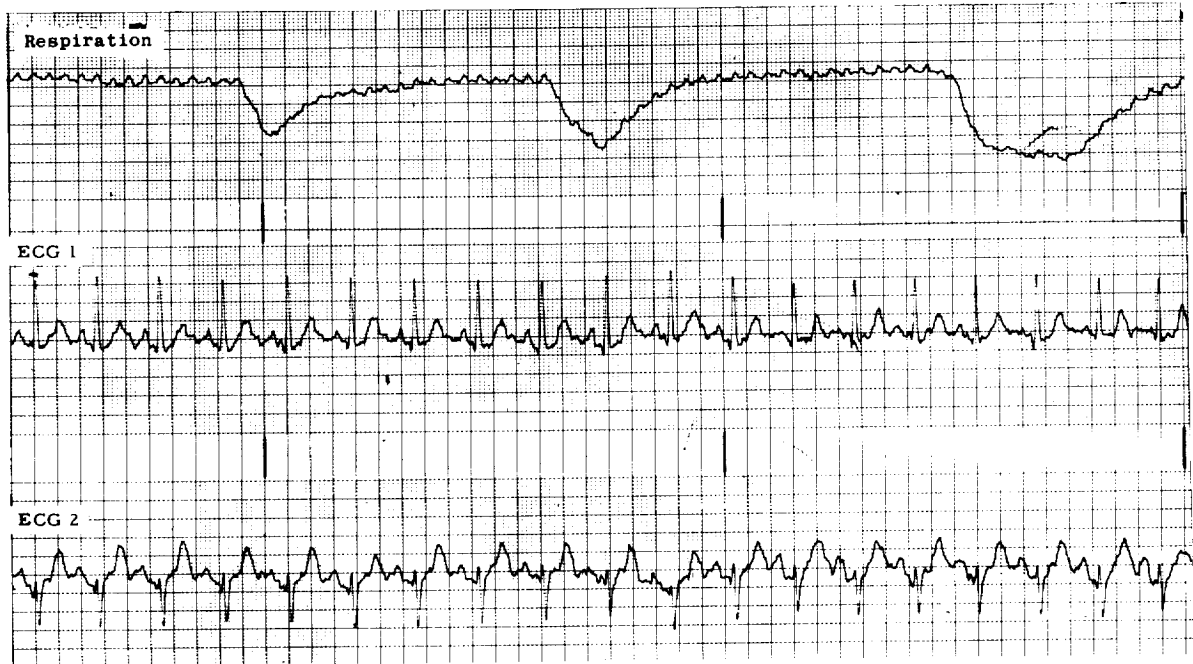
FIGURE 9-9.—Sample of playback record from the onboard tape showing physiological data at drogue parachute deployment, approximately 4 hours and 49 minutes after lift-off. (Recorder speed 25 mm/sec).

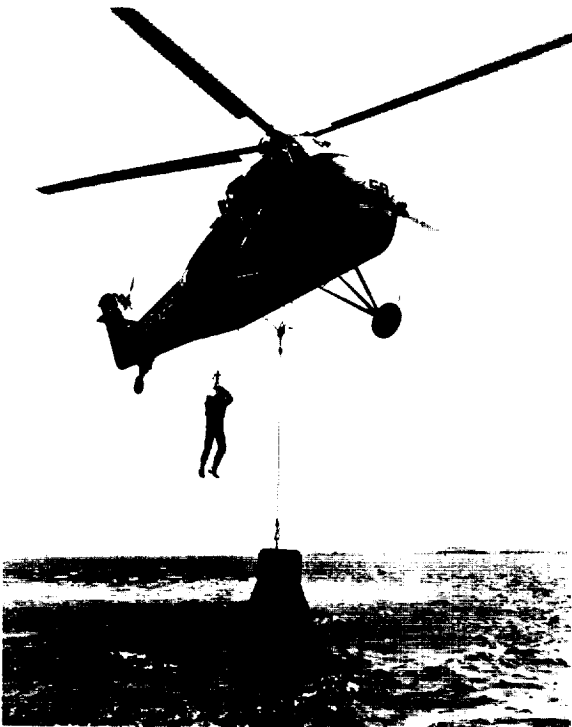
FIGURE 10-9.—HUS helicopter lifting astronaut from spacecraft, side hatch egress practice.

Egress from the small end and side hatch of the spacecraft was practiced with both HUS (see fig. 10-9) and HR2S (see fig. 10-10) helicopters at Langley Air Force Base, Va.

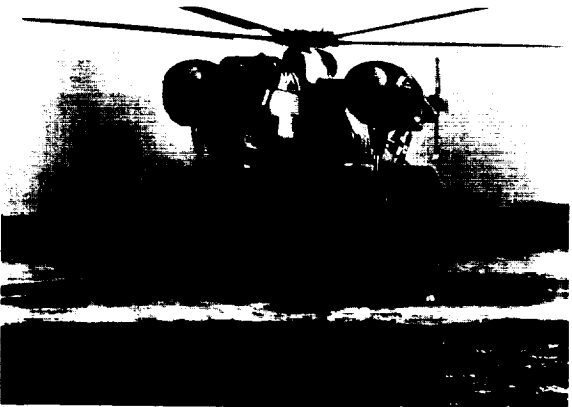
FIGURE 10-10.—HR2S helicopter preparing to remove astronaut from floating spacecraft, egress practice.

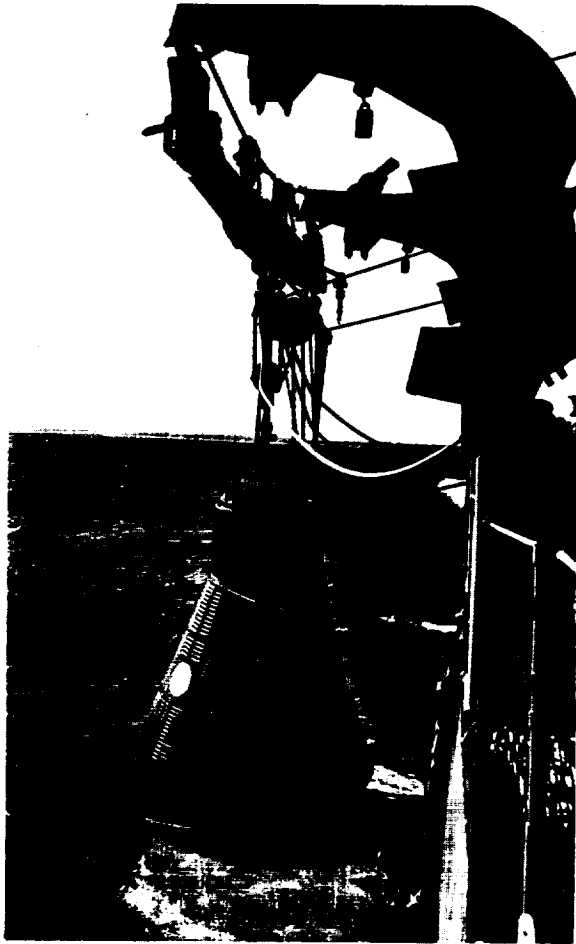
FIGURE 10-11.—U.S. destroyer lifting spacecraft from water with standard boat davits and special lifting beam.

Egress was practiced by other members of the astronaut team with a destroyer (see fig. 10-11) out of Norfolk, Va., and they reported no problems.

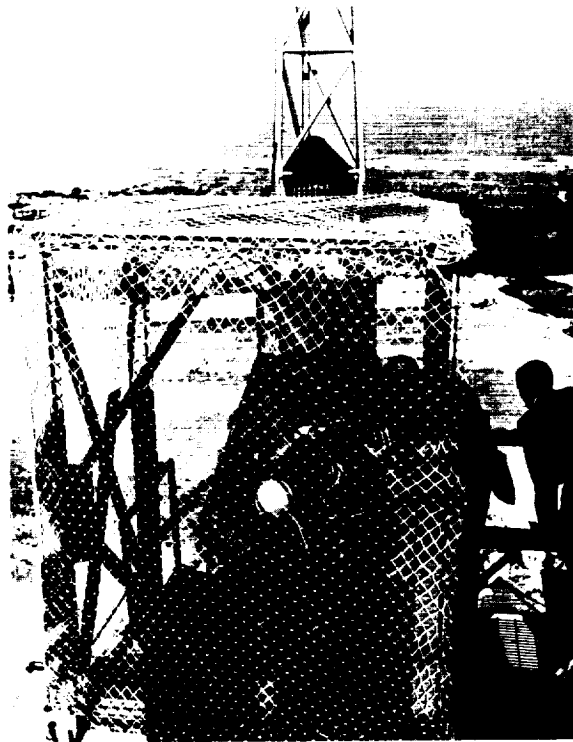
FIGURE 10-12.—Astronaut practicing pad egress with aid of egress tower.

Pad egress practice was accomplished at Cape Canaveral utilizing the Midas Tower (see fig. 10-12) and the M113 armored vehicle. This practice acquainted all launch complex personnel with the problems related to egress from the spacecraft with the launch vehicle in an unsafe condition.

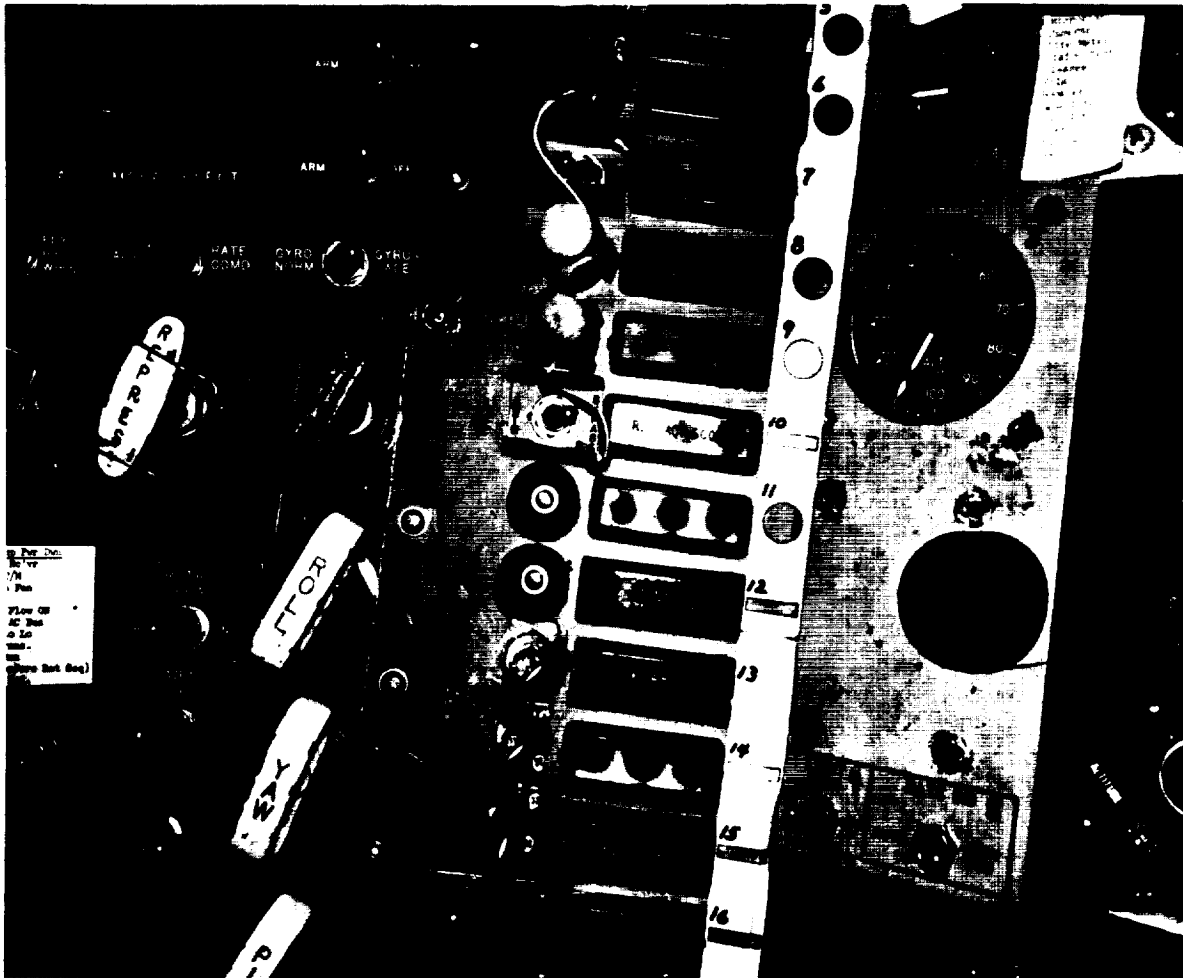
FIGURE 11-1.—MA-6 instrument panel, left section.

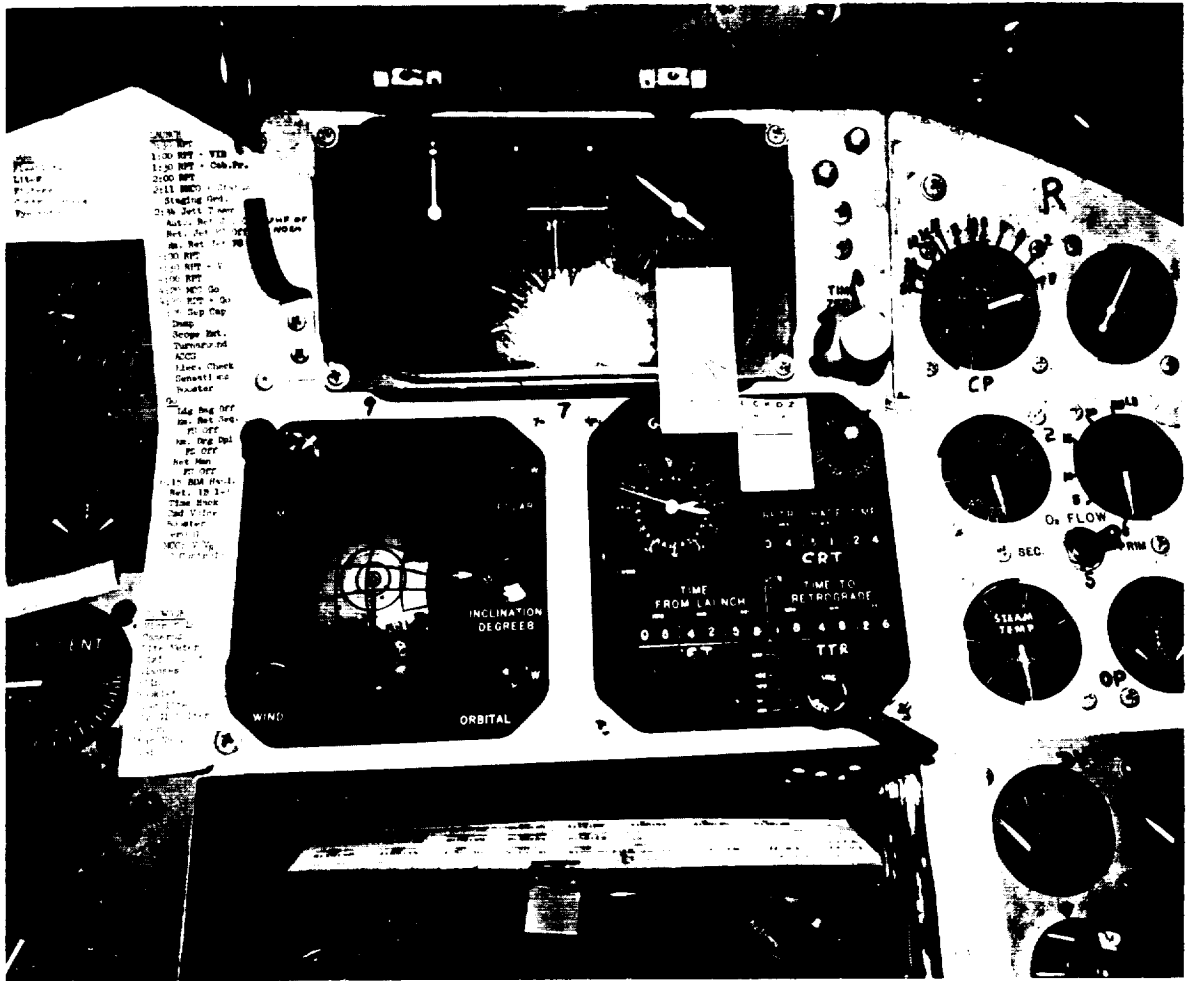
FIGURE 11-2.—MA-6 instrument panel, center section.

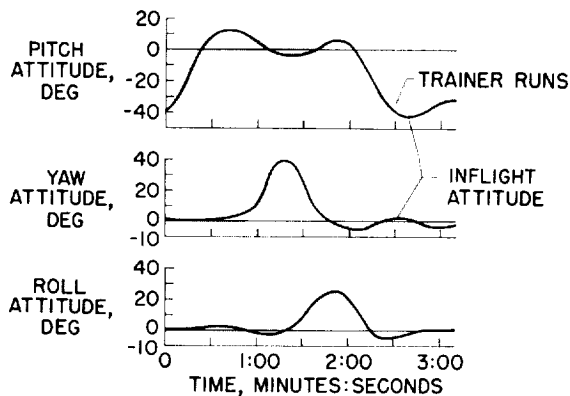
FIGURE 11-3.—MA-6 manual control systems check.

Figure 11-3 illustrates the inflight control systems check with a background envelope consisting of four control systems checks accomplished on the procedures trainer. All spacecraft attitudes are defined as zero when the pilot is sitting upright with the small end of the spacecraft pointing horizontally backward along the flight path. As can be seen from this figure, the attitudes between the flight and procedures trainer varied  $10^\circ$  or less; the rates varied less than  $1^\circ$  per second. The time used to complete the flight maneuver was almost identical to those on the procedures trainer. These inflight data may give the initial impression of a poorly controlled maneuver; however, it should be remembered that during orbital flight, the spacecraft has no aerodynamic stabilizing forces or aerodynamic damping. Except for retrofire, there is no need to control spacecraft attitudes precisely; consequently, during these maneuvers the pilot was looking for qualitative rather than quantitative results.

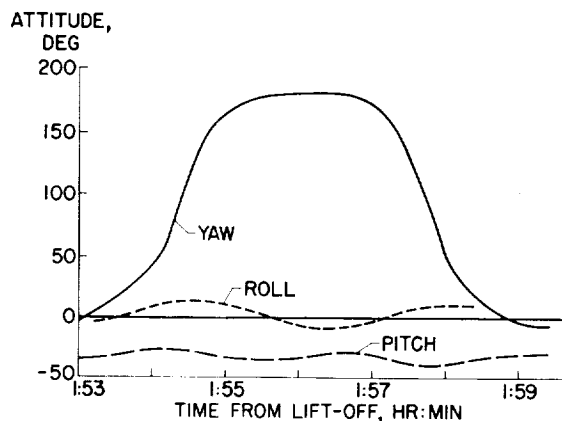
FIGURE 11-4.—MA-6  $180^\circ$  turnaround maneuver.

$180^\circ$  yaw turnaround, using the window, while holding pitch and roll reasonably steady as can be seen in figure 11-4.

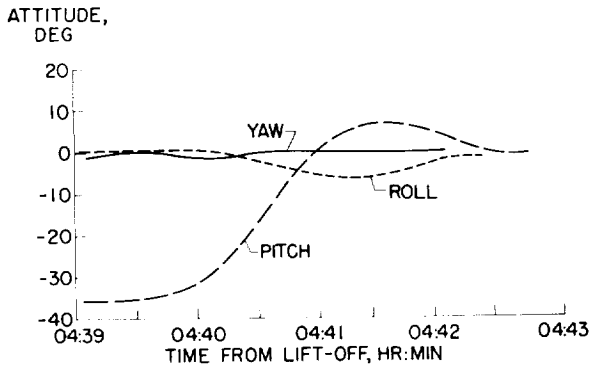
FIGURE 11-5.—MA-6 reentry pitch maneuver.

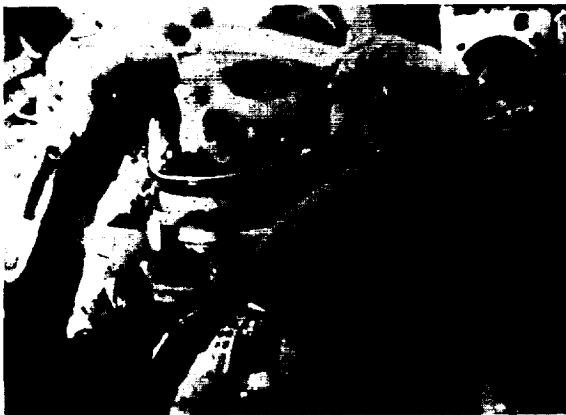
FIGURE 12-2.—Pilot opens visor to eat.

Another experiment related to the possible medical effects of weightlessness was eating in orbit. (See fig. 12-2.) On the relatively short flight of Friendship 7, eating was not a necessity, but rather an attempt to determine whether there would be any problem in consuming and digesting food in a weightless state. At no

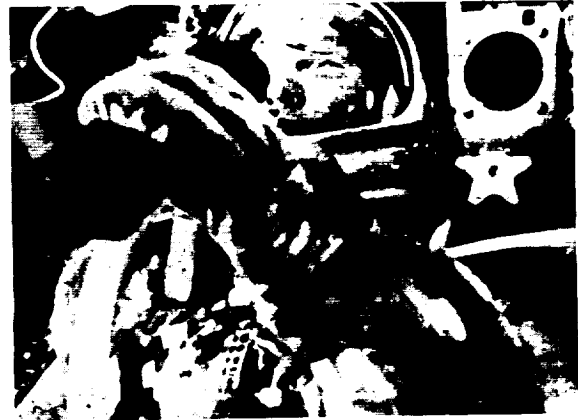
FIGURE 12-12.—During sunset, the pilot used the photometer to view the sun.

I watched the first sunset through the photometer (fig. 12-12) which had a polarizing filter on the front so that the intensity of the sun could be reduced to a comfortable level for viewing. Later I found that by squinting, I could look directly at the sun with no ill effects, just as I can from the surface of the earth. This accomplished little of value but does give an idea of intensity.

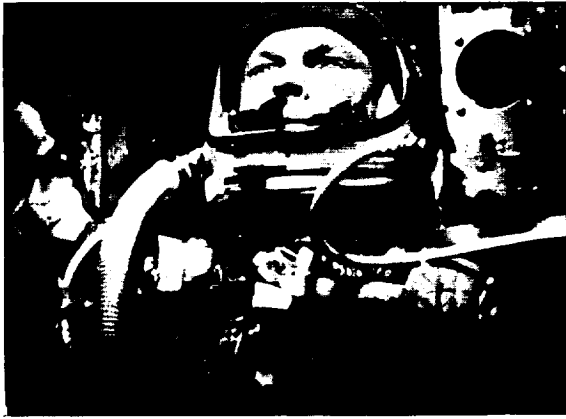
FIGURE 12-15.—Pilot concentrates on instruments while controlling attitude during retrofire.

I could hear each rocket fire and could feel the surge as the rockets slowed the spacecraft. Coming out of zero-g condition, the retrorocket firing produced the sensation that I was accelerating back toward Hawaii (fig. 12-15). This sensation, of course, was an illusion.

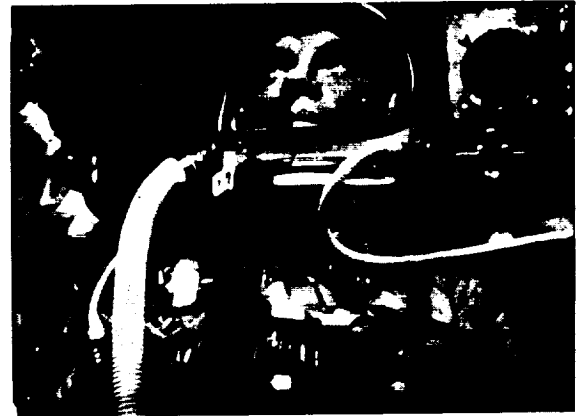
FIGURE 12-16.—Pilot looks out of window at fireball during maximum reentry heating.

The heat pulse increased until I could see a glowing orange color through the window. Flaming pieces were breaking off and flying past the spacecraft window. (See fig. 12-16.) At the time, these observations were of some concern to me because I was not sure what they were. I had assumed that the retro pack had been jettisoned when I saw the strap in front of the window. I thought these flaming pieces might be parts of the heat shield breaking off. We know now, of course, that the pieces were from the retro pack.

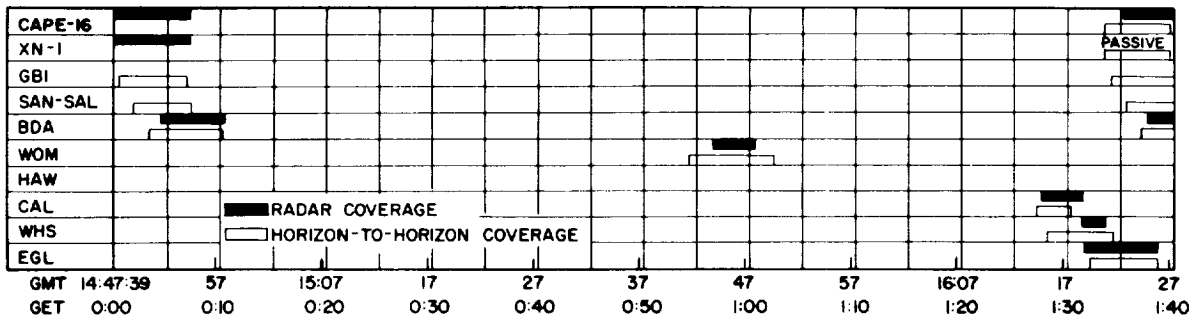
FIGURE A-1. C-band radar coverage, first orbit.

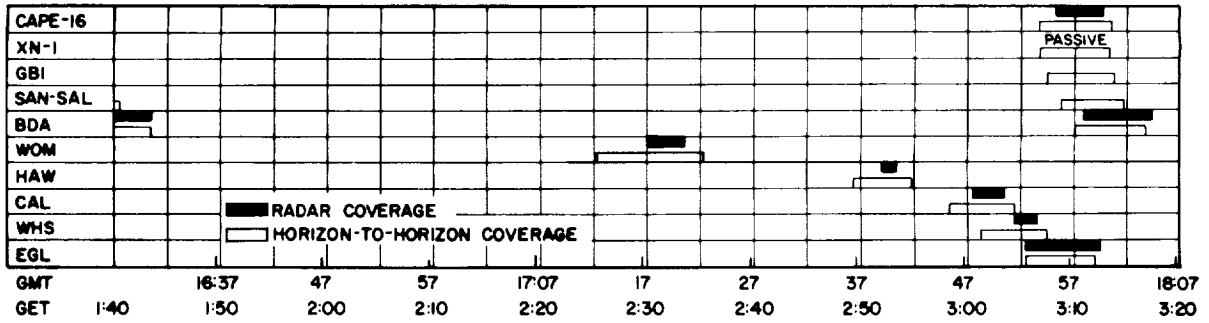
FIGURE A-2. C-band radar coverage, second orbit.

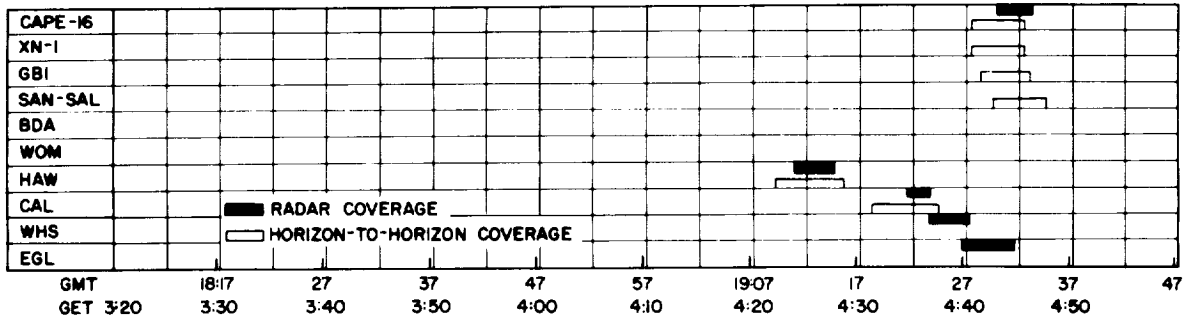
FIGURE A-3. C-band radar coverage, third orbit.
