**RESULTS OF THE  
FIRST UNITED STATES  
MANNED ORBITAL SPACE FLIGHT  
FEBRUARY 20, 1962**

**RESULTS OF THE FIRST  
U.S. MANNED  
ORBITAL SPACE FLIGHT  
FEBRUARY 20, 1962**

**MANNED SPACECRAFT CENTER  
NATIONAL AERONAUTICS  
AND SPACE ADMINISTRATION**

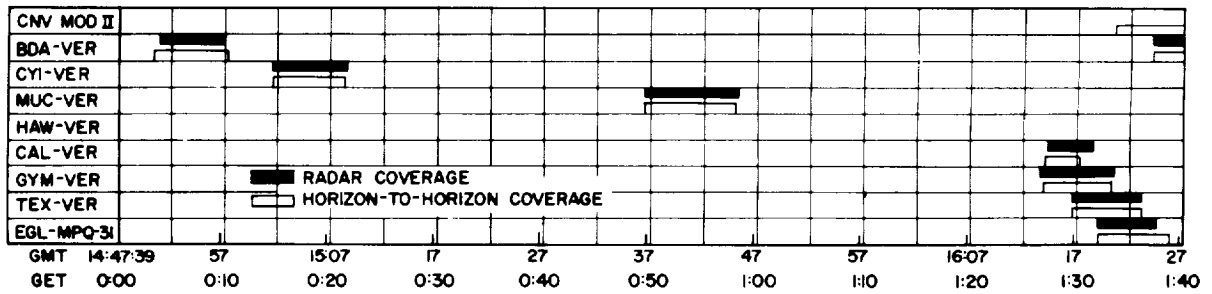
FIGURE A-4. S-band radar coverage, first orbit.

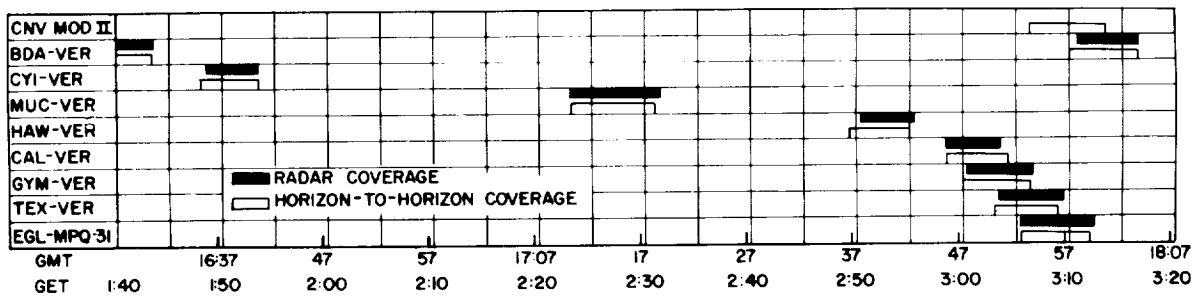
FIGURE A-5. S-band radar coverage, second orbit.

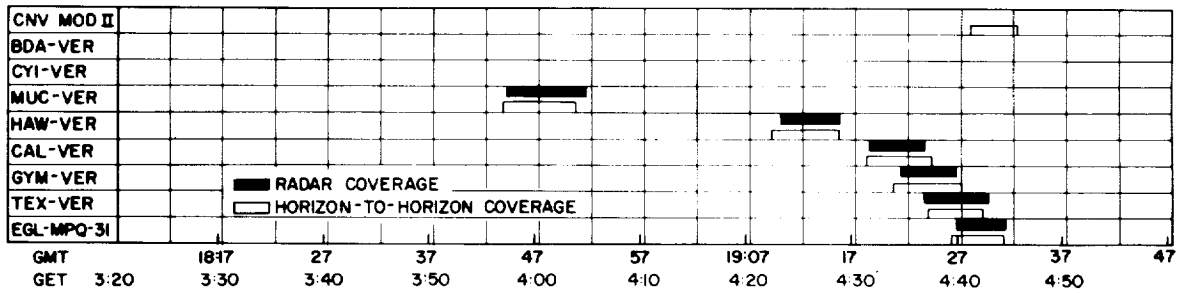
FIGURE A-6. S-band radar coverage, third orbit.

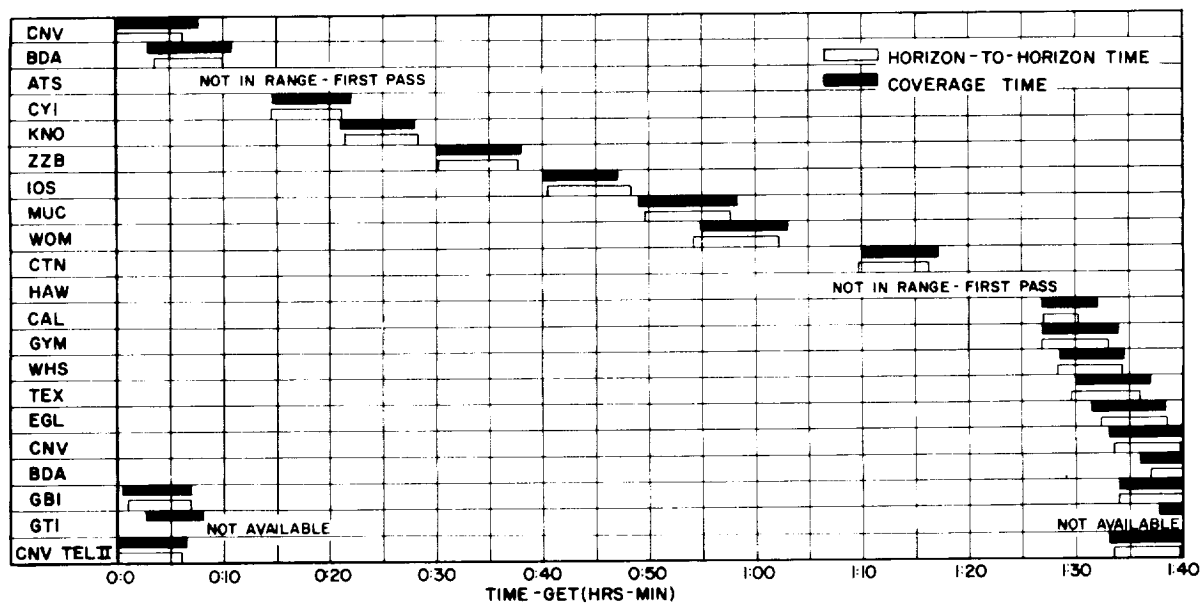
FIGURE A-7. Telemetry reception coverage, first orbit.

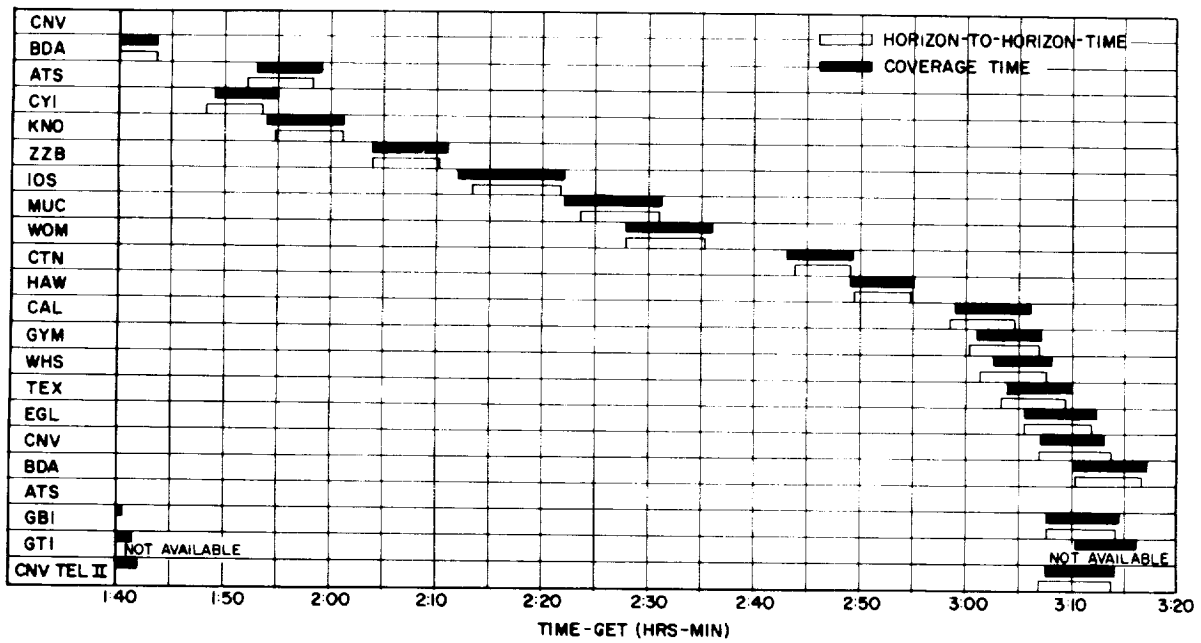
FIGURE A-8. Telemetry reception coverage, second orbit.

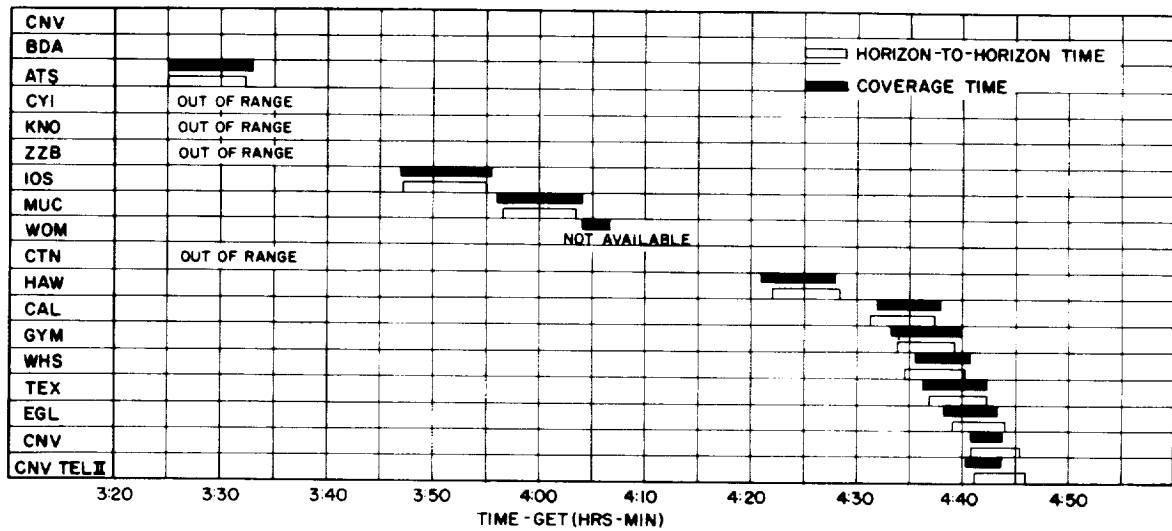
FIGURE A-9. Telemetry reception coverage, third orbit.

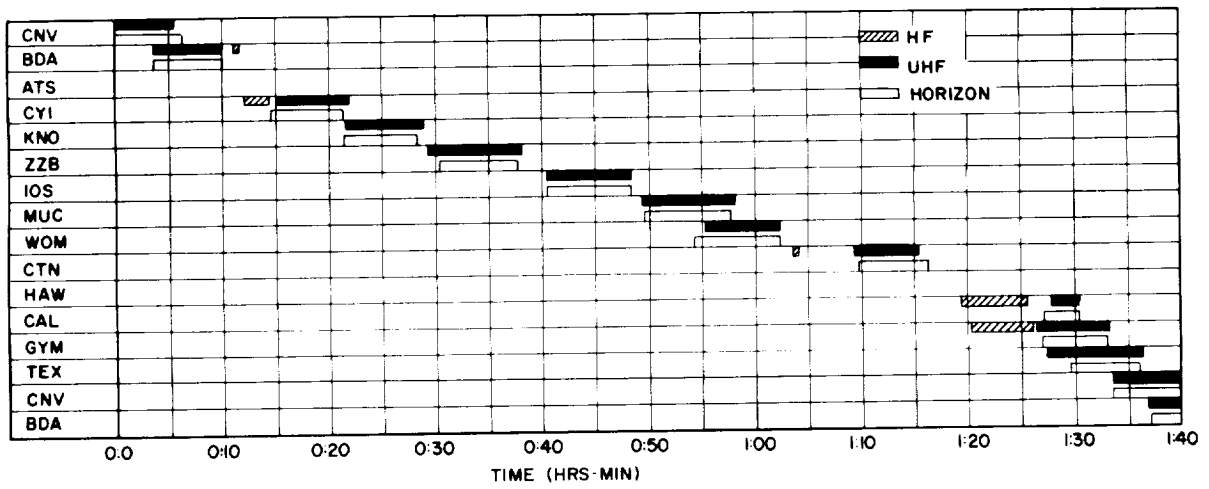
FIGURE A-10. HF and UHF communications, first orbit.

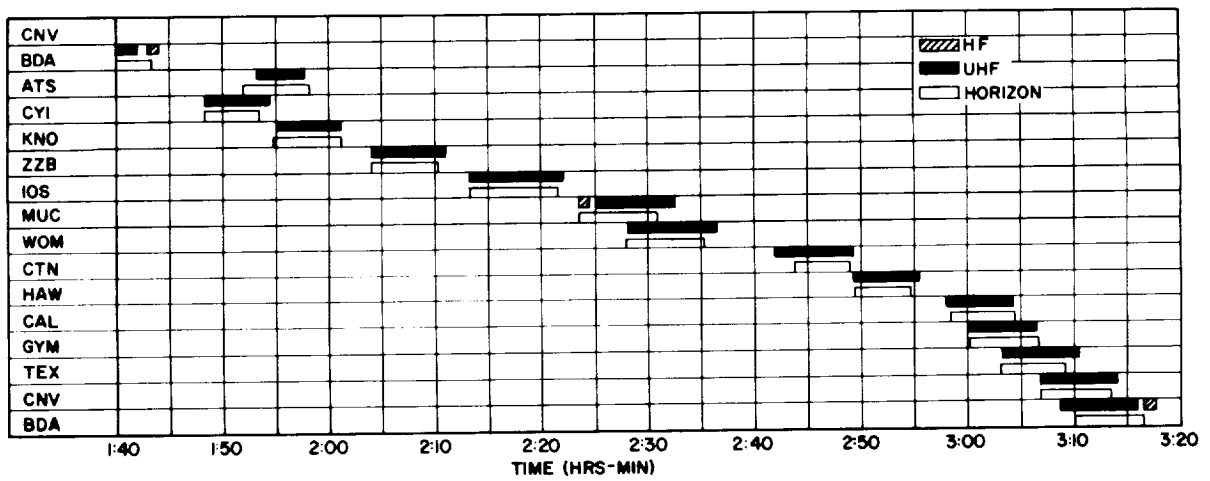
FIGURE A-11. HF and UHF communications, second orbit.

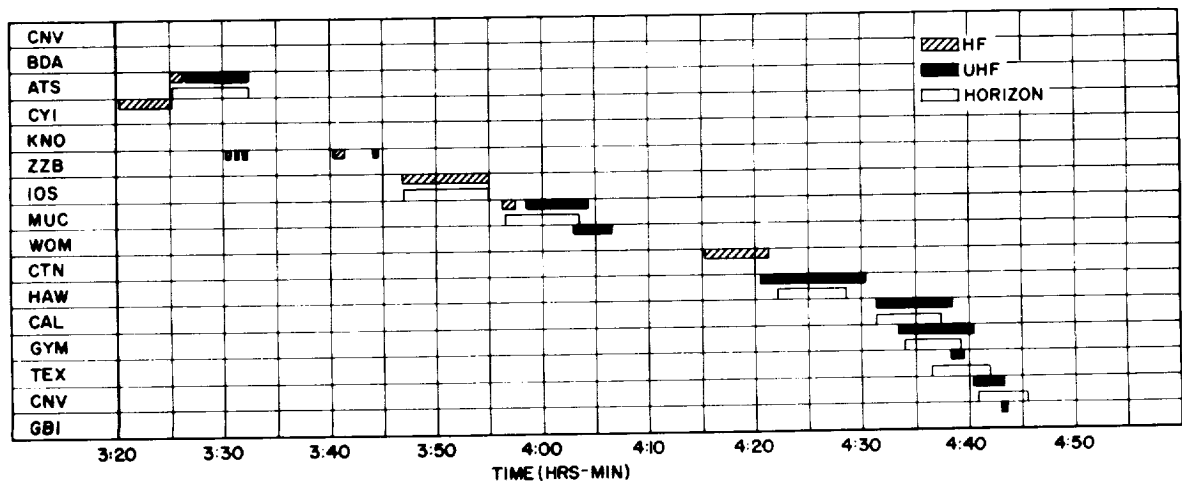
FIGURE A-12. HF and UHF communications, third orbit.
