**NASA
Technical
Memorandum**

NASA TM - 108431

**MICROSTRUCTURAL STABILITY OF WROUGHT, LASER
AND ELECTRON BEAM GLAZED NARLOY-Z ALLOY AT
ELEVATED TEMPERATURES**

By J. Singh, G. Jerman, B. Bhat, and R. Poorman

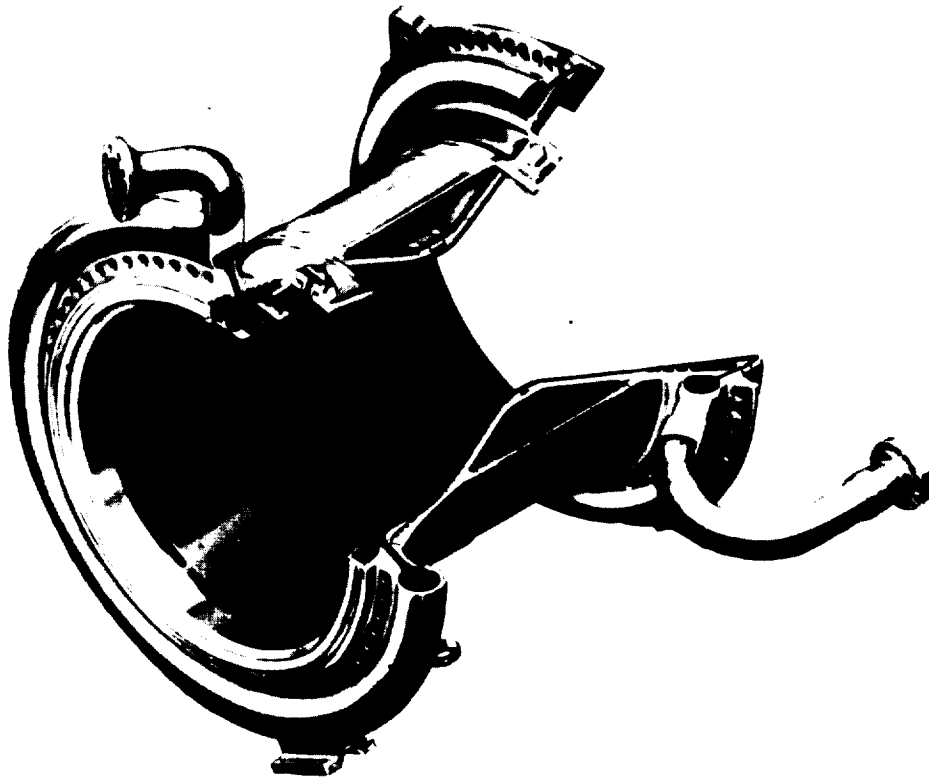
GEOMETRY

- NARLOY Z LINER + EDCu BARRIER + EDNi CLOSE-OUT + INCO 718 STRUCTURE SHELL
- NUMBER OF SLOTS 390
- NUMBER OF ACOUSTIC CAVITIES 30
- INJECTOR END DIAMETER 17.74 IN.
- THROAT AREA 83.41 IN.²
- INJECTOR END TO THROAT LENGTH 14.00 IN.
- CONTRACTION RATIO 2.96:1
- EXPANSION RATIO 5.0:1

OPERATING PARAMETERS (RPL, MR-6.0)

- THROAT STAGNATION PRESSURE 3009 PSIA
- COOLANT INLET PRESSURE 5949 PSIA
- COOLANT INLET TEMPERATURE 96 R
- COOLANT EXIT PRESSURE 4543 PSIA
- COOLANT EXIT TEMPERATURE 477 R
- COOLANT FLOWRATE 26.75 LB/SEC
- HOT GAS WALL TEMPERATURE AT THROAT 1000 F

Figure 1a. SSME MCC.

Wrought NARloy-Z (Cu-3 wt.% Ag-0.5 wt.% Zr + traces of O₂, ~50 p/m) is now used to fabricate the main combustion chamber (MCC) liner (figs. 1a and 1b) for the space shuttle main engine (SSME). MCC liner construction is shown in figure 2. It consists of (A) hot wall, (B) channel lands, and (C) cooling channels. The hot wall thickness ranges from 0.5 to 0.75 mm (20 to 30 mils).

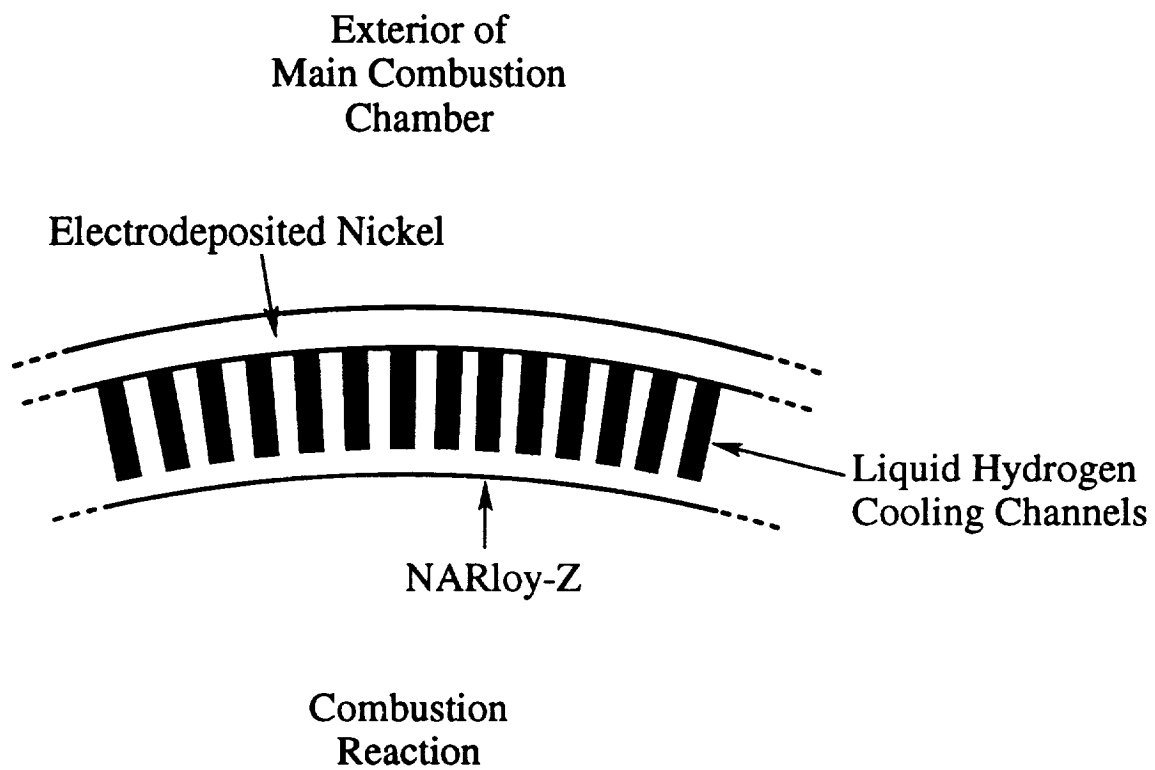
Figure 1b. Schematic of MCC cooling channels and hot wall.

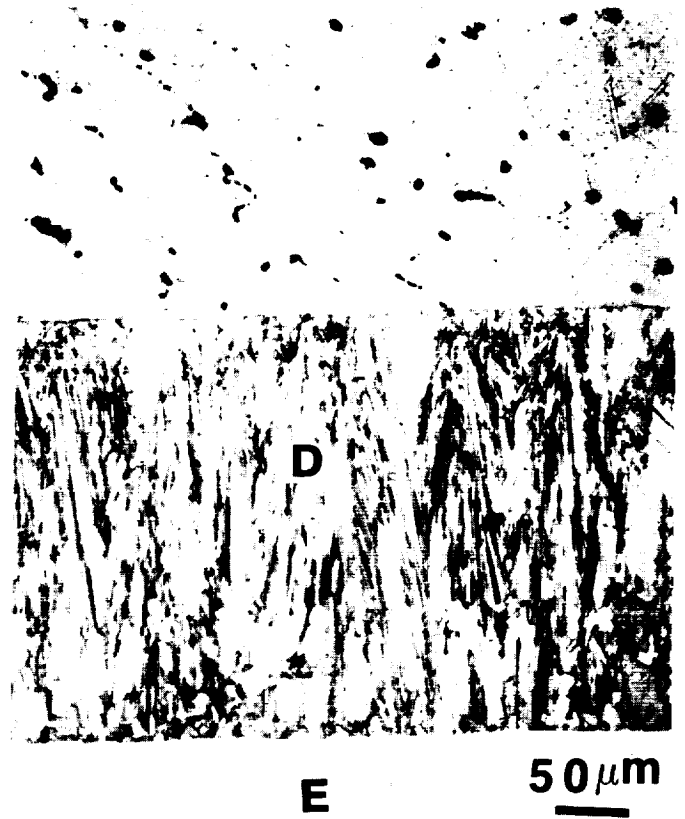
- A – Hot wall
- B – Channel land
- C – Cooling channels
- D – Cold wall (ED Cu)
- E – Electrodeposited Ni

Figure 2. Uniform microstructure in wrought NARloy-Z hot wall.

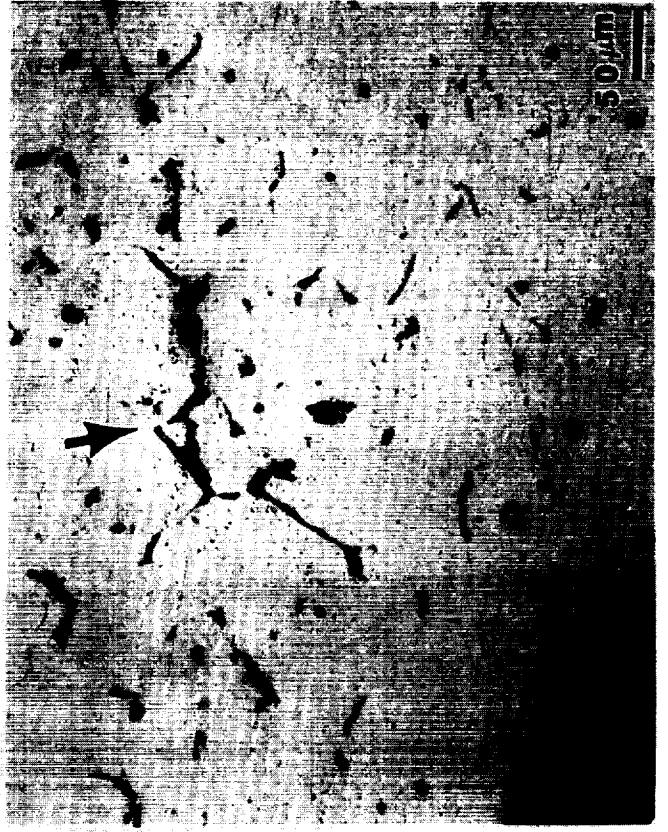
Figure 3. Optical micrographs of microstructural changes in the hot wall (region A) after hot firing.

The hot wall undergoes microstructural changes that include precipitation and coarsening of intermetallic phases in the matrix and grain boundaries (fig. 3). In wrought NARloy-Z, these inhomogeneities tend to lower the mechanical properties at temperatures above 315 °C (600 °F). Since the MCC liner is exposed to temperatures ranging from -252 °C to >540 °C (-422 to >1,000 °F) during hot fire, hot wall life is determined by the number of hot firings and the rate of microstructural degradation.

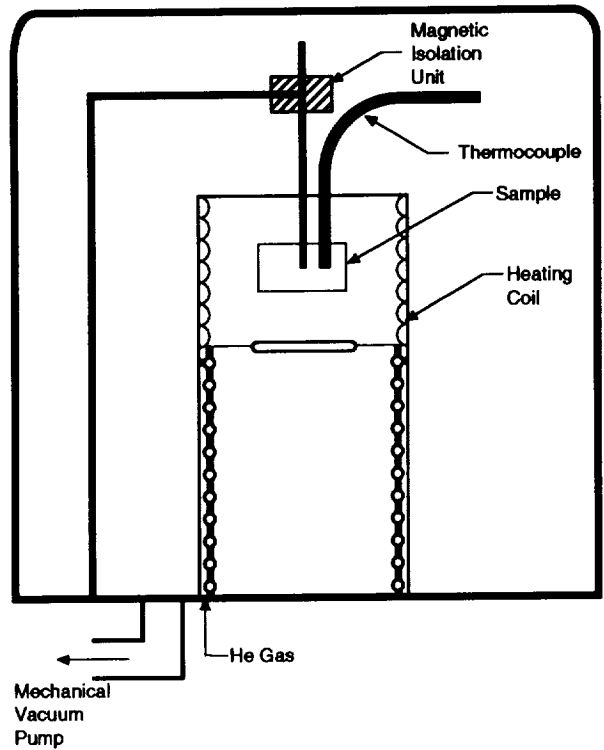
Figure 4. Schematic line diagram of drop-through furnace.

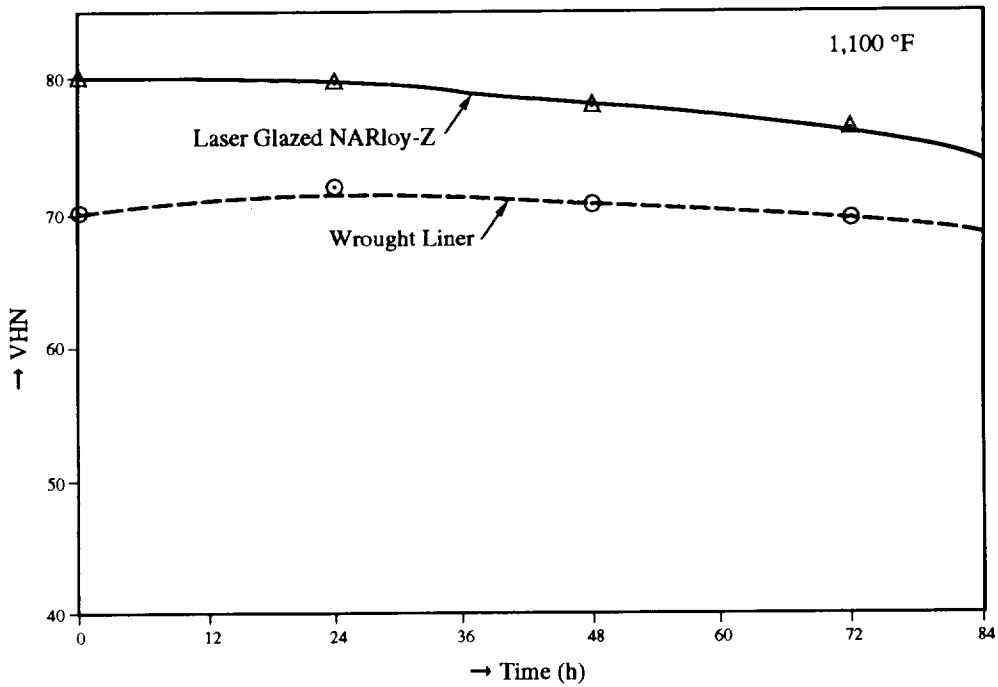
Figure 5. Hardness change in wrought and laser-glazed NARloy-Z as a function of time at 593 °C (1,100 °F).

The hardness change in wrought and laser-glazed NARloy-Z, as a function of exposure time up to 84 h at 593 °C (1,100 °F), is shown in figure 5 and at 649 °C (1,200 °F) in figure 6. There was some drop in the hardness of the laser-glazed NARloy-Z as compared to the wrought alloy after exposing at 593 °C (1,100 °F) for up to 84 h. At 649 °C (1,200 °F), hardness values remained constant for up to 24 h and then dropped slowly by ~7 percent as a function of time (fig. 6). Figure 7 shows hardness changes as a function of temperature from 593 to 760 °C (1,100 to 1,400 °F) for a constant exposure time (24 h).

The average hardness of laser-glazed NARloy-Z was approximately 15 percent higher than the wrought alloy and remained so even after exposing to elevated temperatures ranging from 593 to 760 °C (1,100 to 1,400 °F), as shown in figures 5 to 7. Increased hardness was probably due to the fine-grained microstructure and uniform distribution of the second phase in the Cu matrix. This subject will be discussed further in the next section.

Laser-glazed NARloy-Z was always harder than the wrought alloy by 15 percent or more (fig. 5). The higher hardness of the laser-glazed alloy was probably due to small-grained microstructure, fine and uniform distribution of the second phase in the Cu matrix, and the absence of PFZ and/or grain boundary precipitations. Its overall microstructure remained the same even after exposure to high temperature, with the exception of slight coarsening of the second phase. The wrought alloy, on the other hand, was constituted of a microstructure that was significantly changed by exposure to high temperatures (figs. 10 to 14). The high thermal stability of laser-glazed NARloy-Z is due to the short diffusion distance of solute atoms (i.e., separation between precipitates is small). This feature also prevents precipitation at the grain boundaries. The laser-glazed and EB-glazed alloys also underwent rapid melting and solidification, resulting in an extended solid solubility of Zr solute atoms into the Cu matrix.

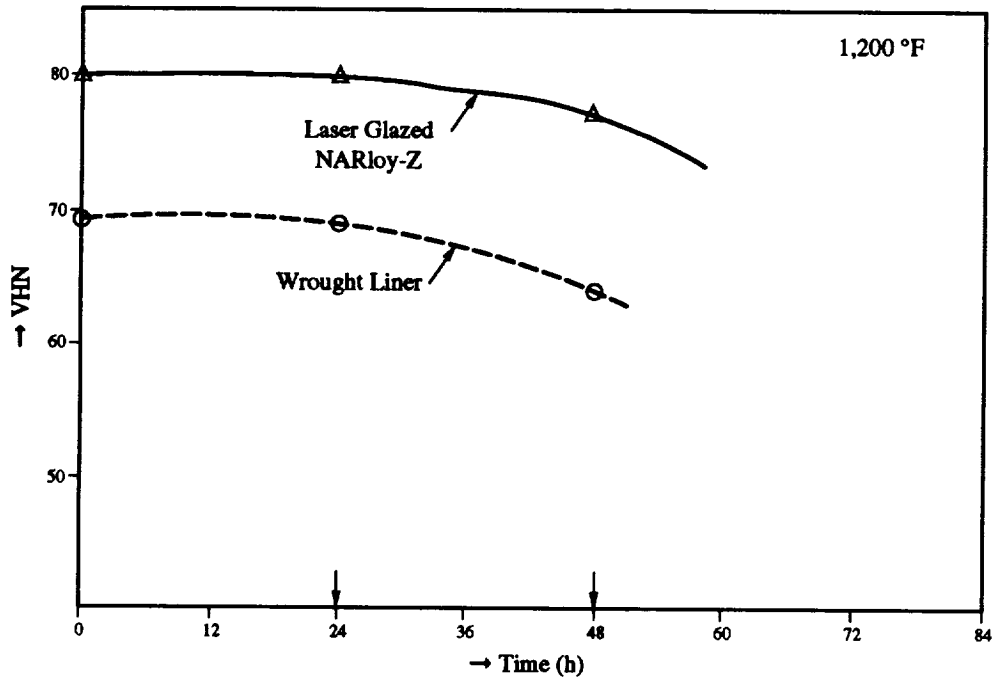
Figure 6. Hardness change in wrought and laser-glazed NARloy-Z as a function of time at 649 °C (1,200 °F).

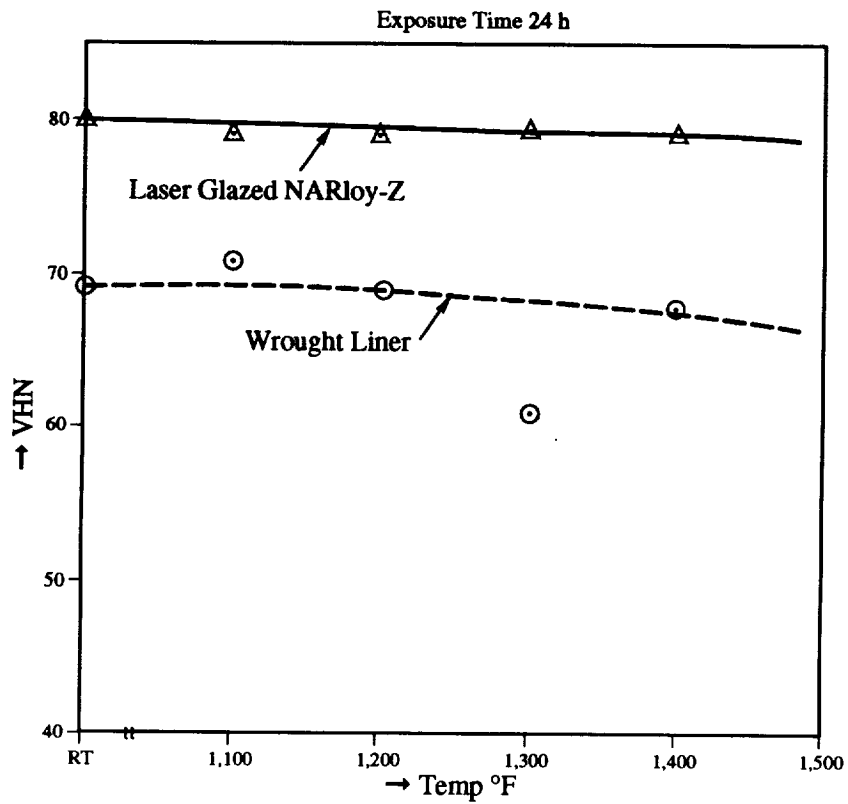
Figure 7. Hardness change in wrought and laser-glazed NARloy-Z as a function of temperatures ranging from 593 to 760 °C (1,100 to 1,400 °F) for 24 h.

When microstructure and hardness measurements were compared, good correlation was obtained between the two. Hardness decreased as the exposure temperatures increased from 649 to 760 °C (1,200 to 1,400 °F), probably due to rapid depletion of Ag and Zr solute atoms from the matrix and coarsening of intermetallic phases in the Cu matrix (figs. 5 to 7).

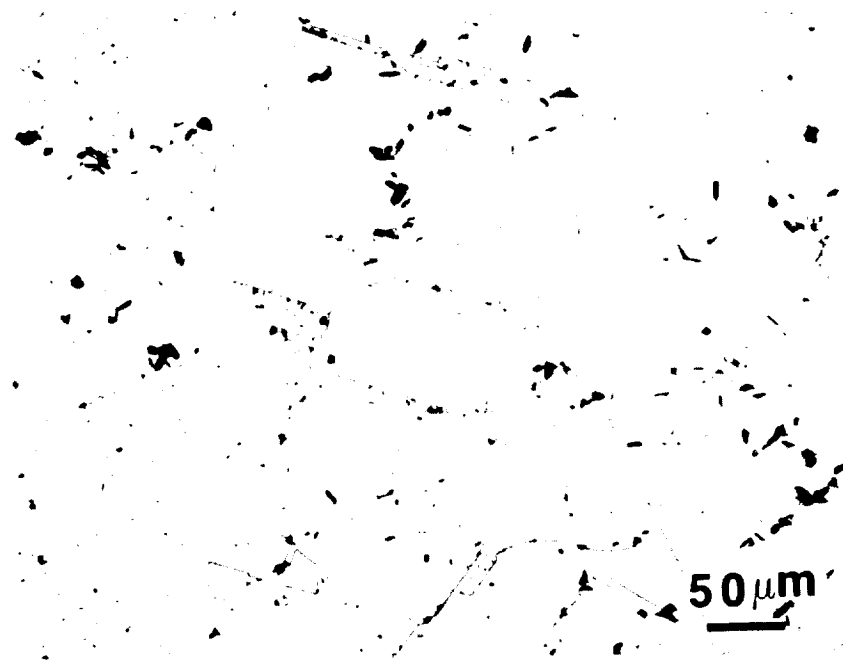
Figure 8a. Wrought NARloy-Z showing two-phase microstructure (intermetallic CuAgZr and Zr oxide) in Cu matrix.

Wrought NARloy-Z. In general, the wrought NARloy-Z starting material had a coarse-grained microstructure (fig. 8a) with an uneven distribution of secondary precipitates. Microprobe analyses showed that Zr was present, probably as Zr oxide Zr_2O_3 (fig. 8b). Ag- and Zr-rich intermetallic phases were present in the Cu matrix (figs. 8c and 8d). In addition, oxides of Ag and Cu were present in the matrix. The secondary phases varied in size from 1 to 10 μm . The average grain size was approximately 150 μm . Figure 9 shows precipitation and coarsening in the Cu matrix and at the grain boundaries after exposure to 593 °C (1,100 °F) for up to 94 h. Figure 10 shows the microstructural changes in NARloy-Z after exposure to 649 °C (1,200 °F) up to 48 h. Precipitate-free zones (PFZ's) were observed near the grain boundaries and large intermetallic phases as shown by arrows in figure 10. The size of precipitates and PFZ width increased at 649 °C (1,200 °F) as exposure time increased from 24 to 48 h. After 24 h exposure at 649 °C (1,200 °F), the volume fraction and size of precipitates in the Cu matrix (fig. 10b) were noticeably larger than those in the starting material. The same was true for NARloy-Z exposed to 594 °C (1,100 °F) for ~94 h (fig. 9).

coarsening of the second phase was observed as a function of time. Further coarsening of second phases was observed after exposing at 649 °C (1,200 °F) for up to 48 h (figs. 18a and 18b). These precipitates were aligned and had a faceted morphology (fig. 18b). However, the second phase sizes were still small and averaged less than 0.5 μm, smaller than those observed in wrought NARloy-Z (10 μm, fig. 8).

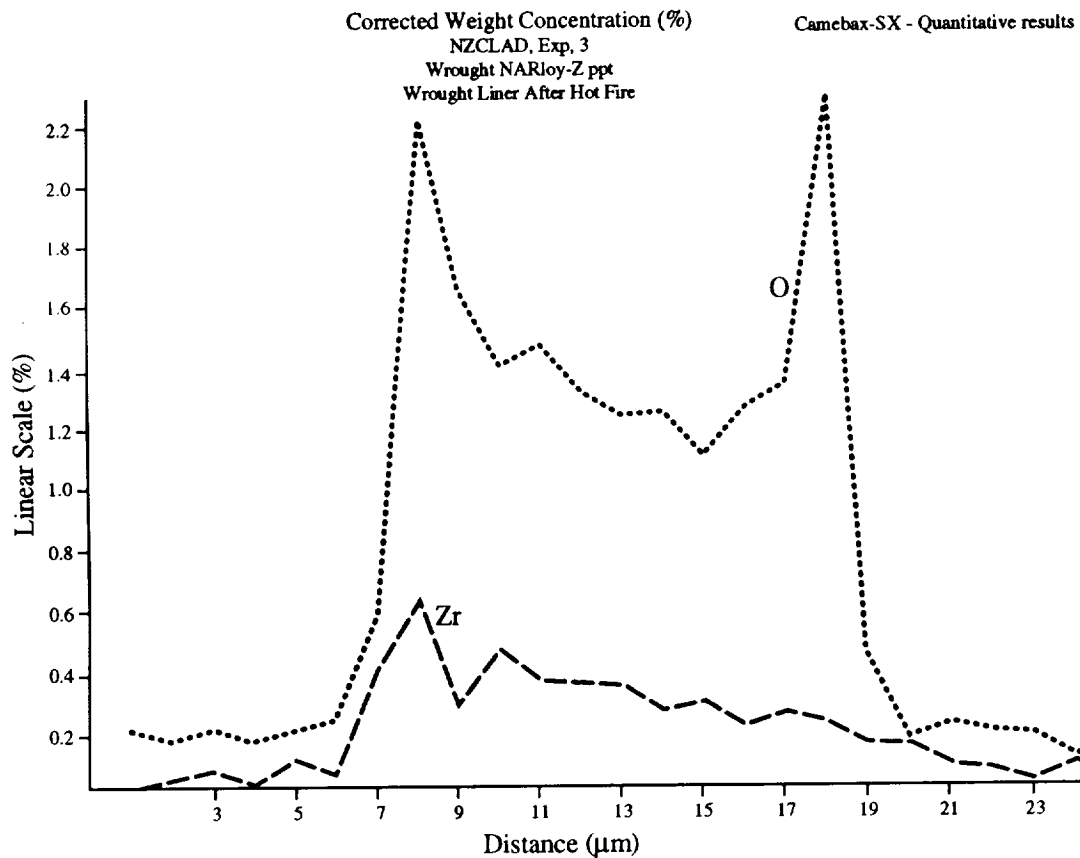
Figure 8b. EPMA across the second phase in wrought NARloy-Z, showing Zr present as Zr_2O_3 into Cu matrix.

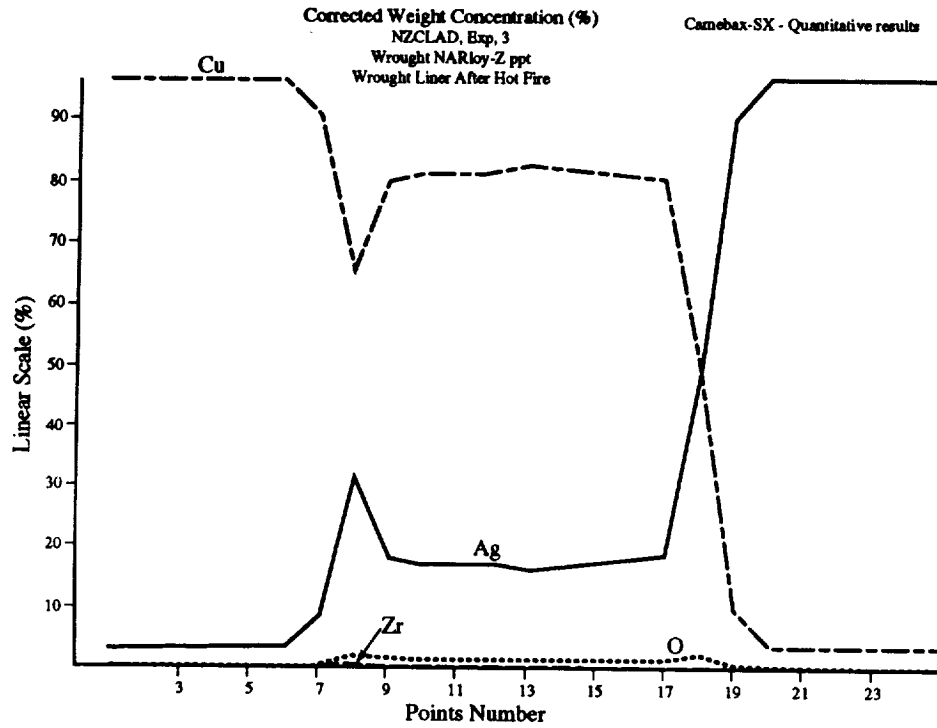
Figure 8c. EPMA across the second phase in wrought NARloy-Z, showing Ag-rich intermetallic phases present into Cu matrix.

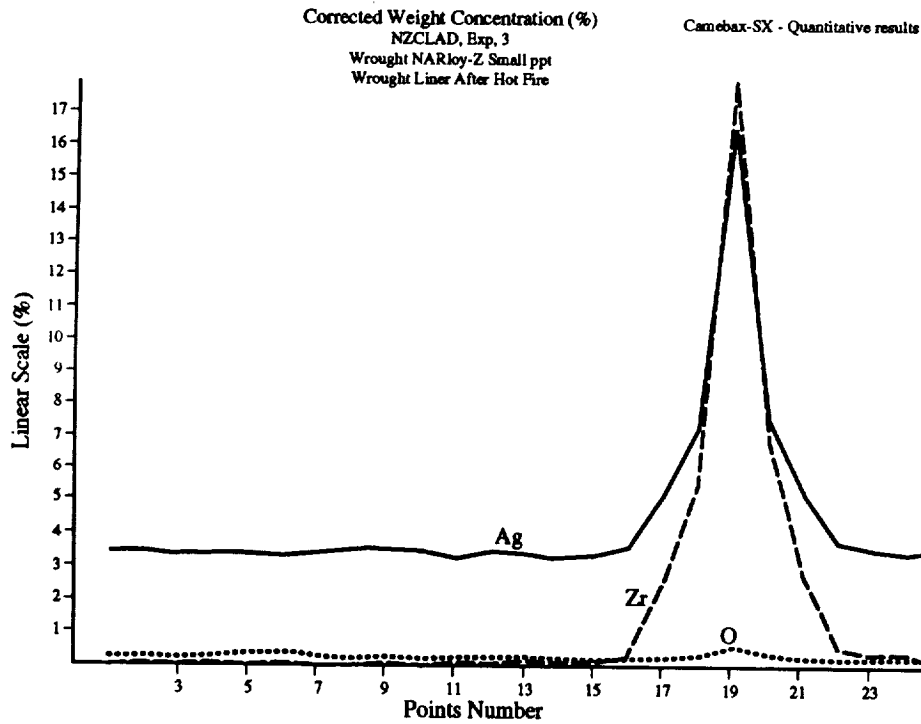
Figure 8d. EPMA across the second phase in wrought NARloy-Z, showing Zr-rich intermetallic phases present into Cu matrix.

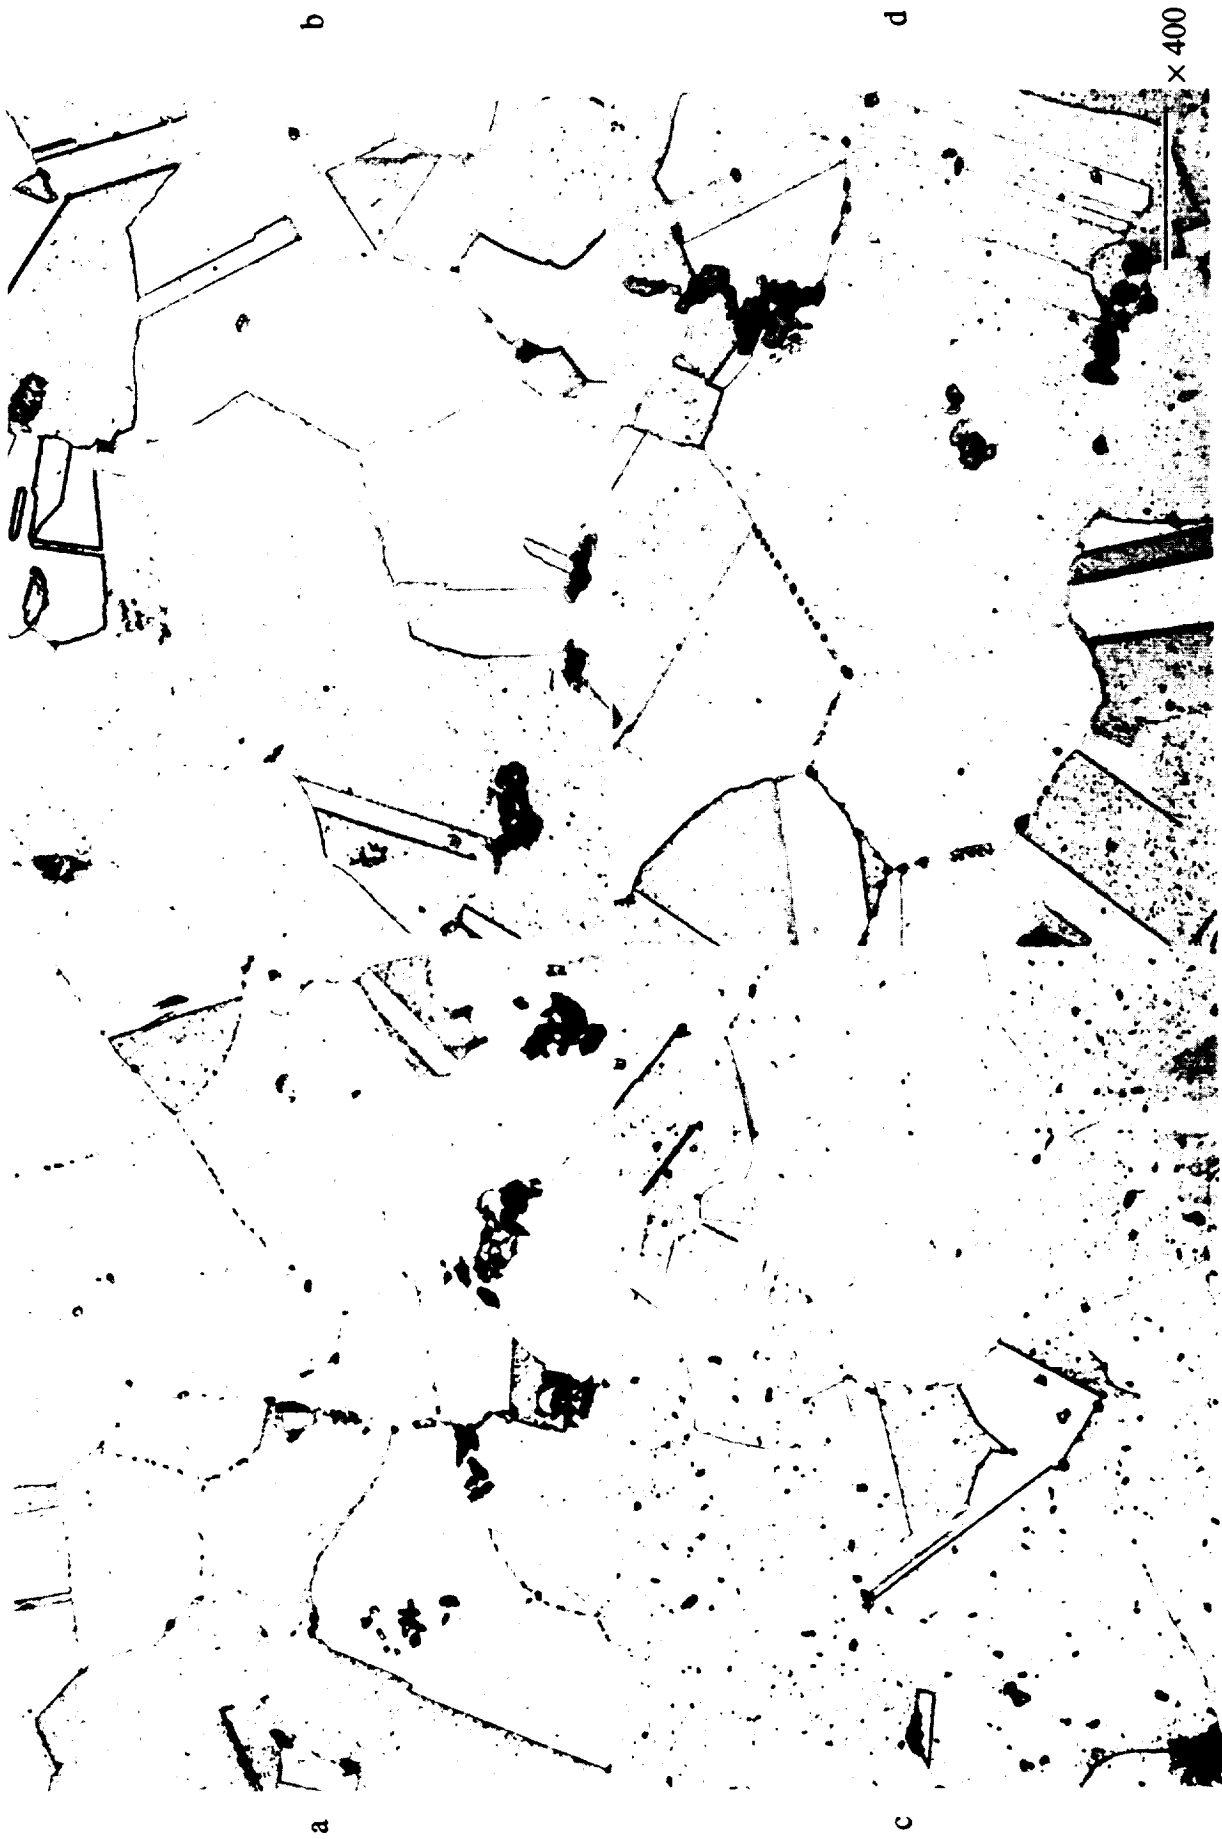
Figure 9. Wrought NARloy-Z showing precipitation of second phases (intermetallic CuAgZr and Zr oxide) in Cu matrix after exposure at 593 °C (1,100 °F) for (a) 24, (b) 48, (c) 72, and (d) 94 h.

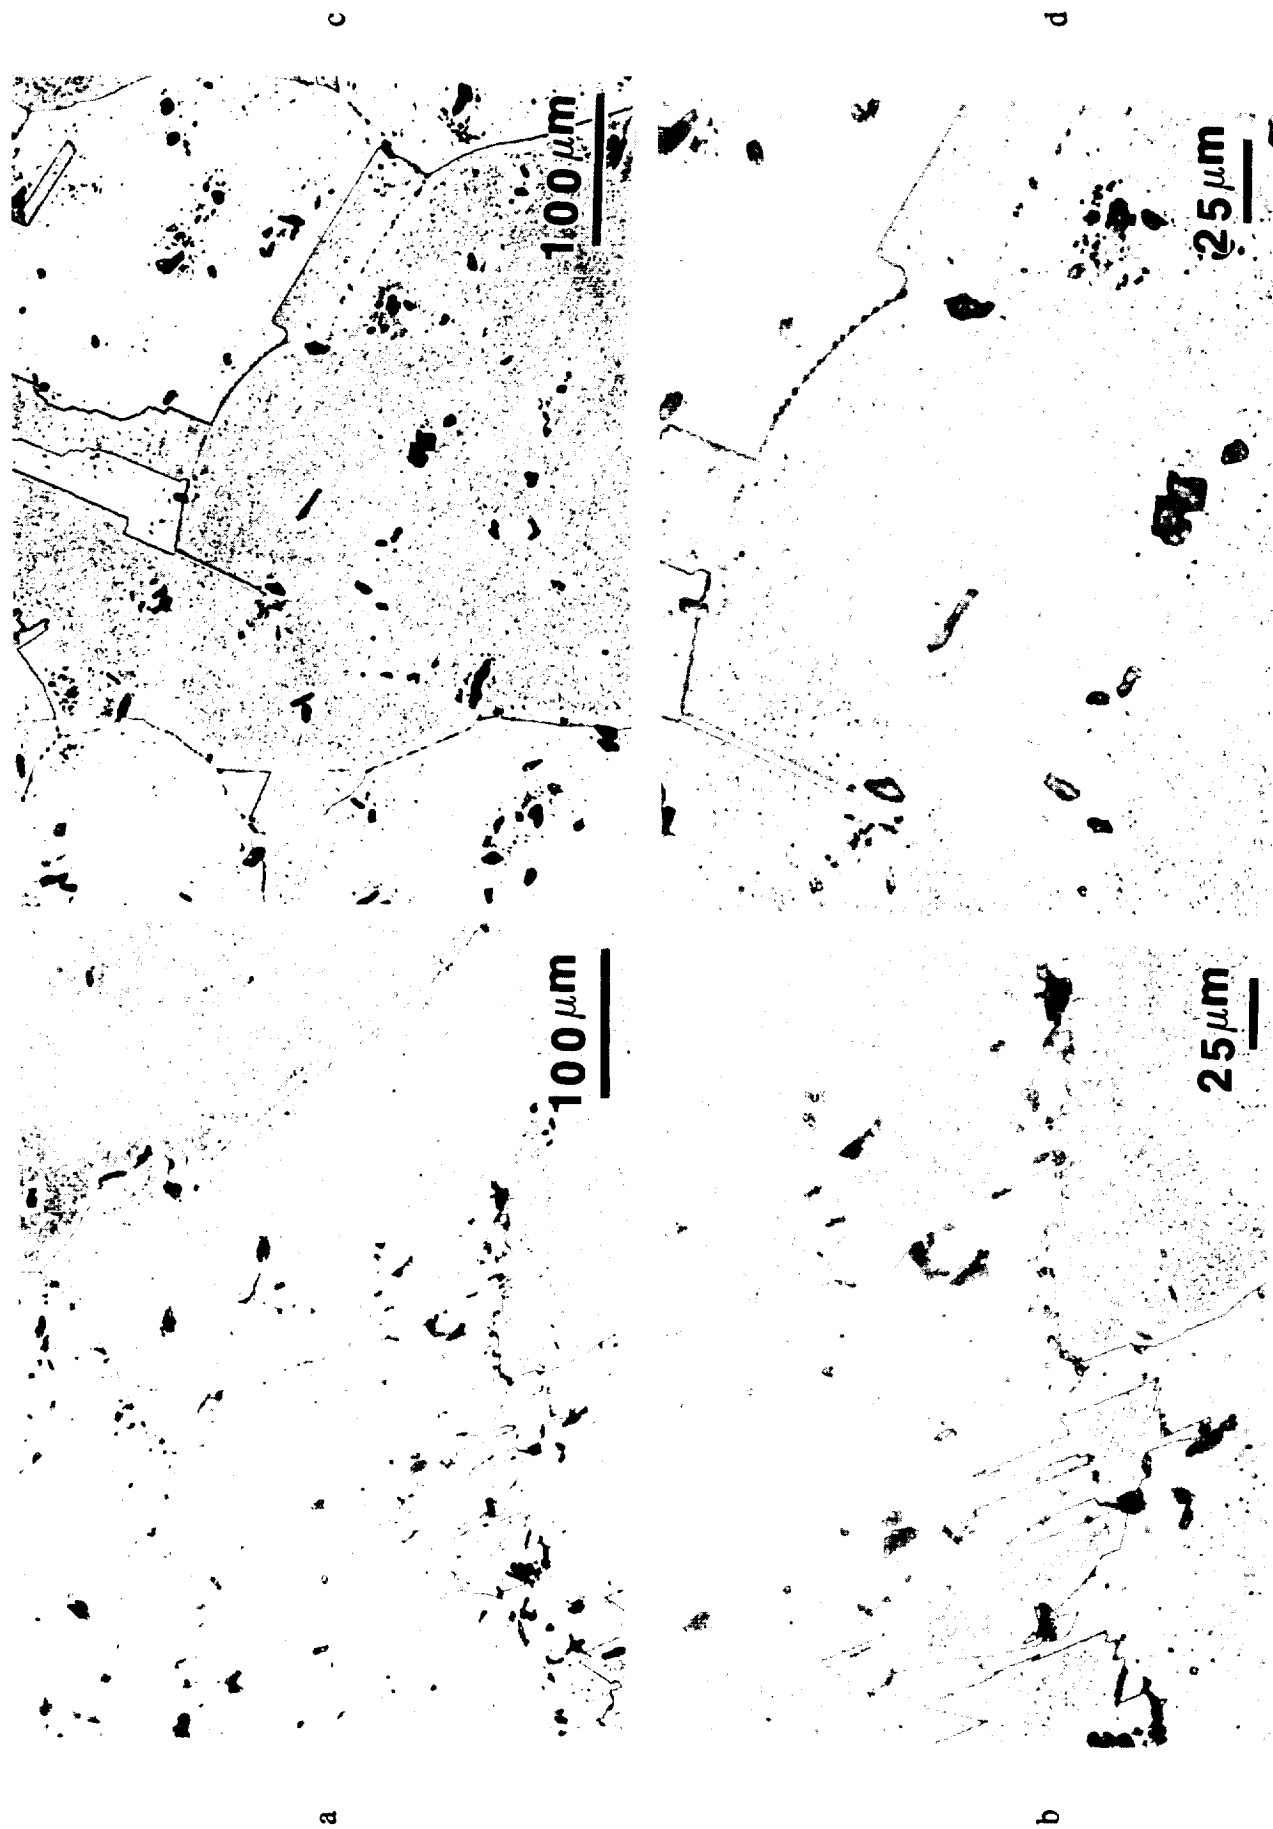
Figure 10. Wrought NARloy-Z showing grain boundary precipitation, PFZ near grain boundaries, and precipitation of second phases (intermetallic CuAgZr and Zr oxide) in Cu matrix after exposure at 649 °C (1,200 °F) for (a) 24 and (b) 28 h.

Two significant features are noteworthy in the wrought NARloy-Z exposed from 593 to 760 °C (1,100 to 1,400 °F): (a) precipitation and coarsening of Ag- and Zr-rich intermetallic phases in the matrix and at grain boundaries and (b) PFZ's near large intermetallic phases and at grain boundaries (figs. 10 to 14).

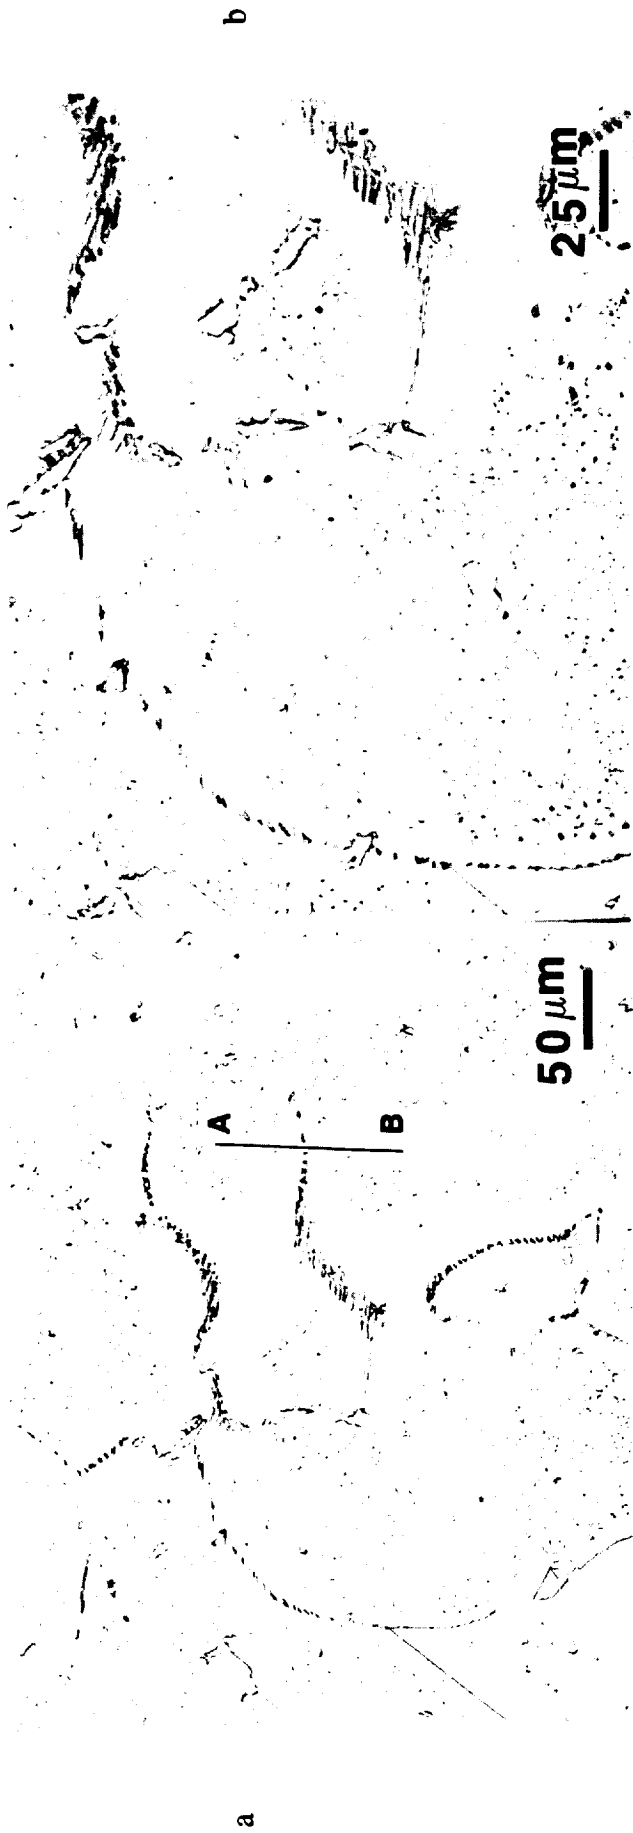
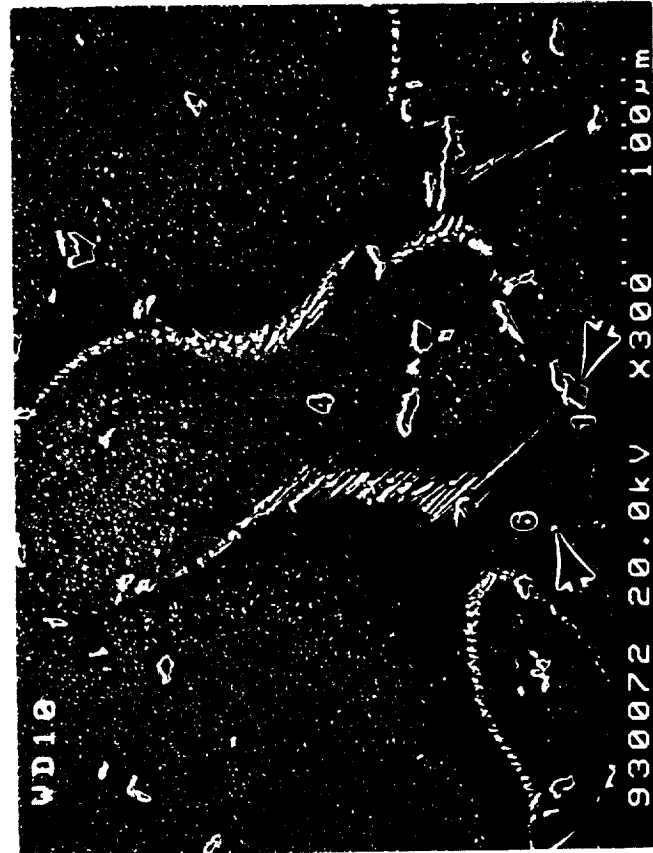
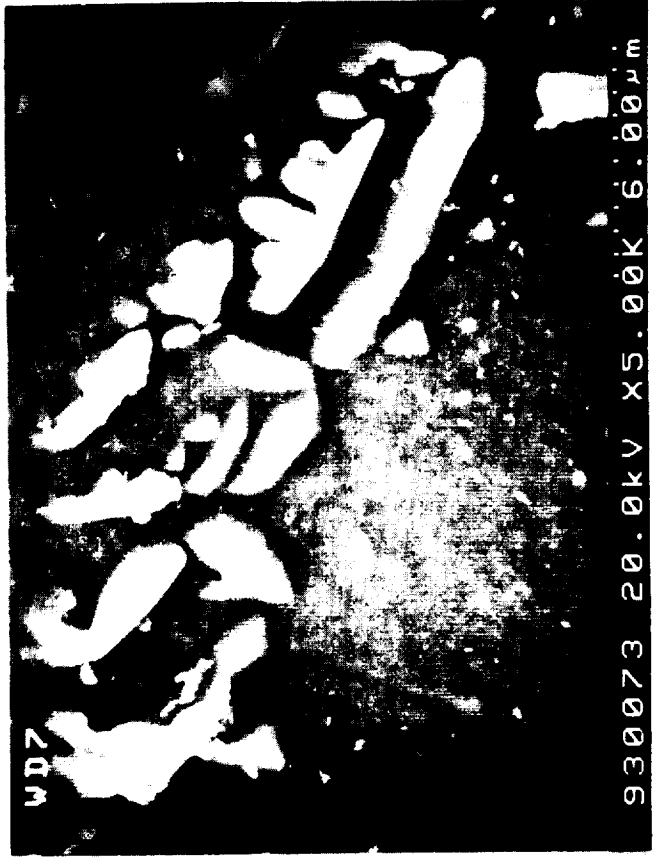
Figure 11. Optical (a: low magnification and b: high magnification) and SEM (c: low magnification and d: high magnification) micrographs of the wrought NARloy-Z showing grain boundary precipitation, PFZ near grain boundaries, and second-phase precipitation (intermetallic CuAgZr and Zr oxide) in Cu matrix after exposure at 705 °C (1,300 °F) for 24 h.

After 24 h exposure at 705 °C (1,300 °F), the wrought NARloy-Z showed relatively large intermetallic precipitates in the Cu matrix and grain boundaries (fig. 11). The PFZ width was also larger than that exposed to 649 °C (1,200 °F) for 48 h (compare figs. 10 and 11). EDS analysis was used to identify the matrix and grain-boundary precipitates as Ag- and Zr-rich intermetallic phases (fig. 12), and an EPMA was carried out across the grain boundary (line AB as shown in fig. 11a) to confirm the analysis. No concentration gradient of Zr and Ag solute atoms was observed across the PFZ and grain boundary (fig. 13), indicating that the precipitation reaction was essentially complete.

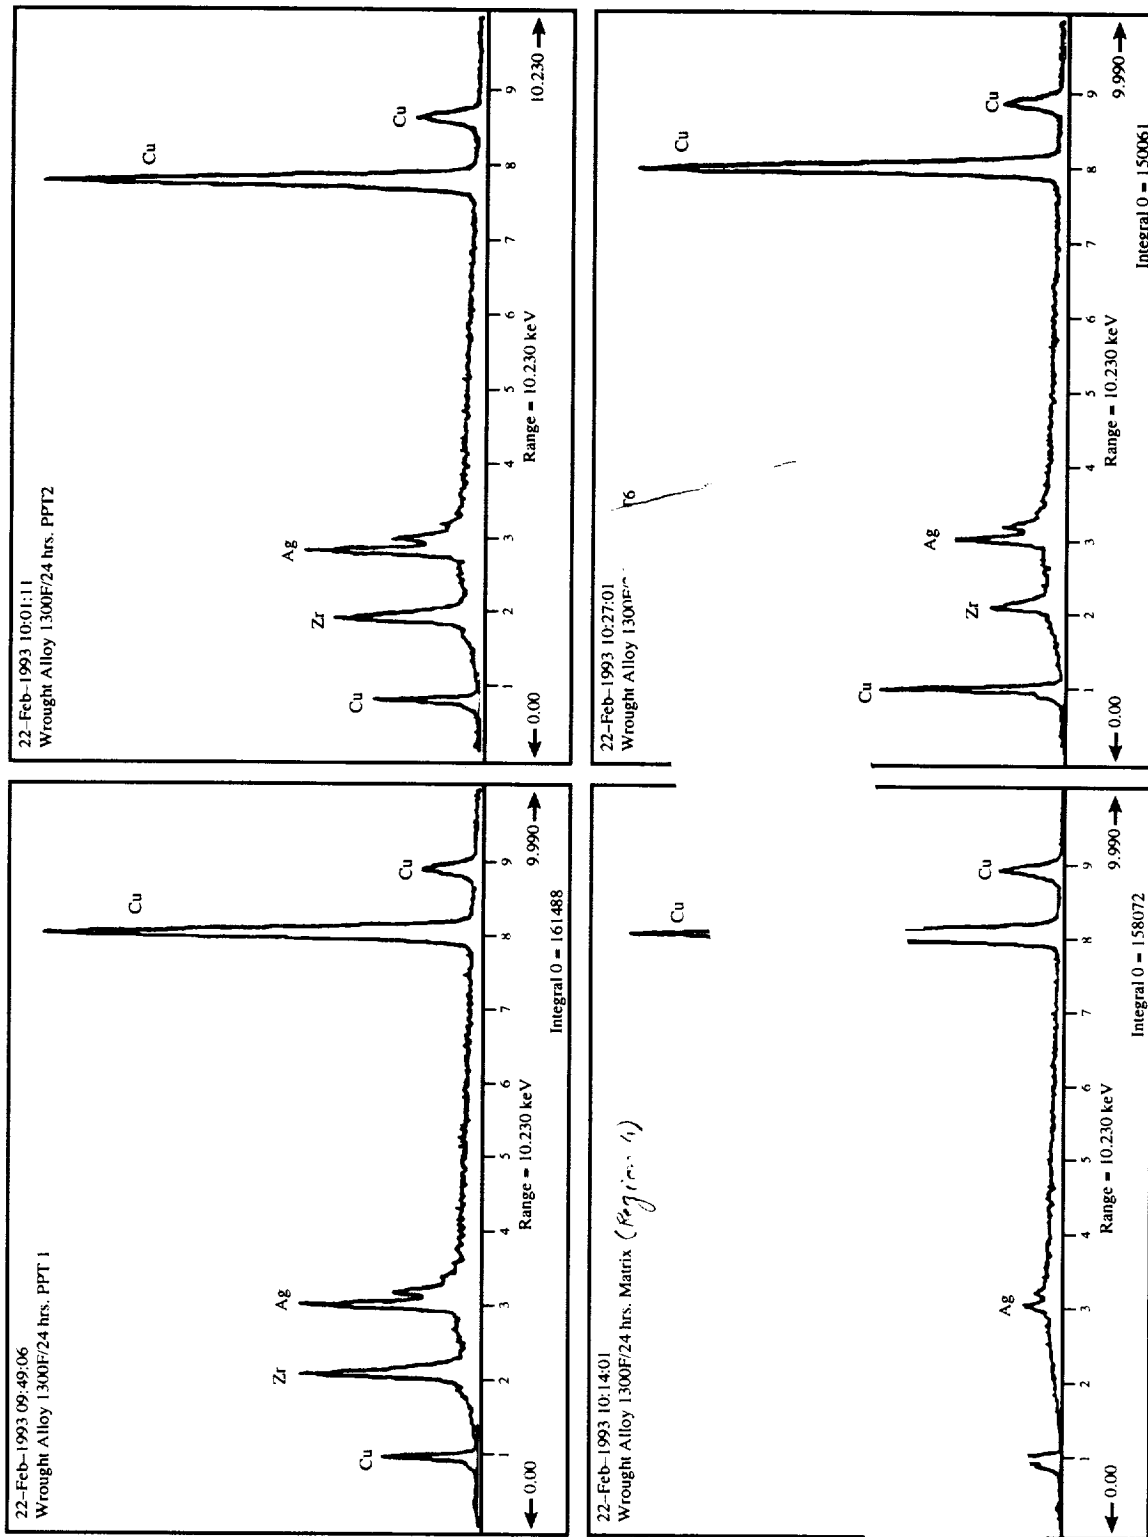
Figure 12. EDS spectrum from precipitates (regions 1 and 2) and matrix (regions 4 and 6), as marked in figure 8c.

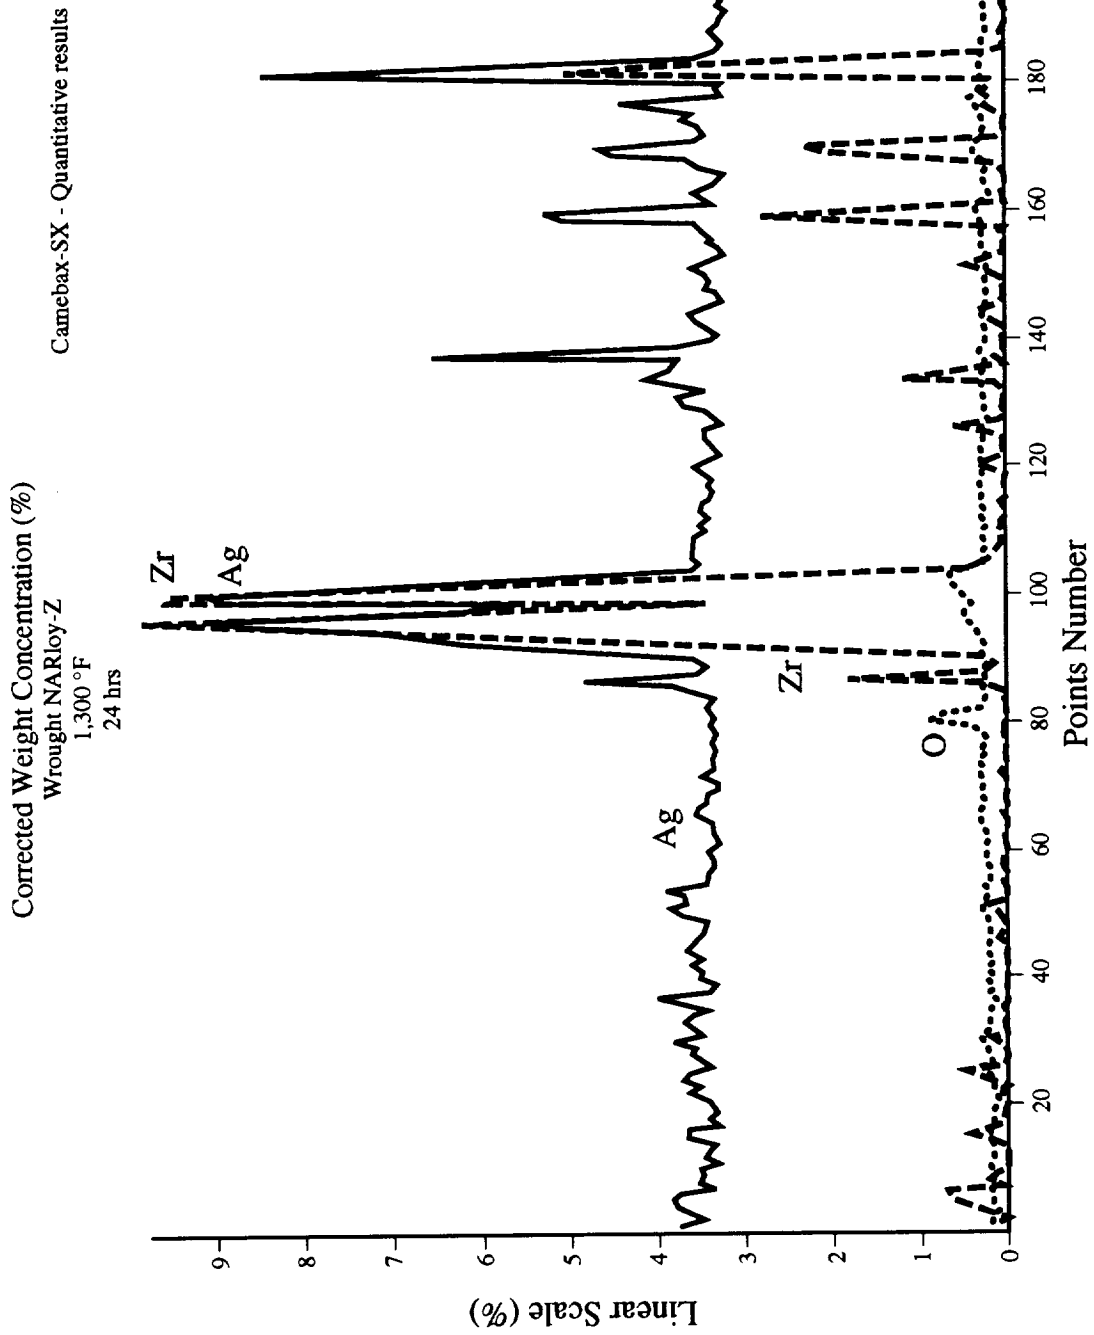
Figure 13. EPMA across precipitate, as marked in figure 11a.

Under equilibrium conditions, the maximum solid solubility of Zr is about 0.15 wt.% in the Cu matrix at ~822 °C (1,512 °F), decreasing as temperature decreases. NARloy-Z contains about 0.5 wt.% Zr and the excess Zr precipitates either as Zr-rich an intermetallic phase or as Zr oxide. Inherent rapid melting and solidification, which occurred in the laser- and EB-glazing processes, created a nonequilibrium condition, thereby extending the solid solubility of Zr in the copper matrix. The atomic size of Zr (0.162 nm) is larger (~30 percent) than the Cu matrix (0.1278 nm). Due to the extended solid solubility of Zr atoms, the lattice strain was developed in the Cu matrix, which probably changed the kinetics of Ag precipitation (compare figs. 10b and 18b). Ag precipitated as elemental Ag in laser-glazed NARloy-Z, whereas Ag- and Zr-rich intermetallic precipitates were observed in the wrought alloy (figs. 13 and

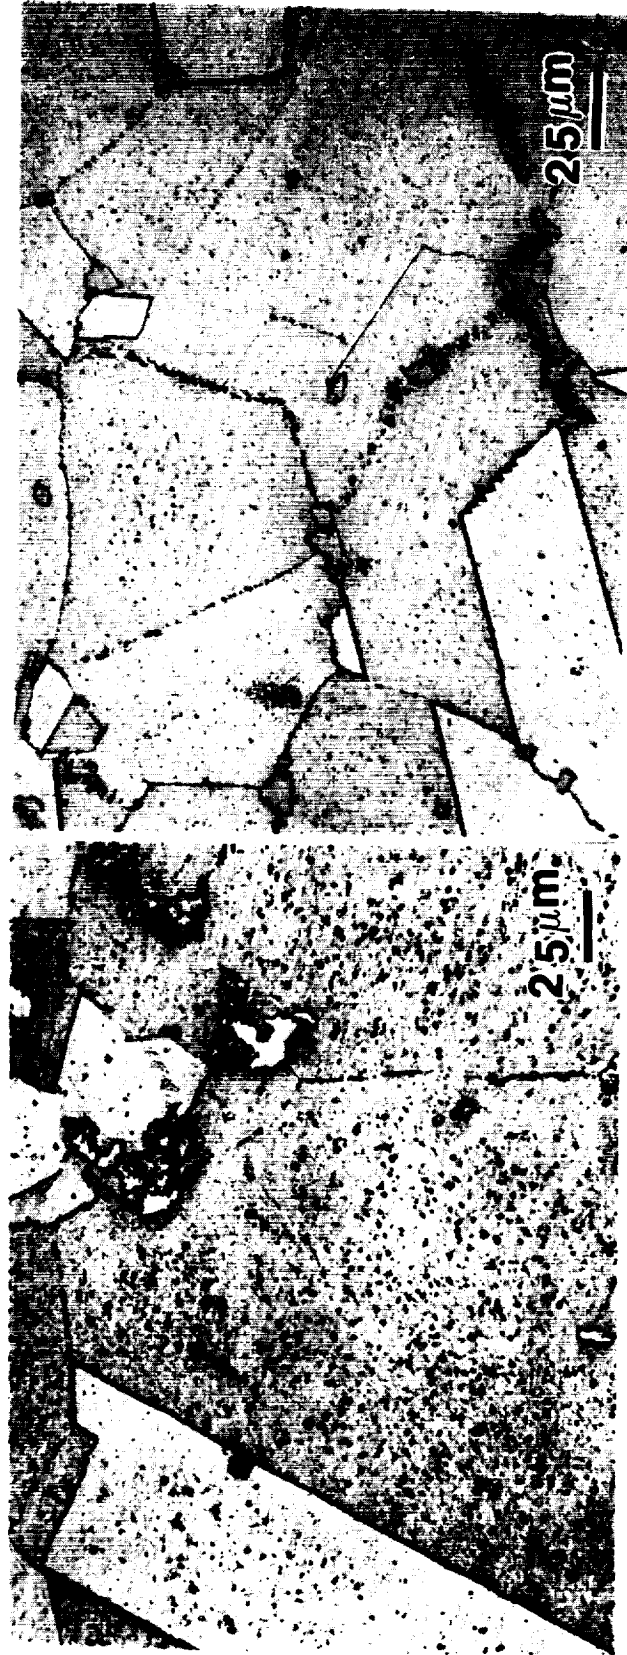
Figure 14. Wrought NARloy-Z showing grain boundary precipitation, PFZ near grain boundaries, and second-phase precipitation (intermetallic CuAgZr and Zr oxide) in Cu matrix after exposure at 760 °C (1,400 °F) for (a) 24 and (b) 48 h.

After exposure at 760 °C (1,400 °F) up to 48 h, the wrought NARloy-Z showed even coarser precipitation of intermetallic phases (fig. 14). The PFZ width was also larger than the NARloy-Z exposed to 649 to 705 °C (1,200 to 1,300 °F).

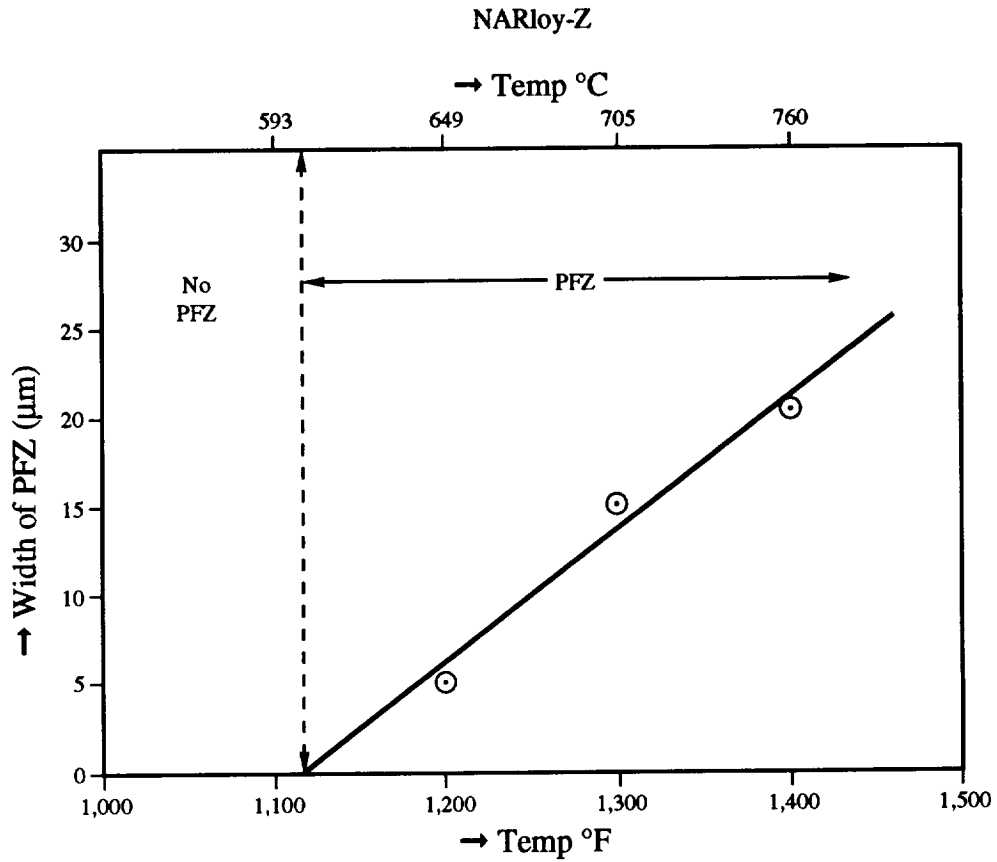
Figure 15. Plot of PFZ width as a function of exposure to temperatures ranging from 649 to 760 °C (1,200 to 1,400 °F).

At temperatures above 649 °C (1,200 °F), PFZ formation probably occurred in response to grain boundary precipitation, migration, and long-range solute atom diffusion. The PFZ width increased as a function of temperature (fig. 15). Extrapolation of the PFZ size to zero in figure 15 indicates that PFZ occurs only above 605 °C (1,120 °F). The prior investigation⁶ was conducted below 538 °C (1,000 °F), which may be why the investigators did not report PFZ formation in wrought NARloy-Z.
