**NASA
Technical
Memorandum**

NASA TM - 108431

**MICROSTRUCTURAL STABILITY OF WROUGHT, LASER
AND ELECTRON BEAM GLAZED NARLOY-Z ALLOY AT
ELEVATED TEMPERATURES**

By J. Singh, G. Jerman, B. Bhat, and R. Poorman

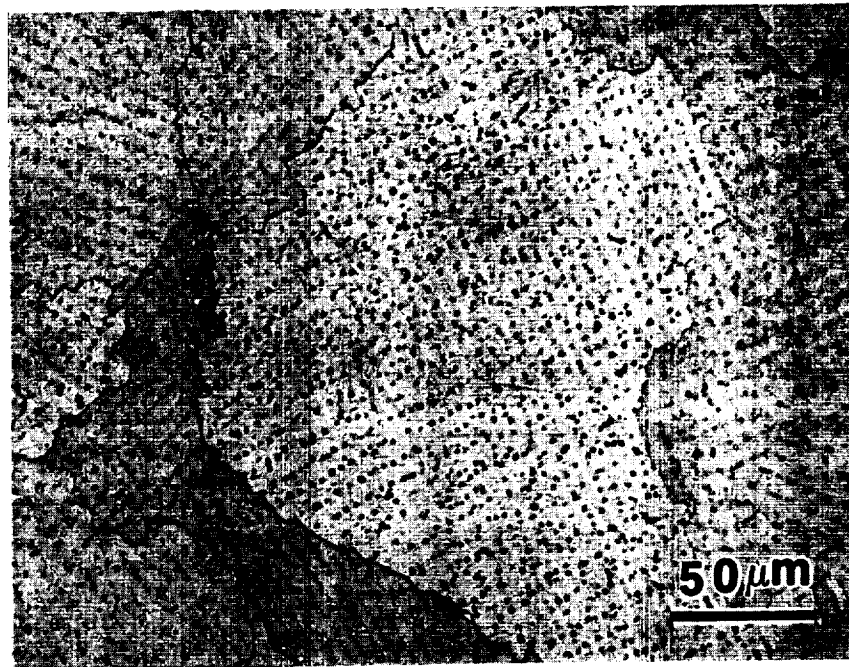
Figure 16. Laser-glazed NARloy-Z showing uniform distribution of second phases in Cu matrix.

Laser and Electron-Beam Glazed NARloy-Z. Metallographic examination of laser-glazed NARloy-Z revealed uniform distribution of second phases in the Cu matrix (fig. 16). No grain boundary segregation was observed. In the rapidly solidified region, the average grain size was 100 μm , which is about half the wrought NARloy-Z grain size (150 to 300 μm). No significant change in the microstructure was observed on exposure at 593 °C (1,100 °F) for up to 84 h (fig. 17). A small amount of

EB-glazed NARloy-Z showed a fine-grained microstructure (fig. 23) that is comparable to laser-glazed NARloy-Z (fig. 16). The melt pool ranged in depth from 0.6 to 2 mm (25 to 80 mils), depending upon processing conditions such as traverse speed and beam current (fig. 24).

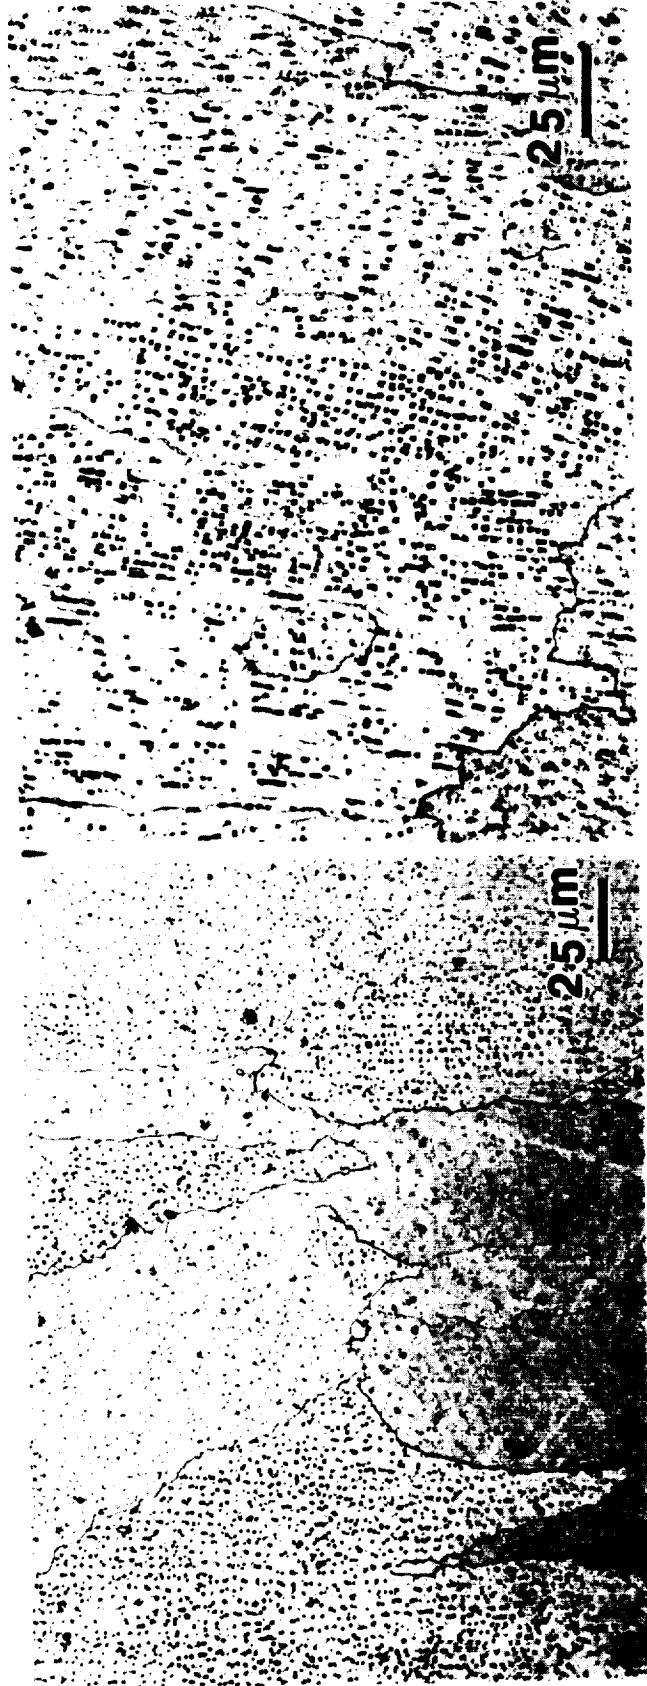
Figure 18. Laser-glazed NARloy-Z showing uniform distribution of faceted second phases in Cu matrix after exposure at 649 °C (1,200 °F) for (a) 24 and (b) 48 h.

coarsening of the second phase was observed as a function of time. Further coarsening of second phases was observed after exposing at 649 °C (1,200 °F) for up to 48 h (figs. 18a and 18b). These precipitates were aligned and had a faceted morphology (fig. 18b). However, the second phase sizes were still small and averaged less than 0.5 μm, smaller than those observed in wrought NARloy-Z (10 μm, fig. 8).

The EPMA technique was used to determine the concentration profile across the aligned precipitate (figs. 18 and 19). Faceted precipitates were mostly Ag, whereas most of the Zr was found in the matrix (fig. 19). The second phases coarsened further on exposures to higher temperatures, 705 to 760 °C (1,300 to 1,400 °F), but the average size was still small and remained at less than 0.5 μm (figs. 20 and 22). Unlike the wrought NARloy-Z, grain boundary precipitation and PFZ's were not observed in the Cu matrix in any of the experiments.

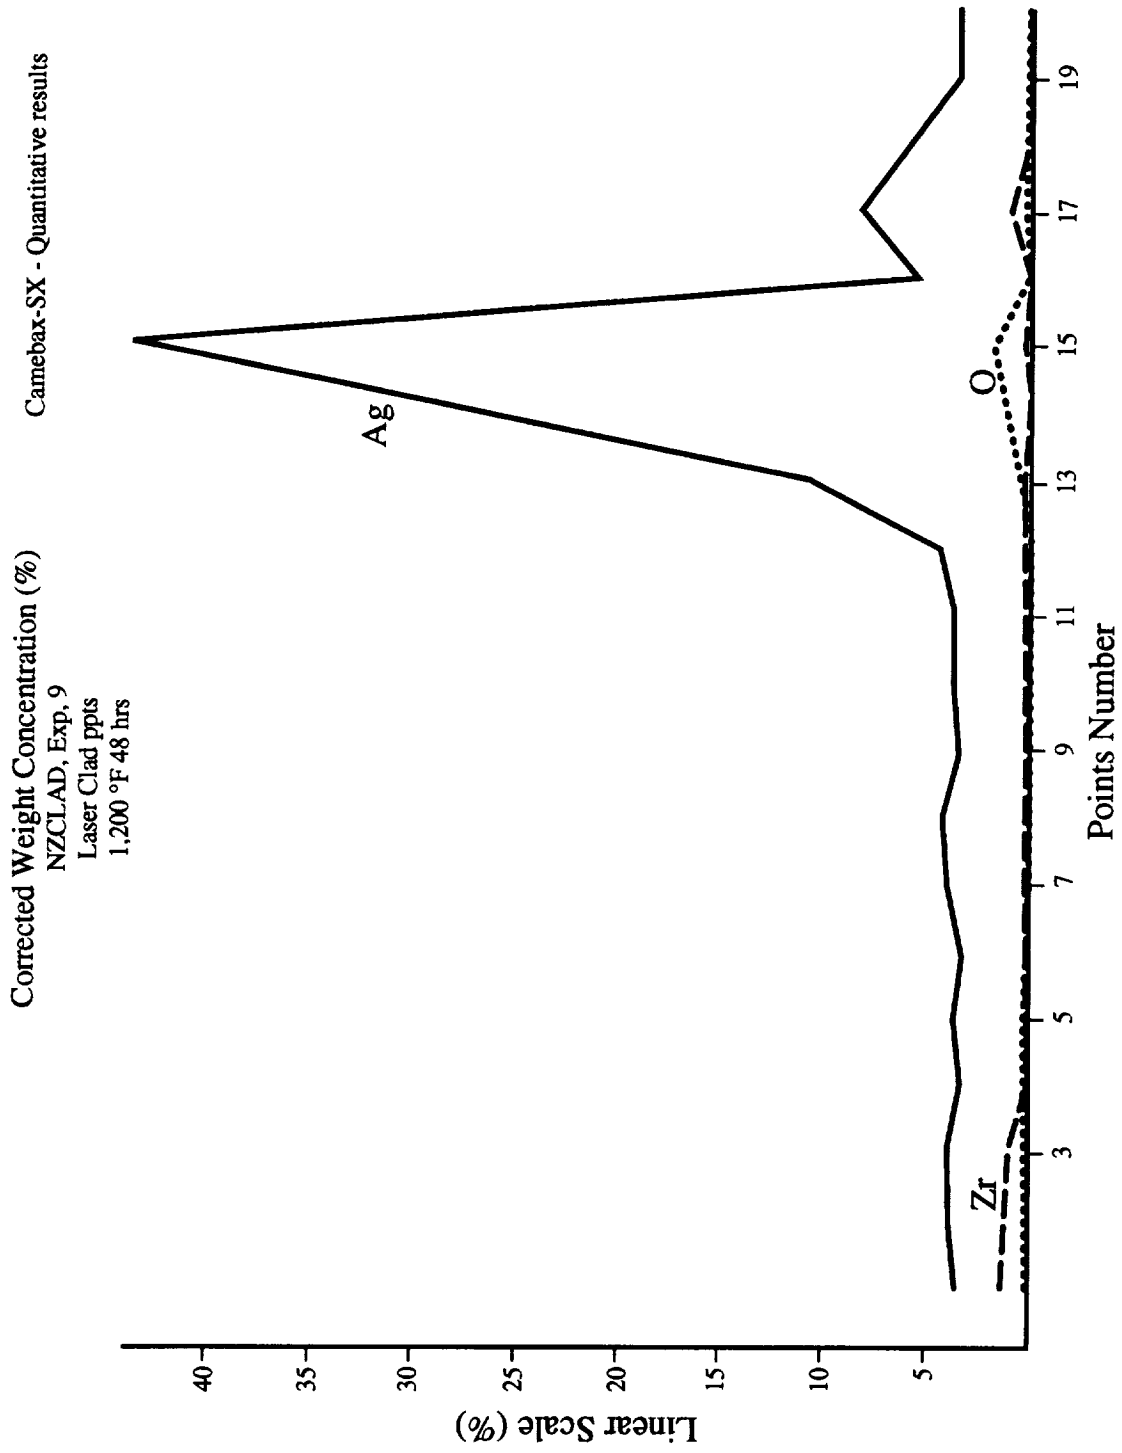
Figure 19. EPMA across the faceted precipitate, as marked in figure 18.

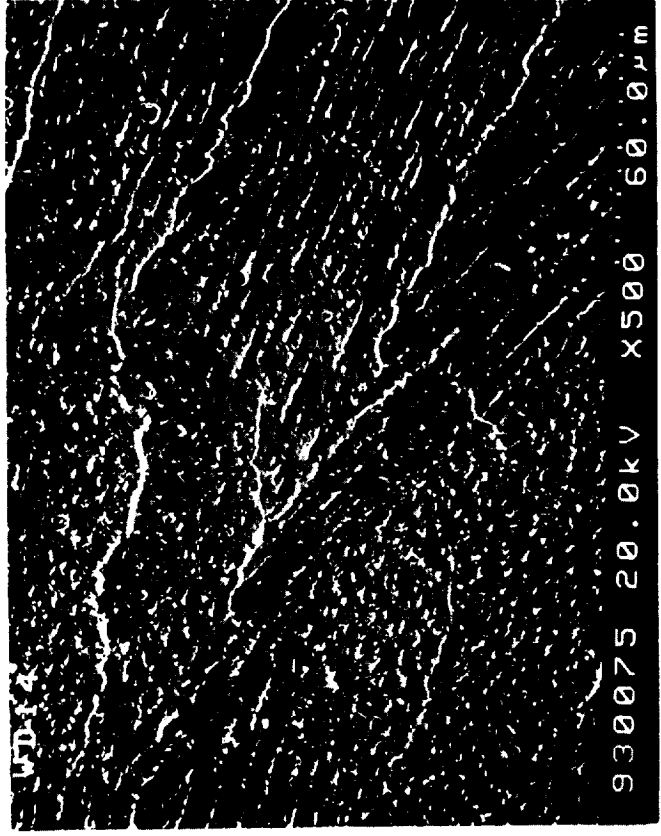
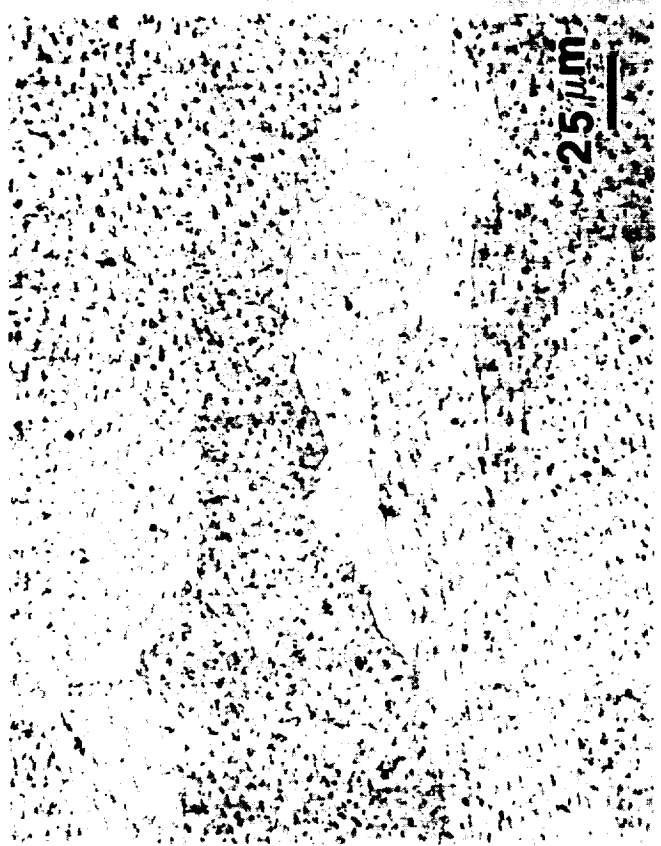
Figure 20. Laser-glazed NARloy-Z showing uniform distribution of second phases in Cu matrix after 24 h at 649 °C (1,200 °F).

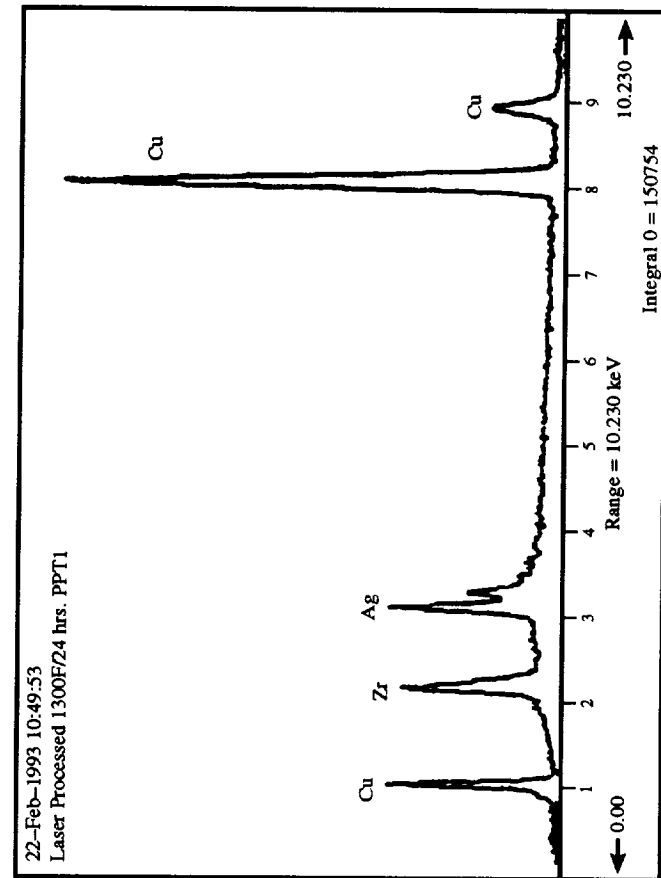
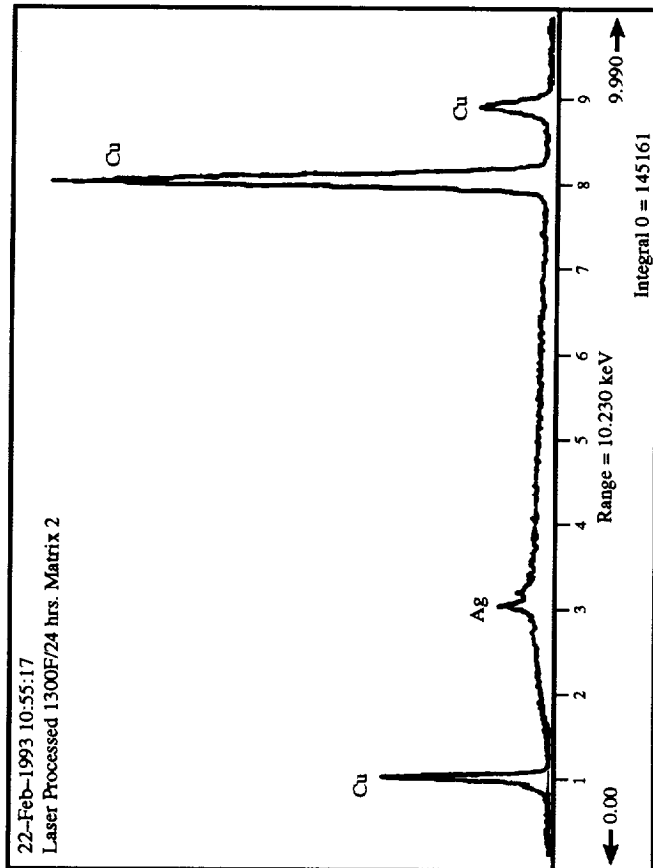
Figure 21. EDS spectrum of precipitate and matrix from figure 20.

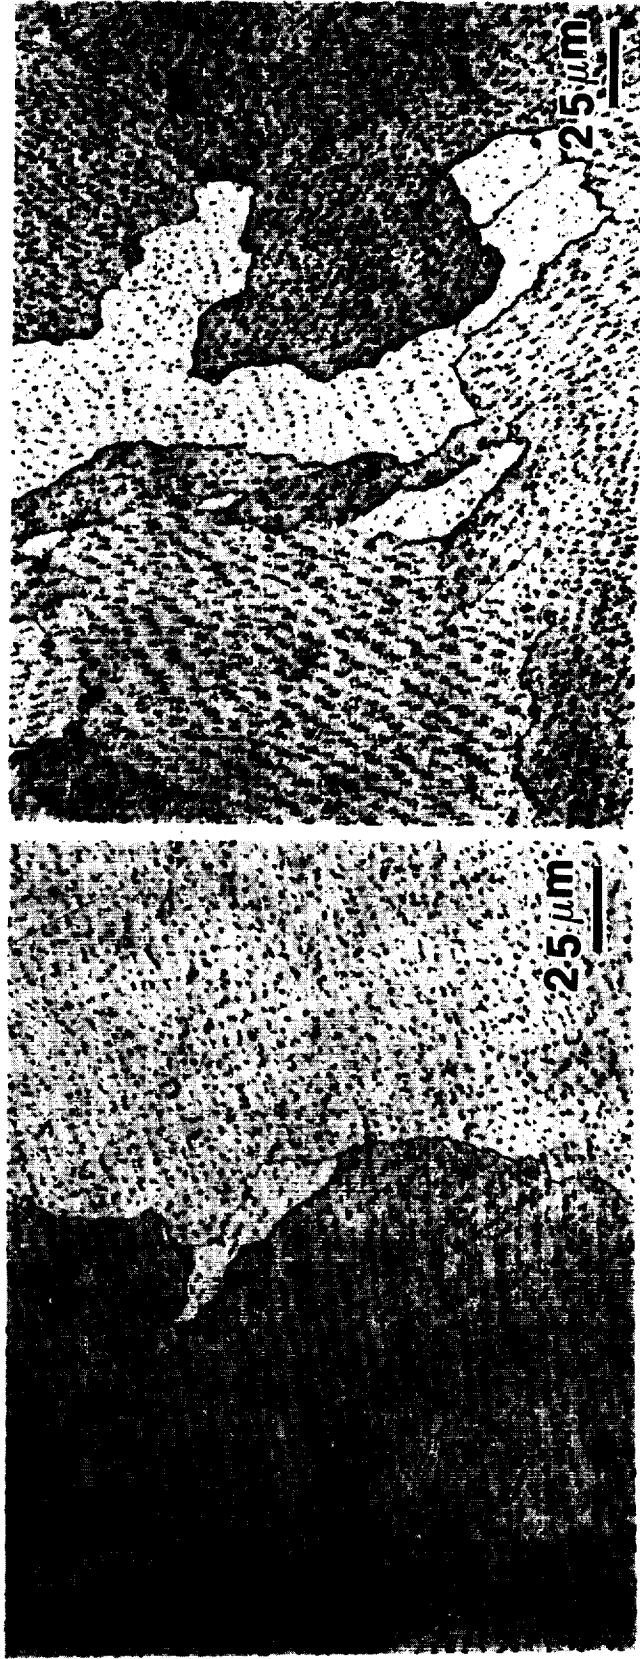
Figure 22. Laser-glazed NARloy-Z showing uniform distribution of second phases in Cu matrix after exposure at 760 °C (1,400 °F) for (a) 24 and (b) 48 h.

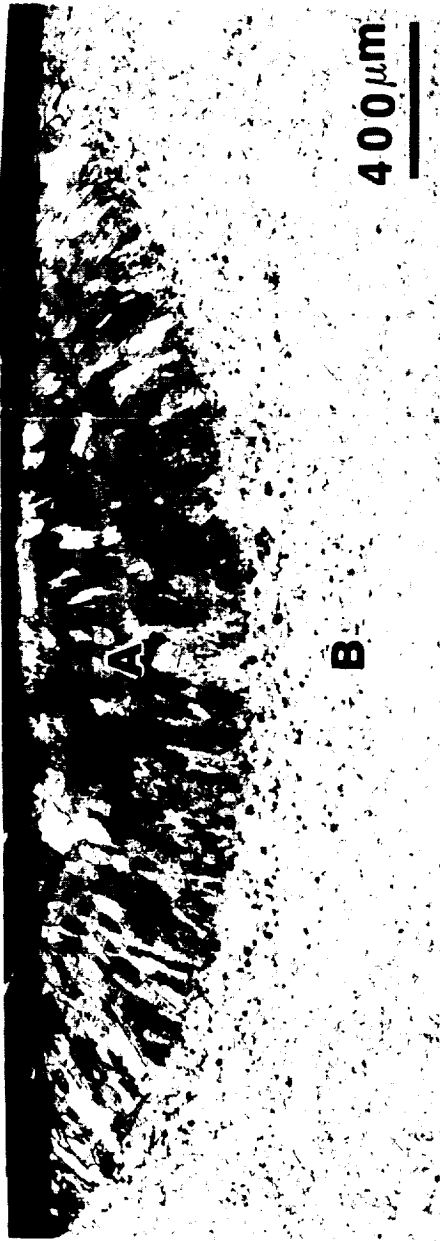
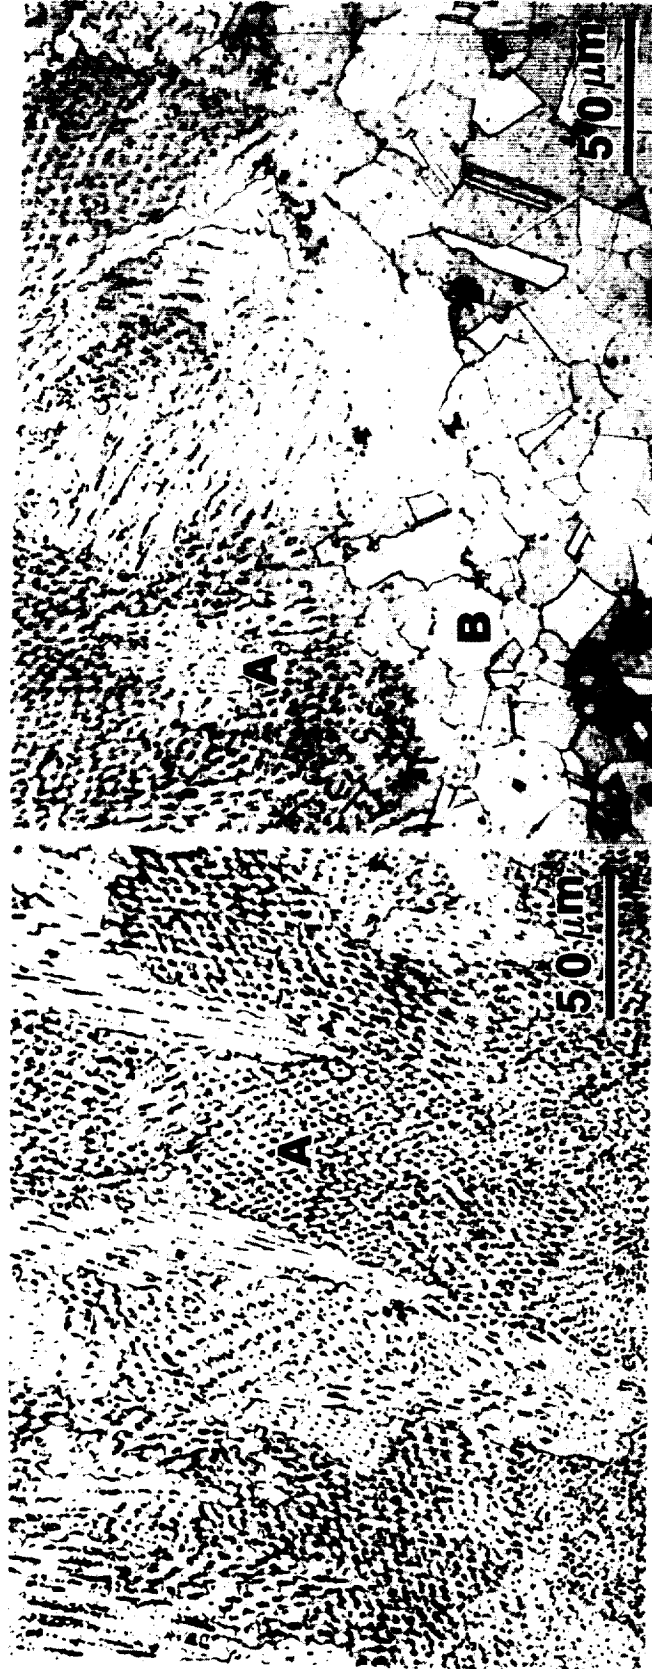
Figure 23. Electron beam-glazed NARloy-Z with uniform distribution of second phases in Cu matrix at a melt depth of ~0.6 mm (25 mils).

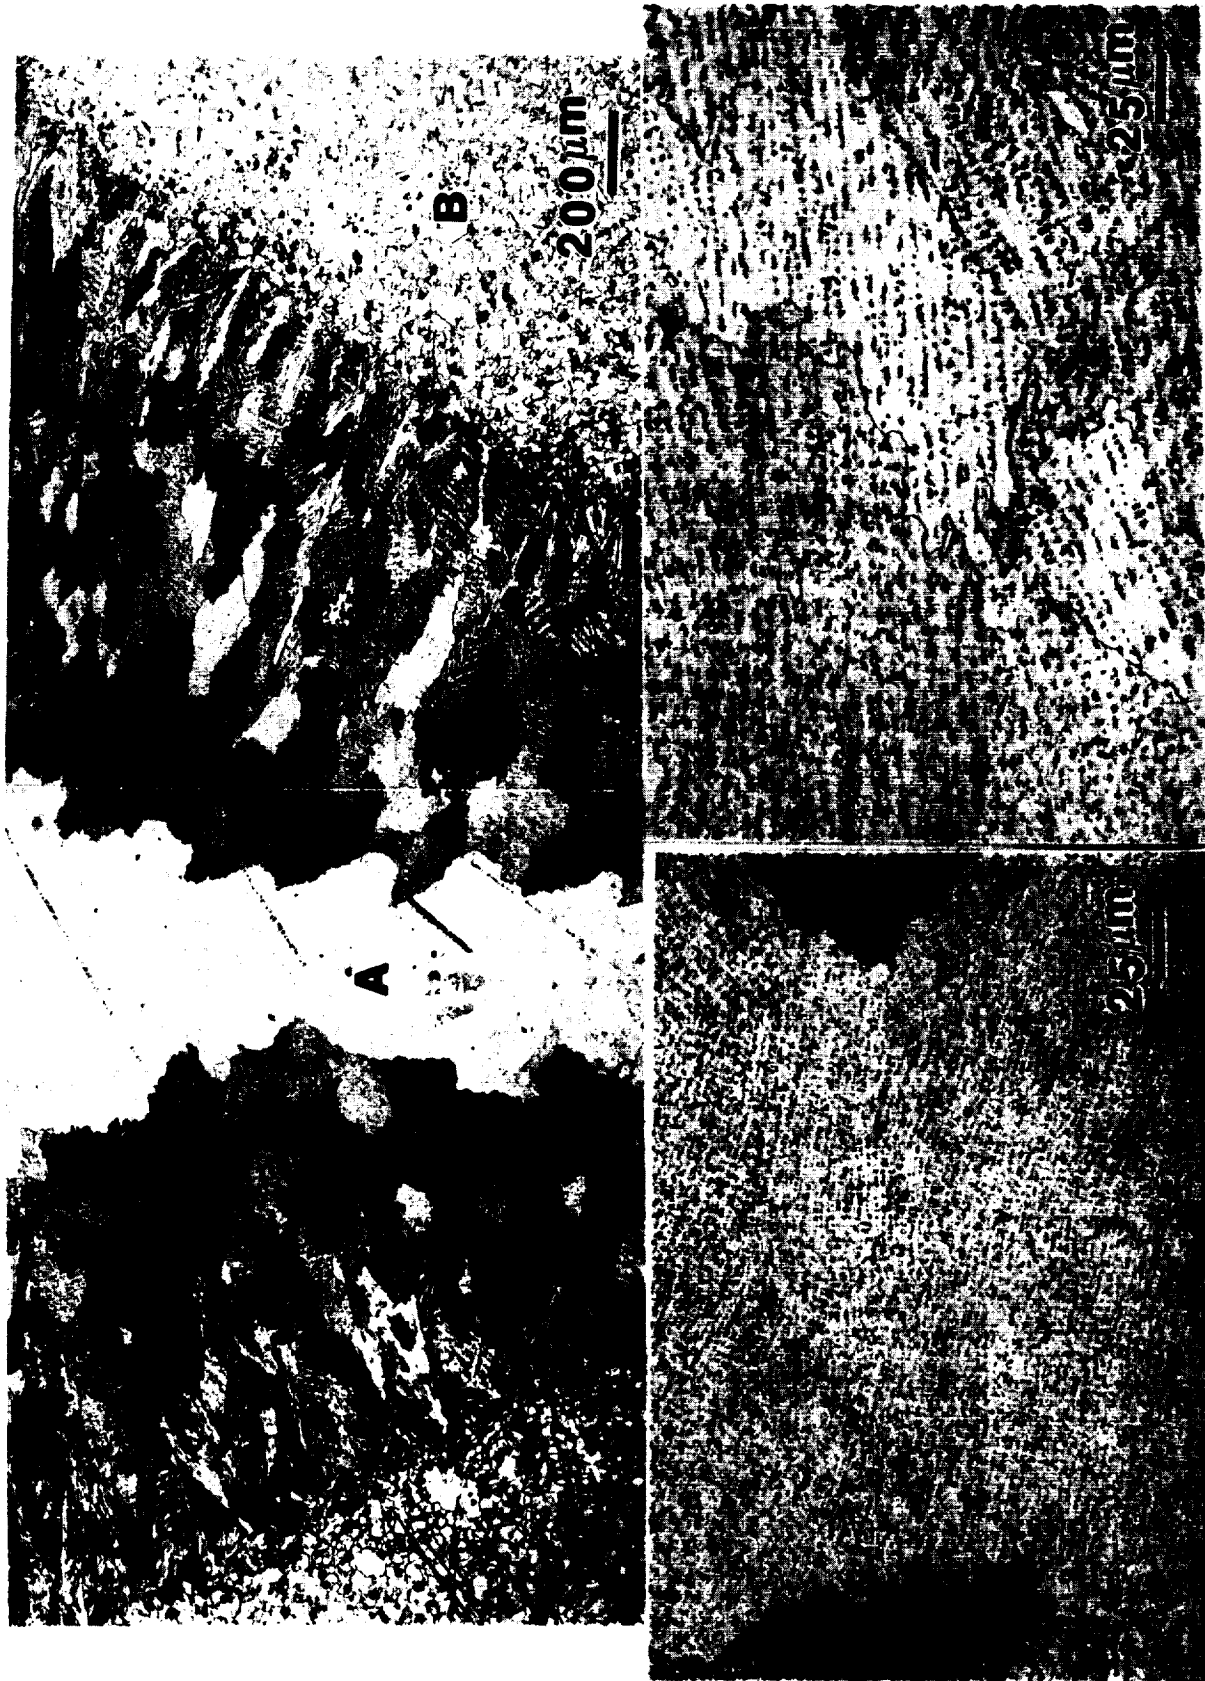
Figure 24. Electron beam beam-glazed NARloy-Z showing uniform distribution of second phases in Cu matrix at melt depth of ~2 mm (80 mils).
