1995 NASA/ASEE SUMMER FACULTY FELLOWSHIP PROGRAM  
JOHN F. KENNEDY SPACE CENTER  
UNIVERSITY OF CENTRAL FLORIDA

CAVITATION EFFECTS IN ULTRASONIC CLEANING BATHS

Dr. Barbara H. Glasscock  
Associate Professor  
Chemical and Materials Engineering Department  
California State Polytechnic University, Pomona  
Pomona, California

August 18, 1995

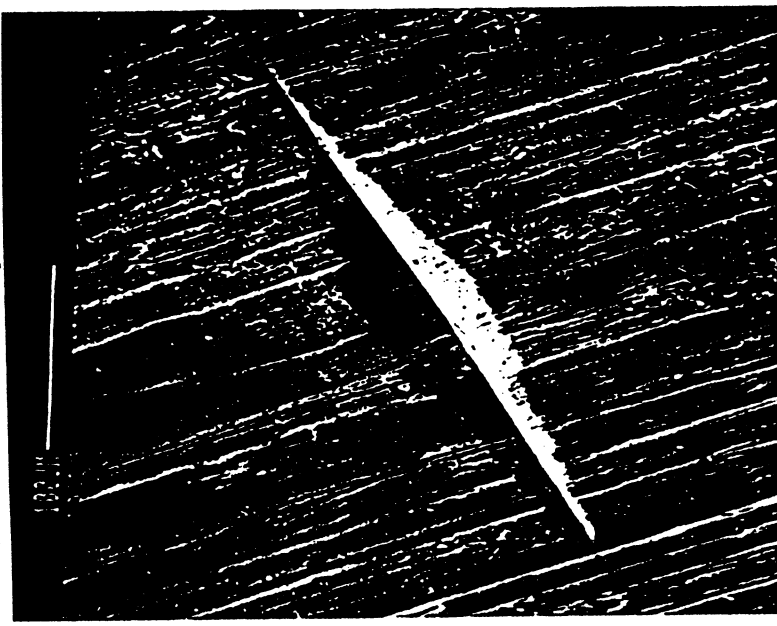
Figure 3-3. SEM of Aluminum (sample AL5-01) in its initial condition (left) and after 20 ultrasonic cleaning cycles (right). Microhardness mark in the center is for reference.

Scanning Electron Micrographs (SEMs) were taken of one coupon of each material type before exposure to the ultrasonics (initial) and after 1, 10, and 20 cycles. Very little change was observed in all cases. Figures 3-3 to 3-7 present the SEM's of the coupons in the initial conditions and after exposure to 20 ultrasonic cleaning cycles. In all of these photos, the diamond-shaped mark in the center is the microhardness mark that was used for reference enabling examination of exactly the same microstructure each time.

In Figures 3-3 and 3-4, some of the inclusions of the aluminum alloys appear more evident after exposure to the ultrasonics. The large stainless steel coupon in Figure 3-5 shows no damage from the ultrasonics with the only effect being perhaps that the surface appears cleaner. The small stainless steel coupon, shown in Figure 3-6, appears to have small trails of very fine dents which may have been caused by vibrations in the mesh basket. The titanium coupon showed no damage after 20 cycles as seen in Figure 3-7.

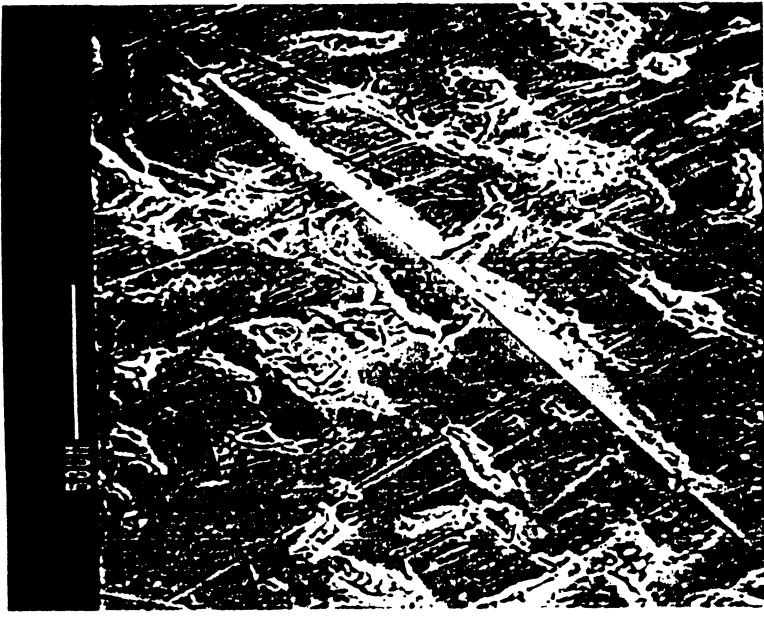
Figure 3-5. SEM of Stainless Steel (sample SS3-57) in its initial condition (left) and after 20 ultrasonic cleaning cycles (right).

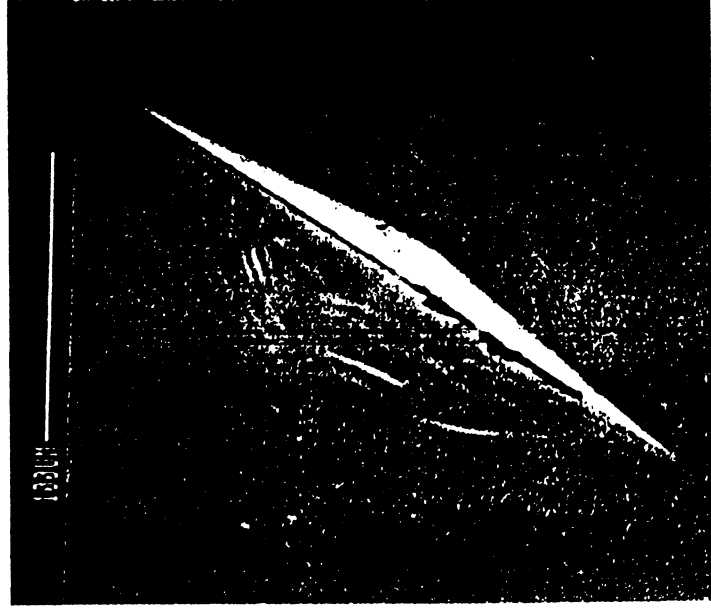
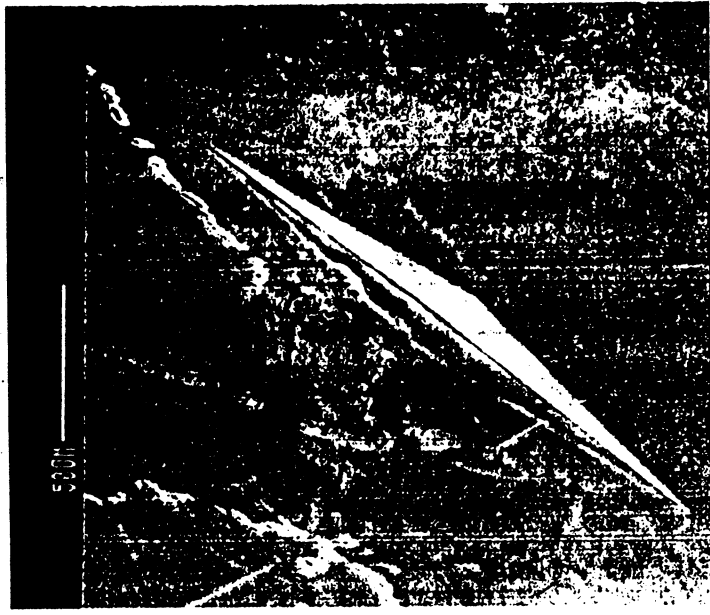
Figure 3-6. SEM of Stainless Steel (sample SS-A1) in its initial condition (left) and after 20 ultrasonic cleaning cycles (right).

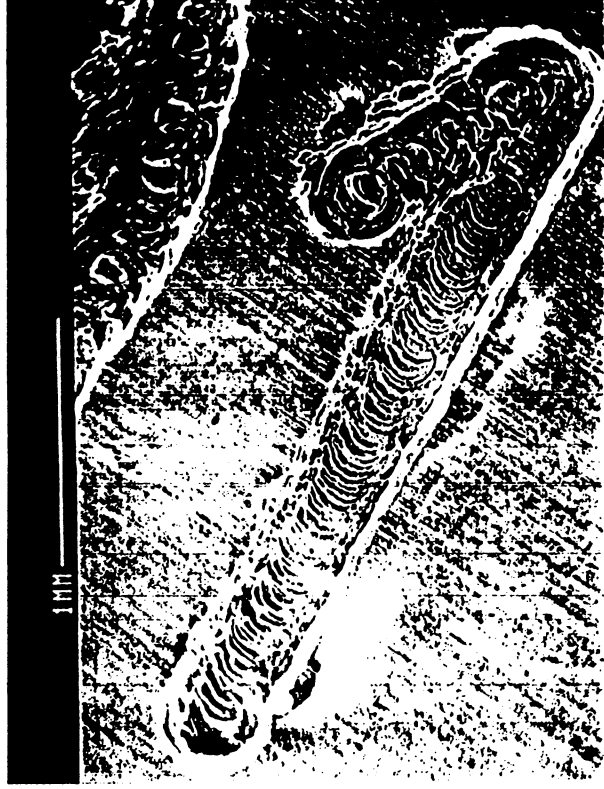
Figure 3-8. SEM of Aluminum (sample A15-01) after 20 ultrasonic cleaning cycles showing cavitation damage in the vicinity of the engraved number "1".

The aluminum coupons did exhibit an interesting phenomenon after 20 ultrasonic cycles. As shown in Figure 3-8, in the vicinity of surface irregularities, such as the engraved numbers, there were areas of cavitation damage to the surface, having the appearance of a "shadow". It is possible that the surface irregularities perturbed the local flow conditions and caused very localized cavitation. This phenomenon was seen only on the aluminum coupons.

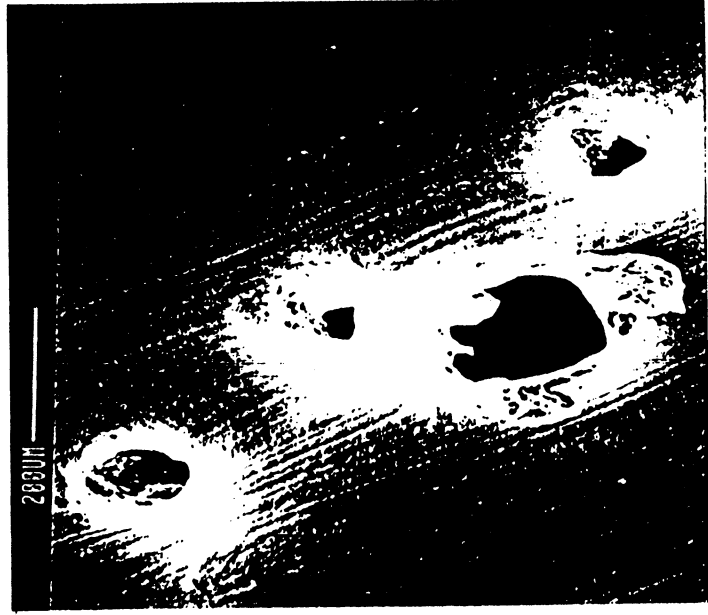
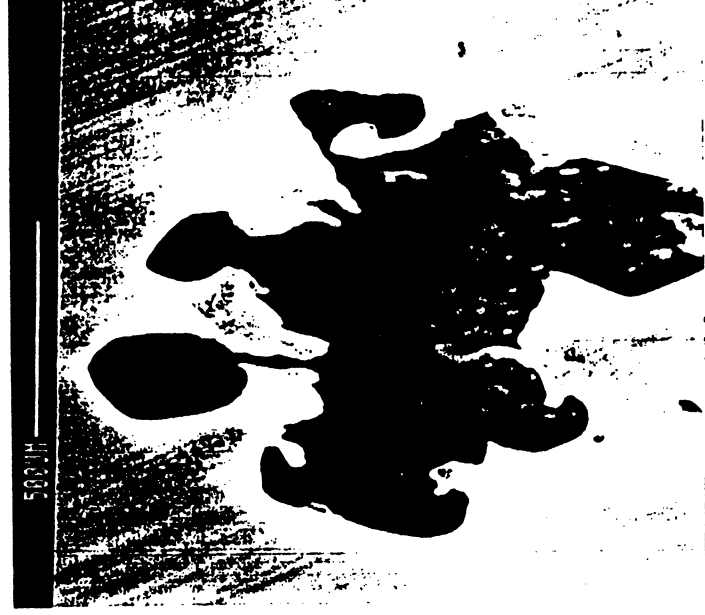
Figure 3-14. Examples of holes in aluminum foil #CR2: holes going in both directions (left); large hole formed by several smaller holes (right).

The aluminum foil sheets, after exposure to the cavitation baths, were marked on the surface by dimples, dents, small and large holes, and crinkling. Figure 3-10 shows examples from sheet A5 of crinkling, which may have been caused by collapsed dents, and dimples which were often arranged in trails. In Figure 3-11 are seen examples of large dents on sheet A1 with small holes in the dents that were formed from both directions. Figure 3-11 also shows a magnified view of a crinkled area on sheet A3. Examples of small and large holes are shown in Figure 3-12. The single hole in the left frame of Figure 3-12 is approximately 320 microns in diameter and was caused by a single event such as a cavitation bubble bursting. The much larger hole in the right frame of Figure 3-12 (3 mm x 5 mm) was formed by the agglomeration of many smaller holes in close proximity with the small holes going in both directions.
