# **Characterization of Damage Accumulation in a C/SiC Composite at Elevated Temperatures**

Jack Telesman, and Mike Verrilli  
NASA Lewis Research Center  
Cleveland, Ohio

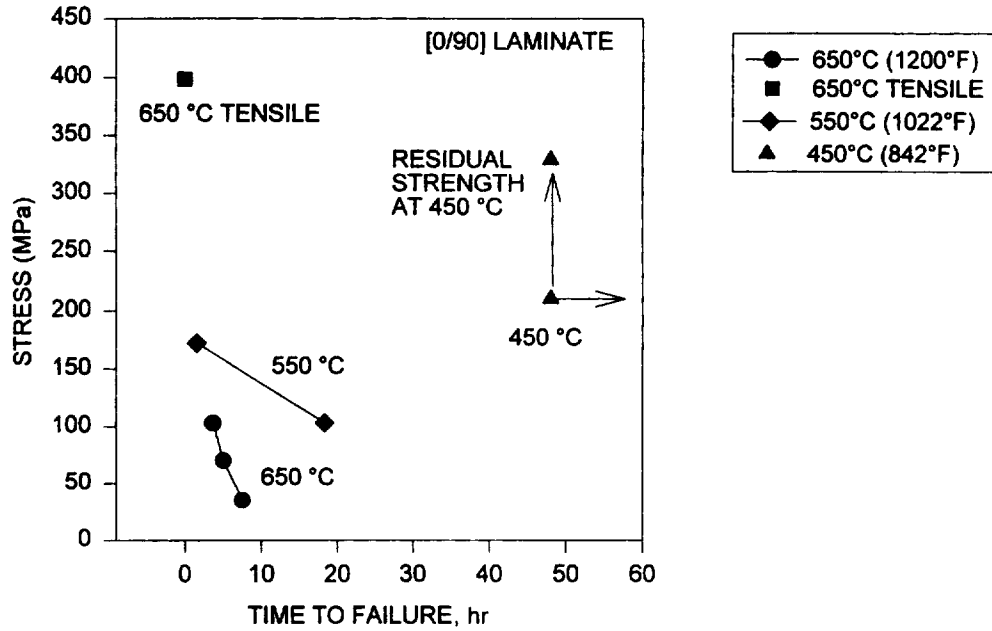
Fig. 5

## STRESS-RUPTURE OF C/SiC CMC AT VARIOUS TEMPERATURES

- STRENGTH OF CMC DEGRADES RAPIDLY ABOVE 550°C
- AT 450°C DEGRADATION IS MINIMAL

The stress-rupture behavior at various elevated temperatures is shown in Figures 4 and 5. The strength of the composite degrades very rapidly for temperatures above 550 °C. At 650 °C and 70 MPa the life is approximately 5hrs. At 450 °C and 200 MPa on the other hand the life is significantly greater than 50 hours and furthermore there is little degradation in the residual strength. The effect of damage accumulation was evident in the stress strain behavior of an interrupted specimen. As shown in Figure 6, a decrease in stiffness occurred very early in life and the degradation continued throughout the test. Similar degradation was observed in the resonant frequency response, Figure 7. At 650 °C the applied load has very little effect on the life, this observation in conjunction with the fact that damage occurs very early in life not only suggests that the environment governs the damage process but also that the presence of inherent cracking hastens the process.

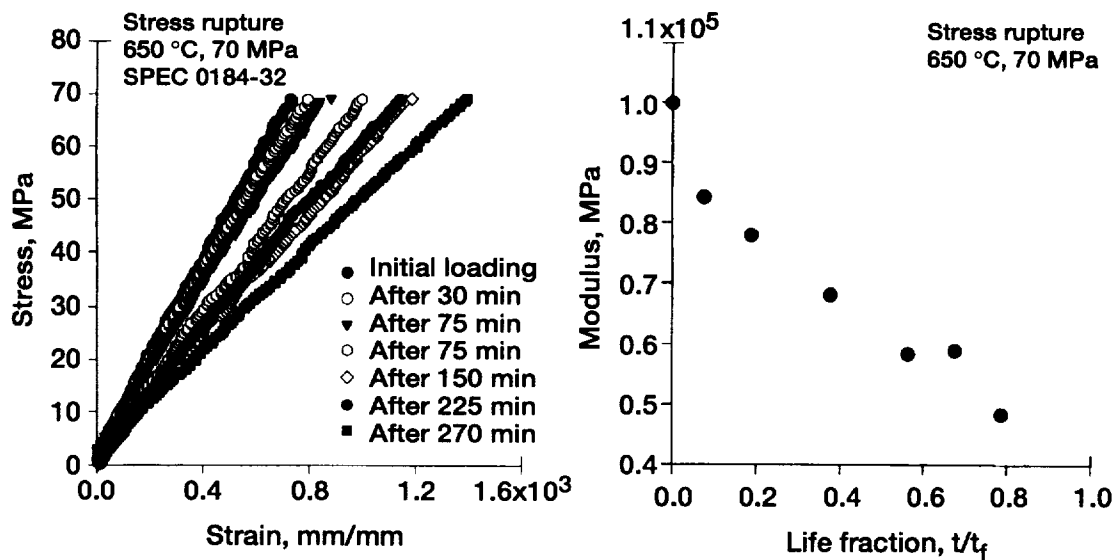
Fig. 6

## STIFFNESS DEGRADATION AS A FUNCTION OF LIFE FRACTION DURING STRESS RUPTURE

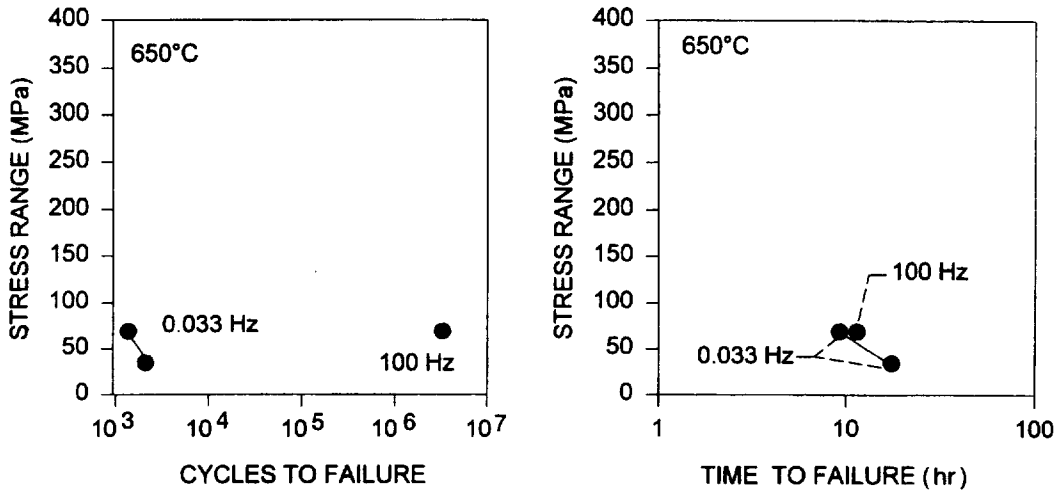
Fig. 9

## EFFECT OF CYCLIC FREQUENCY ON LCF RESULTS

- CYCLIC FAILURE IS GOVERNED BY TIME AT TEMPERATURE
- ENVIRONMENTAL DEGRADATION CONTROLS FAILURE AT 650°C

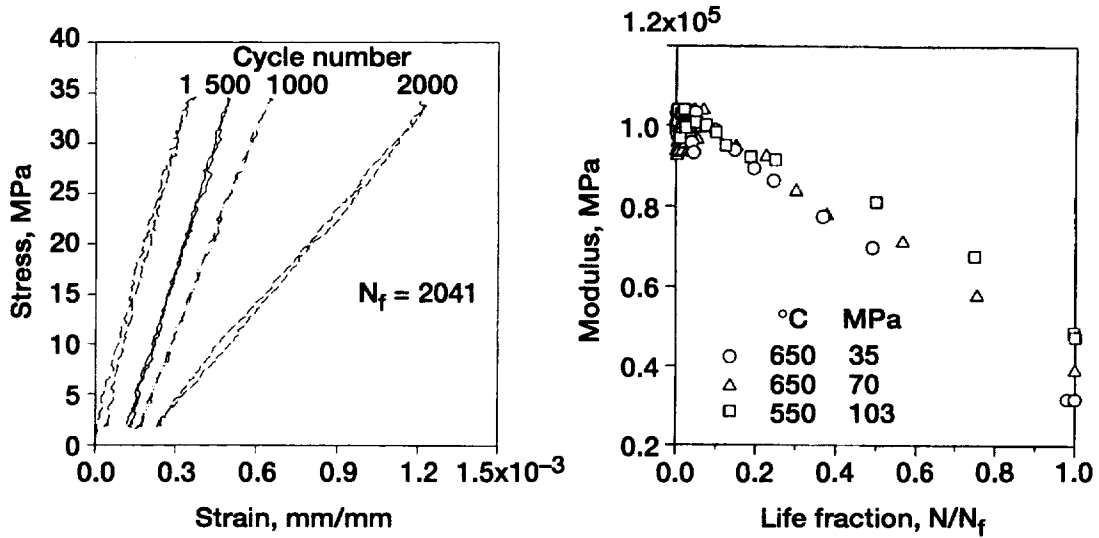
Fig. 10

## STIFFNESS DEGRADATION AS A FUNCTION OF LIFE FRACTION DURING LOW CYCLE FATIGUE

PHENOMENA COULD BE BASIS FOR LIFE PREDICTION MODEL

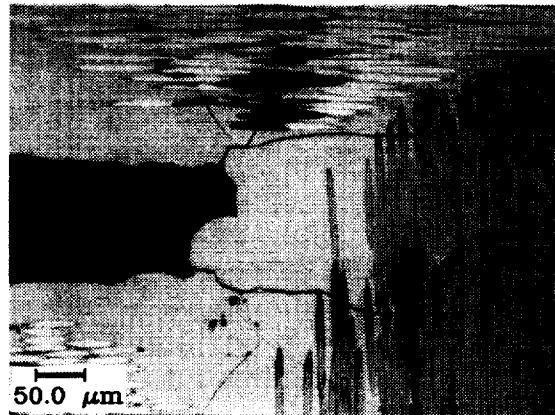
Fig. 13

# ENVIRONMENTAL DAMAGE AT 650 °C

AS-FABRICATED CONDITION

TESTED AT 650 °C, 70 MPa

CRACKS INITIALLY ARE BRIDGED BY THE FIBERS

EXPOSURE AT 650 °C RESULTS IN FIBER OXIDATION AND LOSS OF BRIDGING

This became evident upon inspection of the metallographic sections obtained from the interrupted specimens. As seen in Figure 12, fibers near the surface are being destroyed by the oxidizing environment which enters the specimen by the myriad of inherent cracks, Figure 13. This phenomenon is also apparent on the fracture surface of the stress rupture specimens, Figure 14, where for the most part the C fibers are missing and seem to have been consumed. The carbon fibers on the tensile specimens, on the other hand, are intact. Also evident from the interrupted tests is a progression of damage. The specimen interrupted at 50% of the life show the most extensive damage while the specimen interrupted at 10% of life exhibits the least amount of damage. The fact that damage appears at a very early stage in
