The X-33 Program Update

Charlie Dill, X-33 Assistant Program Manager

**ST Day 2000:
Risk Reduction
for the
Next Generations**

Oct. 11 - 12, 2000

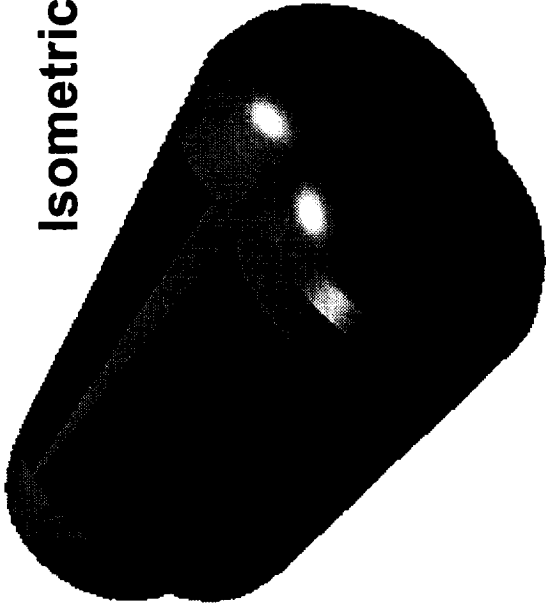
Isometric View

X-33 Elements

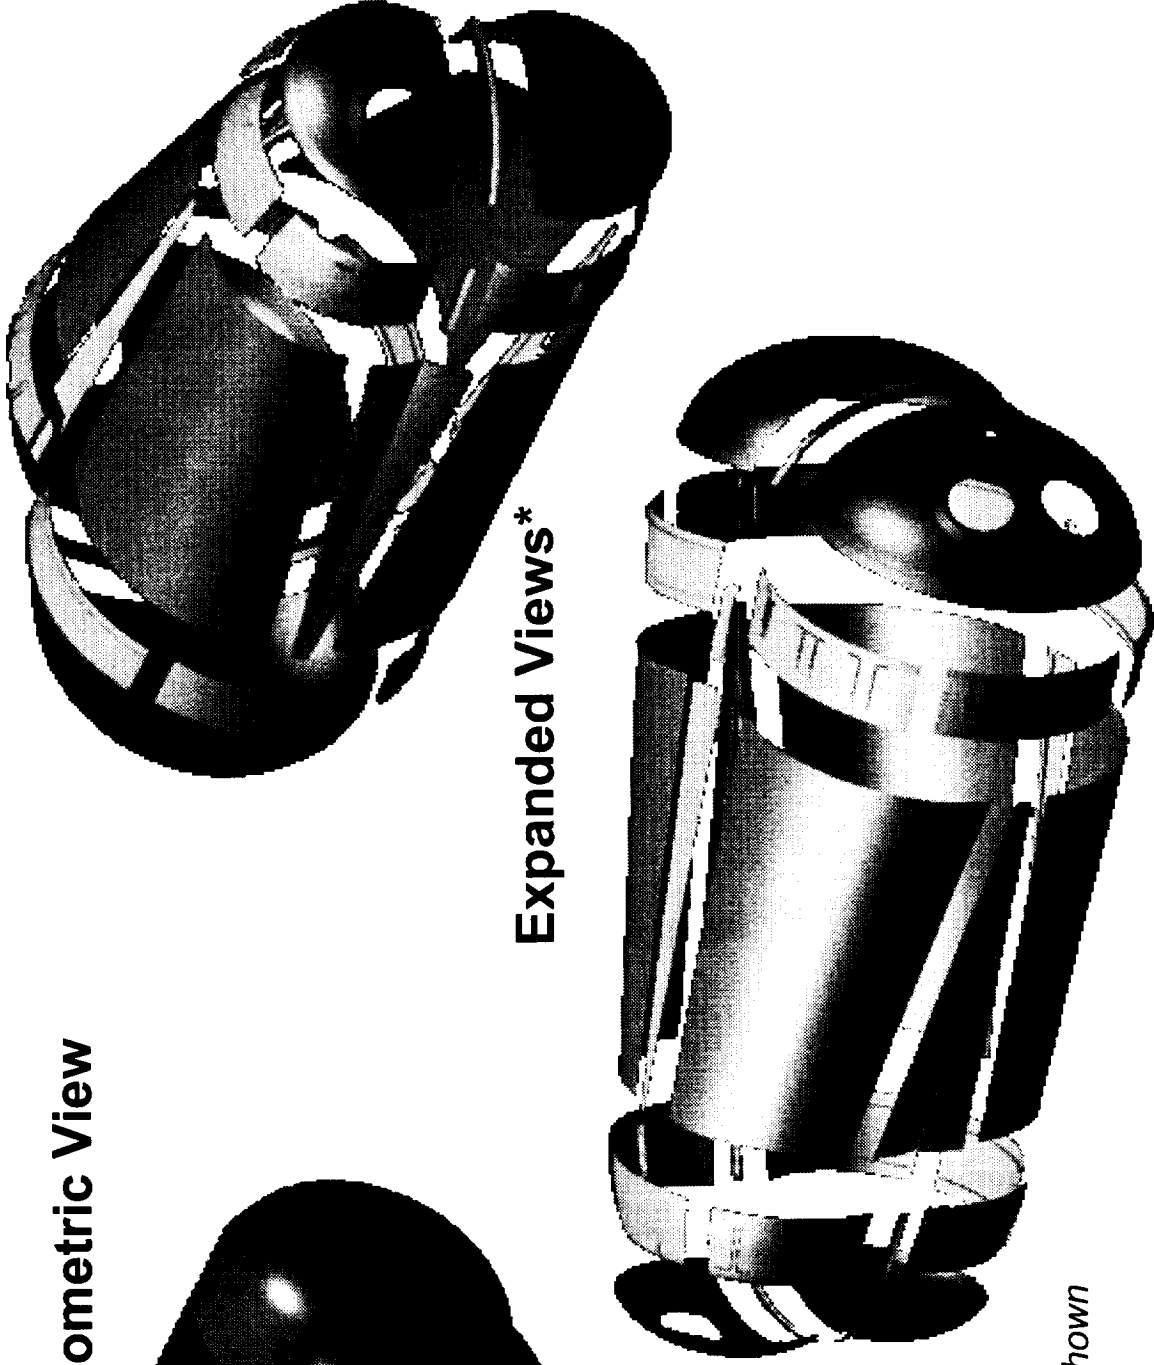
Expanded Views*

**Internal Septums Not Shown*

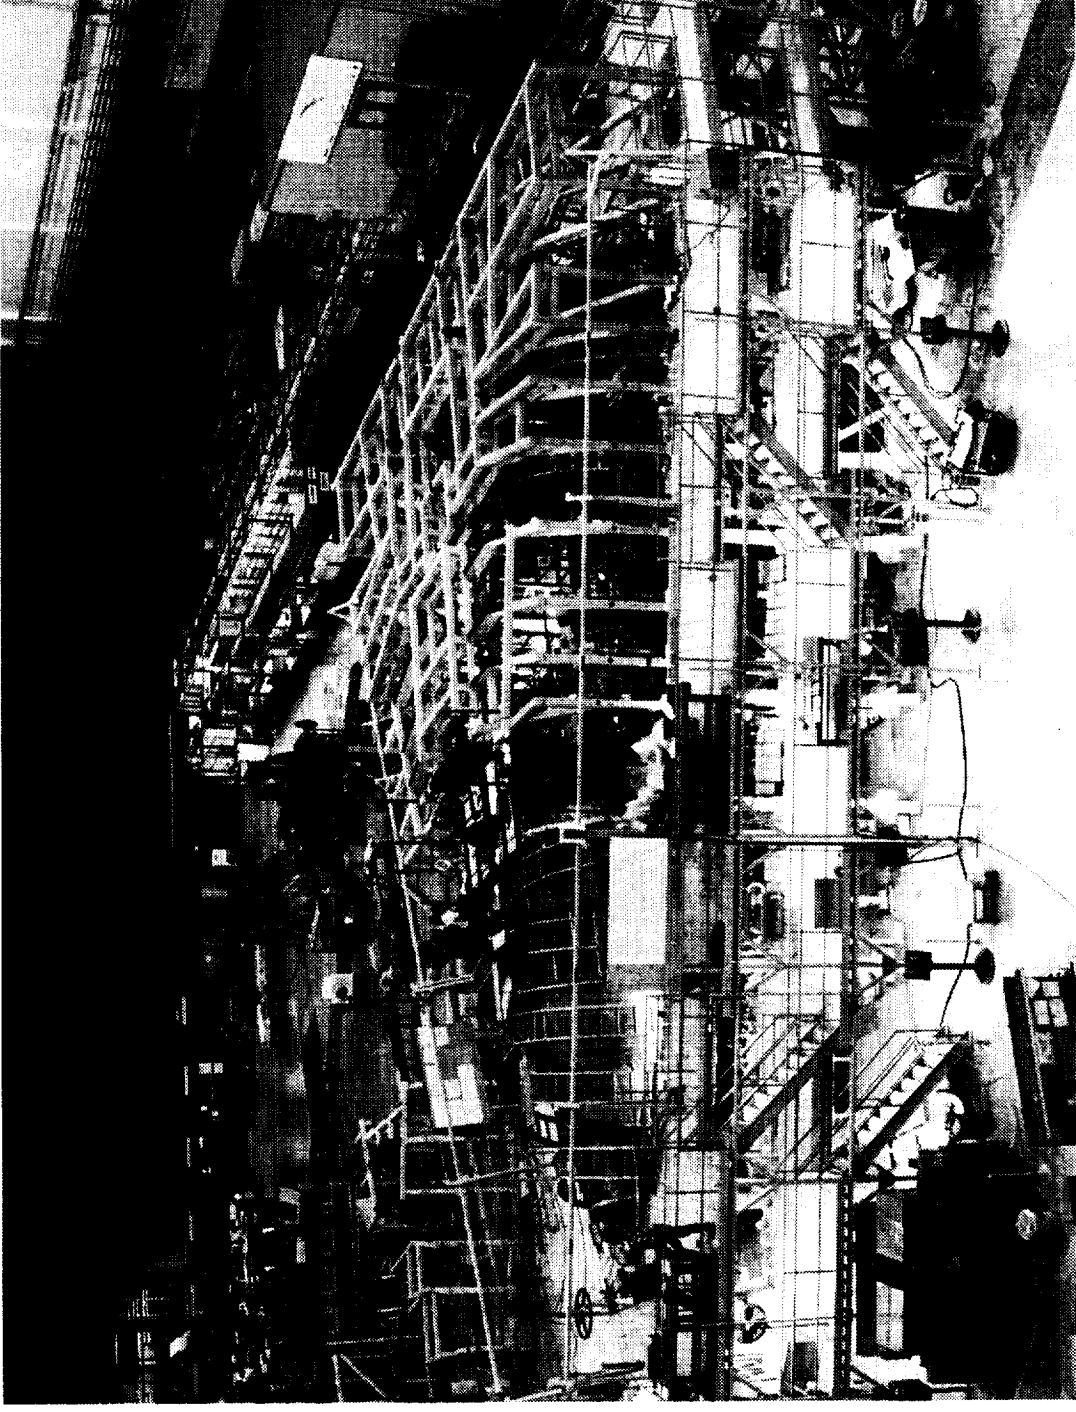
Crews Wiring X-33's Avionics Bay Within Primary Assembly Structure

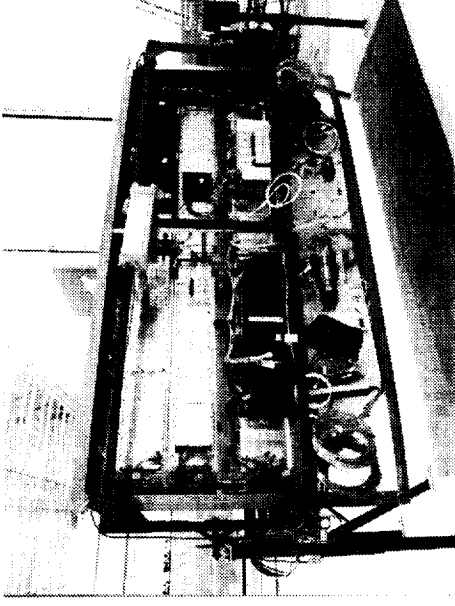
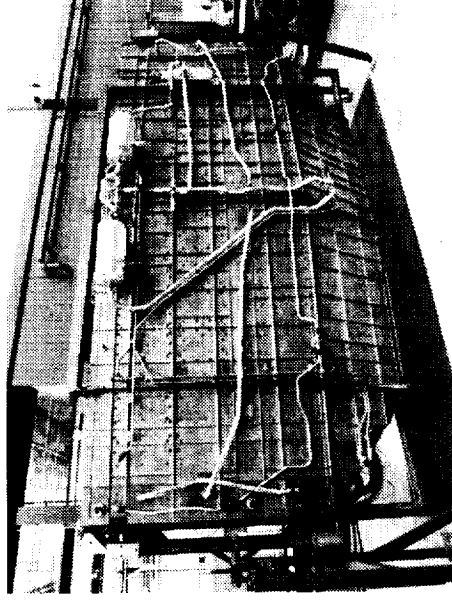
**RCS Auxiliary Propellant Tank and
Control Valve Pallets**

Avionics Bay

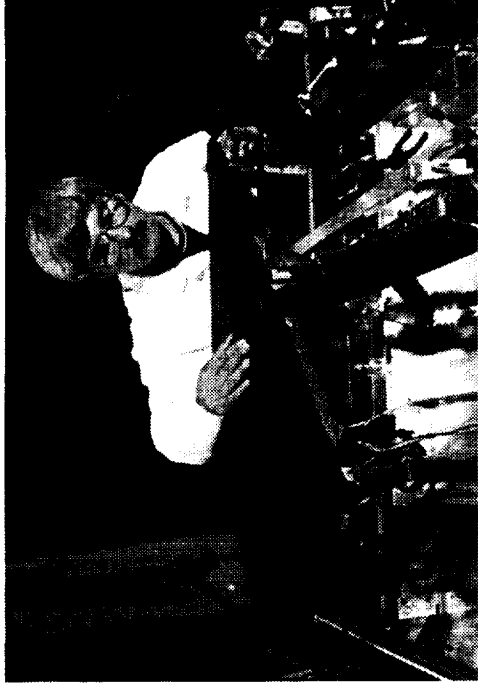
Upper Surface TPS AFRSI/FRSI Blankets

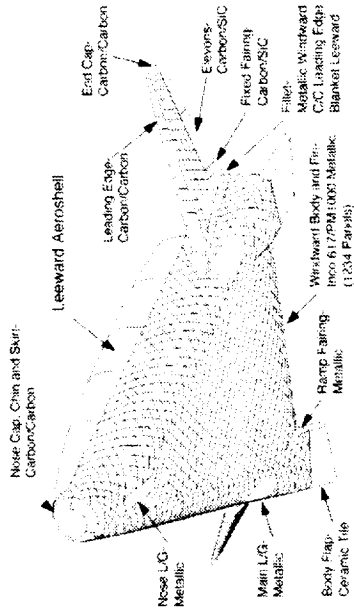
Metallic TPS Panel Layout

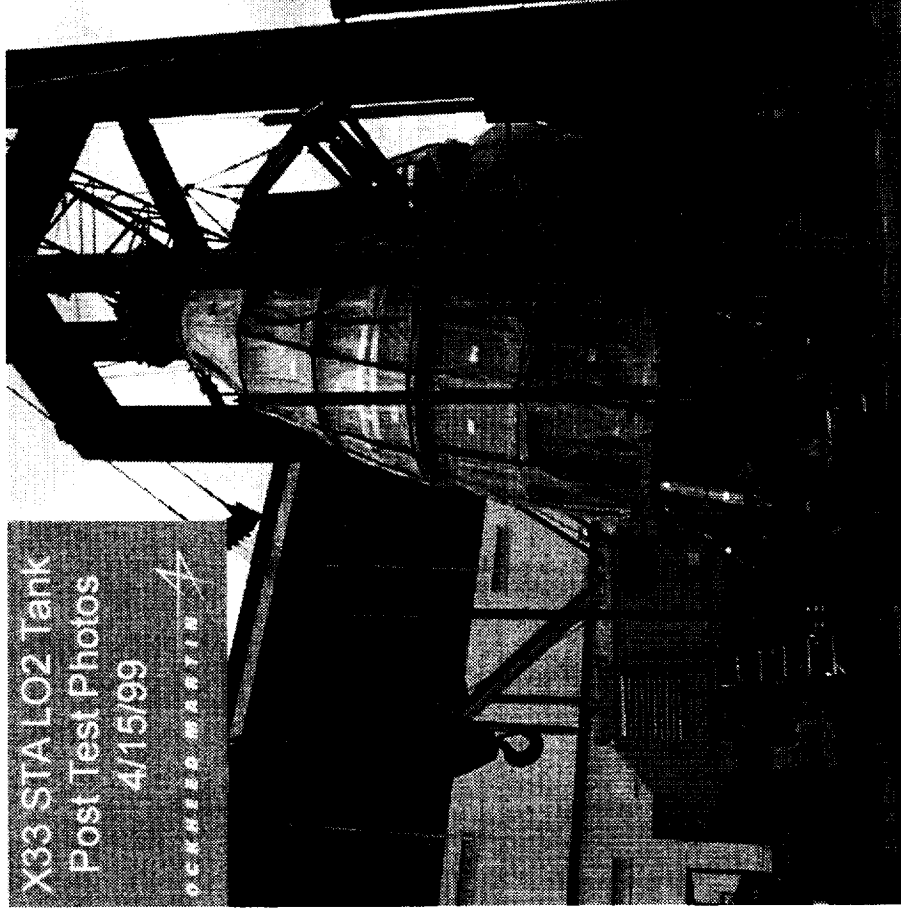
LO₂ Tank Testing at MSFC

- ◆ Test Conducted on Structural Test Article (STA) - Identical to X-33 Flight Tank
- ◆ Successfully Completed LO₂ Flight Tank Structural Verification
- ◆ STA Tank currently at Glenn Research Center for Propellant Densification Tests

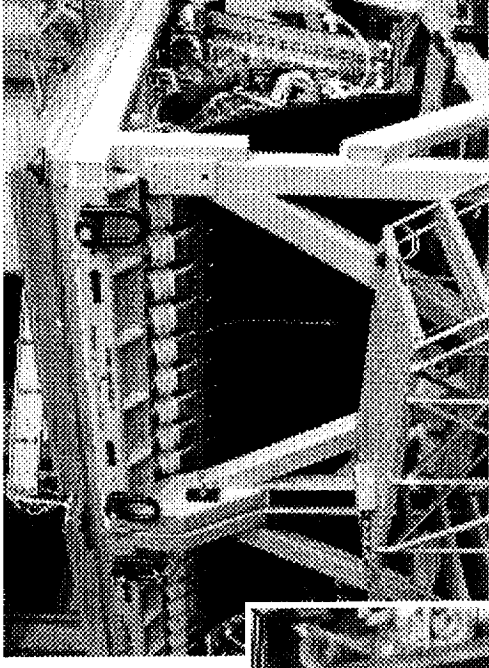
Aerospike Engine, XRS-2200

Single Engine

- ◆ Unprecedented Success With Extensive Test Program
 - Single Thruster: 13 Tests, 985 Seconds
 - Multi Cell: 10 Tests, 49 Seconds
 - Powerpack: 17 Tests, 1506 Seconds
 - Single Engine: 14 Tests, 1563 Seconds
- ◆ No Test Cutoffs Due to Hardware Malfunction
- ◆ Achieved Full Power Level on 6th Test
- ◆ Dual Engine Testing to Begin in October(Flt. Engines)

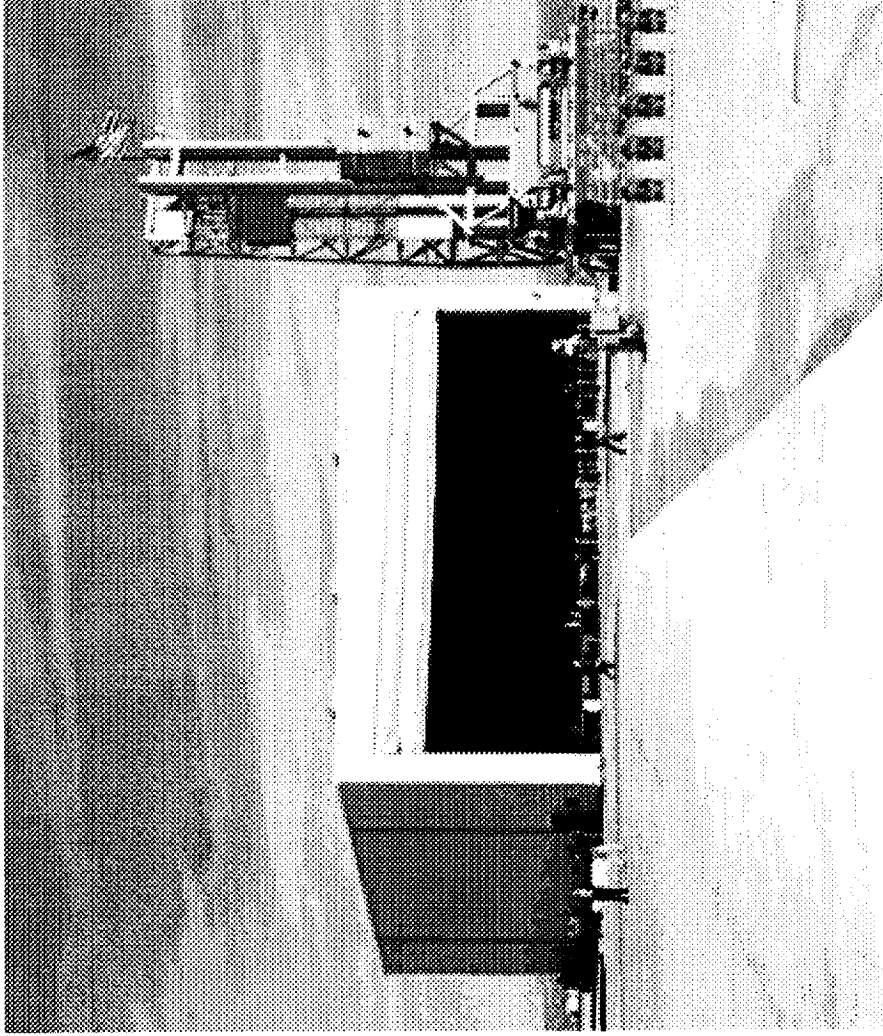
**Translating Shelter and Strong Back with
Weight Simulator**
