Genesis Field Recovery. K.M. McNamara and Genesis Contingency Team, NASA - Johnson Space Center, Houston, TX 77058; karen.m.mcnamara@nasa.gov.

Introduction: The Genesis mission returned to Earth on September 8, 2004 after a nearly flawless three-year mission to collect solar matter. The intent was to deploy a drogue chute and parafoil high over the Utah desert and to catch the fragile payload capsule in mid-air by helicopter. The capsule would then be opened in a cleanroom constructed for that purpose at UTTR, and a nitrogen purge was to be installed before transporting the science canister to JSC. Unfortunately, both chutes failed to deploy, causing the capsule to fall to the desert floor at a speed of nearly 200 MPH. Still, Genesis represents a milestone in the US space program, comprising the first sample return since the Apollo Missions as well as the first return of materials exposed to the space environment outside of low Earth orbit and beyond the Earth's magnetosphere for an extended period. We have no other comparable materials in all of our collections on Earth.

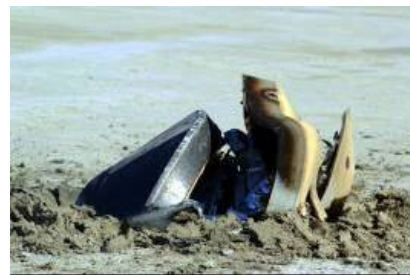
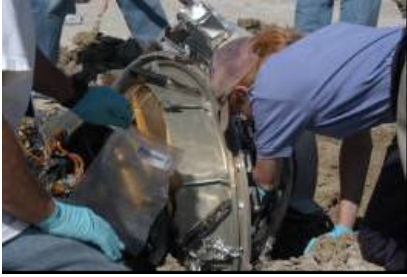
An initial assessment revealed that there were unfired ordnance on the spacecraft. After thorough documentation of the landed condition of the spacecraft, technicians worked quickly to secure and remove the ordnance. That approximately 50% of the capsule was imbedded in the moist Utah soil (the area received substantial rain the week before) made the extraction of these devices as well as the payload an even greater challenge. (Figure 2)

Figure 2. The as-landed condition of the spacecraft before securing the unfired ordnance and the half buried science payload canister. Team members are removing loose collectors.

The second image above shows the payload canister after the exposed portions of the heatshield and backshell were (separated) in the field. Although the crushed portions of the backshell were later removed from underneath the canister cover, the heatshield material on the impact side of the spacecraft absorbed much of the energy of impact and was reduced to little more than carbon fibers and powder. This carbon material is a source of contamination concern for the subsequent analysis of Genesis materials. It is also important to notice that the base of the science canister had sheared completely from the side walls, leaving no choice but to remove the canister upside down in order to contain as many collector fragments as possible in the nearly intact lid.

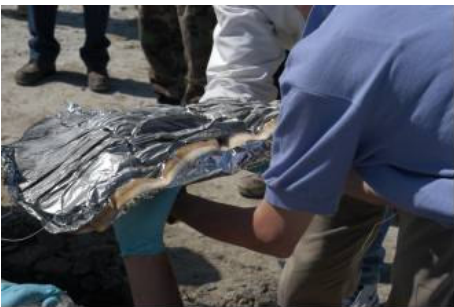
Collector Recovery: Both the sample return capsule and the science canister were breached on impact. The force of the impact caused the molybdenum lid foils in the SRC to come loose from their attach points, crumpling to resemble a flattened pancake which had to be cut in order to remove them from beneath the canister lid. The nine annular foil pieces were completely detached from their thermal blankets and were recovered throughout the spacecraft.

Figure 3. The molybdenum-coated foils are removed from the SRC lid in the field at UTTR.

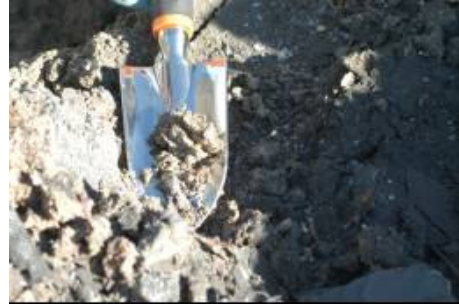
The collector arrays suffered most severely from the impact. Although several large collector fragments were recovered in the field (Figure 2) and later from the canister in the cleanroom, the majority of the collectors were broken into multiple fragments (many < 5 mm x 5 mm). A limited number of these fragments remained attached to the array frame and thus could be identified unambiguously. The majority of smaller fragments were contained in the canister lid by inverting it the canister in the field. These were transported to the cleanroom where they could be recovered and documented. After removal of the canister from the site, contin-

gency team members spent two days searching the soil below, using tweezers and trowels to retrieve hundreds to thousands of collector fragments. (Figure 4) Every effort was made to catalog the field location of collector fragments. Detailed conditions and photos of individual collector materials are discussed elsewhere [2].

Figure 4. Hundreds of collector fragments were retrieved from the UTTR soil below the impact site.
