# **NASA Shuttle Orbiter Reinforced Carbon Carbon (RCC) Crack Repair Arc-Jet Testing**

Presented by:  
ShawnDella Clark  
Prairie View A&M University  
to

ASME District E Student Professional Development Conference

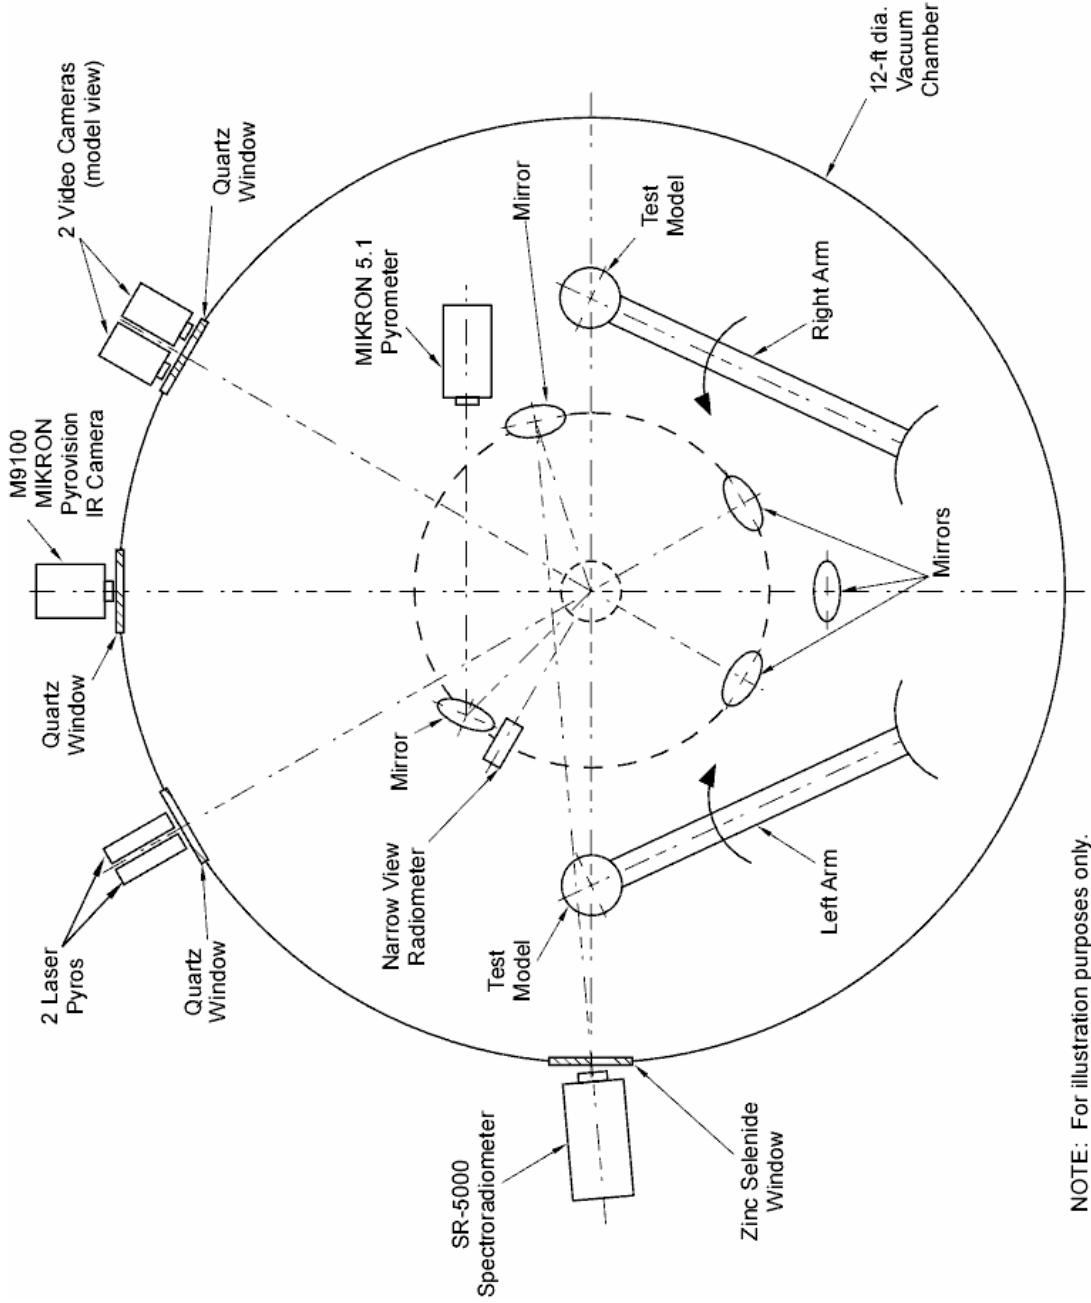
# Test Set-up for TP2

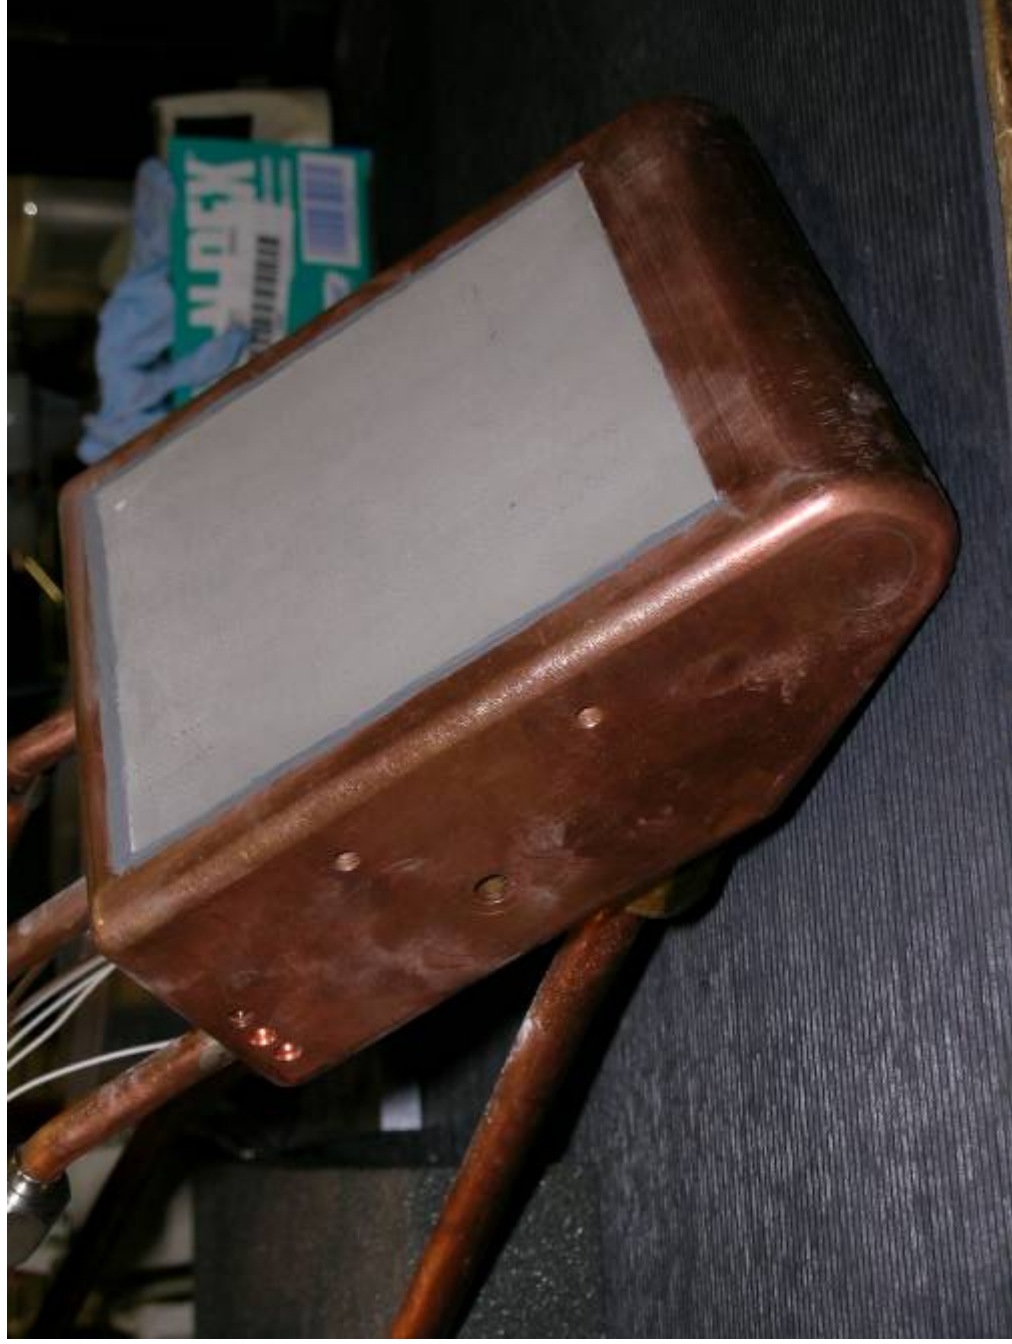
# RCC Calibration Model in Wedge Holder Before Testing

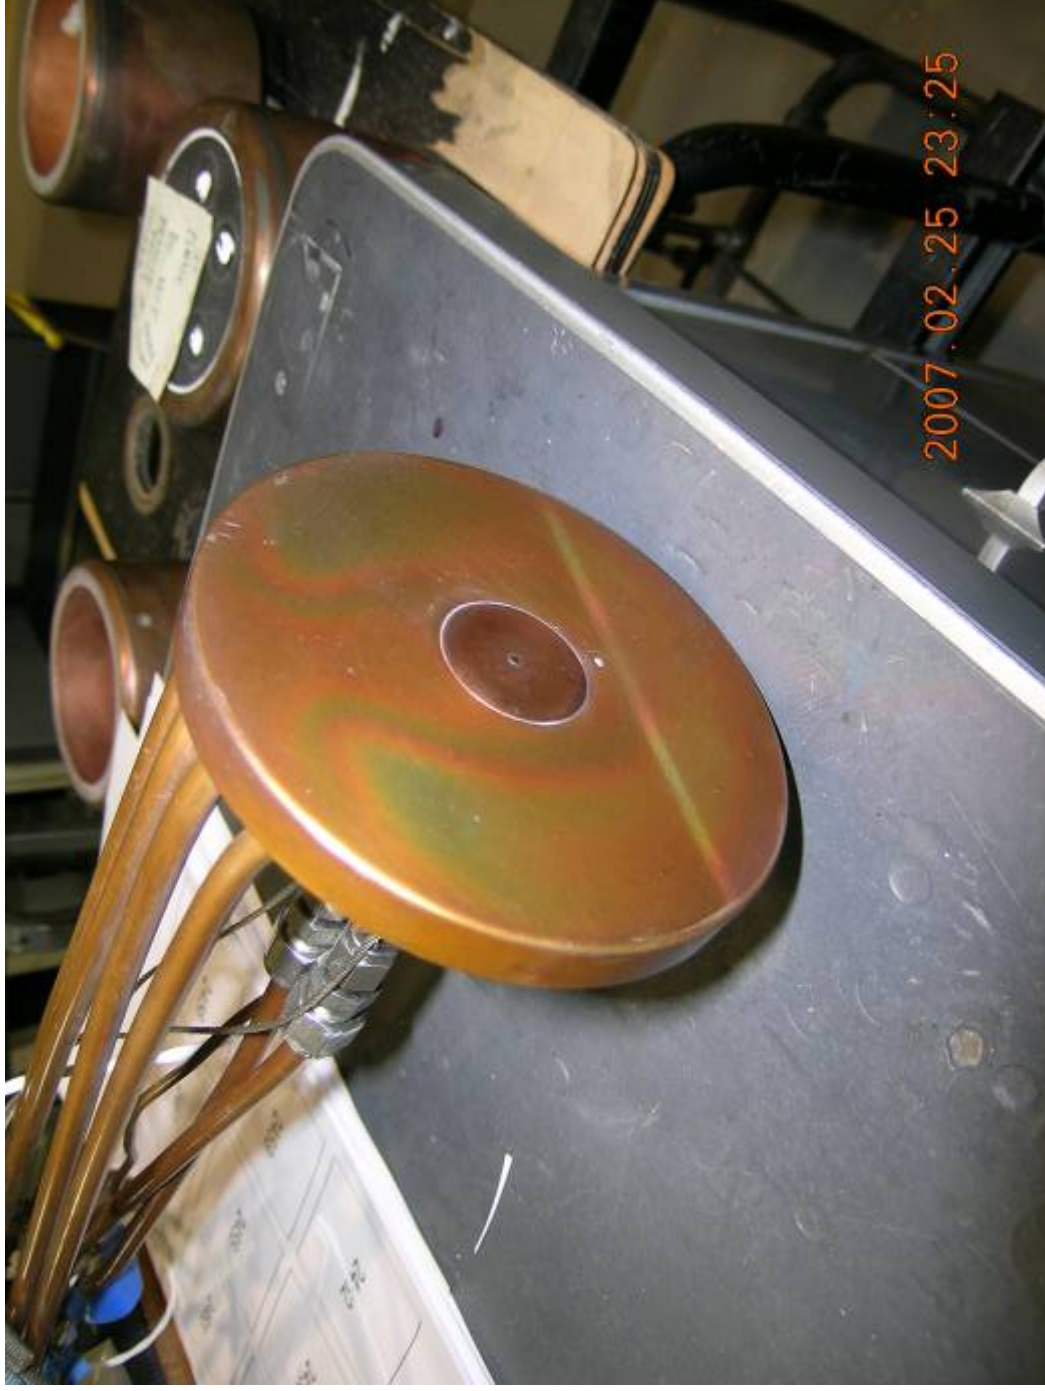
# Dual-Cal Probe to Measure Stagnation Heat Rate and Pressure

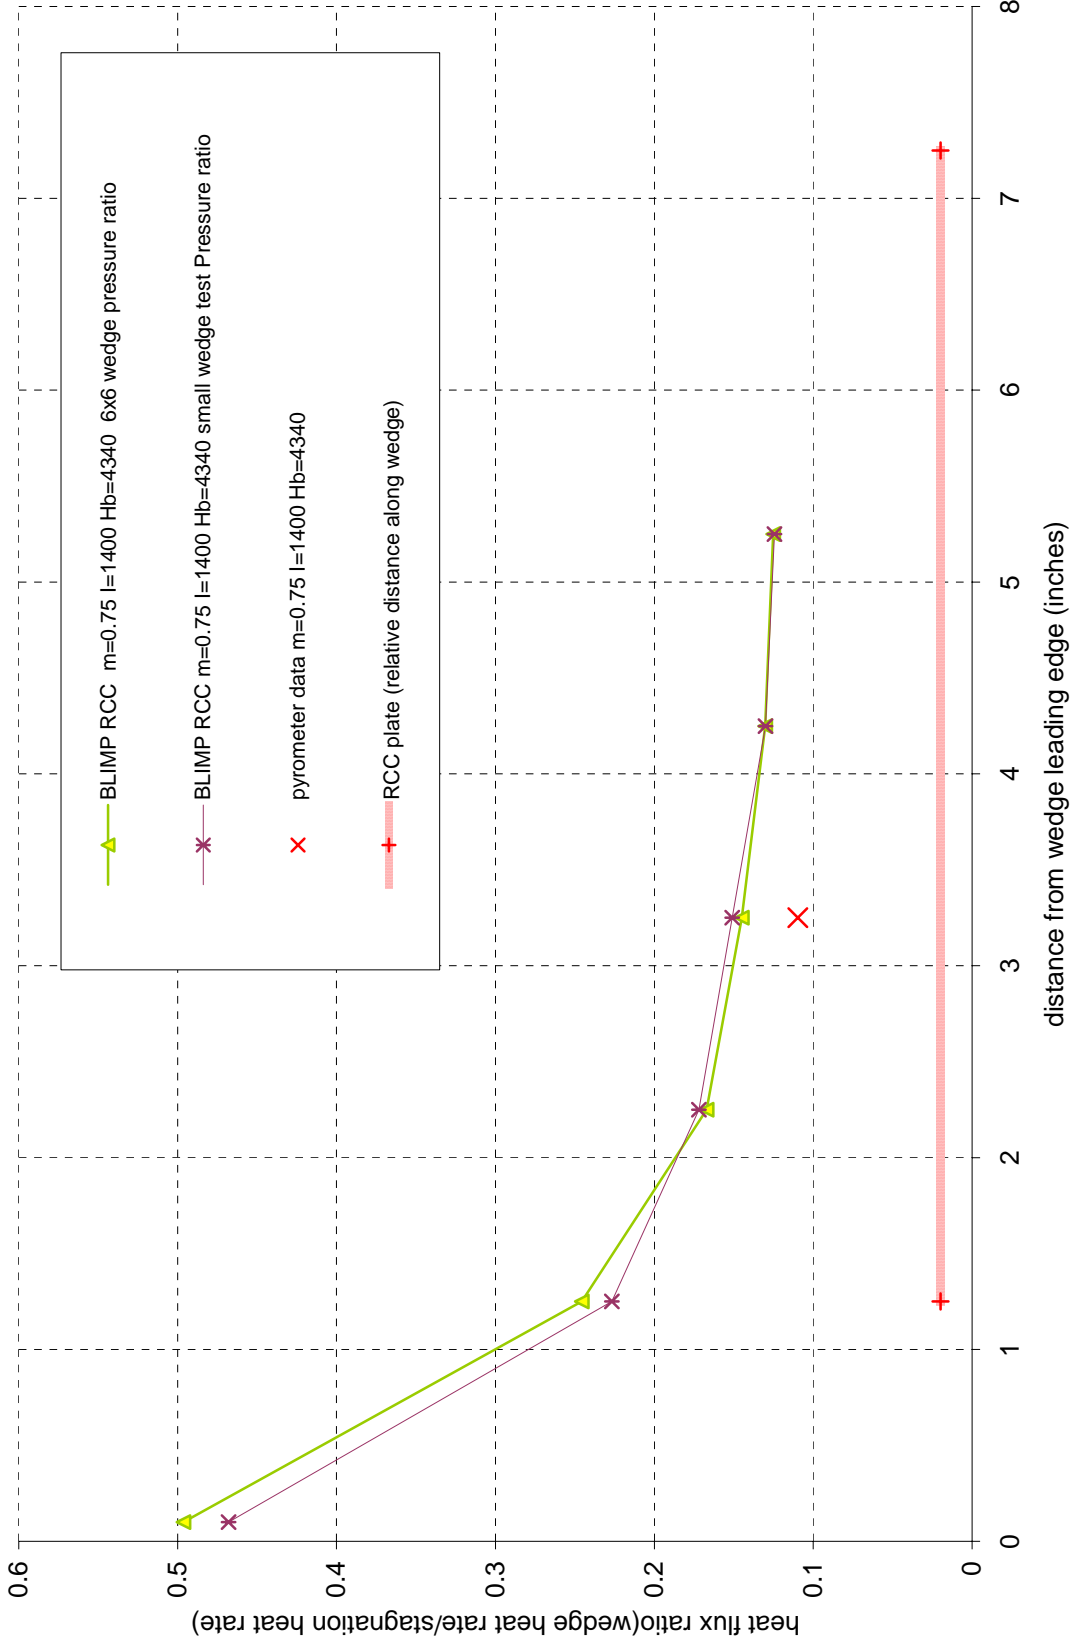
# Heat Flux Ratio vs. Distance on Wedge

- Boundary Layer Integral Matrix Procedure - Kinetic (BLIMPK) code used
- BLIMPK calculates surface heating rates and shear stresses, plus other properties across boundary layer
- Chemical non-equilibrium around wedge with  $\frac{3}{4}$ " wedge leading edge radius
- Required inputs to BLIMPK code:
  - Stagnation enthalpy, based on measured stagnation pressure and heating rate (Hiester-Clark relation)
  - Measured pressure ratio distribution along wedge
  - Measured stagnation pressure
  - Surface emissivity of 0.89
