Apollo Seals: A Basis for the Crew Exploration Vehicle Seals

Joshua R. Finkbeiner,¹ Patrick H. Dunlap, Jr.,² and Bruce M. Steinetz³
NASA Glenn Research Center, Cleveland, OH 44135

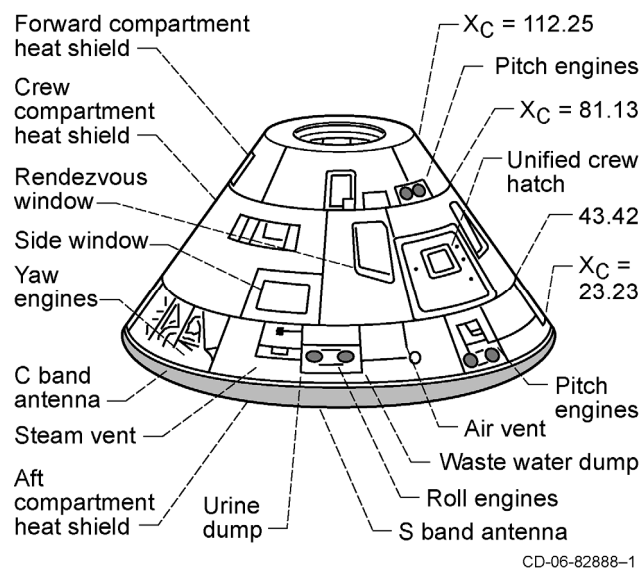
Fig. 1. Apollo Block II command module.⁵

The mission of the Apollo spacecraft was to carry three astronauts to lunar orbit, support a manned excursion to the lunar surface by two of the astronauts, and return the three astronauts safely to Earth. The Apollo capsule was also used for missions to LEO, initially for system testing in preparation for the lunar missions and later for missions to the Skylab space station and for the cooperative Apollo/Soyuz mission with the Soviet Union. The spacecraft was composed of two separate modules: the command module (CM) which housed the crew and served as a reentry vehicle for return to Earth and the service module (SM) which housed the SM propulsion system and provided logistics such as oxygen and electrical power. A third module, the lunar module (LM), was designed to carry two astronauts to the lunar surface and was used for Apollo missions starting with Apollo 9 and ending with Apollo 17 (a LM was also flown unmanned during Apollo 5). Figure 1 shows a schematic diagram of the Apollo command module, and Ref. 2 provides a general overview of the Apollo mission profile and the three modules of the Apollo spacecraft. Reference 3 used modern computer aided design (CAD) software to create a detailed engineering model of the Apollo command and service modules and shows how the intricate systems of the spacecraft were assembled. The CM capsule was a 33° half-angle cone with the blunt aft heat shield formed from a segment of a sphere of radius 469.4 cm (184.8 in). A toroidal section with radius of 19 cm (7.7 in.) provided the transition between the conical and spherical sections. The maximum capsule diameter of 391 cm (154 in.) occurred in the toroidal section.

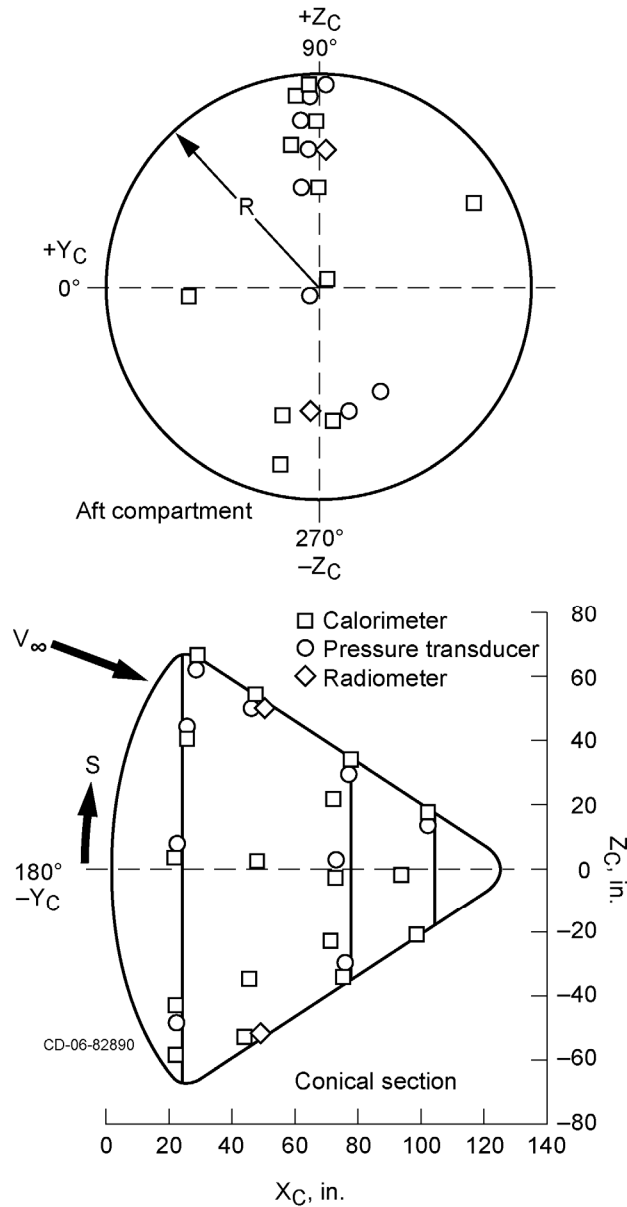
Fig. 2. Apollo spacecraft orientation and measurement locations for Apollo 4 and 6. Orbital entry missions AS-201 and AS-202 were configured similarly.⁴

The coordinate system used to describe locations on the Apollo CM is shown in Fig. 2. The figure also presents locations of pressure sensors and calorimeters to quantify the capsule reentry environment during initial orbital test flights. Figure 3 shows a diagram of the hypersonic flowfield surrounding the Apollo spacecraft during reentry including the stagnation region on the aft heat shield as well as the attached (windward) and separated (leeward) flow regions on the conical portion of the capsule. The 90° angular coordinate location in Fig. 2 corresponds to the windward side of the capsule while the 270° angular location corresponds to the leeward side.

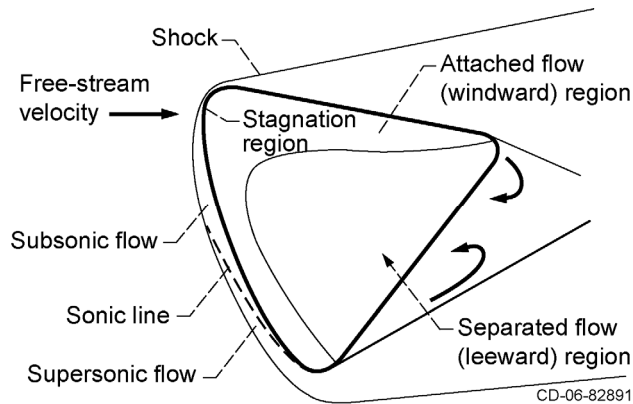
Fig. 3. Description of hypersonic flowfield surrounding Apollo command module during reentry.⁷

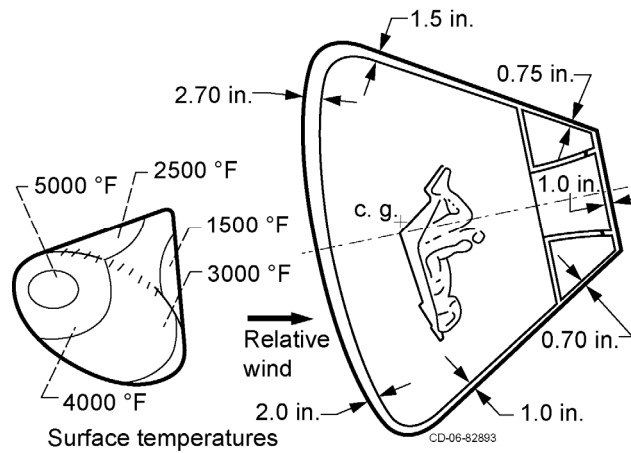
Fig. 5. Command Module heat shield temperature distribution and corresponding ablator thickness.⁹

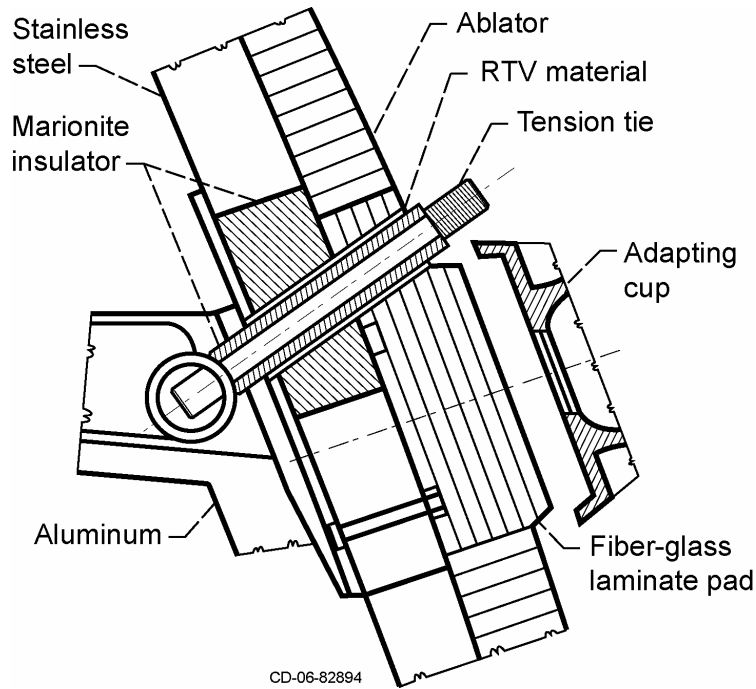
Fig. 6. Sectional view of shear pad and tension tie bolt used to transfer loads from Service Module to Command Module.⁵

The aft heat shield contained several types of penetrations to allow for attachment of the command module to the service module. Six high-density fiberglass-laminate pads were installed near the outer circumference of the aft heat shield to transfer compressive loads between the service and command modules. Three of the six pads were additionally designed to transfer shear loads and were also accompanied by steel tension tie bolts which passed through the ablative heat shield and were fastened to the command module's aluminum substructure. A section view of a compression pad with an accompanying tension tie bolt is shown in Fig. 6. The outer circumference of a tension tie bolt was sealed with RTV to prevent ingestion of high enthalpy reentry gases, and a layer of Marionite insulation prevented excessive thermal conduction from the tension tie bolt to the surrounding stainless steel substructure. Prior to reentry, explosive charges were used to break the tension tie bolts and separate the service module from the command module.¹¹ During reentry, the exposed tips of the tension tie bolts melted flush with the surrounding fiberglass pads while the temperature measurements at the bases of the bolts showed no significant responses.⁵ One of the compression pads can be seen on the Apollo 11 command module shown in Fig. 7, although it appears that the

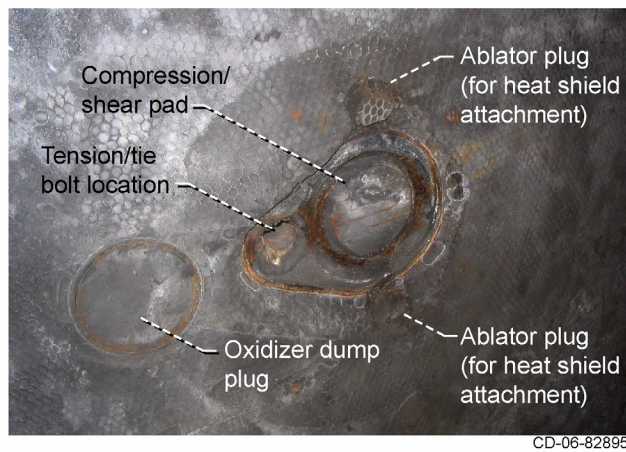
Fig. 7. Photograph of Apollo 11 heat shield penetrations for attachment of command module to service module.

molten tension tie bolt was removed after recovery of the vehicle as part of the post-mission inspection of the heat shield.

In addition to the fiberglass compression pad and the tension tie bolt location, Fig. 7 also shows the locations of two ablator plugs used to protect the mechanical fasteners attaching the aft heat shield to the command module

Figure 7 shows the plug covering the oxidizer dump port on the Apollo 11 command module, and Fig. 10 shows the plug covering the fuel dump port on the Apollo/Skylab 3 command module. The gaps introduced into the aft heat shield by these plugs were sealed with high temperature GE RTV 560¹². During an abort within the first 42 seconds after liftoff, the oxidizer and fuel dump plugs would be jettisoned using small pyrotechnic charges.¹¹ The RCS monomethylhydrazine fuel and nitrogen tetroxide oxidizer would then be dumped through the ports to ensure that they would not pose a fire or chemical hazard to the astronauts and recovery crews.^{13,14} Note that the seals shown in the two figures show strong evidence of ablative mass loss at their outer surfaces.

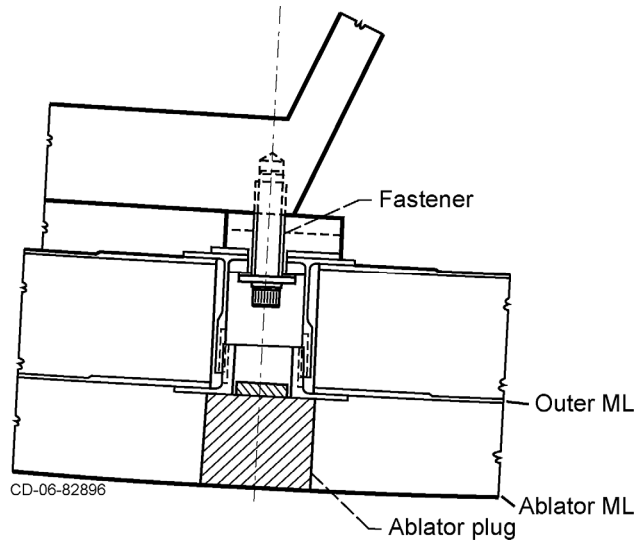
Fig. 8. Mechanical attachment of heat shield to substructure with protective ablator plug (from Apollo drawing V36-320000).

structure. A section view of the ablator plug and mechanical fastener is shown in Fig. 8. The outer circumference of the ablator plug does not appear to have been sealed because of the close tolerance between the access hole and the ablator plug as well as the minimal flow rate through the circumferential gap due to flow stagnation at the base of the hole. Figure 9, a photograph of an ablator plug location on the Apollo/Skylab 3 command module, shows no evidence of a seal or seal material around the circumference of the hole. The location in the photograph appears to be oversized from the drawing and may represent post-mission destructive removal of the ablator plug.

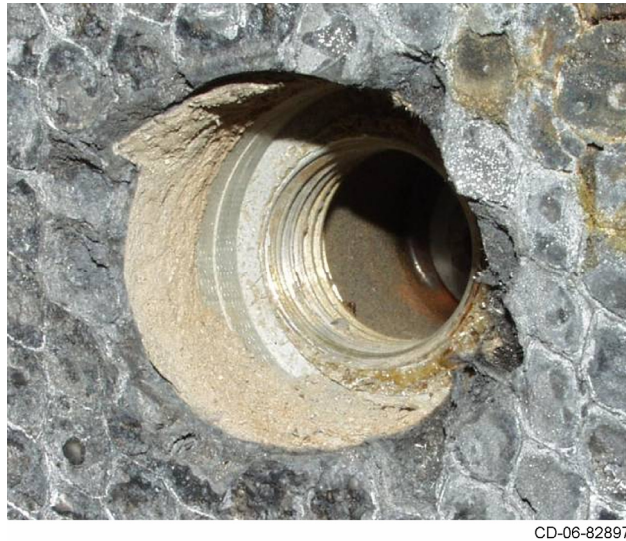
Fig. 9. Photograph of ablator plug hole on Apollo/Skylab 3 aft heat shield.

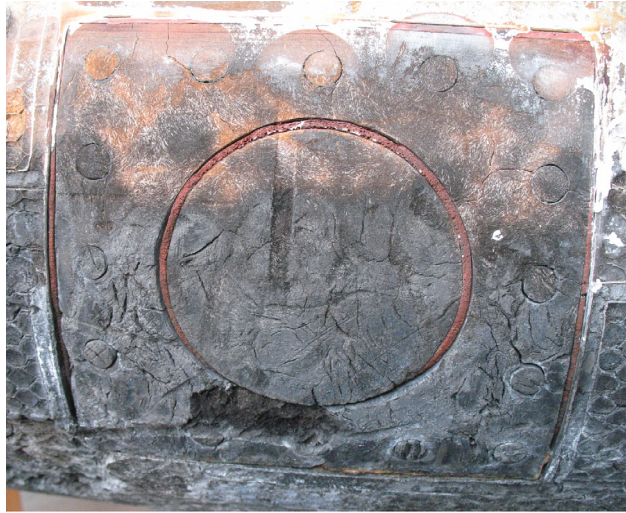
Fig. 10. Photograph of RCS fuel dump plug on Apollo/Skylab 3 command module.

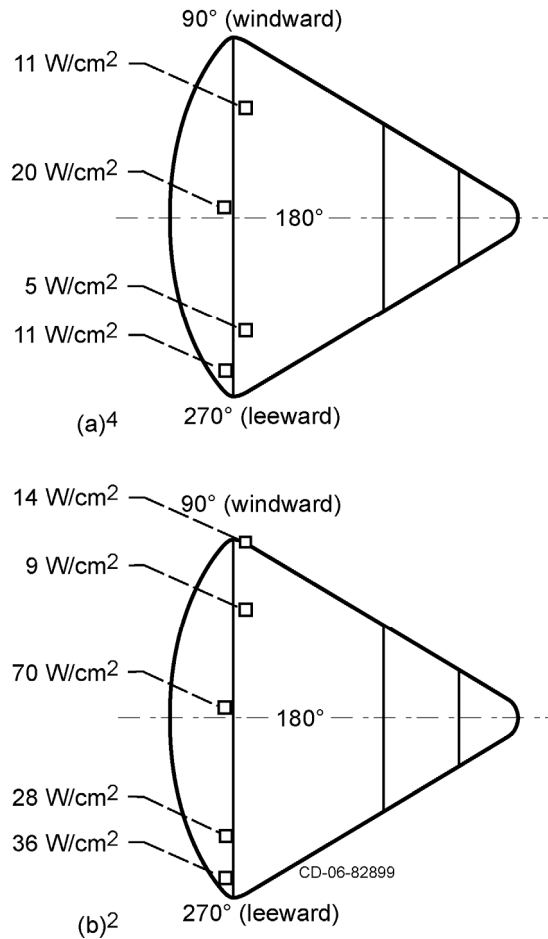
Fig. 11. Heat flux measurements near the aft heat shield-to-crew compartment heat shield interface gap from the (a) AS-201 orbital mission, and (b) Apollo 4 superorbital mission.

The aft heat shield-to-crew compartment heat shield interface gap was located in a region of high heat flux gradient both in the axial direction and around the circumference of the capsule. Figure 11 shows two schematic diagrams of the Apollo capsules with heat flux measurements shown near the aft heat shield-to-crew compartment heat shield interface gap. Heat flux data from the unmanned orbital test flight AS-201 are shown in Fig. 11(a), and heat flux data from the unmanned superorbital test flight Apollo 4 are shown in Fig. 11(b). Heat flux measurements upstream of the interface gap (i.e., on the aft heat shield) were much higher than those downstream of the gap. This demonstrates the high gradient in the axial direction. In addition, the heat fluxes were larger on the windward side of the vehicle (i.e., 90°) than the leeward side of the vehicle (270°) for the same axial locations. While this is only partially clear from the selected heat flux measurements shown in this paper, the broad range of heat flux data

presented in Refs. 4 and 6 fully demonstrate the dependence of the heat flux on the angular position. Another interesting fact is that the heat flux at the 138° location on the AS-201 vehicle (11 W/cm^2) was higher than the heat flux at the identical location on Apollo 4 (9 W/cm^2). This illustrates the general trend observed during the Apollo test flights^{4,6,7} whereby the heat flux to the conical section of the Apollo 4 capsule was lower than that of the orbital test flights. This was attributed to the increased rate of growth of the capsule boundary layer caused by increased ablative mass injection rate from the aft heat shield during superorbital reentry.^{4,7}

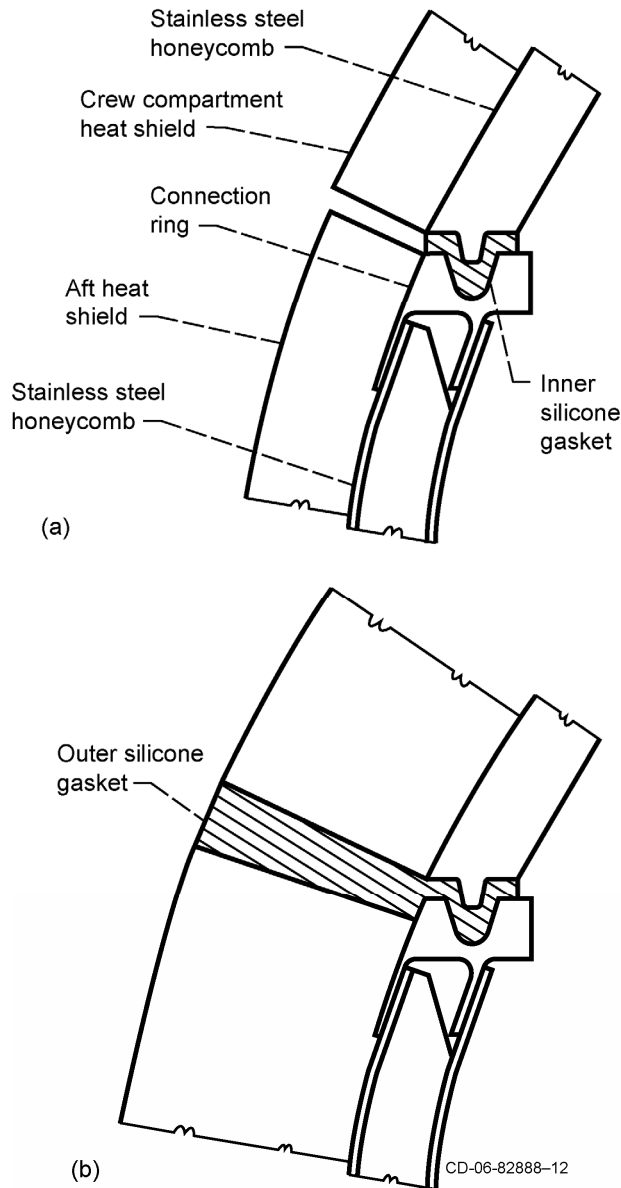
Fig. 12. Section drawings of silicone gasket used in Apollo heat shield-to-crew compartment heat shield interface gap (from Apollo drawings V16-320000 and V36-320000).

The interface gap between the aft heat shield and crew compartment heat shield was sealed with two elastomer gaskets as shown in Fig. 12. The inner gasket (Fig. 12a) was formed first and sealed the gap between the upper stainless steel honeycomb structure and the adjoining lower connection ring. Versilube G-300 (a release agent) was first applied to the crew compartment stainless steel honeycomb surface. The aft heat shield and crew compartment

The primary difference in shape between the inner and outer gaskets was that the inner gasket sealed around a “V”-shaped tooth which was machined into the crew compartment heat shield stainless steel honeycomb. This tooth served two functions. First, it provided a means of aligning the aft heat shield to the rest of the vehicle prior to attaching the heat shield with mechanical fasteners. The tooth ensured that the outer surface of the interface gap would not have any forward or rearward facing steps which would increase localized heating. Second, the tooth would function as a labyrinth seal tooth and form a tortuous flow path in the event of a gasket breach.

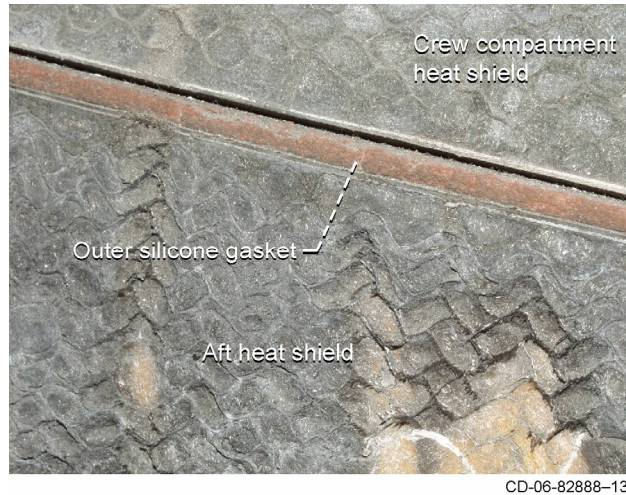
Fig. 13. Photograph of Apollo/Skylab 3 aft heat shield-to-crew compartment heat shield interface region including the outer silicone gasket seal.

crew compartment heat shield interface region including the elastomer gasket is shown in Fig. 13. Of particular note is the rough appearance of the gasket outer surface caused by ablation at high temperatures.

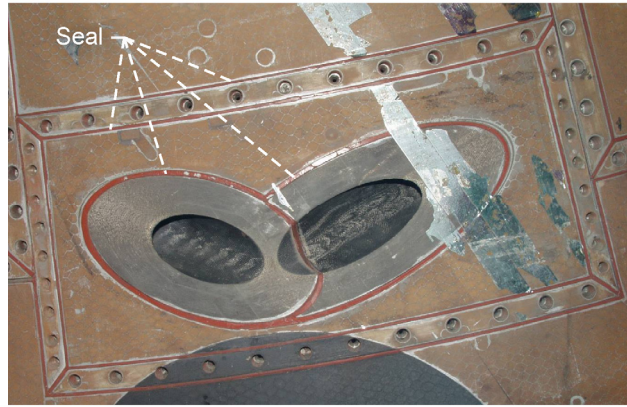
CD-06-82902

Fig. 14. Photograph of Apollo/Skylab 3 RCS roll motors showing silicone thermal seals.

crew compartment heat shield interface gap, the silicone seals on the crew compartment heat shield exhibit little evidence of ablation and qualitatively demonstrate the relatively benign thermal environment imposed upon the crew compartment heat shield.

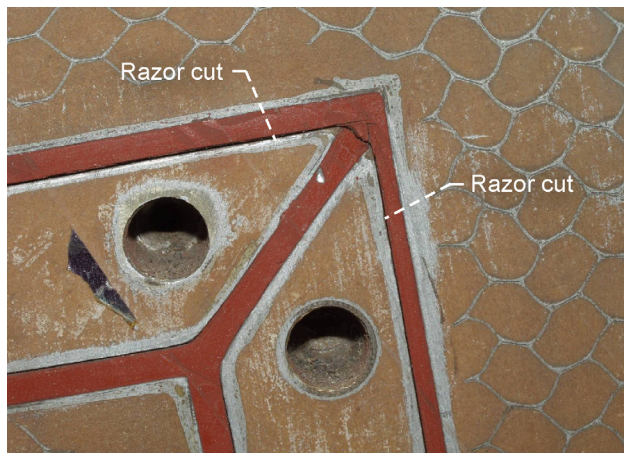
CD-06-82903

Fig. 15. Photograph of Apollo/Skylab 3 access panel corner emphasizing silicone thermal seal. The seal contains razor cuts presumably to allow panel removal.

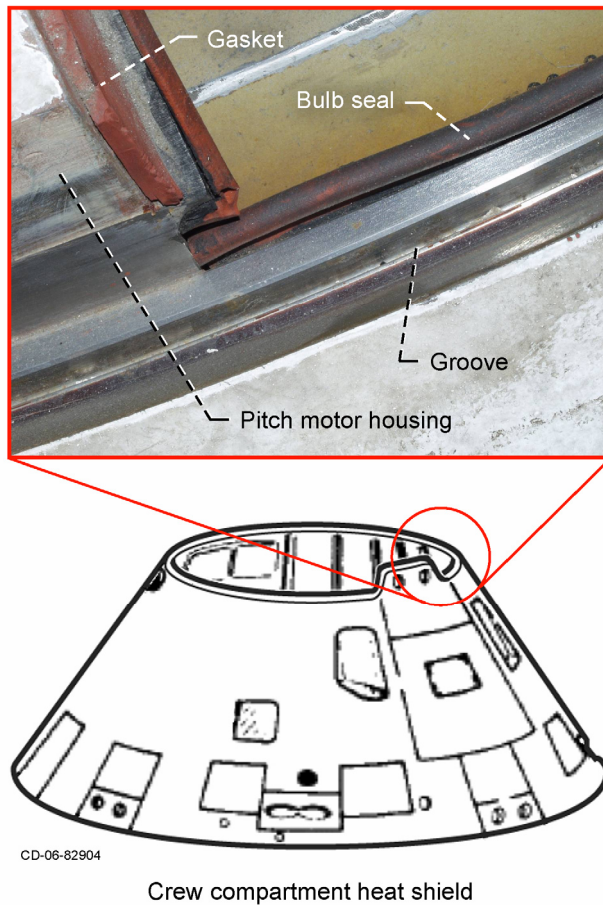
Fig. 16. Downward-looking photograph of top of Apollo/Skylab 3 vehicle showing forward heat shield mounting location and seals.

The forward heat shield was separated from the crew compartment heat shield by a small gap which required seals to prevent ingestion of reentry gases. Since the forward heat shield was jettisoned prior to parachute deployment, it could not adhere to the crew compartment heat shield. However, the low heat transfer rates measured on the forward heat shield mitigated the adhesion concerns. Most of the gap circumference between the two heat shields was sealed with an elastomer bulb seal (engineers working on the project at the time recall this to be heat vulcanized elastomer gum stock per ZZ-R-765¹²) which is shown on the right side of Fig. 16, a downward-looking photograph of a portion of the forward compartment of the Apollo/Skylab 3 capsule. The groove outboard of the seal appears to have served as a seating location for the forward heat shield.

Figure 16 also shows the side of the upper RCS pitch motor which was housed in the forward compartment of the command module. The forward heat shield included a conformal notch which fit around the perimeter of the

Finally, it should be noted that the seals in Fig. 16 appear to have been exposed to low heat loads evidenced by the apparent lack of thermal damage on their outer surfaces. This is expected in light of the low heating rate measurements on the forward heat shield during the unmanned test flights of the command module.^{4,6,7}

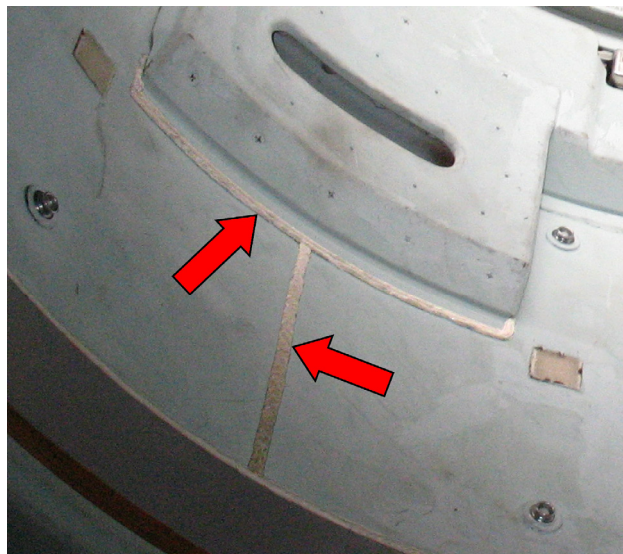
CD-06-82905

Fig. 17. RTV-sealed aluminum joint inside the Apollo/Skylab 3 forward tunnel.

Aluminum panels in the Apollo command module were riveted or bolted together to form portions of the pressure hull and were sealed with RTV. A typical RTV-sealed joint between two aluminum panels can be seen in the photograph of the inside of the Apollo/Skylab 3 forward tunnel in Fig. 17. In this case, white RTV was used to seal the joint between multiple panels. It is thought that RTV-sealed joints such as the one shown in the figure accounted for the majority of unplanned atmospheric losses from the Apollo command module.¹⁵

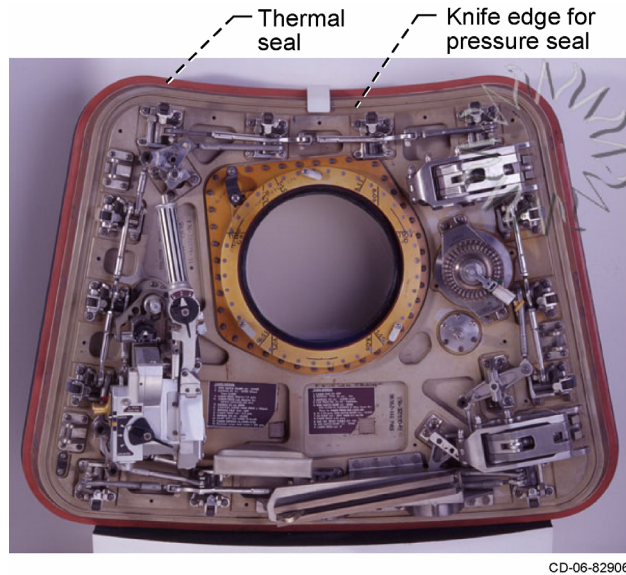
Fig. 18. Photograph of Apollo 11 Unified Crew Hatch (National Air and Space Museum photograph 99-15152-6).

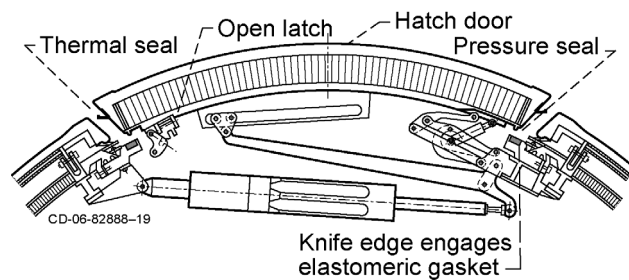
Fig. 19. Schematic drawing (top view) of Apollo Unified Crew Hatch.¹⁷

Although the UCH was located on the leeward side of the capsule during reentry and was therefore subject to low thermal loads, a thermal lip seal was included to prevent ingestion of reentry gases into the gap around the hatch perimeter. A photograph of the Apollo/Skylab 3 mission command module UCH and its high-temperature silicone thermal seal is shown in Fig. 20. Figure 19 shows that the thermal seal was in contact with the hatch frame at a contact angle such that it was angled toward the outboard side of the capsule. During ascent, air in the cavity between the pressure seal and the thermal seal could escape across the thermal seal because the differential pressure would reduce the contact pressure of the thermal seal. This cavity was therefore maintained at near-vacuum conditions during a mission. During reentry, the external pressure on the seal would increase and thereby increase the contact pressure of the seal against the hatch frame. This enhanced the effectiveness of the thermal seal.

The pressure seal on the Apollo UCH was composed of an elastomer gasket attached to the command module hatch frame and an adjoining knife edge formed into the UCH perimeter. The knife edge can be seen on the outer perimeter of the hatch door in Fig. 18 immediately outboard of the latches and linkage mechanism. The knife edge embedded into the elastomer gasket when the door was fully closed, forming an effective pressure seal. Figure 21 shows a photograph of the Apollo/Skylab 3 hatch frame with the elastomer gasket highlighted. A line of discoloration can be seen on the gasket where the hatch knife edge came into contact with the elastomer surface.

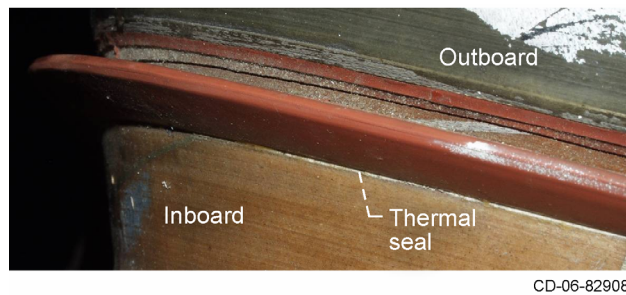
Fig. 20. Photograph of UCH hatch thermal seal on Apollo/Skylab 3 command module.

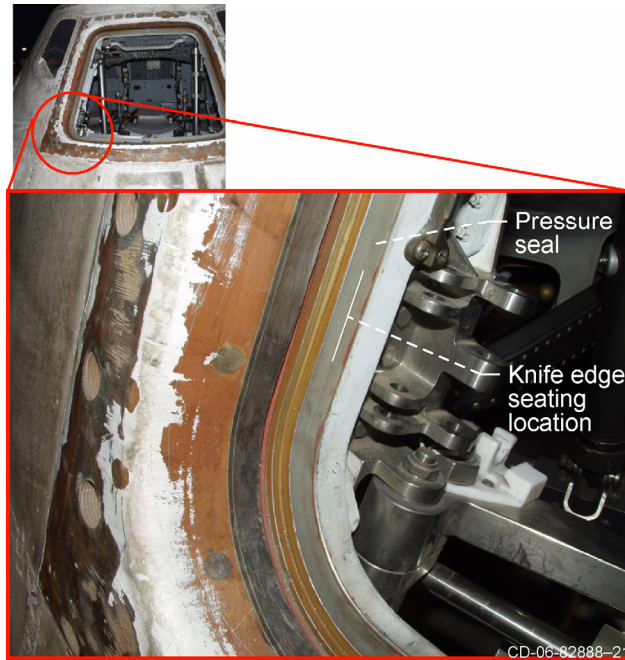
Fig. 21. Photograph of hatch frame on the Apollo/Skylab 3 command module. A residual discoloration can be seen where the UCH knife edge engaged into the elastomer gasket.

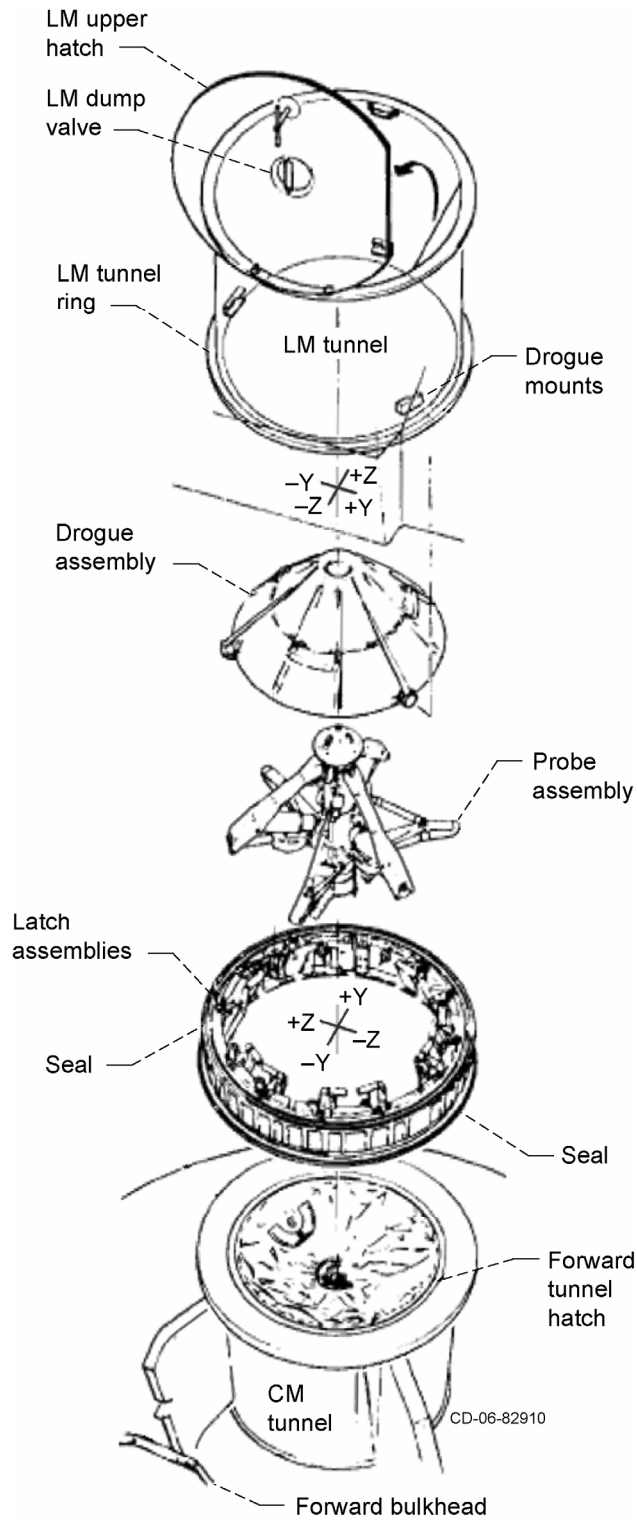
Fig. 22. Apollo docking assembly.¹⁹

Figure 22 shows a schematic diagram of the forward tunnel assembly used to dock the command module to the lunar module. The docking ring was attached to the command module tunnel ring and served as a mounting structure for the latches, electrical connections, and probe assembly for docking with the lunar module. The docking assembly contained several seals: a pressure seal and a thermal seal on the forward tunnel hatch, a pressure seal at the junction between the command module tunnel ring and the docking ring, another pressure seal at the junction between the docking ring and the lunar module tunnel ring, and at least one pressure seal on the lunar module hatch door.

Two seals are indicated on the docking ring in Fig. 22. The first was located between the docking ring and the command module tunnel ring and the second was between the docking ring and the lunar module tunnel ring. The docking ring was jettisoned with the lunar module and therefore could not be examined to determine the nature of the seals. Based on the drawings and photographs of the docking ring and the adjoining command module tunnel ring, it may be inferred that the two docking ring seals were similar to the pressure seals used for the UCH and the

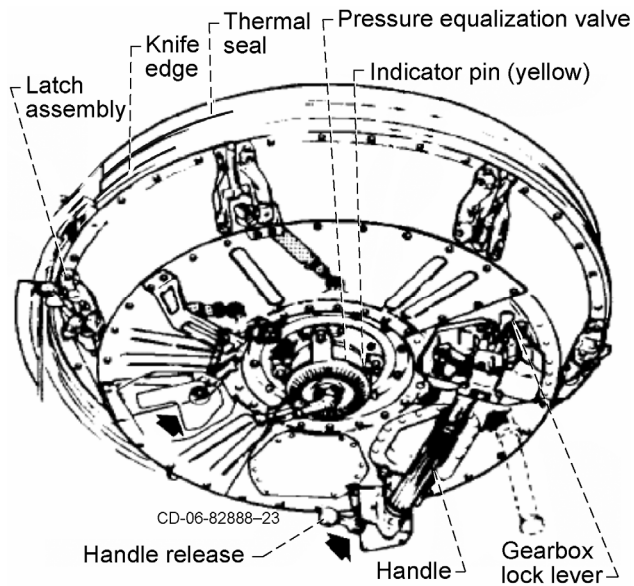
Fig. 23. Drawing of the inboard side of the Apollo command module forward tunnel hatch.¹⁹

Figure 23 shows a diagram of the inboard side of the forward tunnel hatch which includes callouts to an outboard thermal seal and an inboard knife edge which constitutes part of a pressure seal. The thermal seal prevented ingestion of high enthalpy reentry gases into the gap around the hatch. Figure 24, a photograph of the stowed hatch taken during the Apollo 17 mission, shows a thermal seal O-ring formed from a high temperature elastomer material. The thermal seal was compressed against the forward tunnel wall near the location denoted with a number “7” in Fig. 25, a photograph of the forward tunnel in the Apollo/Skylab 3 command module. The thermal seal was not as large as that for the UCH because the thermal environment at the apex of the conical portion of the command module was minimal and did not impose a heavy thermal load onto the seal.

The forward tunnel hatch also contained a pressure seal similar to that on the UCH which was constituted by the knife edge denoted in Fig. 23 which embedded into an elastomer gasket attached circumferentially around the forward tunnel. The elastomer gasket can be seen in the photograph of the Apollo/Skylab 3 forward tunnel in Fig. 25. When the outboard side of the hatch was exposed to vacuum conditions (e.g., the command module was not

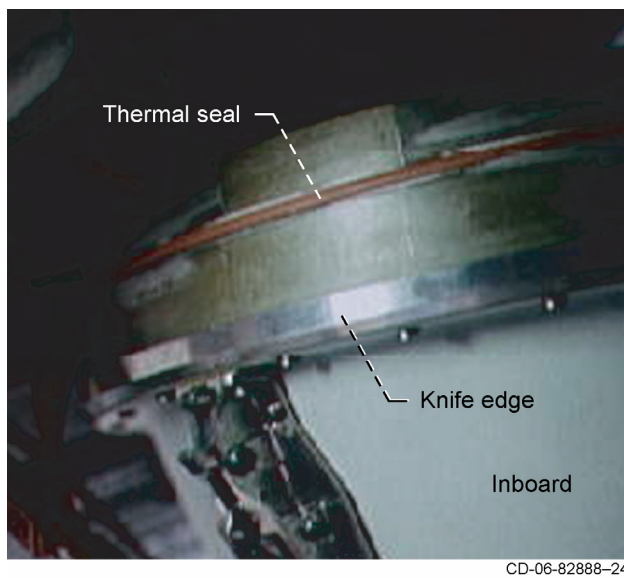
Fig. 24. Photograph of stowed forward tunnel hatch from Apollo 17 (zoomed in from AS17-162-24054).

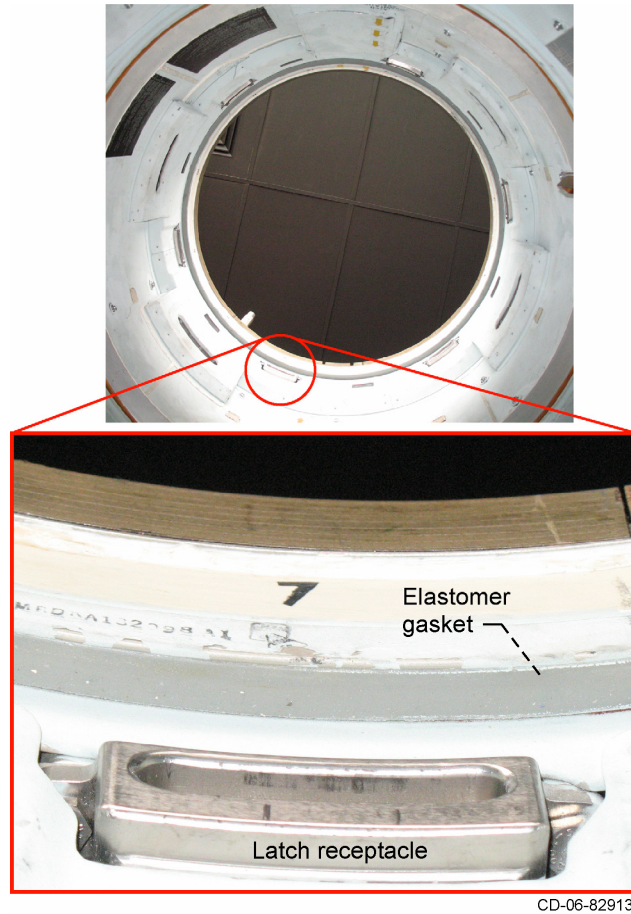
Fig. 25. Photograph of forward tunnel and pressure seal on forward tunnel of Apollo/Skylab 3 command module.

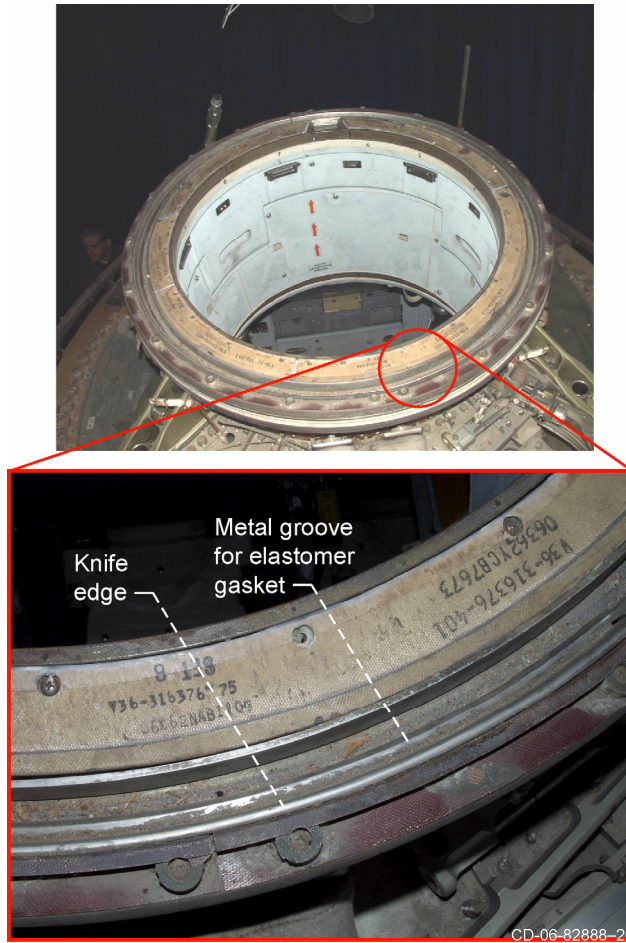
Fig. 26. Apollo/Skylab 3 command module tunnel ring and metal groove for mounting elastomer pressure seal.

forward tunnel hatch. The docking ring appears to have included a circumferential knife edge at each of its axial ends. The knife edge facing the command module embedded into an elastomer band installed around the outside perimeter of the command module forward tunnel. A photograph showing the top of the Apollo/Skylab 3 command module tunnel ring is shown in Fig. 26, where a circumferential groove presumably contained the elastomer pressure seal. Interestingly, a knife edge is shown outboard of the groove in Fig. 26 and may indicate that the junction between the command module tunnel ring and the docking ring contained two pressure seals, with each surface containing both an elastomer gasket and a knife edge.

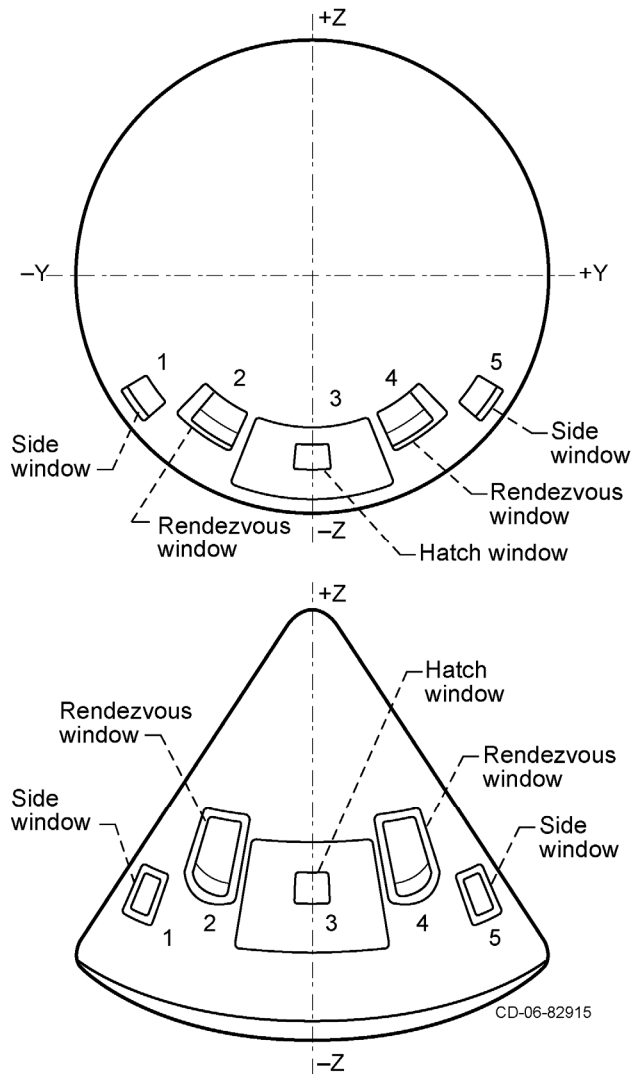
Fig. 27. Window locations on the Apollo command module.²¹

The Apollo command module included five windows as shown in Fig. 27. The side and hatch windows were generally used for observation and photography while the rendezvous windows (windows 2 and 4) were oriented in the forward direction (+X in the figure) and provided visual guidance for docking.

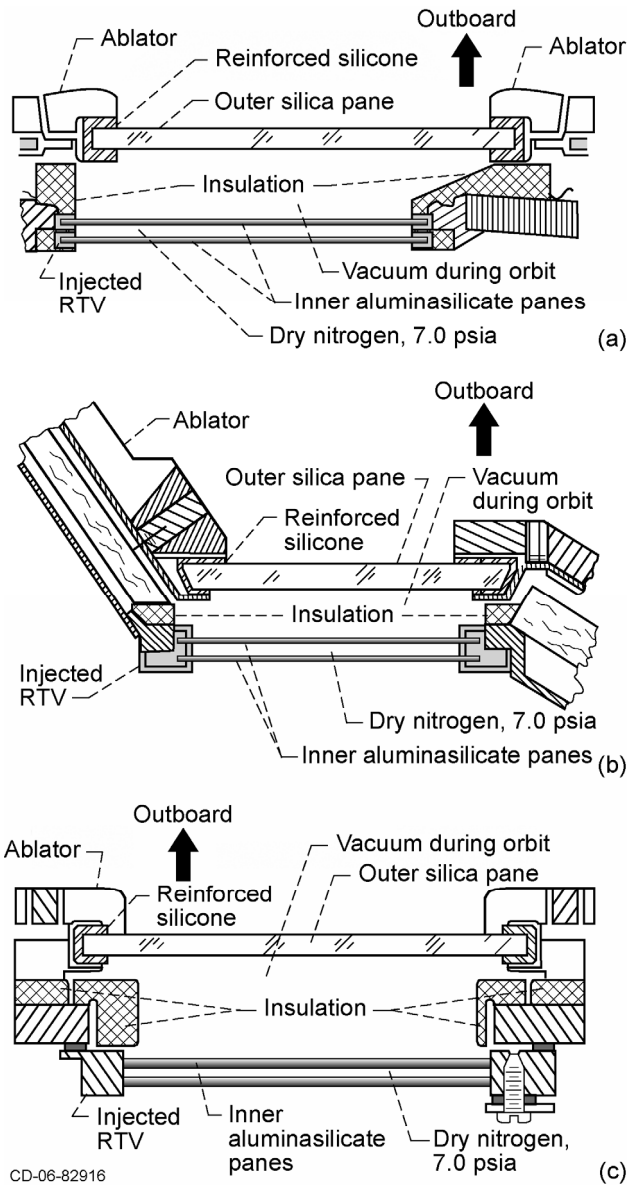
Fig. 28. Apollo command module windows:²⁰ (a) side windows 1 and 5, (b) rendezvous windows 2 and 4, (c) hatch window 3.

Figure 28 shows the construction of each of the three types of windows including the seals necessary to prevent both cabin atmosphere loss and reentry gas ingestion. The windows were made of two aluminosilicate glass inner pressure panes and a fused amorphous silica outer heat shield pane. Each of the inner window panes was coated on both sides with an antireflective coating to reduce glare. The outer pane was coated on the outside with a

The seal around the pressure windows was formed by injecting RTV 560 around the perimeters of the two inner panes and allowing the silicone to cure in place.²⁰ The RTV was held in place while it was curing by heat molded silicone elastomer dams which were installed around the perimeters of the windows.²¹ Once the silicone had cured, the cavity between the inner windows was evacuated and backfilled with 7.0 psia nitrogen gas. A multilayer silicone resin-impregnated fiberglass insulator with an RTV 511 coating was bonded with RTV 511²¹ to the outboard perimeter of the inner window panes to minimize heat conduction to the inner windows during reentry. The outer heat shield window was attached using a glass cloth reinforced heat-molded silicone rubber which was bonded in place with RTV 560. Window 1 and its associated seals and insulation layer from Apollo/Skylab 3 are shown in Fig. 29. A portion of the outer RTV 511 coating is removed from the insulator, so the exposed fiberglass insulation can be seen. Also, the outer heat shield silica pane is missing from the capsule and may have been removed after recovery of the vehicle.

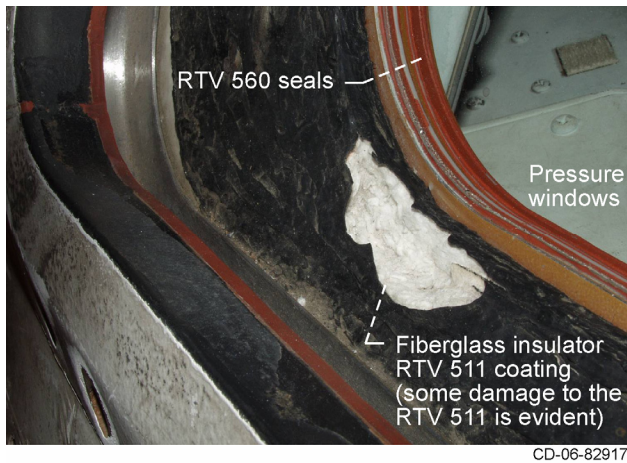
Fig. 29. Photograph of window 1 on Apollo/Skylab 3 vehicle. The outer heat shield silica pane is not present.

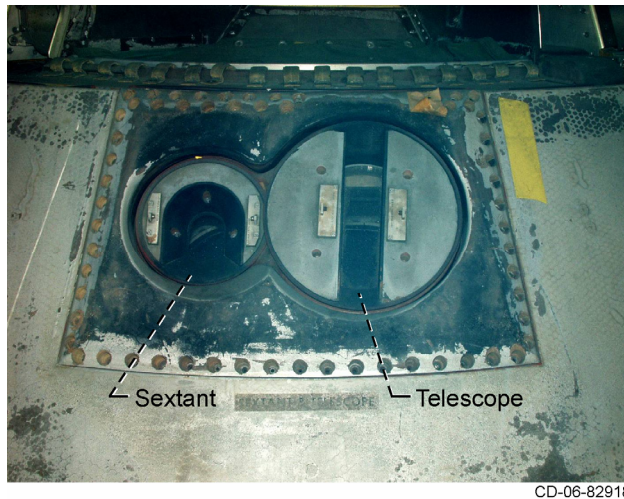
Fig. 30. Sextant and telescope assembly on the Apollo/Skylab 3 command module.

An assembly consisting of a sextant and a scanning telescope, shown in Fig. 30, was installed on the windward surface of the crew compartment heat shield of the Apollo command module. The inclusion of the sextant represented a significant sealing challenge. The sextant penetrated both the pressure hull and the crew compartment heat shield on the windward side of the vehicle. The sextant was free to rotate and was capable of some movement along the axis of rotation. The sealing challenge was overcome using the seal design shown in the schematic diagram in Fig. 31. The flexible thermal seal prevented the flow of high enthalpy reentry gas into the cavity between the cabin and the TPS wall (Fig. 31) while allowing movement of the sextant TPS with respect to the cabin.⁵

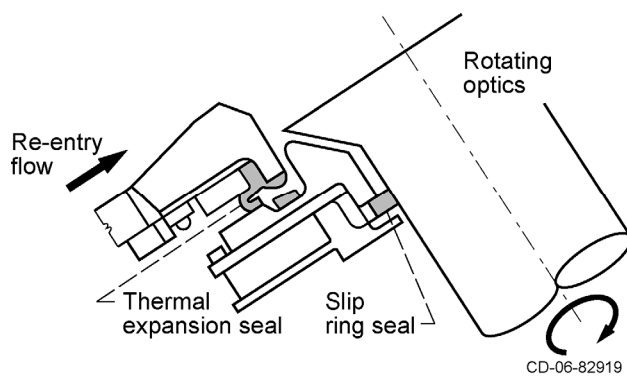
Fig. 31. Sectional view of Apollo command module sextant port.⁵

Additionally, the slip ring seal around the sextant prevented high enthalpy gas flow along the outside circumference of the sextant and into the cabin. The slip ring seal also minimized habitable atmospheric losses from the crew cabin along the outer circumference of the rotating optics.
