Particle Analysis Pitfalls

David Hughes
GSFC

Tony Dazzo
Swales Aerospace

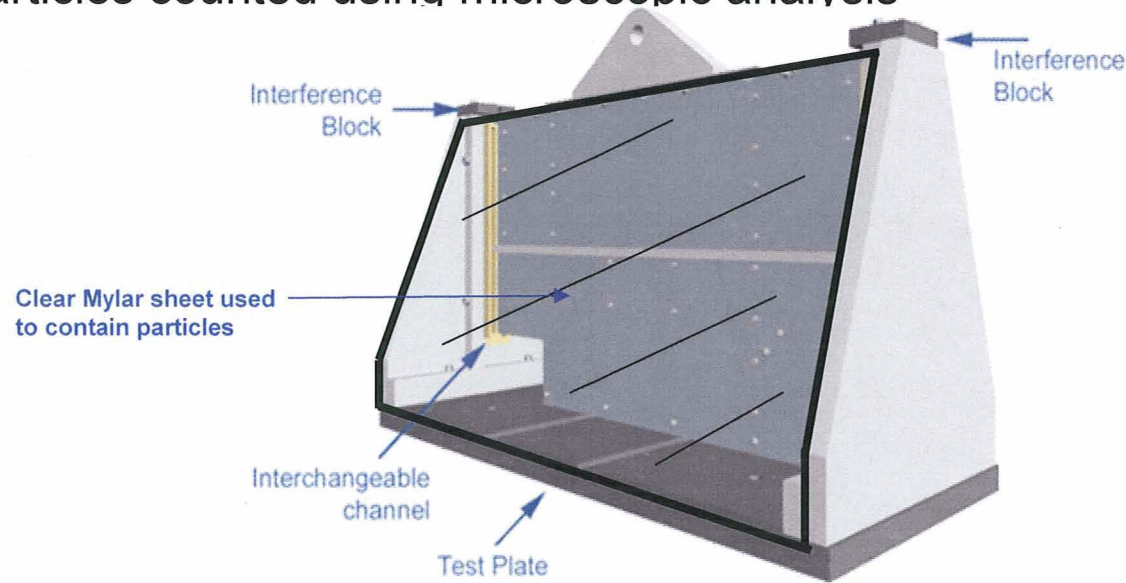
Test Configuration

- This study determined the debris generated during the card removal in a series of different card-lok configurations
 - Card-loks fully locked
 - Interference blocks used
 - Card-loks locked and then unlocked
- Particles vacuumed onto gridded filter paper after test run
 - Particles counted using microscopic analysis

- Caveats
 - Nominal case produced more particles than Card-Locked case
 - Used the Nominal case for conservatism
 - Test boards were warped, so may have generated more particles during insertion than the flight boards will

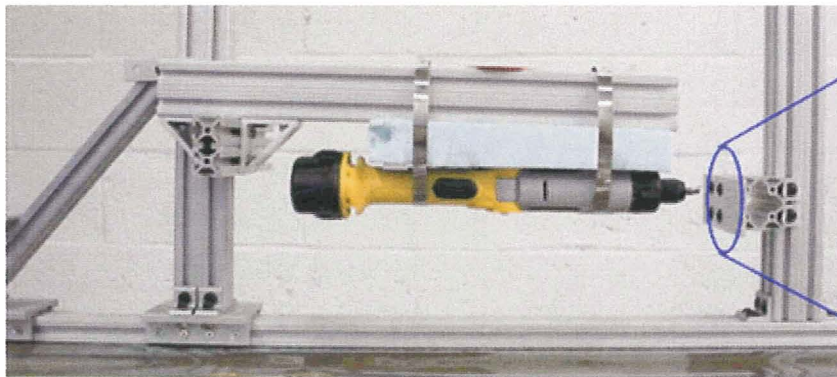
Fastener through-hole

- Determined contamination generated as it correlated to driver speed, force applied to fastener, and stuck/unstuck fastener
- Utilized the CATs team's Head Deformation Test configuration
 - Particle Capture Vacuum Attachment (PCVA) was designed to capture particles for contamination study
- PCVA mounted to fastener mounting plate
 - Bottom of PCVA was attached to filter holder, then the filter holder to a vacuum
- Fastener was extracted through through-hole or left bound for three seconds as determined by test plan
- Filter caught particles as fastener was extracted, and tapelifts were performed on fastener head and driver bit
 - Particles counted using microscopic analysis

- Caveats
 - Only tested #4 torque set fasteners
 - Fastener #4 torque set – 39 count present
 - Fastener #4 SHC – 56 count present
 - Fastener #8 SHC – 16 count present
 - Metallic particles, only
 - In use, tool shaft might chip Lexan cover, but test setup prevented this
 - Locking compound did not shed an appreciable number of particles

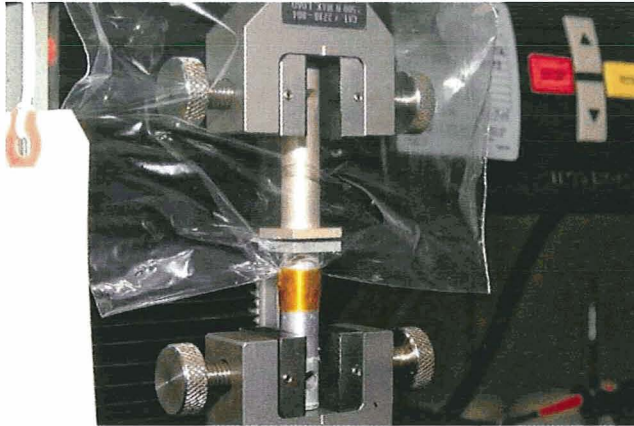
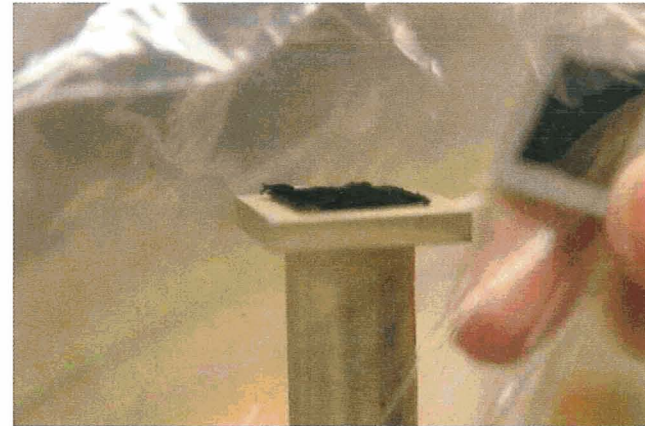
Flatwise Tension:

Flatwise Tension and Shear Testing

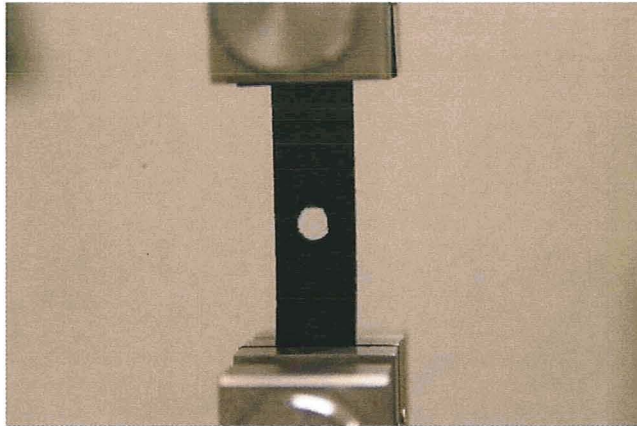
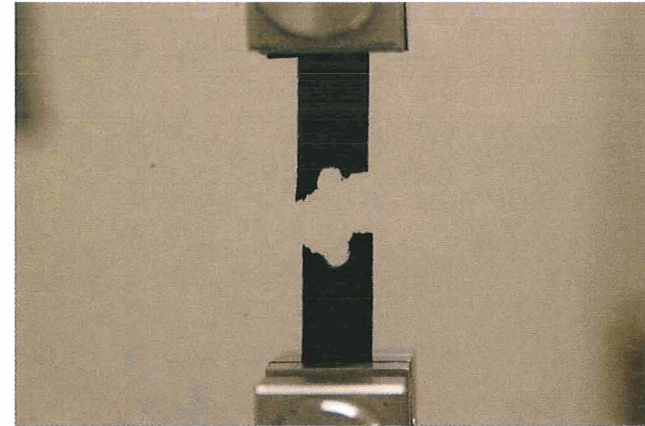
Hole:

Lengthwise Tensile Testing

- Did not count or size particles during lengthwise tensile pull tests, but did see them on high-speed video
- Could not test combined failure modes
