NASA/TM-2008-215349

Vibro-Acoustic Response of Buildings Due to Sonic Boom Exposure: July 2007 Field Test

*Jacob Klos
Langley Research Center, Hampton, Virginia*

September 2008

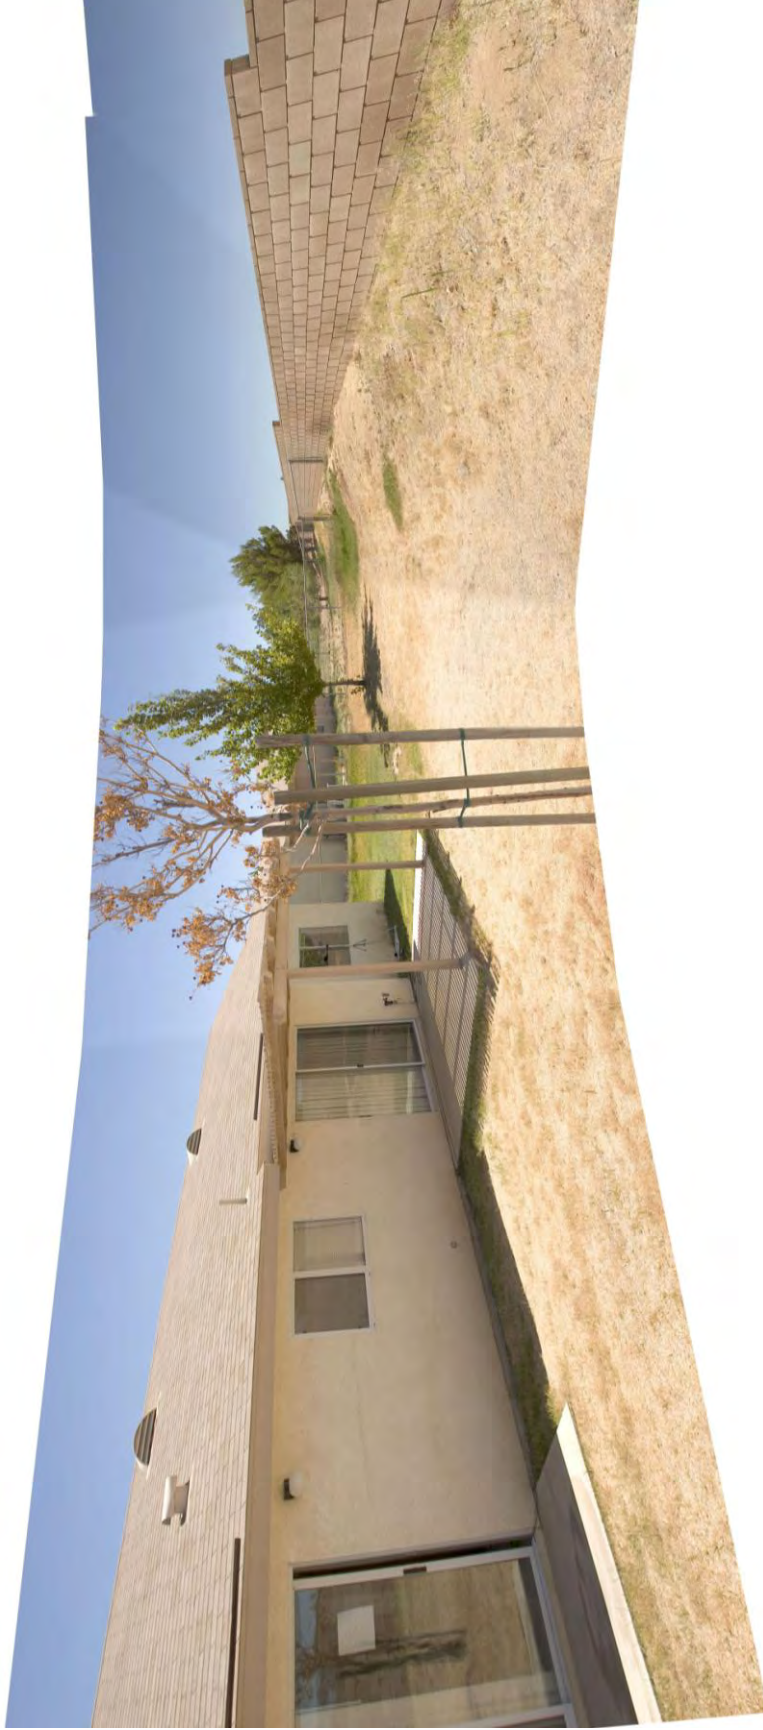
Figure 2.28: Panorama of the back yard of the test house.

Two trees were in the back yard of the test house (Figure 2.28). The presence of these trees may have had an impact on the measurements recorded by the microphones placed in the back yard (Appendix C). The most significant effect of the trees on these measurements appeared to be increased ambient noise due to leaf rustling, which is audible in recordings made on windy days.

There were two vents in the roof of the test house (Figure 2.28) and one in the south wall of the house (Figure 2.26) that vented straight into the attic. Soffit vents were also present in the eaves of the house, which vented into the attic. These may have had an effect on the sound pressures observed inside the attic due to the sonic booms.

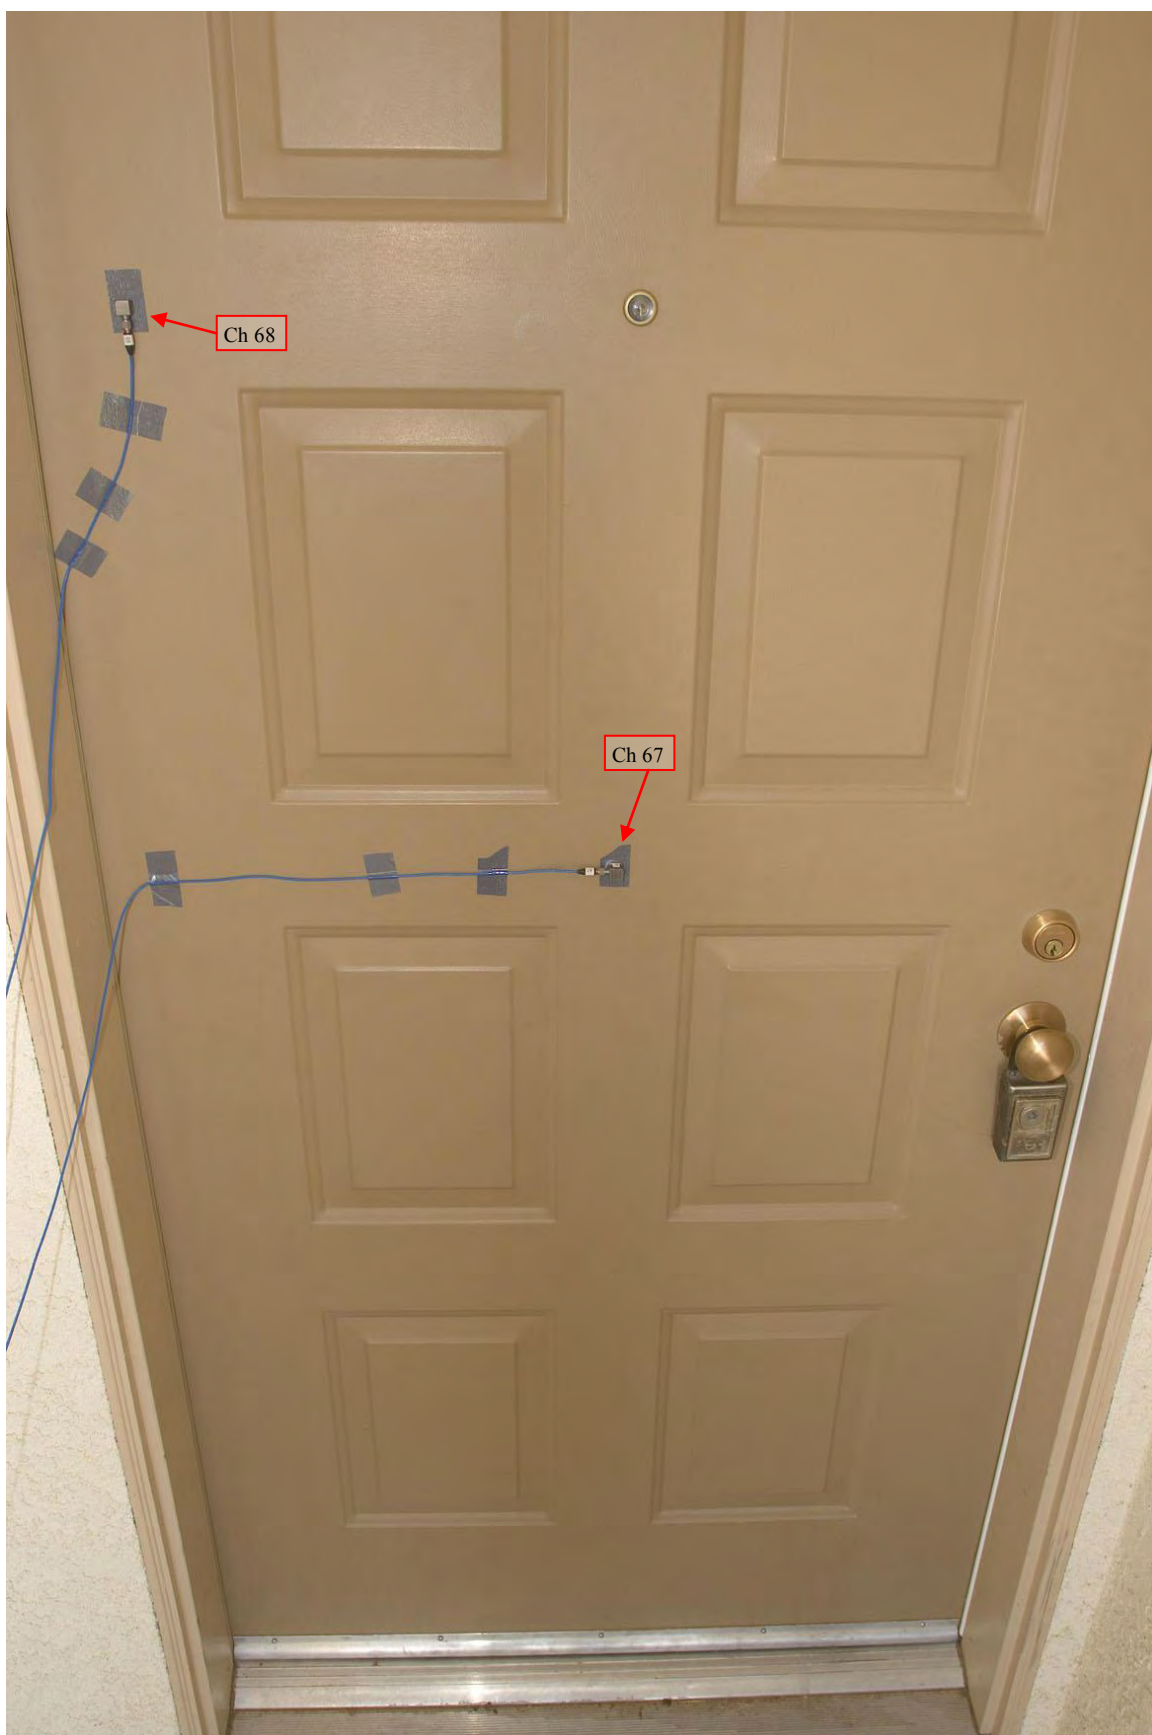
The accelerometers on channels 67 and 68 were removed from the front bedroom and placed on the outside of the front entry door to the house for test on July 18th 2007.

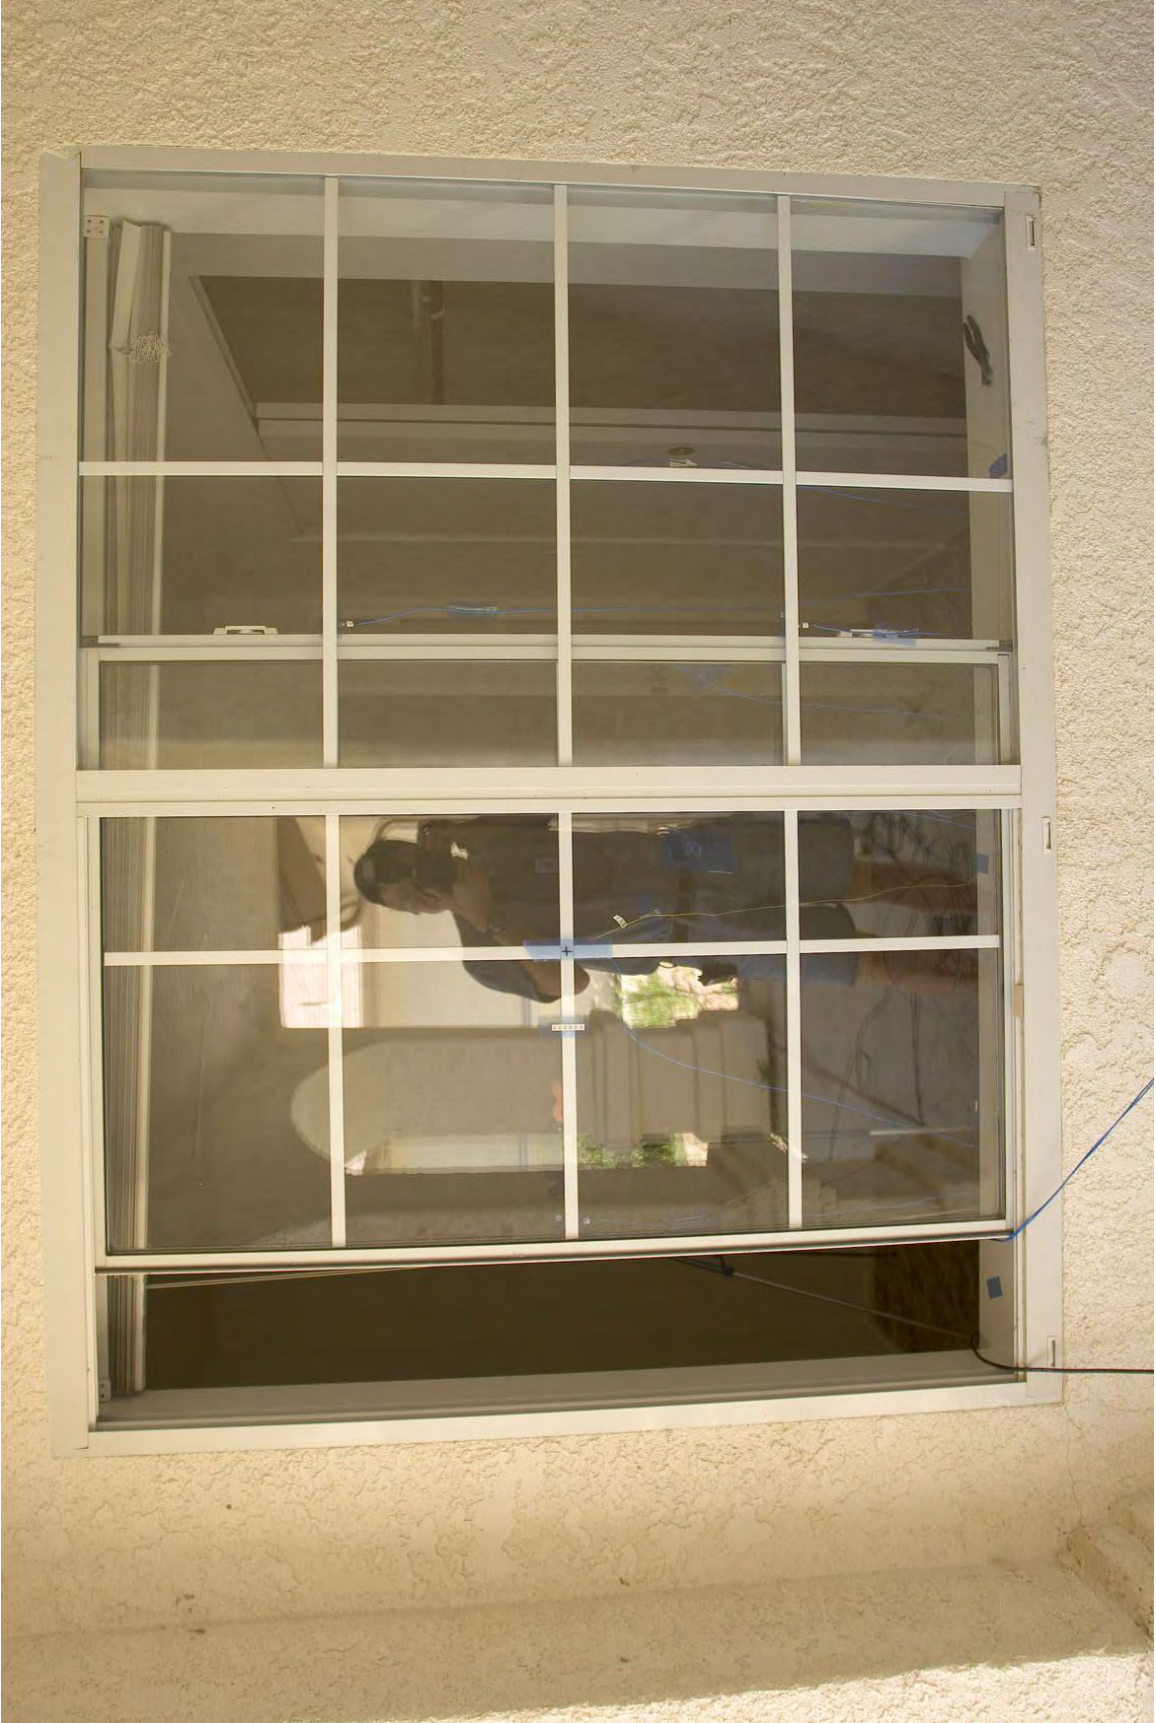
The window for the front bedroom was left cracked open about 6 inches so that the transducer cables could pass to the outside. The window was left open during the boom tests on July 18th, 2007.

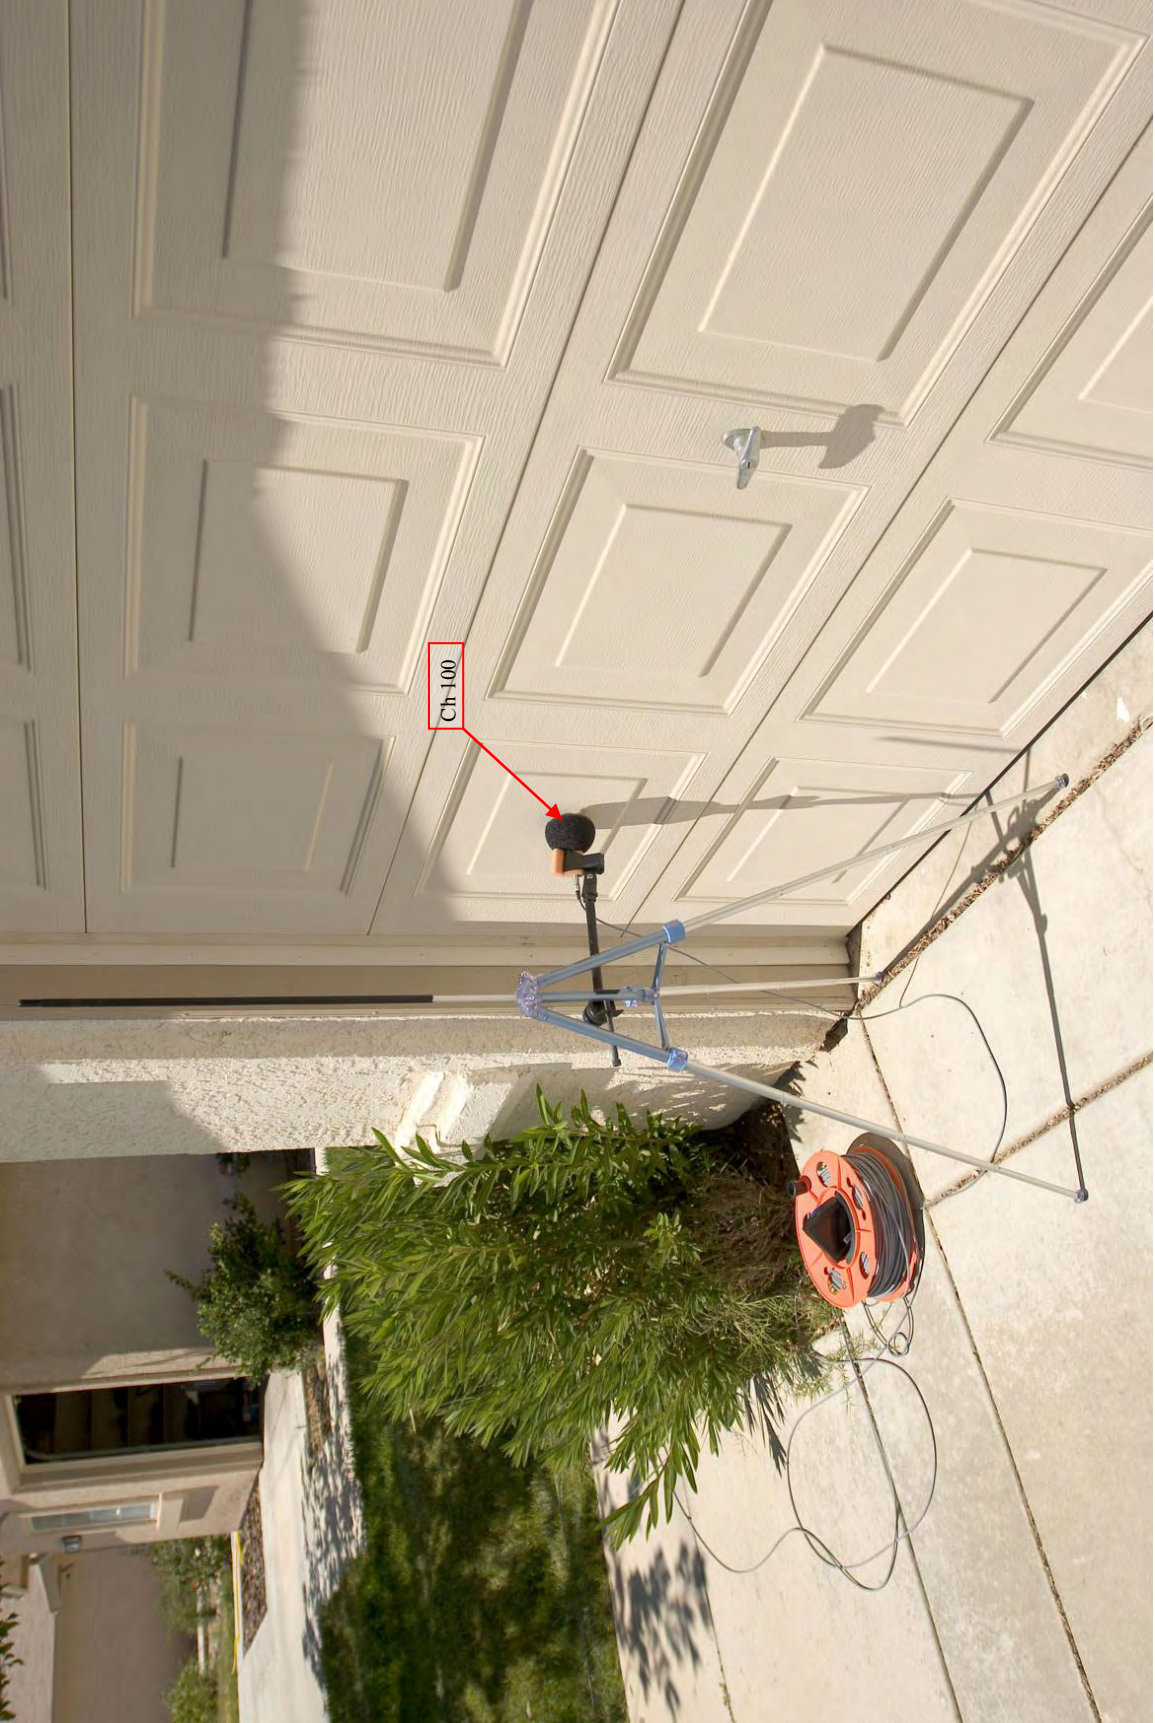
The microphone on channel 100 was removed from in front of the garage bedroom window and placed in front of the garage.

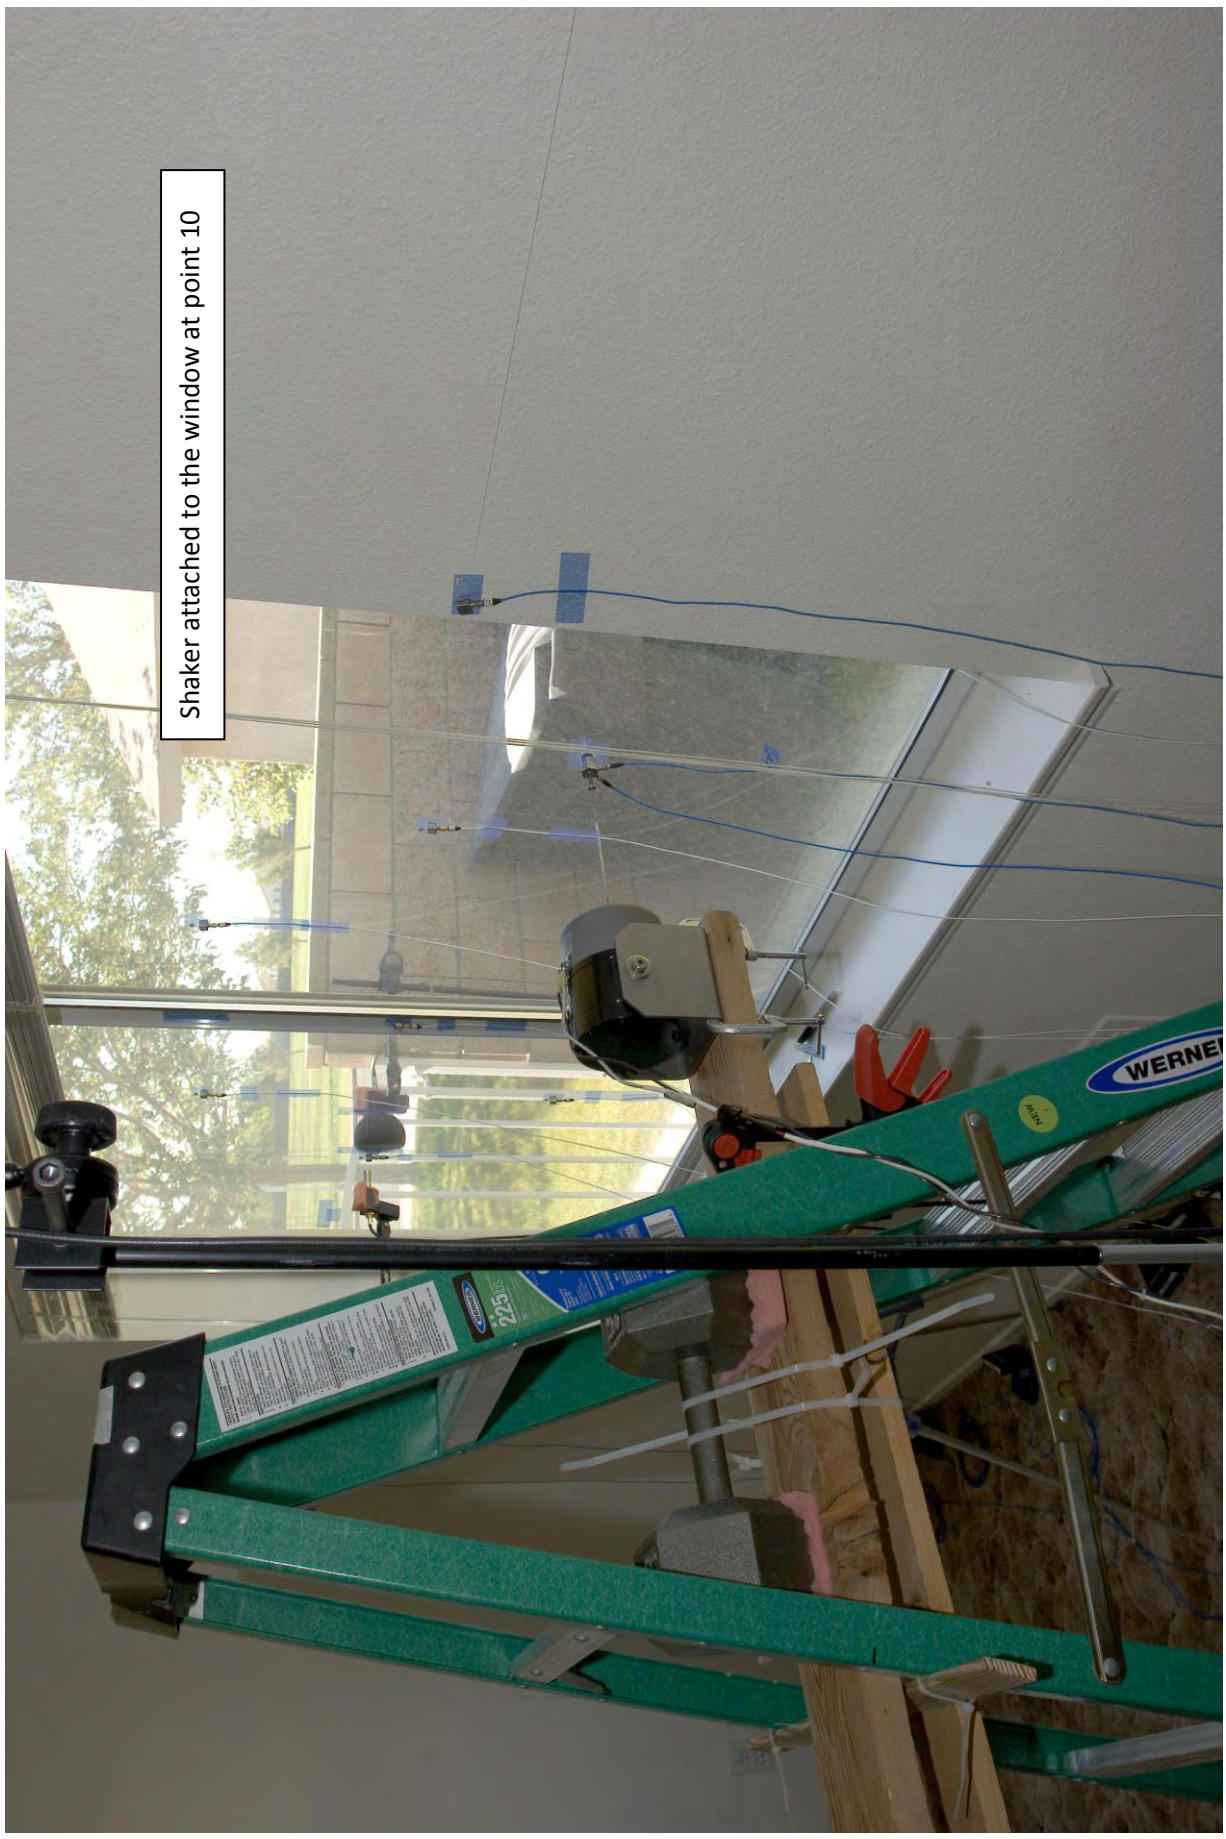
Shaker attached to the window at point 10

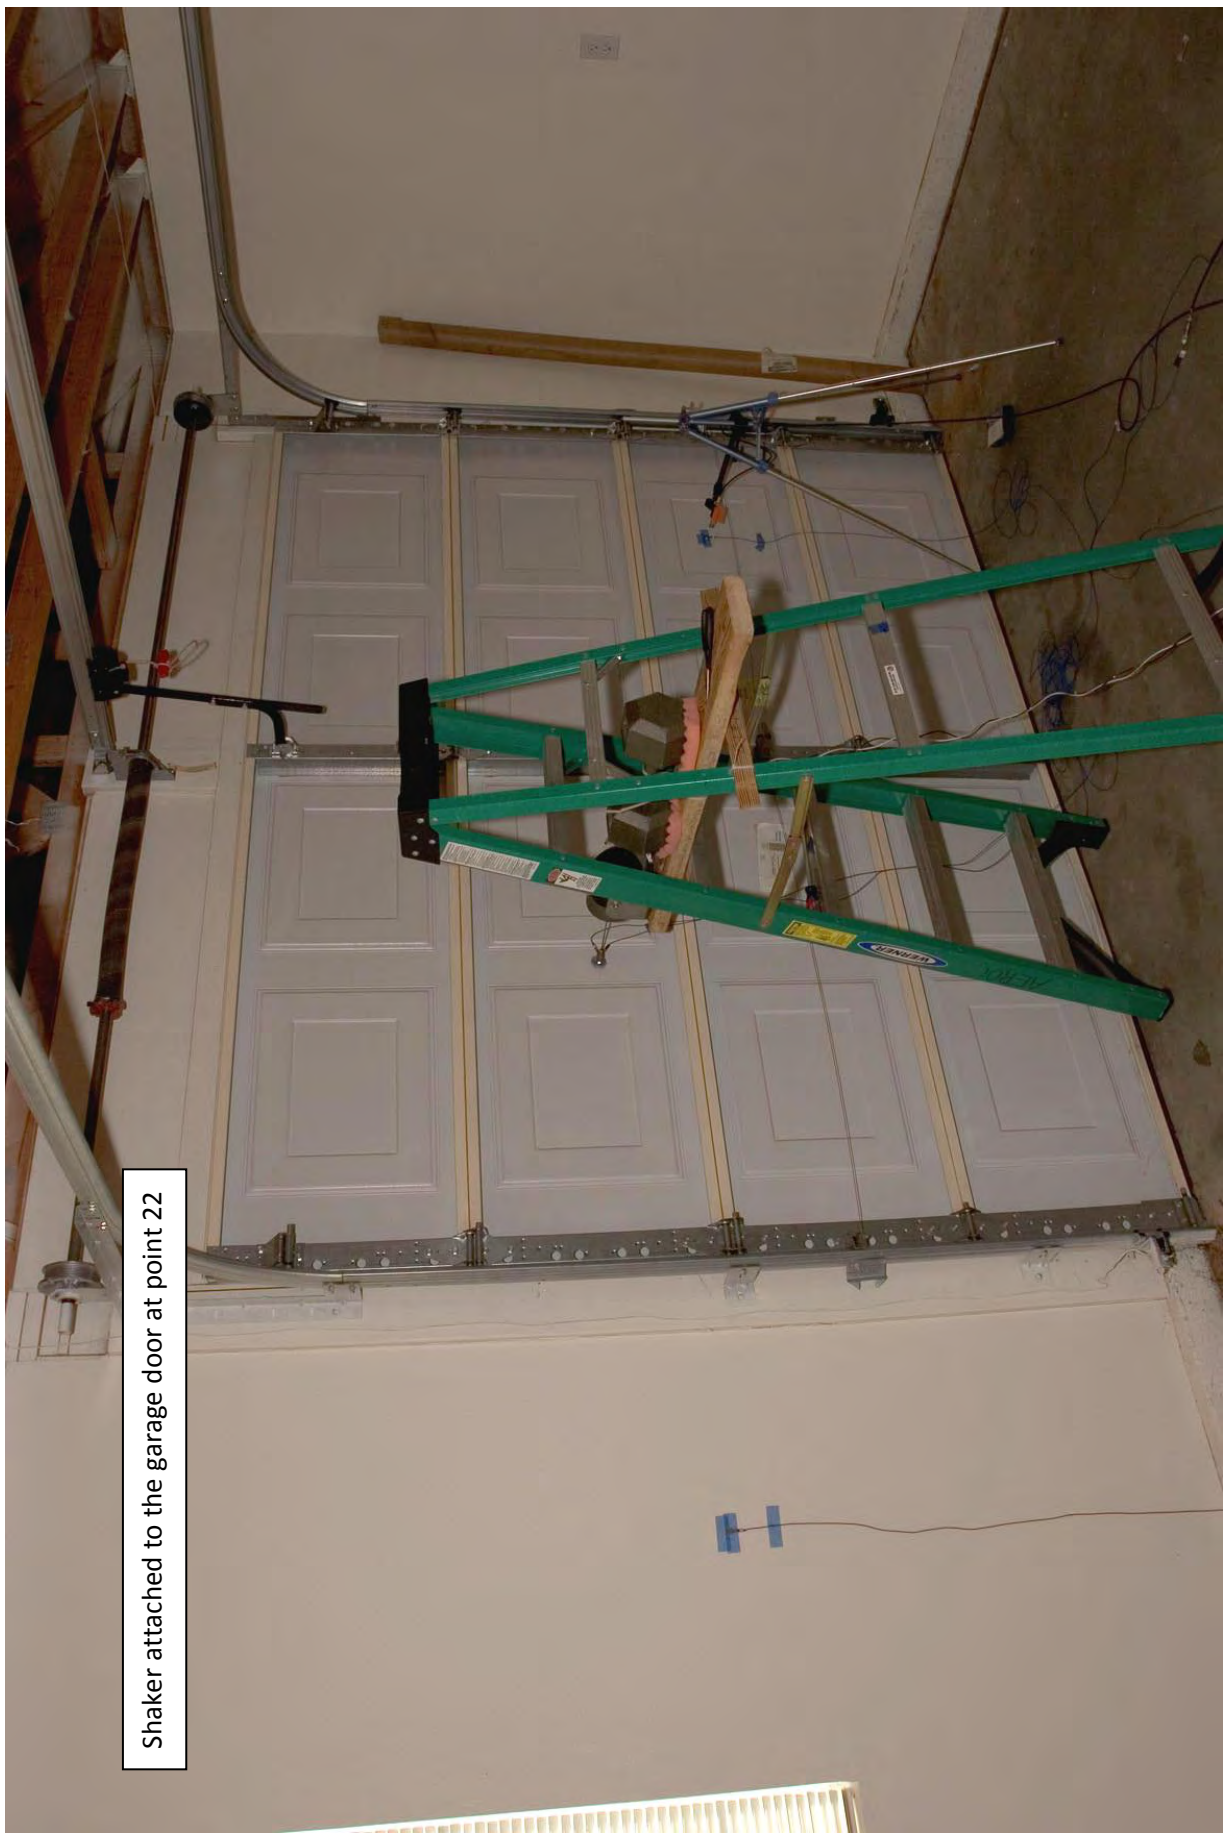
Shaker attached to the garage door at point 22
