# Deployable Aeroshell Flexible Thermal Protection System Testing

Deployable aeroshells offer the promise of achieving larger aeroshell surface areas for entry vehicles than otherwise attainable without deployment. With the larger surface area comes the ability to decelerate high-mass entry vehicles at relatively low ballistic coefficients. However, for an aeroshell to perform even at the low ballistic coefficients attainable with deployable aeroshells, a flexible thermal protection system (TPS) is required that is capable of surviving reasonably high heat flux and durable enough to survive the rigors of construction handling, high density packing, deployment, aerodynamic loading and aerothermal heating. The Program for the Advancement of Inflatable Decelerators for Atmospheric Entry (PAIDAE) is tasked with developing the technologies required to increase the technology readiness level (TRL) of inflatable deployable aeroshells, and one of several of the technologies PAIDAE is developing for use on inflatable aeroshells is flexible TPS. Several flexible TPS layups were designed, based on commercially available materials, and tested in NASA Langley Research Center's 8 Foot High Temp

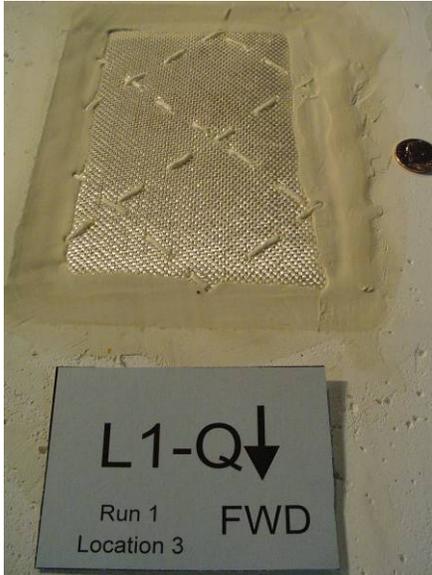
9. Typical PAIDAE quilted sample.

Each layup was tested in both a quilted and non-quilted configuration. This approach was selected to determine if there would be an appreciable increase in the survival of samples with the presence of the quilting yarns and also to determine if the quilting yarns would impact locally the thermal protection of the fabric ply, adjacent to its neighboring outer ply. The quilted samples were fabricated with a pre-fired amorphous silica cord having a nominal diameter of 0.040 inches. Manufacturer’s data indicated that the material was thermally stable as it could operate continuously at temperatures up to 982°C (1800°F) and would not melt until 1593°C (2900°F). The quilting was configured in orthogonal stitch rows with roughly 2in spacing (see Figure 10.). The stitch rows were oriented on the samples so that the stitch rows were at 45° angles to the flow, and penetrated only the outer and insulative layers.

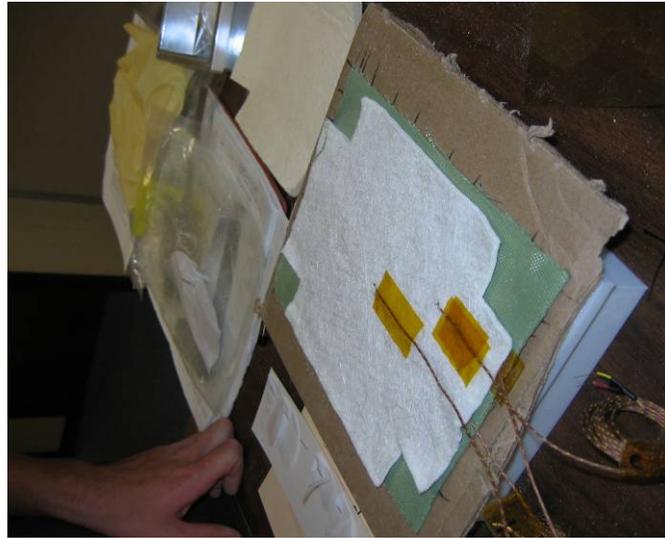
Figure 10. Installation of thermocouples on an un-quilted ply.

Thermocouples were integrated to the plies prior to quilting and measures were taken not to dislodge a thermocouple after quilting. Thermocouples were affixed to the un-quilted samples in their proper locations with Kapton tape, and the plies were laid in a fixture designed for loading the layup on the sample holder (see Figure 11.).

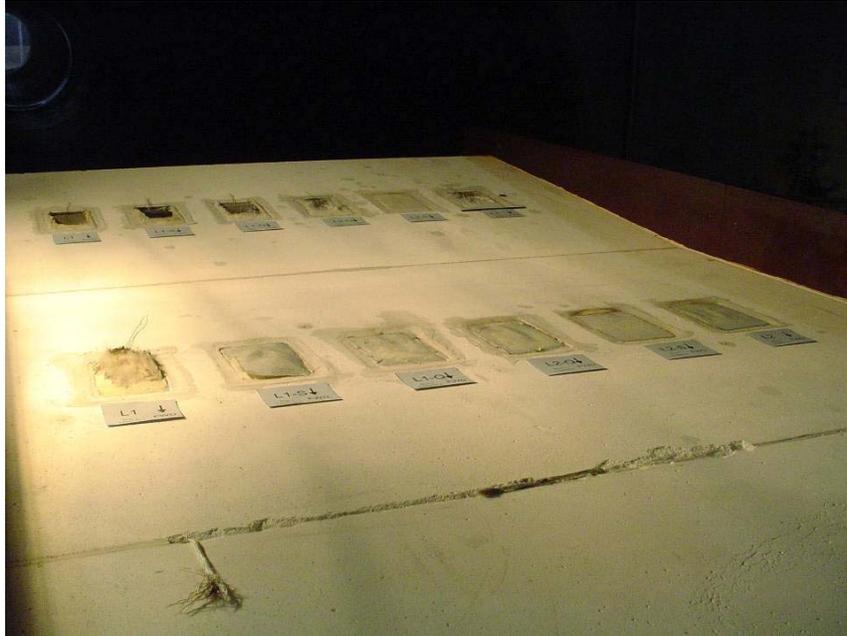
**Figure 12. PAIDAE sled after the first sample run (sled leading edge off picture lower right).**

Layups 1 and 2 were tested in this run with layup 2 recognizable in the pre-test photo by the pink sizing on the BF20 cloth. This was a low pressure run 90 sec in duration with the sled pitched down to  $5^\circ$  AoA. The sled AoA was set and then the sled was injected once the low pressure conditions were established in the test section. The Sauereisen grout around the samples was not as smooth as we would have liked but it was the best transition we were able to achieve. After the end of the run the test surface had several damage sites that were of much greater concern than the wavy grout surface (see Figure 13.). A portion of the Nextel rope filling the gap between the first two test surface plates (visible in the lower left of the figure) had broken free during the run and could be seen

flapping in the flow like a telltale. Pieces of the  $\text{SiO}_2$  insulator block chipped out of the test surface and impact points were visible on the inclined test surface. Several of the samples in the aft location failed before they were visible on the monitor. The failures were investigated prior to the next run. There were several likely causes for the failures: differential pressure during rapid depressurization causing the samples to be loosened enough to flag in the high shear pressure leading to mechanical failure, overloading the sample as it transition through the shear boundary of the tunnel flow, debris from the forward sled locations striking and damaging the samples leading to mechanical sample failure, and higher than predicted heat flux leading to mechanical failure. Unfortunately, there was inadequate instrumentation and video coverage to pinpoint a cause. Also of concern was the observation that the removal of the samples from the sled post-test imparted significant to the  $\text{SiO}_2$  foam around the sample locations. Progressively larger and larger areas of the  $\text{SiO}_2$  on the test surface needed repair for subsequent runs.

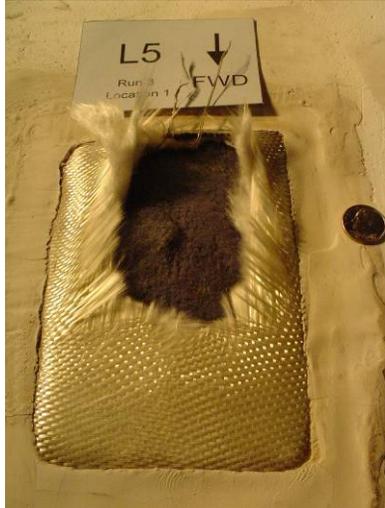
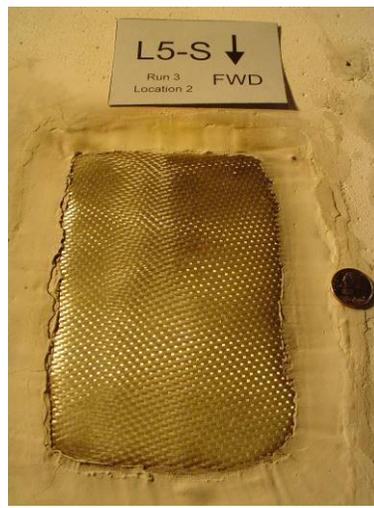
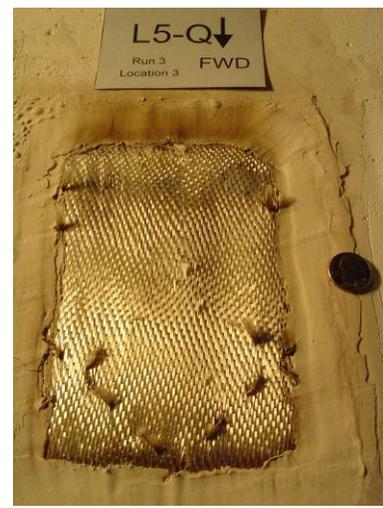
**Figure 13. Run 3, Location 1, Layup 5, post-test.**

**Figure 14. Run 3, Location 2, Layup 5, post-test.**

**Figure 15. Run 3, Location 3, Layup 5, post-test.**

The third run with samples was again a low pressure run with a 90sec duration at 5° AoA using layups 5 and 6. The sled injection angle was returned to 5° AoA. Again upon injection numerous samples failed. All of the layup 6 samples failed, and two of the three layup 5 aft location samples failed. Location 7 layup 5 survived roughly 50 seconds of the 90 second run. Two of the three layup 5 samples in the forward location had nominal performance for the entire run. The sample in location 1 seen in Figure 14 showed surprising behavior. Even though the top XN513 fabric failed, and the first insulation layer, Refrasil1800, failed immediately after the top fabric failed, the

underlying insulation, Pyrogel3350, survived 76 seconds of direct exposure to the test flow. The advertised maximum use temperature for Pyrogel3350 is only 350C, but the surface temperature of the material exposed to the flow was in excess of 700C. Figure 16 shows the quilted layup 5 sample in location 3 post-test. Most of the quilting yarn was burned or sheared off, but that would not be problematic for flight. The quilting will be required to maintain proper configuration of the layup when transitioning from the stowed to deployed state, but after the inflatable is deployed the quilting will no longer be necessary.

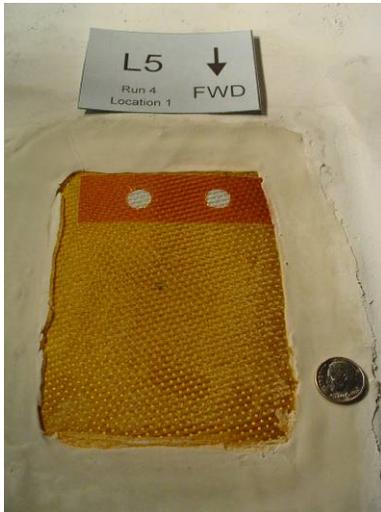
**Figure 16. Run 4, Location 1, Layup 5, pre-test.**

The fourth run with samples was a duplication of the previous run. For this run however to rectify fabric embrittlement by the cement, the protective Kapton top ply was left on the sample when the void between the test fixture and the sample was filled with Sauereisen. Leaving the Kapton on was a trade off. Though the Kapton film would help protect the samples while they crossed the shear boundary of the test flow, and it would protect the outer fabrics from the solvents in the cement, it might have caused problems at rapid depressurization of the tunnel. It might also have meant that the cement would not help hold the sample in the test location. In an effort to minimize potential problems during tunnel rapid depressurization two vent holes roughly 3/8<sup>th</sup>s inch in diameter were punched in the outer Kapton ply to vent the gas trapped between the Kapton plies. Figure 17 shows a sample grouted in place with the protective Kapton film in place. Another issue was discovered with the use of the protective Kapton film when the cement cured. Because there was no adhesion to the Kapton, as the cement cured it pulled away from the film leaving a small raised lip around the joint, seen around the edges of the samples in Figure 18. The raised lip created a small channel around the sample that could have caused heating augmentation issues. To minimize the potential for heating augmentation the fine edges of unsupported cement were broken off prior to the test run, but there was not a smooth transition from the SiO<sub>2</sub> foam to the test sample. Another concern addressed this test run was the potential issue of trapped gas between the outer protective layer and inner Kapton gas barrier plies auto inflating on tunnel depressurization. To that effect a pair of samples was built up in spare sample holders and placed in the test section outside of the flow near a window. A camera was set up to view the two samples during the run. Unfortunately, vibration of the camera at tunnel startup failed the power cord connection and the samples were not visible. Post-test the spare samples looked unchanged. As for the performance of the tested samples with the Kapton

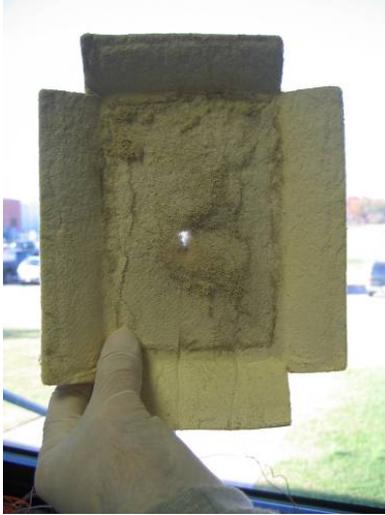
**Figure 20. Position 4, Layup 6, Hole in 6650 insulating ply**

center thermocouple between the top fabric and the insulator ply had bored a hole in the insulator resulting in unacceptable layup performance. Only the location 2 layup 5 sample perform nominally this run versus two in the previous run (see Figure 22.). In locations 1 and 3 the top XN513 fabric as well as the first insulating ply, Refrasil1800, failed shortly after the Kapton top ply burned off (Figure 23. typical). Once again, though, the Pyroel3350 survived exposed directly to the flow nearly the full duration of the run.

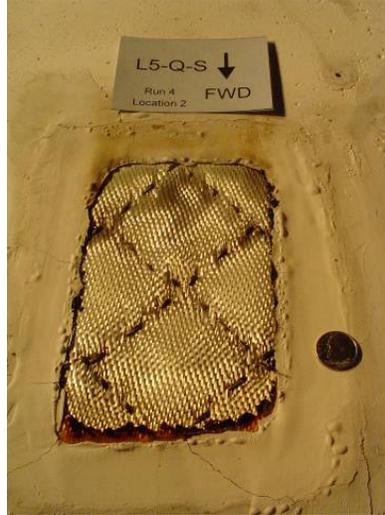
**Figure 21. Run 4, Location 2, Layup 5, post-test.**

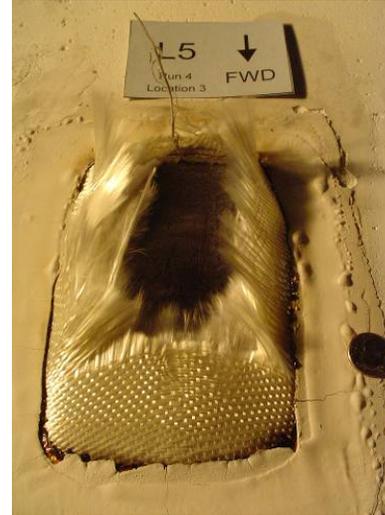
**Figure 22. Run 4, Location 3, Layup 5, post-test.**

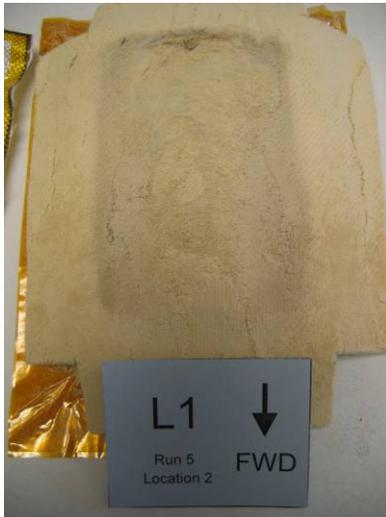
**Figure 25. Run 5, Location 2, Layup 1, Pyrogel 6650 post-test.**

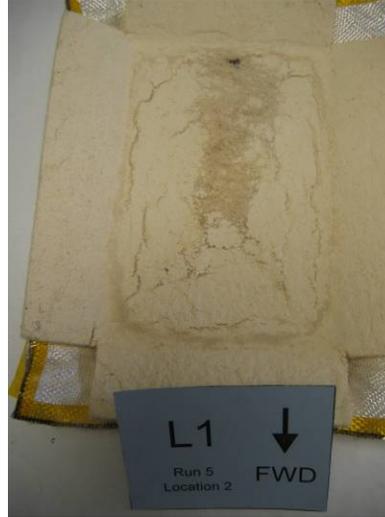
**Figure 26. Run 5, Location 2, Layup 1, Pyrogel 6650 post-test.**

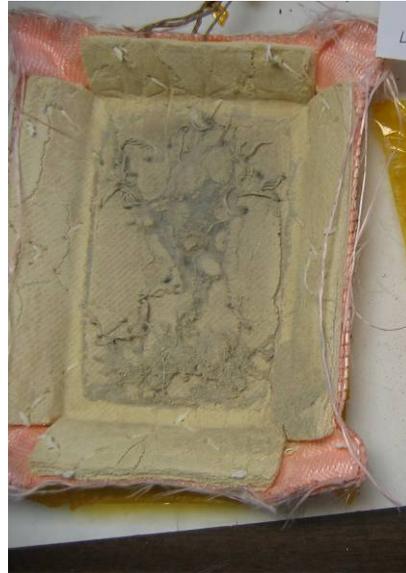
Figure 33. Run7, Location 4, Pyrogel 6650 post-test.

At this point in the testing the low pressure samples had been expended and the decision was made to press on to the high pressure 5°AoA condition. This seventh run with samples was populated with layups 3 and 4 and run time was 100 seconds. A 0.04in thick 2024 aluminum plate was manufactured to investigate protecting one of the ramp samples in the same fashion as the plywood plate in the previous run. Condensation in the test flow obscured the view of locations 9 and 10 at sled injection, so no conclusion can be drawn about the performance of the aluminum plate at location 9. The sample was seen flaring at roughly 7 seconds after sled injection and the thermocouple data indicates total sample failure at that time. Sample location 10, layup 4, survived sled injection and the sample functioned for a short duration. Approximately 10 seconds into the run the top fabric ply, BF20, began to fail. The second fabric ply survived for roughly 50 seconds, but at about 25 seconds thermocouple data between the second fabric ply and the insulator (see Figure 31. T/C 10\_7) exhibited behavior consistent with the T/C boring into the insulator creating a thermal leak path to the underlying Kapton. The thermal short caused the Kapton temperature to climb rapidly to greater than 500°C at which point the sample failed. With a more durable insulator this sample would likely have survived a much longer duration. The sample in location 2, layup 3, showed nominal performance for roughly 30 seconds until the top fabric ply, AF14, began to fail. At that point the heat appeared to have begun to infiltrate the layup and the back Kapton ply temperatures began to rise. Roughly 70 seconds into the test the second AF14 ply began to fail and the entire sample succumbed. The Pyrogel6650 insulator is just not a robust insulator and falls apart rapidly when exposed to vibration and the test flow. The sample in location 3, layup3, survived injection and performance appeared nominal on video for roughly 50 seconds. However, the trailing edge of the sample was definitely hotter than the center of the sample. Video of the sample showed the top fabric, AF14, maintaining integrity for roughly 75 seconds and the second ply letting go at roughly 97 seconds, just 3 second prior to sled extraction, but thermocouple data (see Figure 32.) indicates the insulating ply was losing integrity long before that. At approximately 40 seconds the center thermocouple next to the insulator (3\_3) appears to have bored into the insulator and the back face temperature has begun to rise rapidly. The backface temperature was in excess of 450°C near sled extraction and the sample was on the verge of coming apart. The sample in location 4, layup 4, appeared to be in good shape post test but thermocouple data (see Figure 33.) indicated the insulating ply was severely degraded throughout the run. Examination of the sample out of the holder post test revealed that much of the impregnated aerogel was out of the batt (see Figure 34.). Again had a more durable insulation been used in this layup this sample would likely have performed well. The sample in location 5, layup 4, survived sled injection, but began to lose the top ply, BF20, roughly 35 seconds into the run. The second ply survived the remainder of the run, but thermocouple data indicated the insulator ply was deteriorating throughout the run.

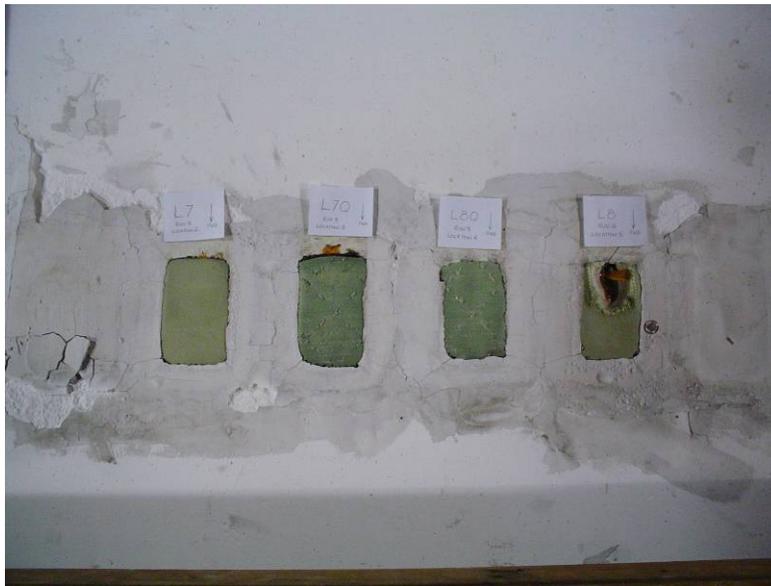
Figure 34. Run 8, forward locations post-test.

layups 7 and 8 respectively failed seconds after reaching the centerline. The sample in location 5, layup 8, the top fabric, Refrasil1554, failed at roughly 39 seconds and the insulating plies Refrasil2000 and Pyrogel6650 failed

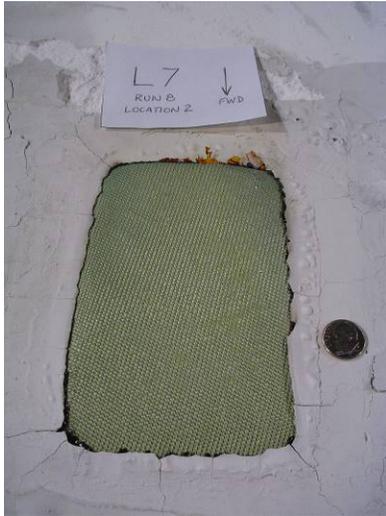
Figure 35. Run 8, Location 2, Layup 7 post-test.

seconds after that. The samples in locations 2, 3, and 4, Layups 7, 7, and 8 respectively survived the entire albeit curtailed run with near nominal performance (see Figures 36, 37 and 38.). The Refrasil1554 on the surviving samples was worn post-test and it was questionable as to whether those fabrics would have survived a full duration (100sec) run.

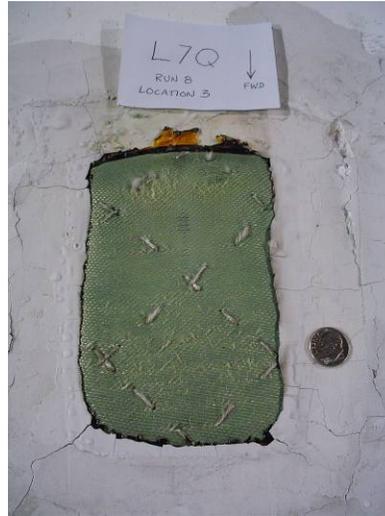
Figure 36. Run 8, Location 3, Layup 7 post-test.

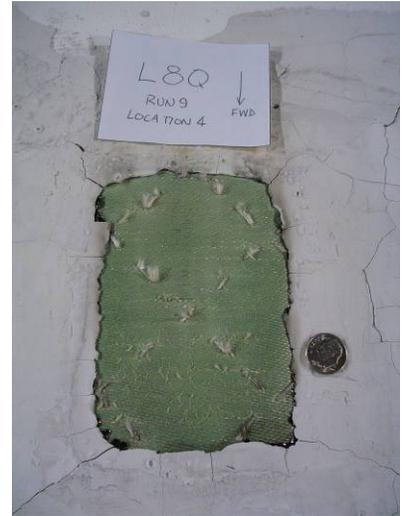
Figure 37. Run 8, Location 4, Layup 8 post-test.

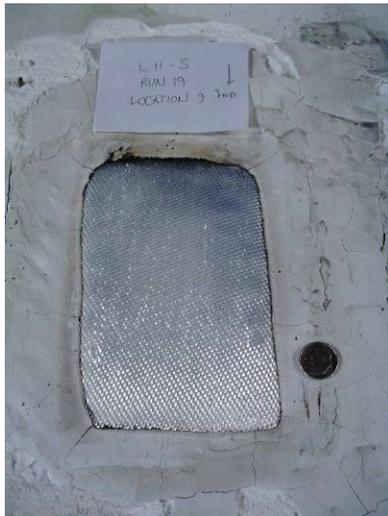
Figure 38. Run 9, Location 9, Layup 11 post-test.

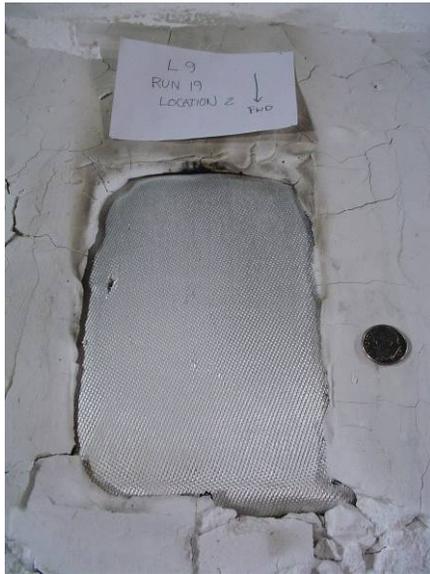
**Figure 40. Run 9, Location 2, Layup 9, post-test.**

The ninth run with samples was a high pressure run at 5° AoA populated with layups 9 and 10 as well as two hybrid layups (11 and 12) built to for the aft locations. The hybrid layups incorporated Upilex gas barrier plies between the outer fabric plies. Sled injection went nominally on the first try, so it seemed our trouble with tunnel gremlins was finally over. Sample location 10 did not survive more than a couple of seconds after the Kapton ply burned off. Surprisingly sample location 9, layup 11, survived the entire run (see Figure 39.) with phenomenal performance, the backface temperature hardly changed throughout the test (see Figure 40.). Sample locations 4 and

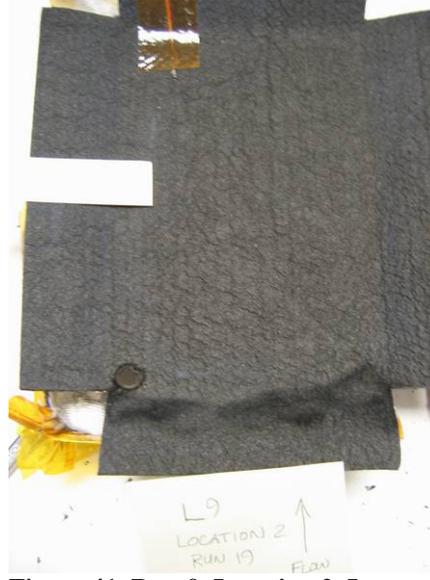
**Figure 41. Run 9, Location 2, Layup 9, KFA5 ply, bottom, post-test.**

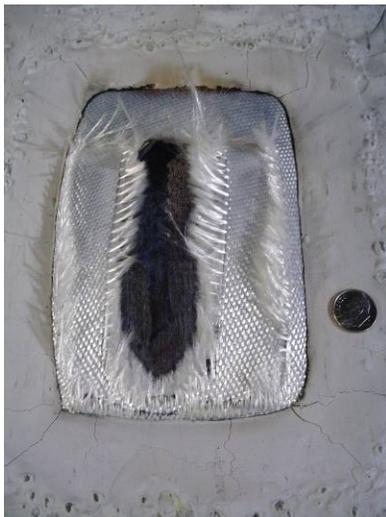
**Figure 42. Run 10, Location 11, Layup 11, post-test.**

charred in the location of the jet impingement, discovered when the samples were examined post test (see Figure 42.).

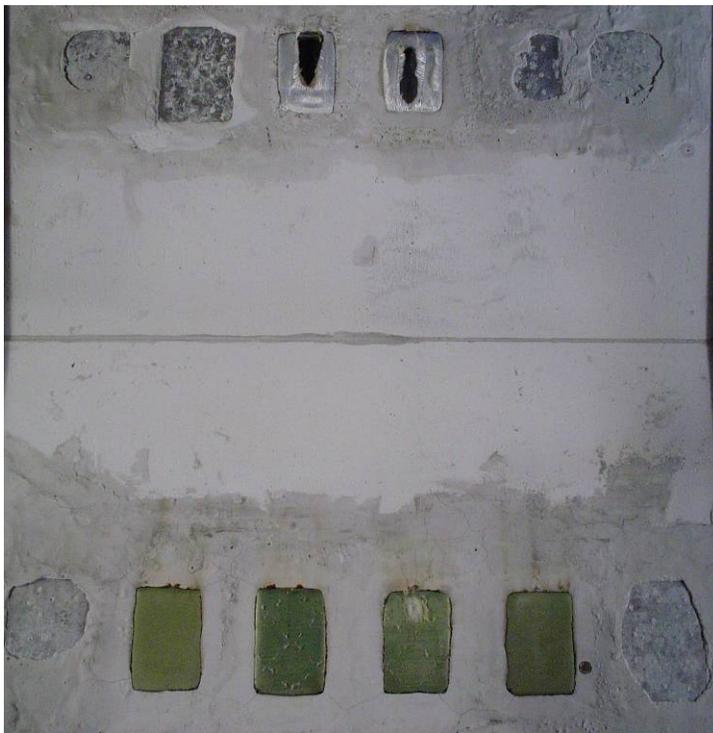
**Figure 44. PAIDAE sled test surface post-test series.**

performance. Sample location 4 survived the full duration of the run, but with a minor burn through of the 1554 top fabric at the center of the aft edge of the sample. The fact that these samples were not subjected to multiple tunnel aborts prior to testing was likely a contributing factor to their success. Figure 45 shows the PAIDAE sled test surface post-run. This picture captures the degraded state of the SiO<sub>2</sub> test surfaces at the end of the test series.
