Cynthia Snoddy

USA/MSFC Chief Engineer
Program Integration

August 2010

Main Propulsion Test Article (MPTA)

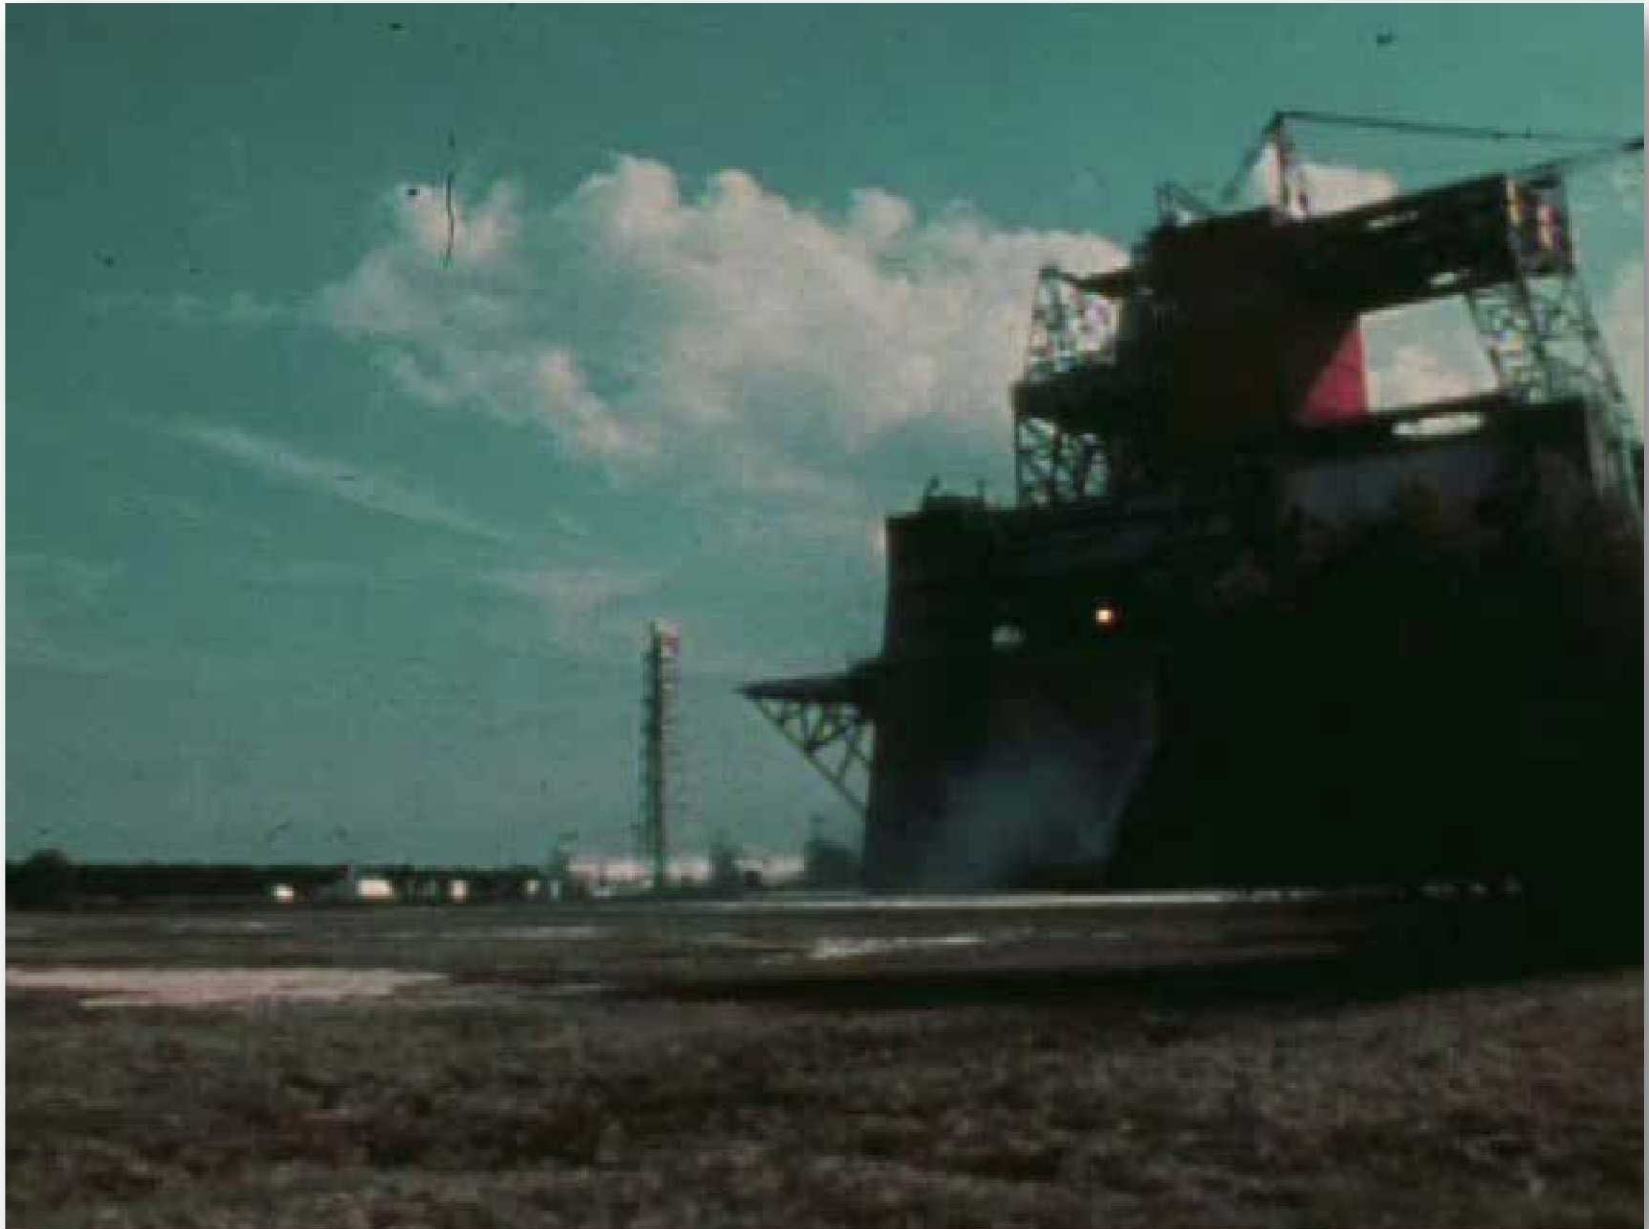
- Scope:
 - The Main Propulsion Test Article integrated the main propulsion subsystem with the clustered Space Shuttle Main Engines, the External Tank and associated GSE. The test program consisted of cryogenic tanking tests and short- and long duration static firings including gimbaling and throttling. The test program was conducted on the S1-C test stand (Position B-2) at the National Space Technology Laboratories (NSTL)/Stennis Space Center.
 - 3 tanking tests and 20 hot fire tests conducted between December 21, 1977 and December 17, 1980
- Configuration:
 - The main propulsion test article consisted of the three space shuttle main engines, flightweight external tank, flightweight aft fuselage, interface section and a boilerplate mid/fwd fuselage truss structure.
