Applied Physics Lab Kennedy Space Center: Recent Contributions

Presentation to the
Florida Institute of Technology

January 20, 2006

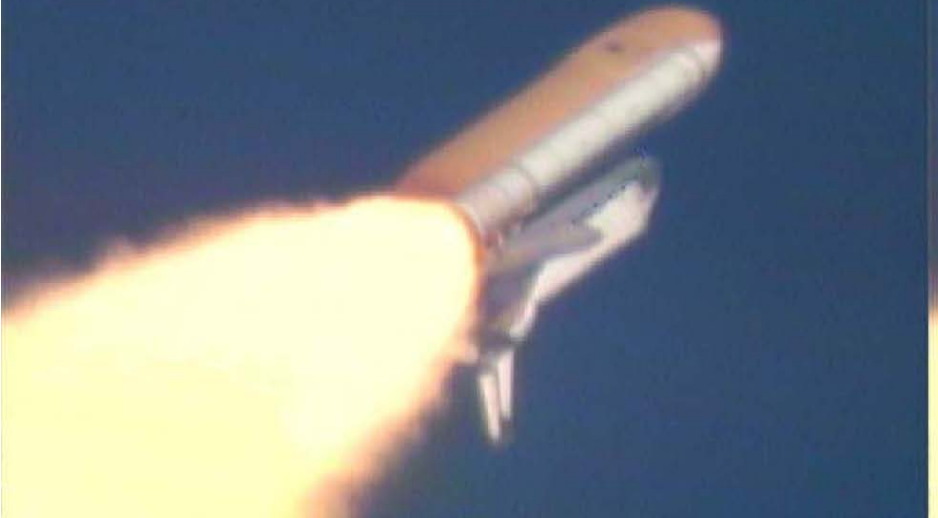
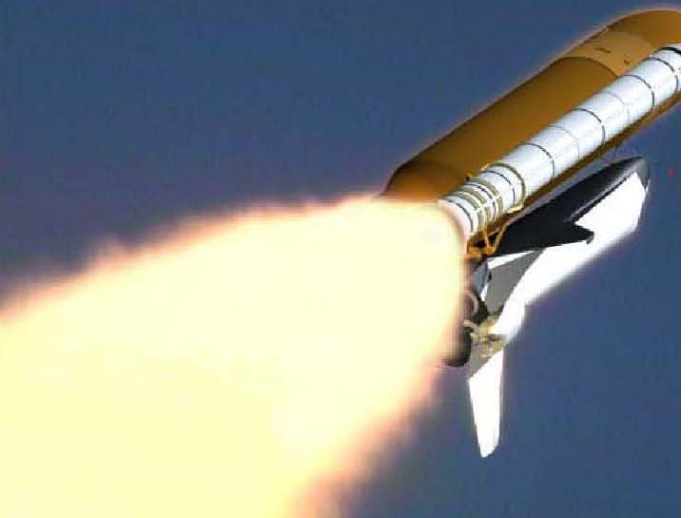
- Analysis of the debris impact velocity and location requires:
 - Scaling: Identification of the size and orientation of the vehicle in the images.
 - Identification of the location of the object's cg within that frame (assumed to be inertial).
- Scaling performed by matching images to a Lightwave 3D graphics model.
- Object identified by analyzing the difference of a background image and the 11 frames in which it appears.
- Object location defined along two intersecting rays (as 2D coordinates in planes normal to the camera to Shuttle vectors).
- Smoothed size, position and velocity solutions compared with wing images “painted” onto 3D model.

E212 Camera Source

ET208 Camera Source

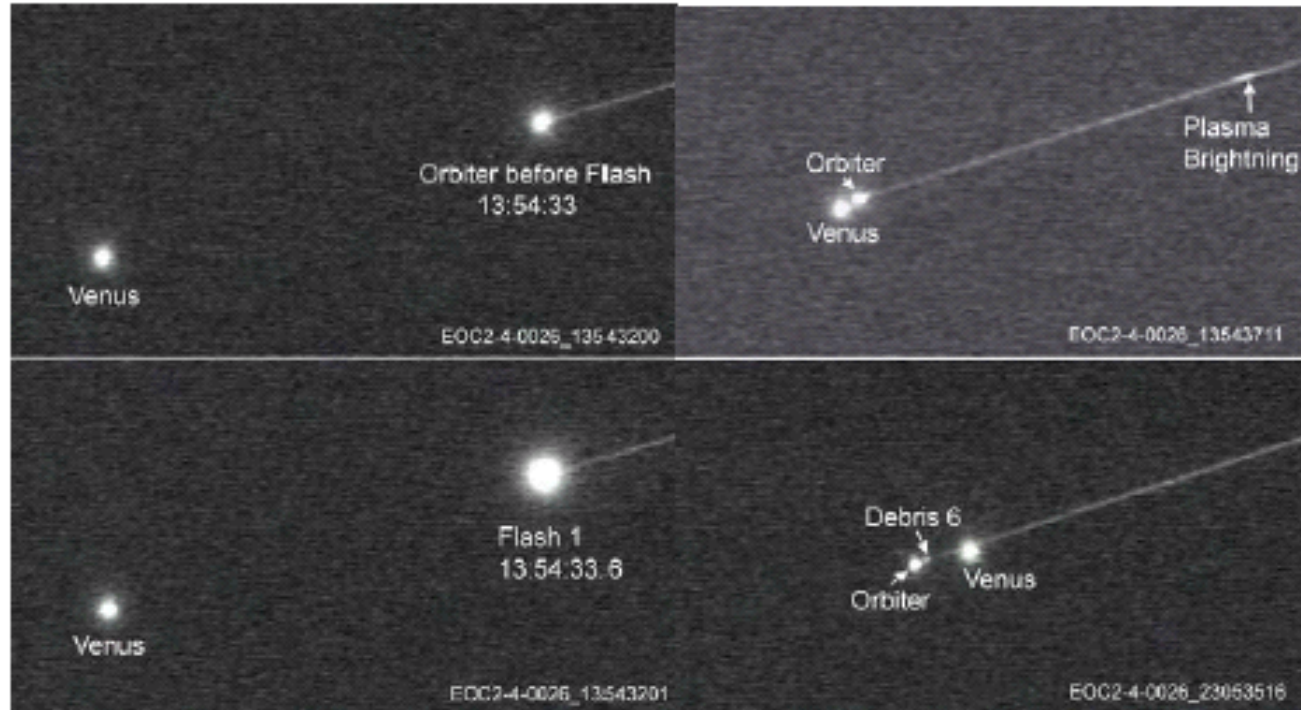
Debris event 6. Images from Sparks, Nevada looking southeast.

1. In some cases the brightness of the Orbiter, plasma trail, and debris can be found.
2. If field of view is known, then the relative position of the debris can be calculated.
3. In some limited cases color information is available.

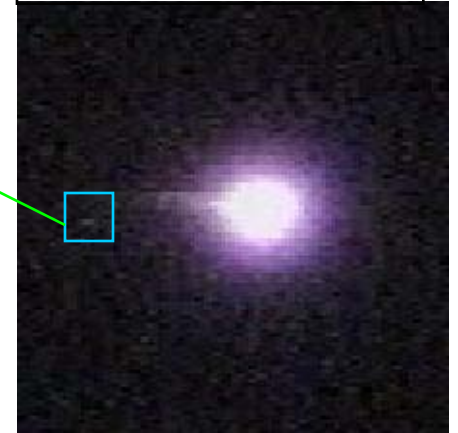
Fairfield, CA: Debris 1

Debris 1
(tile size)
Barely
detectable

Short duration yields a deceleration of $280 \text{ m/sec}^2 \pm 40 \text{ m/sec}^2$

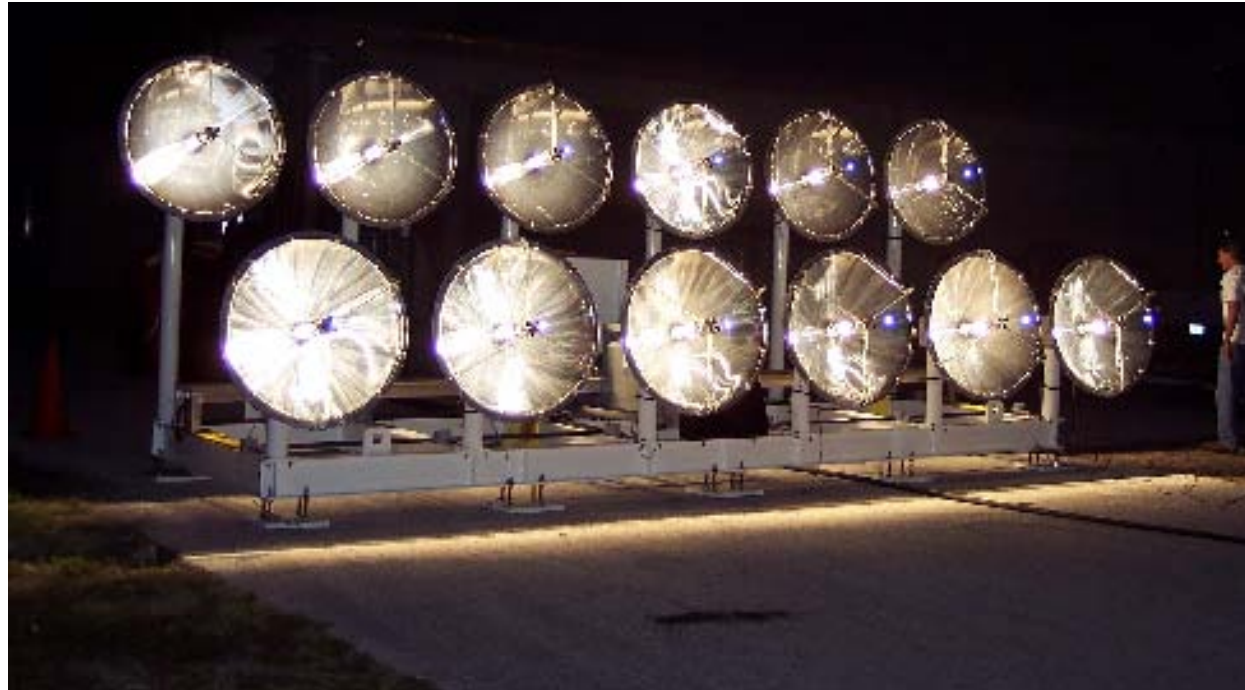
IR Heat Projector System

- IR Heat Projection as a Method for Minimizing Condensation and Ice on the External Tank and ET Feedline LOX Bellows and Brackets.

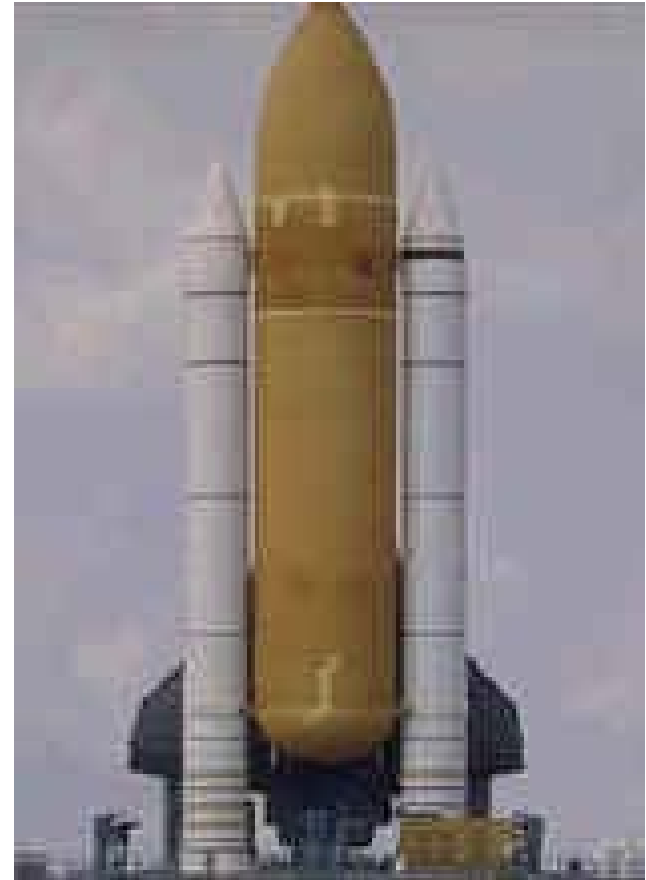
That's 2.5 meter radius with 330 Watts/m²= 6500 Watts.

We need **6500 Watts** projected into this area from 500 feet away.

External Tank is 27.6 feet in diameter, 154 feet long.

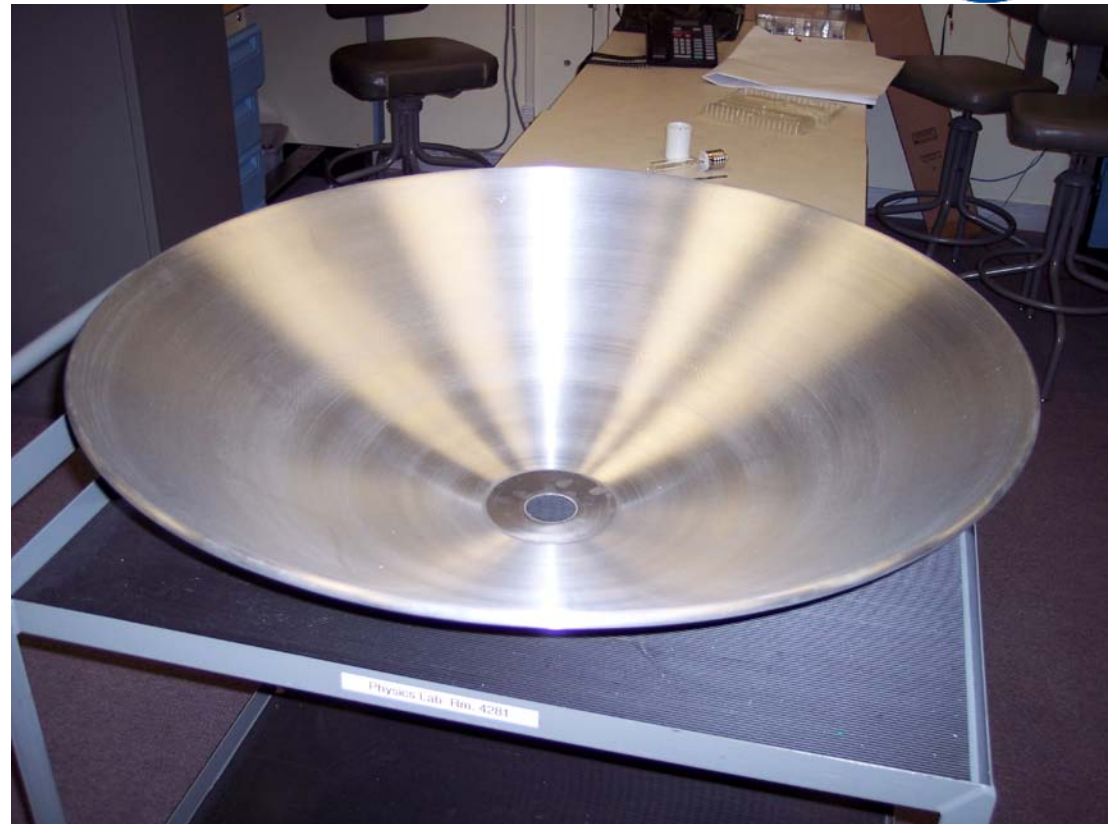
We are proposing to use three foot parabolas for the system.

These parabolas will be polished and mounted on a rugged adjustable alt-azimuth mount.

A three foot diameter parabola with a rough surface.

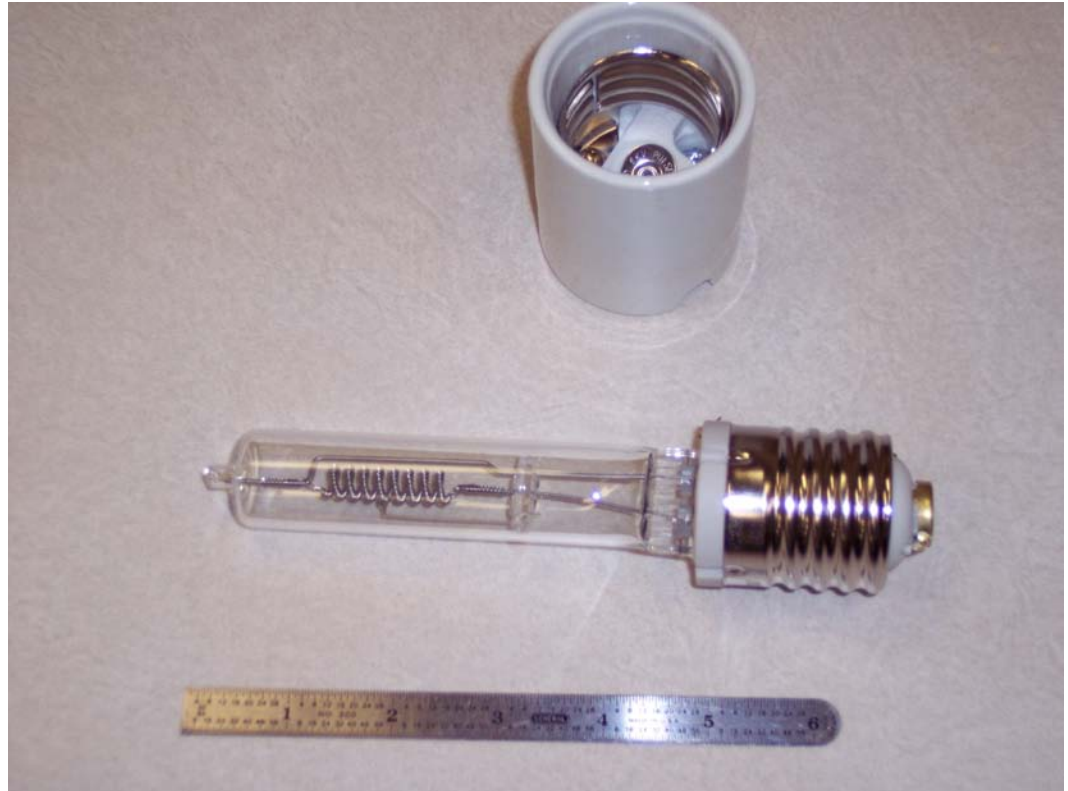
We are proposing to use 2000 Watt, 120 Volt bulbs. We have located these as well as the mating sockets. Sufficient quantities can be on hand within two weeks of ordering. The cost is about \$100 each for the bulbs and \$9 each for the sockets.

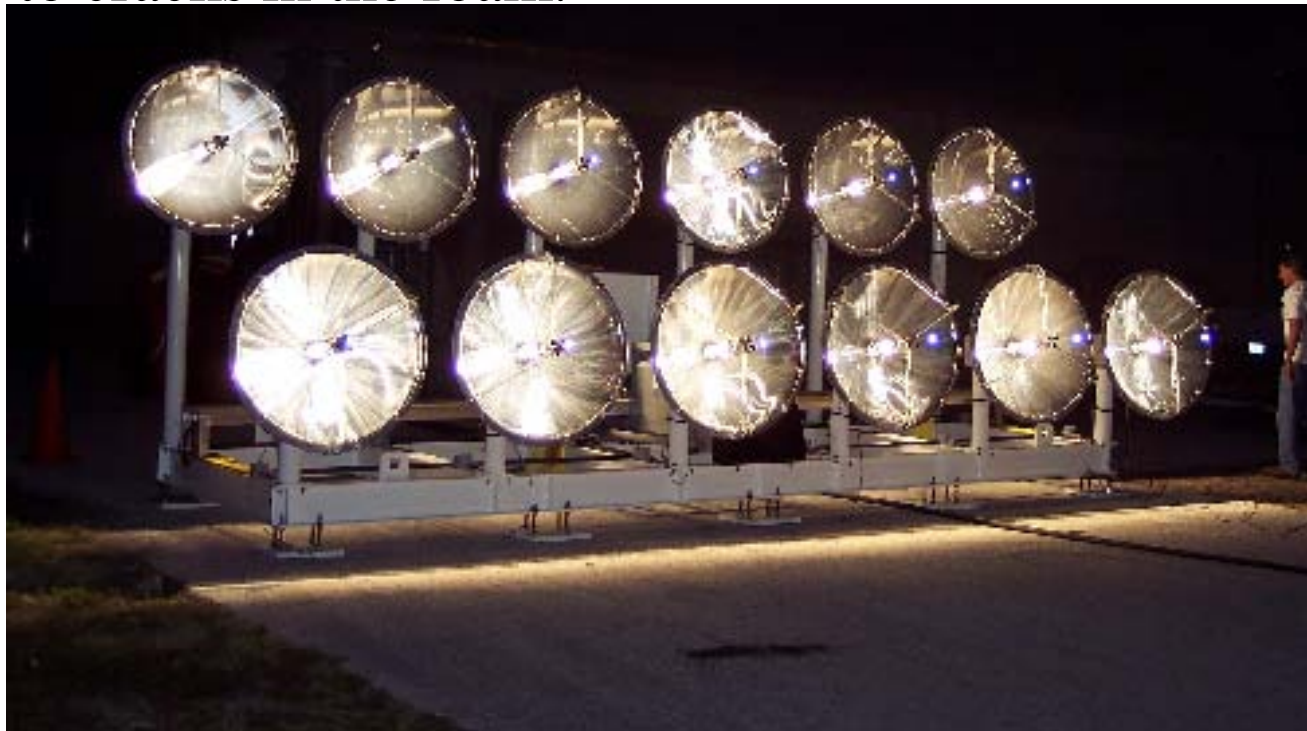
IR Heat Projector System

- System was successfully built and tested on schedule.
- System was not implemented due to decision to replace the ET after TT#1.
- New ET had heaters installed at LOX Feedline Bellows.
- System may be used in future to mitigate “ice balls” due to cracks in the foam.

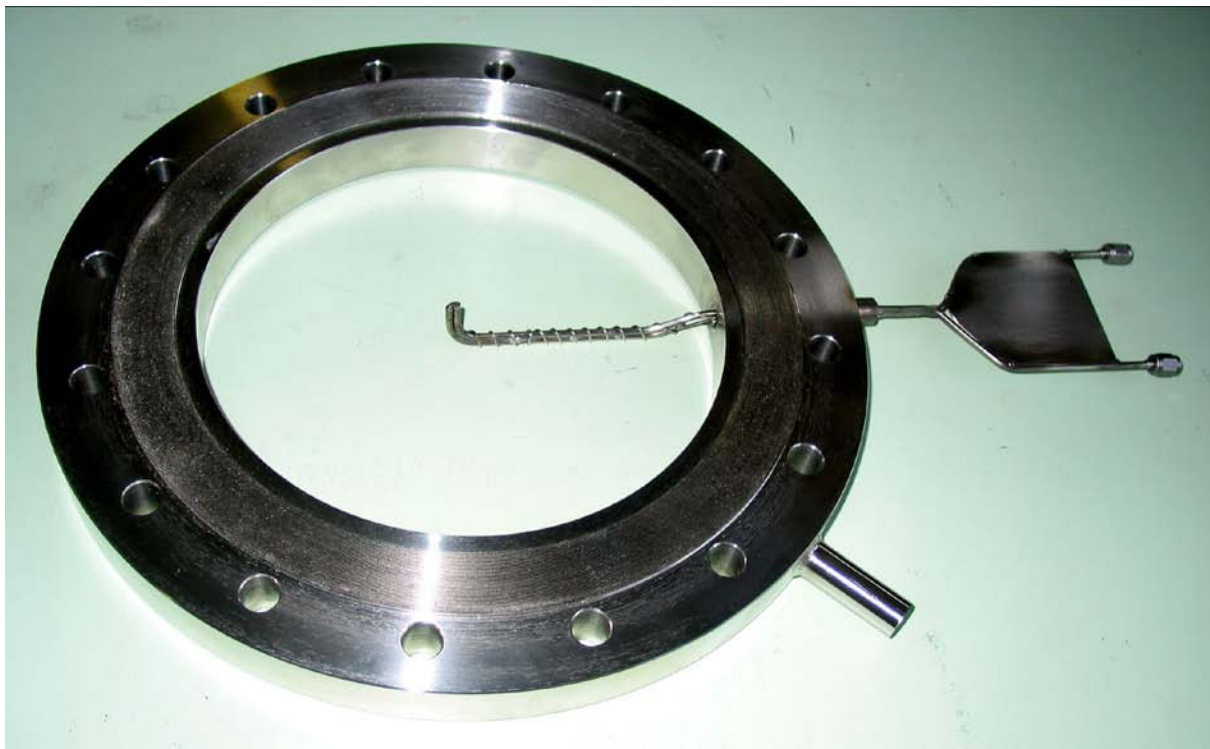
- Excessive He pre-press cycles were experienced during STS-114 tanking test #1 (4/14/05)
- Pitot measurement built and delivered in less than 4 days for TT#2: only measurement of possible vent valve leakage.
- Pitot results confirmed that the ET Vent valve did not leak to within limits of detection.

- Pitot system successfully ruled out Vent Valve leakage on ET120 during two pre-press cycles of TT#2.
- System designed built and flow tested in 4 days.

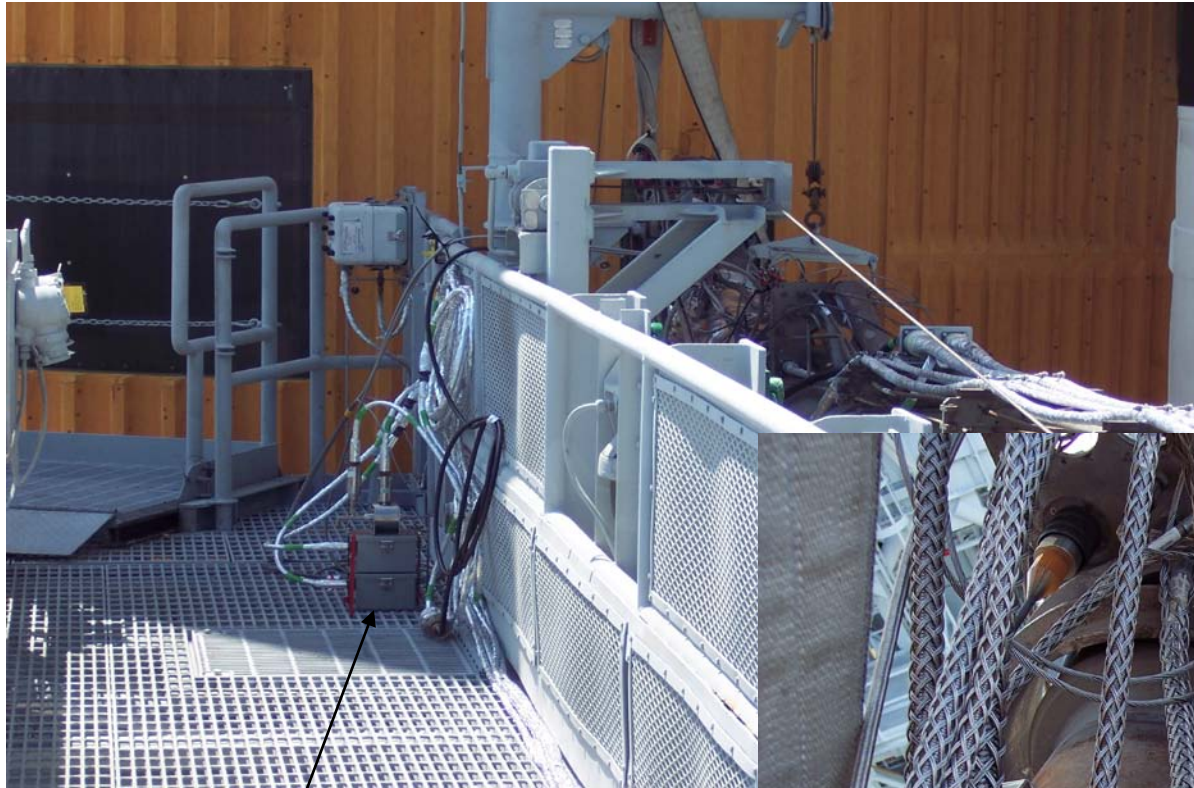
LETF Test Setup

Pitot Tube

Hard Line

Forward
Flex Hose

7" QD

Transducers and cabling
to GMS2

Pitot spool
piece installed
in Vent line

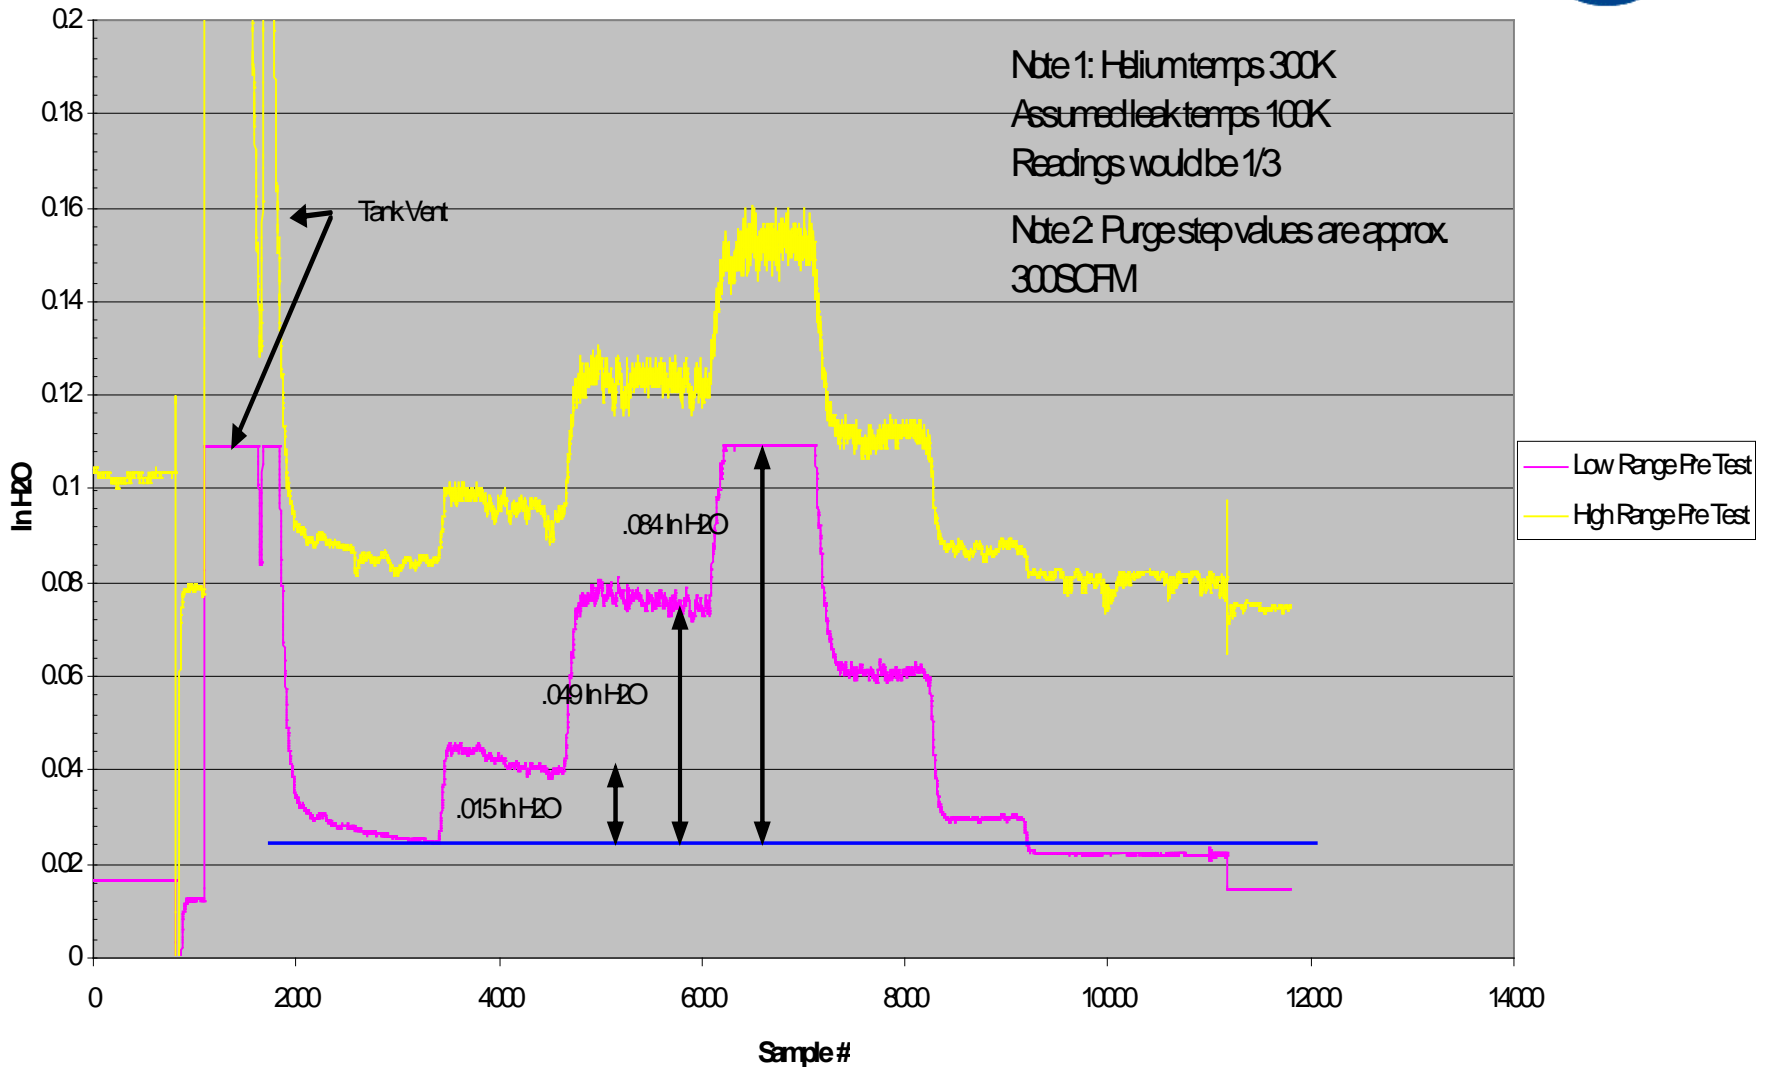
Pre Test Confidence Checks

Helium purges flow through the empty LH2 tank and out vent line

- Measurements tracked to changes in purge flow
- First step was 329 SCFM, measured 264 SCFM using Low Pitot (20% error)
- Second step 329 SCFM, measured 342 SCFM using Low Pitot, (4% error)
- Third step 258 SCFM, measured 233 using High Pitot, (10% error)
 - Low Pitot was at high range of 0.11 inch during peak purge
- Pitot system functioned properly after TT#2 drain

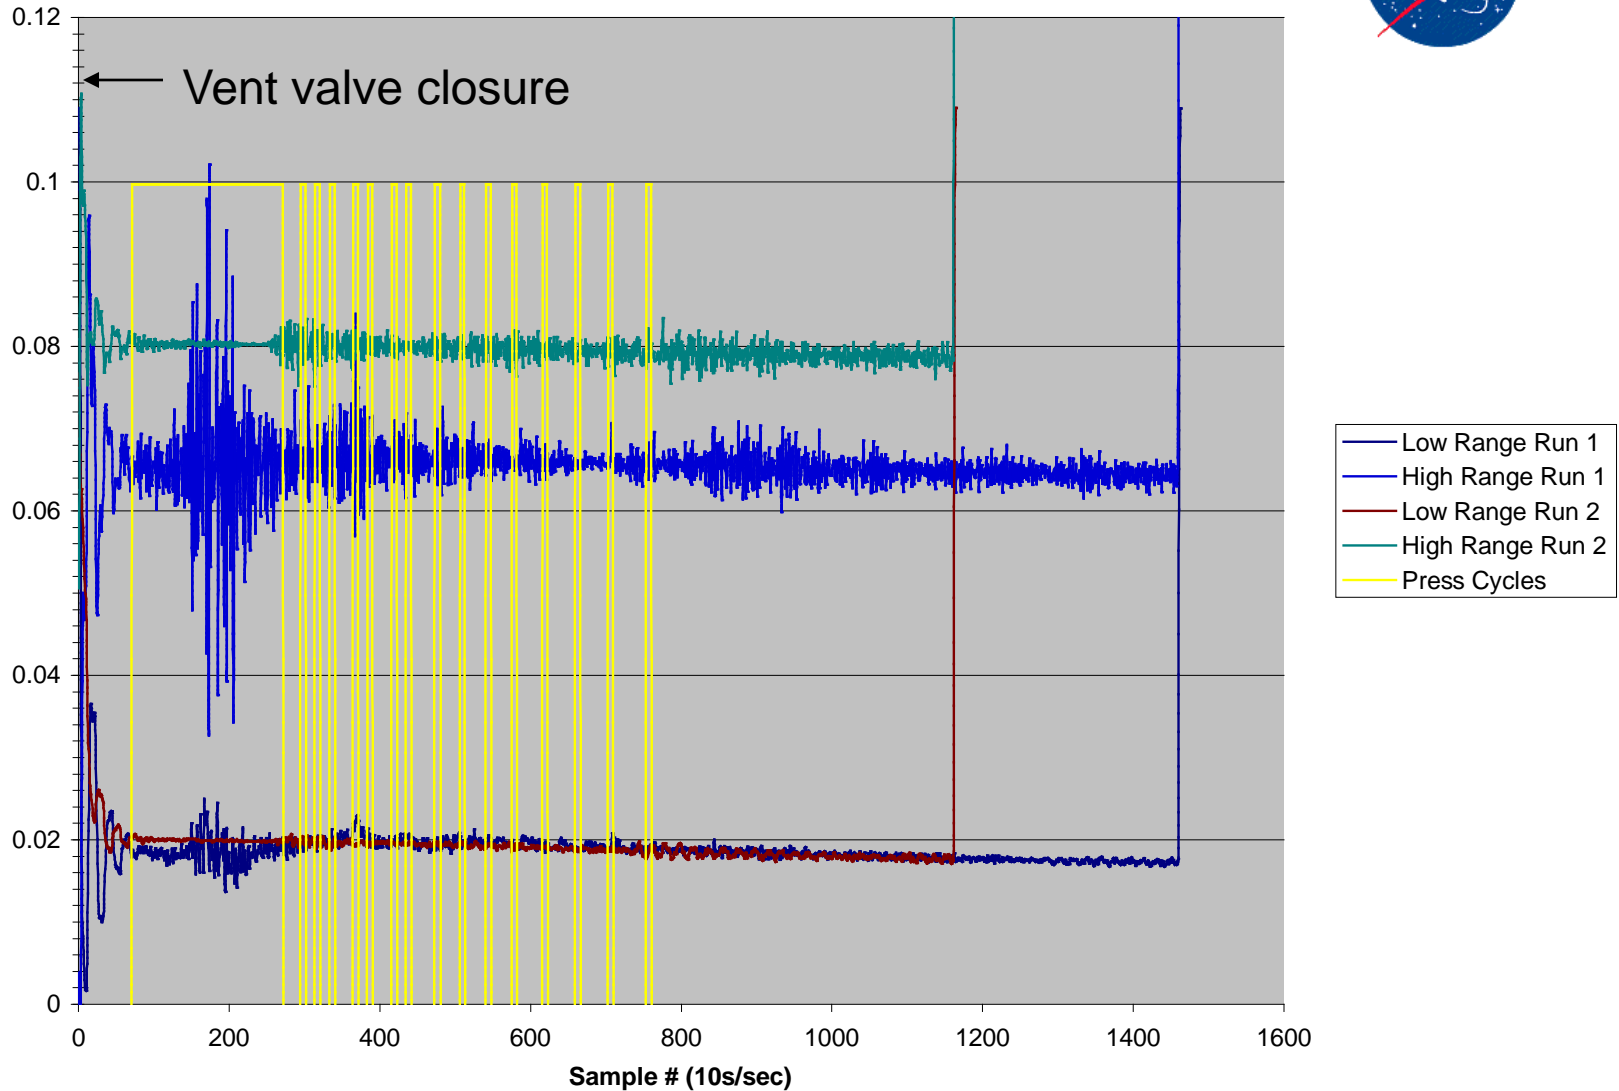
Image shows overlay of two Pre-press cycles TT#2:
Noise amplitude higher on less sensitive measurement!

- No ET Vent Valve leakage detected within limitations of instruments.
- Instrumentation performed as expected except some zero drift in high range Pitot
- Post ET vent closing oscillations caused by “organ pipe” resonance (expected behavior of flow stoppage)
- Unknown noise source during first Pre-press appears to be electronic noise.

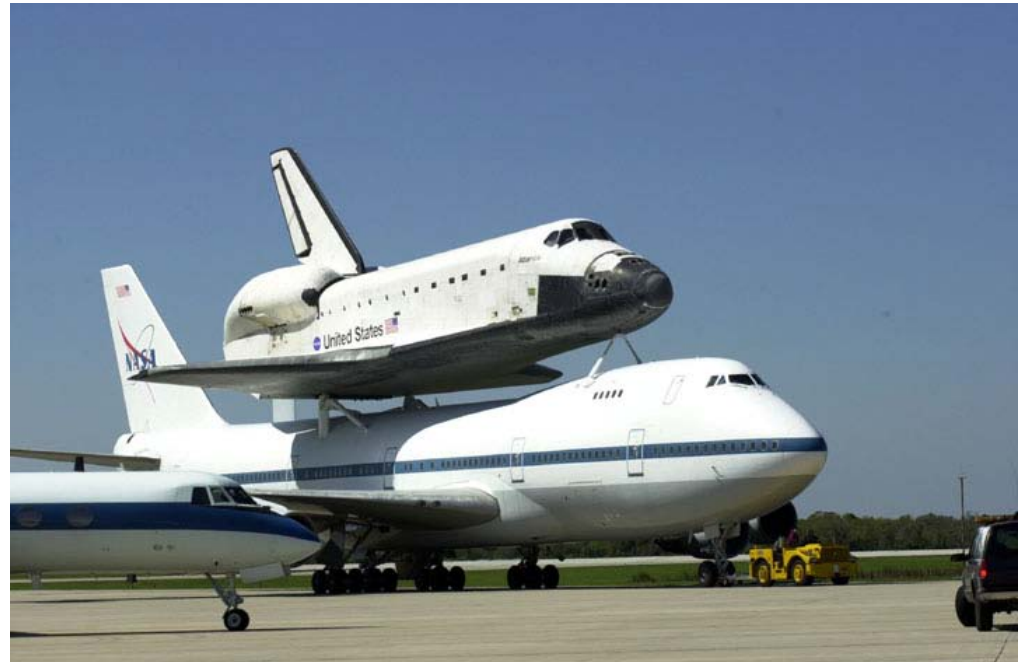
Atlantis returning to KSC in March of
2001 after landing in California.

In March of 2001
Atlantis landed in
California and was
exposed to severe
rain.

This resulted in
excessive absorption
of water by the
Orbiter tiles.

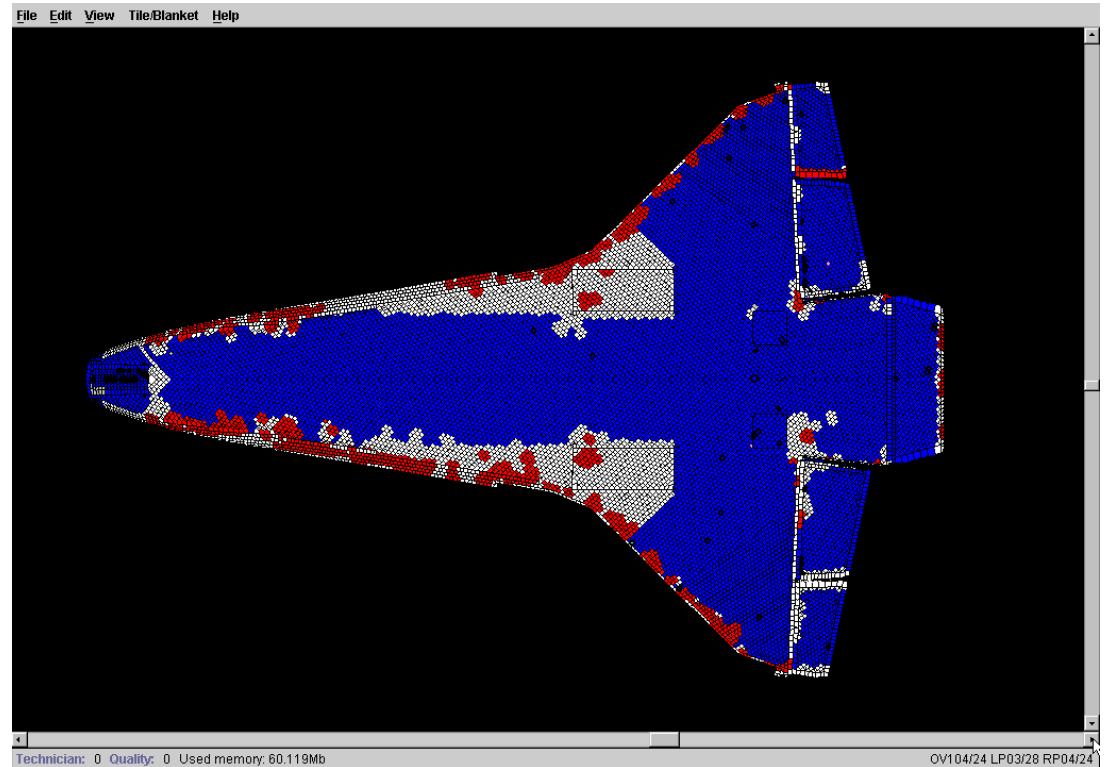
Wet tiles were found by using an infrared camera to locate cold regions due to the evaporation of water.

The blue areas indicate wet tiles on the underbelly of Atlantis.

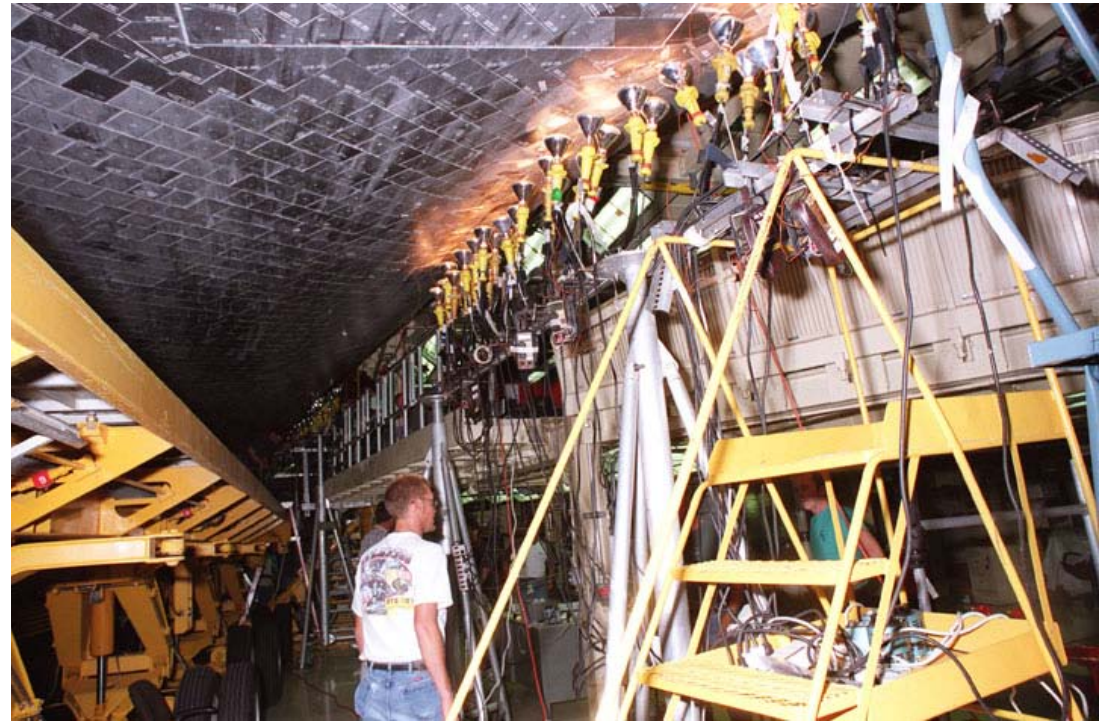
The water was then removed by boiling it out, tile-by-tile, using heat lamps.

Heat lamps being used to dry tiles on Atlantis.

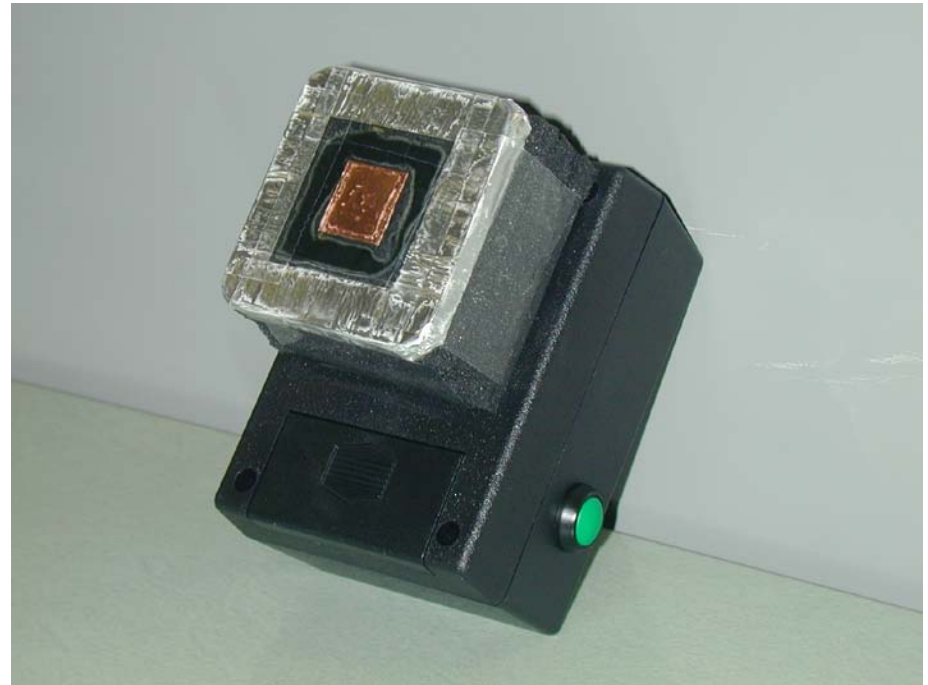
So a simple capacitive sensor was fabricated and given to Shuttle engineers to try out.

Concept version of capacitance based water detector for Shuttle tiles showing the detection electrode.

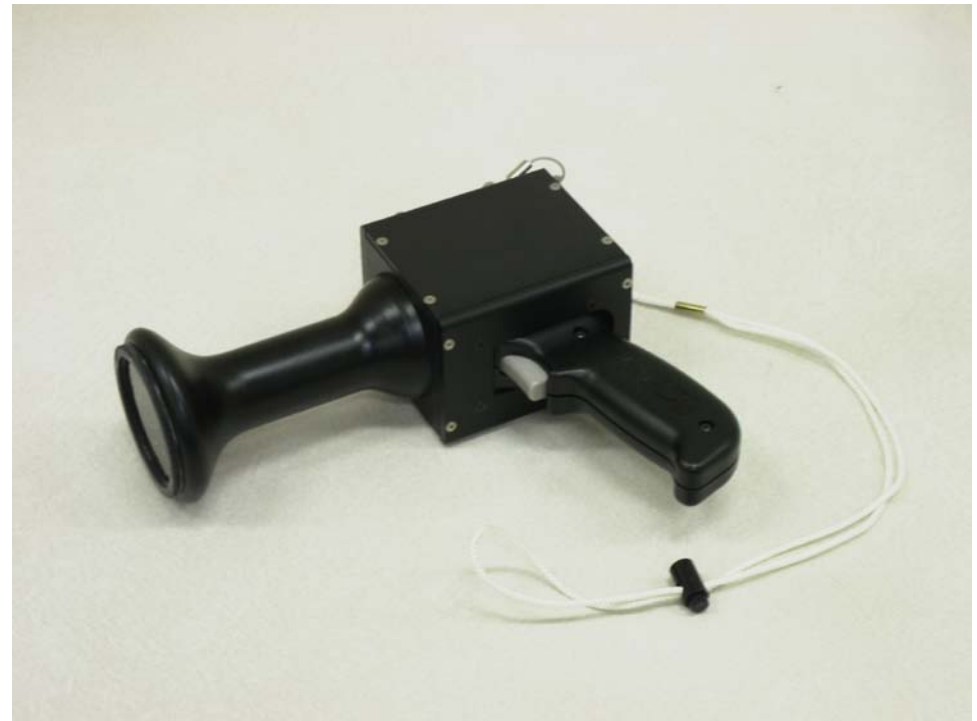
Two levels of
sensitivity for thick or
thin tiles,

Field version of the capacitive tile
water sensor.

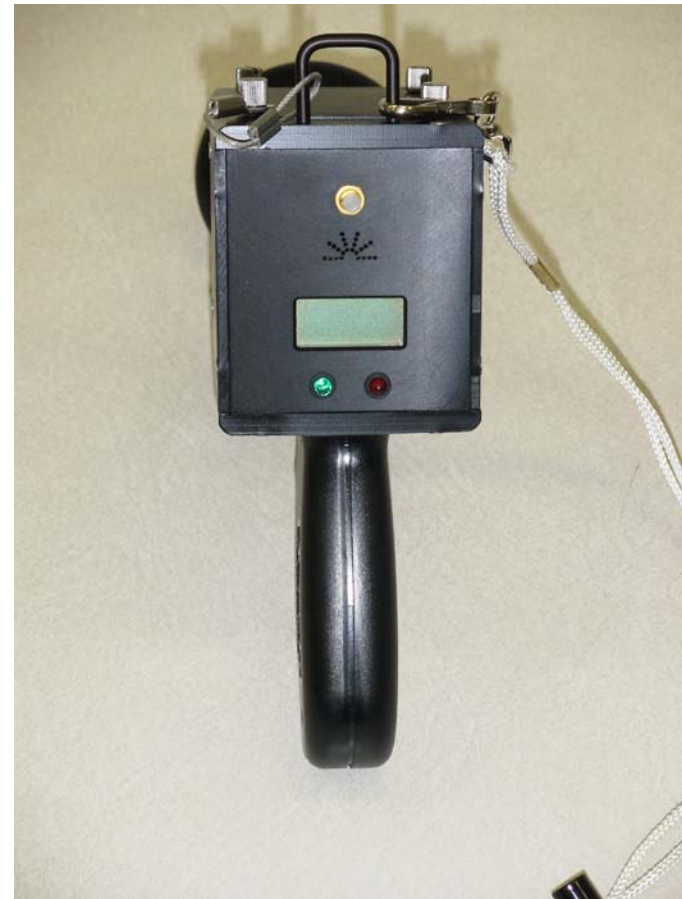
An audio alarm indicating water.

Back of field prototype sensor.

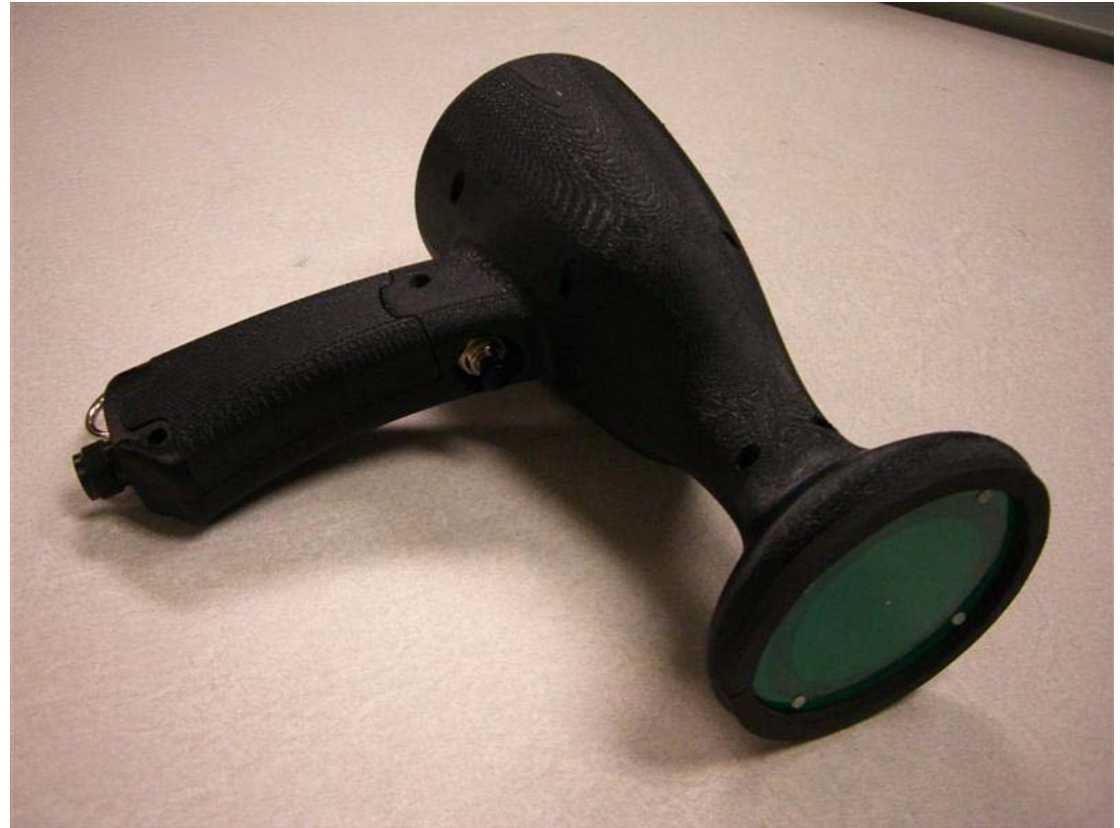
ABS Plastic

Smaller Handle

Four of these are now shop aids and have been delivered to Shuttle personnel.

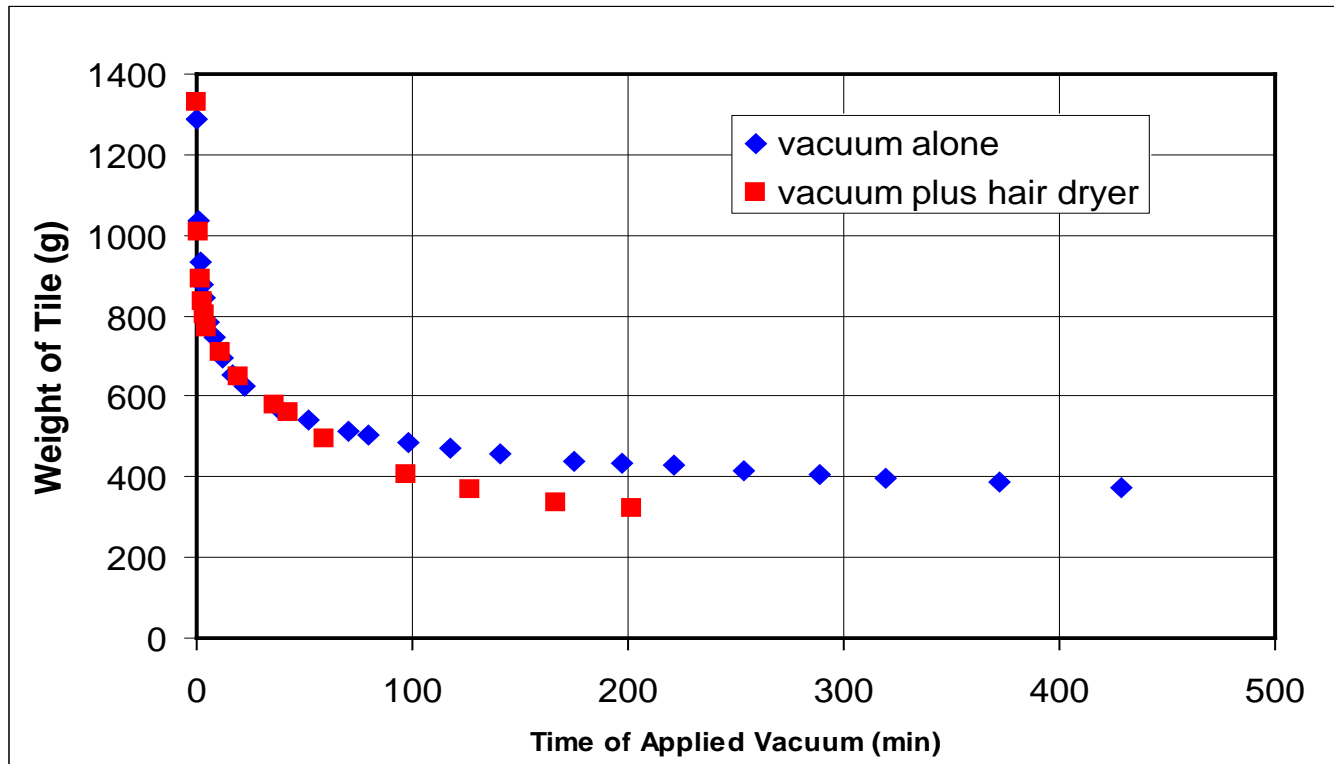
A plot of tile weight versus time while being vacuum dried (dry weight is about 235 grams). Heat improves the drying rate, but the majority of the water is removed in the first hour regardless of heating.

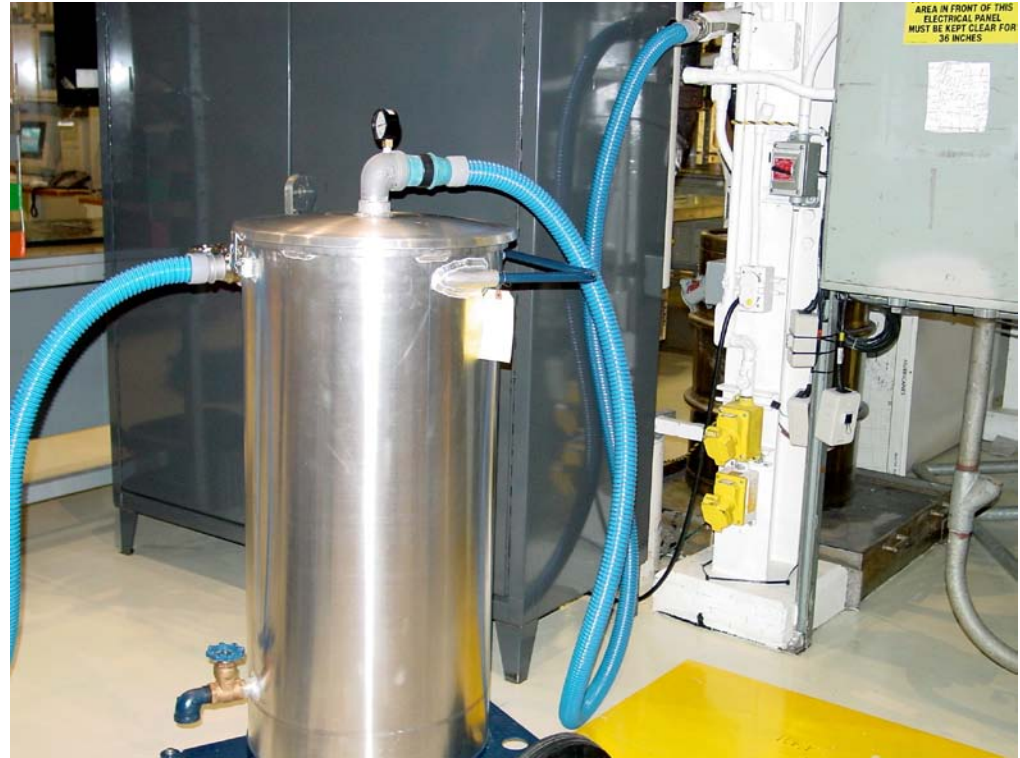
We then developed a field prototype, designed to pump water from 25 tiles at a time using the facility vacuum system within each of the Orbiter Processing Facilities.

Field system water separator attached to facility vacuum system.

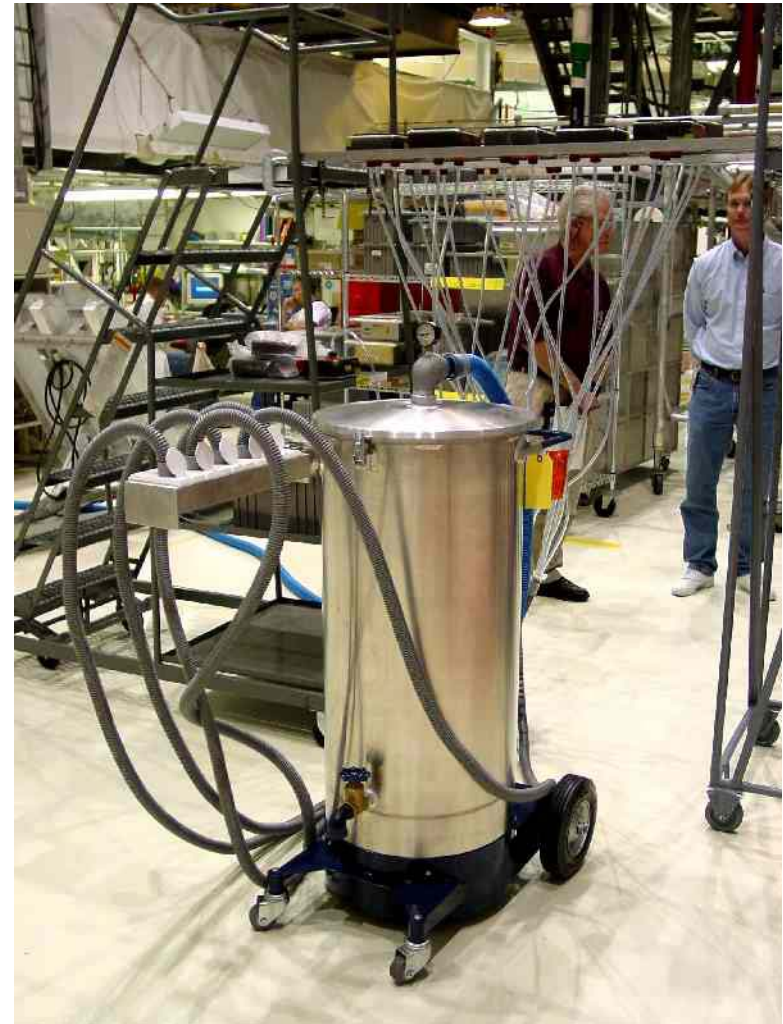
2003 demo in OPF 1 on ten wet tiles

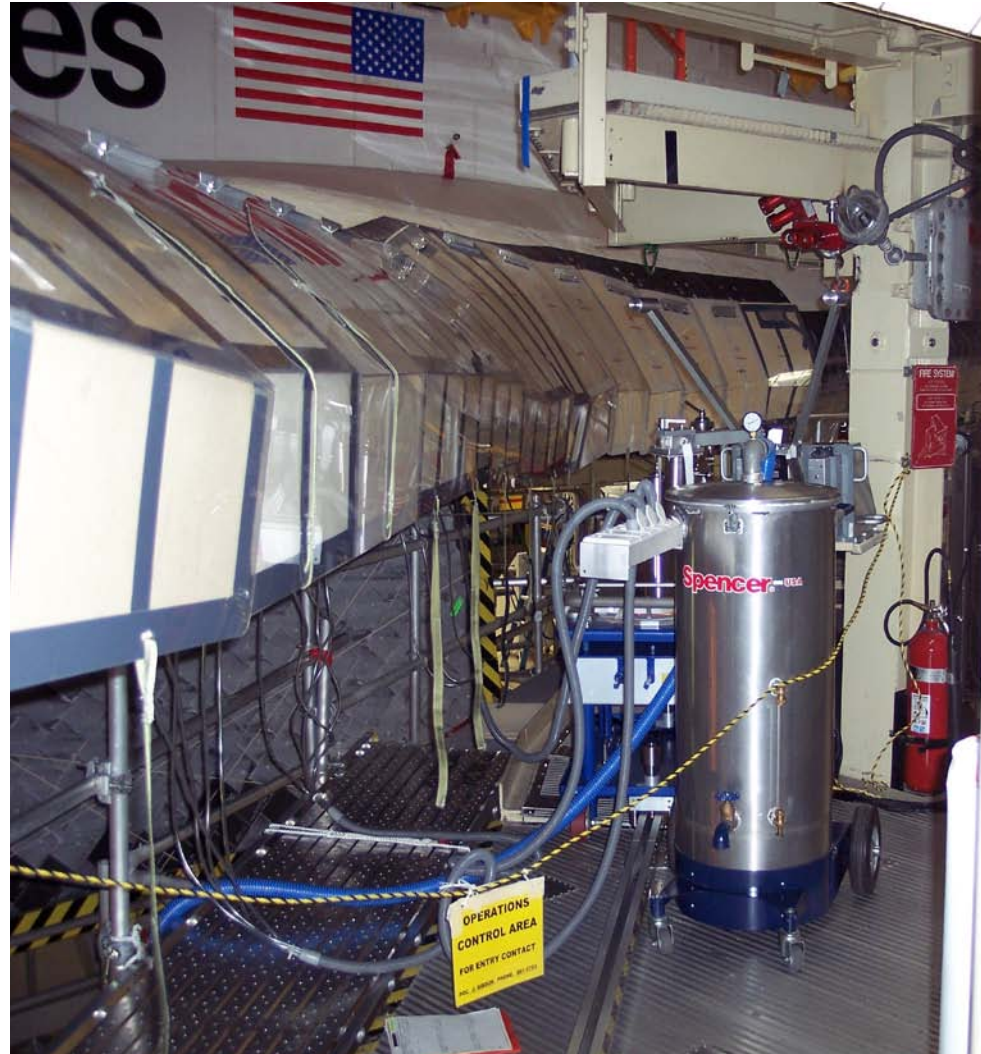
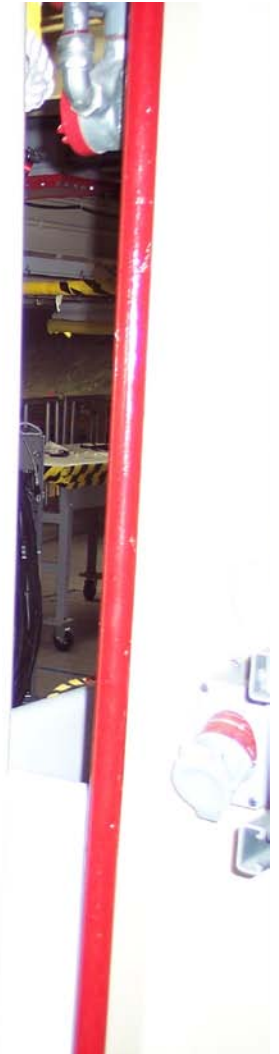
Water Removal From Shuttle Tiles

The system on a platform in front of the right wing of Discovery.
