Applied Physics Lab Kennedy Space Center: Recent Contributions

Presentation to the
Florida Institute of Technology

January 20, 2006

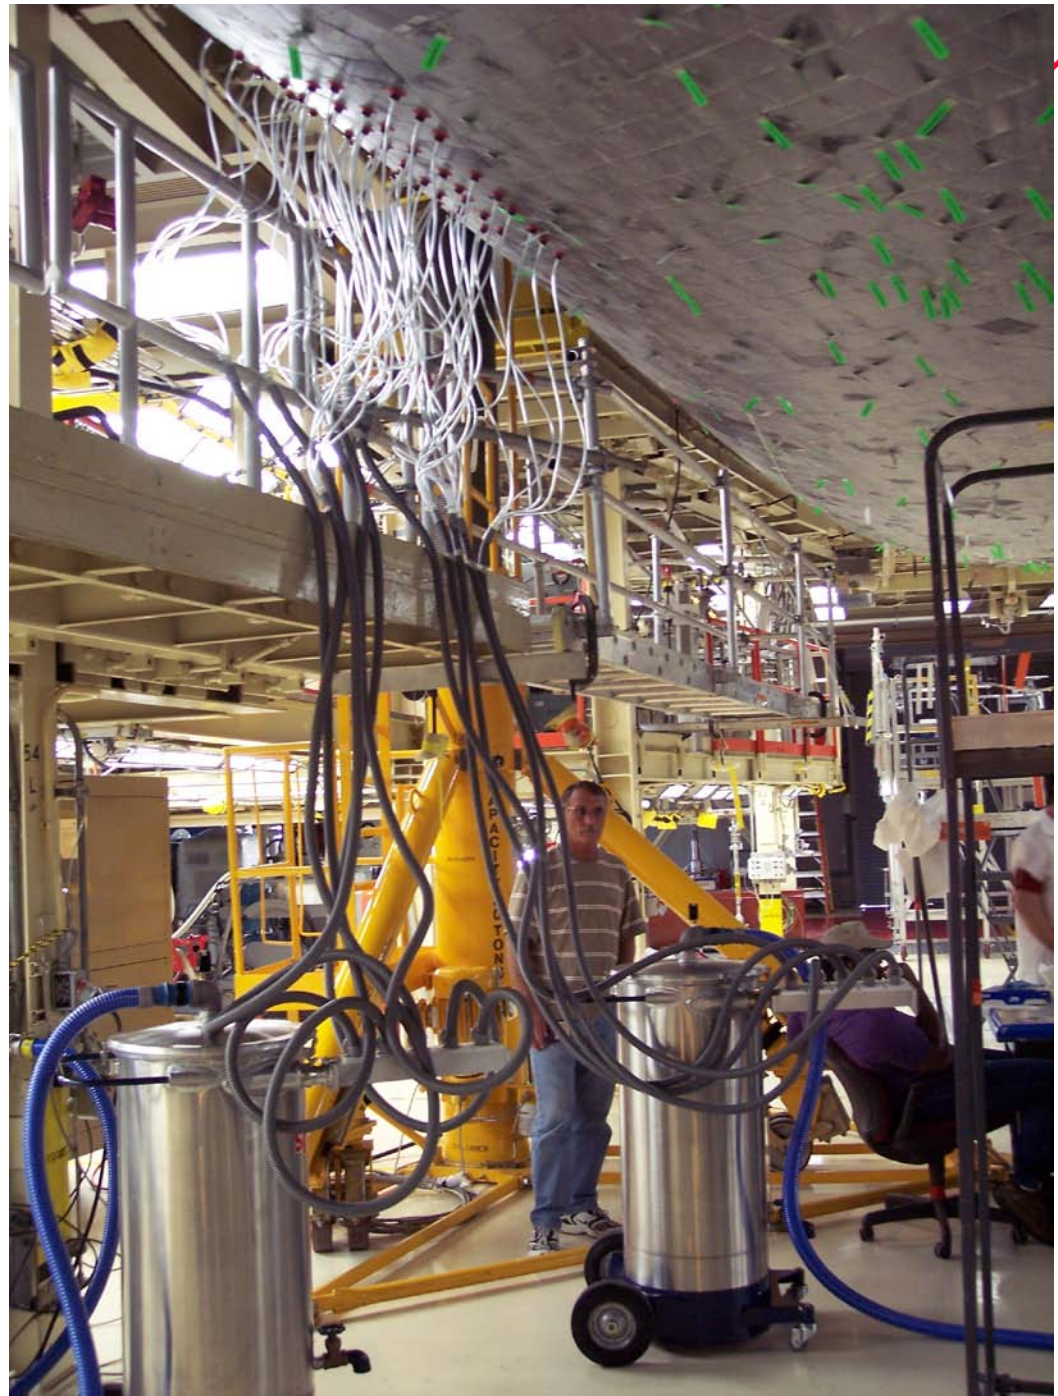
50 tiles being dried
on Discovery's left
side. Sept. 2005

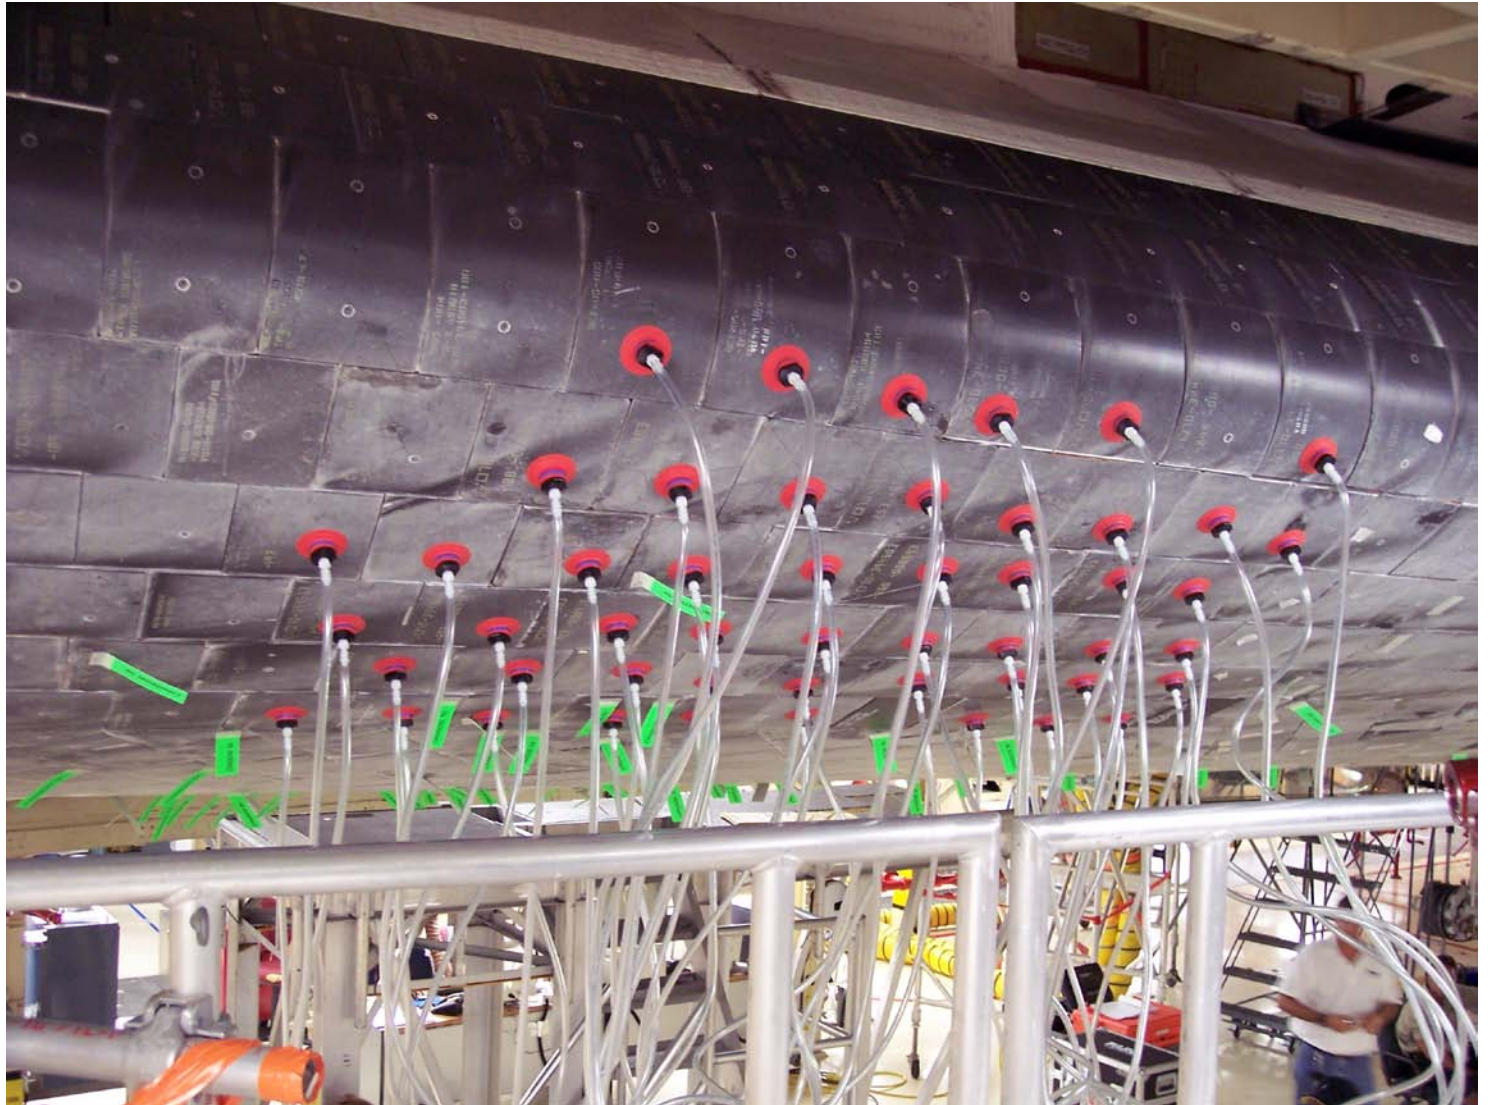
50
Tiles
being
dried.

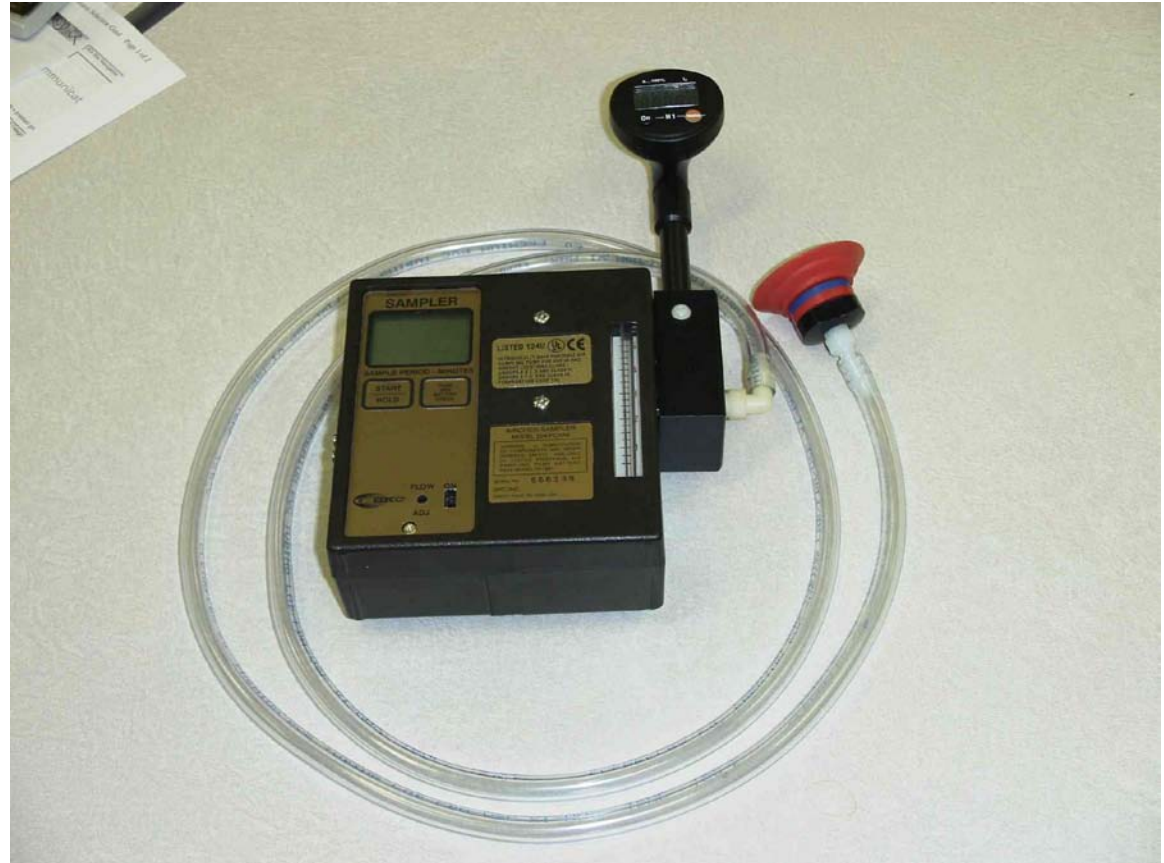
The unit to the right can be used to locate residual water, but pulling an air sample from an enclosure and measuring the humidity of this air.

Four of these were delivered as shop aids earlier in the year and are being used in the field to locate hidden water.

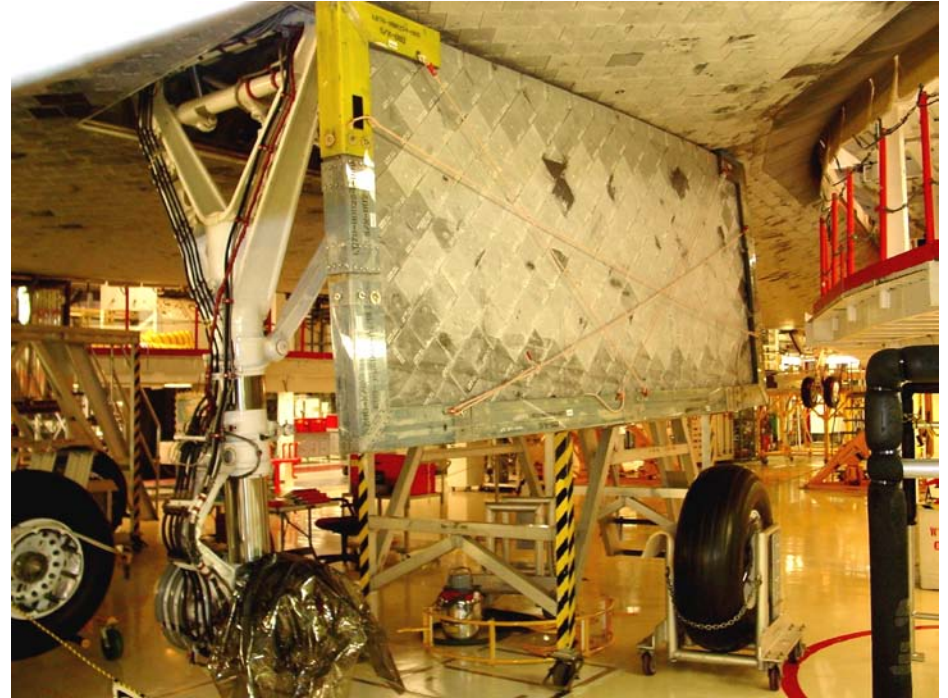
The tiles are only 7% glass by volume and are partially coated with a thin (0.01 inch) layer of black borosilicate glass to increase their emittance.

Typical acreage tiles are 6 inches by 6 inches by 2.5 inches in size.

Shuttle Landing Gear
Cover Showing Tiles

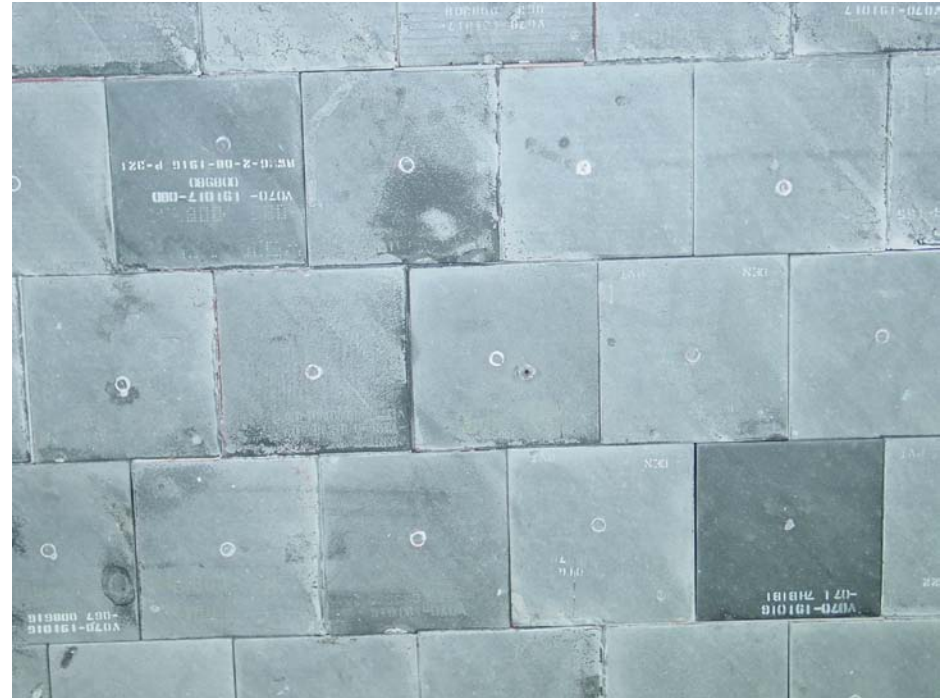
This compound burns out on reentry and must be reapplied before the Orbiter can be exposed to the weather.

A few Orbiter acreage tiles showing markings, variations in color, and water proofing holes.

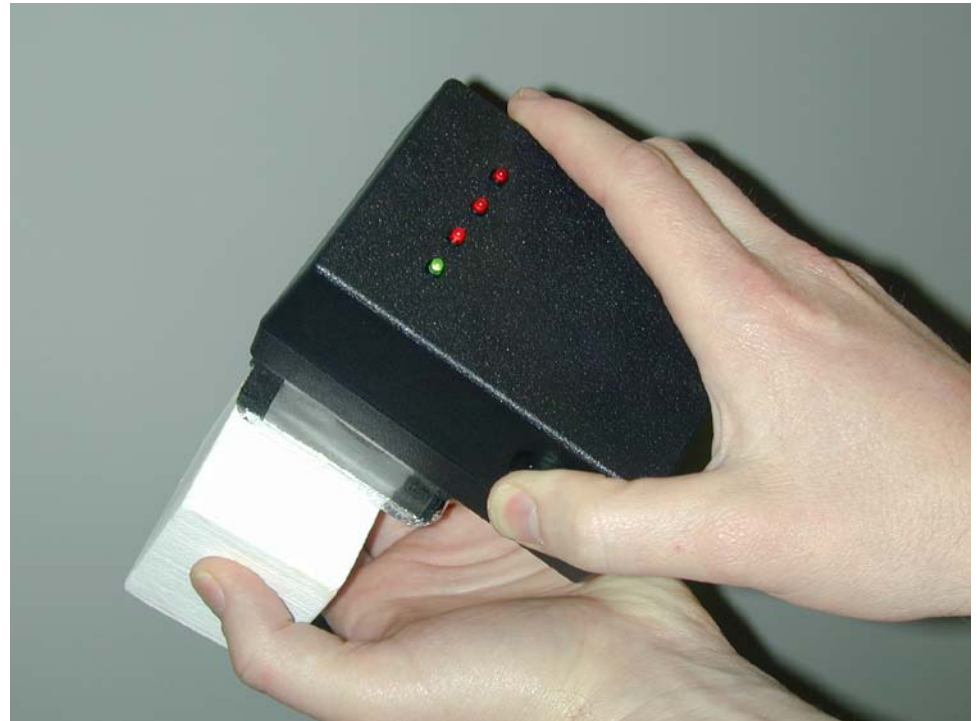
Capacitive water sensor being used on an uncoated tile sample.

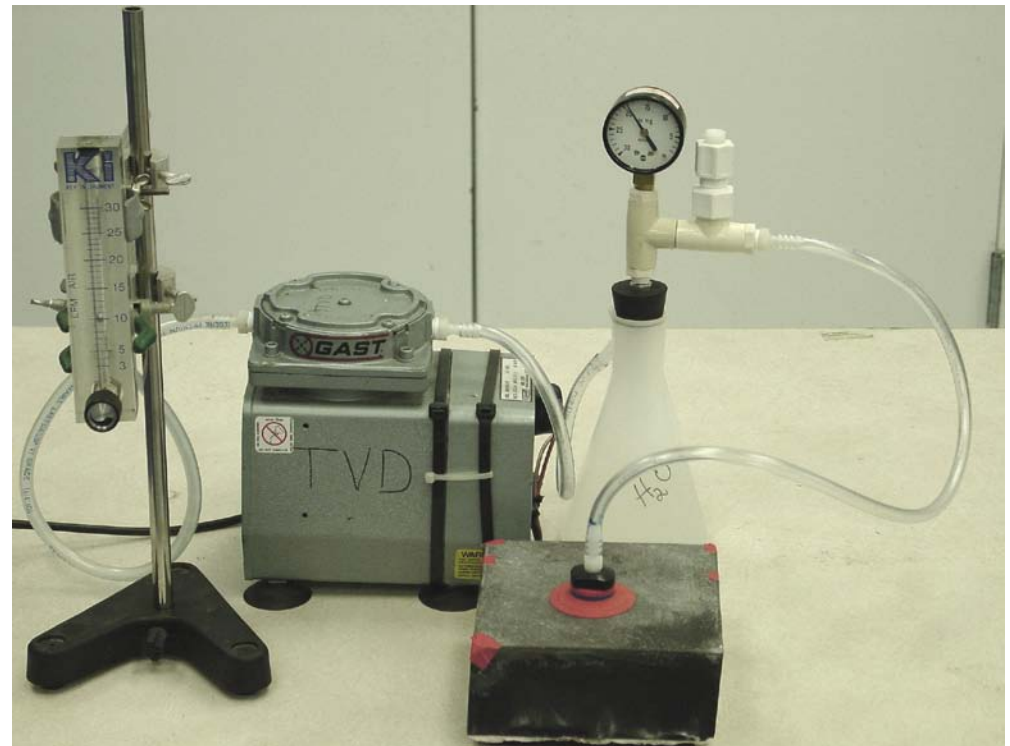
Early experimental system showing tile, suction cup, water separator, pump, and gages.

Tests were done to validate the safety of this process and no problems were found.

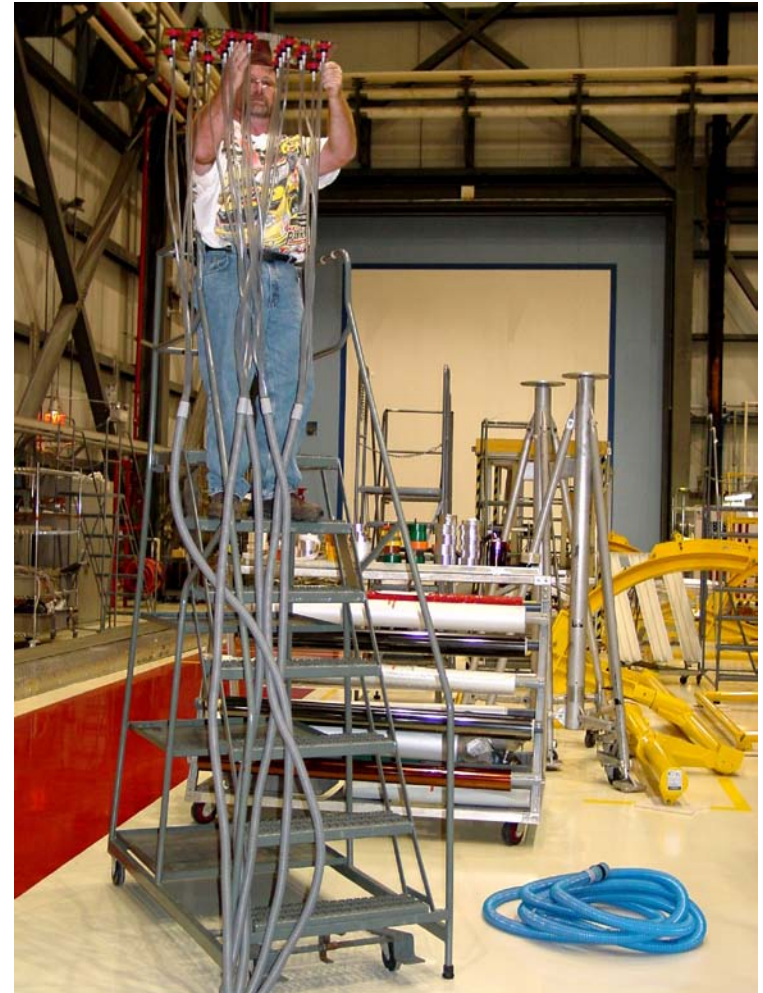
The resulting 25 lines can then be attached to 25 tiles, allowing parallel drying with a single system.

The existing facility system provides 7 in Hg at each tile allowing significant drying to occur over a two hour period.
