NASA/TM—2005-212624/PART2

Vibration Based Crack Detection in a Rotating Disk

Part 2—Experimental Results

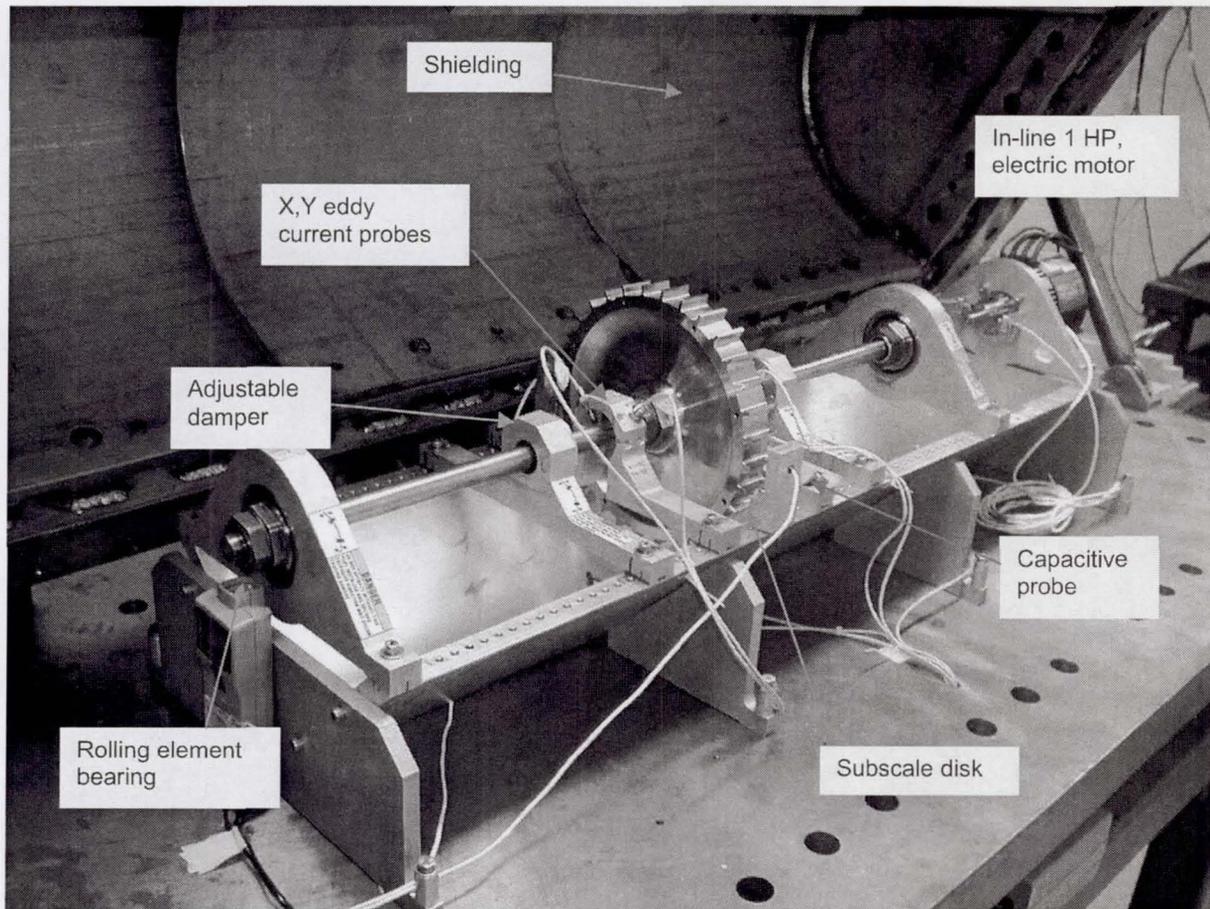
Figure 1.—Rotordynamic test stand.

Figure 1 shows the experimental facilities utilized for this study. The system has an adjustable shaft length, and thus, allows one to select an appropriate length to assure operation beyond the system's first critical speed. Here, the maximum length was used based on the rotordynamic calculations of reference 5 that indicated a critical speed of 2610 revolutions per minute (rpm). The stainless steel shaft length and diameter were 30.75 and 0.79 in., respectively. The shaft was supported by precision angular contact ball bearings that were assumed to provide isotropic stiffness. The single disk, as seen in figure 1, was mounted at the mid-span of the shaft. Figure 2 shows a schematic of the disk. The nickel disk was designed to safely handle rotational speeds up to 25000 rpm in the undamaged state. A thinned web area and gear teeth were implemented to imitate the web area and blades of a turbine disk. Note that the gear teeth were also needed due to the fact that the capacitive displacement sensors utilized during experimentation were specially designed, both concerning the hardware and the analysis software, to monitor radial blade tip clearances. The nickel alloy, Haynes X-750, was the material used for the disk. The disk's final design had an outside diameter of 9.25 in. and a bore thickness and outside rim thickness of 1.00 and 1.25 in., respectively. The thinnest portion of the web was 0.10 in., with the cross-section and height dimensions of the blades being 1.25 by 0.13 in. and 0.33 in., respectively. The weight of the disk was 10.75 lbf. Lastly, eight holes, 0.20 in. diameter each, were placed midway in the rim section. The eight holes were spaced every 45 degrees. The holes were designed for future studies as possible mass attachment points or notch initiation sites.

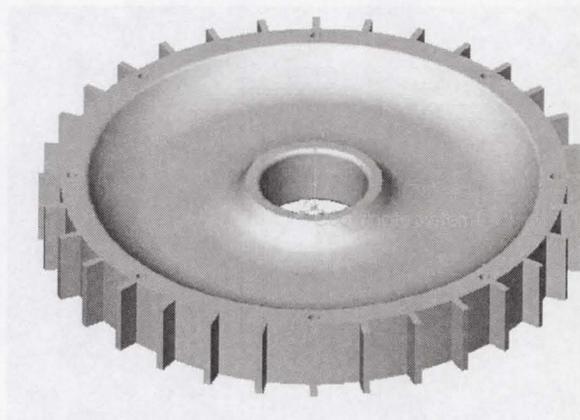
Figure 2.—Schematic of subscale disk.

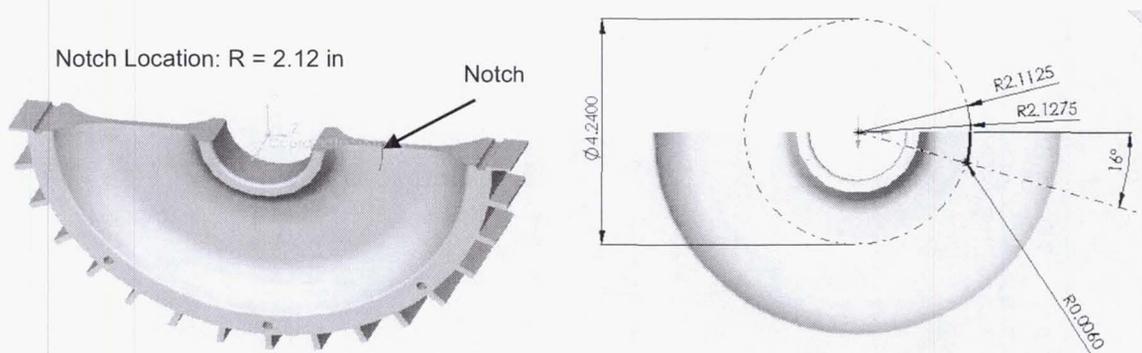
Figure 3.—Schematic showing 1.2 in. circumferential length notch.

The experimental procedure involved conducting five repetitions of spin-up/spin-down tests with an undamaged disk, followed by five repetitions with a damaged disk (i.e., notched). During the tests blade tip clearance data and shaft vibration data were continuously recorded. The maximum rotational speeds attained were between 5000 and 5400 rpm with acceleration/deceleration rates of 60 rpm/second. Note that the maximum speed was beyond the calculated critical speed of 2610 rpm, thereby guaranteeing post-critical operation. Following the baseline experiments, the disk was removed from the test stand and a 1.2 in. circumferential notch was induced approximately mid-span in the web area using electric discharge machining (EDM). This area was chosen because it had the largest stresses based on the finite element analysis of Part 1 (ref. 5). The notch had a width of 0.015 in. due to the wire thickness and burn area of the EDM process. Careful consideration was given during reassembly so as to maintain the baseline conditions for all system parameters, except of course, for the notch. Various views of the notched disk are shown in figures 3 and 4.

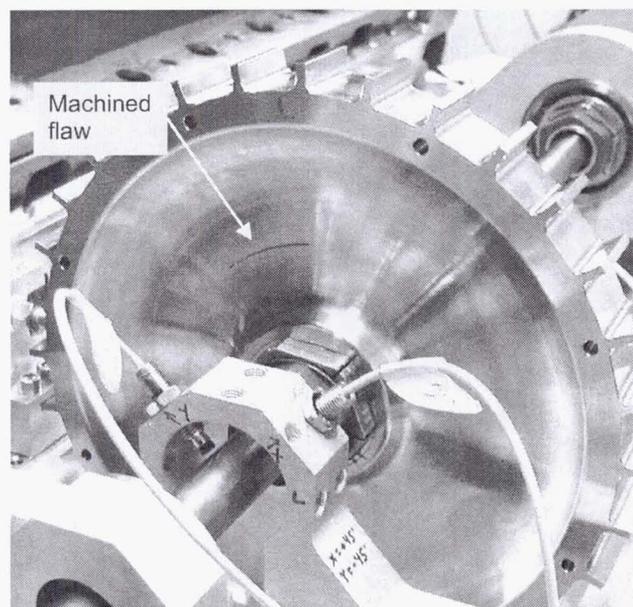
Figure 4.—Image of notched disk

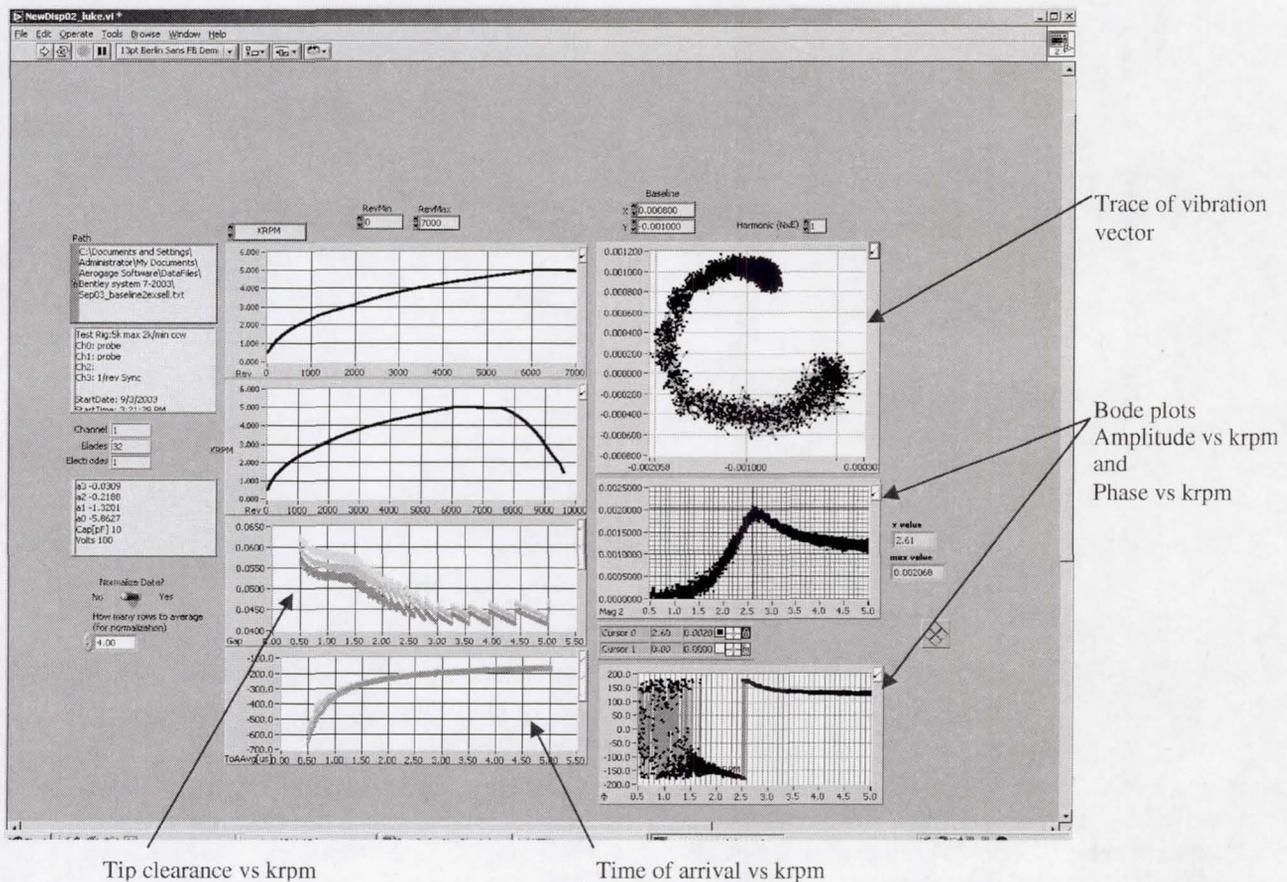
Figure 5.—Typical blade tip clearance data displayed using software associated with the capacitive sensors for the undamaged, baseline disk.

Typical results for the un-notched, baseline case are shown in figures 5 and 6. Figure 5 displays an image of the capacitive probe system's post processing software, while figure 6 represents results from the eddy current probe system. As mentioned in the introduction, shifts in the center of mass are tracked by monitoring the 1-x component of the vibration response. The 1-x component, or first harmonic response, follows the amplitude and phase lag of the synchronous whirl of the rotor system. Changes in the center of mass induce changes in the amplitude and/or phase of the 1-x component. The synchronous whirl behaviors are usually displayed as Bode plots where the amplitude and phase of the system are plotted as functions of rotational frequency. These plots are indicated in figures 5 and 6. Individual blade tip clearance values at multiple rpms are shown in figure 7, again, for a typical baseline test. For the un-notched baseline condition, the rotor's critical speed and the associated maximum amplitude, calculated using the blade tip displacements, were 2614 rpm (standard deviation = 96 rpm) and 0.0021 in. (standard deviation = 0.00011 in.), respectively. Utilizing the eddy current probe data the average critical speed and maximum amplitude were 2332 rpm (standard deviation = 36 rpm) and 0.0031 in. (standard deviation = 0.00021 in.), respectively. The discrepancy between the two sensor systems was probably due to the differences in calculation methodologies, although, the capacitive system's values agreed well with the calculated results (2610 rpm) of Part 1 (ref. 5).

After extracting the post critical 1-x amplitude data from the blade tip clearance measurements (see figs. 5 and 8) for both the baseline and notch tests, a second order polynomial curve fit was conducted using the data. In addition, the statistical significance of the coefficients was calculated. The values of the coefficients as well as their associated statistical significance as represented by the t-values (ref. 7) are shown in table 1. Note that the frequency range of the exported data was 4500 rpm to the maximum speed (between 4900 and 5400 rpm).

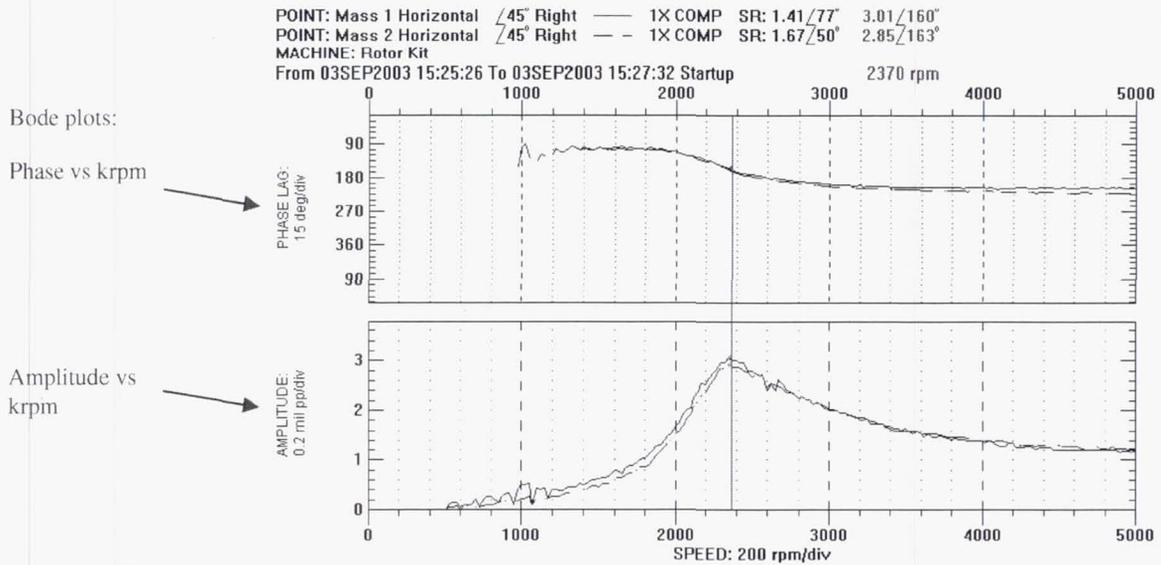
Figure 6.—Bode plots of vibrations displayed using software associated with the eddy current sensor system for the undamaged, baseline disk.

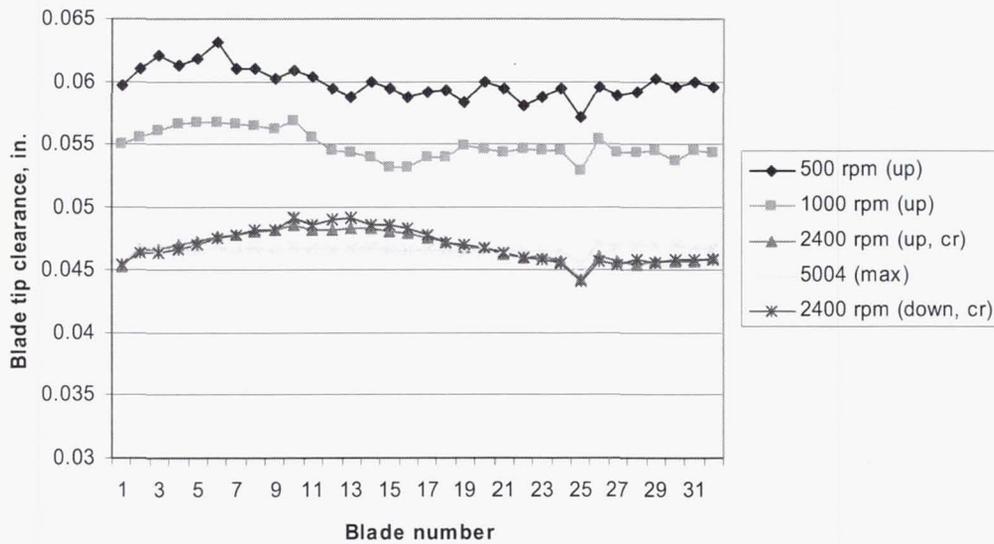
Figure 7.—Blade tip clearance values as a function of rotational speed for a typical baseline test.

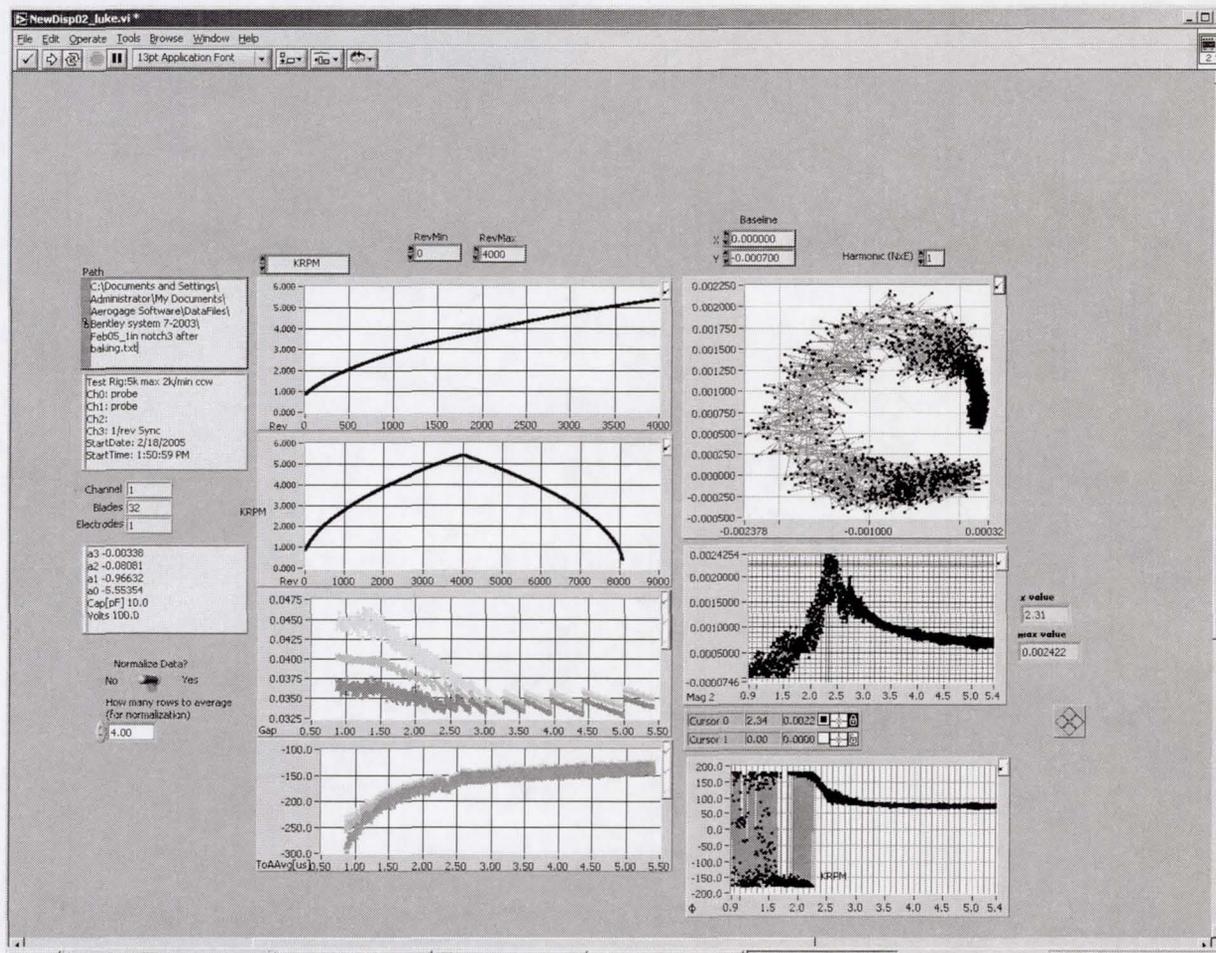
Figure 8.—Typical blade tip clearance data displayed using software associated with the capacitive sensors for the notched disk.

After the introduction of a notch in the disk's web area, the system was carefully reassembled. Typical results for the notched disk are shown in figures 8 through 10. One notable observation included an increase in the noise level concerning the capacitive probe system. This was apparent in the Bode plots as well as the trace of the vibration vector as seen in figure 8. One explanation involved possible mechanical changes in the overall system induced during reassembly. These mechanical changes were indicated by the modifications in the critical speeds and associated maximum amplitudes of whirl as measured by the two sensor systems. The critical speeds and amplitudes of whirl for the system after reassembly were 2658 rpm (standard deviation = 331 rpm) and 0.0018 in. (0.00059 in.) for the blade tip clearance sensor system and 2448 rpm (standard deviation = 61 rpm) and 0.0060 in. (standard deviation = 0.00028 in.) for the eddy current system that was used to monitor the shaft vibrations. Noteworthy were

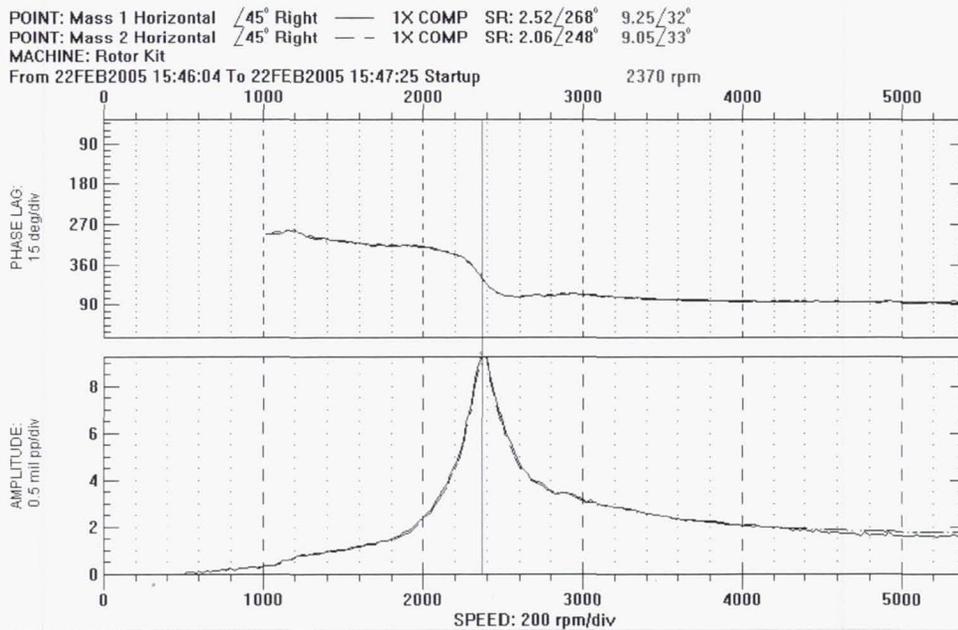
Figure 9.—Bode plots of shaft vibrations displayed using software associated with the eddy current sensor system for the notched disk.

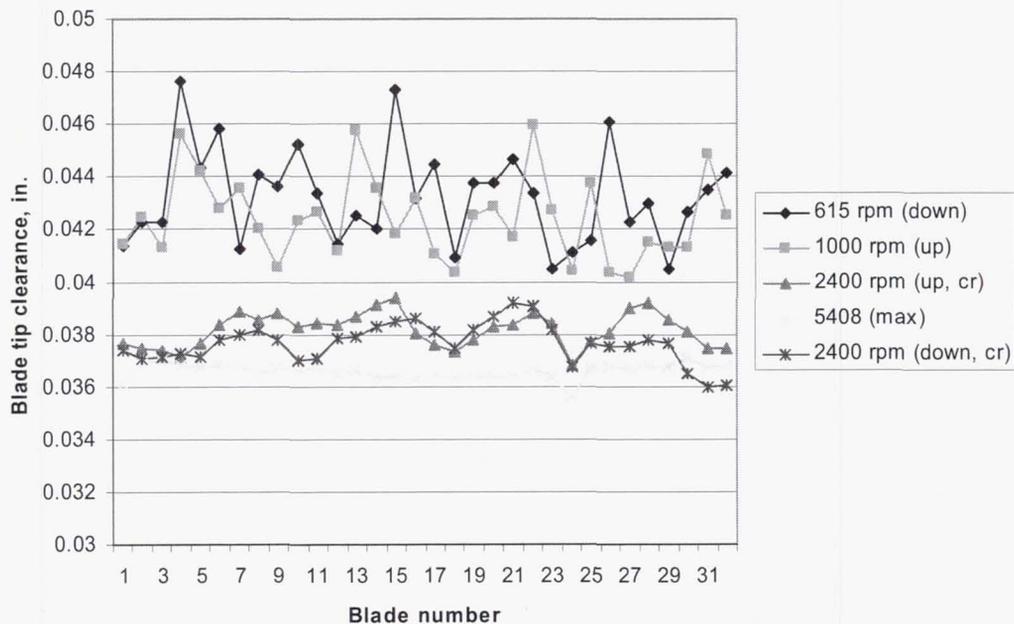
Figure 10.—Blade tip clearance values as a function of rotational speed for a typical notched test.

the increased standard deviations regarding all the values as well as a statistically significant 5 percent increase in the critical speed as measured by the eddy current system. Another noise related observation after reassembly was an apparent choppiness of the blade displacement data in figure 10, especially for rotational speeds below 1000 rpm. Above this speed, the measurements regulated and looked very similar to the baseline tests. Note that in order to obtain better signals regarding the capacitive probe system, the sensors were moved closer for the notched disk tests (compare the offset values in figures 7 and 10). Lastly, during the time frame of the experiments it was discovered that the capacitive probes were sensitive to moisture absorption due to the humidity in the laboratory. As a result, the probes needed to be dried in a low temperature oven and recalibrated prior to each test.

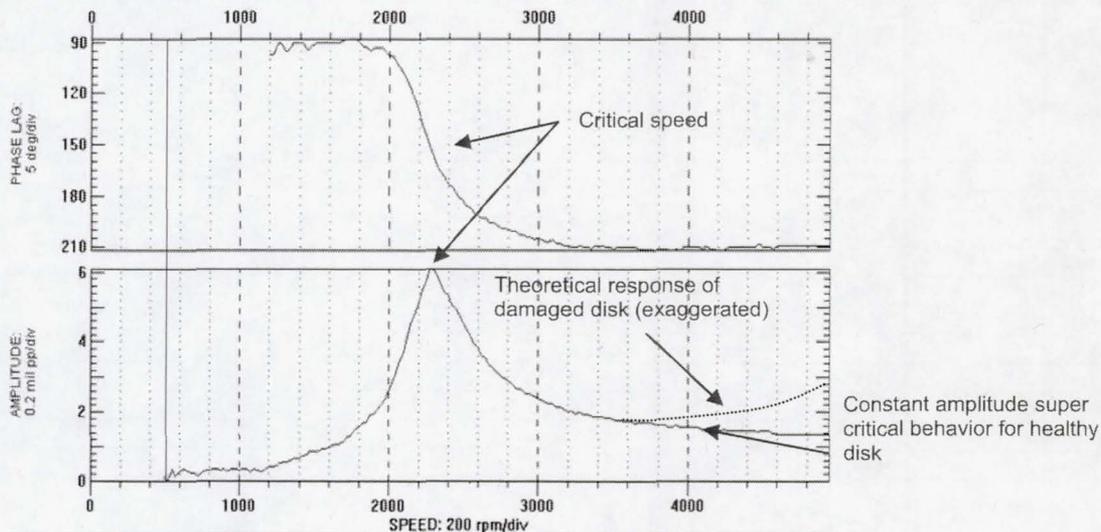
Figure 11.—Exaggerated view of post critical 1-x amplitude behavior (dotted line) of a damaged disk system.

figs. 5 through 10) or rotor response, increases as a function of speed until the critical speed is achieved at which point the amplitude is at its maximum and a 180 degree phase inversion occurs. After the critical speed the system's 1-x amplitude decreases to a level equal to the system's eccentricity and then maintains a constant value even with increasing speed. Note that the eccentricity vector defines the location of the system's center of mass. The maintenance of constant amplitude occurs due to the fact that the rotor now rotates about the system's center of mass. Furthermore, an ideal Jeffcott rotor system defines the eccentricity vector as a fixed constant regardless of rotational speed. For the center of mass based damage detection approach studied here, a crack is assumed to open up as the centrifugal forces increase with speed. Therefore, the shifting of mass as the notch opens causes the eccentricity of the system to change with speed. Figure 11 shows an exaggerated representation of the effects of damage, and the associated speed dependent eccentricity, in the post critical speed domain for the current system.

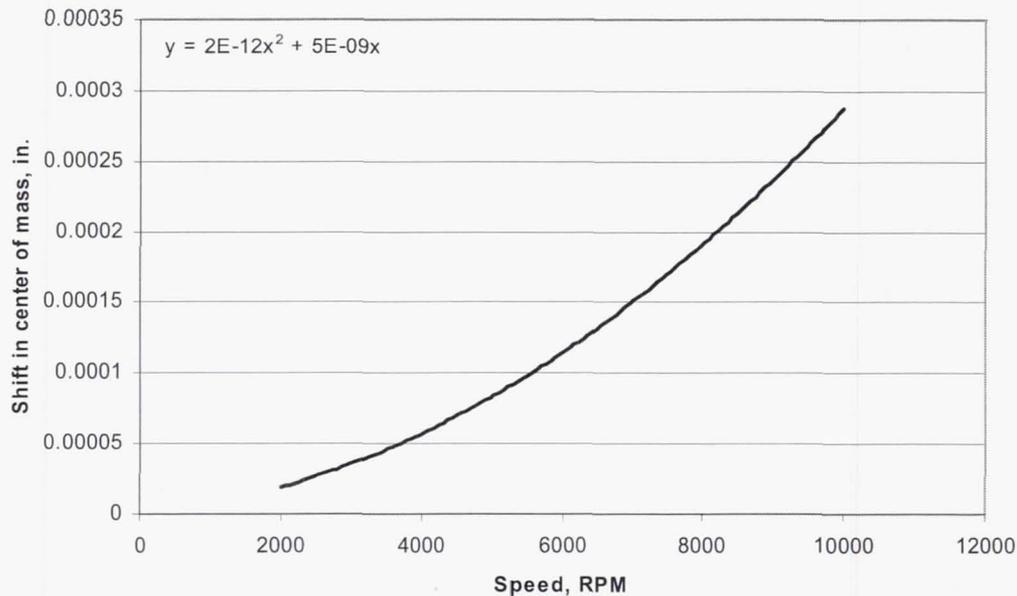
Figure 12.—Finite element analysis results defining amplitude change of the eccentricity vector due to speed dependent opening of a circumferential notch in the web area of the disk (1.2 in. notch). The second order polynomial curve fit of the finite element based results are indicated on the plot.

In Part 1 (ref. 5), FE based analyses defined the change in center of mass (i.e., a change with respect to an initial undamaged value) for the disk as a function of notch size and speed. Figure 12 shows the analysis results for the particular 1.2 in. notch employed here. The change in amplitude as a function of frequency was shown to be a second order polynomial as indicated in the figure (units: in. and rpm). Note that the coefficient values were very small and difficult to measure experimentally. Furthermore, at this point no effort was made to define the disk's initial eccentricity vector (amplitude and phase), hence, the values of the particular coefficients describing the shift/change in the center of mass were values observable only if the changes due to the notch were in-phase with the disk's eccentricity vector (causing increasing amplitude). The coefficients would be different if the phase difference between the initial eccentricity vector and the change vector was something other than zero degrees. Therefore, the approach taken here was to analyze the post critical 1-x amplitude behavior regarding the experimental data and search for a statistically significant coefficient for the ω^2 term that would only be present due to a speed dependent eccentricity vector resulting from a notch. Because the blade tip clearance system utilized modifiable, in-house software, data was easily exported for further analysis of the post critical amplitude behavior. This was not the case for the eddy current measurement system used to monitor the shaft vibrations.

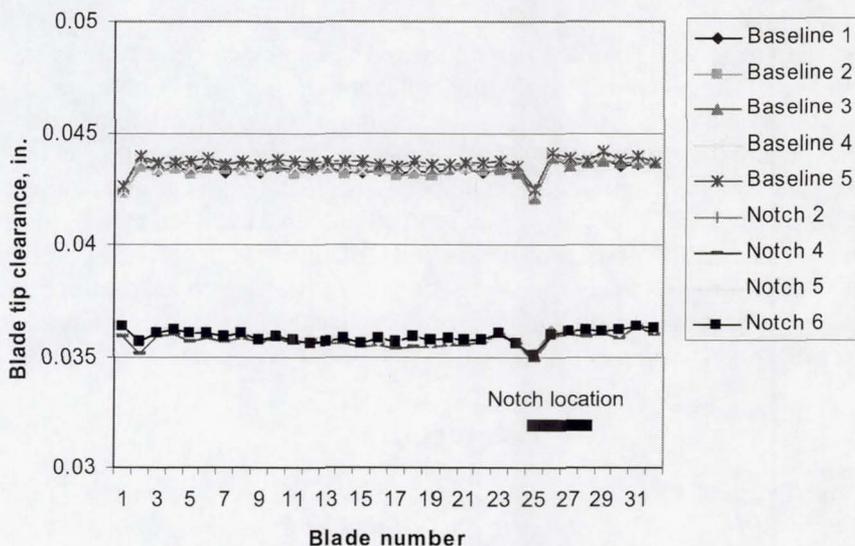
Figure 13.—Comparison of blade tip clearance values at 4900 rpm. The notch location is indicated in the plot.

Next, comparisons of blade displacement behaviors between the baseline and notched cases were conducted as seen in figures 13 and 14. Multiple data sets were grouped together in an effort to see any unusual deformation behavior in the vicinity of the notch. Note that the notch was circumferentially located in the vicinity of blades 25 through 28 as indicated in figures 13 and 14. Typical subtraction results (= baseline - notch) are shown in figure 14. No obvious patterns were seen in either plot that indicates additional extensions of the affected blades (i.e., blades 25 through 28).

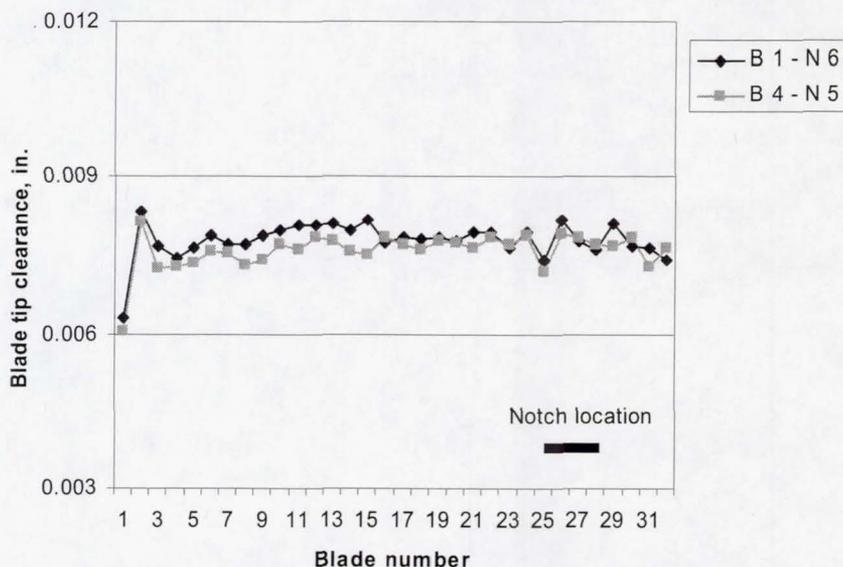
Figure 14.—Typical results regarding the subtraction of notch test results from baseline results at 4900 rpm.
