Micromechanical Characterization and Testing of Carbon Based Woven Thermal Protection Materials

**Parul Agrawal¹, John T. Pham², James O. Arnold³,
Keith Peterson¹, Ethiraj Venkatapathy³**

1. ERC Inc., NASA Ames Research Center, Moffett Field, CA 94035.
2. USRA, NASA Ames Research Center, Moffett Field, CA 94035.
3. NASA Ames Research Center, Moffett Field, CA 94035.

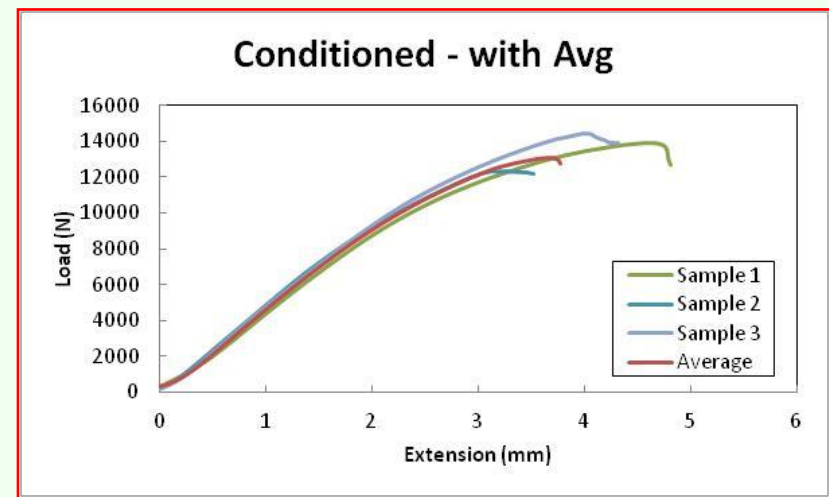
Fabric Test – Pre and Post Conditioning

- **Conditioning reduces the variability in the mechanical properties of the fabric.**

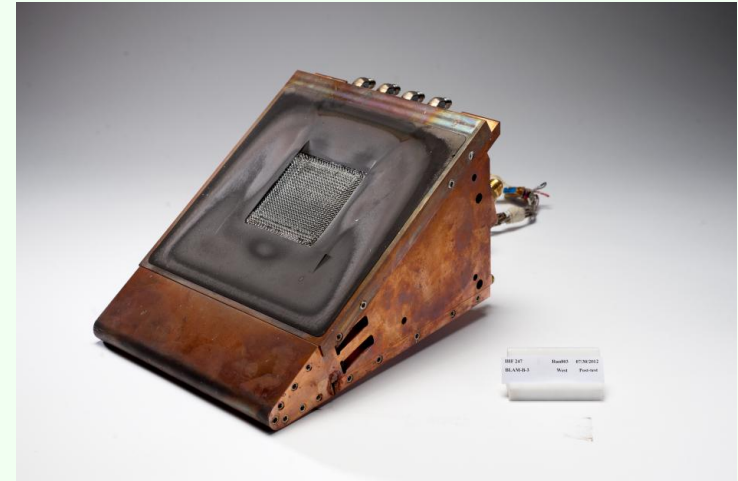
Arcjet Test II : BLAM test at ARC

- Evaluate the down selected fabric's ability to maintain structural integrity under combined aerothermal and biaxial loading.
- Evaluate the rate of layer loss as a function of different combined loads.

Model	Heat Flux on Fabric (W/cm ²)	Warp Running Load (lbs/in)	Weft Running Load (lbs/in)	Run Time (seconds)
BLAM-B-3	136	750	375	35

The tests showed that the structural layer continues to bear the mechanical loads after the loss of thermal layers.

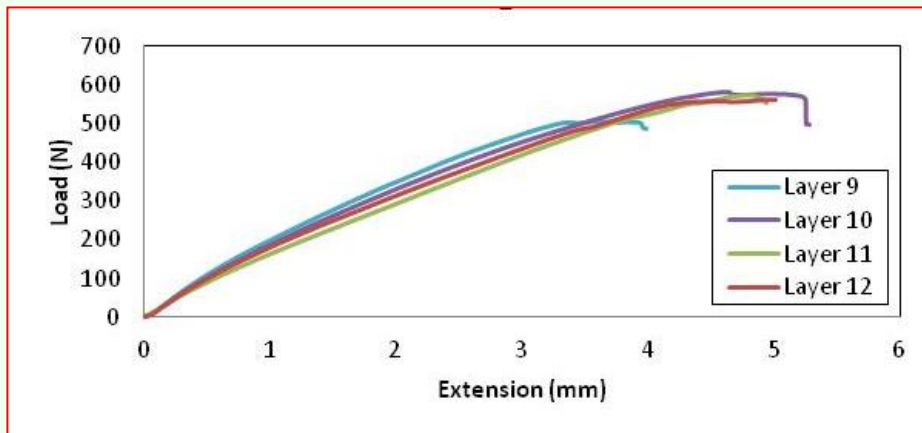
Yarns from unexposed fabric

- Individual yarns from the bottom structural layer were carefully extracted and mechanically tested.
- ~ 50% reduction in strength of yarns (in the structural layer) due to arcjet exposure.

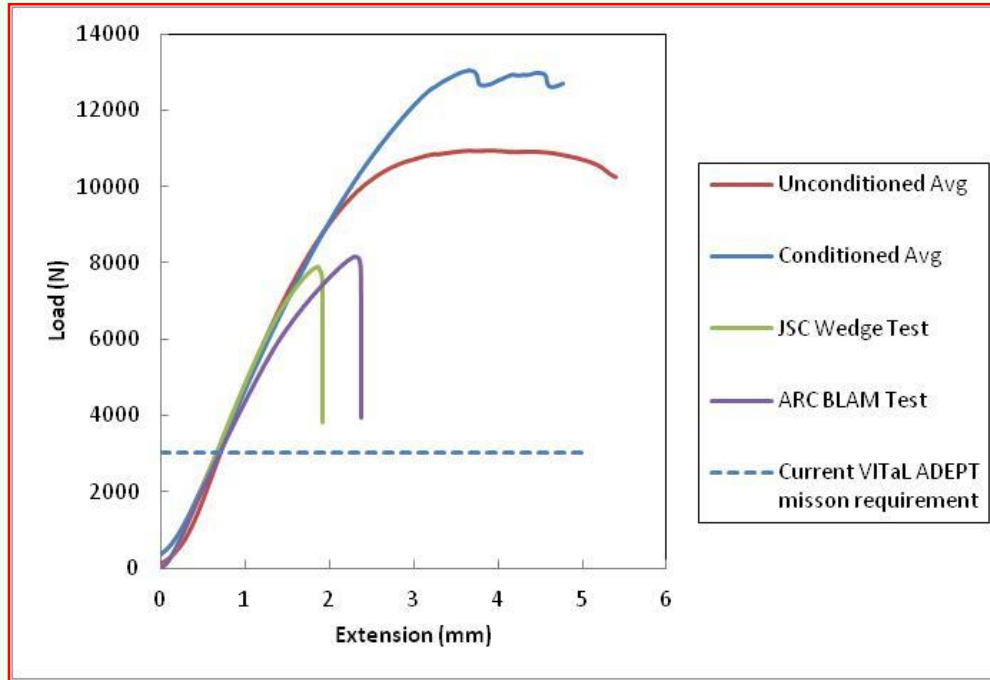
Fabric Test – Pre and Post Arcjet Exposure

- Preliminary experiment indicate ~ 40% reduction in load bearing capacity of woven cloth due to arcjet exposure
- A brittle failure (post exposure) as opposed to slow reduction in strength for pre-exposure cloth.
- The cause of embrittlement needs to be investigated.

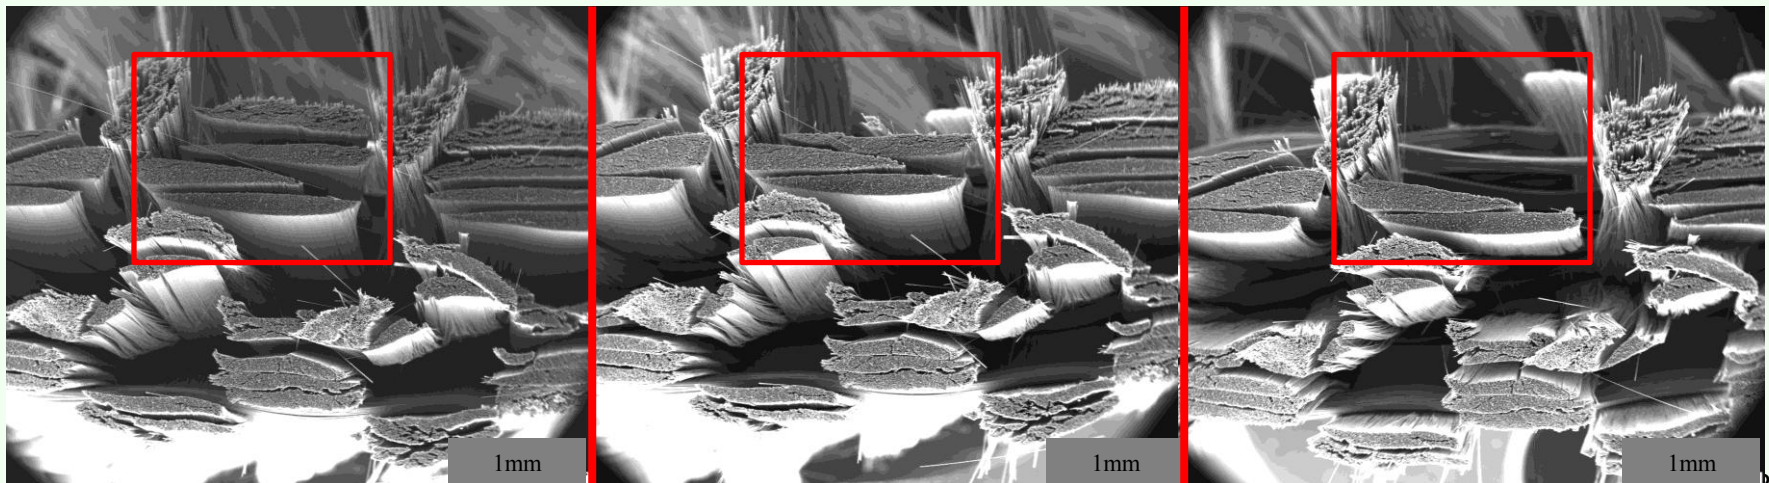
- **Micro-precision tool and magnifying lens utilized to systematically extract structural yarns, layer by layer**
- **Cloth and surrounding yarns remain intact**
- **Extraction of first two layers imaged below**
