Improvements in High Speed, High Resolution Dynamic Digital Image Correlation for Experimental Evaluation of Composite Drive System Components

Presented at the AHS 69th Annual Forum, Phoenix, Arizona, May 21–23, 2013. Copyright © 2013 by the American Helicopter Society International, Inc. All rights reserved.

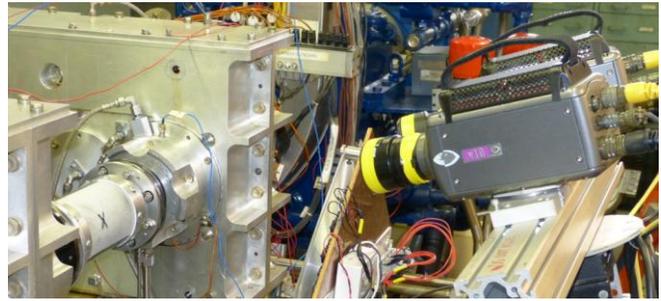
Figure 2. Image of the cameras (right), LED array (middle), and shaft (left).

An image of the cameras, LED array (copper plate in front of the cameras), and composite tube installed in the test rig is shown in Figure 2. The high speed cameras are Phantom V10 cameras with a 4 megapixel black and white sensor. The triggering method is similar to the previously reported system (Ref 1) except for the addition of the LED system and a variable timing delay between camera and LED trigger signals provided by the microcontroller. Before synchronous operation, the camera and LED triggers are operated at a user specified frequency to avoid timeout. A button on the microcontroller switches the microcontroller over to synchronous operation at the beginning of the test. An optical sensor is used to provide a pulse as reflective strips on the shaft pass by. One or multiple reflective strips can be used. The microcontroller counts the pulses from the optical sensor and triggers the cameras at the desired locations and rotation intervals. In this way, one location or the entire shaft can be imaged at any rotation interval. The separate trigger signals provided by the microcontroller allow for sub-microsecond compensation of the trigger latency difference between the cameras and LED driver.

Figure 8 shows examples of the resolved features in a small section near one end of the test element. Again, the improved lighting reduces measurement noise and allows for the use of a smaller field of view on the test article while operating at 5000 rpm. 100 mm lenses were used for this test and the cameras were mounted such that the intersection of the focal planes was parallel to the rotation axis (the camera assembly was tilted 90 degrees compared to what is shown in Figure 2).

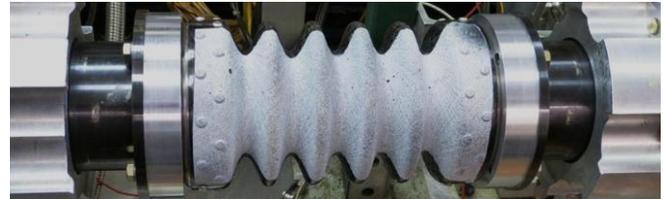
Figure 7. Filament wound flexible composite element mounted in the test rig.

Flexible shaft couplings add a significant amount of weight to rotorcraft drive systems. One possible concept to reduce the weight of these components is to construct a flexible element which is integral to the shaft. This eliminates the need for additional fasteners and flanges, however the durability and fatigue characteristics of such a structure is an area warranting more detailed investigation. High speed DIC on these structures could provide data needed for model development and assist with damage detection and deformation mode characterization during operation. In order to evaluate the high speed DIC methods on a coupling with complex shape, filament wound flexible elements were acquired from Lawrie Technology, Inc. These flexible elements have a more complex geometry and smaller tow size than the previously tested composite tubes. Tests that were performed included some of the various speed and torque conditions used in the damaged tube tests. The mounted test article is shown in Figure 7.
