The Komplast Experiment: Space Environmental Effects after 12 Years in LEO (and Counting)

Sergei K. Shaevich¹, Nikolai G. Aleksandrov¹, Andrei E. Shumov¹, L.S. Novikov², John A. Alred³, David J. Shindo³, Michael Kravchenko⁴, and Johnny L. Golden⁴

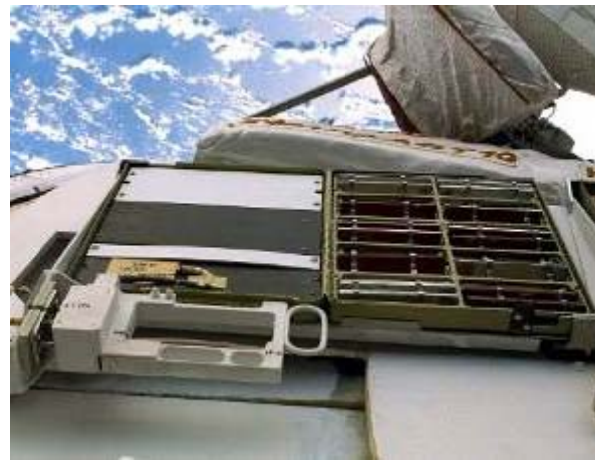
Figure 2. Komplast panels Nos. 2 (a) and 10 (b) on the surface of the FGB.

Figure 2 shows closer views of Komplast panels Nos. 2 and 10 on the surface of the FGB in flight.

These specimens were exposed on Komplast Panel 10 on the exterior surface of the FGB (Figure 2b) and consisted of thin-layer plates of grade KMY-4ЛC carbon composite epoxy, as well as plates of KMY-4ЛC carbon composite and АМГ6 aluminum bonded using [BK-9] epoxy adhesive.

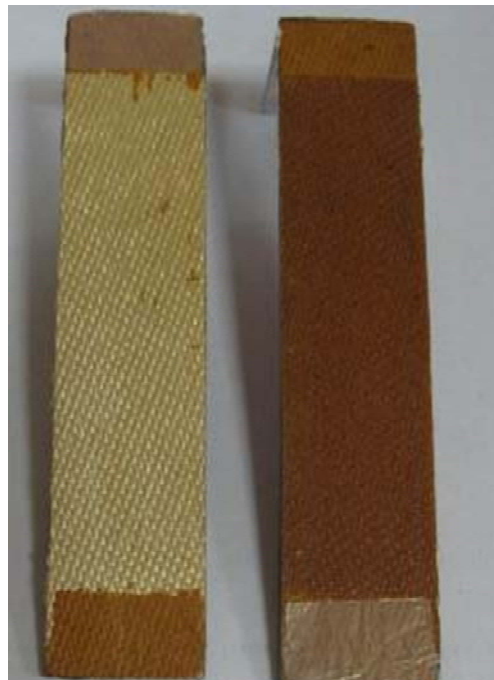
Figure 5. Example of "adhesional" failure of an exposed adhesive bonded joint specimen during laboratory testing.

The investigations conducted on adhesive specimens demonstrated that all three types of epoxy adhesives retain functionality in FGB structures for 30 years. This conclusion is based on the results of studying fracture resistance parameters, the surface and volume properties of the adhesive layers in the adhesive specimens after 12 years of exposure in space, and their additional irradiation with electrons at a dose equivalent to 30 years of exposure in space. In this context, the failure of all the adhesives studied was "adhesional" (Figure); i.e., at the interface with the substrate material, while the polymer base of all the adhesive layers (hardened epoxy polymer) was resistant to the effect of spaceflight factors, and in adhesive bonded joints on the FGB this polymer base is protected against direct spaceflight factors by the bonded elements.
