NASA/TM-2014-218505/Volume I (Corrected Copy)
NESC-RP-13-00852

Evaluation of Agency Non-code Layered Pressure Vessels (LPVs)

*William H. Prosser/NESC
Langley Research Center, Hampton, Virginia*

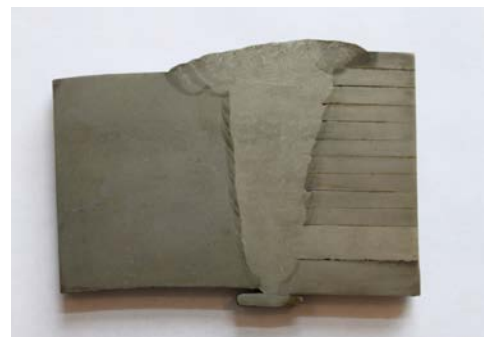
(a)
**Figure 5.0-2. Cross-sectional Diagram of LPV ((a) monolithic head
and (b) cross section of actual vessel)**

5. Vent holes could be drilled through all of the layers except the inner shell of the vessels, as shown in Figure 5.0-2(a), ensuring that pressure did not build up between layers and also providing a means of detecting leakage, indicating inner shell failure before catastrophic rupture of the vessel. (Note that a similar technology was developed in parallel in Germany in the coal gasification industry for the war effort, where an inner layer was used as the pressure seal and the outer shell layers were vented).

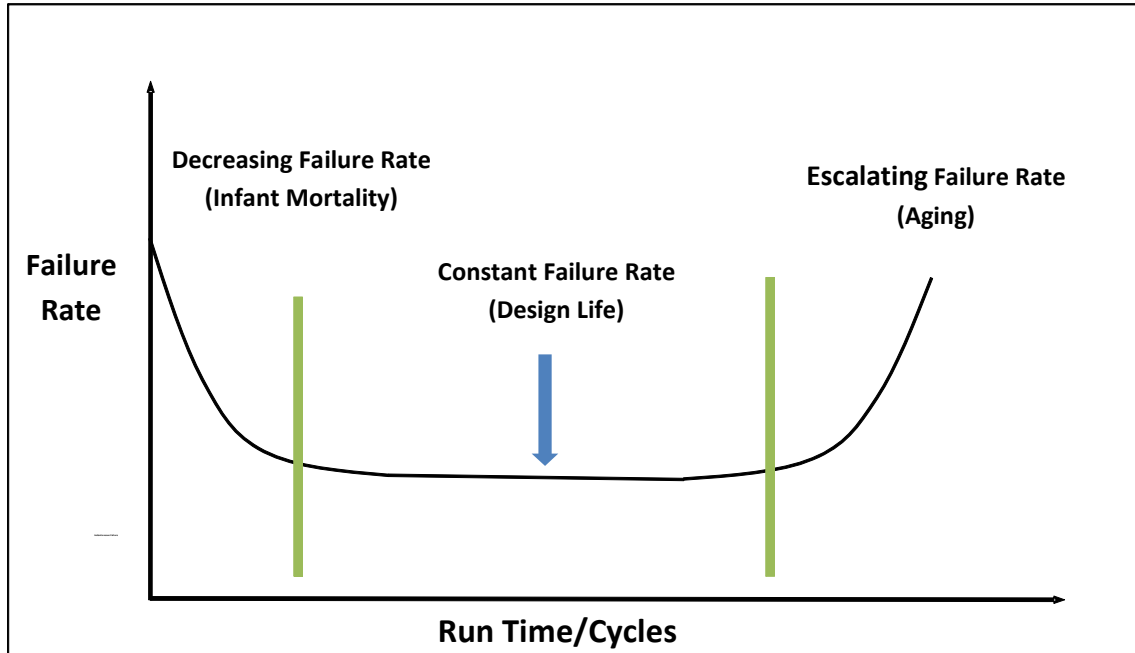
Figure 6.1.5-1. Notional Bathtub Curve Illustrating Changes in Failure Rate versus Time/Cycles

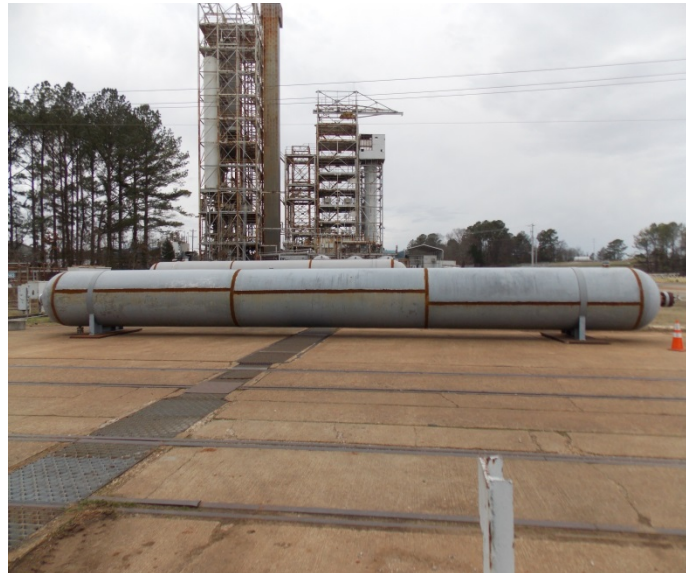
Figure 7.1.2.3-1. MSFC Vessel V0256 with Welds Stripped for Inspection (A225 head material; MLP 1143 shell material)

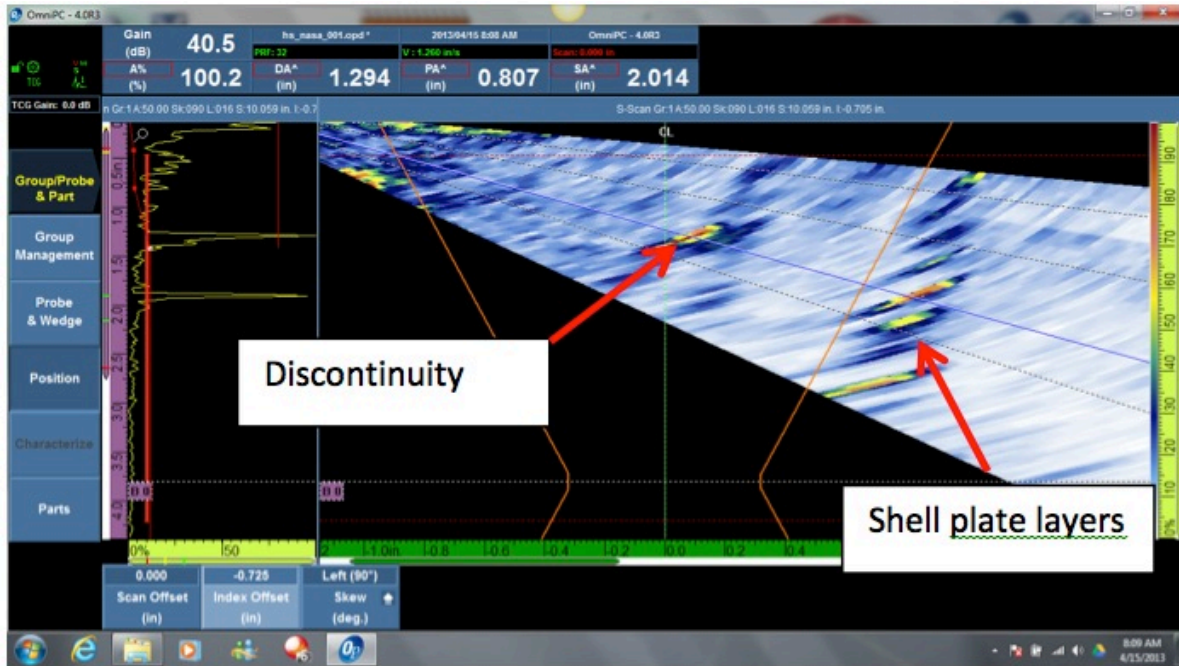
Figure 7.1.2.3-3. PAUT Scan of Head-to-Shell Weld Region (top portion)

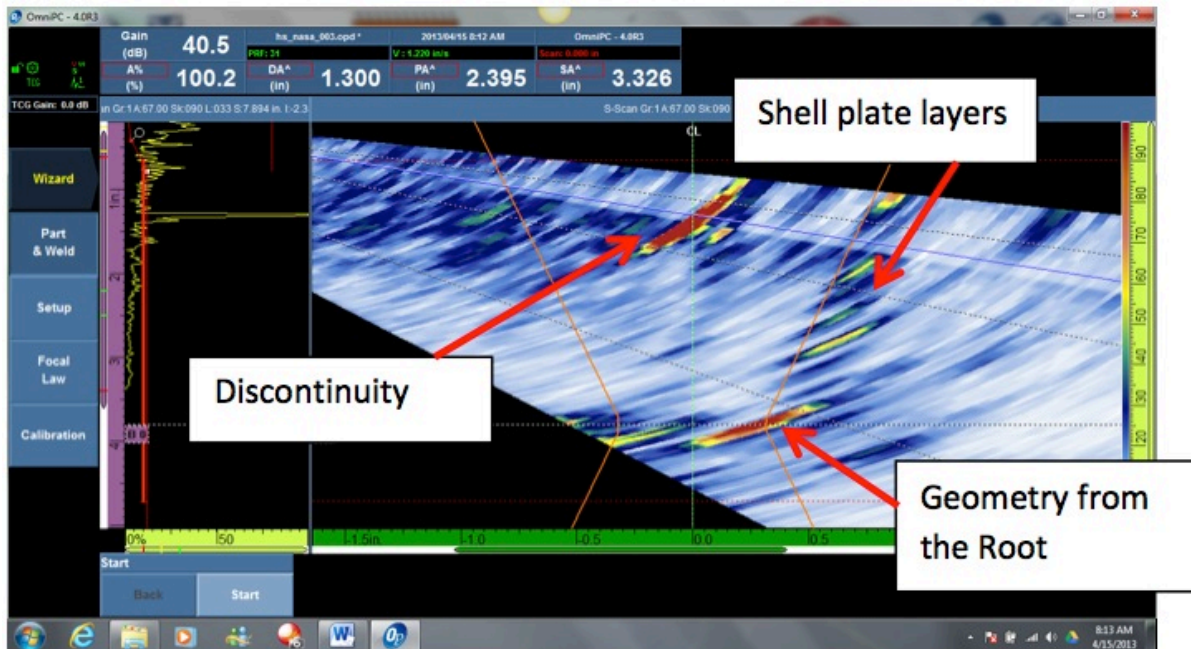
Figure 7.1.2.3-4. PAUT Scan of Head-to-Shell Weld Region (bottom portion)

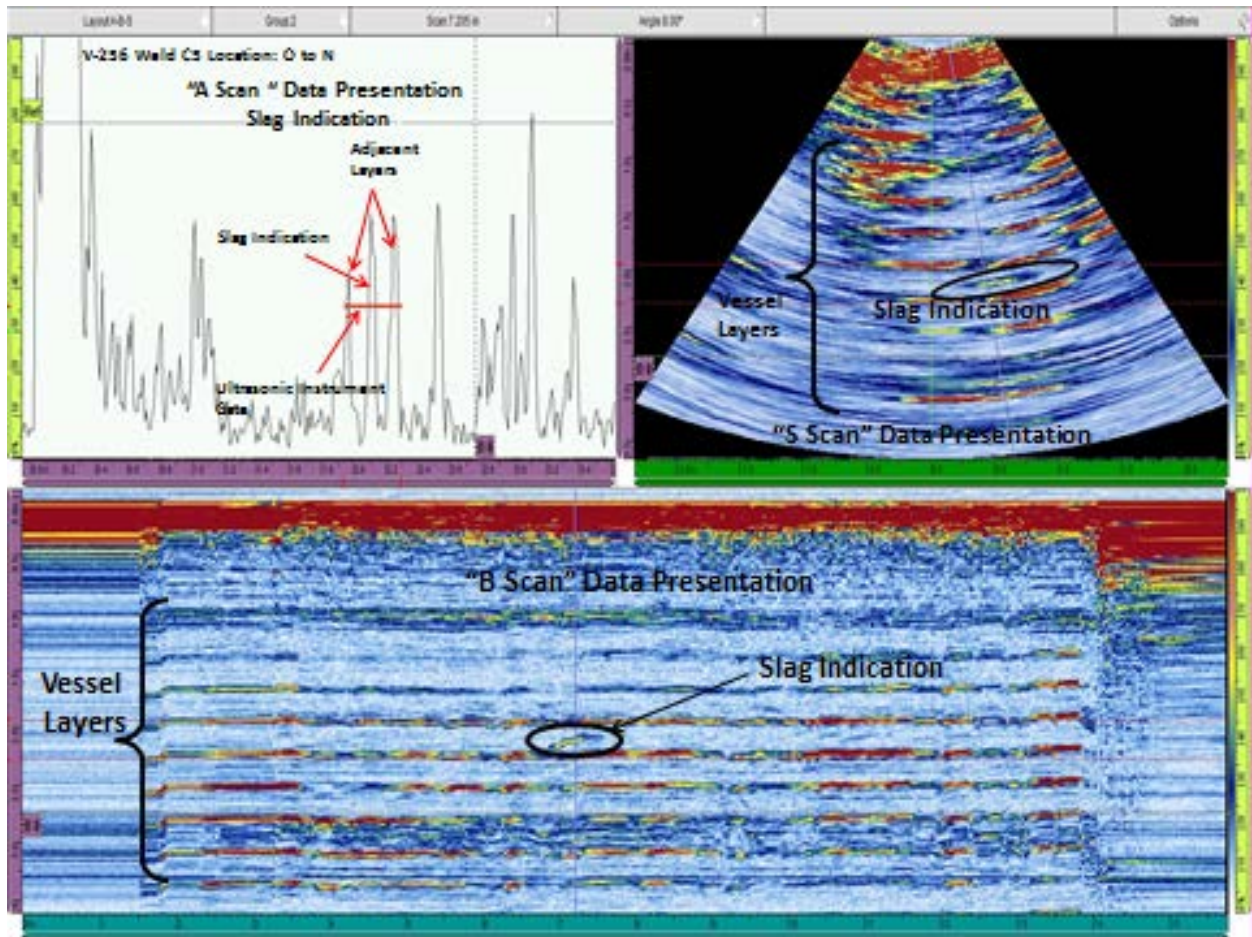
Figure 7.1.2.3-7. PAUT Scans for Indication in C5 Weld O to N Location, Indicative of Slag

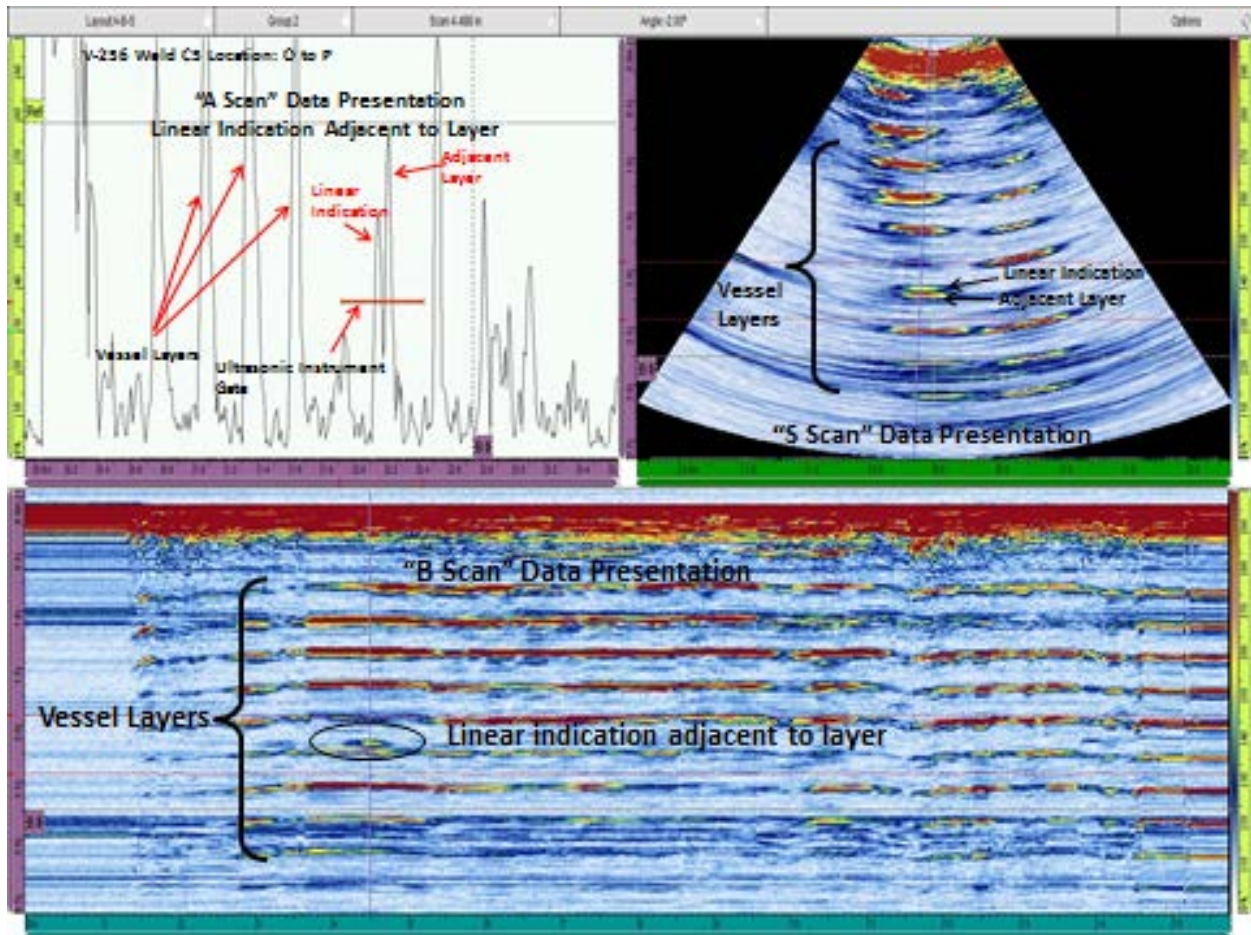
Figure 7.1.2.3-8. PAUT Scans for Linear Indication in C5 Weld O to P Location, Indicative of Lack of Fusion

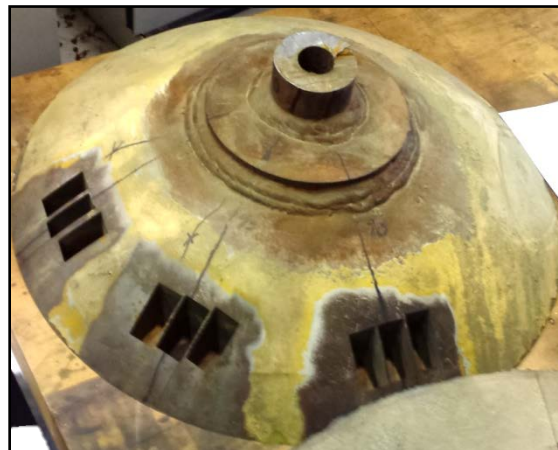
Figure 7.2.1.2-3. V0032-1 Sectioned for Metallographic Microstructural Examination for Determining Material Orientation

Metallographic microstructural evaluations at 50× and 100× magnifications were performed on A225 material from V0032 and GRC V0296 for determining material orientation³. (Note: testing of the V0296 head was still ongoing when this report was prepared.) Nine total samples in three orthogonal planes (C-M, R-C, and M-R) were taken at three equidistant circumferential locations around each head with 45° spacing between samples. Three samples were taken as close as possible to each nominal circumferential location as possible to expedite the metallurgical evaluation, instead of evaluating a single sample. Evaluation of a single sample would have required its polishing mold to be broken in order to evaluate a different sample face. As such, a small tradeoff in accuracy was accepted for expediency. Photographs and cut plans of the location in which blanks were evaluated from the V0032 head are provided in Figures 7.2.1.2-3 and 7.2.1.2-4.

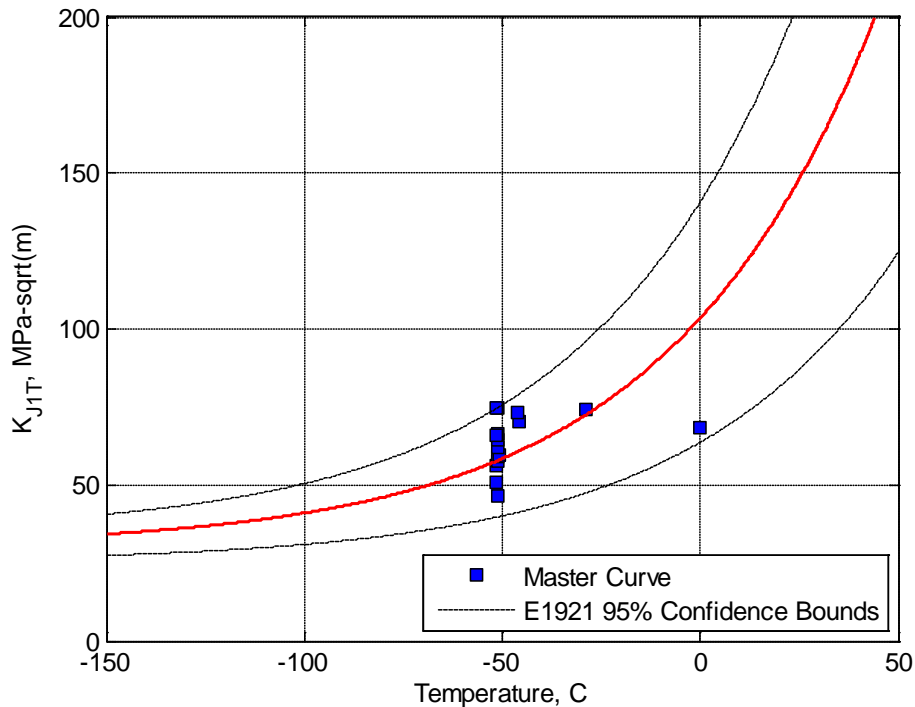
Figure 7.2.1.2-11. Master Curve Plot for 1146 Material

Master Curve plots for the 1143 and 1146 materials are shown as the red lines in Figures 7.2.1.2-10 and 7.2.1.2-11, respectively. Ninety-five-percent confidence bounds have been determined according to E 1921-13 and are also shown as the black dashed lines.

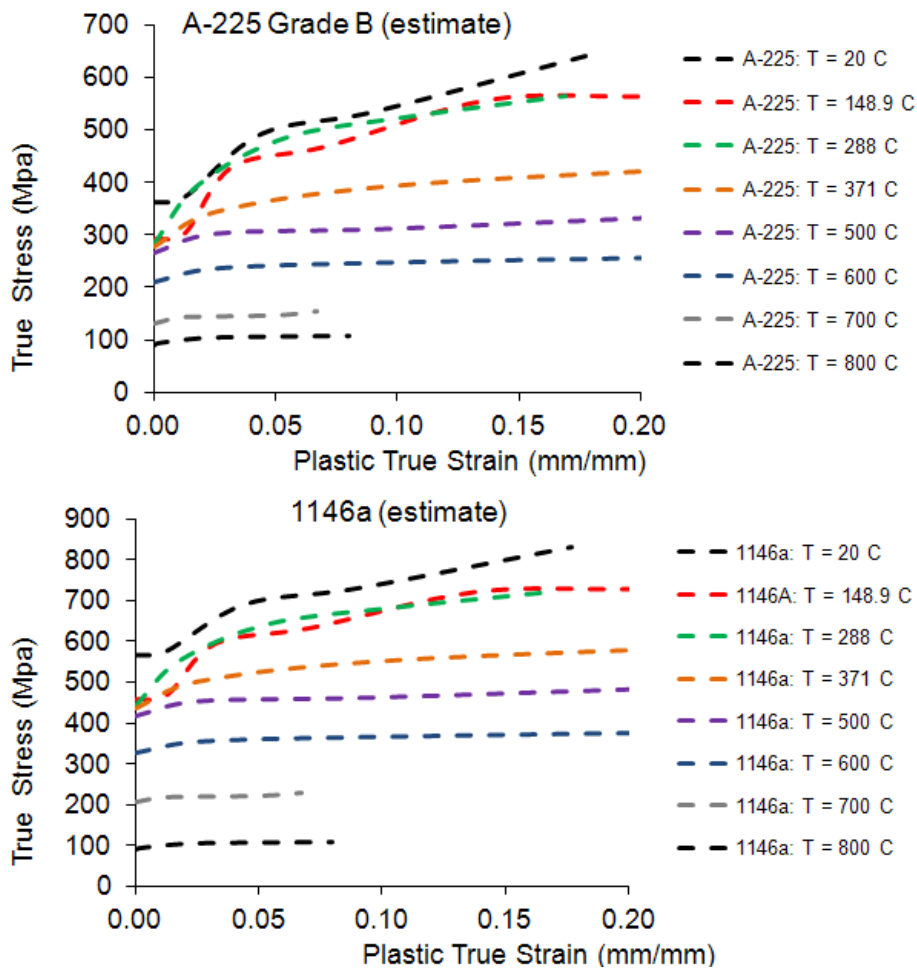
Figure 7.2.2-4. Stress Strain Curves Used for Mechanical Portion of Analysis

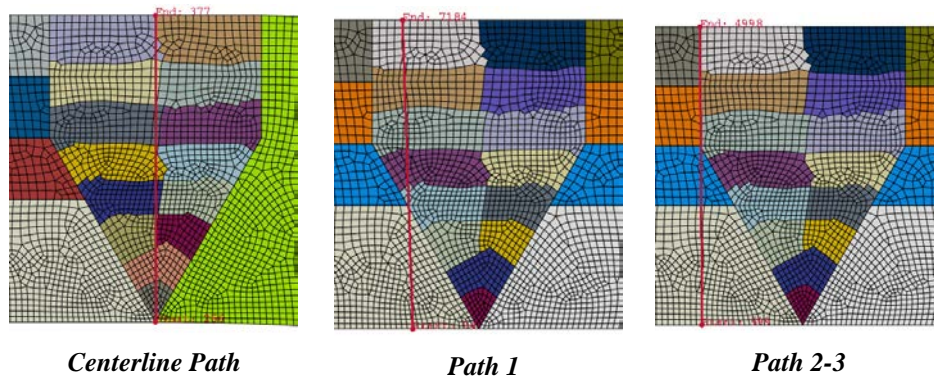
Figure 7.2.2-9. Line Path Definitions for Through Thickness Stress Plots

In this section, line plots are provided and compared. Line plots of stress are provided along three paths, as illustrated in Figure 7.2.2-9. One represents a plot through the weld centerline, one intersects layer 1 with the weld (path 1), and one intersects layers 2 and 3 and the weld (path 2-3). Figure 7.2.2-10 illustrates line plots of axial and hoop WRS for the shell-to-shell case. The solid black and solid red lines compare results between isotropic and kinematic hardening. It is seen that the axial stress differences are relatively small except at the ID of the vessel. *It is noted that the differences between isotropic and kinematic hardening are much greater in the as-welded condition prior to application of the hydrotest.* The dashed lines in Figure 7.2.2-10 are for the monolithic case. The monolithic shell results do not compare well for the axial stresses and are conservative for hoop stresses.

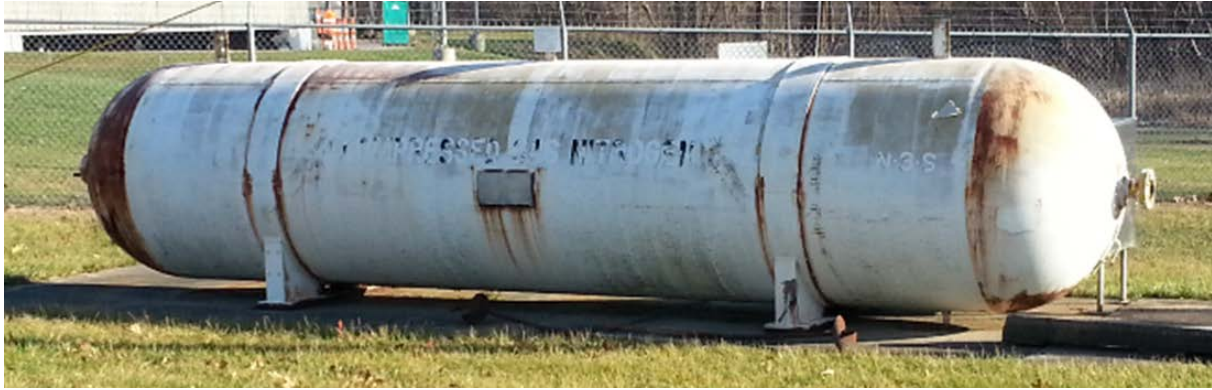
Figure 7.2.3.1-1. Pretest View of PV0236 (vessel measures 52-inches ID × 24 feet long, has an internal volume of 306 cubic feet and a design pressure of 2,800 psig, has a layered shell construction, and was fabricated in 1959)

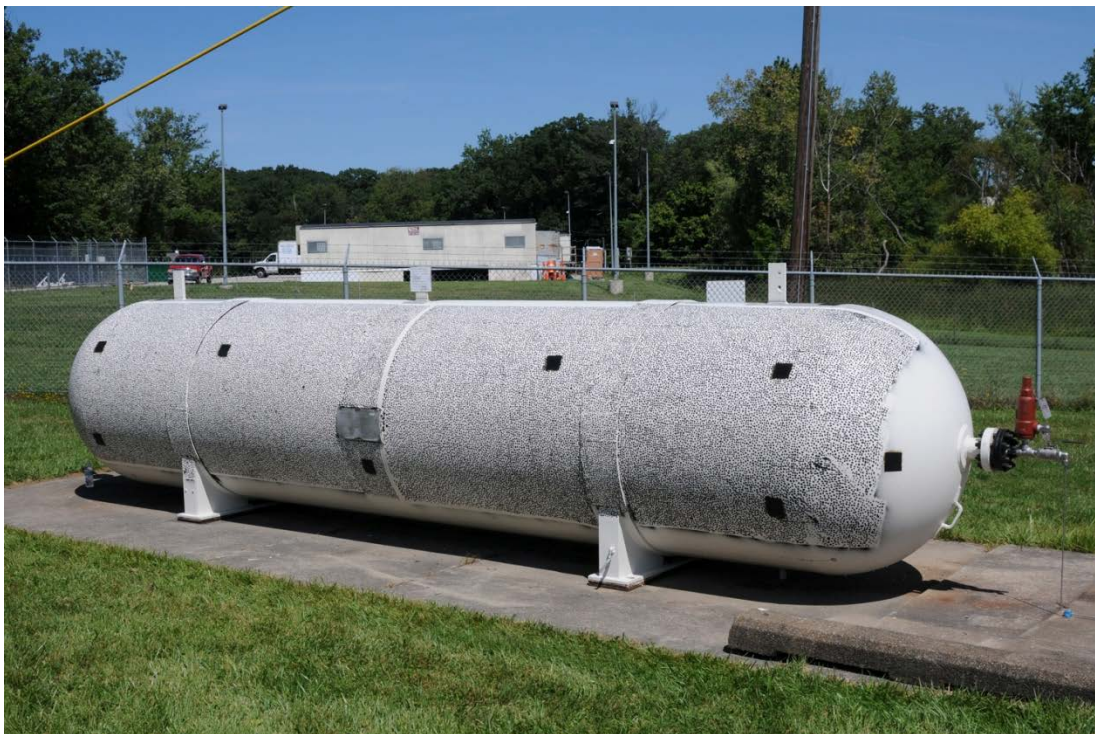
Figure 7.2.3.3-3. Pressure Vessel with Completed Dot Pattern

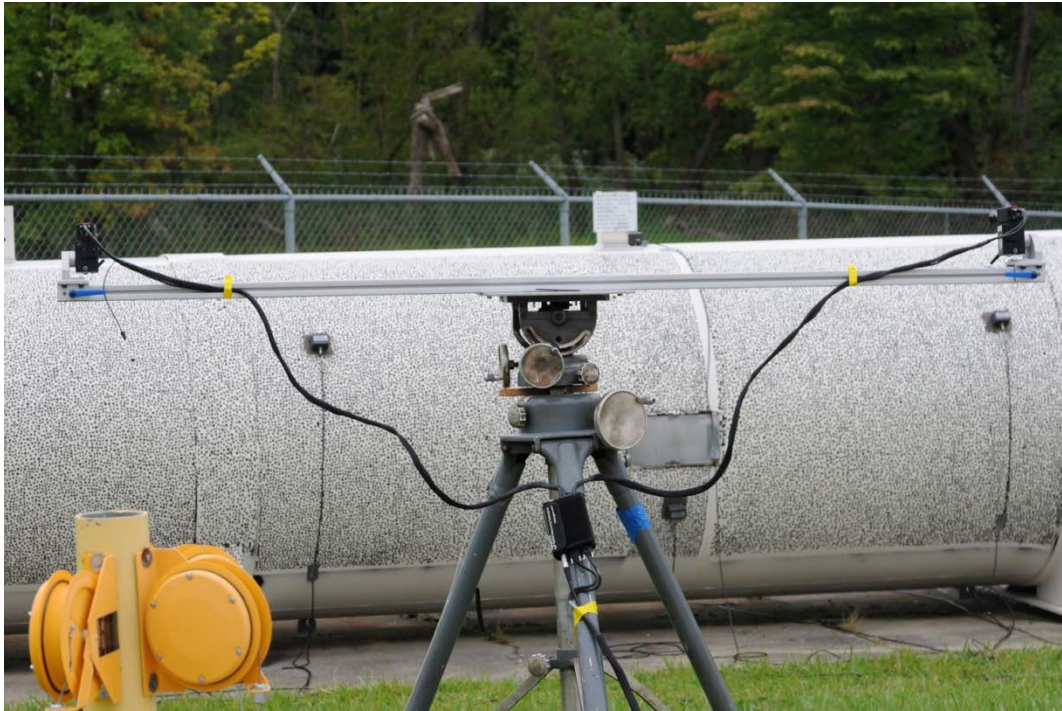
Figure 7.2.3.3-5. Aramis Camera Pair in Test Configuration (note acoustic sensors on vessel)

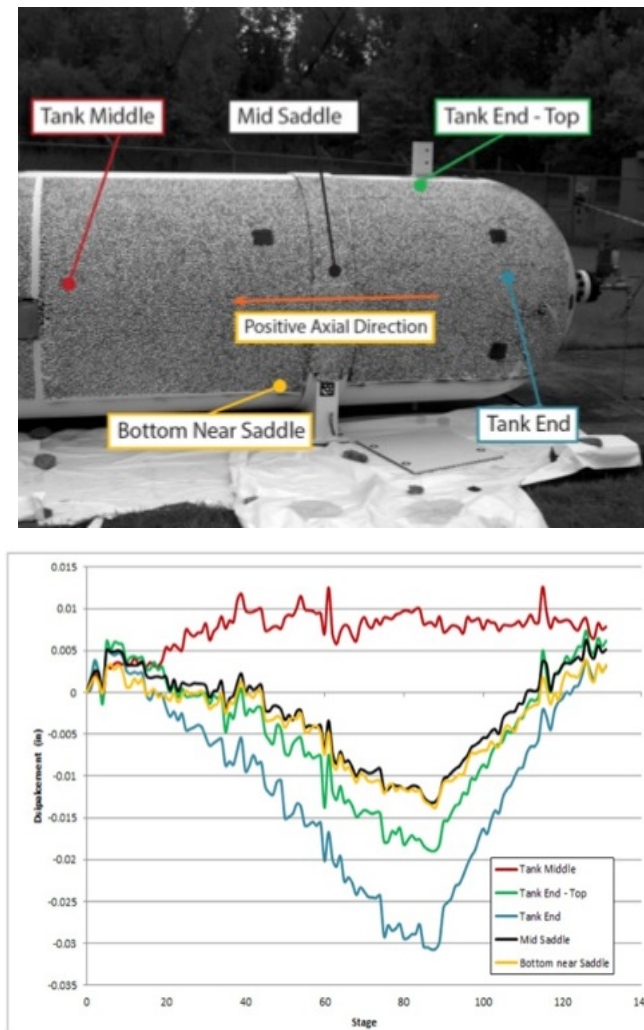
Figure 7.2.3.4-2. Vessel Point Locations and Respective Displacement Plotted versus Stage Number

Predicted axial deformations and hoop strain will be the primary values used for comparative purposes with Aramis measurements. In post analysis, measured data can be taken from any desired point location within the data field. The left-hand image in Figure 7.2.3.4-2 depicts an Aramis image for the second excursion with the relative locations on the vessel where displacement data were taken, along with the positive direction of the vessel cylindrical axis. The graph on the right-hand side of the figure plots the axial deformation of those points as a function of stage number. Refer to Table 7.2.3.4-1 for correlation of pressure to stages. From the graph in Figure 7.2.3.4-2, the relative noise can be estimated to have an average on the order of 2.5- to 3.0-thousandths of an inch, which is in line with the expected 2.3×10^{-3} -inch system capability.

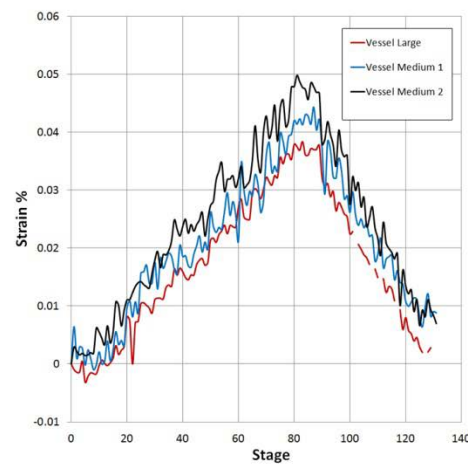
Figure 7.2.3.4-4. Selected Axial Section Lines on Color Overlay of Axial Displacement (X-direction) at 4,200 psi

Aramis data field to obtain the strains along that line. Aramis measures the difference in displacement between the two endpoints of the section line, effectively creating an optical extensometer over its length. Three section lines were selected along the axial direction of the vessel to generate strain data. Figure 7.2.3.4-4 shows the vessel location of two “medium” and one “large” length section lines, with their respective strain plots as a function of stage number. Note that the longer section line is slightly less noisy due to the greater averaging that results over a longer physical length on the vessel. This longer section line is more representative of the overall growth of the vessel during pressurization.

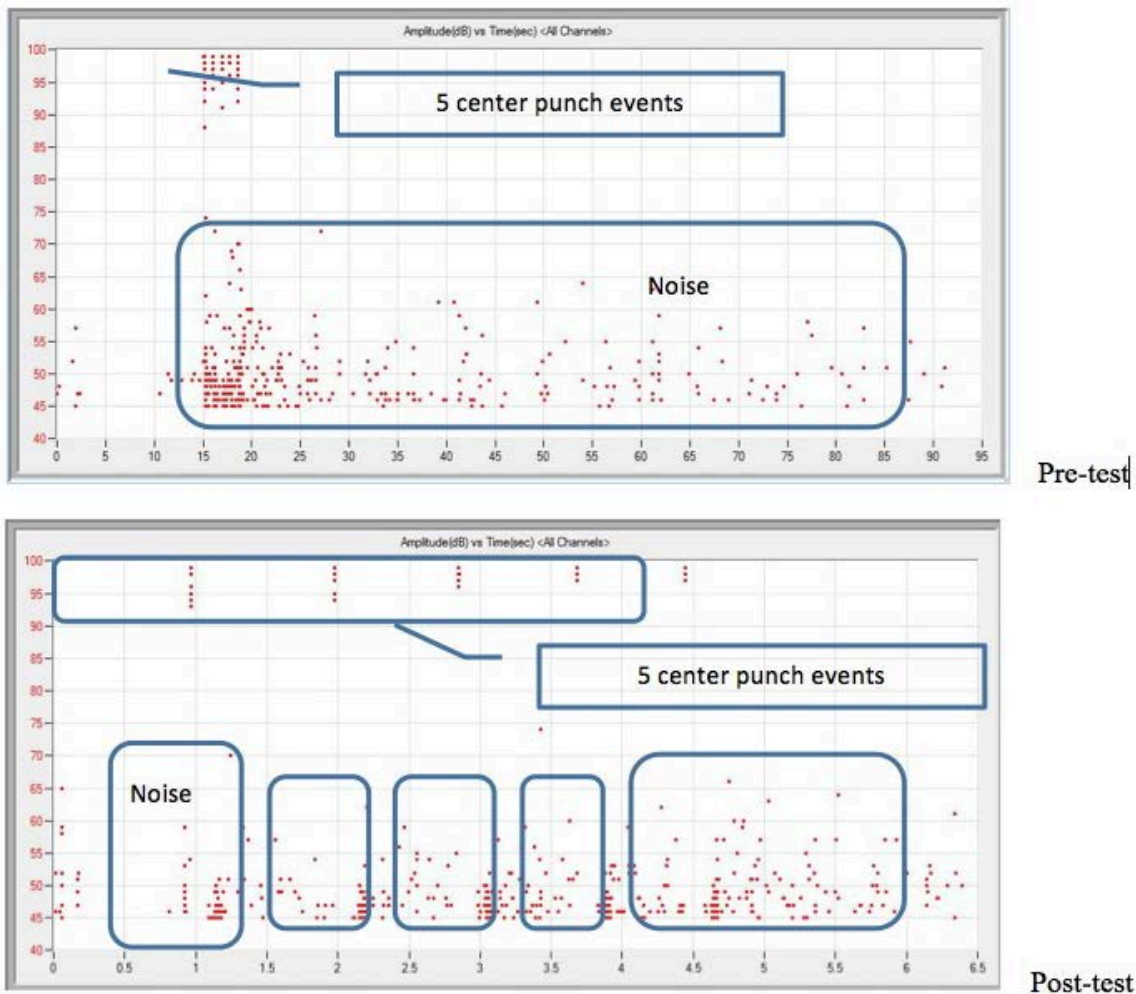
Figure 7.2.4-7. Location Event Amplitudes versus Time

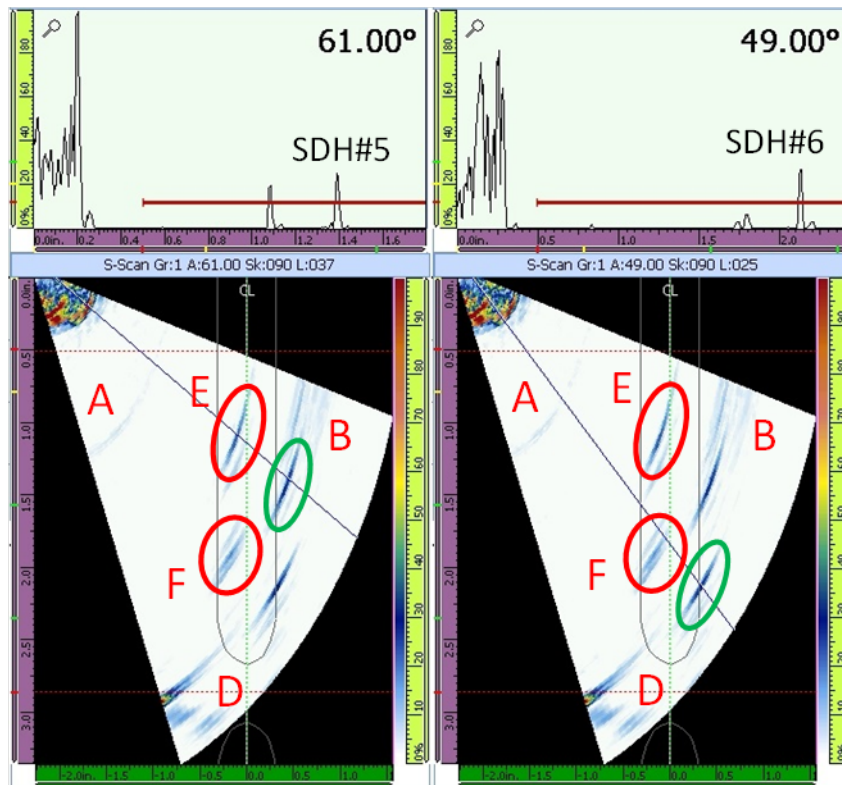
Figure 7.2.5.3-3. S-scans Showing Lower Two SDHs on Multilayered Side of Weld and A-scan of Each Hole at Angle of Peak Response

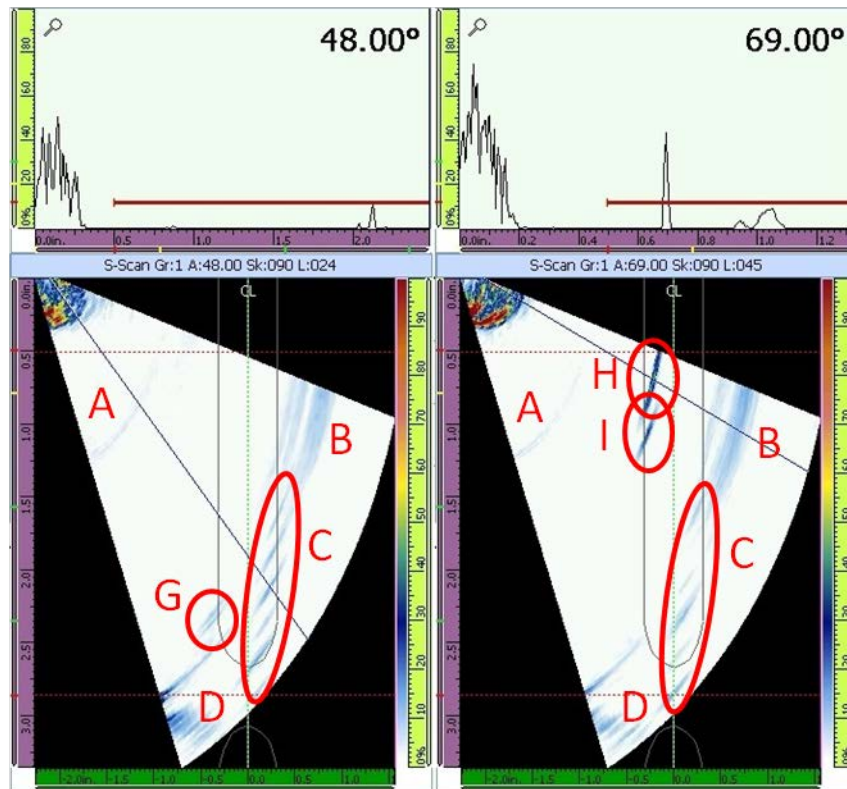
Figure 7.2.5.3-6. Two S-scans Showing Unidentified Indications Not Associated with Known Flaws or Part Geometry

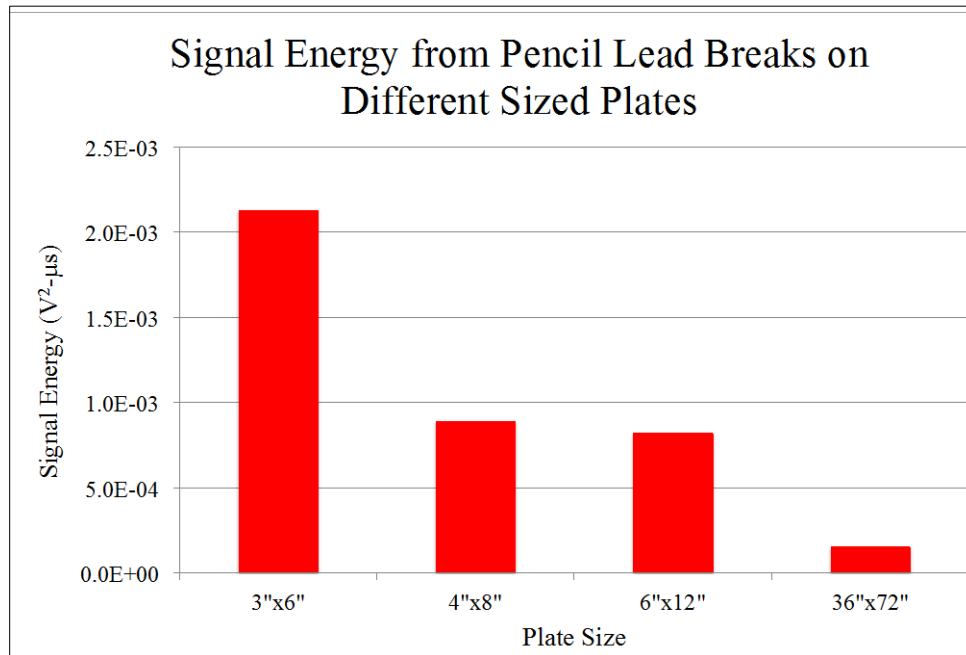
Figure 7.2.6-2. Bar Graph Comparing Measured Signal Energies from Different-sized 1/4-inch-thick Plates

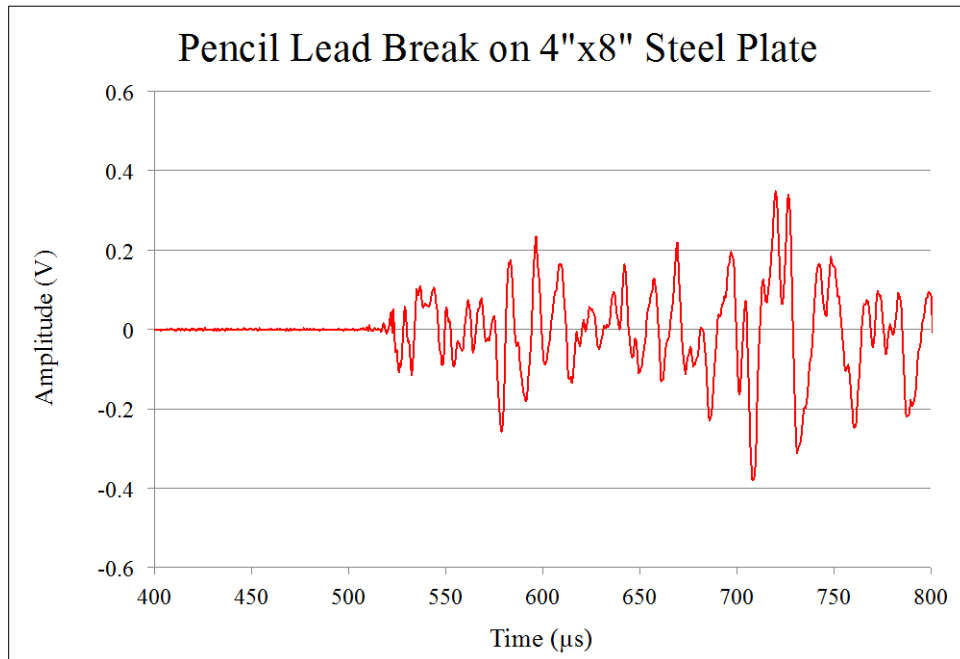
Figure 7.2.6-5. Early Waveform from Pencil-Lead Break on 4- by 8-inch Steel Plate

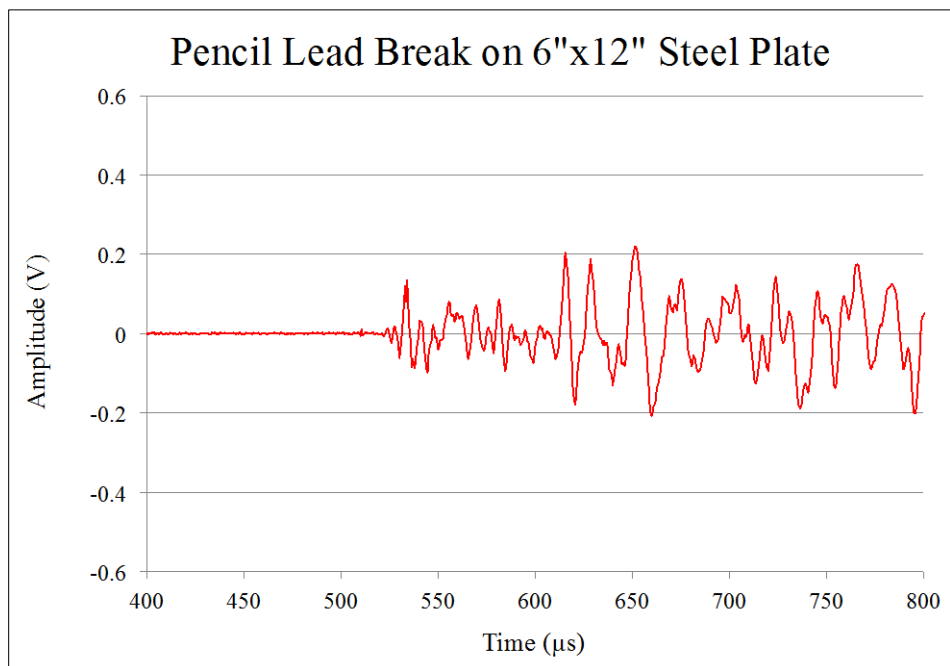
Figure 7.2.6-6. Early Waveform from Pencil-Lead Break on 6- by 12-inch Steel Plate

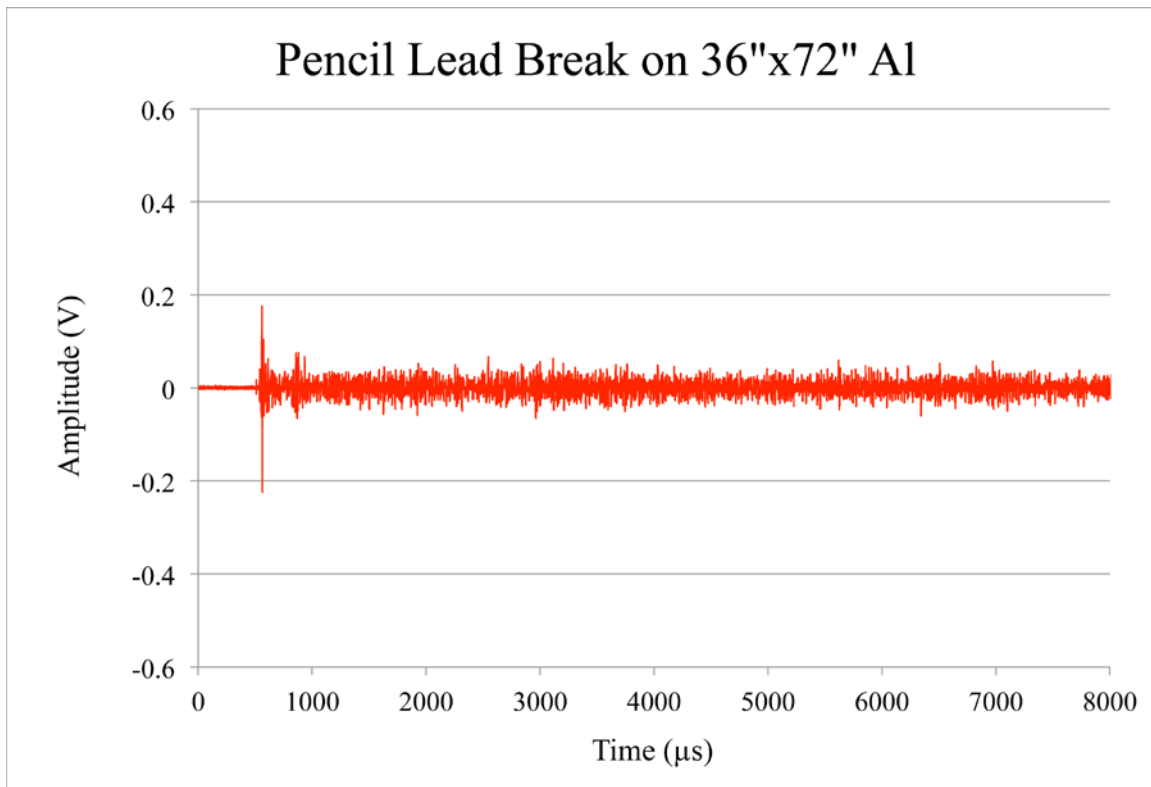
Figure 7.2.6-7. Full Waveform from Pencil-Lead Break on 36- by 72-inch Aluminum Plate

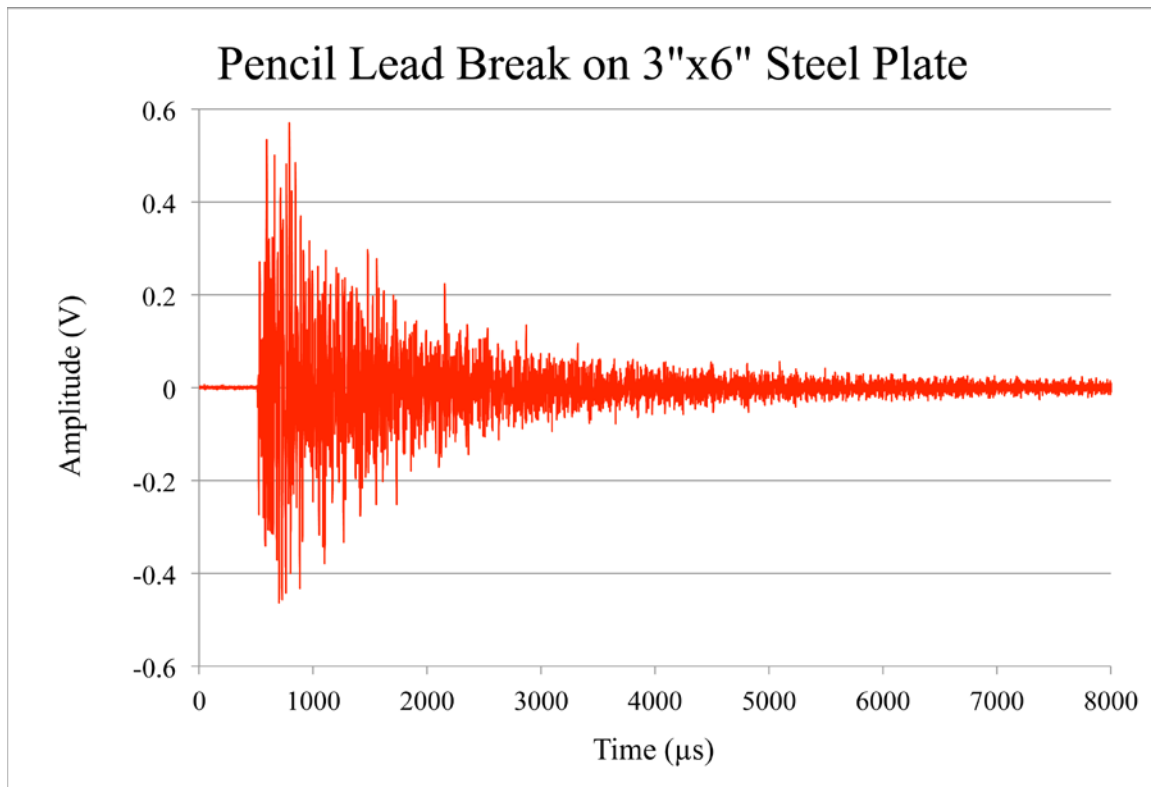
Figure 7.2.6-8. Full Waveform from Pencil-Lead Break on 3- by 6-inch Steel Plate

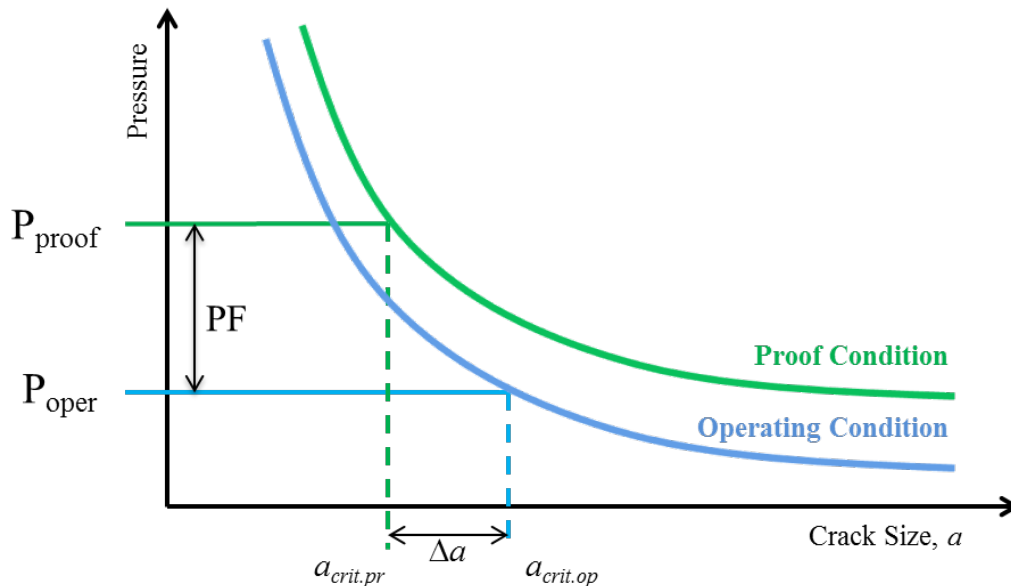
Figure 7.3-2. Proof Test Concept with Proof and Operational Critical Crack Size Curves
