Forward Skirt Structural Testing on the Space Launch System (SLS) Program

J.D. Lohrer, R.D. Wright
Orbital ATK Propulsion Systems, Promontory, Utah

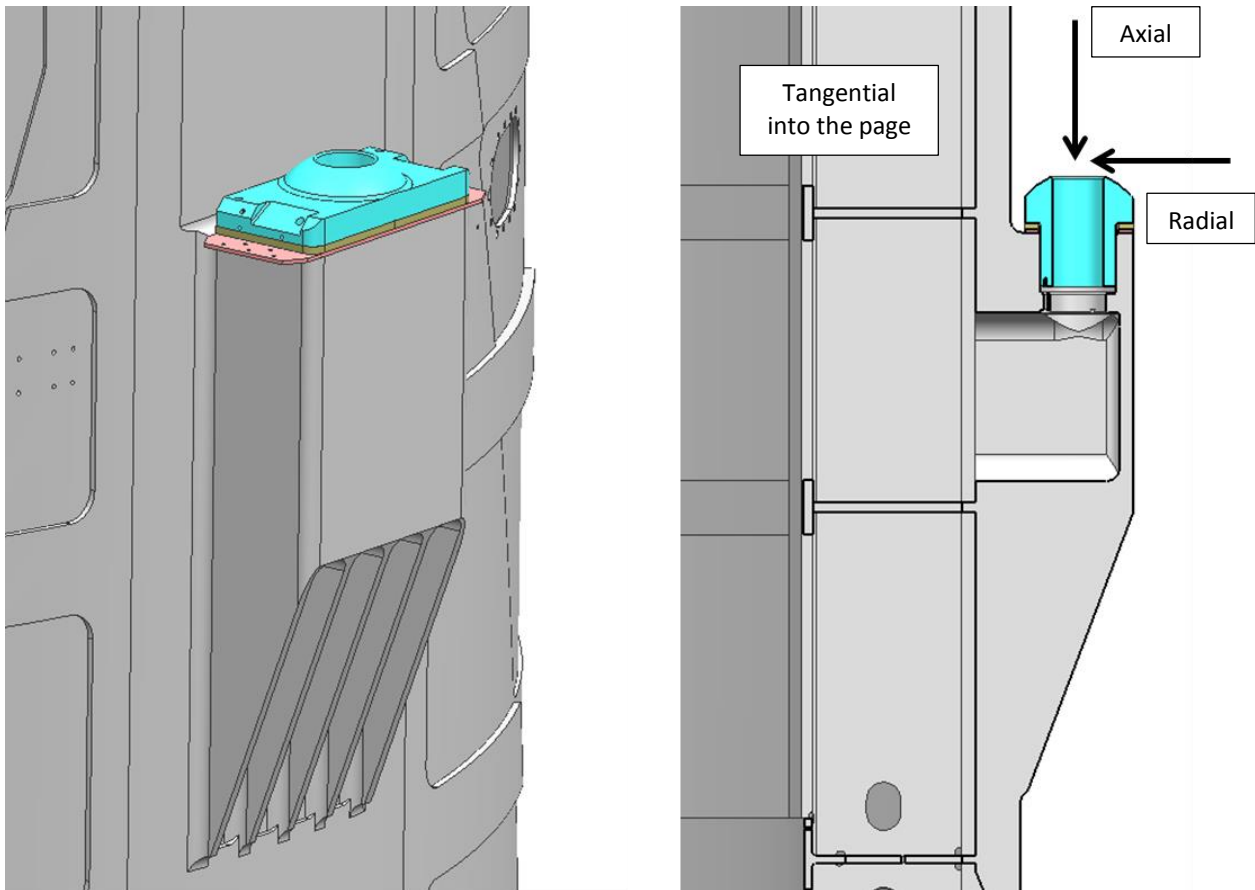
Figure 3. Forward skirt loads.

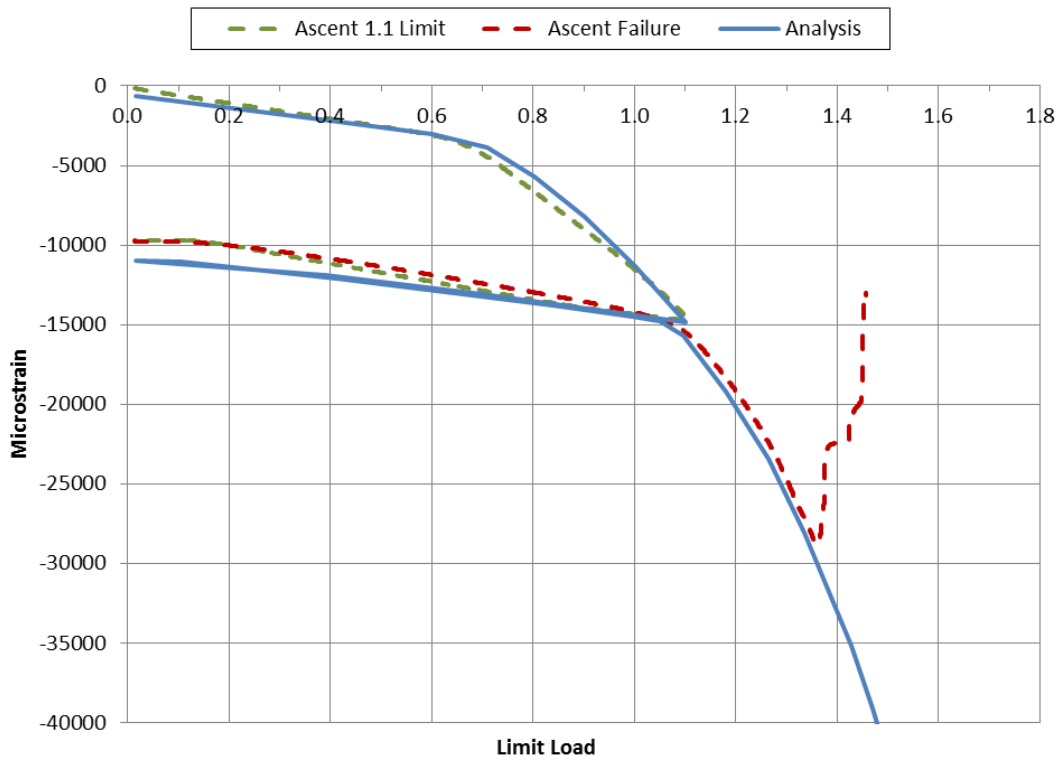
Figure 12. FSTA-1 bore gage strains.

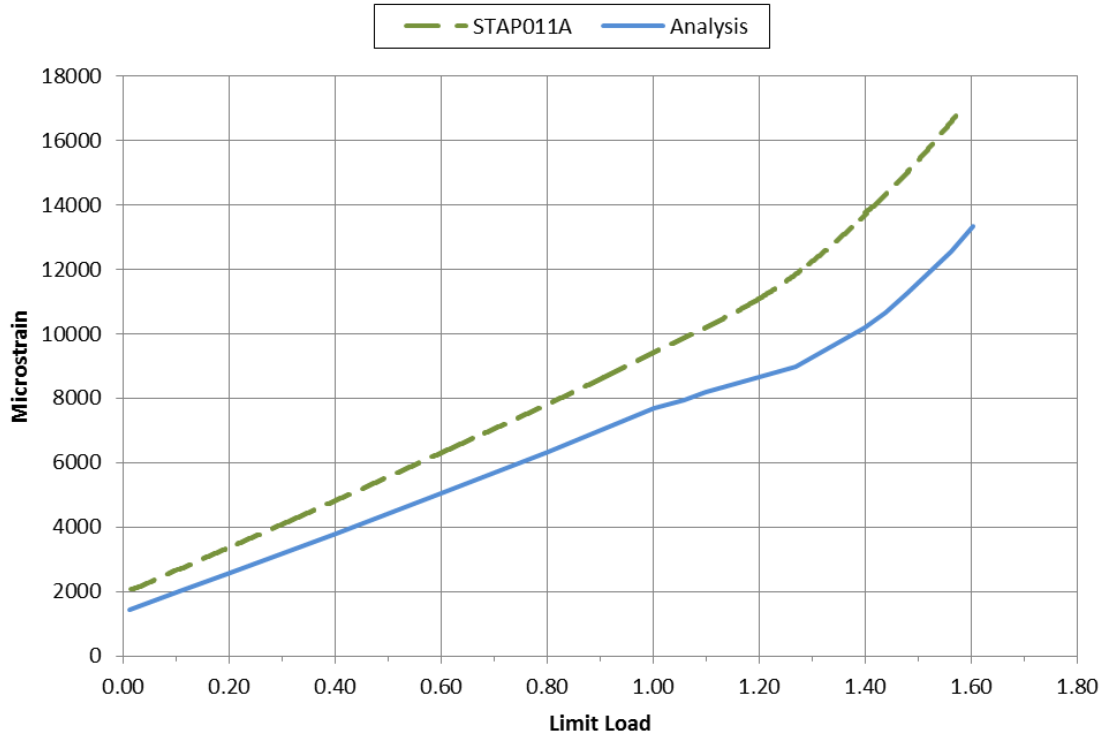
Figure 13. FSTA-2 radius gage strains.

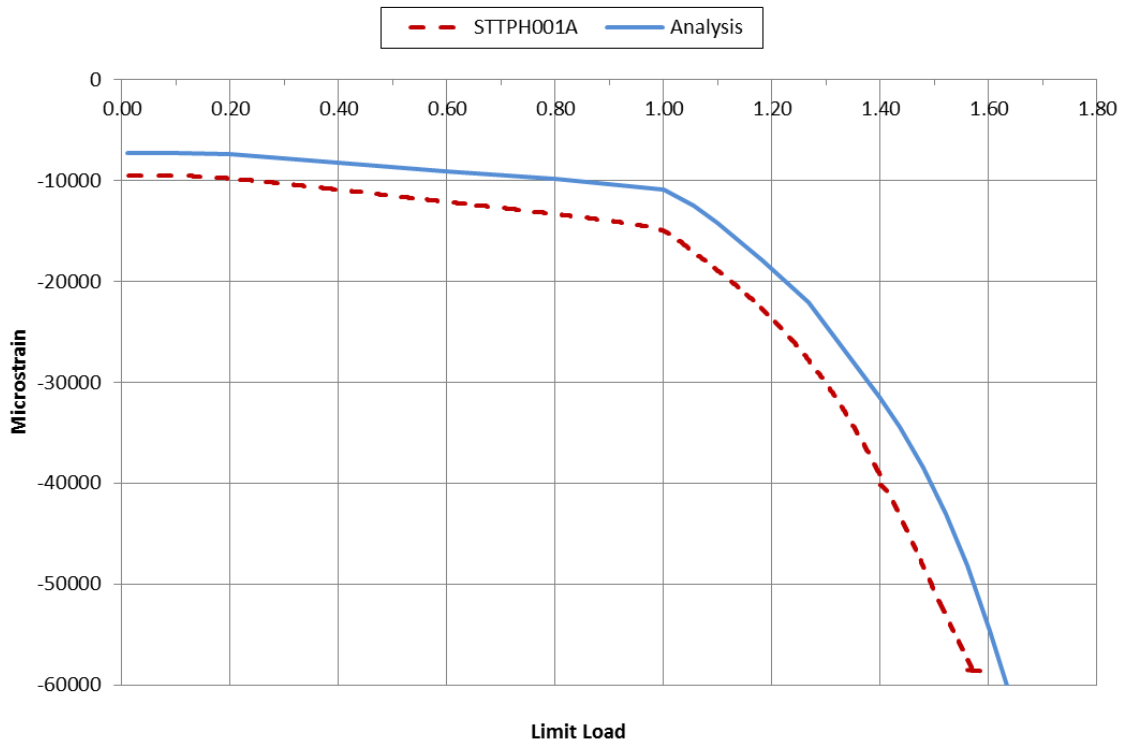
Figure 14. FSTA-2 bore gage strains.

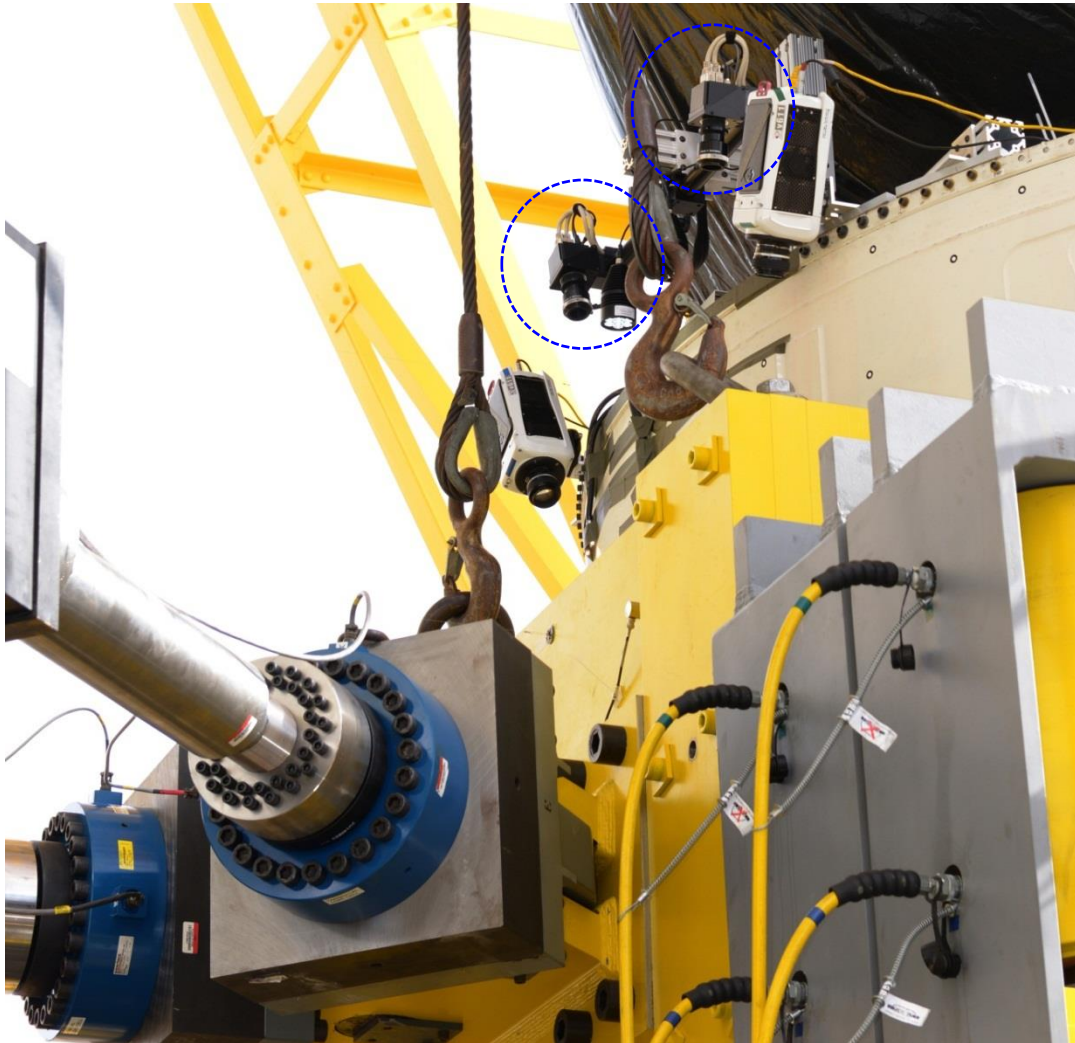
Figure 15. ARAMIS digital cameras viewing post radius.

The ARAMIS system was used to determine strain at the post radius by processing digital images of a speckled paint pattern. Digital cameras shown in Figure 15 recorded images of the speckled paint pattern shown in Figure 16. ARAMIS strain results are shown in Figure 17 for FSTA-2 just prior to failure. Note a high strain location develops near the left side. This high strain compares well to analysis prediction for both FSTA-1 and FSTA-2 as shown in Figure 18. The strain at this location was also plotted versus limit load in Figures 19 and 20. Both FSTA-1 and FSTA-2 had excellent correlation between ARAMIS and analysis strains.

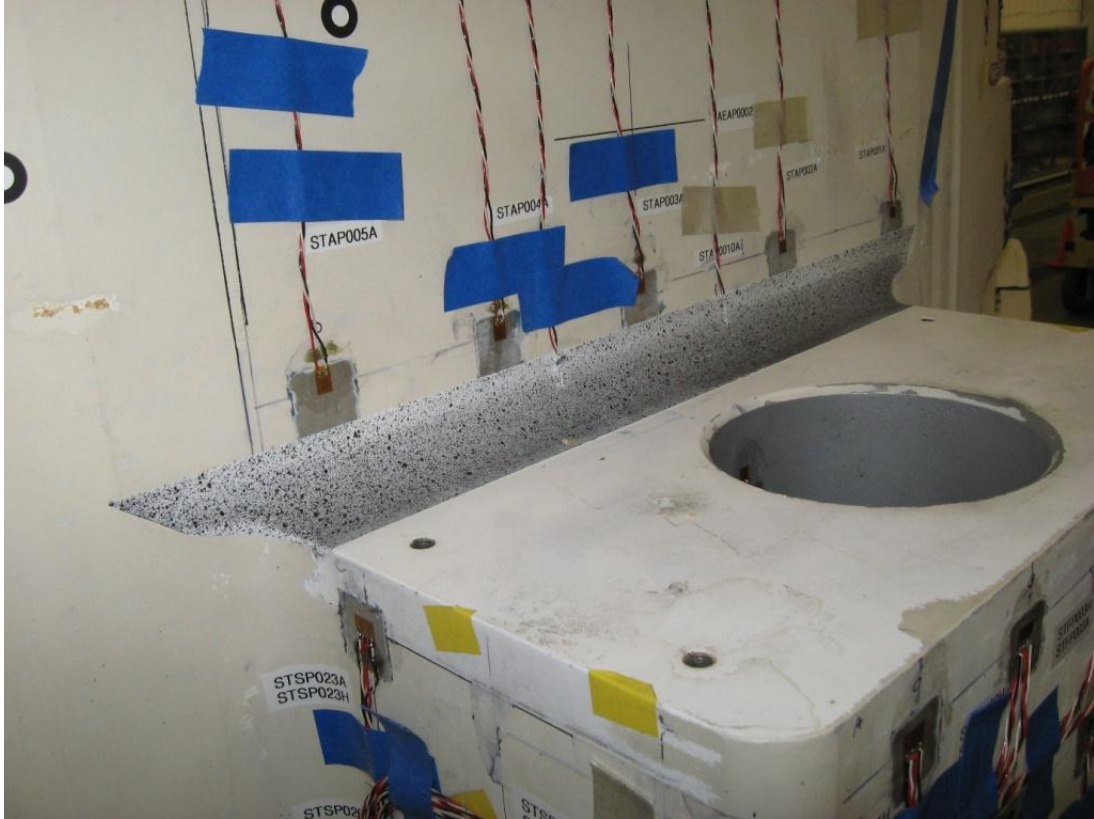
Figure 16. Post radius speckle pattern.

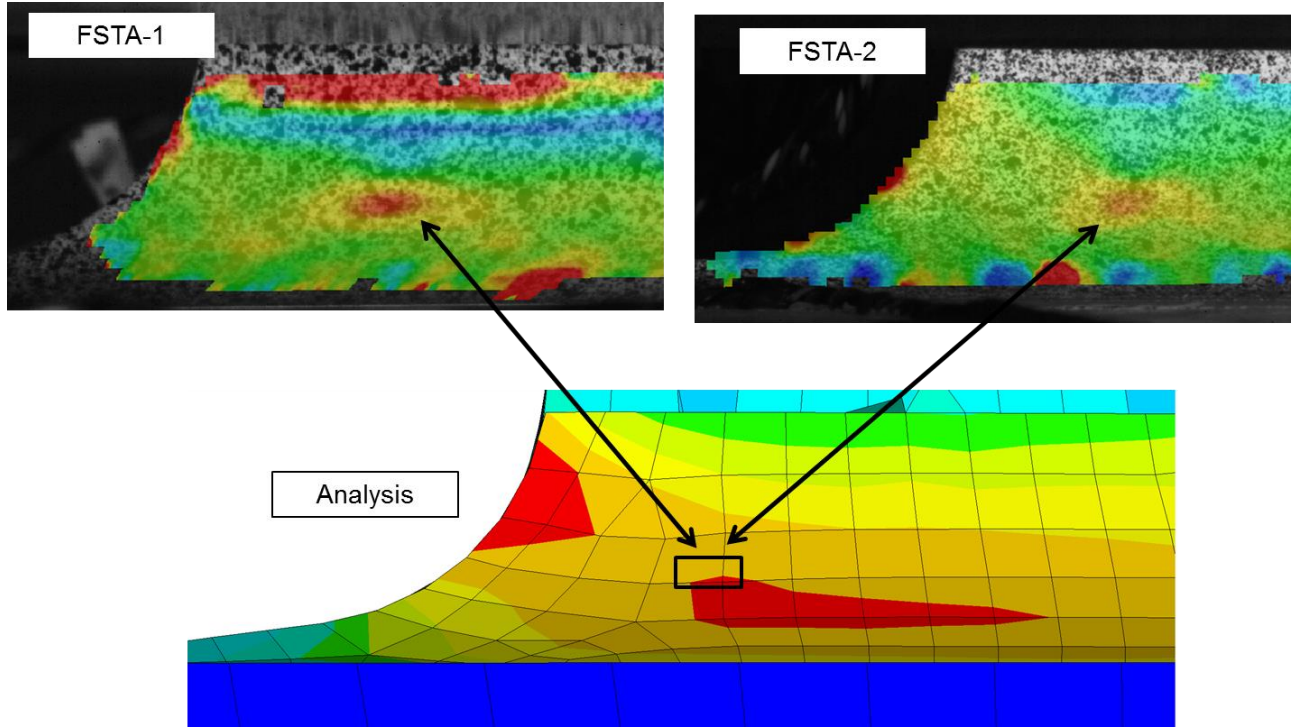
Figure 18. ARAMIS versus analysis strain at hot spot.

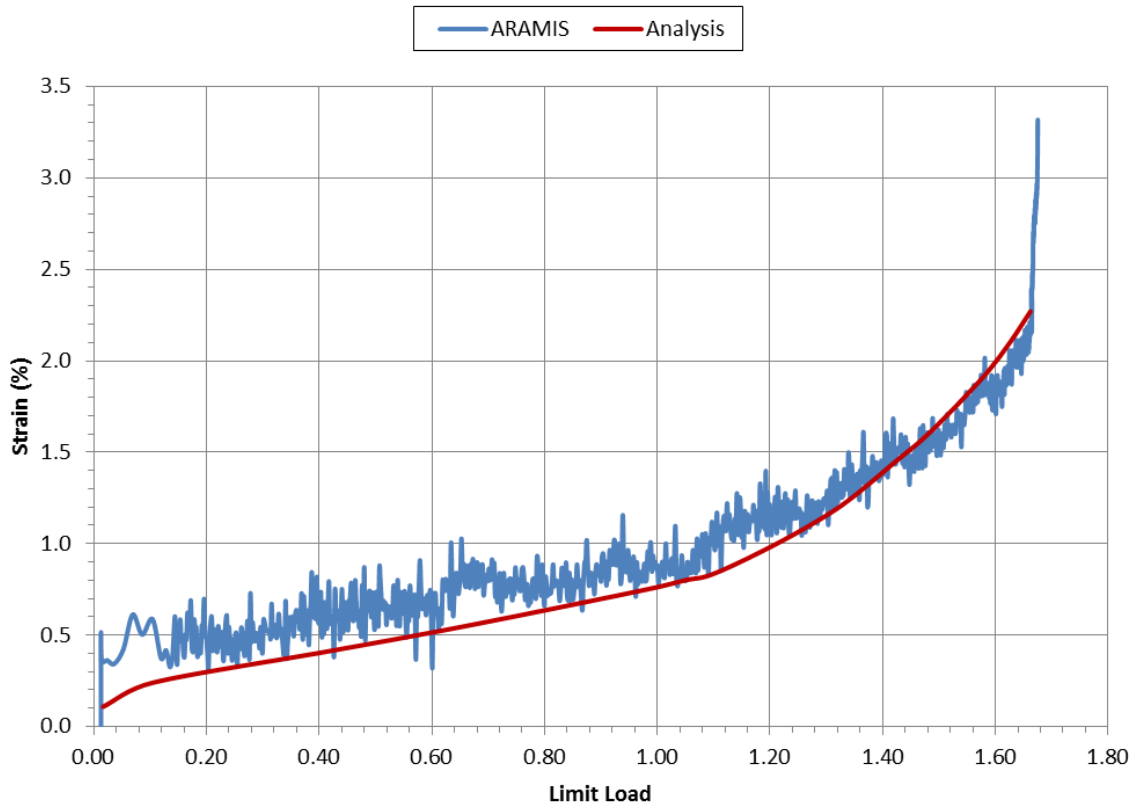
Figure 19. FSTA-1 ARAMIS versus analysis strain.

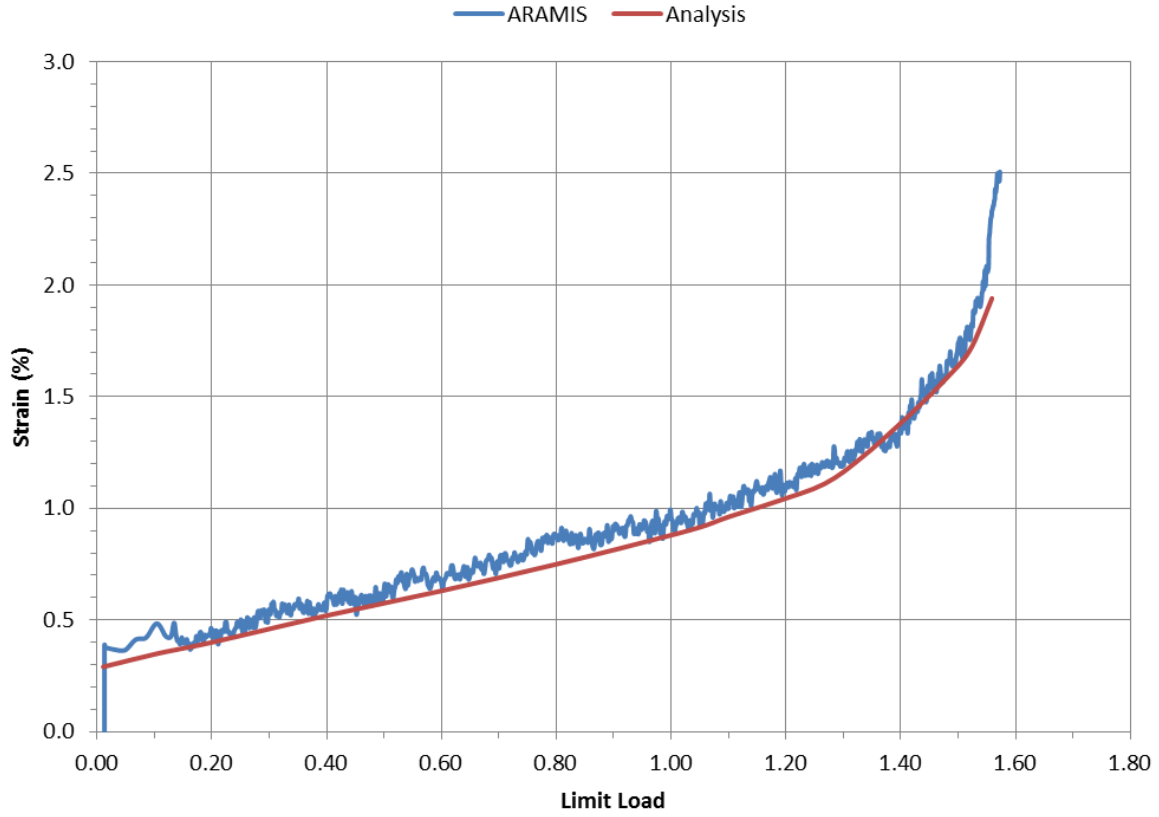
Figure 20. FSTA-2 ARAMIS versus analysis strain.

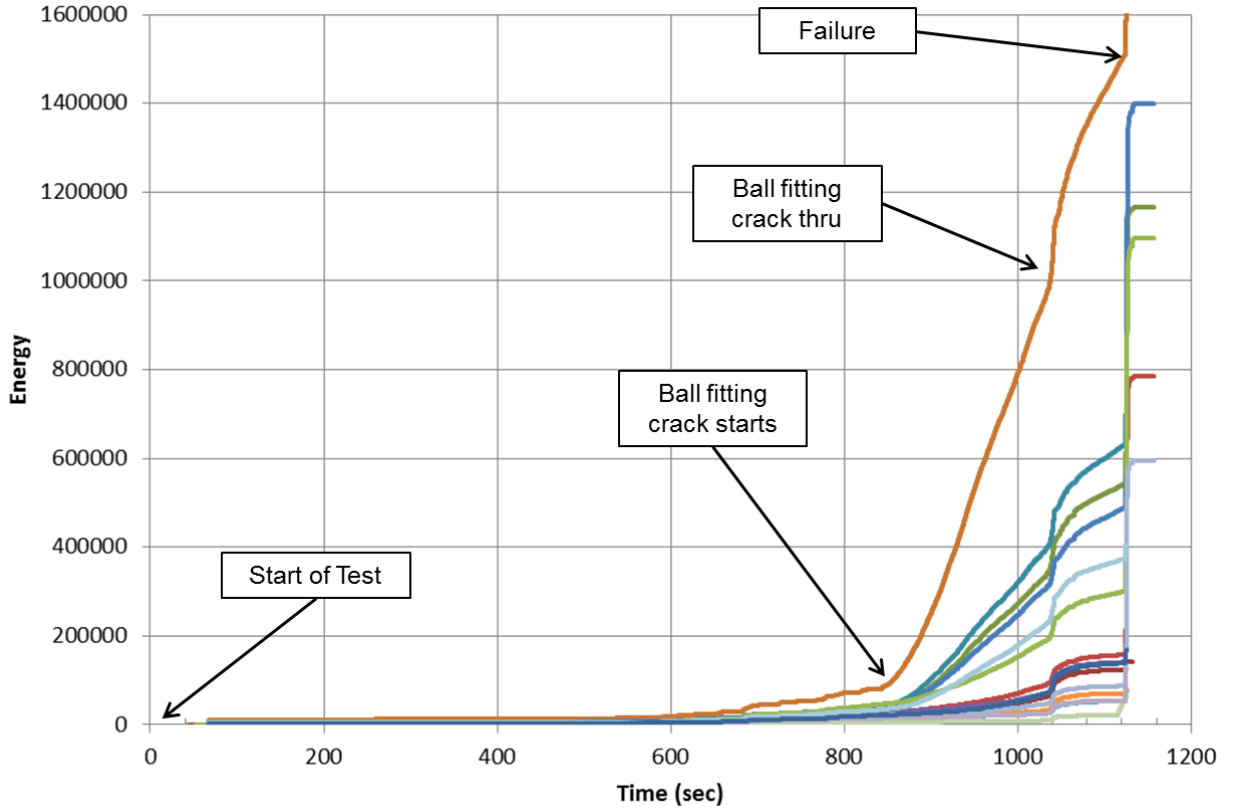
Figure 22. FSTA-1 acoustic energy events.

used to reconstruct when the crack occurred. The AE energy versus time plot for FSTA-1 is shown in Figure 22. The energy increased considerably at 850 seconds (152% limit load), indicating a crack could have formed at this point. The only visual evidence found that could have corresponded to this was the crack that initiated in the ball fitting. The cracks in the forward skirt aluminum structures would likely have been lower energy due to a lower modulus and all that were found after failure correlated to occurring after the initial crack in the post radius. This was verified by high-speed cameras used to record the failure.
