# Extravehicular Activity Development of Unforeseen International Space Station Maintenance

ICES-2016-061

Sarah Kazukiewicz Korona

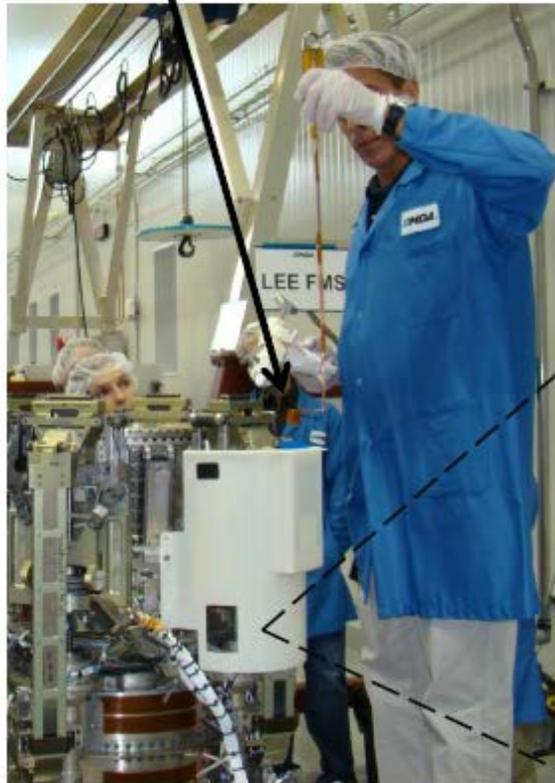
BLT insertion into  
latch housing

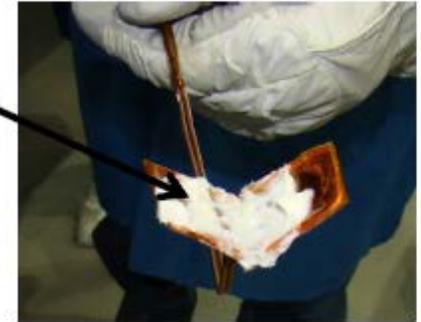
Lube on BLT

Note: on-orbit will be gray-  
colored Braycoat lube

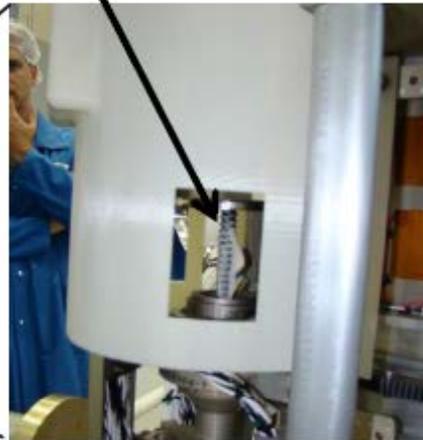
Lube applied to Latch  
Ball-screw

Note: no viewing window  
on-orbit (blind operation)

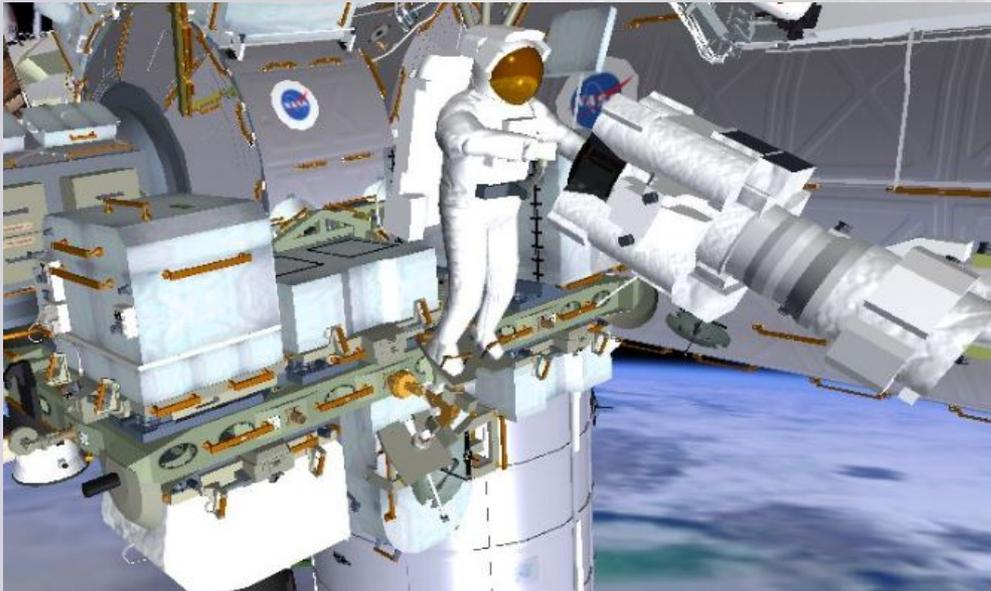
Executed Position

- Discovered the body position and orientation on how the LEE was presented to the EVA crew member needed improvement.
  - All of these steps helped the team gain confidence that the ballscrew would get lubricated every time.
