Suomi-NPP Mission On-orbit Experience with Toroid Ball Bearing Retainers under Unidirectional and Reversing Motion

Abstract

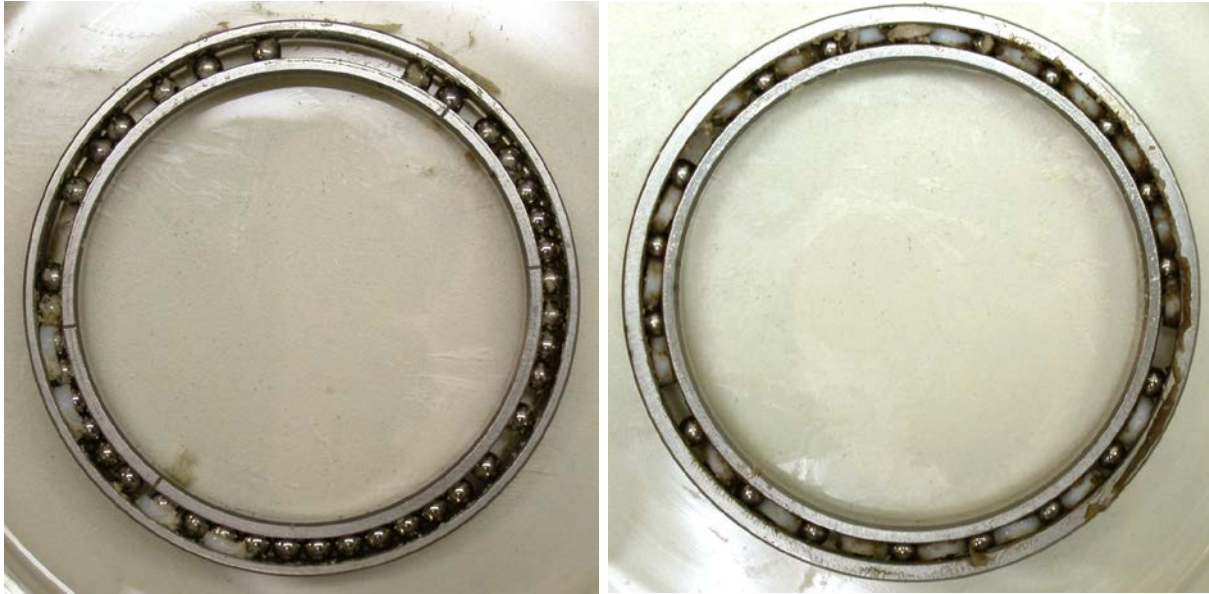
Figure 4. Test Unit #2 bearing condition from 2009 disassembly

Test unit 2 started experiencing higher torque spikes at about the 5 year mark of its 'operational' life. The torque generated by the unit exceeded limits at the 5.3 year mark of its life (2/20/2009). At this point, the unit was disassembled to inspect the bearings. It was found that the bearing toroids had experienced severe wear. The toroids of one end of the bearing pair were almost totally destroyed and the other bearing showed severe wear of the toroids. The temperature of the test units was initially set at 41 °C as a predicted worst case temperature. In the September 2012 timeframe the temperature was changed to more closely match that of the measured on-orbit values. The test unit temperature was changed from 41 °C to 18 °C. At the time, it was thought that the accelerated wear of the test unit #2 bearings was the result of an overly conservative temperature prediction leading to a premature loss of lubrication.

Figure 4 shows the wear of the bearing toroids for test unit 2. The left picture shows the 'heater' end bearing and the left shows the 'encoder' end bearing. The 'heater' end bearing was thought to run at a slightly higher temperature than the other, leading to more severe wear.

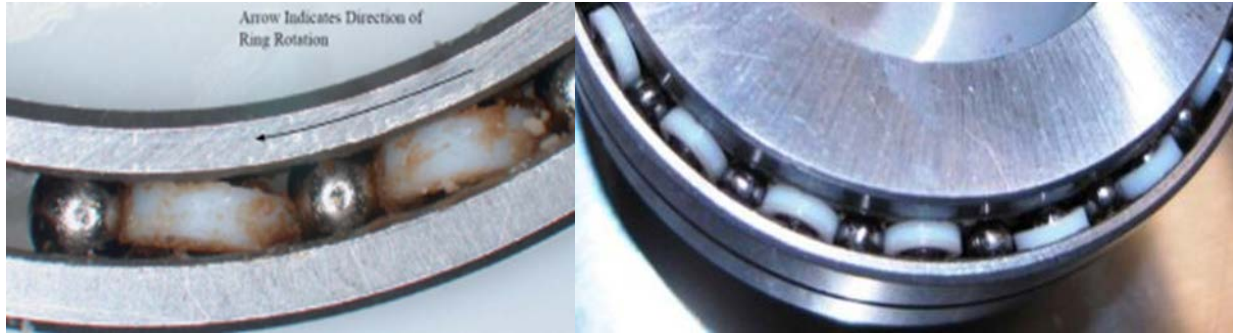
Figure 5. Comparison of Test Station#2 bearing with a similar bearing in relatively good condition with equal direction reversals after 6X times the number of revolutions.

A comparison of the Test Station #2 life test bearing with rotation in one direction and a similar life test bearing that rotated equally in both directions is shown in Figure 5. The bi-directional bearing is clearly in much better condition than the ATMS bearing despite achieving six times the number of revolutions.

Left Figure: ATMS uni-directional test bearing at 63 Mrevs

Right Figure: Similar bi-directional bearing at 362 Mrevs

Reversing bearing rotational direction minimizes toroid wear because it reduces the chance for the toroids to get stuck/pinned in one orientation. The toroid that is pinned by the driving ball will tend to rub in one spot causing the lubricant to dry out and also inhibits the supply of fresh lubricant. The photos of the worn toroids from post-test inspection (see the next section) clearly show that the toroids were locked in one orientation forming ball pocket wear divots. From the steel ring-on-block tests reported in Reference 3, the wear rate of unlubricated (dry), PTFE test samples was >1000 times the wear rate of those lubricated. This obviously has a major effect on toroid wear life.

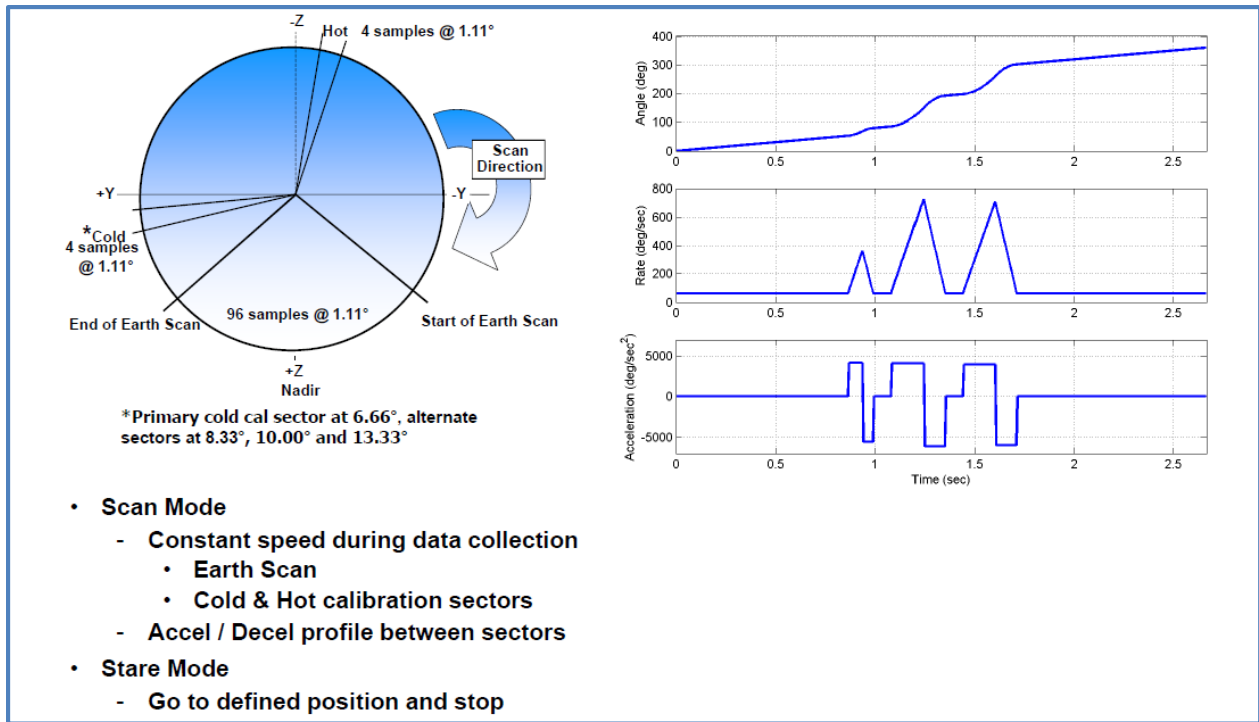
Figure 6. ATMS Scan Profile Description

The ATMS bearing application, by comparison, did not involve any reversals in its operation. The ATMS motion profile is uni-directional for the entire life of the instrument. There are accelerations and decelerations in the ATMS profile, but no opportunities for reversal of motion. A description of the ATMS profile is provided in Figure 6. Note that the primary data collect occurs during the Earth scan at constant speed as does the cold and hot calibrations. In order to minimize revisit time to the required 8/3 of a second per revolution, the scanner must accelerate and brake at extremely high levels (4500 to 5000 deg/s²) three times each revolution. At first it was thought that these high acceleration levels were responsible for ball skidding leading to premature life. However subsequent analysis showed that the dynamic loads were very small compared to the bearing preload making skidding unlikely.

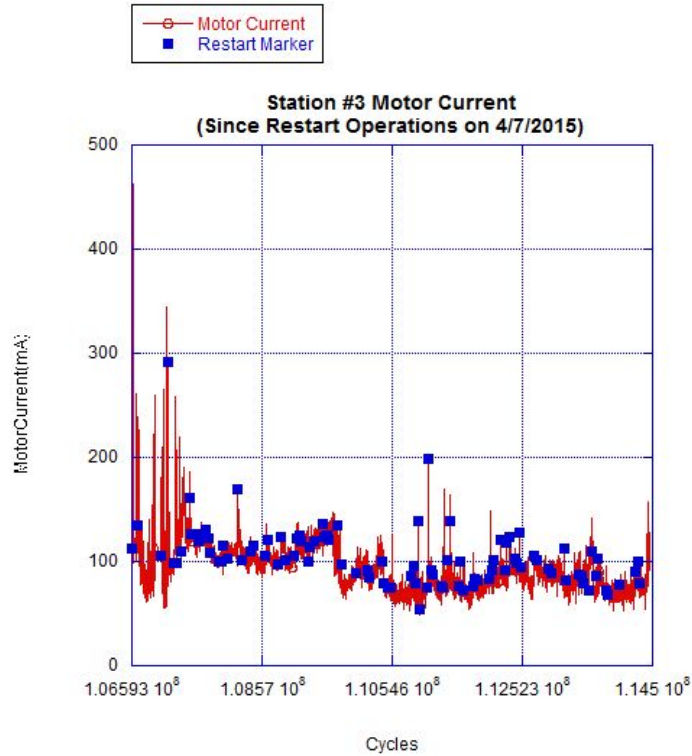
Figure 11. Motor Current of Test Station #3 (12/08/2015) – blue squares indicate reversals

The six reversals per day were tested on two running bearing test stations at different times. At this period of time, both stations were down because both stalled in late 2014 due to high torque and were shut down pending new engineering direction. The reversal testing was started on test station 3 in April 2015 while test station 1 was restarted in March of 2015 running the normal scan profile without reversals. While test station 3 was being used for reversal testing, test station 1 stalled in early August of 2015. At this point in time we needed to develop more experience with reversals, so we decided to restart station 1 doing daily reversals. At first, test station #1 was reluctant to re-start, but eventually did in mid-August 2015. Test station #1 was run with the daily reversals for about a month before its disassembly. At the time of its test termination, test station #1 was past its 2X mission life. Test station #3 continues to run with good results and is almost at its 2X life point as this is being written. Figure 11 shows the motor current data for test station #3 as of December 8, 2015 and Figure 12 shows the motor current for test station #1.

It is anticipated that the toroids in the test station #3 bearings are compromised to some extent, but no definitive statement can be made as to their actual state. It would be logical to expect that the station 3 toroid condition is somewhere between the states of the disassembled test stations 1 and 2.

The reversals on test stations 1 and 3 were successful in giving these bearings new life. However due to the debris generated by the failure of the toroids, some torque spikes are expected to occur. The toroid debris is being ground up by the action of the balls against the races. It is thought that the reversals arrest the further degradation of intact toroids as contact surfaces are being re-wetted with remaining lubricant.

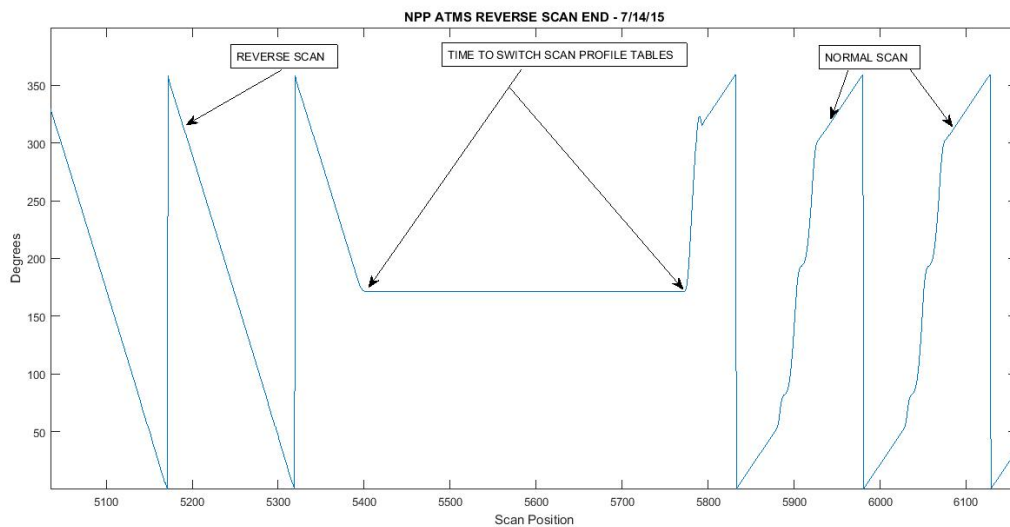
Figure 13. Scanner Recovery from Reverse to Normal Scan

Figure 13 shows the transition from reverse and then back to normal. The figure shows the scan angle vs scan telemetry sample number of the dataset. There are 148 data samples per complete scan rotation.

Northrop Grumman was tasked to develop and test a command sequence to have the scanner go in a reverse direction. They came back with an elegant and simple process of uploading a new scan profile table that would perform the desired operation. Once loaded, this new table would be enabled by command at a time desired and then another command would be issued to go back to a normal scan table. Northrop Grumman tested this process on their simulator and also on the sensor Engineering Development Unit. Also, after a number of discussions and some test information from the still running bearing test stations, we settled on doing six contiguous scans in reverse direction once per day above 74 degrees North latitude.
