14th International Symposium on
Nondestructive Characterization of Materials

**Composite Overwrapped Pressure Vessel
(COPV) Liner and Thin Wall Metallic
Pressure Vessel Inspection Scanner
Development and Assessment**

Regor Saulsberry

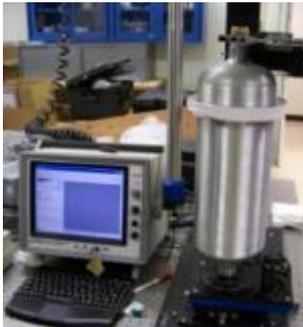
External EC added to desktop profilometry scanner

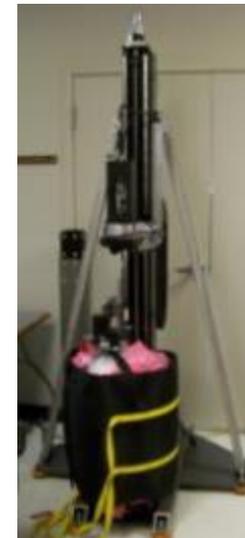
7'
Nitrogen/Oxygen Recharge System (NORS) and Orion profilometry system developed, validated and used extensively by the ISS NORS Program

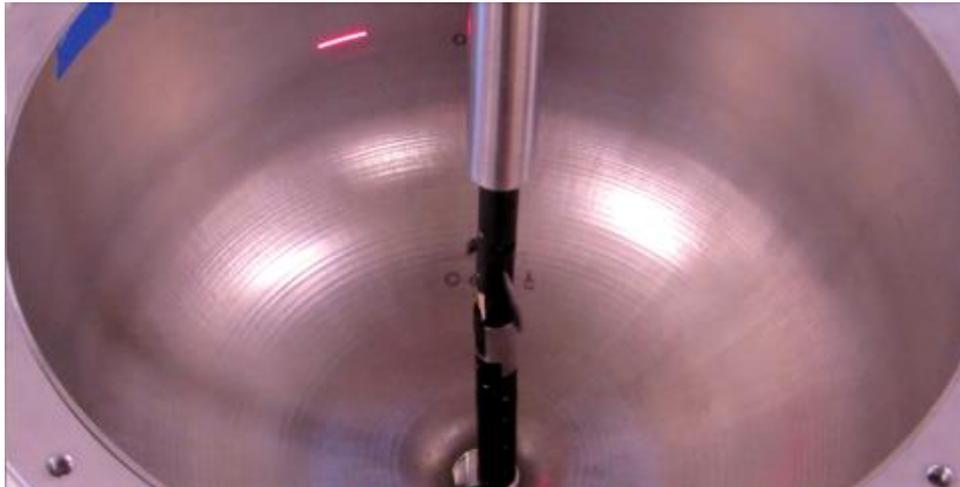
**Profilometry
Scan**
