Deformation Mechanisms of NiAl Cyclicly Deformed
Near the Brittle-to-Ductile Transformation Temperature

NASA Grant #NCC3-116

Final Report December 17, 1992

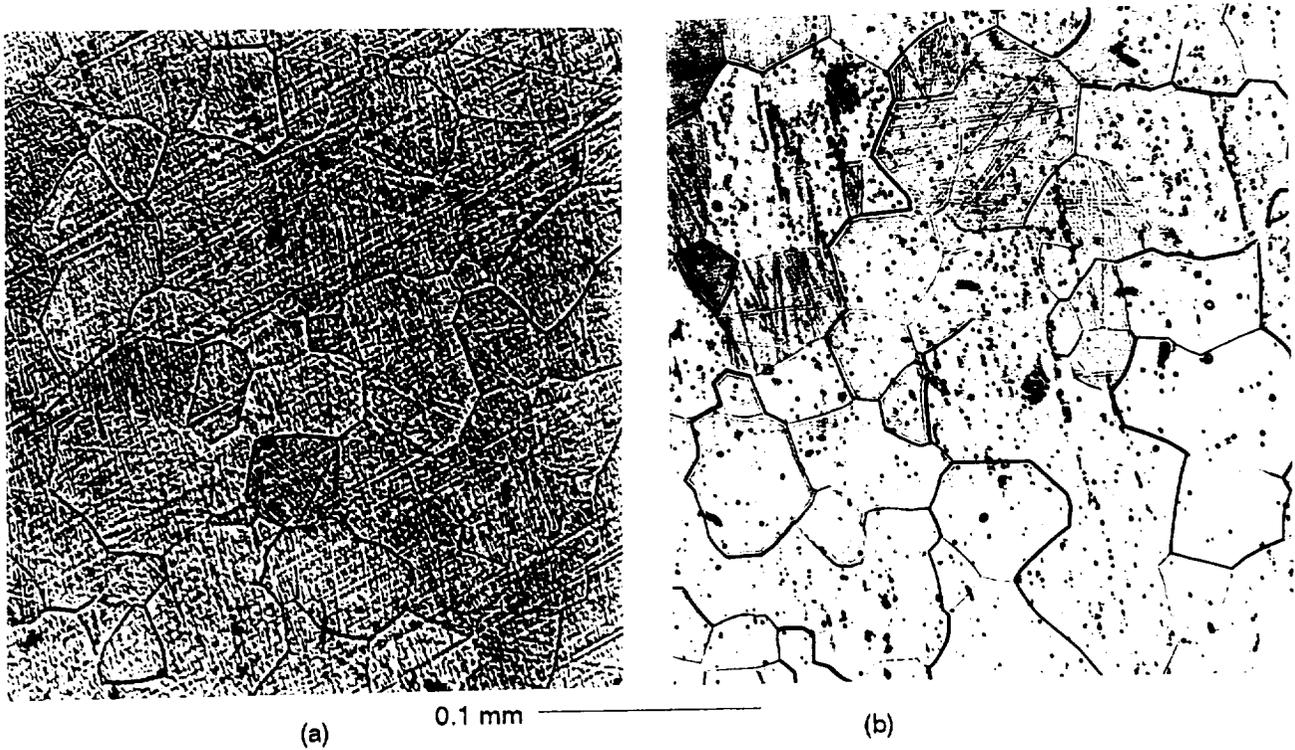
Figure 3.1 - Recrystallized, equiaxed structure of as-extruded NiAl in (a) transverse and (b) longitudinal directions. Average linear intercept grain size is $39 \mu\text{m}$.

Transverse and longitudinal metallographic sections were taken from the extrusion. Sections were mounted in bakelite, polished on standard grit paper wheels, and polished with 1 and 3 μm slurries on cloth wheels. Since NiAl is a hard, difficult to polish material, a special final polish was also used. A solution of 150 ml H_2O , 150 ml colloidal silica, 10 ml H_2O_2 , 1 ml HF, and 1 ml HNO_3 in conjunction with a clean cloth wheel was used to achieve a smoother surface. Specimens were etched for 1 to 3 minutes with a solution of 100 grams molybdc acid, 150 ml water, 50 ml hydrofluoric acid to expose the grain boundaries. The extruded material had a recrystallized, equiaxed grain structure, shown in Figure 3.1, with an average linear intercept grain size of 39 μm .

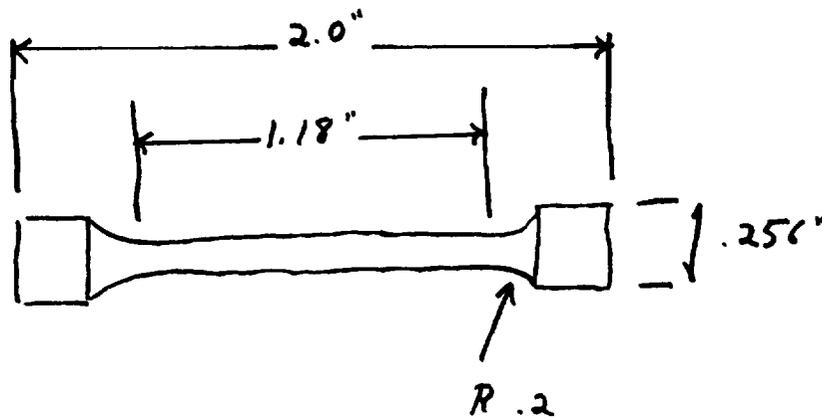
Figure 3.2 - Specifications for tensile specimen.

Uniaxial tensile tests were conducted to determine the monotonic BDTT for this heat of material. Blanks for cylindrical, button-head, tension specimens were electro-discharge machined from the extrusion and ground parallel to the extrusion axis. The tensile specimens had approximately 30 mm long and 3 mm diameter gage sections as shown in Figure 3.2. The gage sections were electropolished in a methanol-10% perchloric acid solution at 205 K and 1.0 Amps prior to testing to eliminate surface flaws that could result in premature failure.

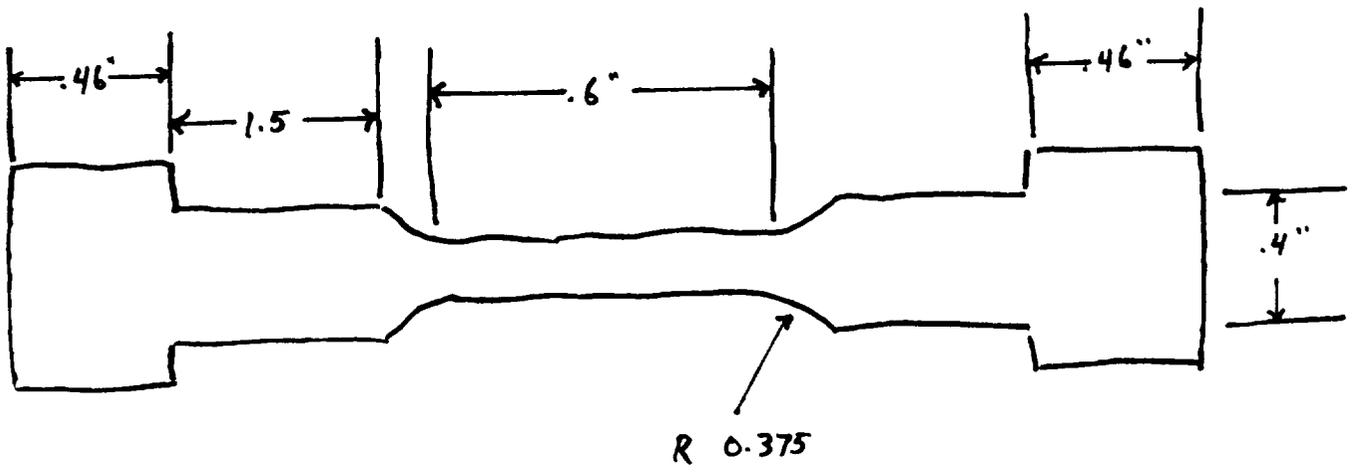
Figure 3.3 - Specifications for low cycle fatigue specimen.

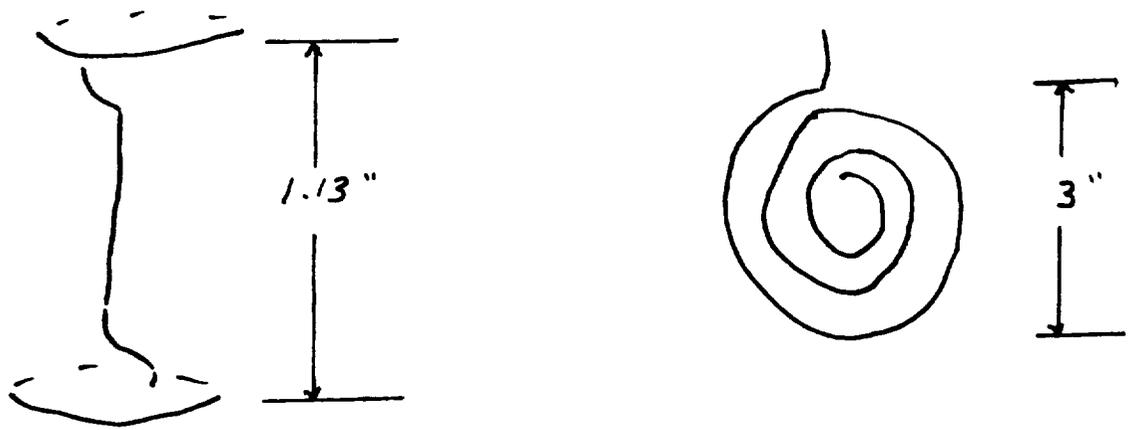
Figure 3.4 - Induction coil design (a) front and (b) top views.

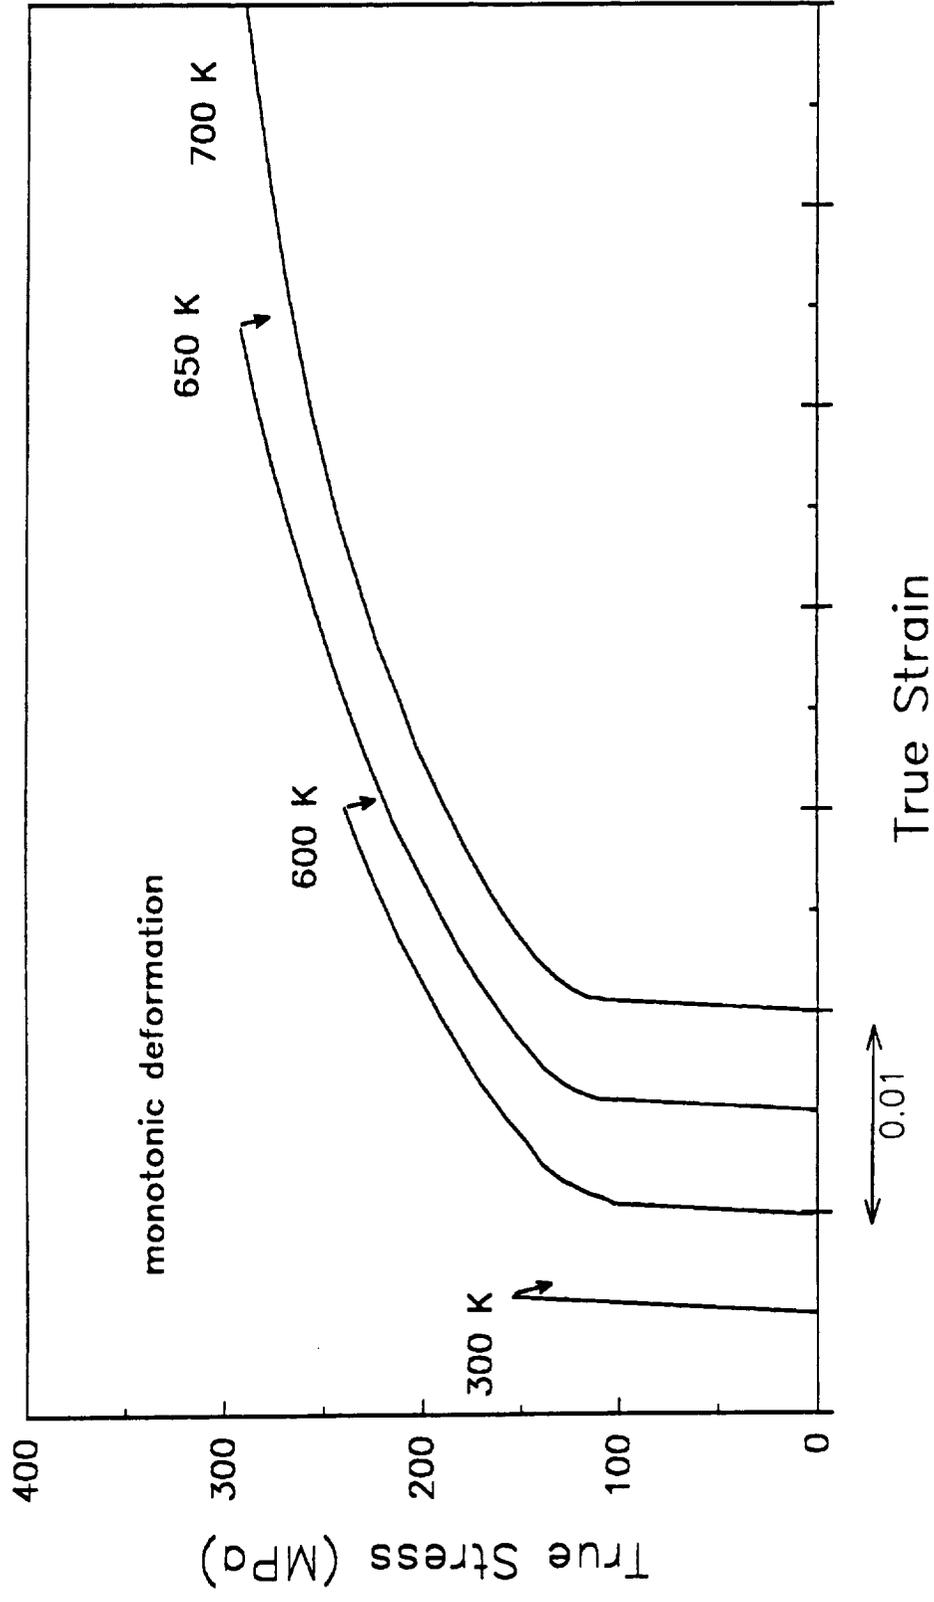
Figure 4.1 - True stress versus true strain for tensile test conducted at $\dot{\epsilon} = 10^{-4} \text{ s}^{-1}$. Curves were shifted to the right for clarity. Test at 700 K continued to 18.2%.

The true stress versus true strain data for tensile tests conducted at $\dot{\epsilon} = 10^{-4} \text{ s}^{-1}$ are shown in Figure 4.1 (initial strain off-set from zero for clarity). The room temperature (300 K) test failed elastically. Previous work in NiAl has shown that the fracture stress with zero ductility corresponds to the yield stress. For this heat of material tested at 10^{-4} s^{-1} , the yield stress dropped from 155 MPa at 300 K to 141 MPa at 700 K and the fracture stress increased from 155 to 374 MPa in the same temperature range. The percentage of intergranular fracture, relative to transgranular cleavage, in the fracture surfaces decreased with increasing temperature from $39 \pm 4\%$ intergranular at 600 K to $28 \pm 2\%$ at 700 K, Figure 4.2.

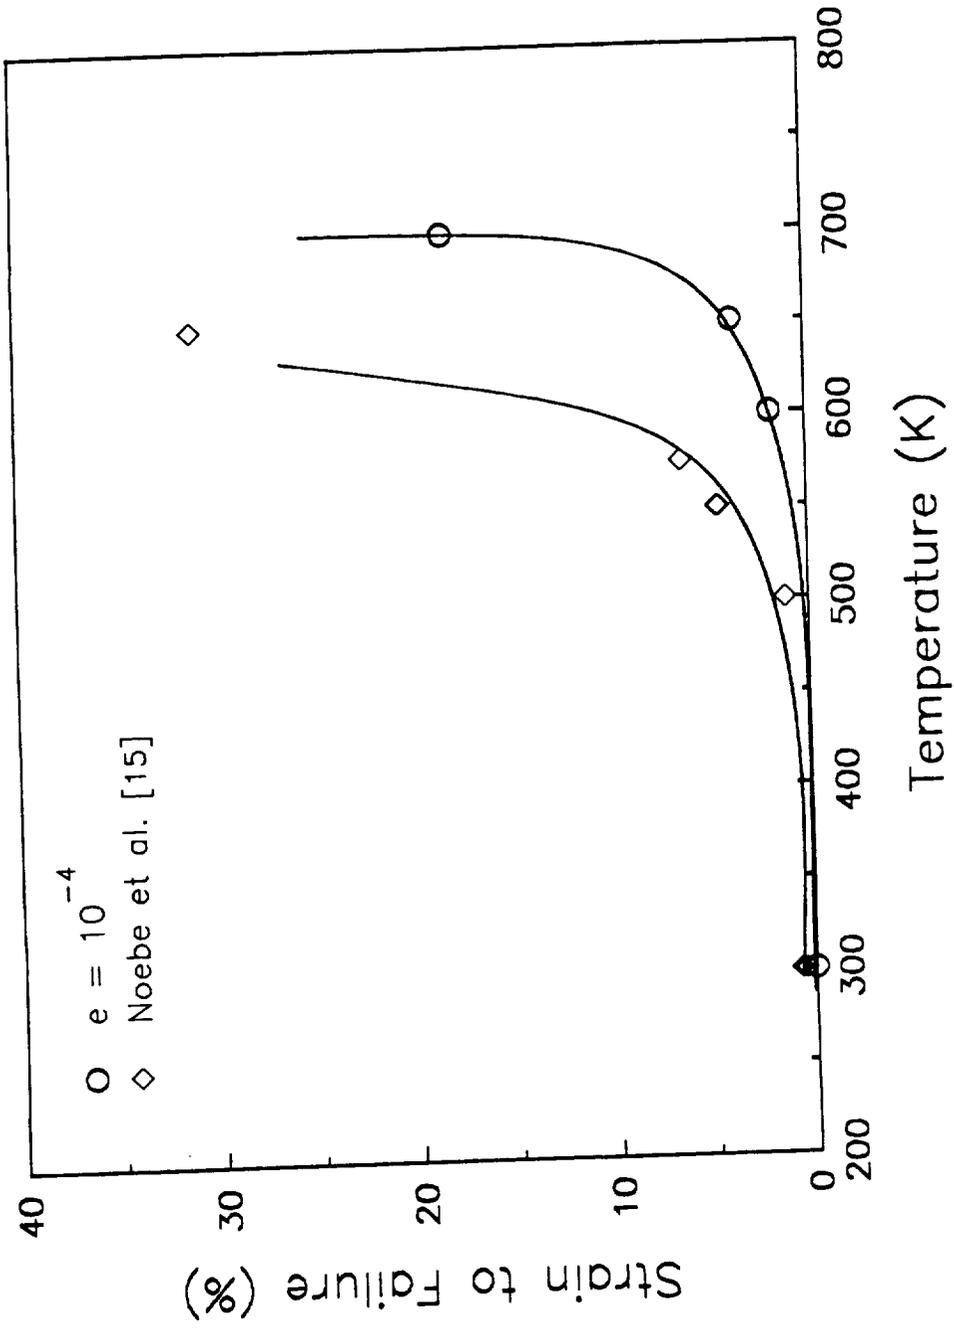
Figure 4.3 - Tensile true strain to failure as a function of temperature for specimens tested in this study and reported by Noebe, et al. [15] both at $\dot{\epsilon} = 10^{-4}$.

Figure 4.3 demonstrates that tensile elongation showed a precipitous increase with temperature and closely resembled previously published curves [15]. Plastic strain was calculated both from the load-time chart by assuming constant volume and by calculating the reduction in area from the diameter of the gage after failure. Good agreement was obtained from these two methods. A BDTT of 650 K was obtained from the data in Figure 4.3 using the method previously described. This is a relatively high BDTT compared to average transition temperatures for polycrystalline NiAl [14,16]. Of the factors identified in reference 16, the vacancy content resulting from the cooling rate from the extrusion is the most likely reason for the high BDTT of this heat. The composition and interstitial content of this alloy is comparable to those studied previously [16].

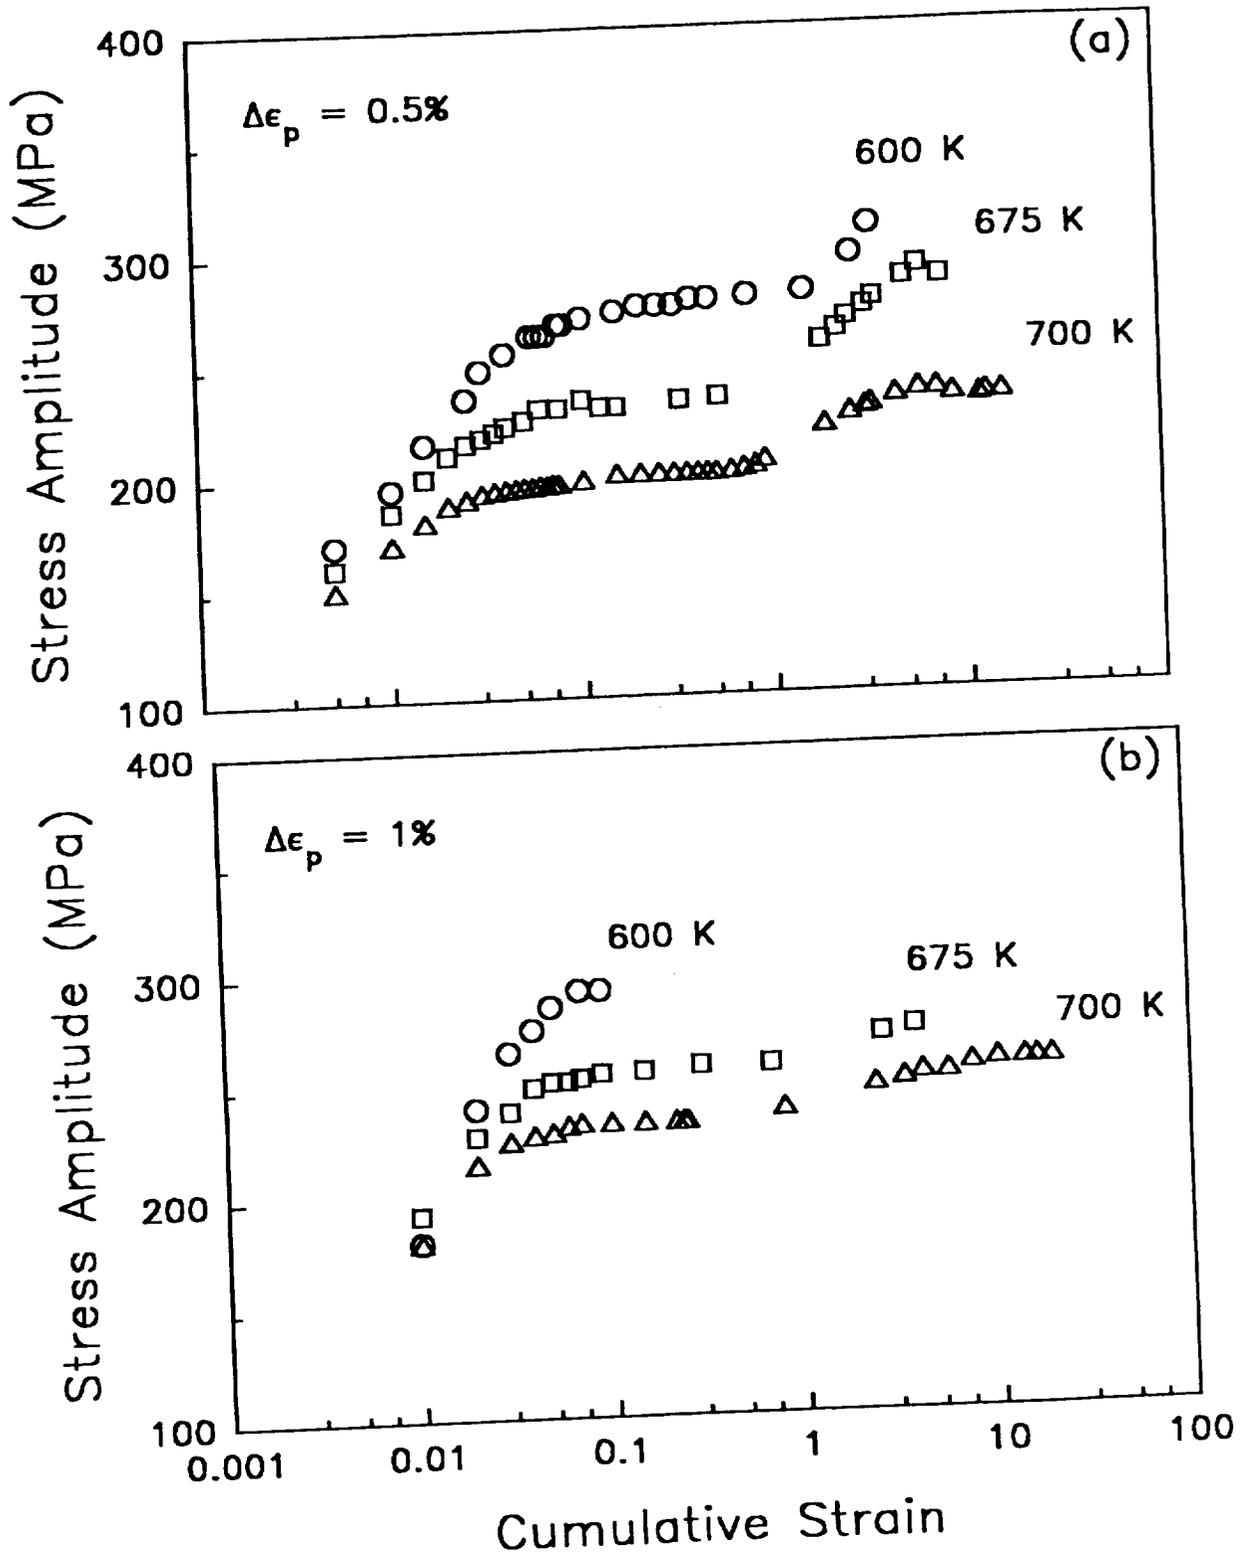
Figure 4.4 - Stress amplitude versus cumulative plastic strain for all three temperatures at $\dot{\epsilon} = 10^{-4} \text{ s}^{-1}$ (a) $\Delta\epsilon_p = 0.005$ and (b) $\Delta\epsilon_p = 0.01$.

The change in fatigue response with temperature for both plastic strain ranges is shown in Figure 4.4. Cumulative plastic strain used as the horizontal axis in these figures is the number of cycles multiplied by the imposed plastic strain range. Figure 4.5 shows an example of the hysteresis loops, recorded intermittently on an x-y plotter, which confirmed the accuracy of the test control as well as provided the stress amplitudes as a function of number of cycles. In all test conditions, rapid hardening occurred for the first few cycles. No cyclic softening or load drop was observed under any conditions. Figure 4.6 shows the estimated fatigue life curves for 600 and 700 K using the universal slopes equation. Since there was no necking at these temperatures, fracture strength was substituted for ultimate

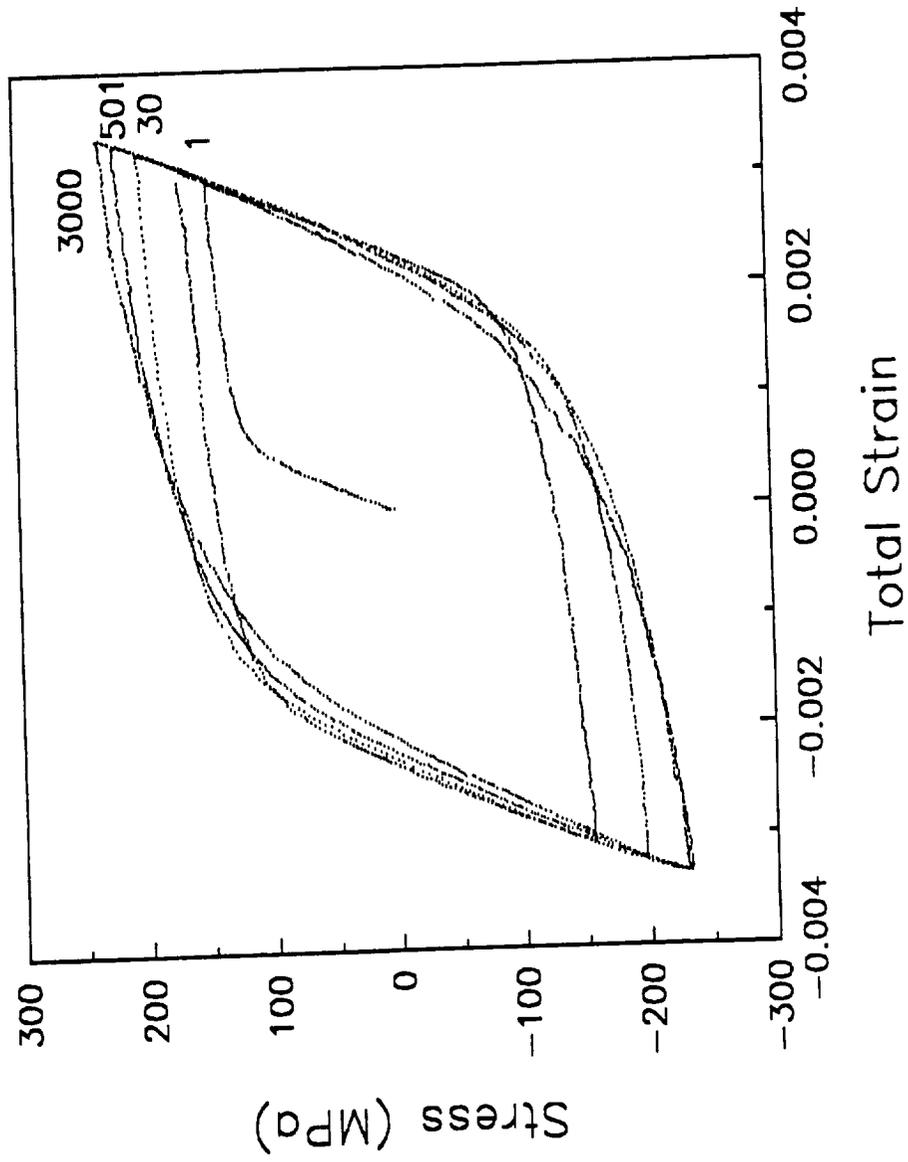
Figure 4.5 - Digitized points from hysteresis loops taken during a test at 700 K, $\Delta\epsilon_p = 0.005$.

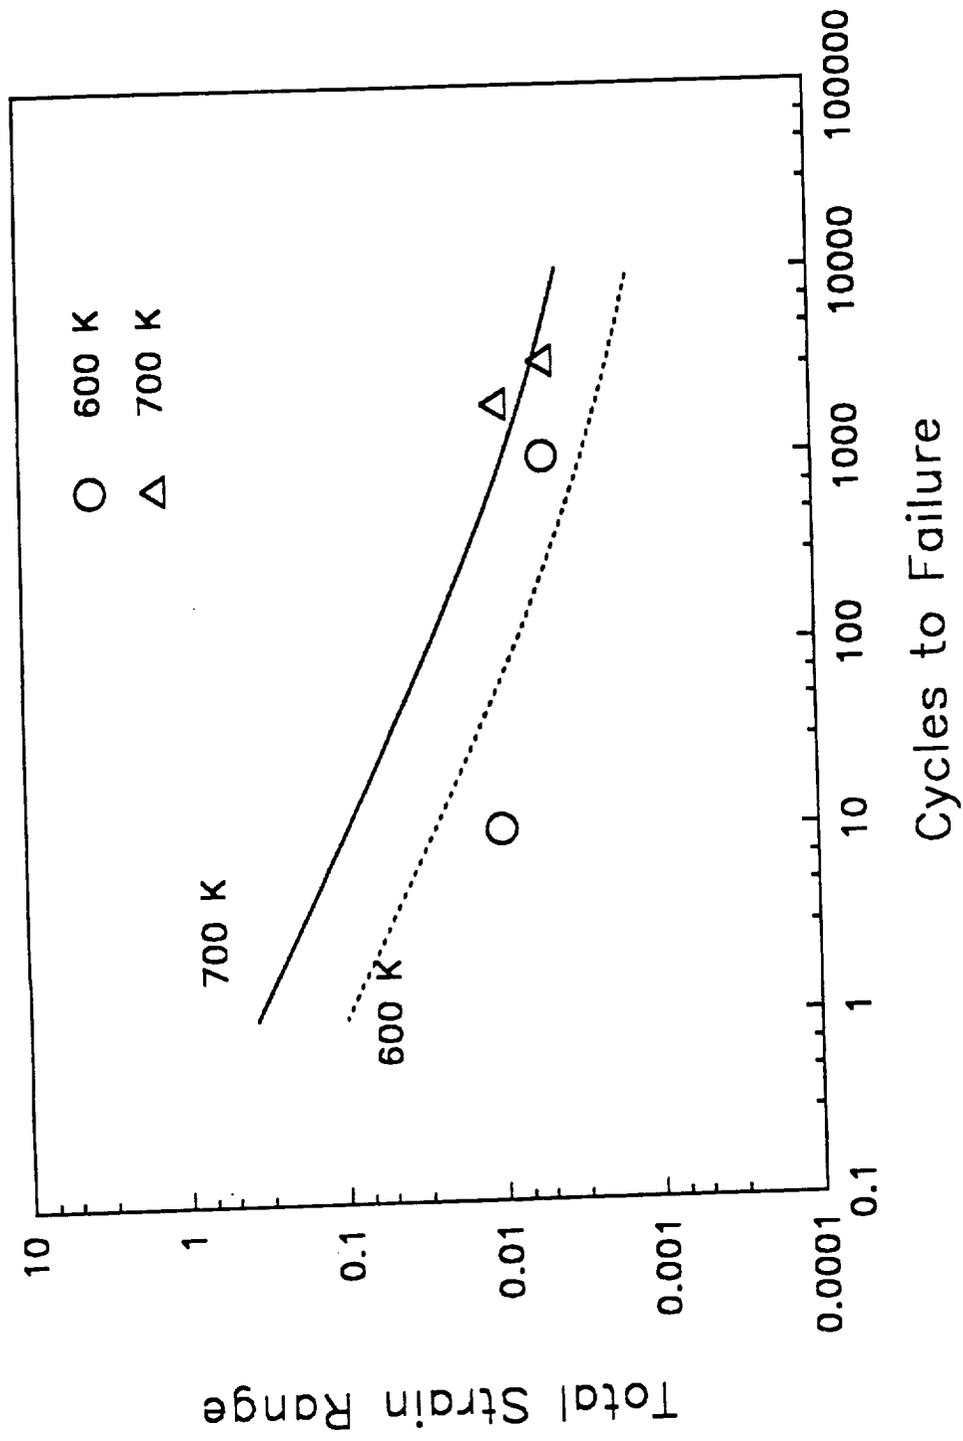
Figure 4.6 - Lines represent estimated fatigue lives using the universal slopes equation. Data points are total strain range at time of failure from this study.

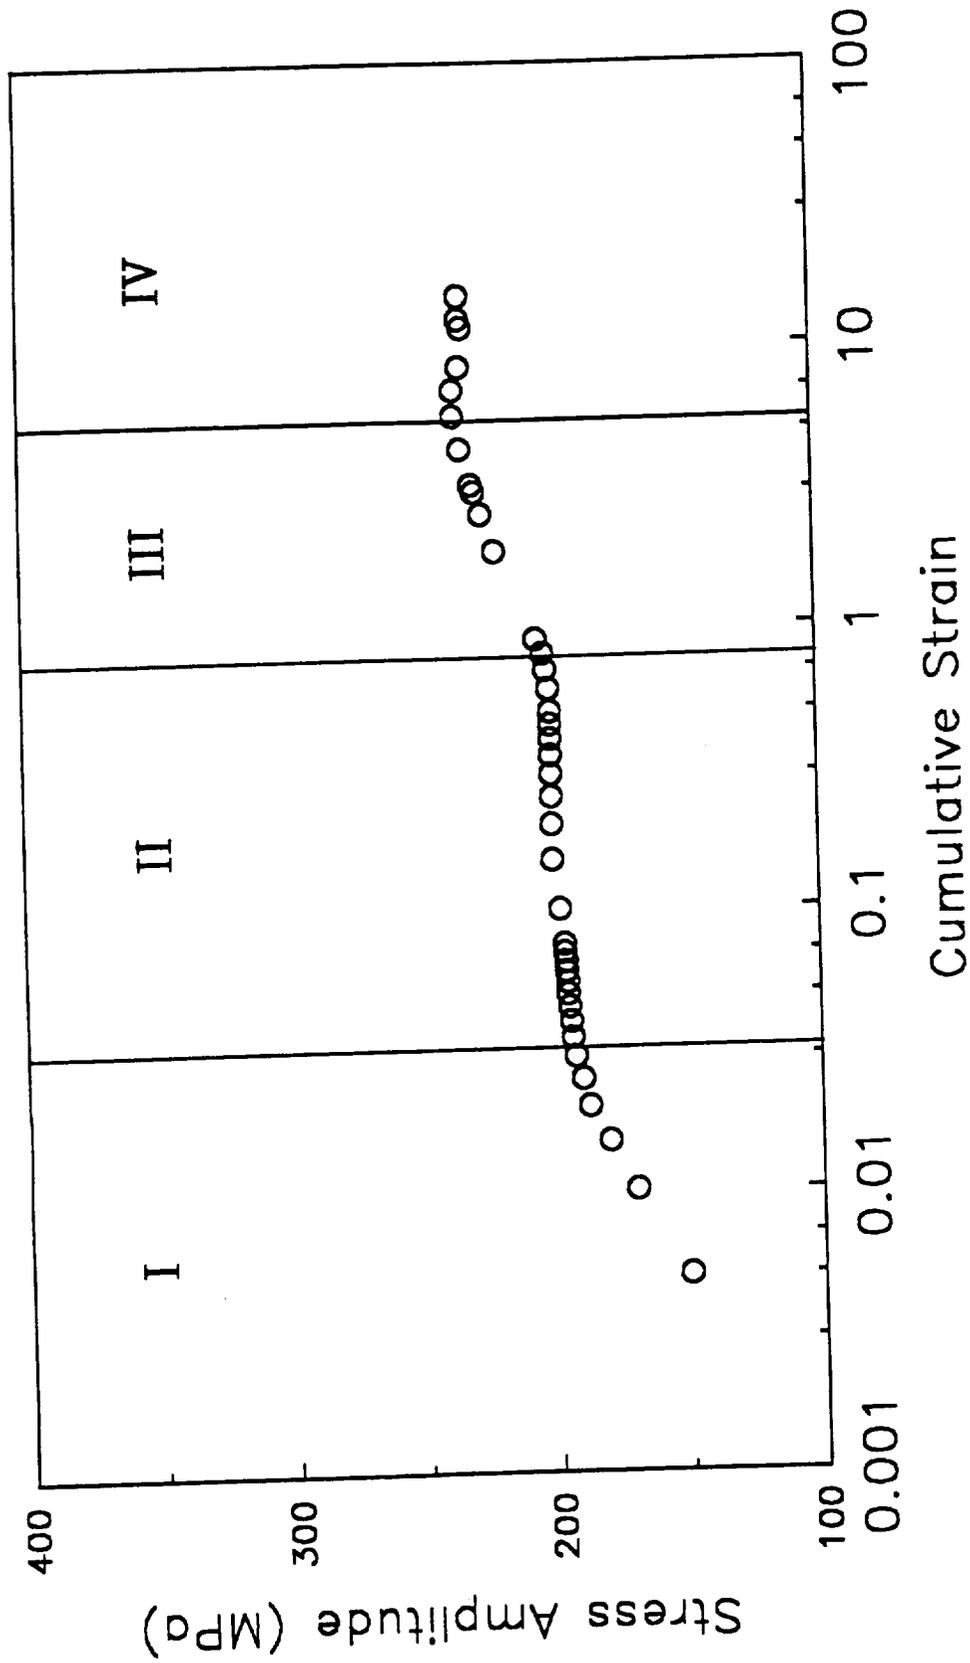
Figure 4.7 - Stress amplitude versus cumulative plastic strain for sample tested at 700 K, $\Delta\epsilon_p = 0.005$, and $\dot{\epsilon} = 10^{-4} \text{ s}^{-1}$. Regions I-IV indicate areas of rapid cyclic hardening, a stress plateau, additional hardening, and returning to relative stability.

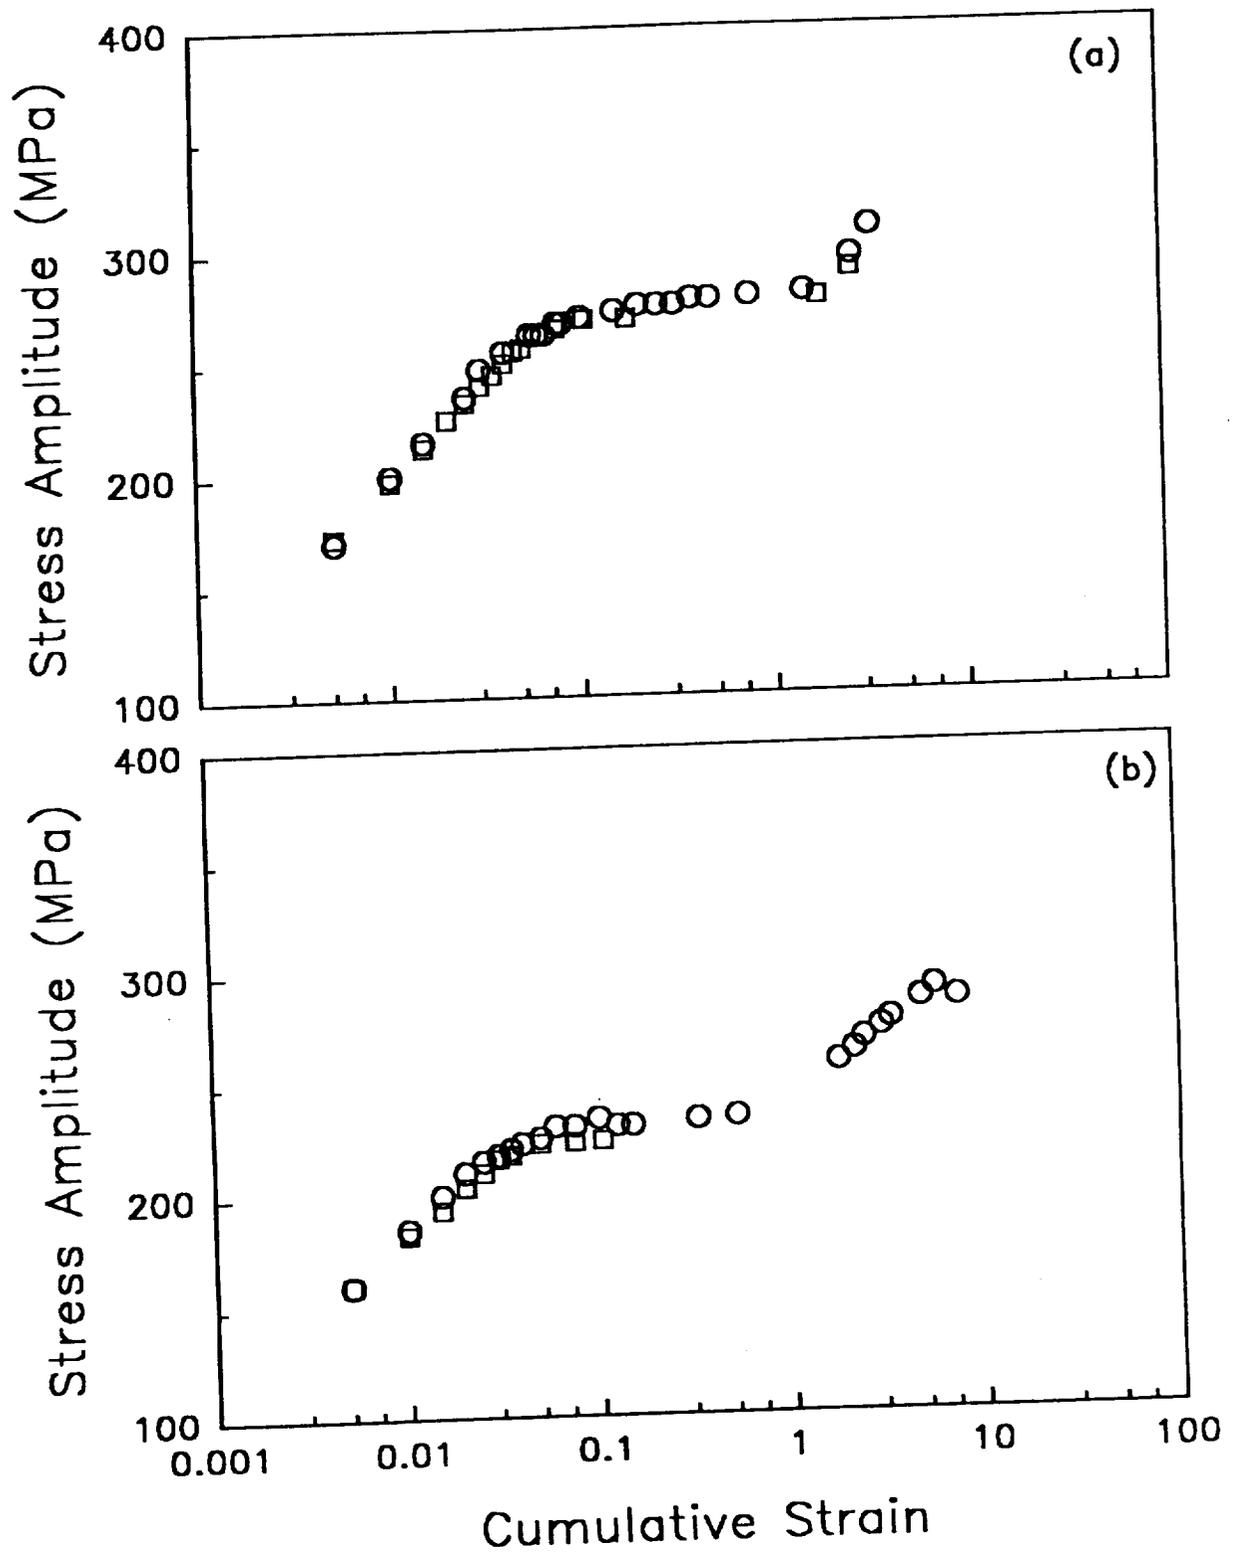
Figure 4.8 - (a) Duplicate LCF tests conducted at 600 K, $\Delta\epsilon_p = 0.005$.
 (b) Interrupted tests conducted at 675 K, $\Delta\epsilon_p = 0.01$.

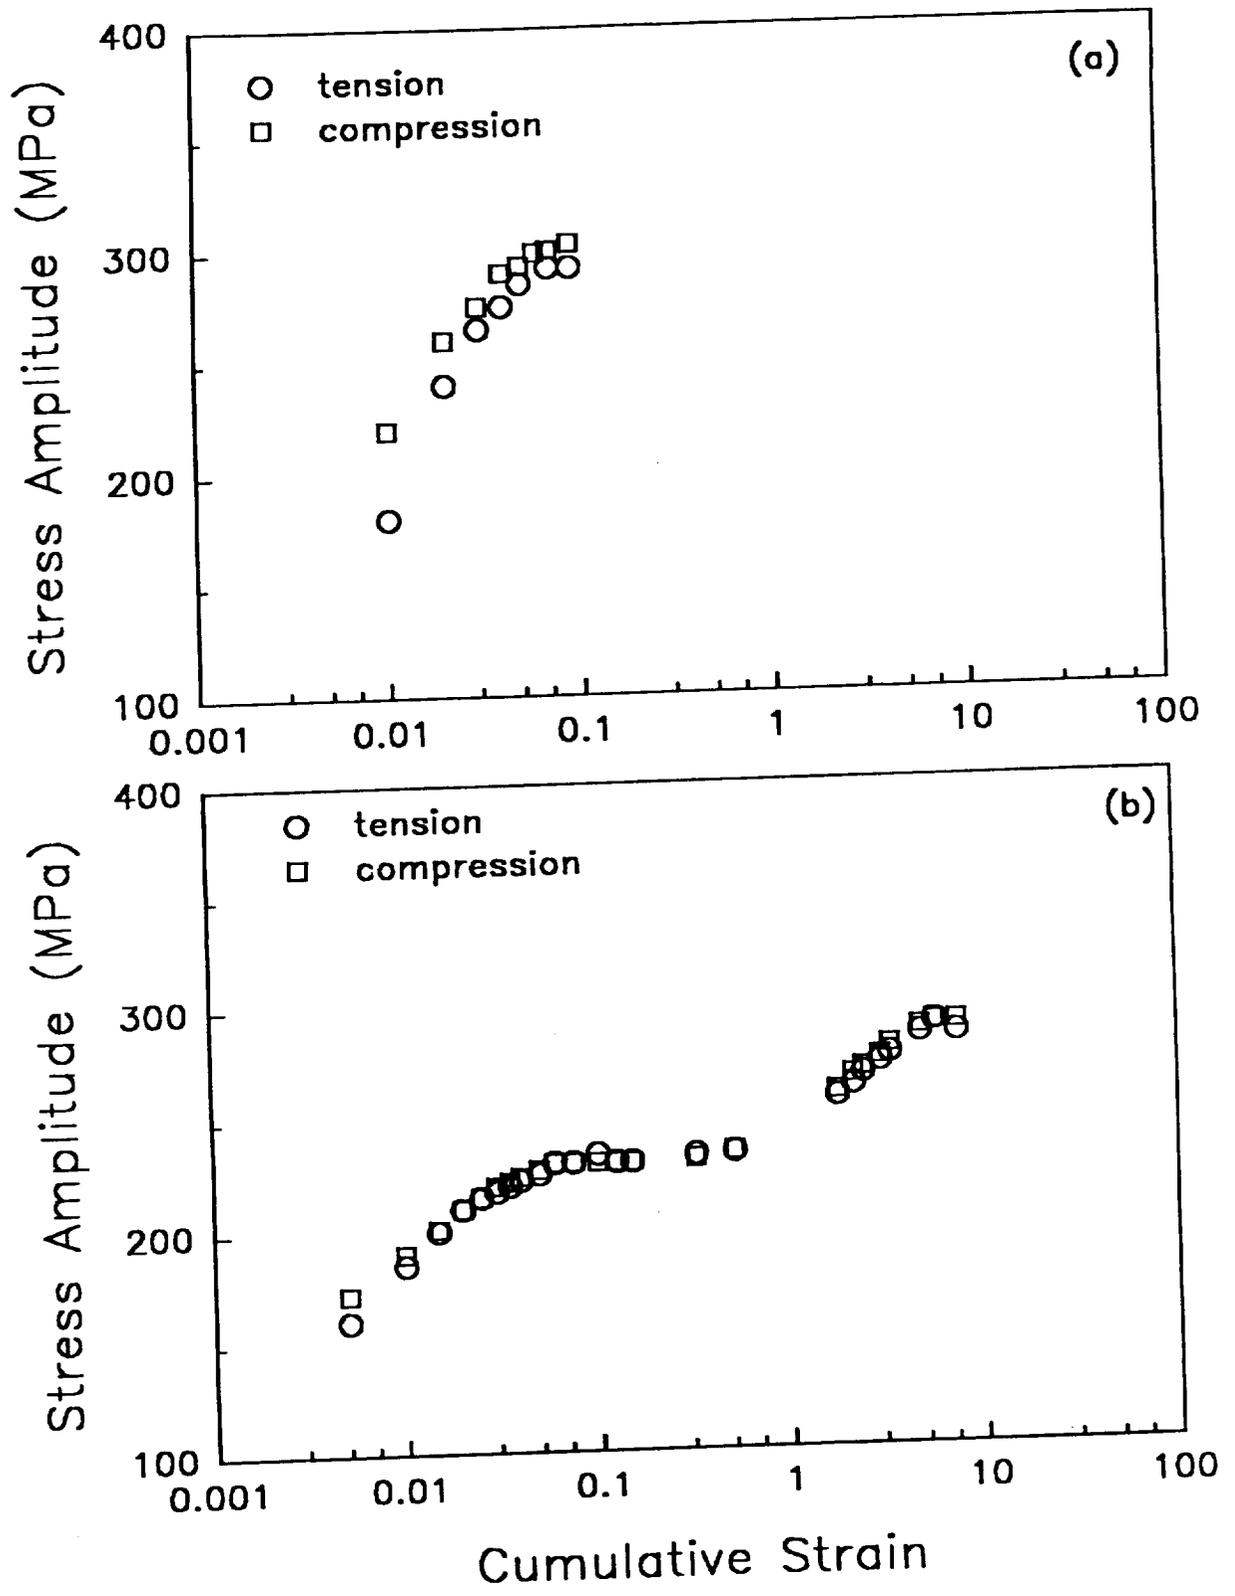
Figure 4.9 - Tensile and compressive stress amplitude versus cumulative plastic strain for $\Delta\epsilon_p = 0.01$, $\dot{\epsilon} = 10^{-4} \text{ s}^{-1}$, (a) 600 K and (b) 700 K.

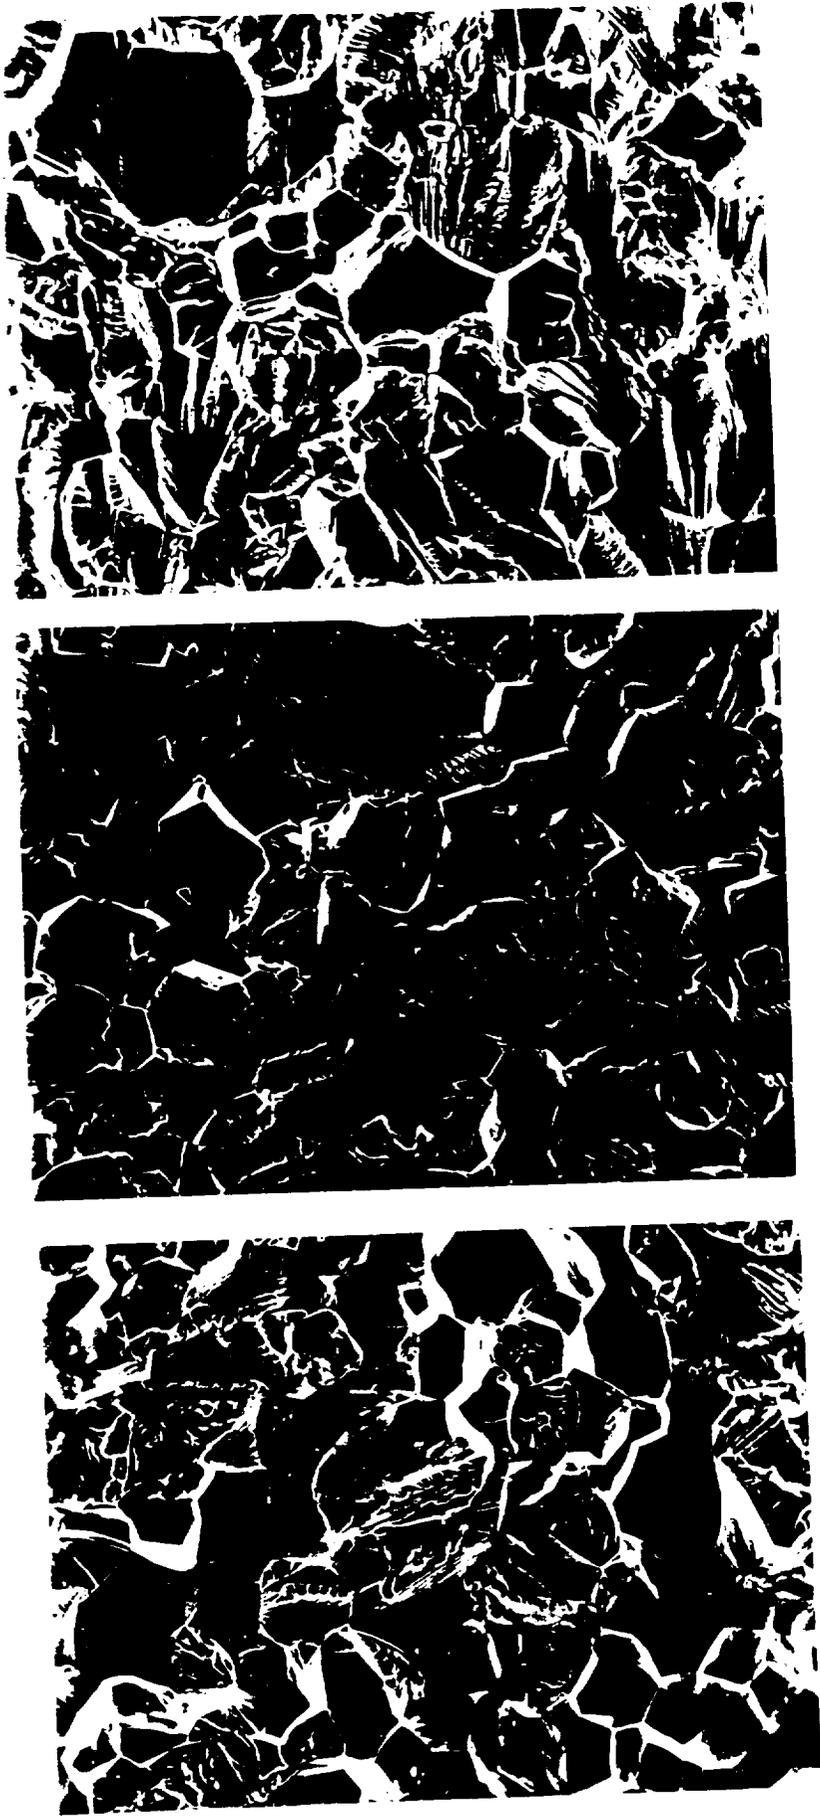
Figure 4.11 - Portion of the fracture surfaces at (a) 600 K (b) 675 K and (c) 700 K showing, respectively, 47%, 32%, and 33% intergranular fracture.

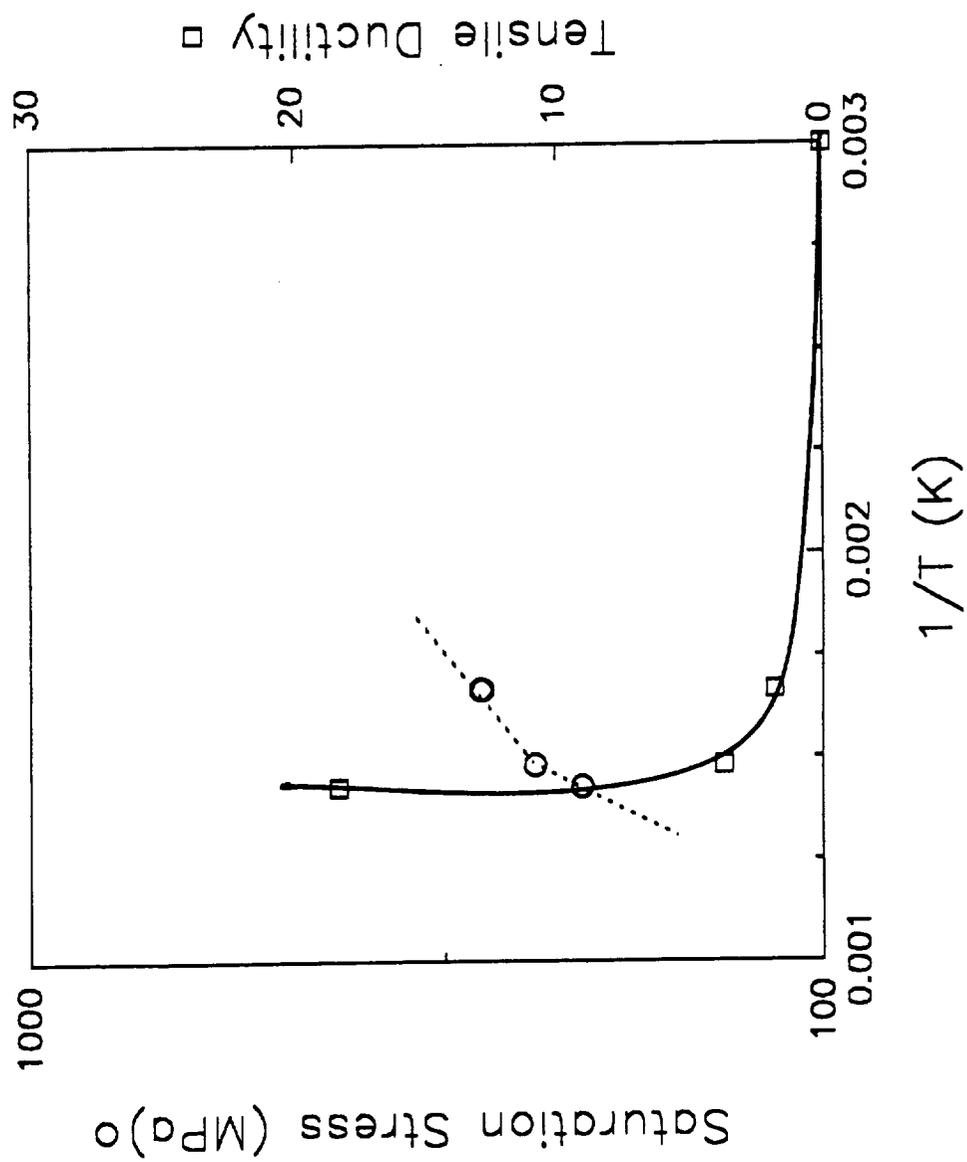
Figure 4.24 - Log saturation (region II) stress and monotonic ductility versus $1/T$ for tests conducted at $\dot{\epsilon} = 10^{-4} \text{ s}^{-1}$ and $\Delta\epsilon_p = 0.005$.
