4th IAASS Conference - Making Safety Matter

***Nondestructive Evaluation and Monitoring Results
from COPV Accelerated Stress Rupture Testing,
NASA White Sands Test Facility (WSTF)
(No. 1878627)***

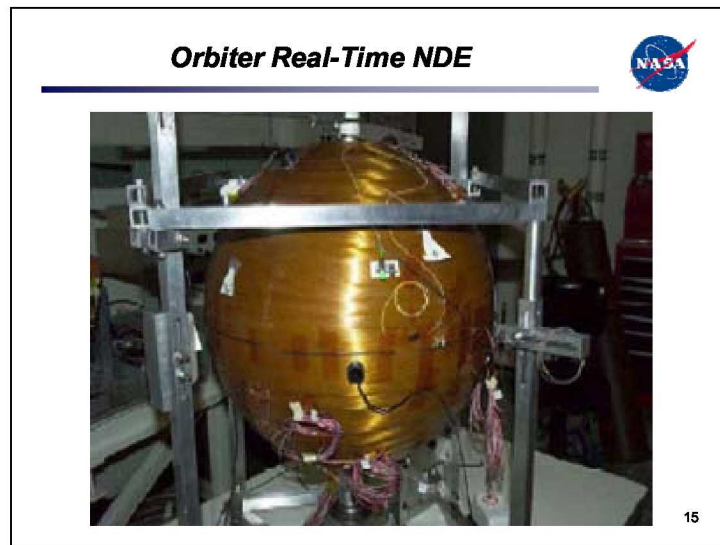
OMS Kevlar Pretest NDE Conclusion

- The large ripples around the girth weld raised a question, but other no observed indications were an issue with planned stress rupture testing
 - Eddy current sensors were placed over the peak of each girth ripple and monitored during pressurization to verify the liner did not flex causing a metallic fatigue concern
 - Decrease of stand-off between the fixed composite surface and liner ripple would indicate a liner buckle and associated air pocket
 - Stand-off remained fixed during pressure cycles, indicating that the indications were not a concern

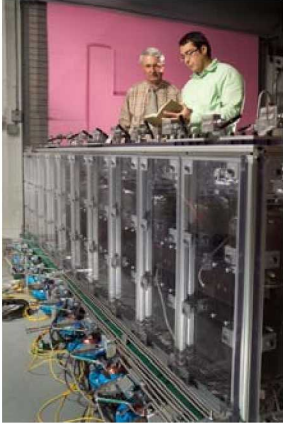
20 carbon vessels and real-time NDE in WSTF Lexan protective enclosure allows inspection while at test pressure

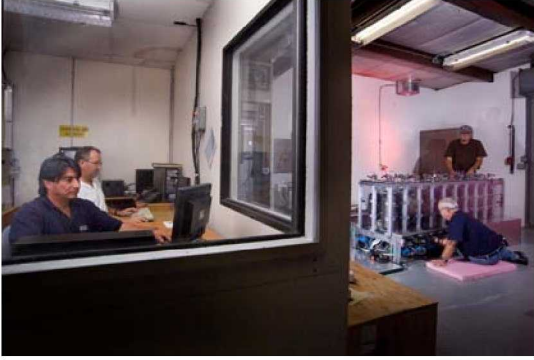
Team of WSTF (using Digital Wave 32 channel) and Physical Acoustics AE experts evaluate response of different AE systems during system checkout
