# COMPOSITE OVERWRAPPED PRESSURE VESSEL (COPV) STRESS RUPTURE TESTING

Nathanael J. Greene<sup>(1)</sup>, Regor L. Saulsberry<sup>(2)</sup>, Mark R. Leifeste<sup>(3)</sup>, Tommy B. Yoder<sup>(4)</sup>,  
Chris P. Keddy<sup>(5)</sup>, Scott C. Forth<sup>(6)</sup>, Rick W. Russell<sup>(7)</sup>

<sup>(1)</sup> NASA Johnson Space Center White Sands Test Facility, P.O. Box 20, Las Cruces, NM 88004, U.S.A.,  
Email: Nathanael.J.Greene@nasa.gov

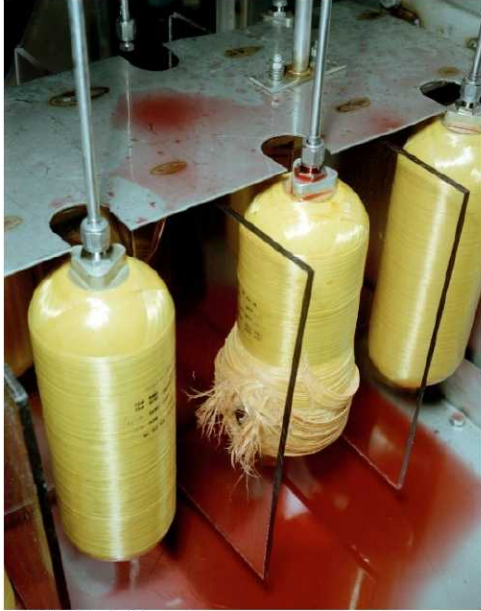
wstf0580-0703  
Figure 1. The first flight-rated COPV stress rupture tests were at WSTF

Investigation into the stress rupture failure mechanism for Kevlar in COPVs began during the development of the technology in the early 1970s. Kevlar overwrapped rubber-lined vessels were developed and tested in 1974 by Lawrence Livermore National Laboratories (LLL) on contract to NASA Lewis Research Center (now NASA Glenn Research Center (GRC)) [2]. Kevlar 10.80 cm (4.25 in.) diameter (Ø) spheres were developed and stress rupture tested at LLL in 1978 [3,4]. Also in 1978, Kevlar 8.6 cm (3.4 in.) Ø x 26.9 cm (10.6 in.) vessels (Fig.1) were stress-rupture tested at NASA WSTF [5], and 26.04 cm (10.25 in.) Ø spheres were stress rupture tested at JSC [6]. Time, temperature, and pressure data were collected on Kevlar COPVs so that predictions of a reliable lifetime under sustained load could be made. The test data collected demonstrated a large scatter in

the time-to-failure data. Further testing, using the latest developments in nondestructive evaluation (NDE) and computerized predictive models, was needed to better understand Kevlar COPV stress rupture failure.

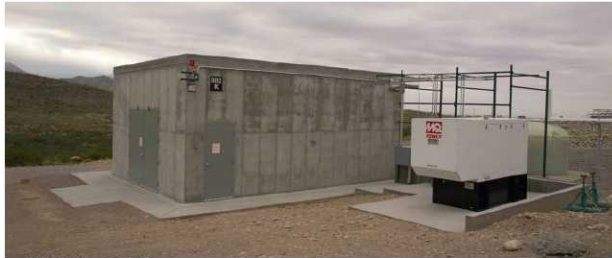
wstf1005e08438

Figure 4. Test Cell 862

Stress rupture testing of S/N 007 was conducted in the WSTF Hazardous Fluids Test Area in Test Cell 862. The test cell is 2.0 lb TNT blast-rated and has dual heating and cooling units to control the temperature of the vessel and test system to within  $\pm 2.8$  °C (5 °F). The instrumentation and pressure system is remotely controlled to protect personnel from stored energy. The test cell also provides dedicated power backup to ensure testing is not compromised. Fig. 4 is a photograph of the test cell and backup generator.

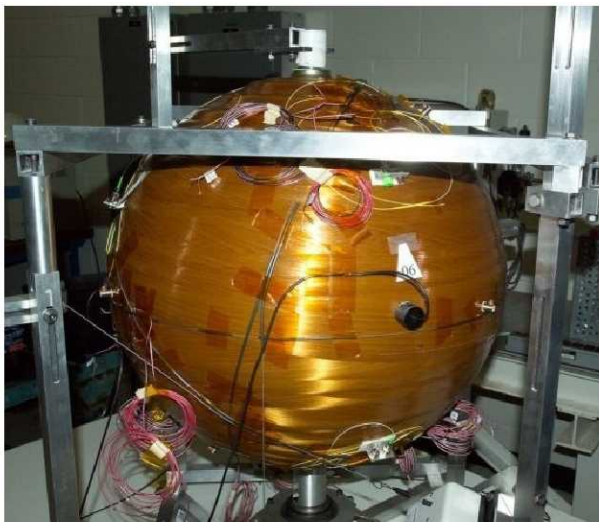
wstf1105e08998

*Figure 7. Typical Kevlar-epoxy vessel pre-test instrumentation*

Test vessels used for parameter development were highly instrumented with strain gauges, fiber optic Bragg gratings (FOBG), linear variable displacement transducers, girth cables, Raman spectroscopy, pressurized thermography, overwrap and liner eddy current thickness monitors, internal volume, acoustic emission, audio, high speed and 30-frame/second video, and full field strain measurement. S/N 007 was instrumented with all these listed except FOBG.

A sample photo of a vessel with instrumentation installed prior to test is shown in Fig. 7.

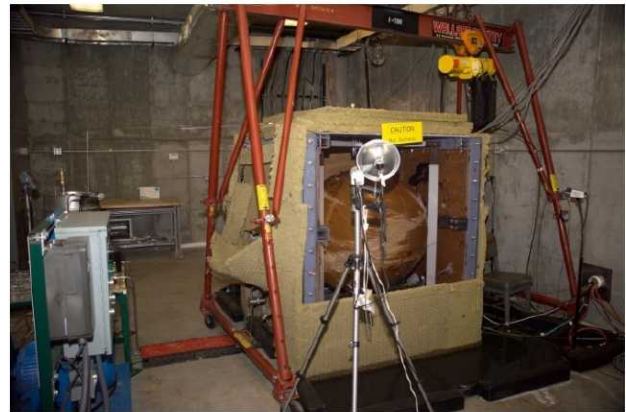
wstf1105e11453

*Figure 8. Kevlar vessel upon completion of stress rupture test*

The S/N 007 COPV, tested in stress rupture to failure, exhibited a burst failure mode after 0.9 years with a peak of 1.1 times maximum expected operating pressure and at a temperature of 79 °C (175 °F) (within temperature certification). The vessel exceeded the 95 percent confidence interval high prediction calculated by the

stress rupture model. Figure 8 shows the S/N 007 vessel after hydraulic stress rupture testing.

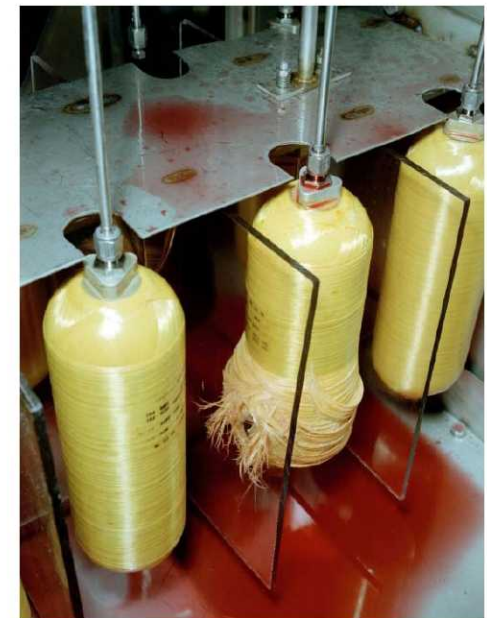
*The first flight-rated COPV stress rupture tests were at WSTF*

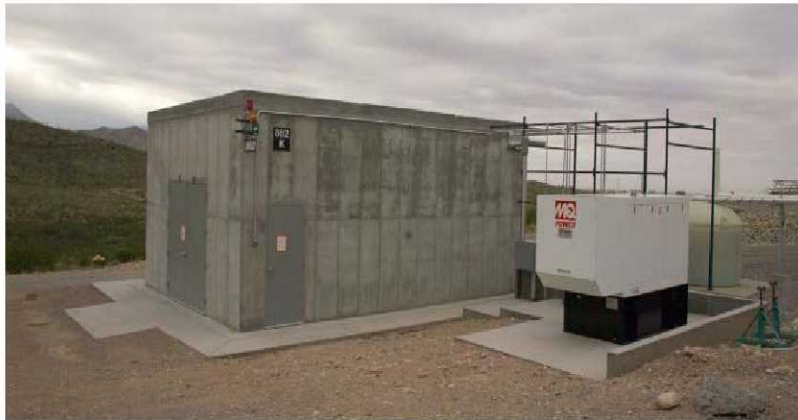
wstf1005e08438

- WSTF Hazardous Fluids Test Area
  - 2.0 lb TNT blast-rated
  - System temperature controlled to within  $\pm 3$  °C (5 °F)
  - Instrumentation and pressure remotely controlled
  - High volume pump system 103 MPa (15,000 psig) rated
  - Thermal control of 1 °C (2 °F) inside vessel enclosure

Test Cell 862 of the HFTA

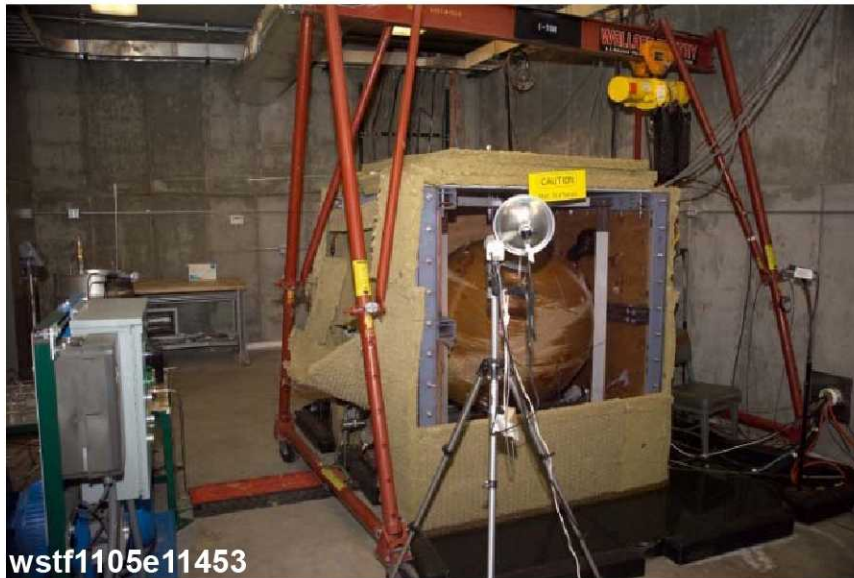
- S/N 007 COPV tested in stress rupture to failure
  - Burst failure after 0.9 years
    - Peak of 1.1 times MEOP at 79 °C (175 °F) (within temperature certification)
    - Exceeded 95% confidence interval high prediction of stress rupture model

*Kevlar vessel upon completion of stress rupture test*
