Use of Modal Acoustic Emission to Monitor Damage Progression in Carbon Fiber/Epoxy Tows and Implications for Composite Structures

Jess M. Waller, Regor L. Saulsberry, Ralph Lucero
NASA-JSC White Sands Test Facility

ASNT Fall Conference & Quality Testing Show

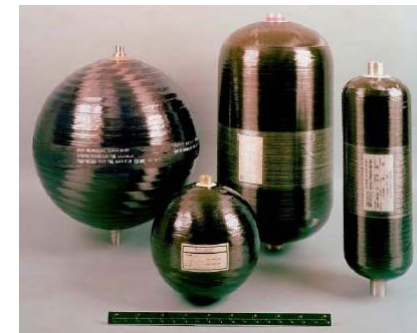
- Presently have 17 high pressure COPVs on ISS (most are C/Ep)
 - Up to seven additional COPVs are planned and under development
- Long term reliability risk levels are 10^{-6} or lower except for NTA and SpaceDRUMS COPVs, which have risk levels of 10^{-4} to 10^{-5} §
 - Reliability much lower if C/Ep overwrap sustains impact damage

**The NORS system is still under development.

***The CIPAA system is transported to and from the ISS with each Shuttle mission. The very high FOS indicates a very low risk of rupture.

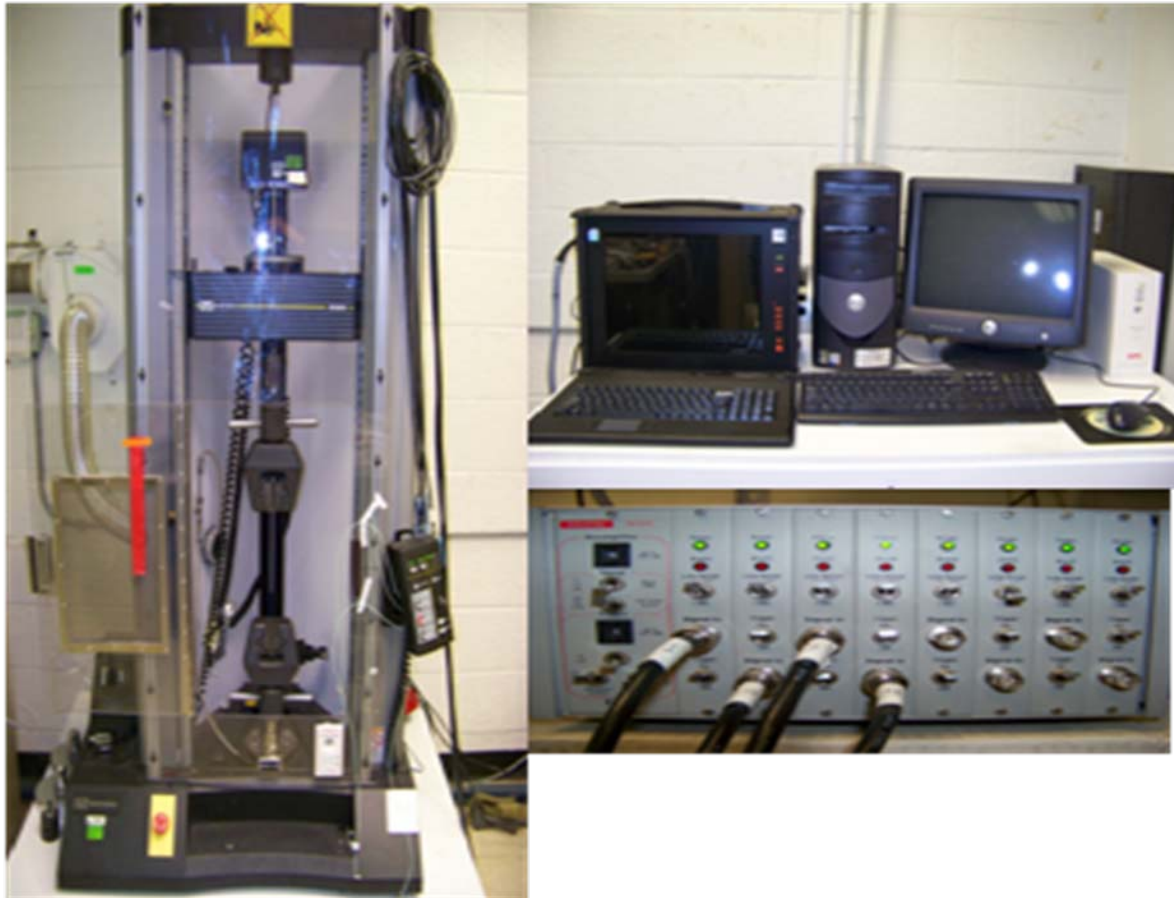
Load control and AE data acquisition system (DACS) consisted of:

- Instron® 5569 Series Electromechanical Test Instrument (left)
- DigitalWave Corp. FM-1 8-channel DACS (lower right)
- AE and tensile test CPU controllers (upper right)
