EVALUATION OF MARAGING STEEL FOR APPLICATION TO SPACE LAUNCH VEHICLES

SUPPLEMENTARY REPORT
MAY 1964
DOUGLAS REPORT SM-43105

MISSILE & SPACE SYSTEMS DIVISION
DOUGLAS AIRCRAFT COMPANY, INC.
SANTA MONICA/CALIFORNIA

**PREPARED FOR:
NATIONAL AERONAUTICS AND
SPACE ADMINISTRATION
UNDER CONTRACT NAS 7-214
WOO-PR-63-172**

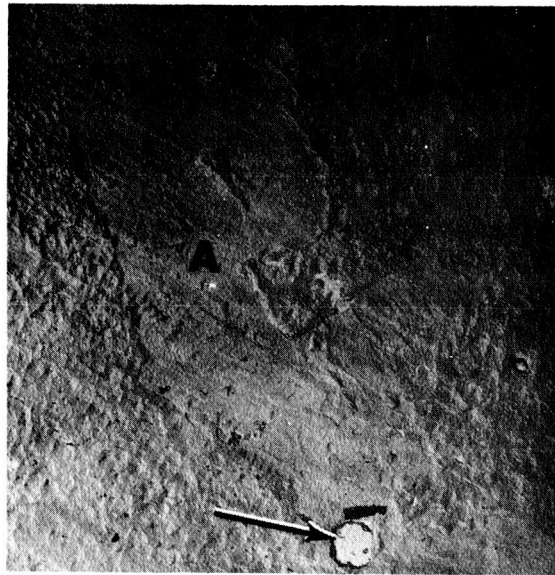
B

AS DEPOSITED WELDMETAL. A INDICATES POSSIBLE
AUSTENITE IN MARTENSITIC MATRIX. ARROW
INDICATES TiN INCLUSION. PCR Cr @ 45°

Figure 2 illustrates the appearance of as-deposited weldmetal. Figure 2A shows a low magnification optical micrograph which exhibits the interpass fusion line. The microstructure apparently consists of as-quenched martensite and islands of retained austenite. The austenite occupies approximately 9% by volume according to X-ray diffraction data. Figure 2B shows the typical structure as revealed by electron microscopy at 6,500 X. Scattered inclusions of TiN (as identified in Reference 1) are also shown in the electron micrograph. These inclusions are commonly found in weldmetal.

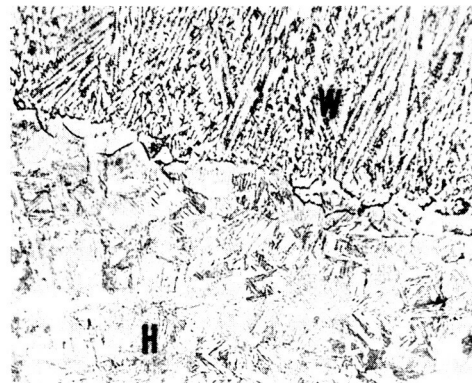
FIGURE 6

A, B AND C REPRESENT THE DEVELOPMENT OF NITRIDES IN BAND.
 AUSTENITIZED AT 1800°F FOR 16 HOURS THEN AGED. D AND E SHOW
 WHERE TYPICAL CRACKS DEVELOPED. CRACK IN HAZ(H).
 ILLUSTRATION F SHOWS INTERGRANULAR CRACKS ADJACENT TO
 FUSION LINE.

Another unusual observation pertains to a rather high incidence of cracking in bands located within, or very close to, the heat-affected zones. Table I, under the remarks column describes the locations and conditions under which the cracks were observed. Figures 6D and 6E illustrate typical crack regions. Figure 6D indicates the most common location in banded heat-affected regions near the overlap of the two weld passes. One additional type of crack was observed, however in only one of the specimens examined. Figure 6F illustrates this unusual type which appears to be intergranular in appearance and located adjacent to the weld fusion-line.

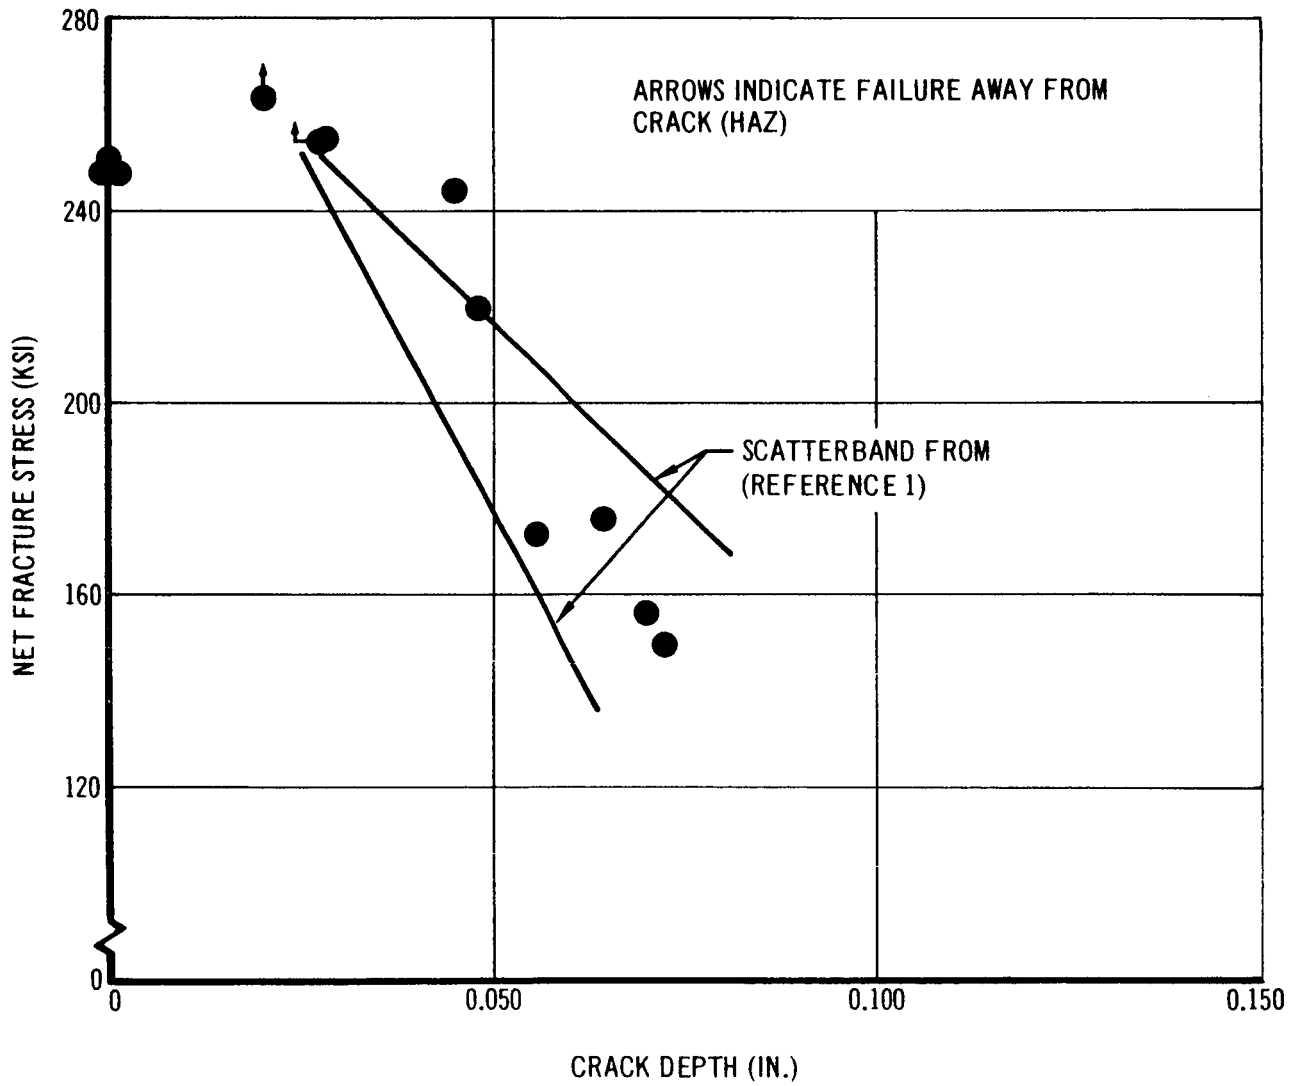
FIGURE 8

COMPARISON OF DIRECTLY-AGED WELDMETAL, REFERENCE 1,
WITH WELDMETAL AUSTENITIZED AT 1800°F 16 HOURS,
AIR COOLED THEN AGED (900°F, 3 HOURS)

The microstructural observations on the effects of prolonged austenitizing treatments revealed that substantial microstructural changes in weldmetal could be produced. Austenitizing at 1800°F, followed by aging, produced a uniform aged-martensitic matrix containing a general dispersion of apparent TiN particles. No austenite was detectable by X-ray diffraction. Hence, compared to directly-aged weldmetal (containing about 11% austenite by vol.) a significant microstructural difference was developed. Testing specimens subjected to the 1800°F treatment would, therefore, permit the determination of the effect of measureable austenite content on fracture toughness. Weldmetal and parent-plate specimens were subjected to the 16 hour, 1800°F treatment, aircooled, and aged at 900°F for 3 hours. Partial-thickness crack (PTC) fracture toughness specimens were tested as described in Reference 1. The results are presented in Figures 8 and 9 for weldmetal and parent plate, respectively. The scatterband for directly-aged

material (Reference 1 data) is shown for comparison. (Tabulated data are presented in Table II.) As may be seen, the fracture strengths of the austenitized-and-aged specimens generally fall within the scatterband for their directly-aged counterparts reported in Reference 1. The microstructural differences had no apparent effect on fracture toughness.

(Figures 8 and 9, Pages 29 and 30, should be corrected to reflect these changes for the zero cracked specimens)

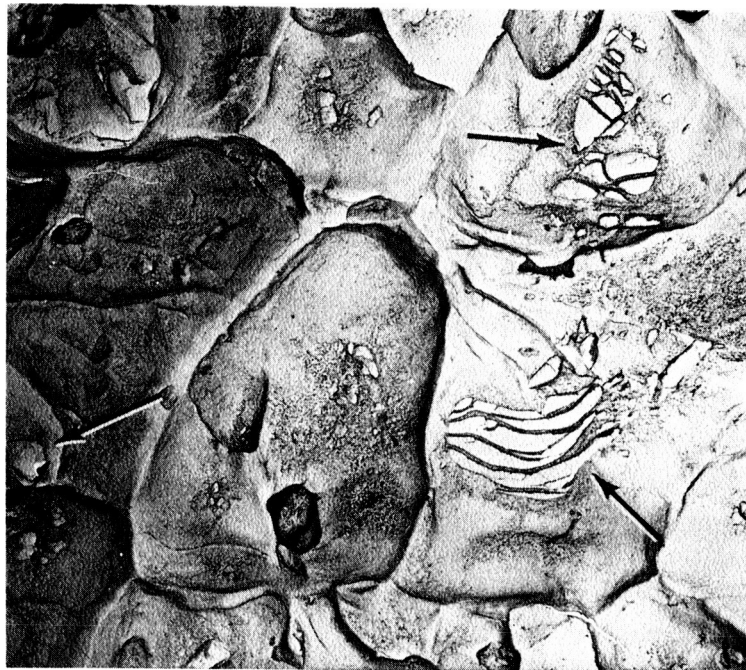
FIGURE 10

FRACTURE SURFACE OF WELDMETAL. AUSTENITIZED 1800°F 16 HOURS,
AIR COOLED, AGED 900°F 3 HOURS. ARROWS INDICATE
SOME TIN INCLUSIONS. PCR CR AT 45°
CARAPELLA'S ETCH

Several of the fracture toughness specimens were employed for electron fractographic evaluation. This work was done to determine microstructural relationships to fracture. Replicas of fracture surfaces were made by the plastic-carbon method (chromium shadowed at 45°) using a nitrocellulose substrate on the fracture surface. Figures 10A and 10B show typical weldmetal fracture surfaces of specimens subjected to the 1800°F austenitizing treatment followed by 900°F aging. Several small clusters of what was previously identified as TiN are apparent (Reference 1). However, the TiN dispersion seems to be somewhat finer than the more massive dispersions found in directly-aged weldmetal (Reference 1). No evidence of austenitic islands were observed on the fracture surfaces as had been previously found in directly-aged weldmetal. The appearance of the fractures shown in Figures 10A and 10B are consistent with the microstructural observations displayed in Figure 4. Significantly, the fracture surfaces exhibit substantial quantities of TiN and very flat features around the TiN inclusions. Clearly, the nitrides are promoting brittle fracture. The presence of austenite in the directly-aged weldmetal does not appear to be detrimental to fracture toughness. Titanium nitrides,

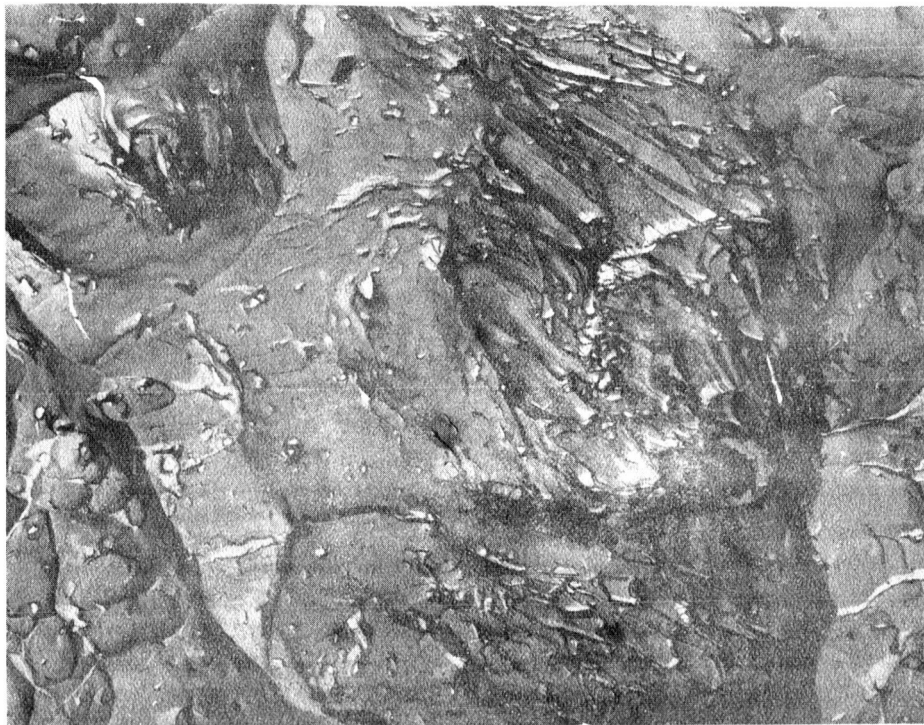
A

FRACTURE SURFACE OF HEAT-AFFECTED-ZONE FAILURE AUSTENITIZE 1800°F 16 HOURS,
AIRCOOLED, AGED 900°F 3 HOURS PCR AT 45°
NO ETCH

MASSIVE TIN INCLUSION. FLAT, BRITTLE FAILURE

Additional evidence on the brittle-fracture tendencies of the nitrides was gathered from heat-affected zone and parent plate fractures. Figure 11A shows an extensive flat-fracture region around nitrides on the surface of a heat-affected zone fracture. The dimpled structure shown in Figure 11B, typical of a ductile failure, was much more common on this specimen. Note the virtual absence of nitrides in the dimpled region. Figure 12 shows similar relationships for parent plate. In every instance, the nitrides were observed to promote the formation of localized, flat brittle-type fractures.

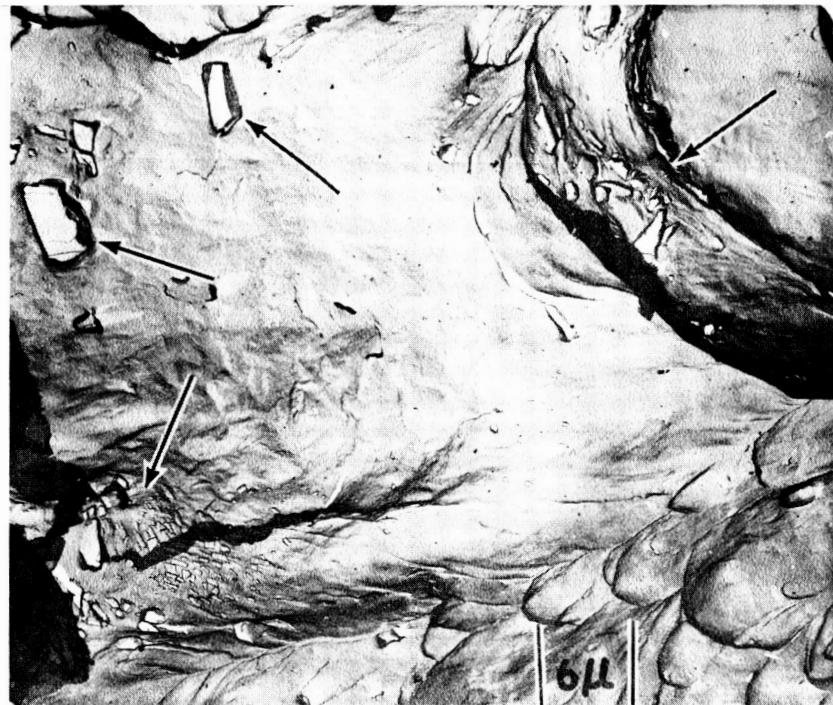
FIGURE 12

BRITTLE FRACTURE AREA CAUSED BY NITRIDES (ARROWS)
NOTE DIMPLES IN LOWER RIGHT CORNER. AUSTENITIZED 1800°F,
16 HOURS, AIRCOOLED, AGED 900°F 3 HOURS. PCR CR AT 45°
NO ETCH

DIMPLES INDICATING DUCTILE FAILURE

NOTE DIMPLES IN LOWER RIGHT CORNER
