"DAMAGE TO SOLIDS CAUSED BY CAVITATION"

Royal Society Discussion on Deformation of Solids Due to  
Liquid Impact

Frederick G. Hammitt \*

Department of Nuclear Engineering

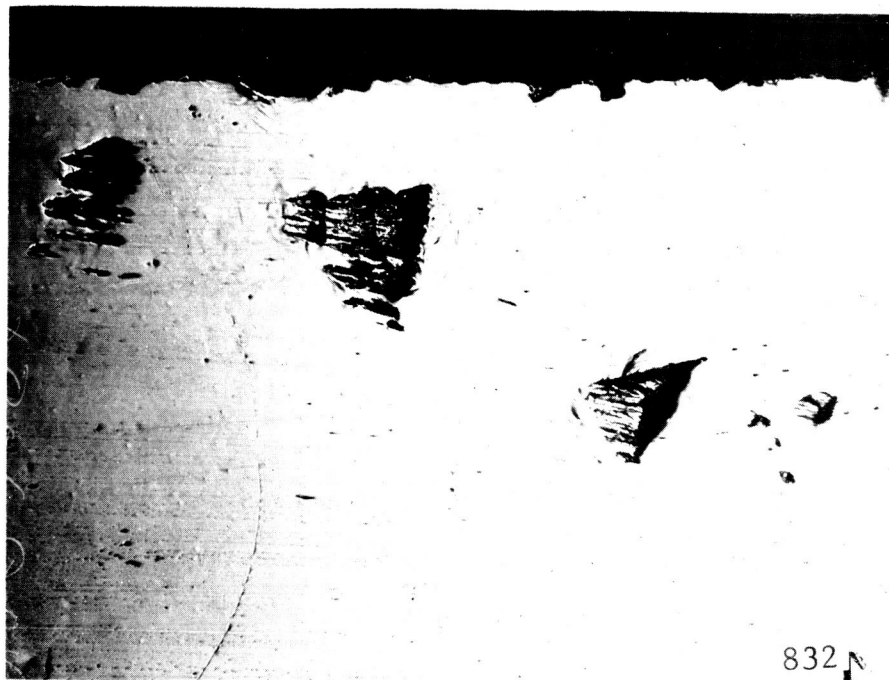
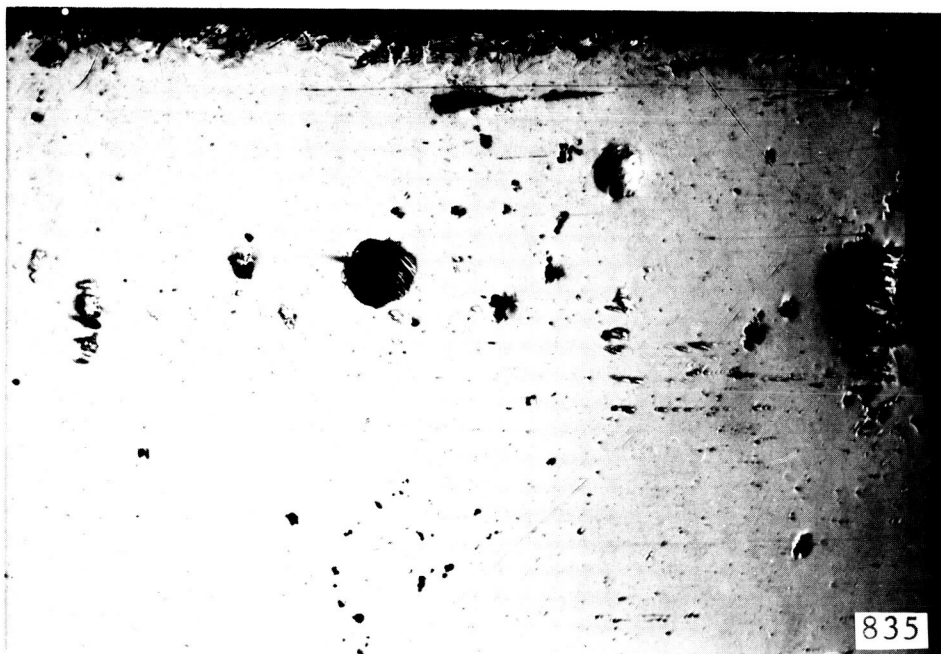
FIGURE 2. Development of Cavitation Damage at Two Locations on 302 Stainless Steel Specimen with Water, (a) 15 hrs, (b) 30 hrs.

Fig. 2 and 3 comprise two series of photomicrographs showing both "crater" and "fatigue-type" pits after an initial test duration, and then again after considerable additional testing. The fact that neither their shape nor their depth profile (as shown by detailed "proficorder"\* tracings<sup>5</sup> change during additional testing, is taken as strong evidence that these pits are indeed "single-event" failures.

The "crater-type" pits caused (in most of the cases which were examined) by room temperature water on stainless steel, typically had a depth to diameter ratio between 15 and 40. However, Fig. 4 shows a microsection of a crater incurred in Cb-1Zr alloy by room temperature mercury with depth to diameter ratio of about 4, showing the effect of a possibly larger force imposition on a somewhat weaker material. Also, crater-type pits of a large depth to diameter ratio have recently been observed on stainless steel in a centrifugal pump test in a high-temperature alkali metal.<sup>8</sup> Assuming that the forces from such alkali metal and from room-temperature water may be roughly similar, but that the mechanical properties of the stainless steel are considerably reduced at elevated temperature, these observations may not be inconsistent. Hence it may be reasonable to expect that the depth to diameter ratio will be a function of the fluid, material, and flow conditions.

In the venturi tests, it has generally been observed that a ridge is raised around the craters, of a considerably smaller height than the crater depth, and, in the great majority of cases observed (about 90 percent), predominantly on the downstream side of the crater. Fig. 5 is a proficorder trace of such a crater. The explanation for this non-symmetry of the ridge is not known at present, but the very existence of a ridge suggests that the craters are formed by single-bubble implosions.
