NASA TN D-2953

FLIGHT-TEST TEMPERATURE DATA FOR AN ALTAIR-IIIC1 ROCKET MOTOR

by James L. Raper
Langley Research Center
Langley Station, Hampton, Va.

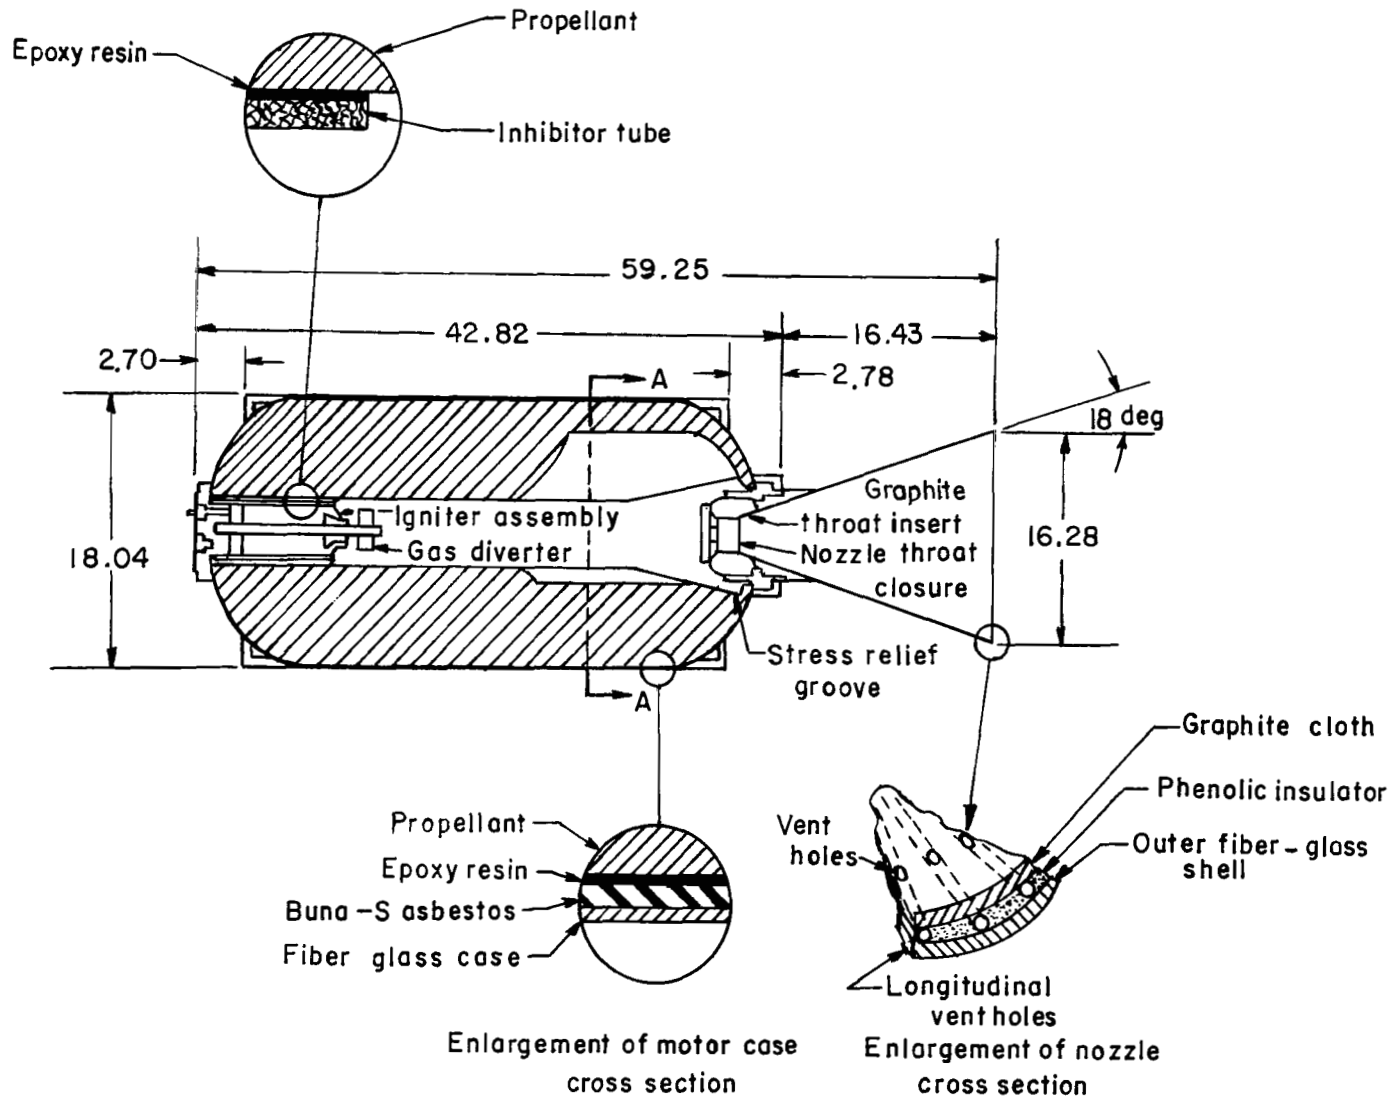
Figure 1.- Altair-IIIC1 motor. All linear dimensions are in inches.

(a) Schematic. (See figure 1(b) for section A-A.)

The Altair IIC1 rocket motor consists basically of a fiber-glass pressure vessel lined with buna-S asbestos insulator, a propellant charge cast into the chamber, and a conical divergent nozzle. Figure 1(a) shows a schematic of the motor assembly. The detail at the top of figure 1(a) shows the location of the previously mentioned inhibitor tube. Figure 1(b) shows the propellant core geometry. Figure 1(c) shows details of the forward dome and cylinder insulator. Note the location on the side wall where boric-acid-loaded synthetic rubber insulation has been added to a previously uninsulated portion of the forward cylinder as previously mentioned. Figure 1(d) shows a cross section of the motor in the aft cylinder area. Note that the insulator is thickest at the points where the propellant first burns through to the chamber wall. The thinnest insulator location is opposite the thickest propellant section. Note also that two strips of boric-acid-loaded synthetic-rubber insulator have been added at the locations opposite minor grain slots to prevent previously experienced chamber-wall hot spots. Figure 1(e) shows details of one of 2 typical places or one of four typical places of the after-cylinder insulator as indicated by the two sections taken through figure 1(d).

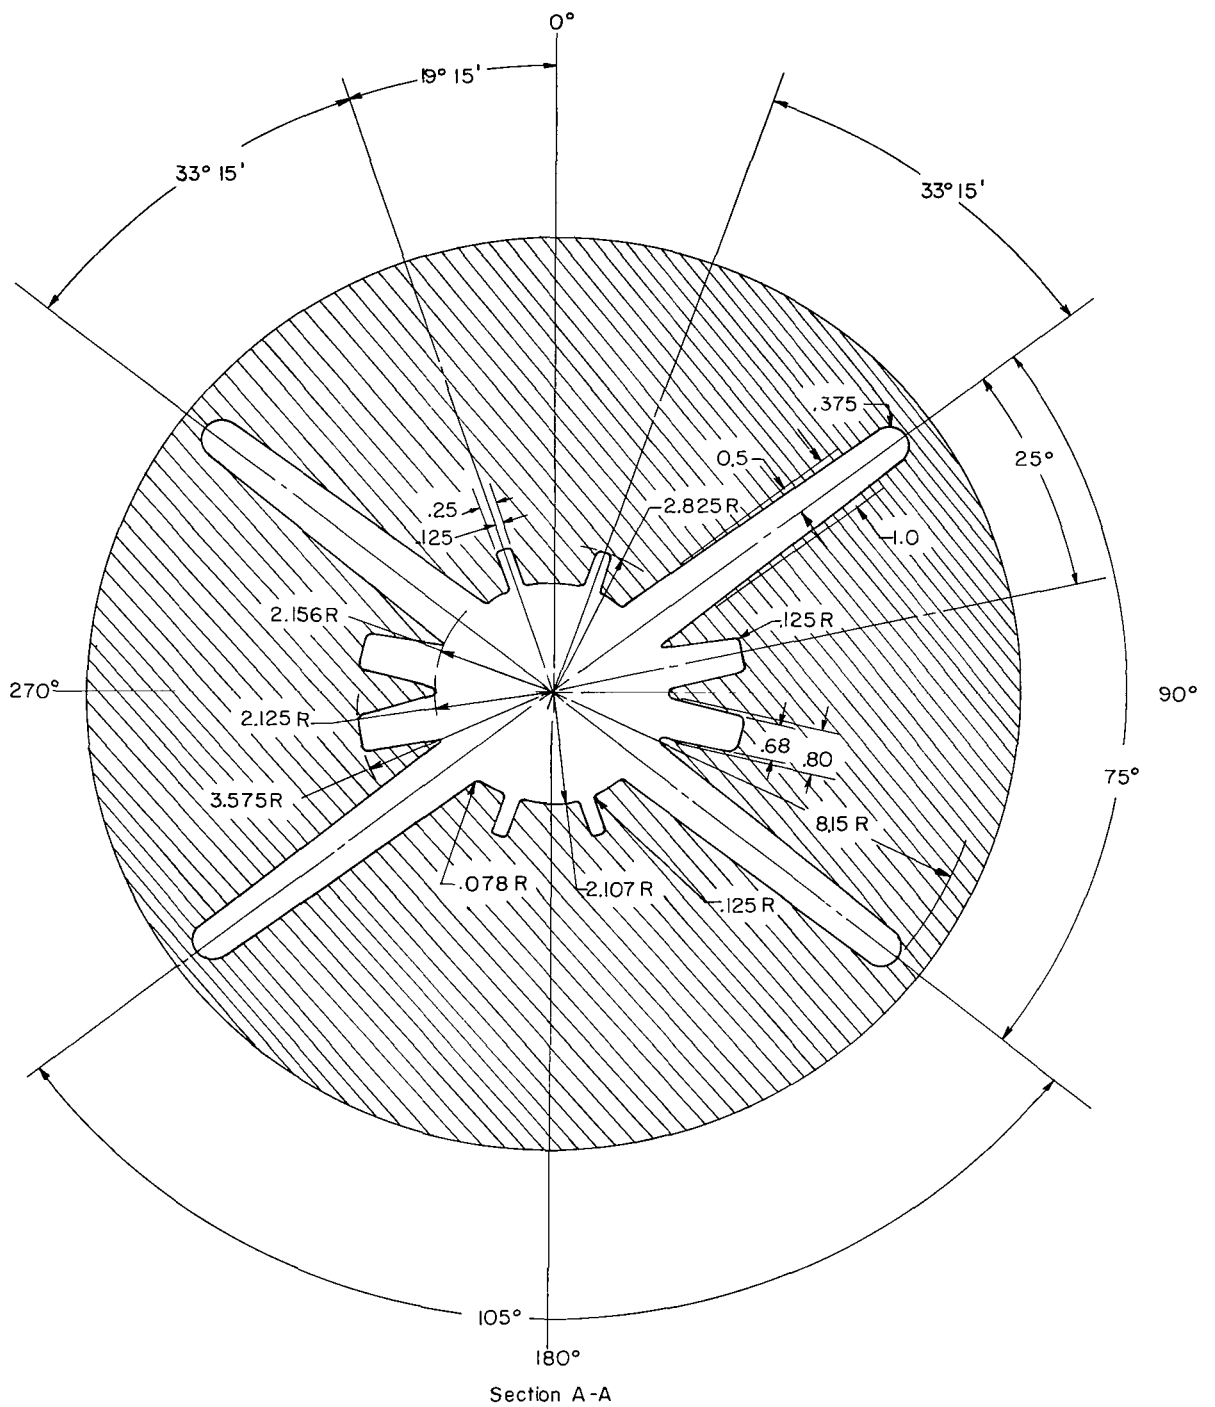
Figure 1.- Continued.

(b) Propellant core geometry.

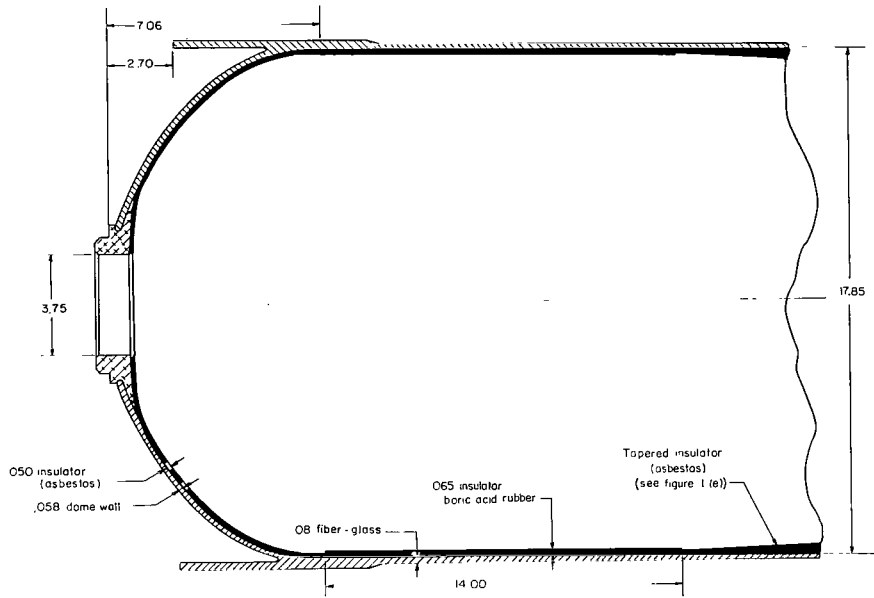
(c) Details of forward dome and cylinder insulator.

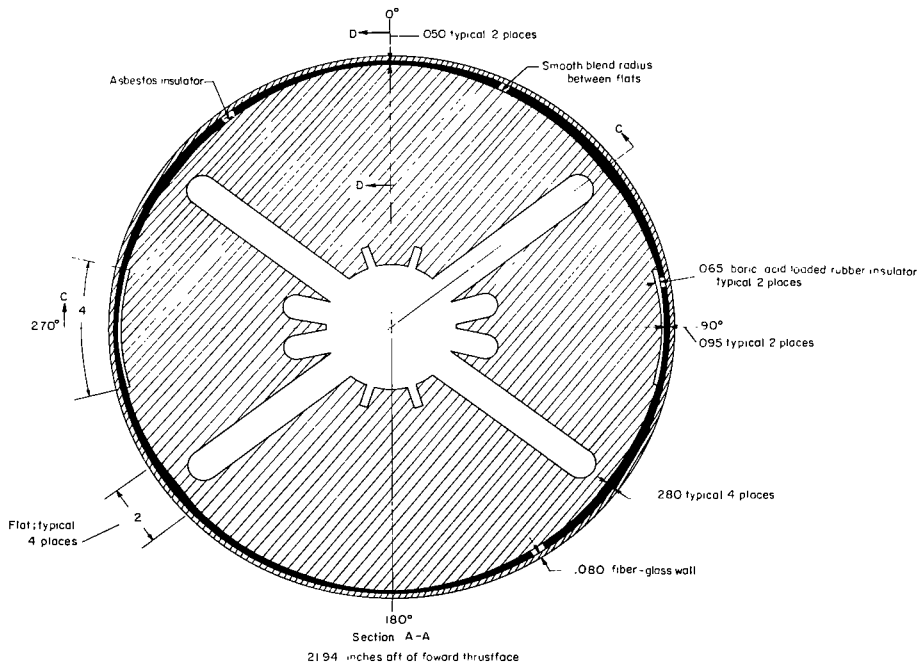
Figure 1.- Continued.

(d) Insulator cross section. (See figure 1(e) for sections C-C and D-D.) Cross section of motor in aft cylinder area.

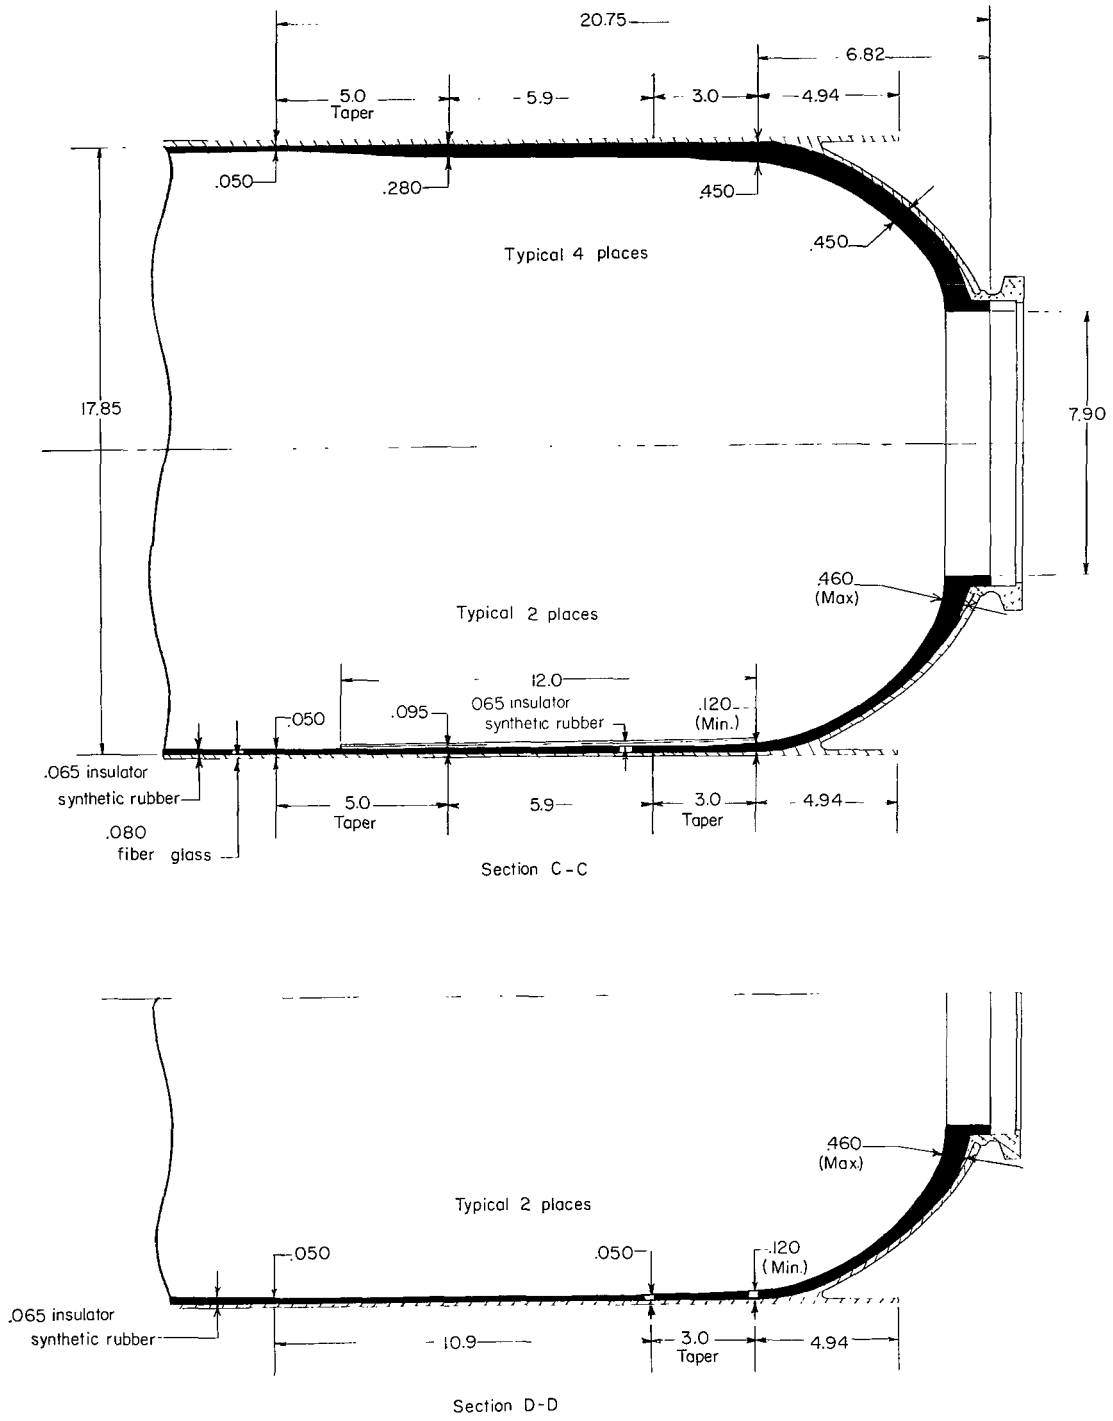
Figure 1.- Concluded.

(e) Aft-chamber asbestos insulator.

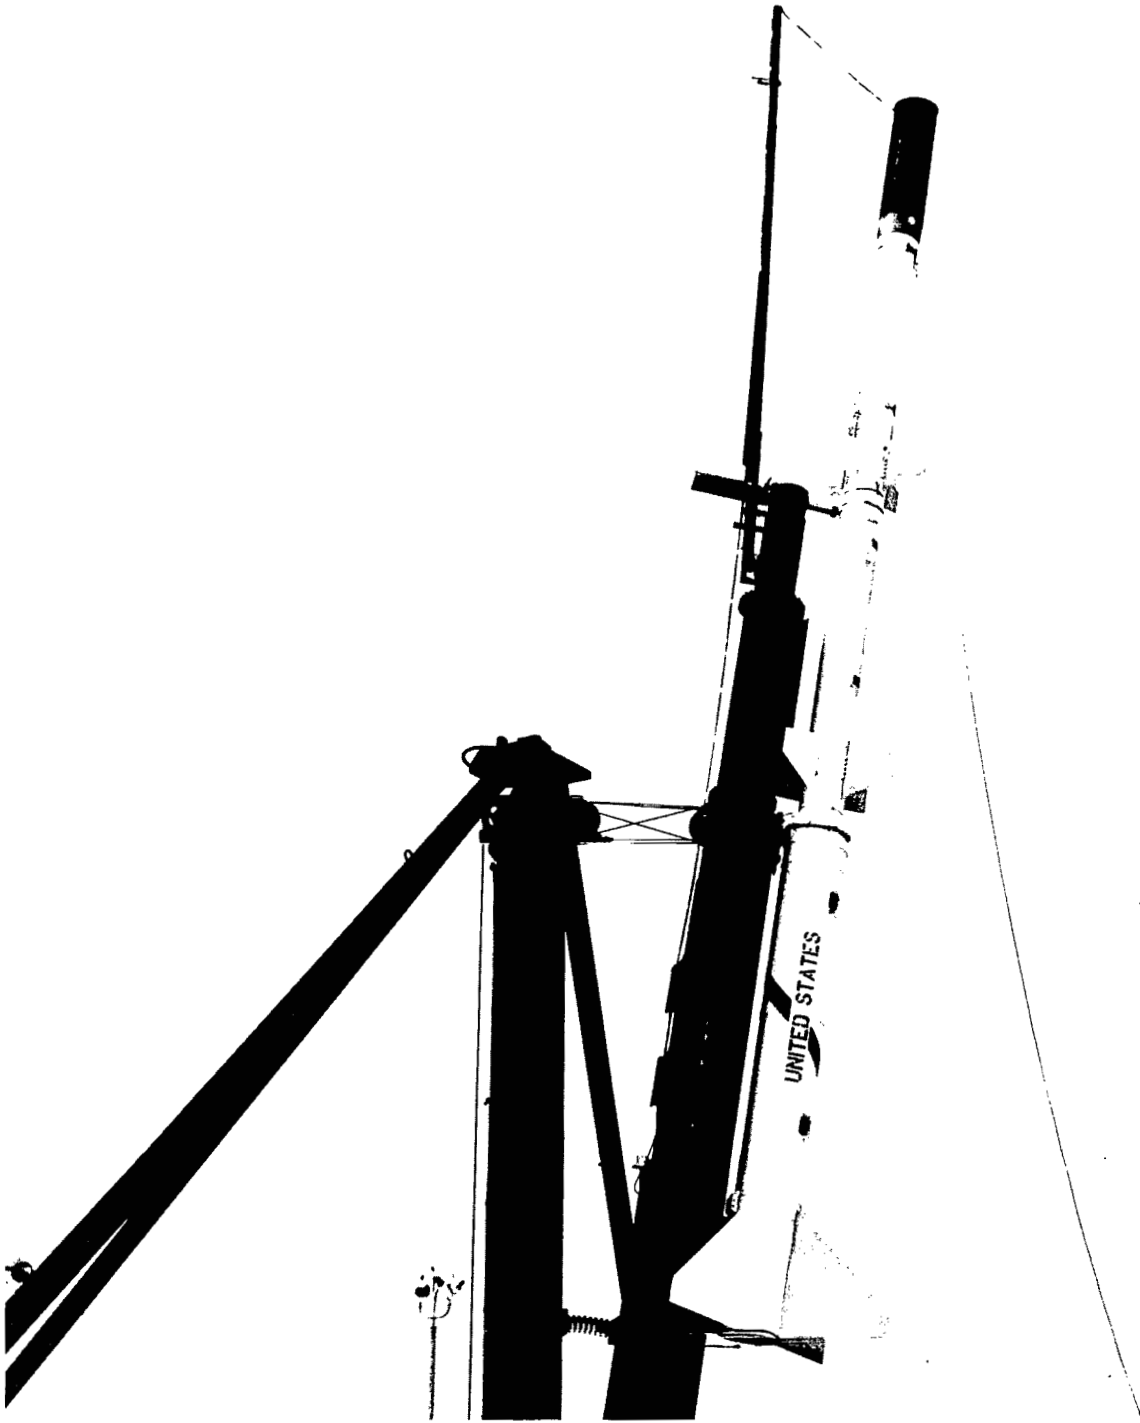
Figure 2.- Modified Javelin on launcher.

A modified Javelin vehicle was launched from Wallops Island, Virginia, on April 15, 1964, to flight test an Altair IIC1 (X-258) (S/N RH-65) rocket motor in a spinning environment similar to that of the Scout vehicle. The primary objective was to obtain flight-performance and temperature data to correlate with AEDC static tests. Modification of the basic Javelin vehicle consisted of substituting the Altair-IIC1 as the fourth stage in place of an Altair-IA6 with the other stages remaining the same (Honest John, Nike, Nike). Figure 2 shows the vehicle on the launcher.

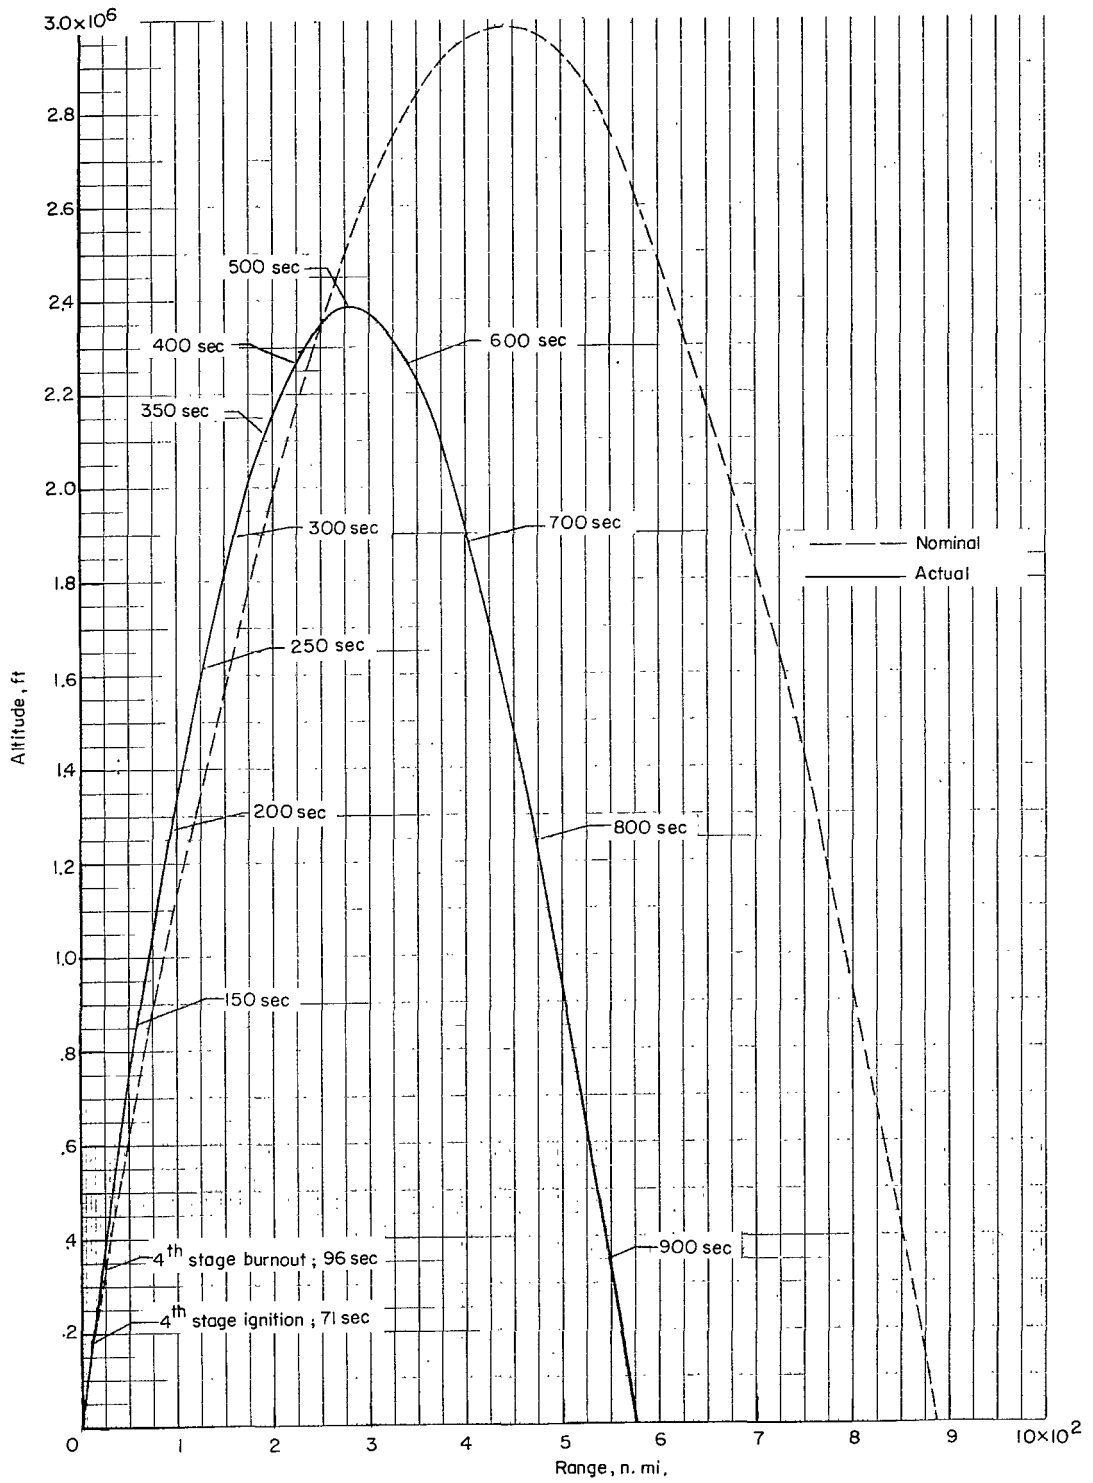
Figure 3.- Comparison of actual and nominal flight path.

Figure 3 shows a comparison of the actual and nominal altitude-range plot. Failure of the fourth-stage heat shield to eject at the proper time resulted in a performance level lower than expected. The heat shield did eject as noted in table I where actual flight events are compared with nominal event times.

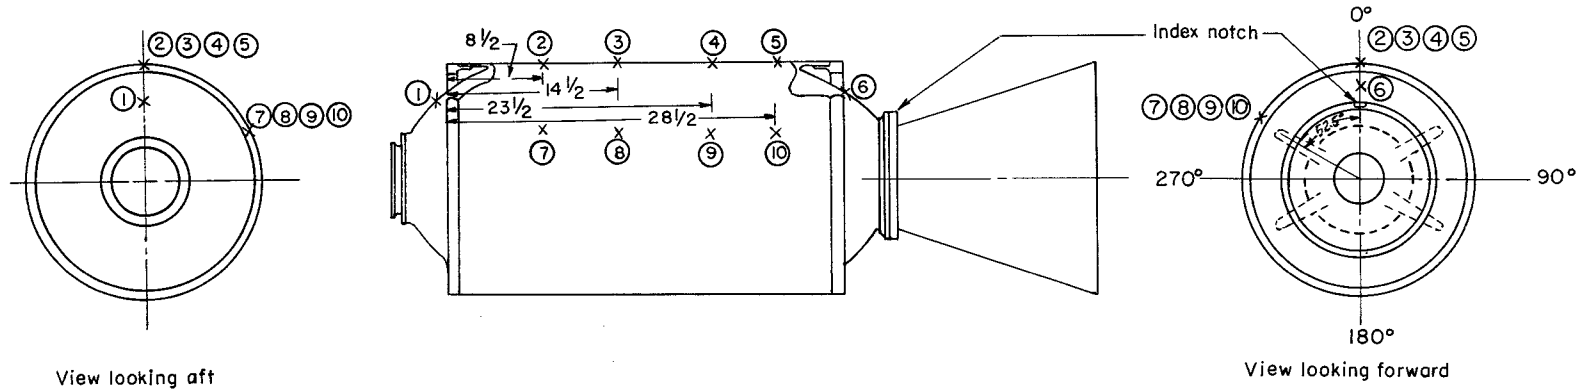
Figure 4.- Temperature-sensor locations. All dimensions are in inches.

Instrumentation in the payload for monitoring performance is listed with respective ranges in table II. Figure 4 shows schematically the location of the 10 thermistors which are of primary interest in this report. Figures 5 to 7 are photographs of the actual thermistor locations on the flight motor.

Figures 9 to 13 compare the results of the flight test and of the static altitude tests. As indicated in the figures, the flight motor had silver conductive paint on the forward dome but was natural elsewhere. Examination of the data for thermocouple (TC) 4 in figure 11 indicates that the addition of an aluminum-foil wrapping to a natural case can increase the maximum temperature of the case from 400° F to 700° F. It should be noted that for TC 4 the maximum temperature for the foil-wrapped case occurs 150 seconds after that for the nonwrapped case. Similar results were observed during the static test of an Altair-IIIB1 (S/N RH-47) motor tested at 200 rpm as indicated in reference 2. Examination of the Altair-IIIB1 motor after testing showed a large deposit of resin on the aluminum foil. As a consequence of this resin boiloff, the fiber-glass filaments in the chamber midsection were left essentially unbonded. This condition resulted from a case surface temperature of 700° F measured over a grain slot (fig. 4).

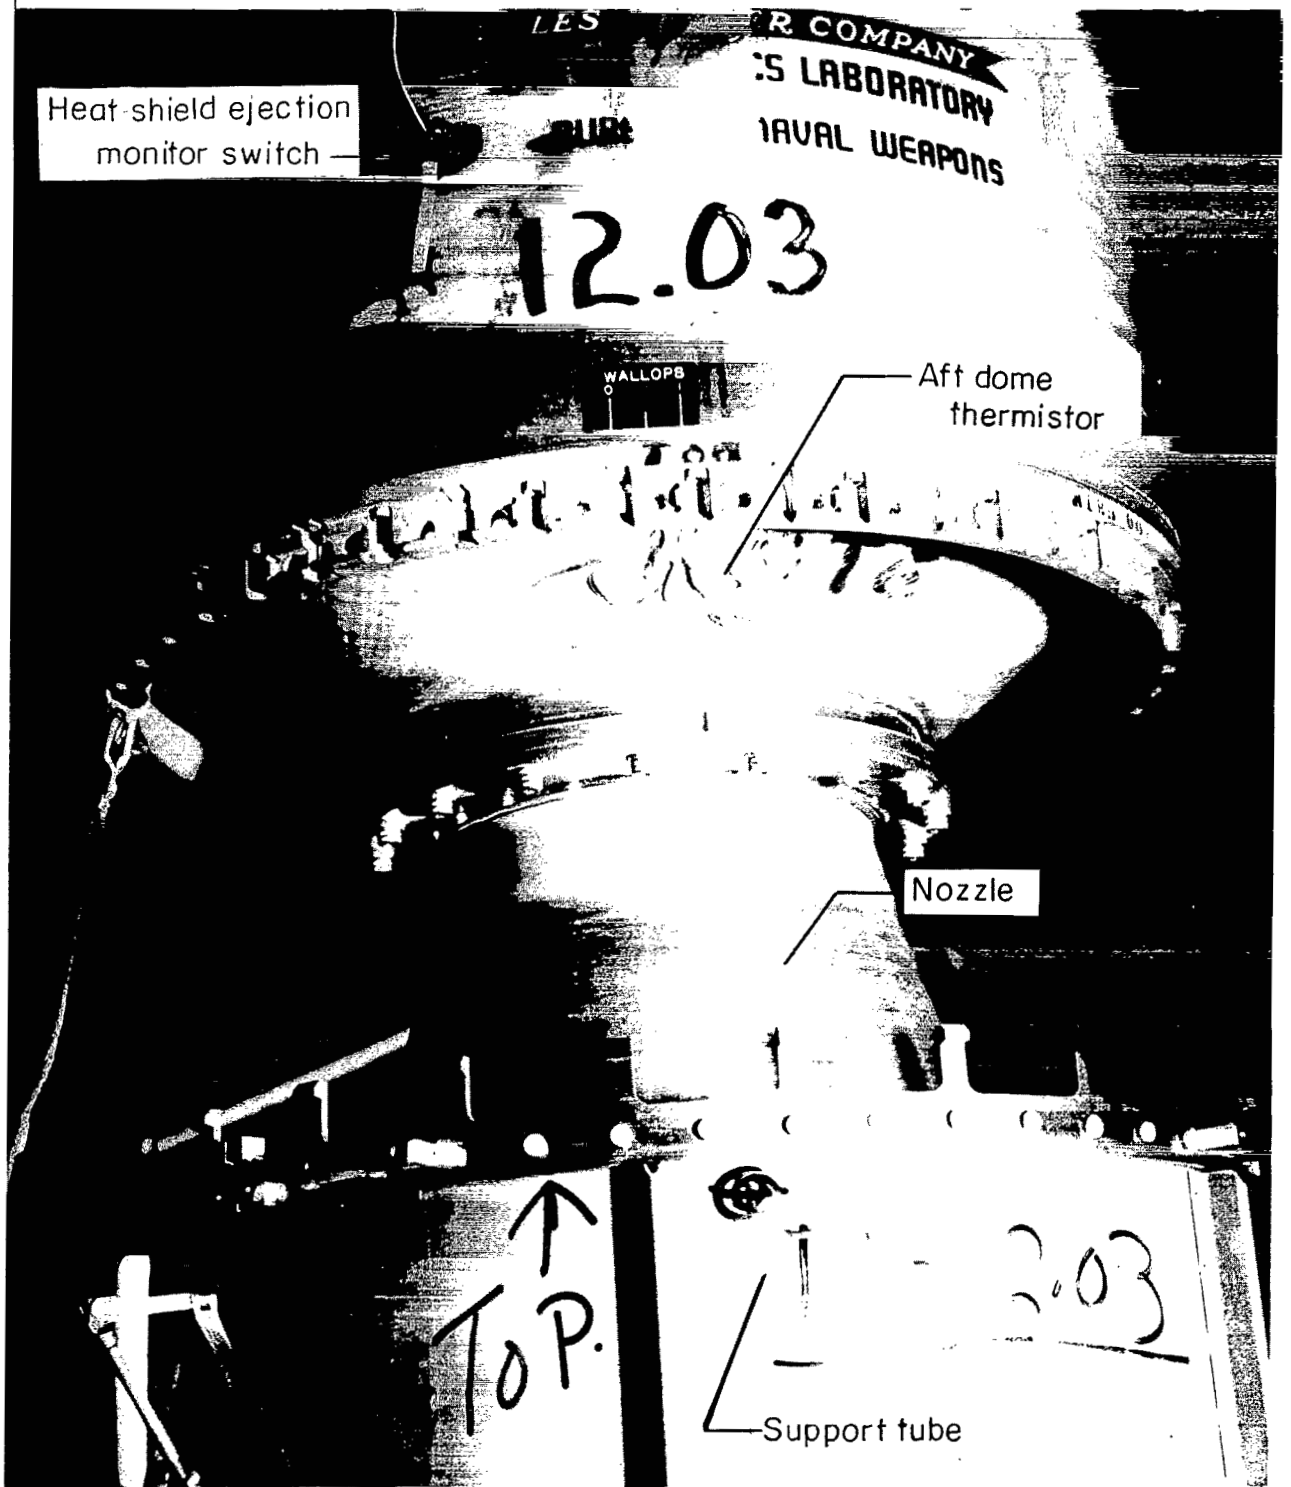
Figure 5.- Altair-IIC1 instrumentation (aft end).

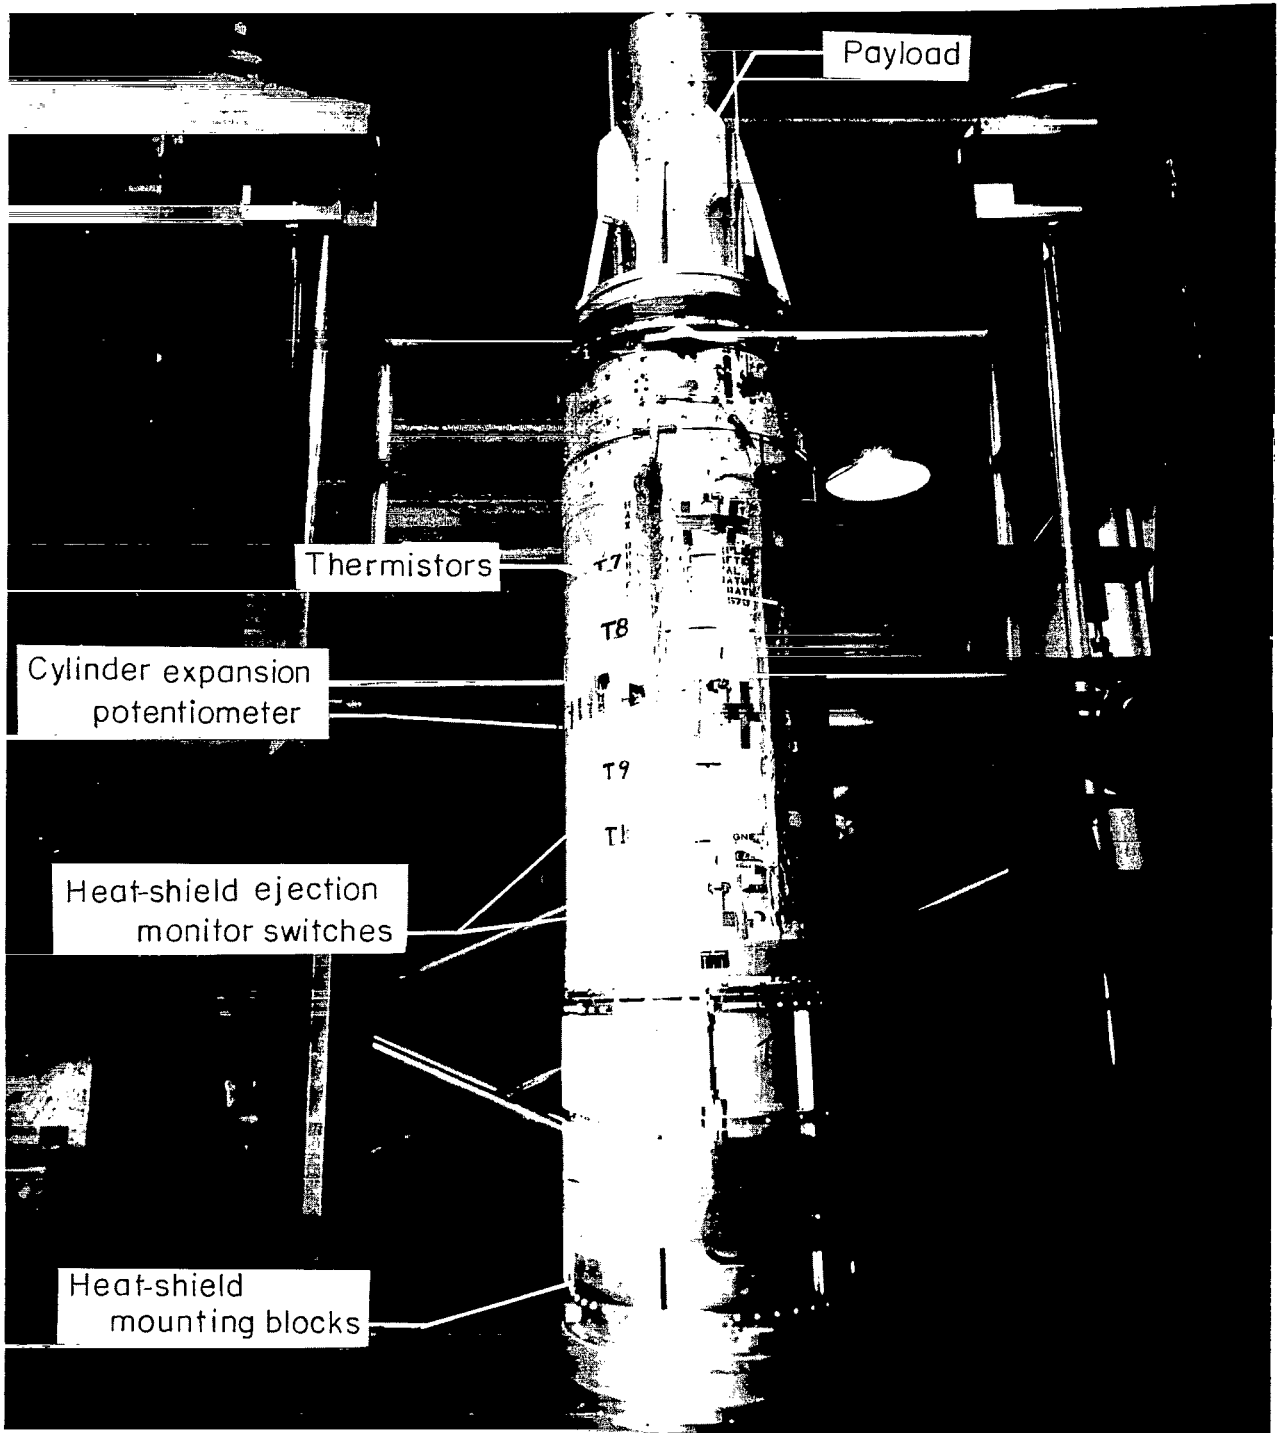
Figure 6.- Altair-II C1 payload stage.

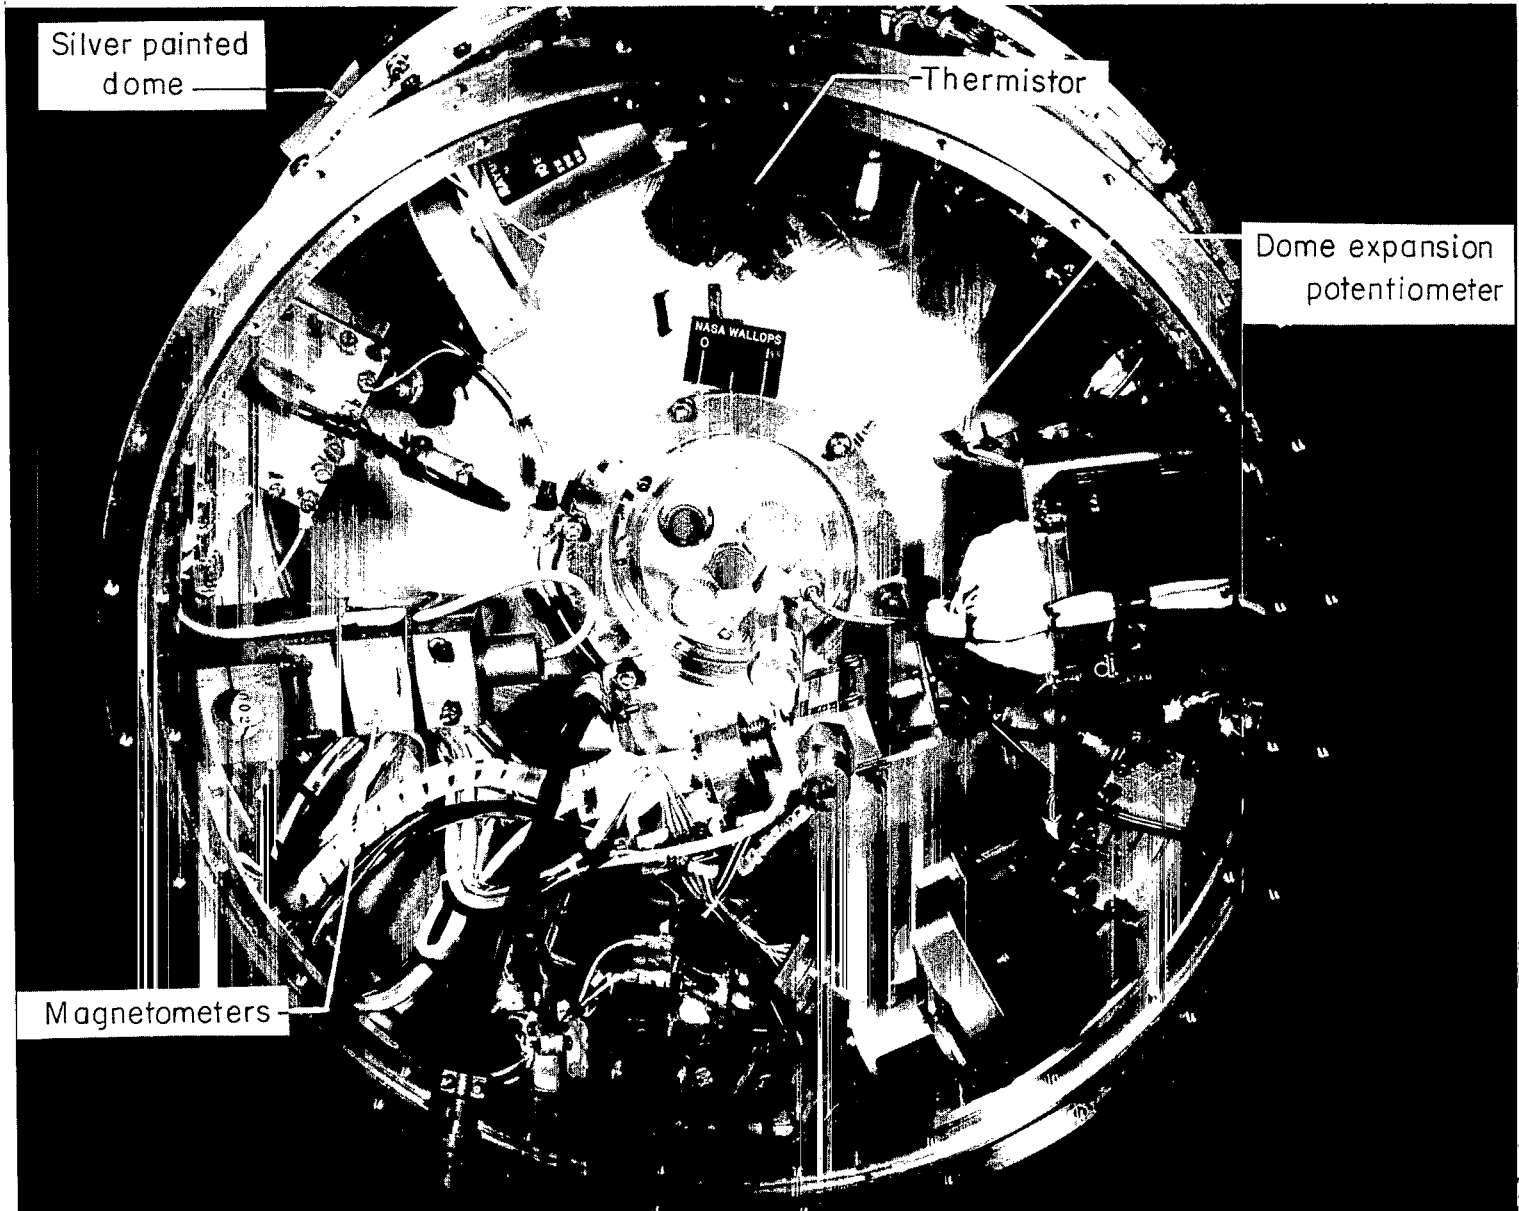
Figure 7.- Altair-II instrument compartment (forward end).

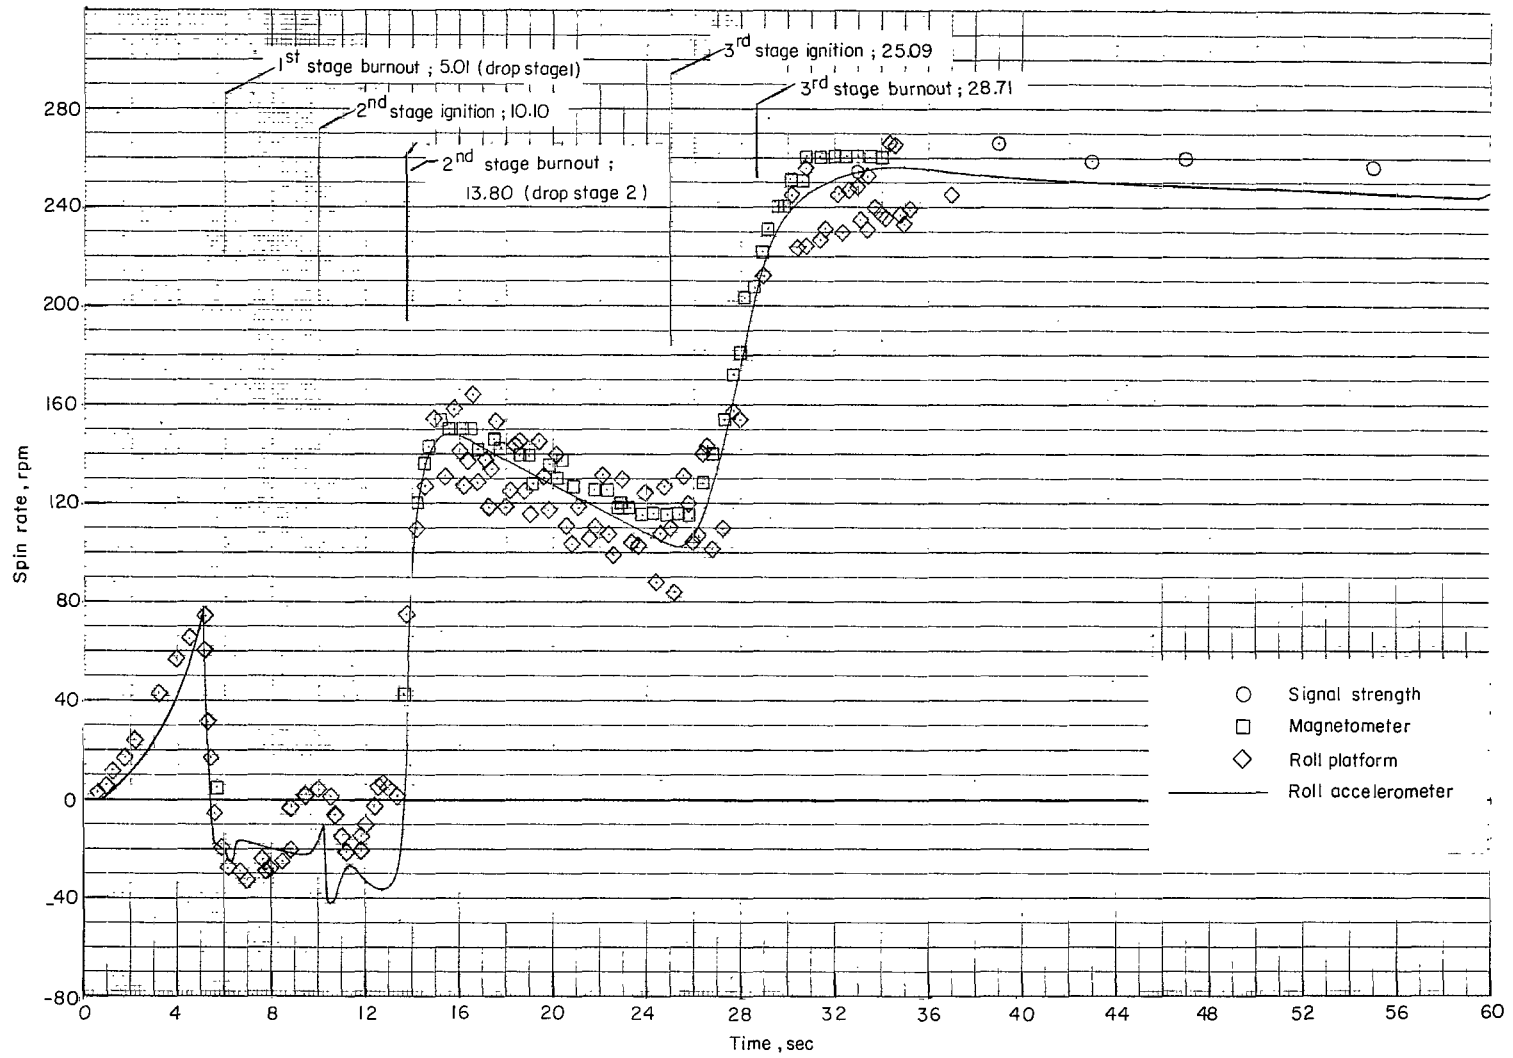
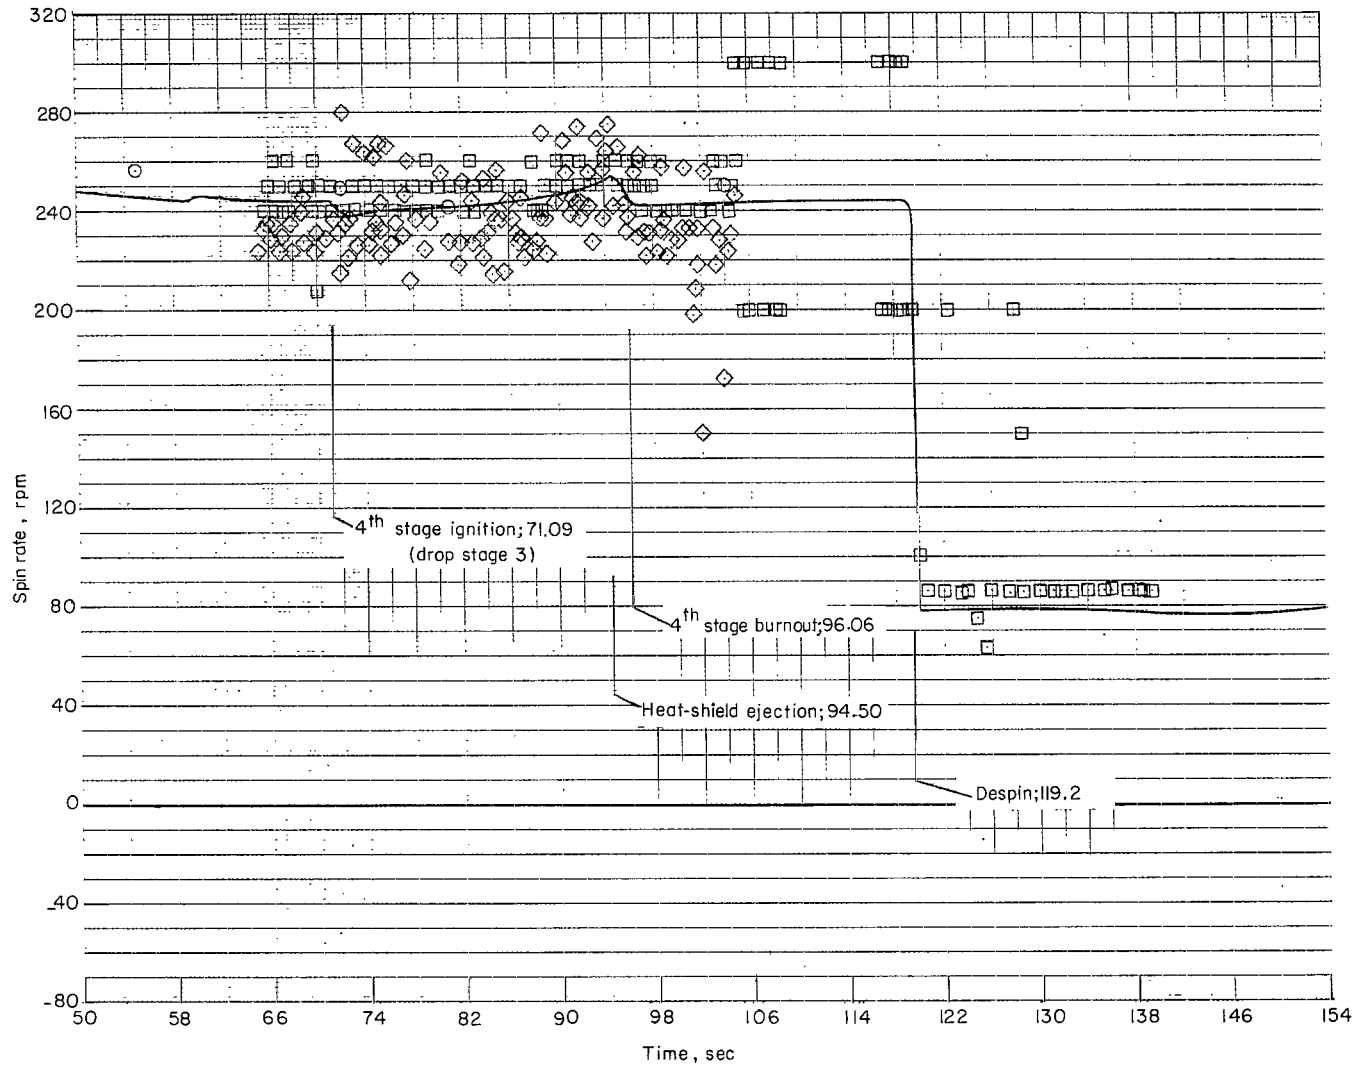
Figure 8.- Comparison of spin rate obtained from various sources.

A prime requirement for the flight test was to have a spin rate equal to or slightly greater than that of Scout during motor burning. The spin rate was produced by canting the first-stage fins 30 minutes and the third-stage fins 37 minutes. Since spin rate was deemed to be a primary measurement it was measured by several instruments and the results are shown in figure 8.

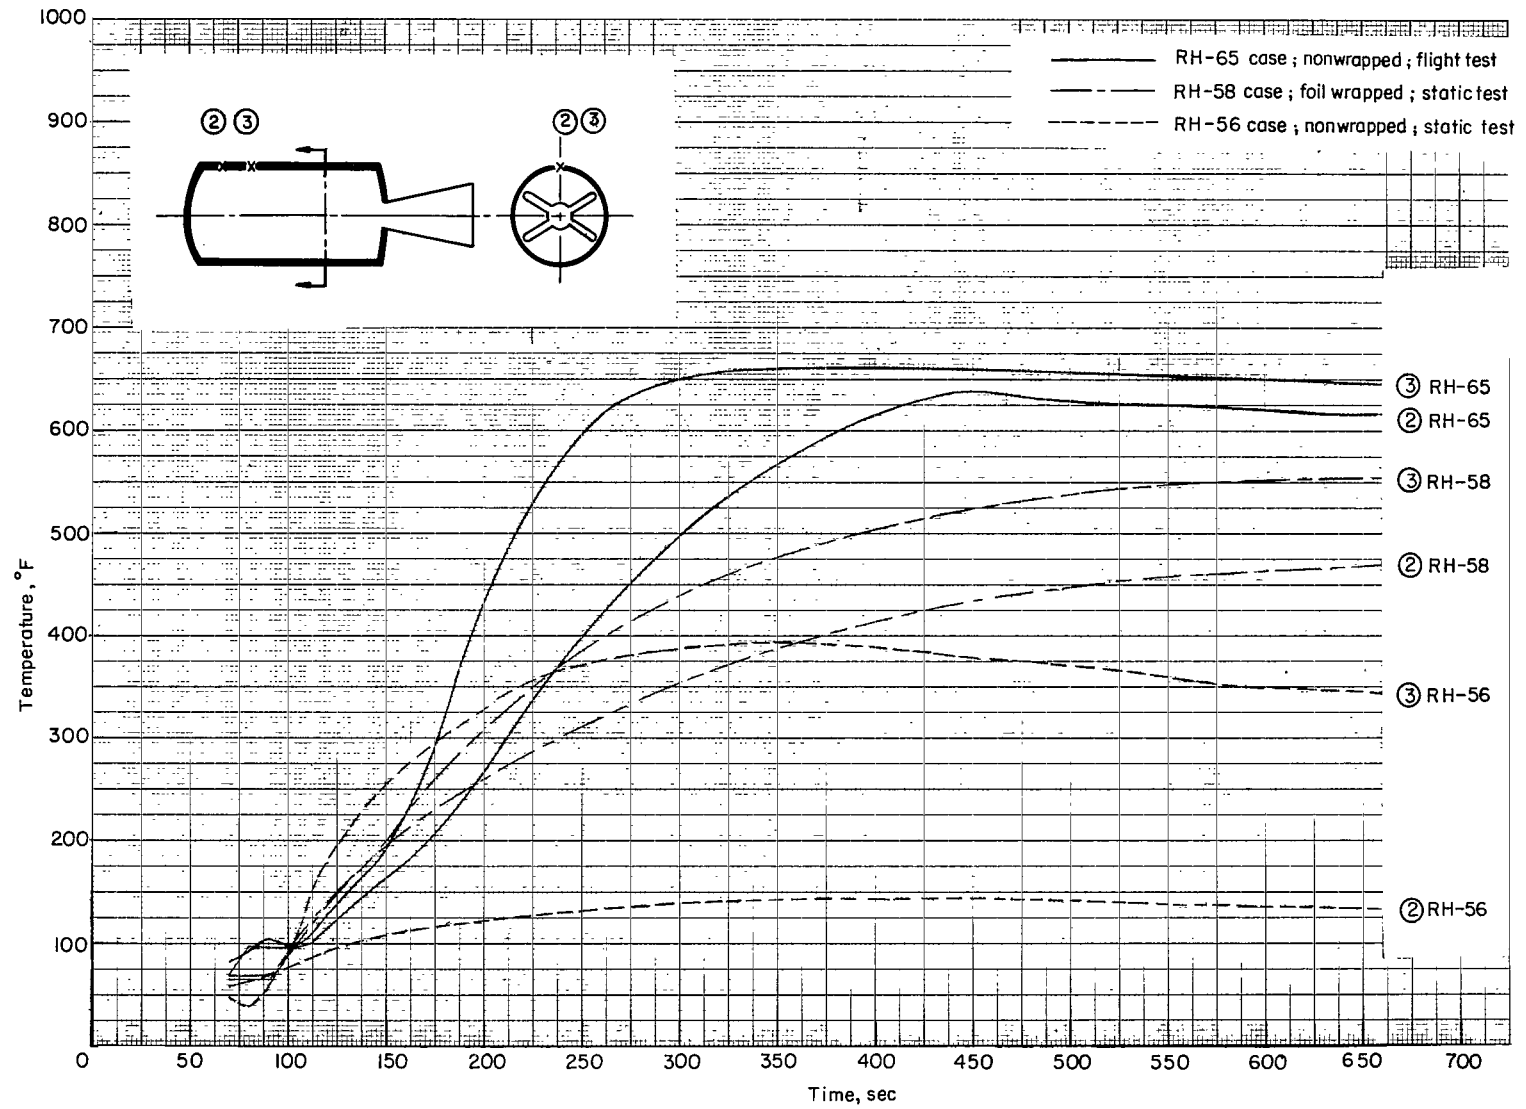
Figure 9.- Forward-cylinder temperatures measured at thermocouples 2 and 3.
