NASA TN D-2953

FLIGHT-TEST TEMPERATURE DATA FOR AN ALTAIR-IIIC1 ROCKET MOTOR

by James L. Raper
Langley Research Center
Langley Station, Hampton, Va.

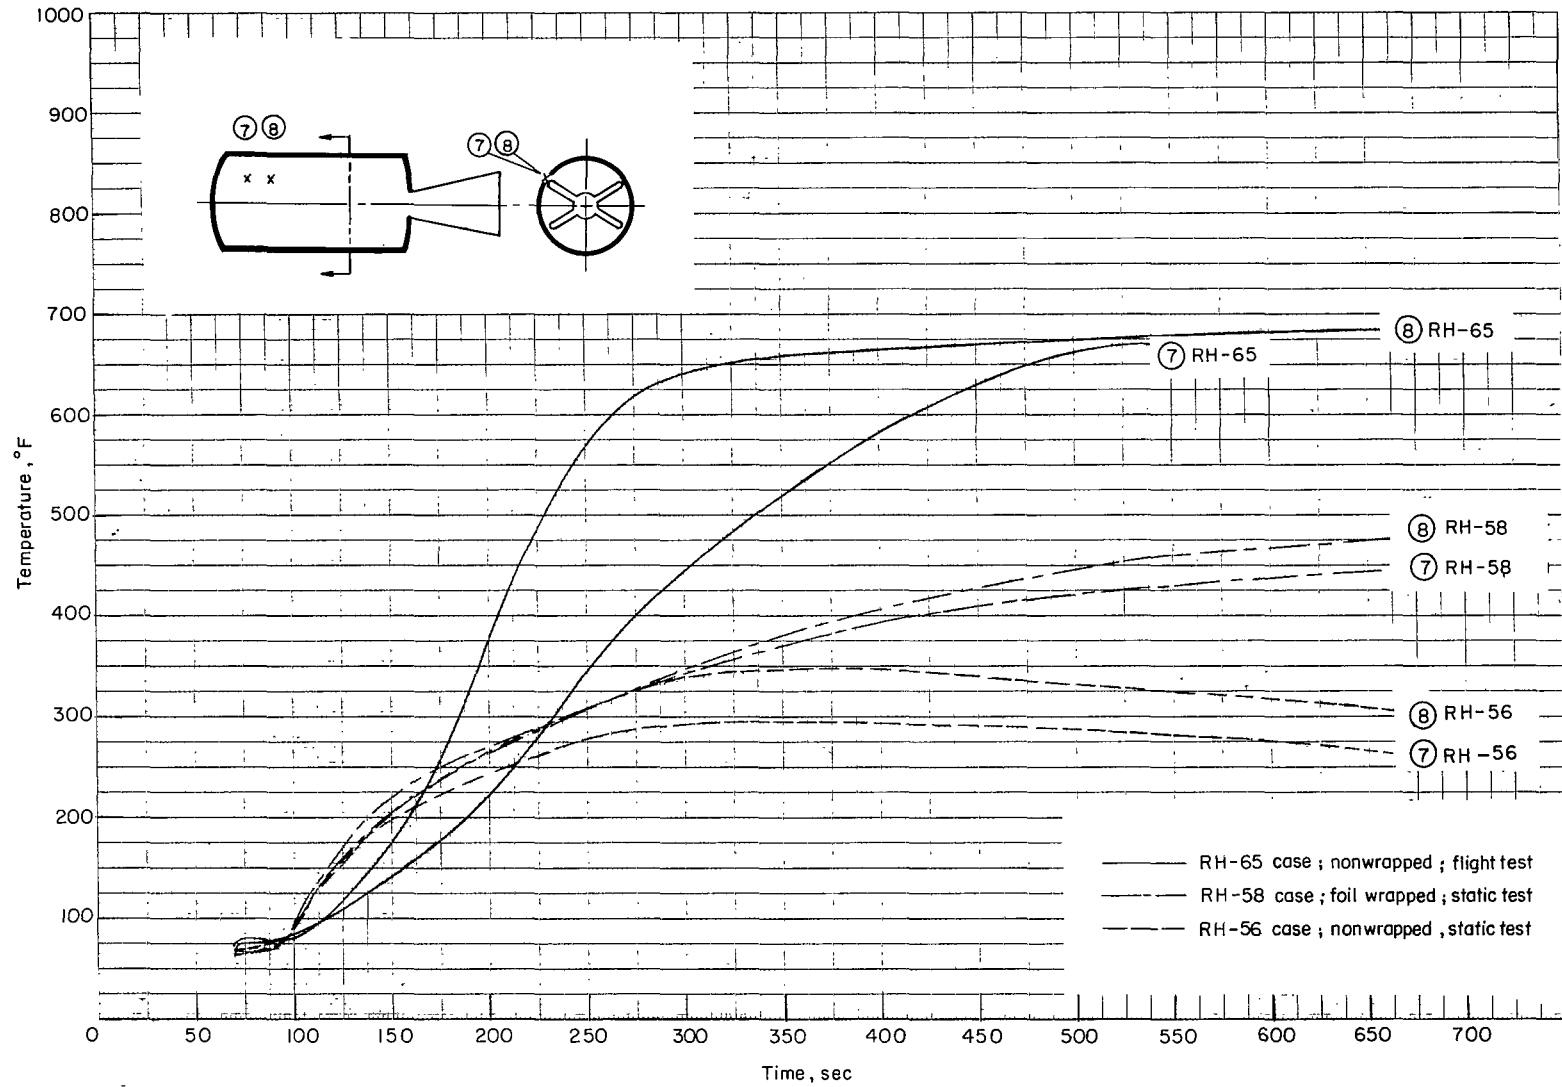
Figure 10.- Forward-cylinder temperatures measured at thermocouples 7 and 8.

Figures 9 to 13 compare the results of the flight test and of the static altitude tests. As indicated in the figures, the flight motor had silver conductive paint on the forward dome but was natural elsewhere. Examination of the data for thermocouple (TC) 4 in figure 11 indicates that the addition of an aluminum-foil wrapping to a natural case can increase the maximum temperature of the case from 400° F to 700° F. It should be noted that for TC 4 the maximum temperature for the foil-wrapped case occurs 150 seconds after that for the nonwrapped case. Similar results were observed during the static test of an Altair-IIIB1 (S/N RH-47) motor tested at 200 rpm as indicated in reference 2. Examination of the Altair-IIIB1 motor after testing showed a large deposit of resin on the aluminum foil. As a consequence of this resin boiloff, the fiber-glass filaments in the chamber midsection were left essentially unbonded. This condition resulted from a case surface temperature of 700° F measured over a grain slot (fig. 4).

Based on the Javelin data, the temperatures measured in flight on the chamber side walls are significantly higher than for the static tests. For the unwrapped motor cases (RH-56 and RH-65), the chamber-wall temperature in the flight test was 400° F greater than in the static tests as shown in figures 10 and 11. Even though the heat shield did not eject as planned, it had no effect on the side-wall temperature histories since there was no indicated temperature increase prior to the time that the heat shield did eject. A possible reason for this difference between flight- and static-test data at simulated altitude is in the test environments. The static tests are generally performed at a simulated altitude of about 100,000 feet while the flight test of the Javelin vehicle extended up to 2.4×10^6 feet as shown in figure 3. The considerably lower density of the flight environment reduces the case heat transfer to the surrounding atmosphere compared with the transfer which occurs in the AEDC tunnel tests. In figure 14 temperature for the forward dome of Scout S-122 is compared with the temperature on the Javelin and AEDC motor tests. An Altair-II1 (RH-61) was used on Scout S-122, but dome temperatures would be the same as those from Altair-II1 motors since dome insulation is identical. The Scout S-122 motor had an aluminum-foil blanket over the forward dome and was spinning at approximately 160 rpm. Each flight test shows larger maximum temperatures - a maximum temperature which occurs much later than in the static tests - and a much lower rate of cooling after maximum temperature.

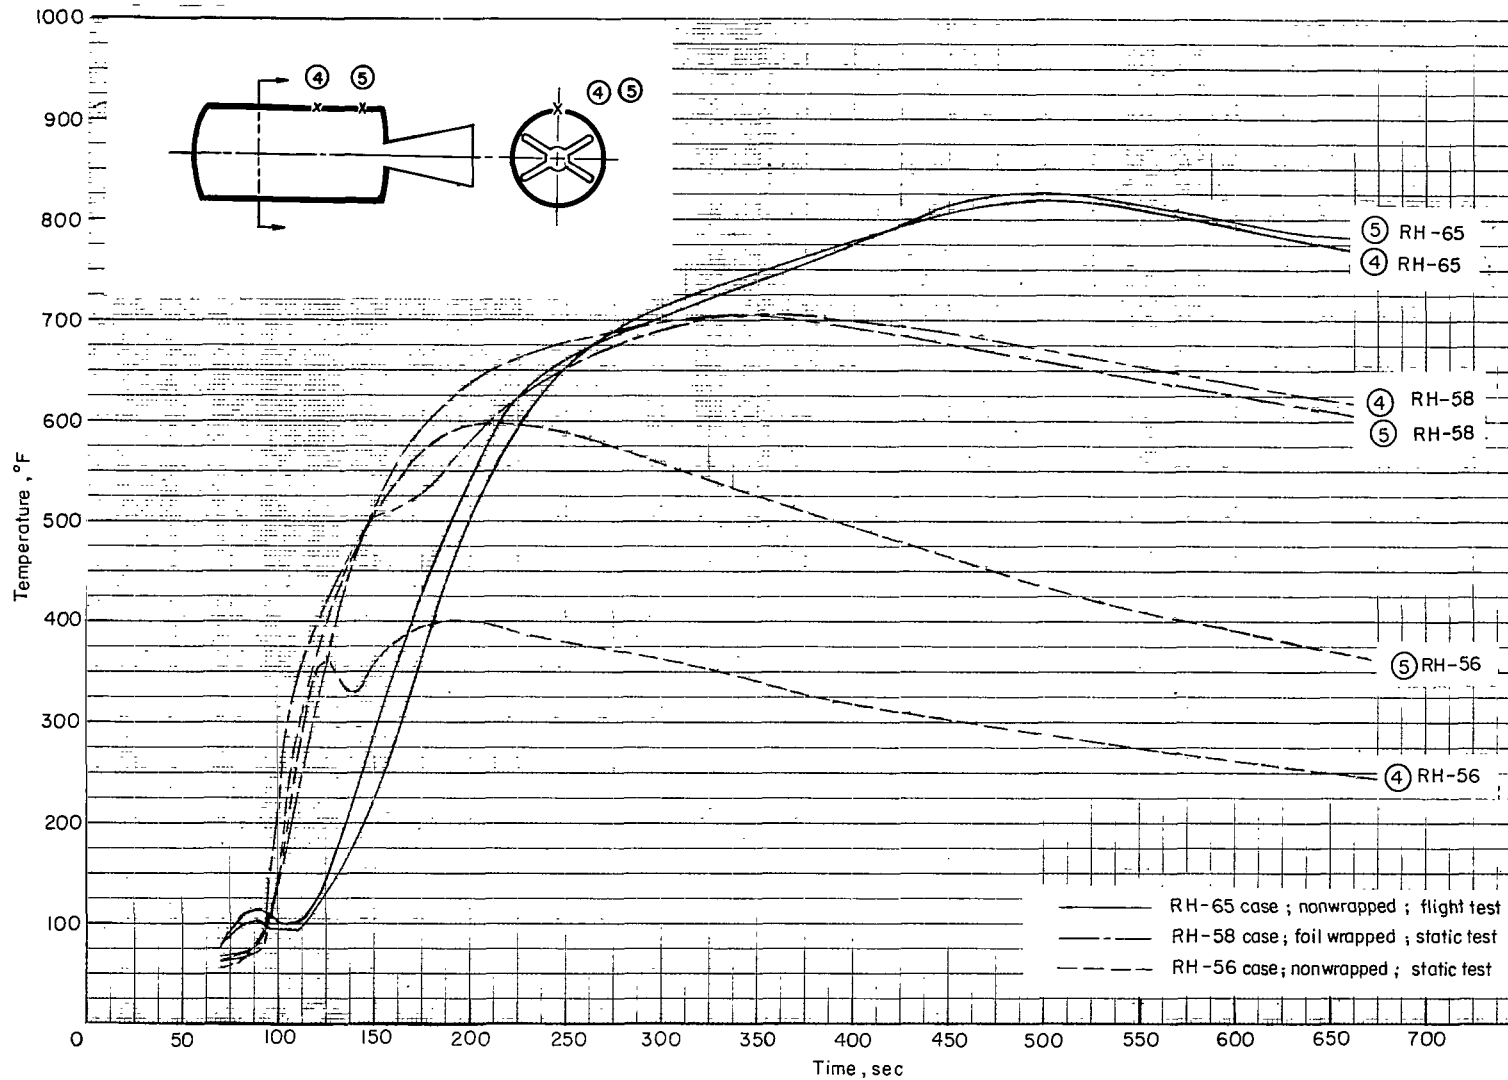
Figure 11.- After-cylinder temperatures measured at thermocouples 4 and 5.

and resin boiloff. A motor case charred to this extent is incapable of transmitting any significant bending or compressive loads. Reference to figure 11 indicates that the motor problems due to temperature become serious about 75 seconds after motor ignition.

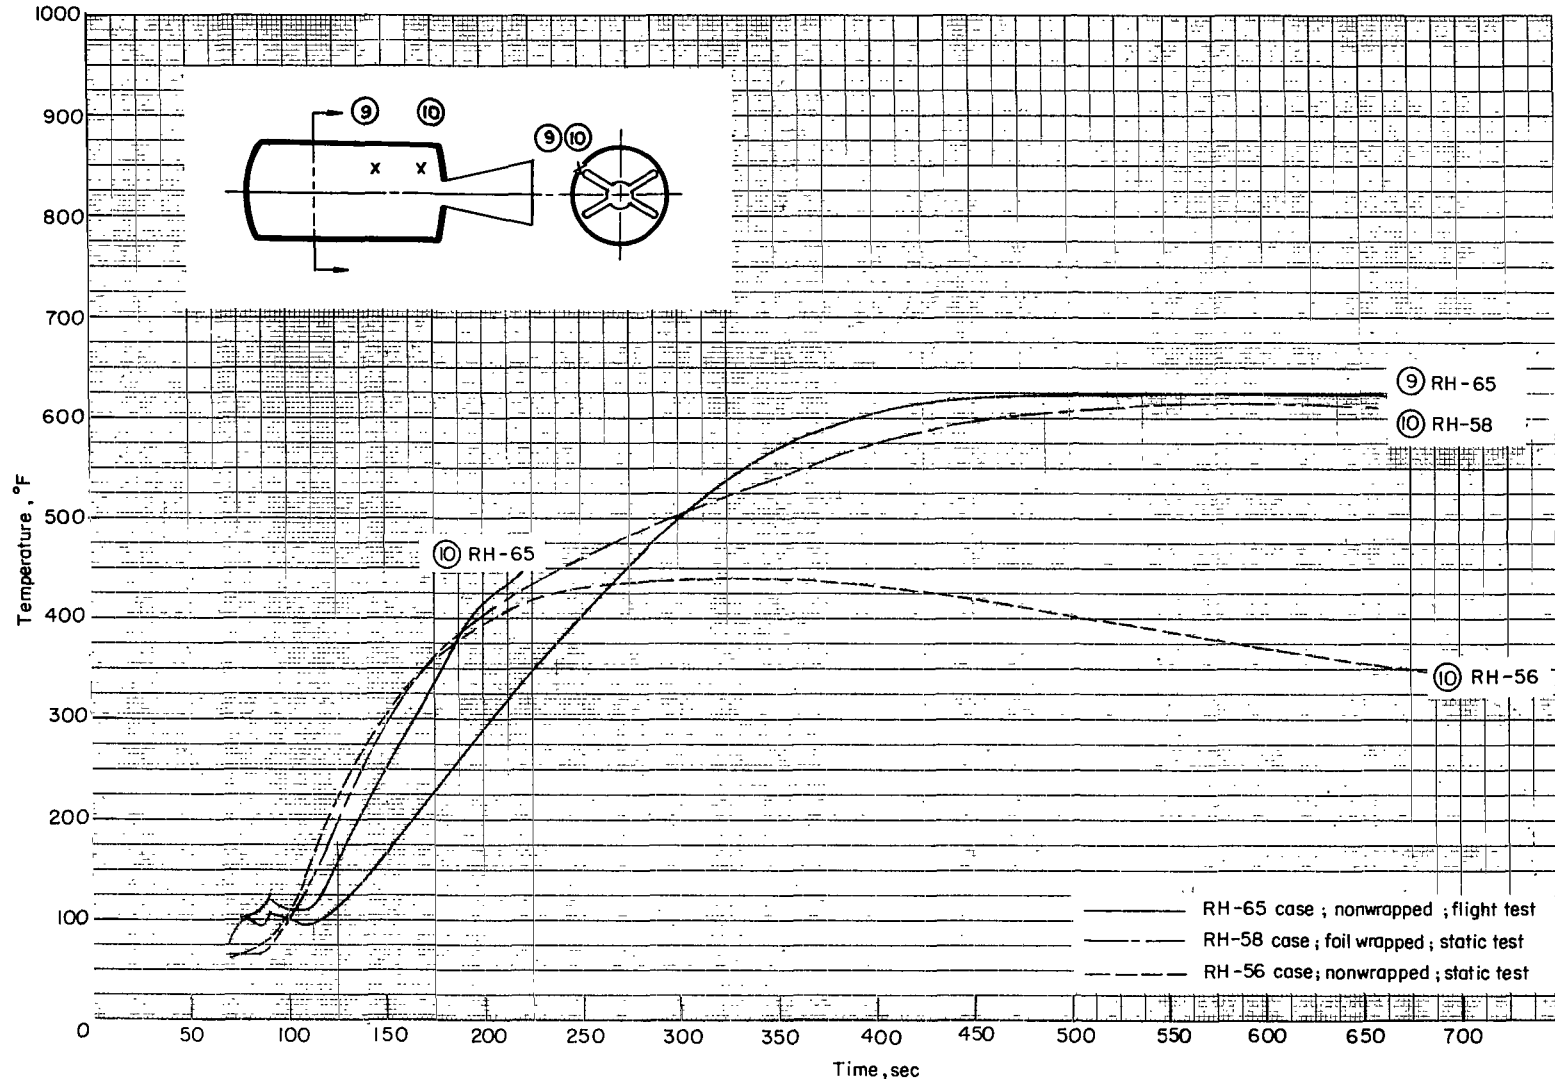
Figure 12.- After-cylinder temperatures measured at thermocouples 9 and 10.

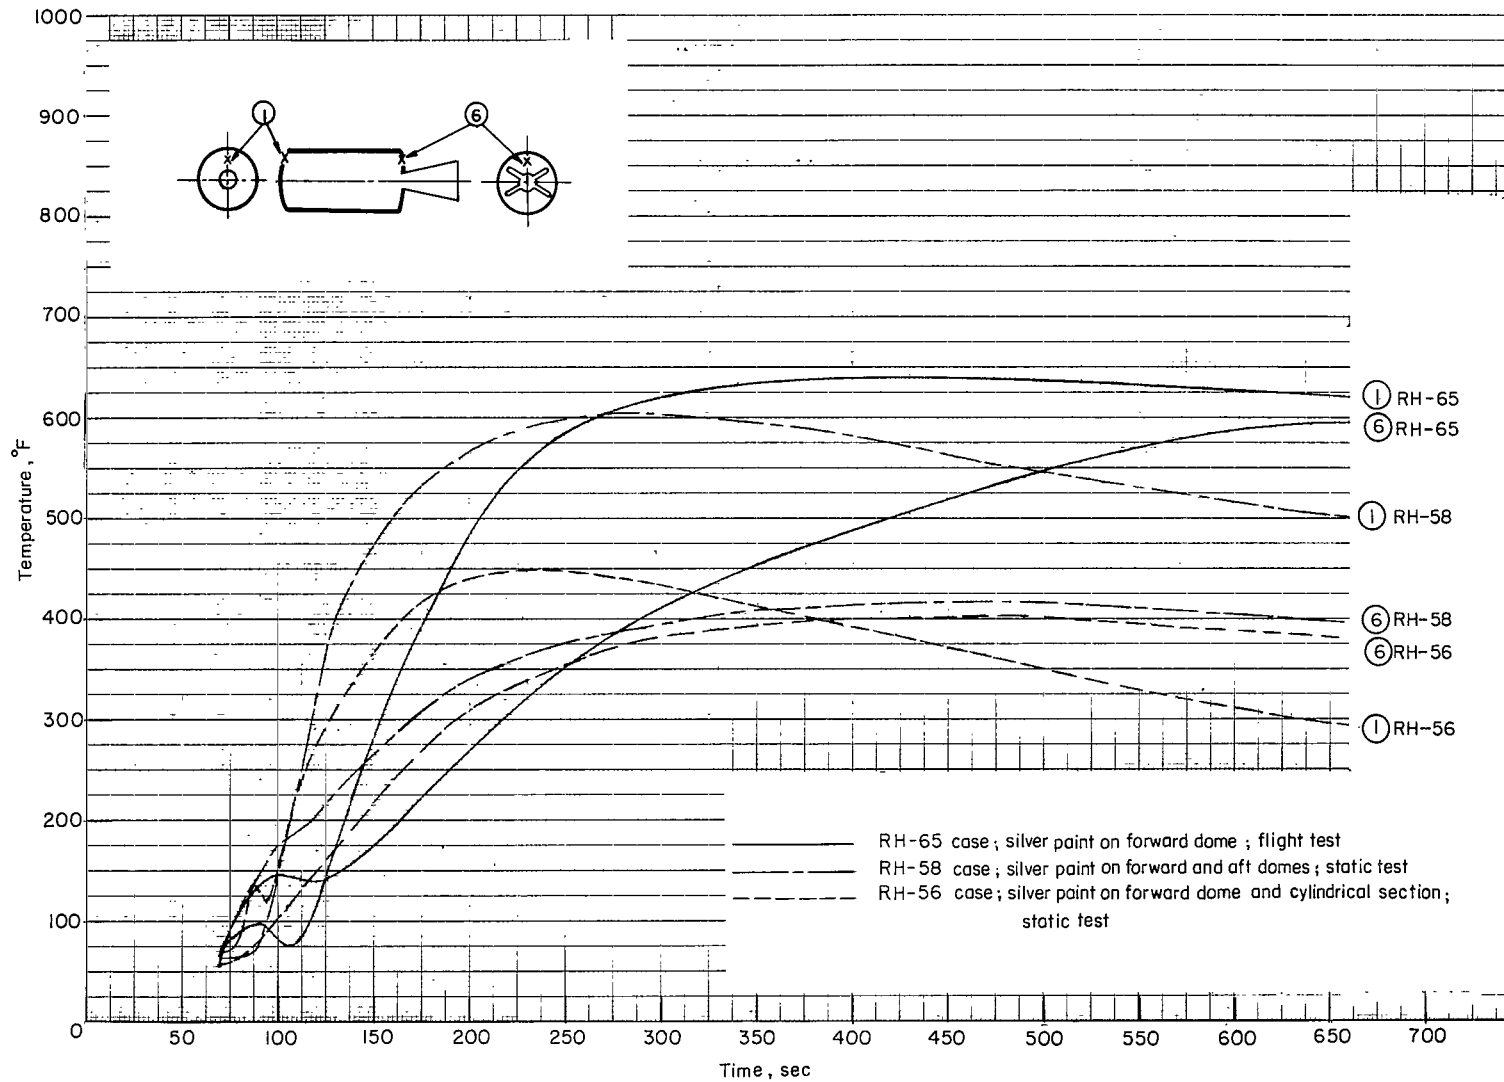
Figure 13.- Forward- and after-dome temperatures measured at thermocouples 1 and 6.

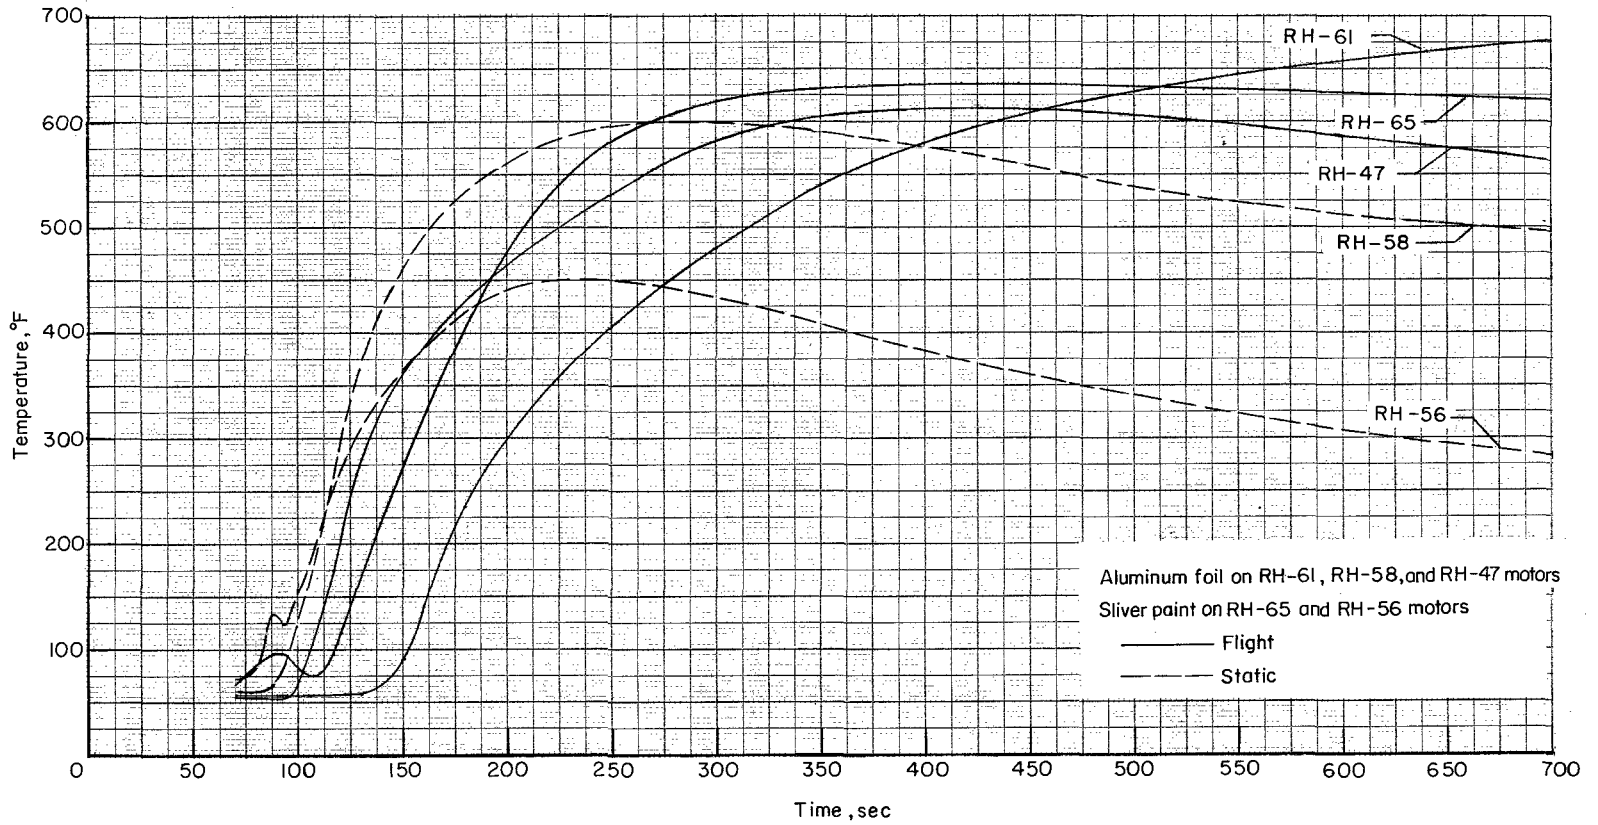
Figure 14.- Comparison of forward-dome temperatures from static and flight tests.
