EVALUATION OF A SUBSCALE INTERNALLY INSULATED FIBER-GLASS PROPELLANT TANK FOR LIQUID HYDROGEN

by Laurence J. Heidelberg
Lewis Research Center
Cleveland, Ohio

The use of fiber-glass-reinforced plastics as a structural material, in conjunction with internally located foam insulation for liquid-hydrogen propellant tanks, was investigated by designing, fabricating, and experimentally evaluating a subscale tank. The tank consisted of three main components: a structural shell of filament-wound fiber glass, an internal insulation system of polyurethane foam encapsulated in a vacuum-tight jacket of aluminum-Mylar-aluminum foil laminate, and an impermeable liner of the same laminate. Liquid-hydrogen boiloff tests were used to determine the thermal performance and pressure-cycling tests were used to evaluate structural performance.

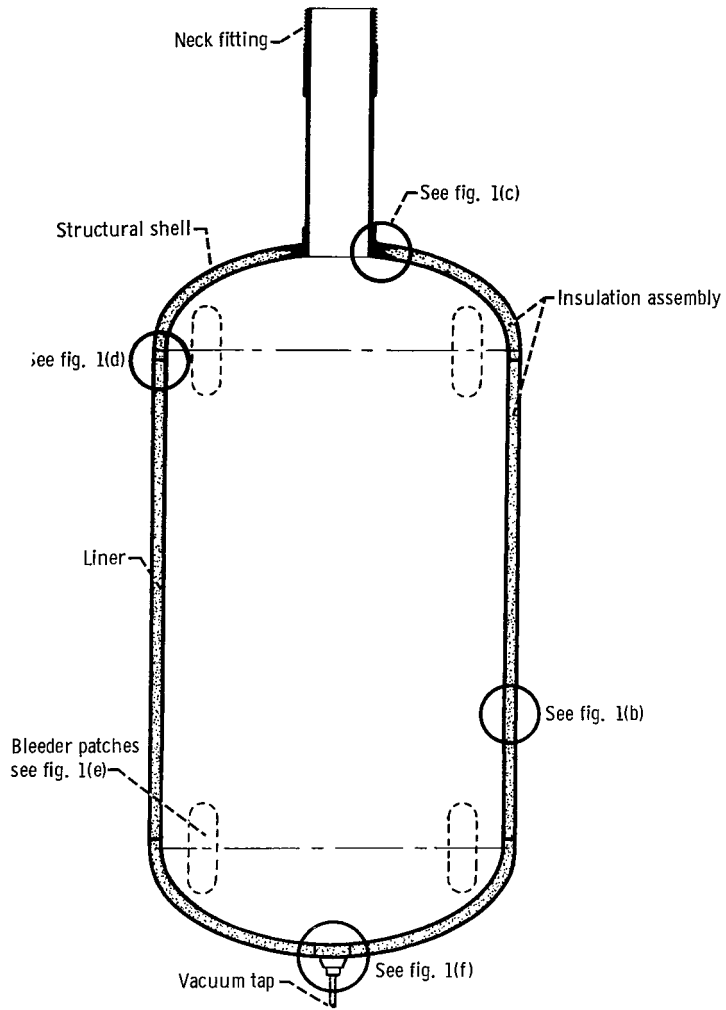
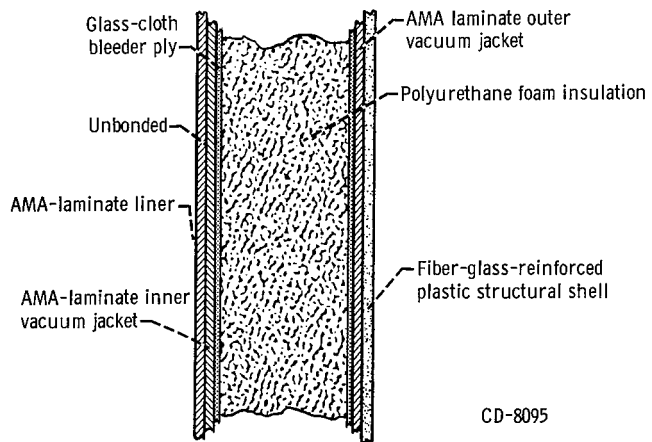
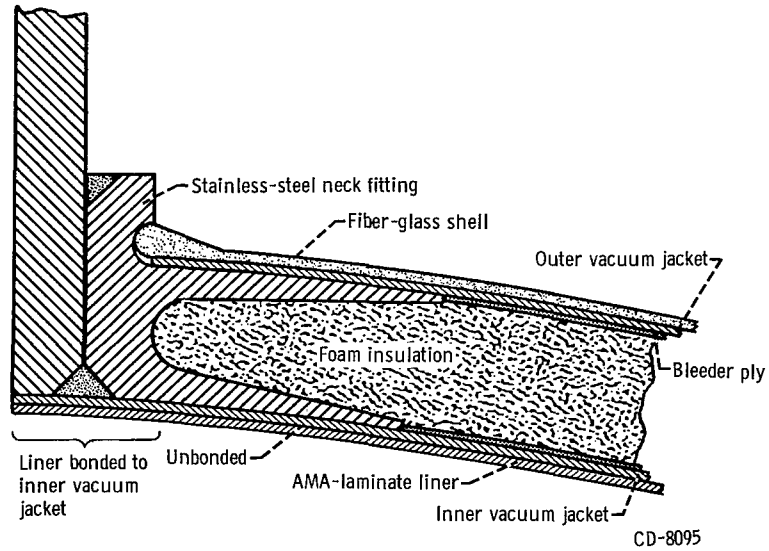
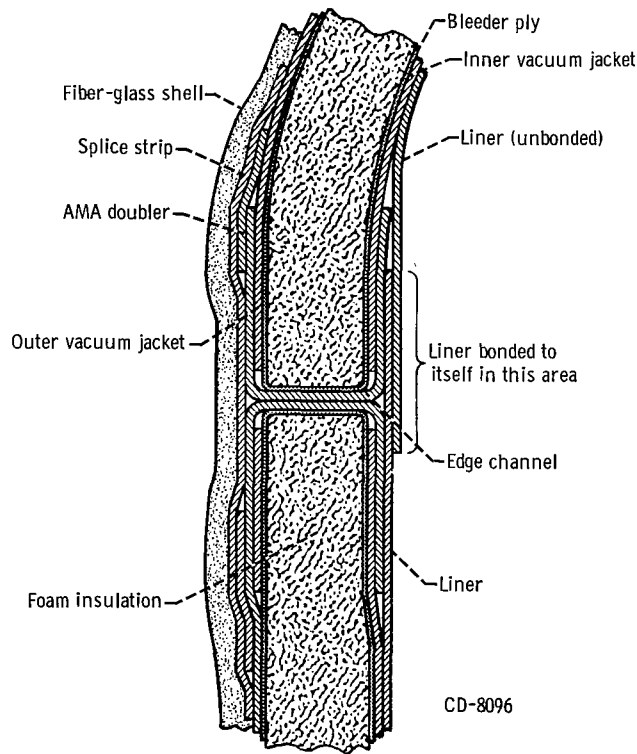
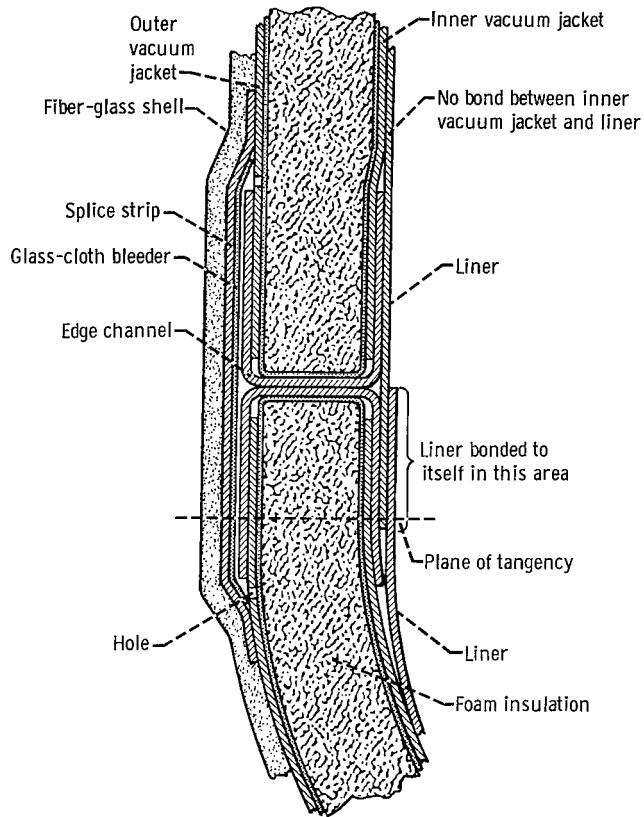
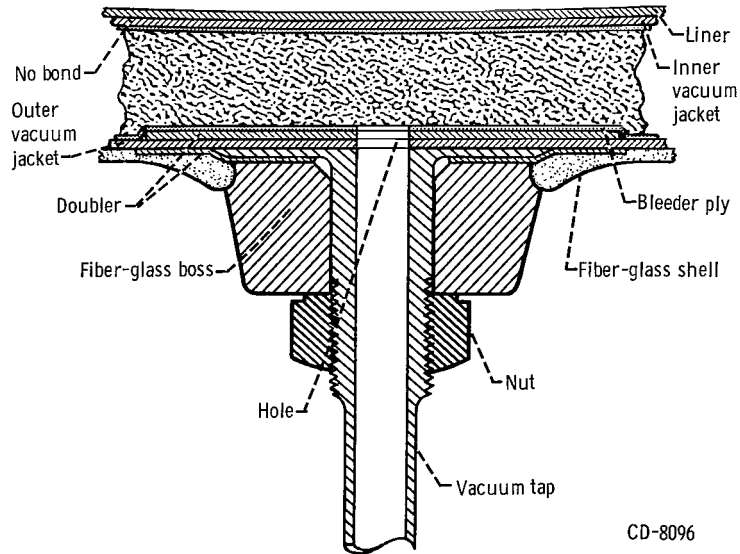
Figure 1. - Details of filament-wound liquid-hydrogen test tank. All surfaces bonded except as indicated. (Not to scale.)

An 18-inch-diameter by 36-inch-long pressure-vessel configuration with an approximate capacity of 40 gallons was selected for the test tank. The major components as shown in figure 1 are: (1) a filament-wound fiber-glass structural

(a) Complete test tank.

(b) Enlarged typical section through tank wall.

(c) Detail of neck fitting (doublers not shown).

(d) Detail of typical splice between dome and cylinder.

(e) Detail of section through bleeder patch (doublers not shown).

(f) Detail of vacuum tap.

shell; (2) a three-piece insulation assembly comprised of a top dome, a cylinder section, and a bottom dome; and (3) a cryogenic liner assembly comprised of two dome ends and a cylinder which are assembled to fit closely against, but not bonded to, the inner walls of the insulation assembly.

An important feature incorporated in the design of this tank is a glass-cloth layer between the foam to vacuum jackets (see figs. 1(b) and 5). The glass cloth is a bleeder ply (provides a path for gas flow) incorporated to serve the following purposes: (1) facilitate checking the vacuum jackets of each of the insulation components, (2) permit monitoring of the vacuum within the insulation during evaluation tests, and (3) permit rapid detection and vacuum

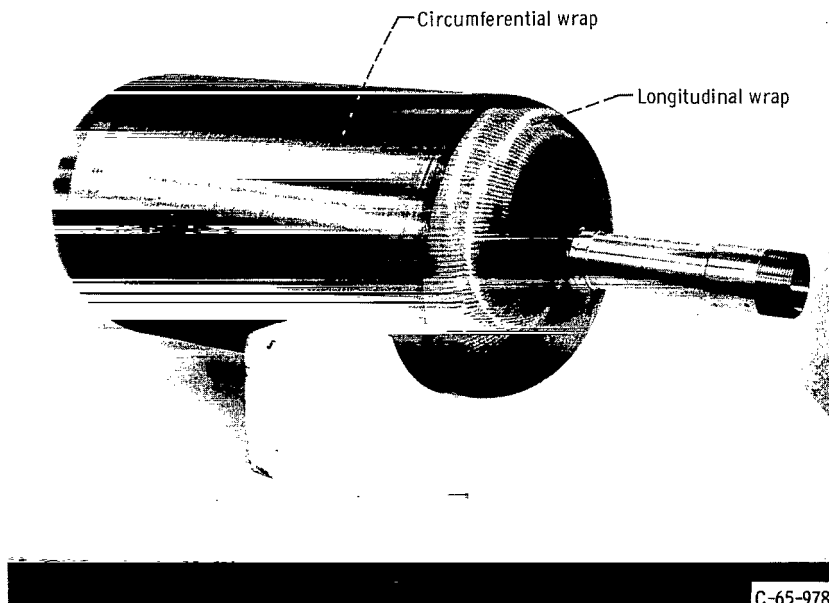
Figure 2. - Completed filament-wound test tank.

The filament-wound shell is of balanced design consisting of two layers of longitudinal wrap (412 total ends per in.) and four layers of circumferential wrap (736 total ends per in.). Roving, consisting of 20-end S/HTS fiber-glass wet impregnated with a low-temperature curing epoxy resin system, was used in winding the shell. Figure 2 shows the completed filament-wound tank.

The completed tank, shown in figure 2, weighs 17.20 pounds. A weight breakdown is as follows:

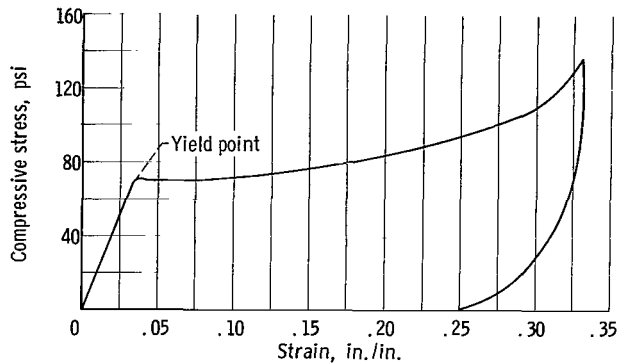
Figure 3. - Typical stress-strain curve for polyurethane foam. Room-temperature compression test; density, 4 pounds per cubic foot; modulus of elasticity, 2500 pounds per square inch.

The foam acts as both an insulator and a structural media for transmitting the internal loads to the structural shell. The foam-insulation thickness for this tank was 0.50 inch and was selected to facilitate the fabrication of the dome ends by foam-in-place techniques. The cylindrical section of foam insulation was made by machining a foam cylinder. Various density foams were tested at the Lewis Research Center to determine compressive yield strength at both room temperature and -320° F. Figure 3 shows a stress-strain curve obtained during testing. This curve shows a distinct yield point typical of all the tests in this series. Figure 4 summarizes the results of these tests. As expected there is a substantial increase in strength with a decrease in temperature. The selection of a 4-pounds-per-cubic-foot density foam was based on its strength at -320° F being greater than the 100 pounds per square inch required. Later in the program, it was realized that the room-temperature strength is the controlling factor in the selection of the density. Since a temperature gradient from near room temperature to -423° F exists in the foam when storing liquid hydrogen, local yielding would occur first in the foam at the highest temperature (that is on the outer surface). For the 4-pounds-per-cubic-foot foam, yielding would occur when a pressure of just 70 pounds per square inch is exerted.

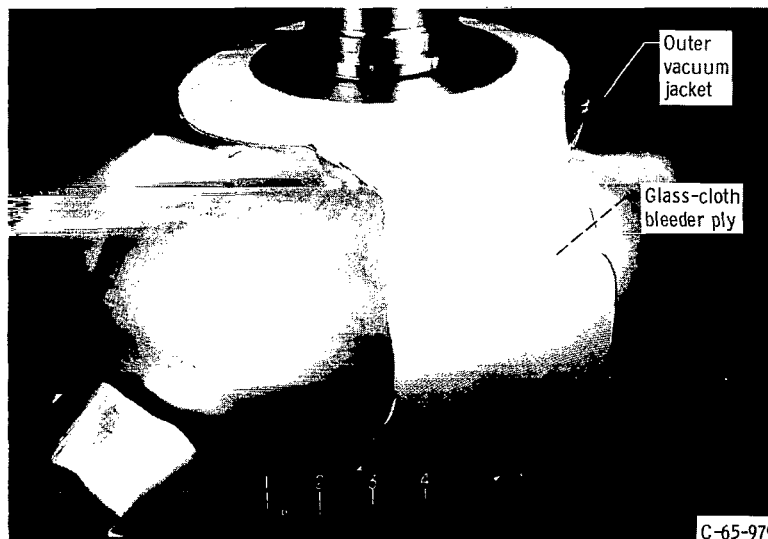
Figure 5. - Top dome insulation (outer vacuum jacket peeled away to expose bleeder ply).

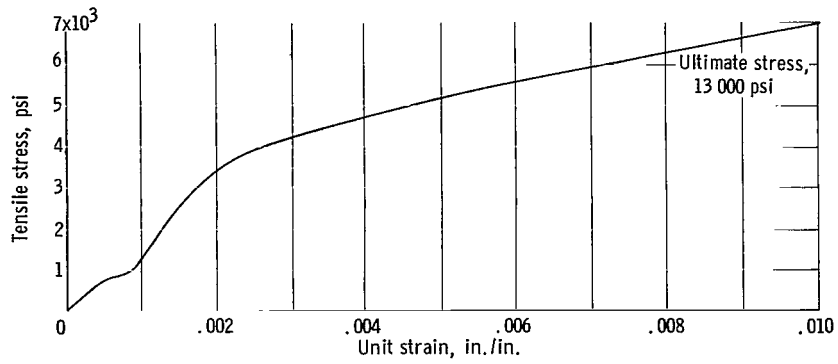
Figure 6. - Room-temperature stress-strain curve for AMA laminate (0.0007 in. aluminum, 0.001 in. Mylar 0.0007 in. aluminum).

A materials-testing program was undertaken to determine the properties of the AMA laminates. Tests were conducted at both room temperature and -300° F. Table I shows the results of these tests. Figures 6 through 9 are typical stress-strain curves recorded during the tests. Figure 6 is a curve of a room-temperature tensile test of the AMA laminate. It should be noted that this curve does not exhibit a yield point but, yields gradually rather than abruptly. When the same test is run at -300° F (fig. 7), the curve shape is the same but the stress values are nearly twice as high for the same strain. It is obvious that a strain of 0.0115 inch per inch is much beyond the elastic limit of this material. Thus, when this material is used as a liner it will be oversized after the first pressure cycle and wrinkles will occur.

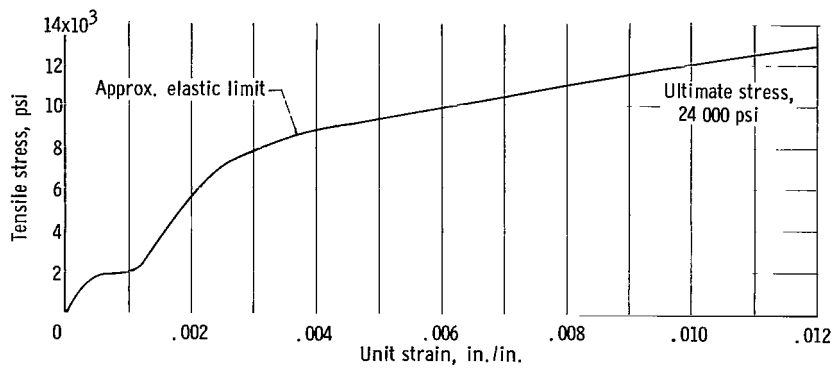
Figure 7. - -300°F stress-strain curve for AMA laminate (0.0007 in. aluminum, 0.001 in. Mylar, 0.0007 in. aluminum).

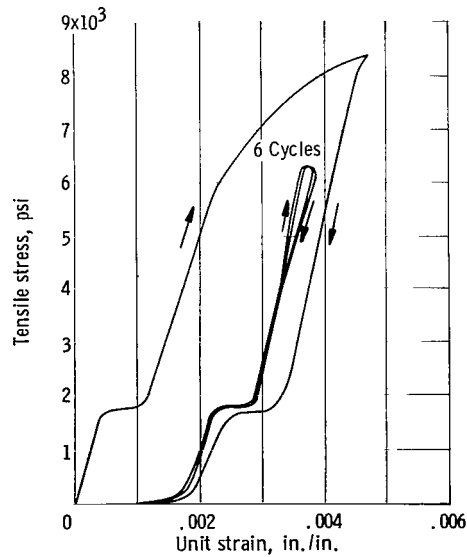
Figure 8. - Stress-strain curve of AMA laminate showing six loading cycles after an initial stress of 8300 pounds per square inch. Temperature, -300°F .

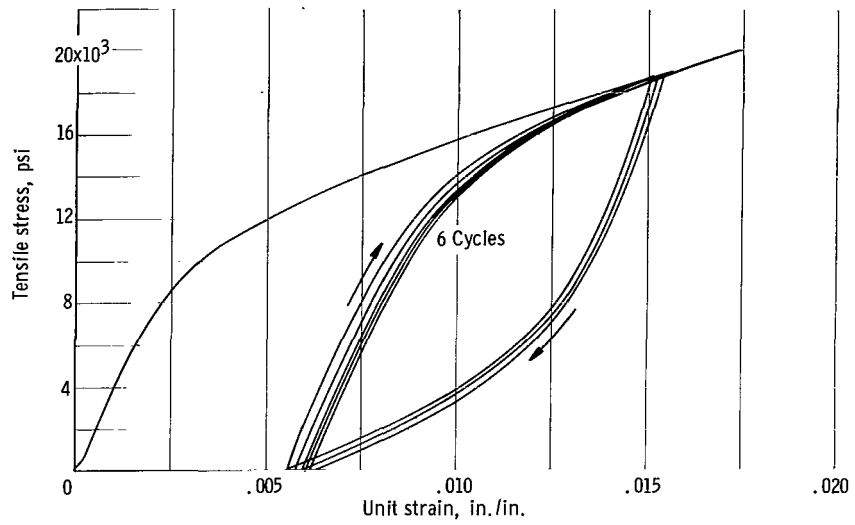
Figure 9. - Stress-strain curve for prestressed (10 040 psi at room temperature) AMA laminate at -300° F.

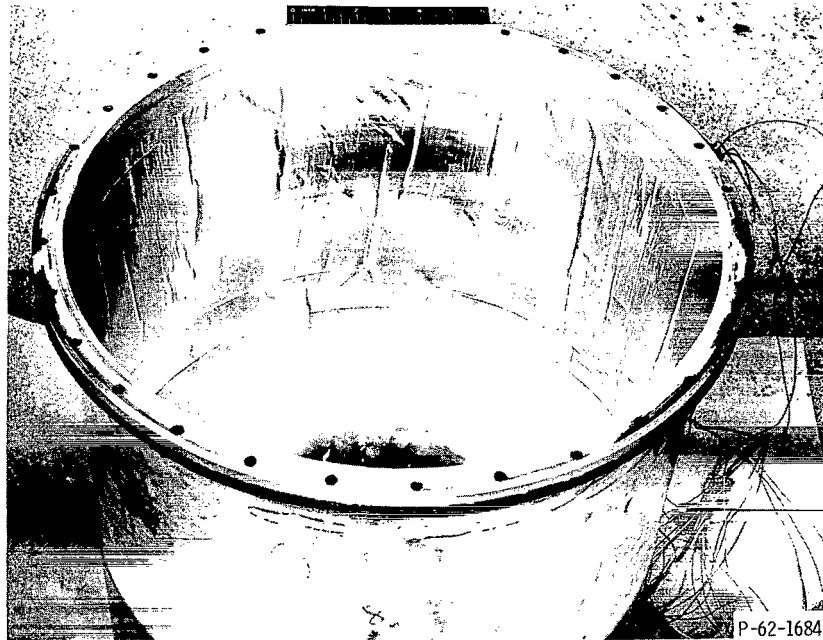
Figure 10. - Uninsulated filament-wound tank with test liner wrinkles after two temperature and pressure cycles.

Prior to fabrication of the test tank, uninsulated but lined filament-wound tanks, similar in geometry to the test tank, were pressure cycled with liquid hydrogen in a vacuum chamber to check the reliability of the adhesive joints with respect to maintaining a seal. The liner shown in figure 10 has gone through two temperature and pressure cycles. After some initial failures a reliable leak-tight adhesive bond was achieved. However, it was decided that some method of reducing the size of the wrinkles in the liner must be found or the resulting sharp creases formed upon repressurization would cause leaks or even breaks. If the liner material is stressed beyond its elastic limit, subsequent loadings to a lower stress produce no further permanent set. This can be seen in figure 8 where the AMA laminate was first stressed to 8300 pounds per square inch and then cycled from 0 to 6250 pounds per square inch six times. It was decided to fabricate the liner and vacuum jackets from 25-pound-per-inch-load (10 040 psi) prestretched AMA laminate to keep the permanent set and, therefore, the wrinkles to a minimum. Figure 9 shows a cycling test of this prestretched material at a temperature of -300° F and a strain of 0.015 inch per inch. It should be noted that most of the strain is within the elastic range. Even with this prestressed material some permanent set was expected when it was used in the test tank. But, it was felt that the bond between the foam insulation and the inner vacuum jacket would stabilize the wrinkles that would occur thus preventing the formation of sharp creases.

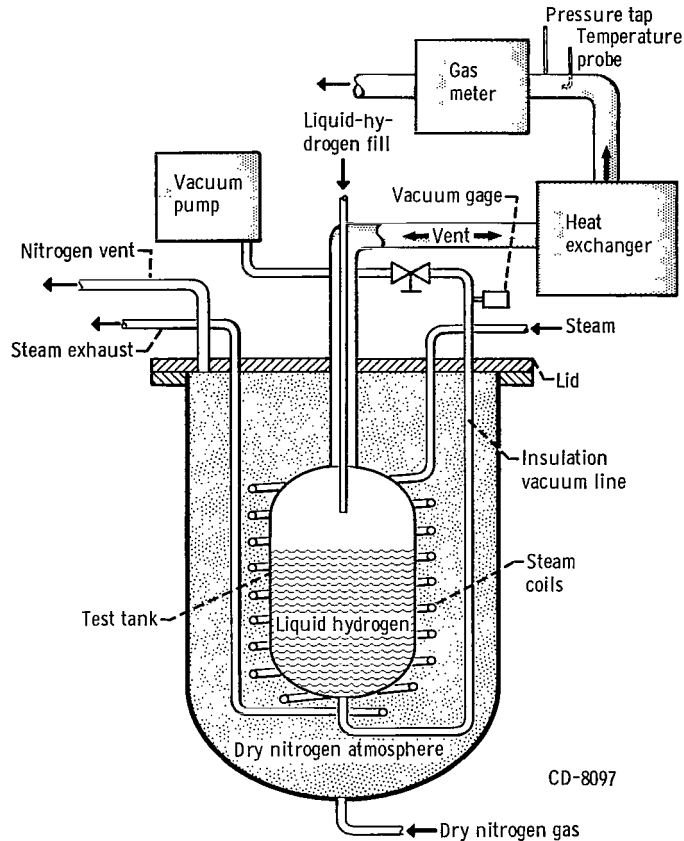
Figure 11. - Controlled-environment test facility.

An insulation vacuum line ran from the bottom of the test tank through the lid to a vacuum gage and pump. The insulation was valved off and not pumped on when the tank was being tested. Thermal performance tests were run with insulation vacuums ranging from 5 to 250×10^{-3} torr. Copper-constantan thermocouples with a liquid-nitrogen reference temperature were used to measure the outside surface temperatures of the tank wall.

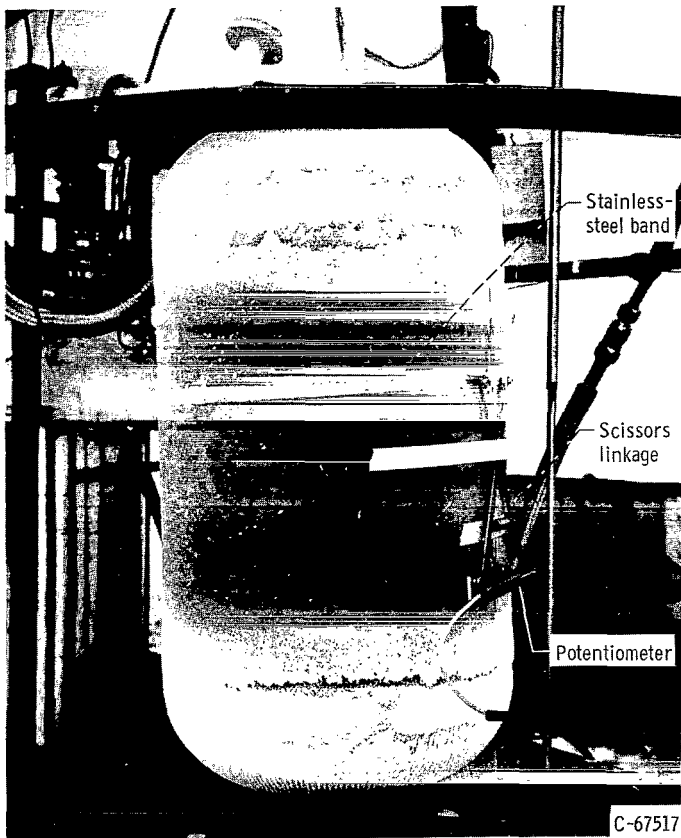
Figure 12. - Strain-gage equipped tank in outdoor test facility.

(2) The occasional breakaway of an area of frost and changes in wind velocity cause a scatter in boiloff data which makes the determination of thermal conductivity more unreliable. Figure 12 shows the frost formation on the tank during a test. Note the areas of frost that have fallen off and that frost only occurs in the vicinity of the heat shorts; that is, the intersections of the the domes with the cylinder.

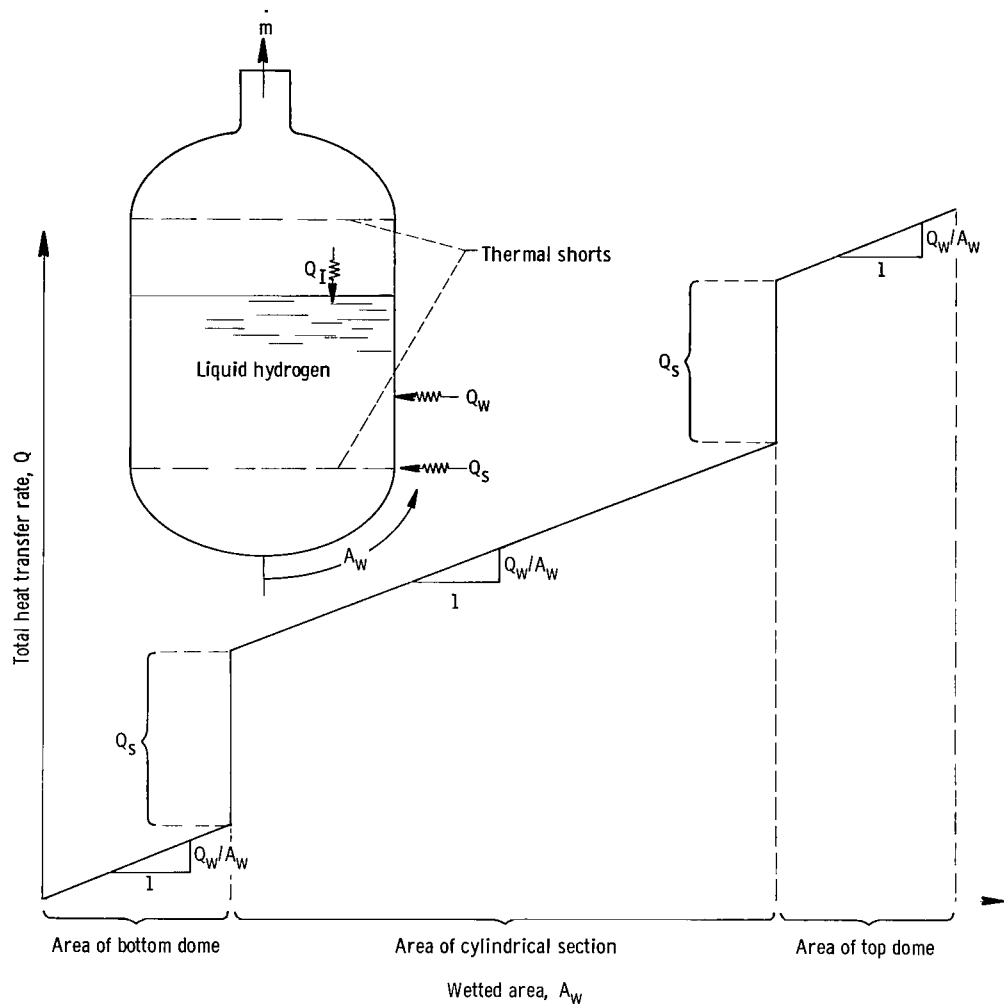
Figure 13. - Idealized curve of heat-transfer rate and wetted area for a liquid-hydrogen tank.

Figure 13 shows an idealized curve of Q against A_W . It is possible to use the slope of either of the dome sections or the cylindrical section to obtain the heat flux. The wetted area of the bottom dome is not shown on the data plots because of the more complicated geometry of the dome sections, the heavier liner in this section (excessive deviation from one-dimensional heat transfer), and the nearness of a heat short. The axis of the data plots was shifted to the right so that the wetted area of the bottom dome was eliminated. Since the heat-transfer rate through the bottom dome is assumed to be constant, the dome area can be eliminated without effecting the result, the slope of the Q against A_W plot. Thus, the heat flux is determined only for the cylindrical section which is by far the largest section of the tank.

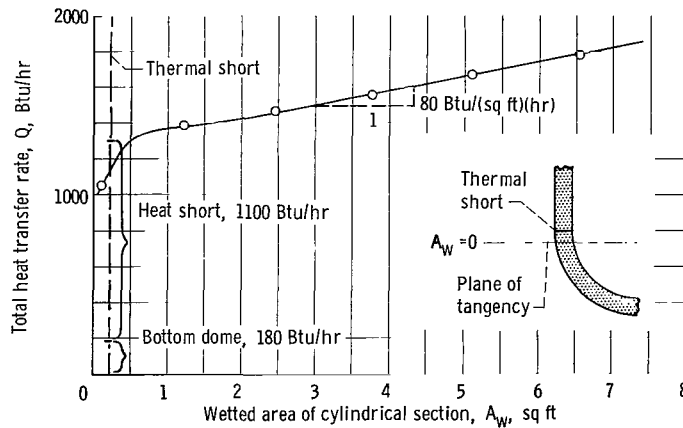
Figure 14. - Variation of total heat-transfer rate with wetted area for liquid-hydrogen test tank in an atmosphere of dry nitrogen at 65° F. Thermal conductivity of insulation, 0.094 (Btu)(in.)/(hr)(sq ft)(°F).

The results of three boiloff tests are shown in figures 14, 15, and 16 where the heat-transfer rate is plotted against the wetted area of the cylindrical section of the tank. The two runs in the controlled-environment facility (figs. 14 and 15) resulted in an average thermal conductivity of $0.096 \text{ (Btu)(in.)}/(\text{hr})(\text{sq ft})(^\circ\text{F})$.

As shown in figures 14, 15, and 16, there is a large heat short at the intersection of the bottom dome and the cylindrical section of the insulation. This heat short is caused by the heavy AMA laminate used on the edge of each insulation section (see fig. 1(d), p. 5). The heat short was calculated to be 1050 Btu per hour, while the value, determined by extrapolating the curve (see figs. 14 to 16) and assuming the heat flux through the bottom dome the same as in the cylindrical section, varied from 1000 to 1340 Btu per hour, depending on ambient conditions. At 75 percent of tank capacity more than 50 percent of the heat transfer was due to this heat short. Calculations show that if Mylar were used instead of the AMA laminate to seal the edges of the insulation sections, the heat short to the liquid would be reduced to approximately 1 Btu per hour.

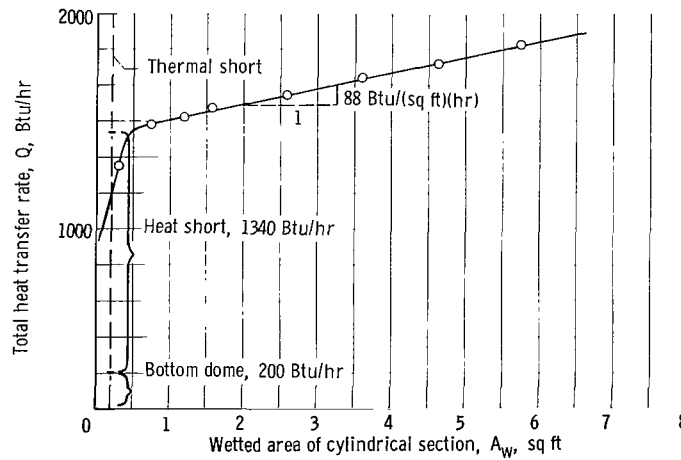
Figure 15. - Variation of total heat-transfer rate with wetted area for liquid-hydrogen test tank in an atmosphere of dry nitrogen at 85° F. Thermal conductivity of insulation, 0.097 (Btu)(in.)/(hr)(sq ft)(°F).

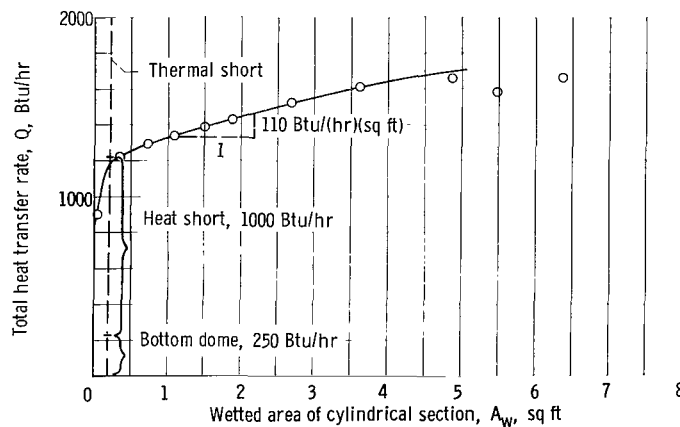
Figure 16. - Variation of total heat-transfer rate with wetted area for liquid-hydrogen tank in outdoor test. Temperature, 60° F, wind speed 17 mph, dew point, 45° F; thermal conductivity of insulation 0.117 (Btu)(in.)/(hr)(sq ft)(°F).

The outdoor run (fig. 16) yielded a thermal conductivity K of $0.117 \text{ (Btu)(in.)}/(\text{hr})(\text{sq ft})(^\circ\text{F})$ which is about 15 percent higher than the runs in the controlled environment. It is felt that this value is not as accurate as those obtained from the runs in the controlled environment for the following reasons:

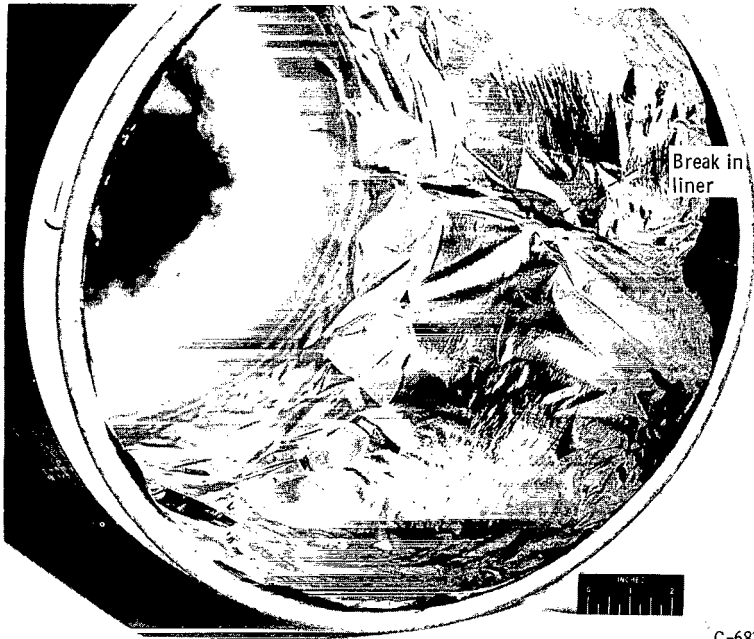
Figure 17. - Inside of tank (showing failure in liner).

Liner failure occurred suddenly with a longitudinal break in the cylindrical section of the tank (see fig. 17). Figure 18 shows the brittle fracture of the Mylar in the liner. Both the liner and the inner vacuum jacket failed at the same place. It should be noted that, even though the liner was highly stressed, all adhesive joints remained leak-tight. Upon examination of the inner vacuum jacket it was discovered that the break occurred along the butt joint of the glass-cloth bleeder ply (see fig. 19). Since the glass-cloth reinforced the vacuum jacket everywhere but at the butt joint where the cloth ends were not spliced, this was the area of highest stress. Instead of the inner vacuum jacket uniformly straining along the entire circumference, most of the expansion occurred over the very small length of this maximum stress area. Thus, the local unit strain was many times higher than it would have been for a uniformly strained material. It is probably the vacuum-jacket failure that initiated the failure in the liner at the same location. It is possible that this failure could have been prevented if the ends of the glass cloth were spliced at the butt joint with a bonded glass-cloth tape.

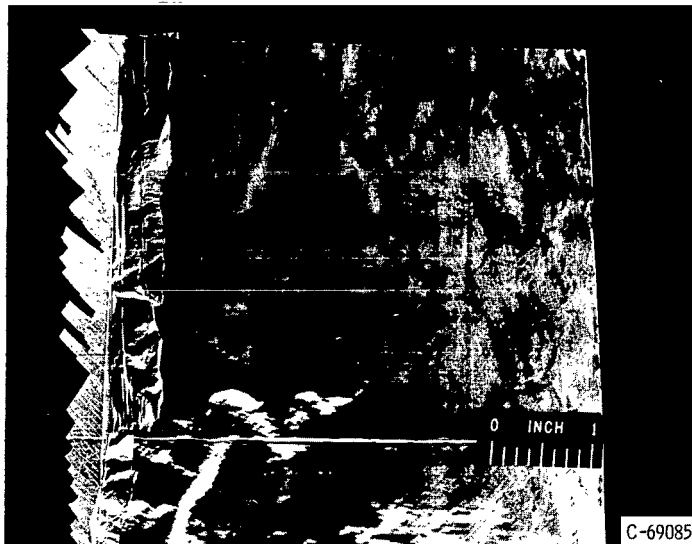
Figure 18. - Section of liner material at break.

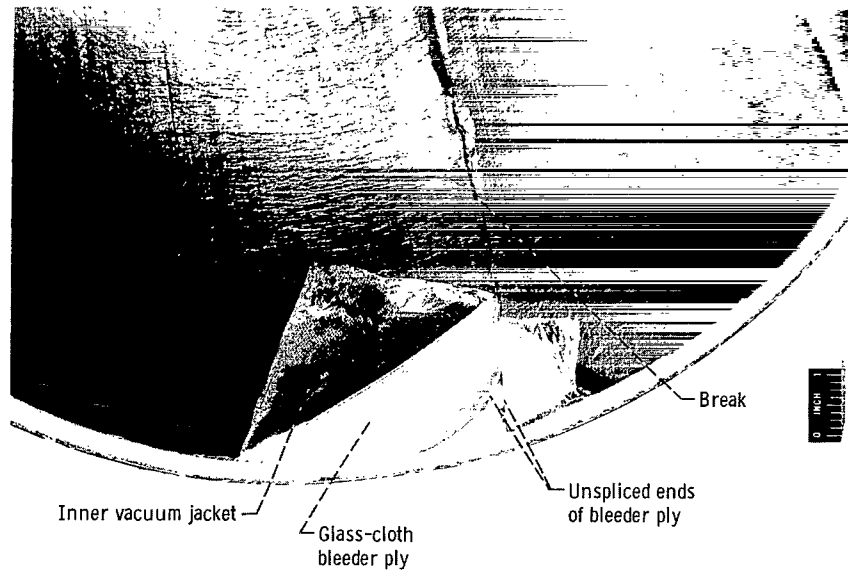
Figure 19. - Failure in inner vacuum jacket (liner removed from tank).

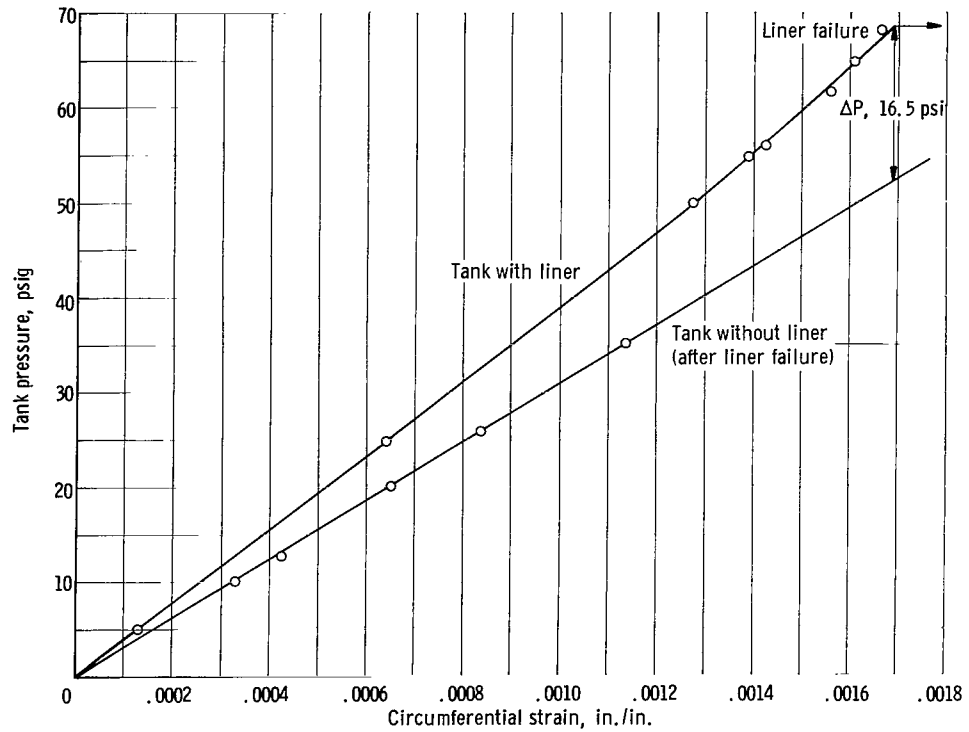
Figure 20. - Effect of liner failure on circumferential strain of tank wall.

The circumferential strain of the fiber-glass shell was measured during pressure tests of this tank both before and after liner failure. Figure 20 shows a plot of this strain against internal tank pressure. When failure occurred at 68.4 pounds per square inch gage, the release of the load carried by the liner and vacuum jacket resulted in increased load on a corresponding strain in the fiber-glass shell. Since the strain at failure, 0.0017 inch per inch, results from a load of only 51.9 pounds per square inch gage after failure, the difference between 68.4 and 51.9 pounds per square inch gage was assumed to be the load the liner and vacuum jacket were taking. Thus, the liner and jacket were taking an internal pressure load of 16.5 pounds per square inch and correspondingly stressed to 29 000 pounds per square inch at failure. This is an increase in tensile strength from the 25 000 pounds per square inch at -300° F listed in table I. The 51.9 pounds per square inch gage carried by the fiber-glass shell results in a composite wall stress of 12 000 pounds per square inch, well below its ultimate of 120 000 pounds per square inch.

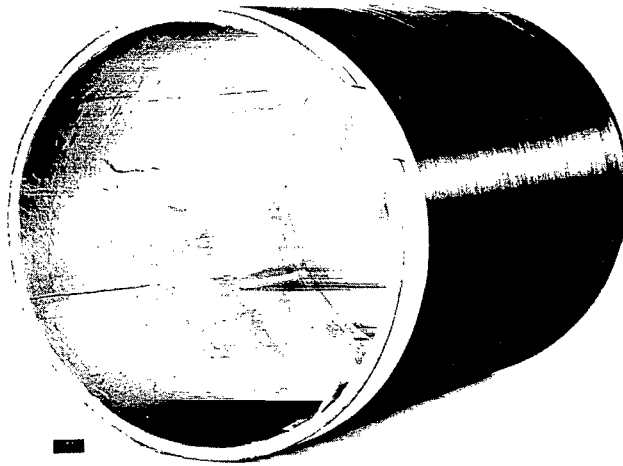
Figure 21. - Inner vacuum jacket after testing.

Final examination of the tank revealed the existence of wrinkles indicating the liner and inner vacuum jacket material has been stressed beyond its elastic limit and thus has taken a permanent set in spite of prestressing the AMA laminate. It was found that the wrinkles in the vacuum jacket (see fig. 21) are not sharply creased as in the preliminary liner tests but rather they are rounded and not likely to be leak sources. It appears that the glass cloth and foam help stabilize the wrinkles and prevent the formation of sharp creases.
