REPORT NO. 55E 799  
DATE 19 JULY 1963  
NO. OF PAGES 57  
N.A.S. NO. ZXL-63-015

DATA FOR THE DETERMINATION OF ALLOWABLE  
BURST STRESSES FOR THIN-WALLED  
CYLINDRICAL PRESSURE VESSELS

REPORT NO. 55E 799

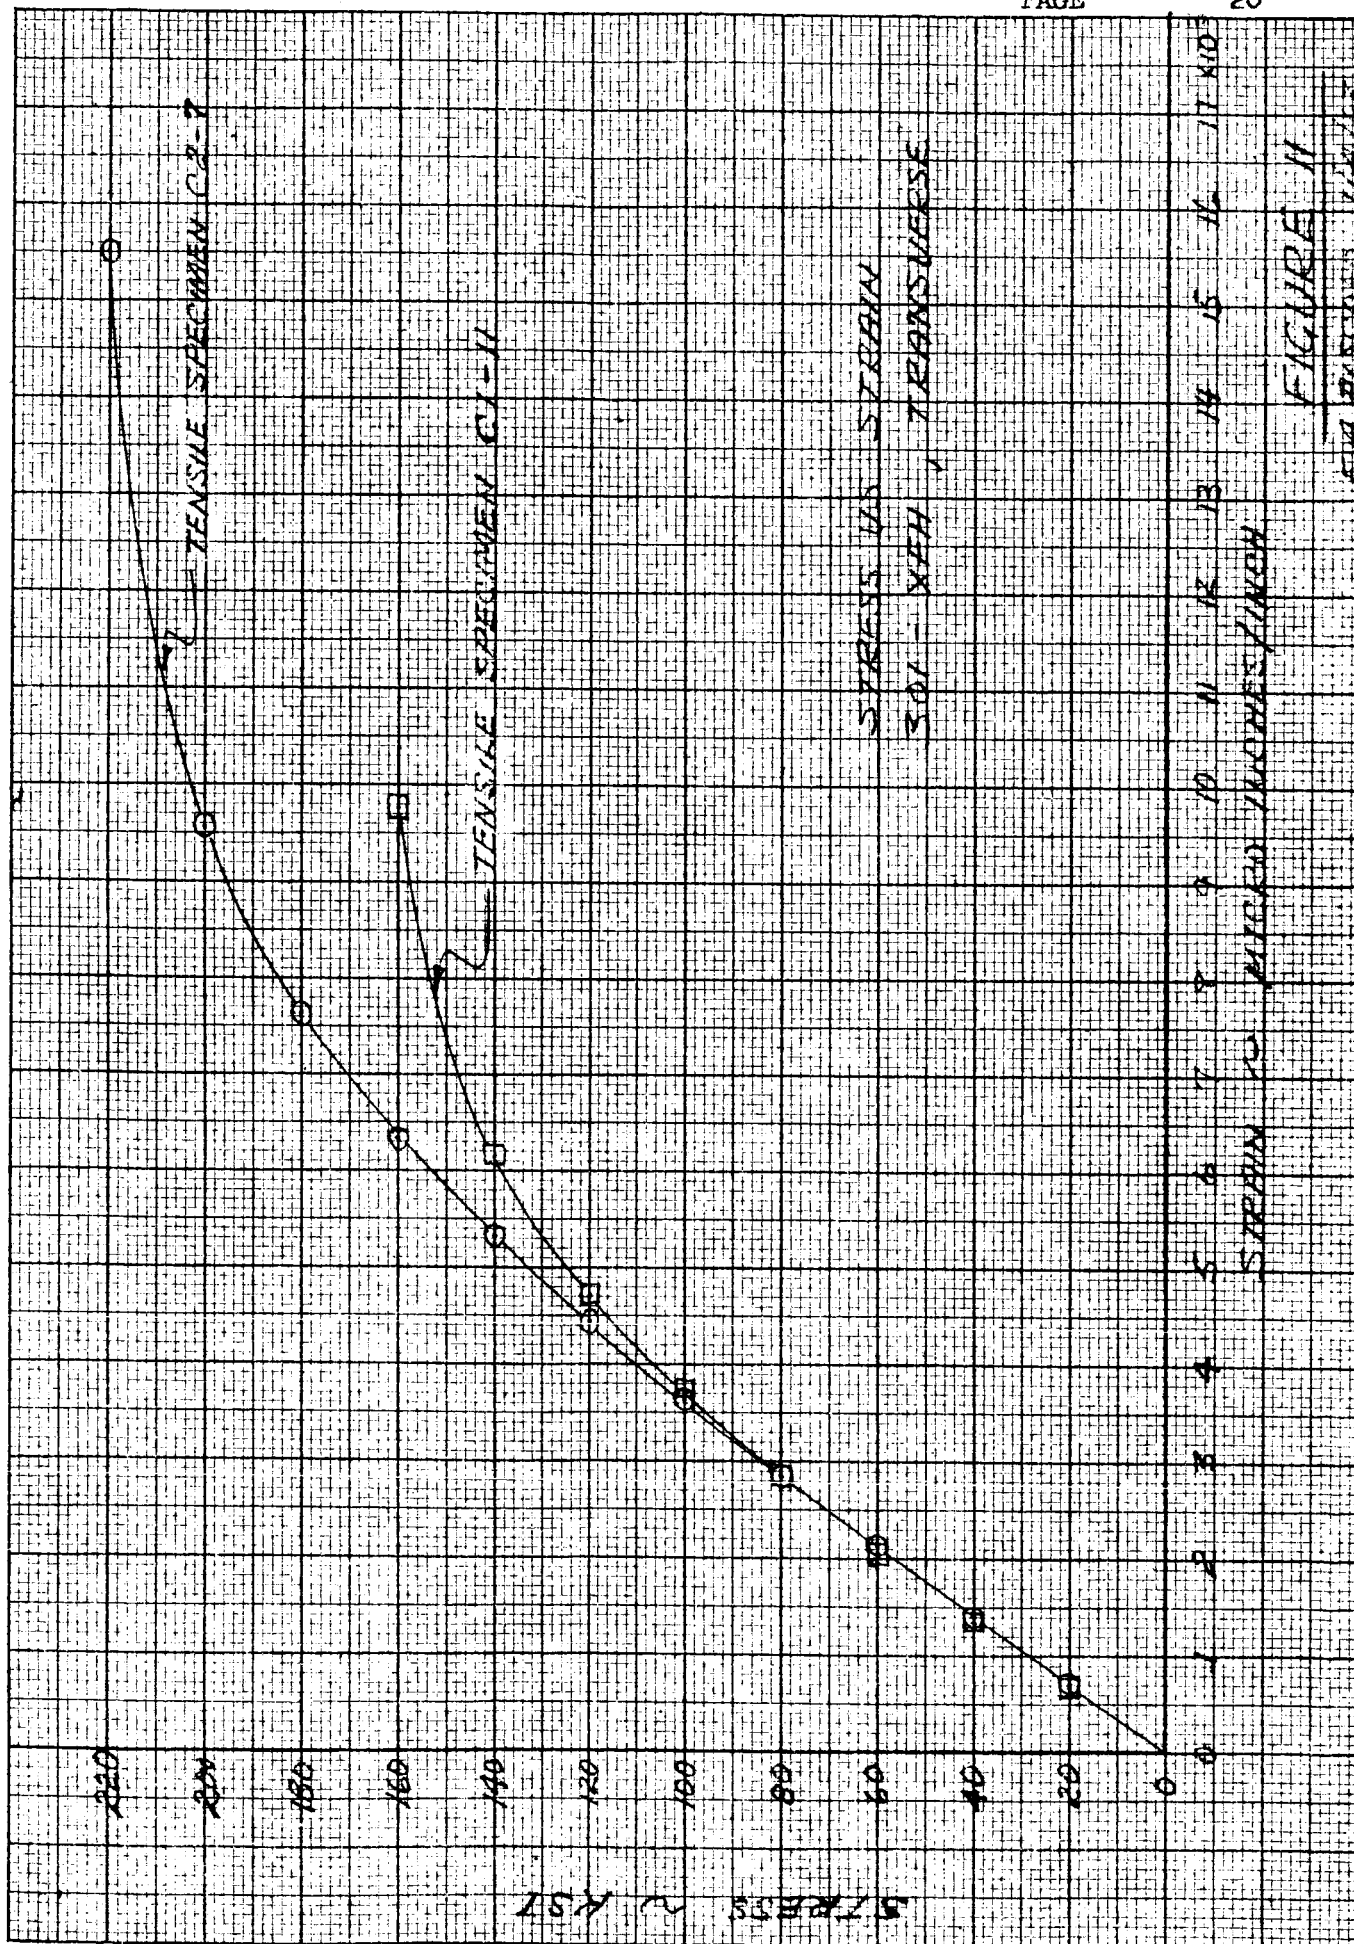
FIGURE 11

- c. Percentage difference between material uniaxial rupture stress and specimen hoop rupture stress (based on final radius and original thickness).
8. Figure 10 through 15 present stress-strain curves for longitudinal and transverse grain directions of the tensile control specimens. Data from which these curves were drawn were obtained from the specimens instrumented with strain gages (two specimens for each grain direction).
