# EFFECT OF NUCLEAR RADIATION ON MATERIALS AT CRYOGENIC TEMPERATURES

LOCKHEED NUCLEAR PRODUCTS

QUARTERLY REPORT NO. 2

October 21, 1965 Through January 21, 1966

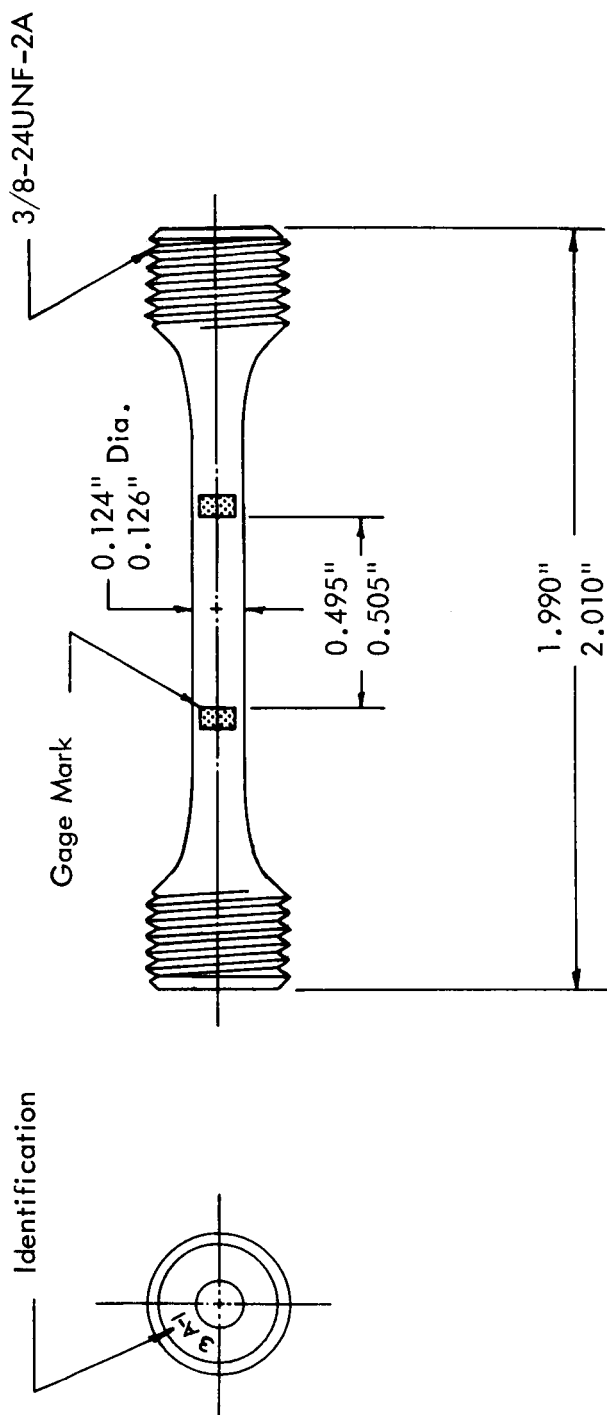
FIGURE 19 TENSILE SPECIMEN

Note: Diameter at gage marks shall be center diameter +  $0.002''$  +  $0.004''$ .

The tensile specimen shown in figure 19 and discussed in detail in reference 5, represents a miniaturization of the standard ASTM E-8 specimen (ref. 3). It is essentially a cylindrical tensile coupon two inches overall length, with threaded ends. The specimen gage length is 0.5 inch with a nominal diameter of 0.125 inch at the mid-point in the gage length, which conforms to the standard 4:1 gage length to diameter ratio. There is a slight taper to the mid-point of the gage length to insure fracture in that area.

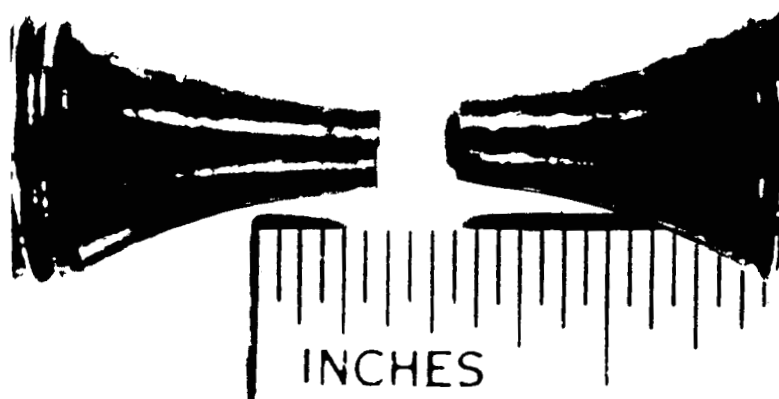
FIGURE 21 FAILED 18 Ni-300 LOW-CYCLE FATIGUE SPECIMEN

Side Elevation

View of Fracture  
(cup)

View of Fracture  
(cone)
