FINAL REPORT

DEVELOPMENT OF BRAZING PROCESSES
FOR PYROLYTIC GRAPHITE

Jet Propulsion Laboratories
4800 Oak Grove Drive
Pasadena, California

RDR-1453

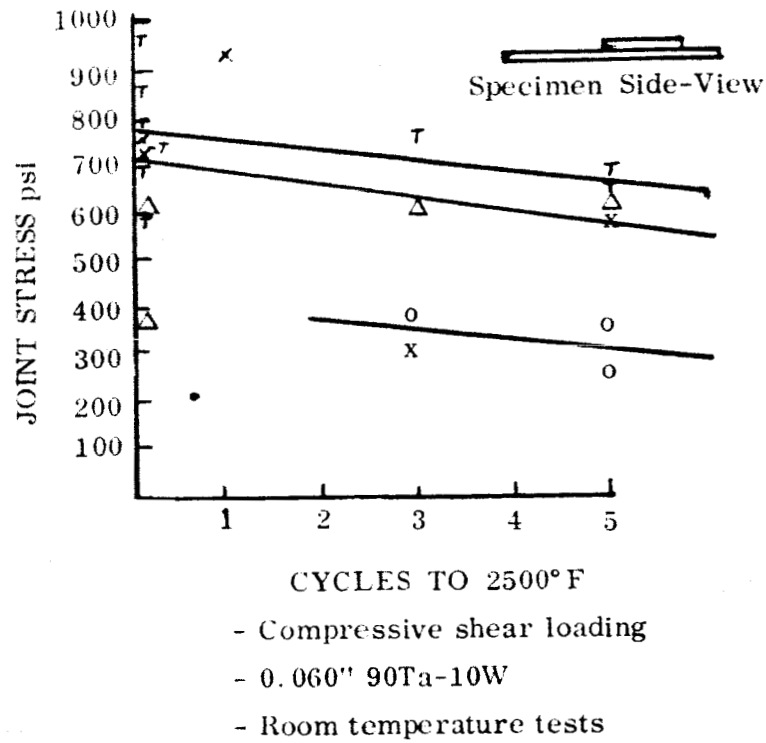
FIGURE 7. JOINT STRENGTH AFTER THERMAL CYCLING

Design A was used in an additional evaluation of braze alloys 2, 3, 4 and beta titanium. Room temperature strengths of joint determined in compressive shear are shown for beta titanium in Figure 6. The distribution of strength data as brazed is approximately Gaussian with an average strength of 770 psi. After 3 cycles to 2500° F the strength fell to 725 psi (single value) and to 650 psi (2 results) after five cycles. Figure 7 shows the effect of cycling on the other braze alloys compared with the line for beta titanium. Before making any decision on the elimination of braze alloys, remelt temperatures were determined under 30 lbs. load for these joints. The stress varied from 60-90 psi because of variations of area, but this could not be correlated with the stress. Temperature was raised until failure occurred leading to the results in Figure 8.

On the basis of loss of strength on cycling (Figure 7) and on the remelt temperatures (Figure 8), alloy 2 was dropped from the program. Alloys 3 and 4 in addition to beta titanium were carried forward into the next stage of evaluation on tubes.

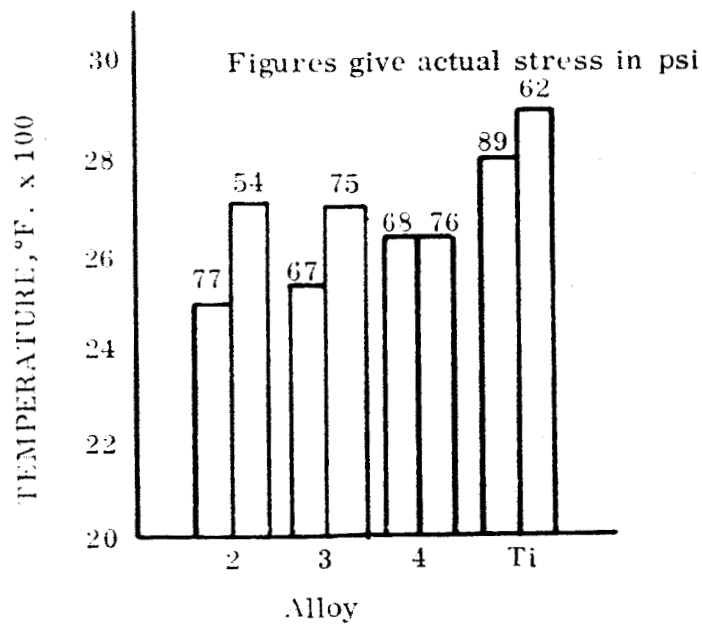
FIGURE 8. REMELT TEMPERATURES UNDER 30 POUNDS LOAD

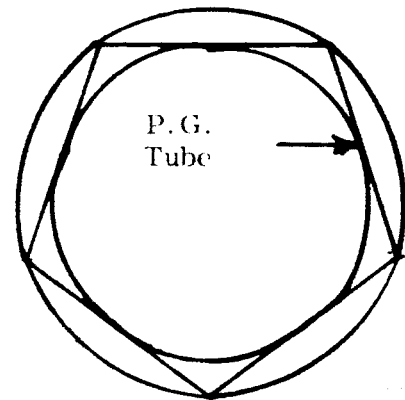
Five basic joint designs were proposed to solve the stress problem, and were included in Solar RDR 1457 dated January 6, 1965. These basic designs are shown in Figure 9 reproduced from RDR 1457, and can be described as:

1. Spiral
2. Corrugation
3. Scarf
4. Compression
5. Segmented scarf

The basic concept requires the metal tube to be on the outside. This is because the metal will shrink on to the pyrolytic graphite, placing the wall in compression normal to the basal planes. If the positions were reversed, the graphite would be in tension normal to the basal planes, leading to failure because of the low strength in tension in this direction.

The joint between the metallic member and the pyrolytic graphite must perform two functions. One is to provide a joint able to withstand the pressure within the thrust chamber, and the second is to prevent gas leakage. This dual solution was the basis for the compression joint (type D), where leakage might be tolerated in the joint because a flexible member could be added to provide a gas seal. Type B includes a multiple seal using a flexible foil, and Type E is based on the modified values of expansion coefficient on a scarf, but might require a gas seal. The straight scarf, type C, modifies the axial expansion on the joint line, but not the circumferential. It does provide a joint to all of the basal planes in the graphite so that load transmission should be aided. The spiral type A is based

FIGURE 9. PROPOSED BASIC JOINT DESIGNS

on some degree of flexibility in the joint, although the spiral must not be so short in the radial direction that it acts as a stiff column.

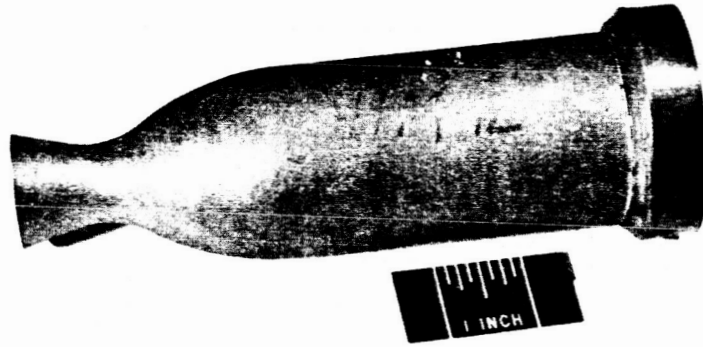
It was noted that the quality of the pyrolytic graphite chambers did not seem equal to the quality of the two-inch tubes used in earlier studies. Figure 15 compares the chambers and tubes. More work was done on the two inch tubes, therefore.

FIGURE 15. COMPARISON OF PYROLYTIC GRAPHITE CHAMBER AND TUBE SURFACES

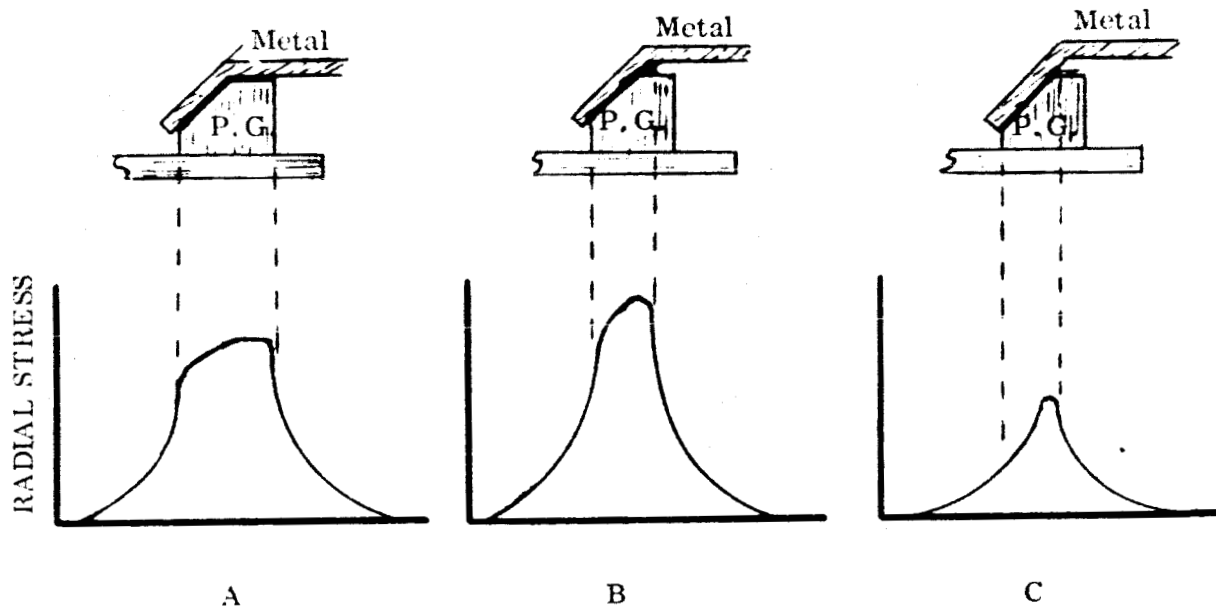
FIGURE 16. SCHEMATIC STRESS PATTERN
